Creekmore Cabin
Elkmont Historic District
Great Smoky Mountains National Park
Historic Structure Report

September 2014

Historic Structure Report

Creekmore Cabin
LCS#: 264273

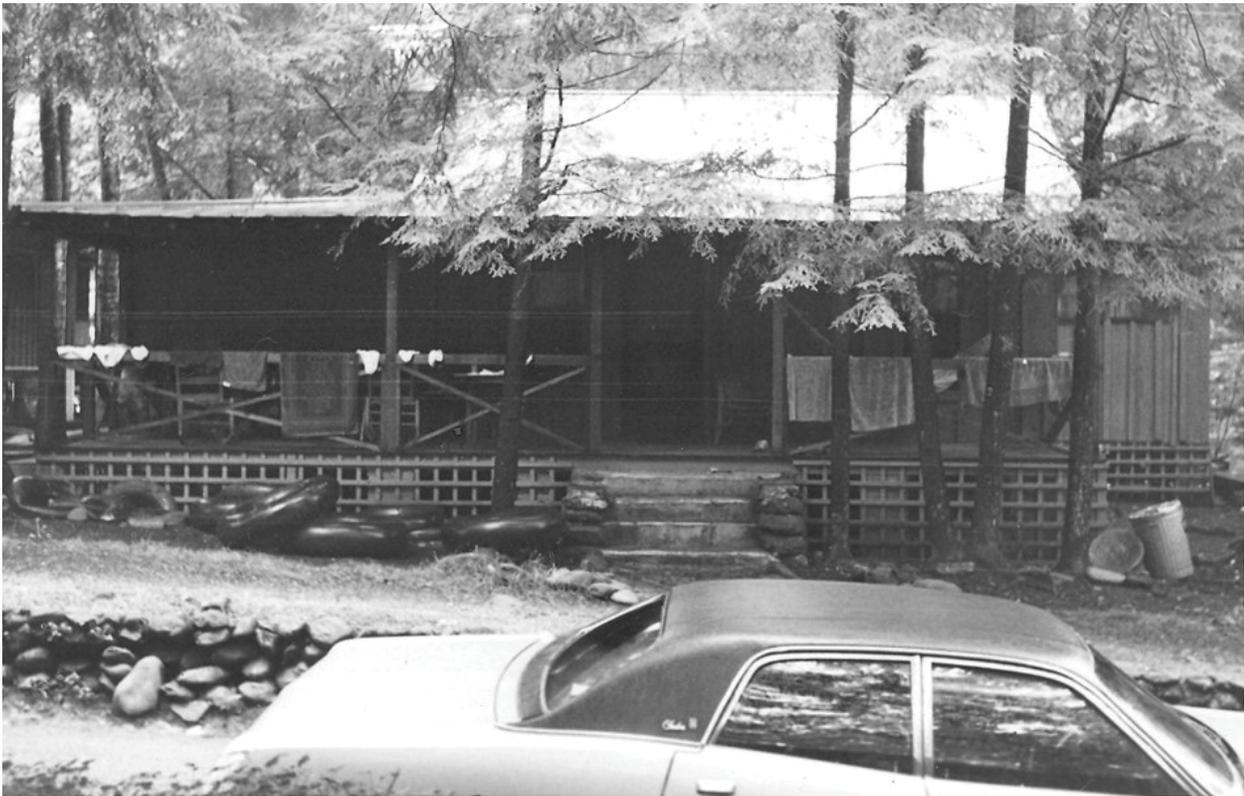
Figure 33. Character-defining rustic elements were removed and replaced in the 1980s when the house was still in use. Wet towels hung on the railings and a pile of innertubes point to a day at the river. (Family collection)

A major design change was made to the front of the cabin in the 1980s, perhaps when the south porch was enclosed. The front porch was rebuilt. Deck boards were replaced and the character-defining rustic elements were removed: the bark-peeled posts, railings, and diagonal branches. New posts and railings replaced them. The new porch did not attempt to replicate the old; posts are standard 4x4s, the railings and x-braces 2x4s (*Fig. 34*).

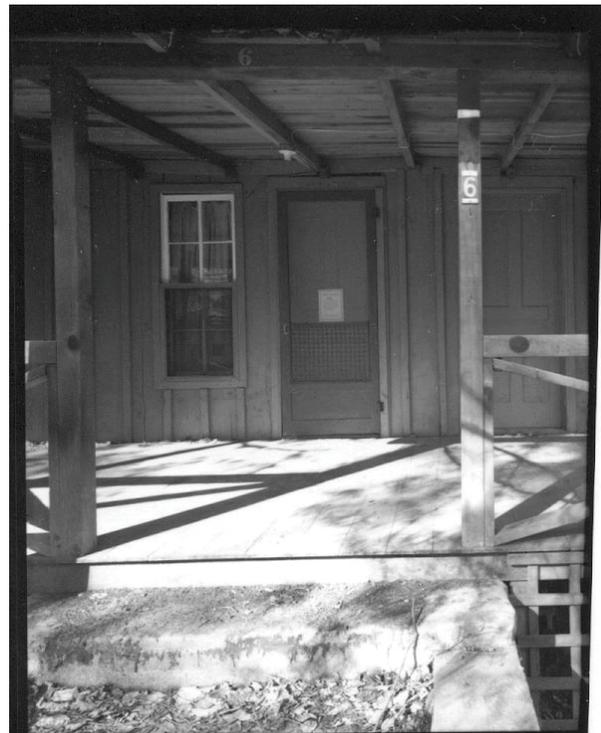
Figure 35. Gutter above entrance bay of front porch. Note the house number 6 above the entrance, and another on the north post of that bay. (HABS-250-G-11)

Documentary photographs taken by the Historic American Buildings Survey (HABS) in 2001 show gutters in four places at that time. They have since fallen or been removed. On the porch, gutters were in place above the entrance bay and along the roof's south sloping edge. This south gutter ran the length of the south side of the house (*Fig. 35*).

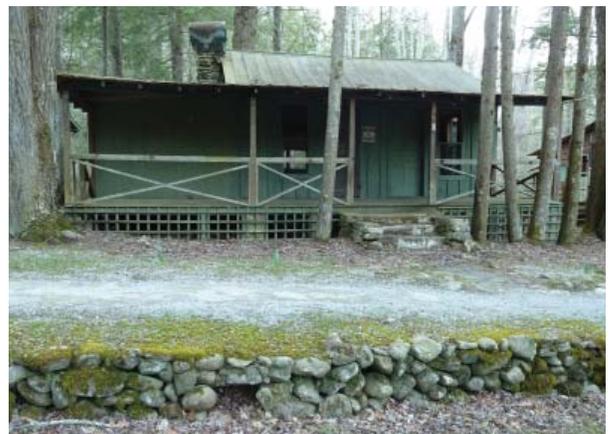
Retaining walls built of mortared stacks of local river stone run north-south along both sides of Jakes Creek Road through much of the northern end of the Appalachian Club Complex. The retaining wall in front of Creekmore Cabin has deteriorated in some locations. On the west side of Daisy Town Road, a few feet beyond the retaining wall and about two feet above the roadbed,

Figure 37. River stone retaining wall and gravel walkway in front of Creekmore Cabin.

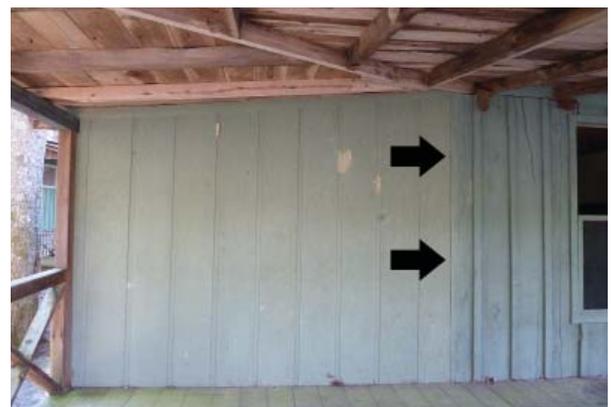
Figure 44. Seam in cladding of east elevation.

and-batten siding, clearly delineates the east expansion from the original main block.

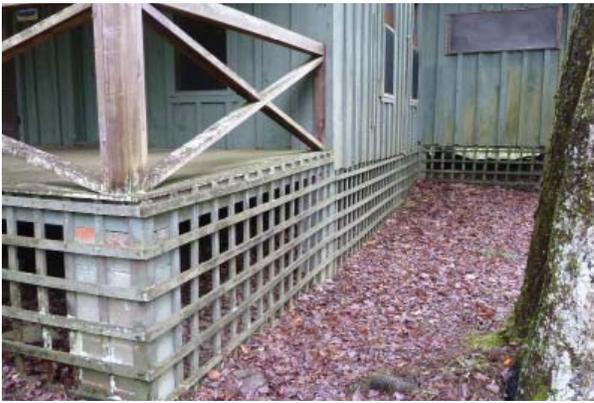
Figure 46. Lattice grid at foundation.

end of the front porch (Fig. 46). At the south elevation, only remnants of the vertical wood strips remain. The increasingly taller foundation supports of the west rooms are exposed as the grade slopes steeply to Jakes Creek to the south, and are easily accessed.

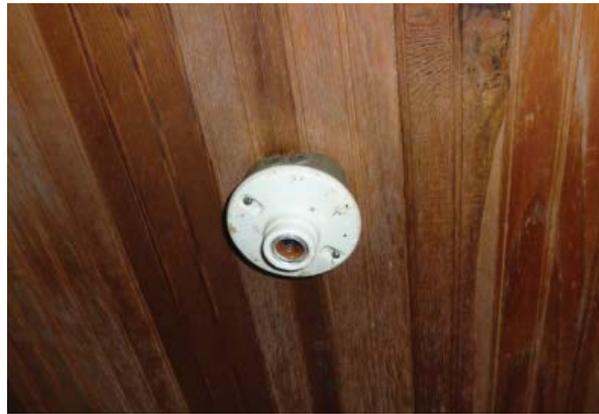
Figure 49. Typical ceramic lamp base mounted on ceiling.

The present electrical distribution system is a mix of vintage mid-twentieth-century non-grounded, cloth-wrapped insulated cable together with late-twentieth-century vinyl-wrapped cable. Elsewhere is a mix of mid- and late-twentieth-century in-wall and surface-mounted receptacles and switches. Ceiling-mounted ceramic lamp bases are used in many rooms of the cabin (*Fig. 49*).

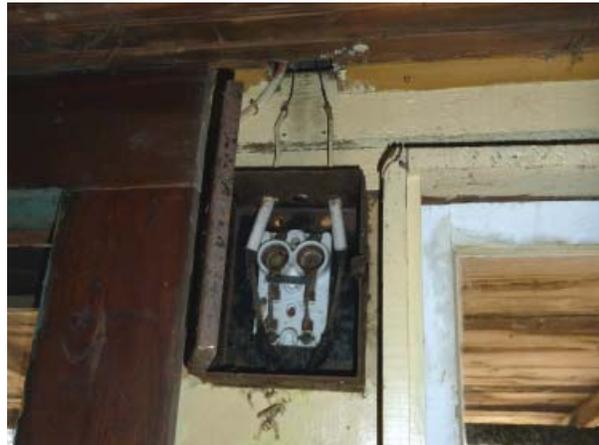
Figure 50. Early fuse box with ceramic tubes in Living Room (Room 102).

An early fuse box with two ceramic tubes remains intact on the east wall of the Living Room (Room 102) just south of the main entry door (*Fig. 50*). A more modern electrical panel with 120 volts and 70 amps is mounted to the east wall of the Kitchen (Room 108) at the rear of the cabin.

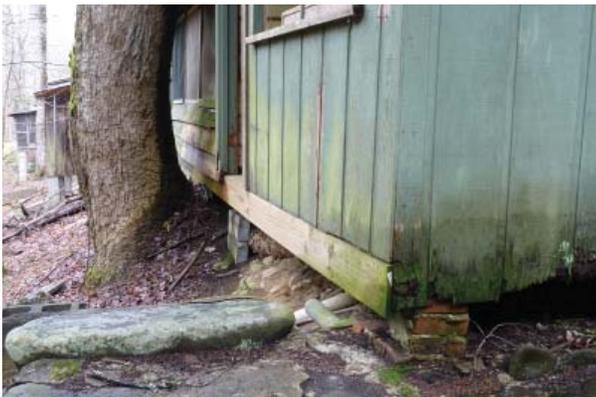
Near the south end of the west elevation are partially collapsed CMU piers that once supported a wood deck. The deck is no longer intact, but

Figure 55. Southwest corner of cabin, location of collapsed deck.

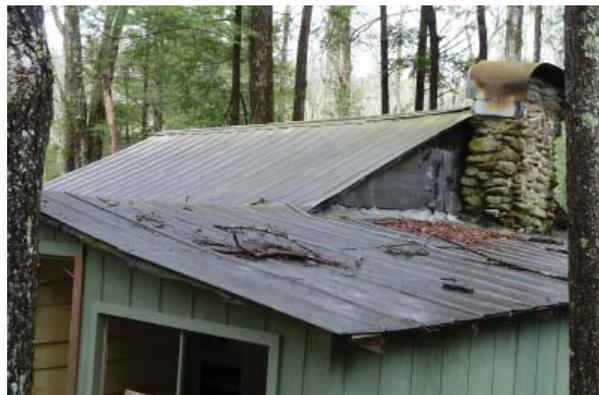
Figure 57. Metal roof of main block and south extension.

The roof remains a serious threat. The unpainted, galvanized 5-V metal roofing has leaks in various locations and has caused visible damage on the interior of the rooms, particularly the ceilings. The low roof pitch and shallow overhangs at the edges exacerbates the problem of water infiltration. In addition to water damage, there are some concerns about the structural integrity of some roof additions, particularly in the Northwest Bedroom (Room 105). Modern shoring has been installed in this room and in the Living Room Extension (Room 101) to help support the shed roofs. The top plates of the front (east) porch that support the roof rafters appear to be sagging and may benefit from additional support.

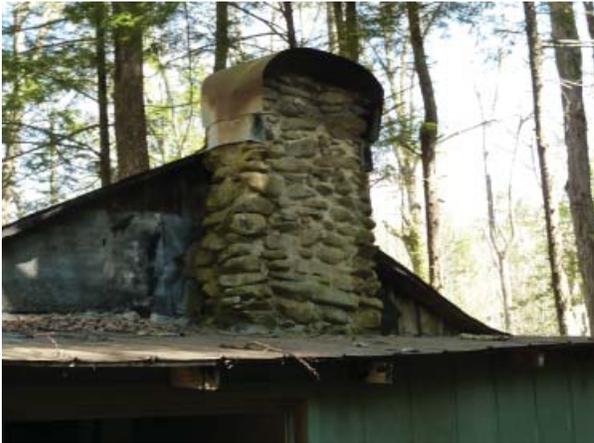
The river stone chimney centered on the south side of the gable roof is not the original chimney. The chimney has a folded tin cap and the ends are covered in bailing wire (Fig. 58).

Figure 58. River stone chimney with tin cap.

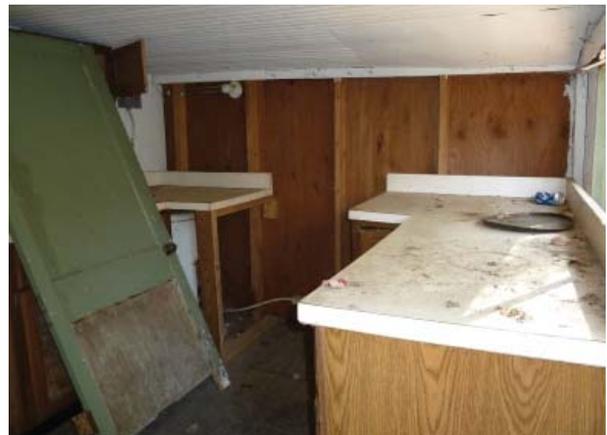
Figure 61. Back door stored in the Kitchen (Room 108).

The west elevation doorway does not have a door installed. Its 1920s-era two-panel door, which measures 2'-5" wide by 6'-3" tall by 1⅜" thick, is damaged with a missing bottom rail and sits in the Kitchen (Room 108). The door hardware includes two 3½" by 3½" brass-plated five-knuckle hinges and modern brass knobs.

The exterior doorway in the west wall does not have its two-panel wood door intact. The door is stored inside the Kitchen (Room 108) and is described in the *Exterior Features* section above (Fig. 61). On the interior, the door surround is made up of various pieces of scrap wood. The north wall doorway provides access to the Dining Room (Room 107) and has a missing door.

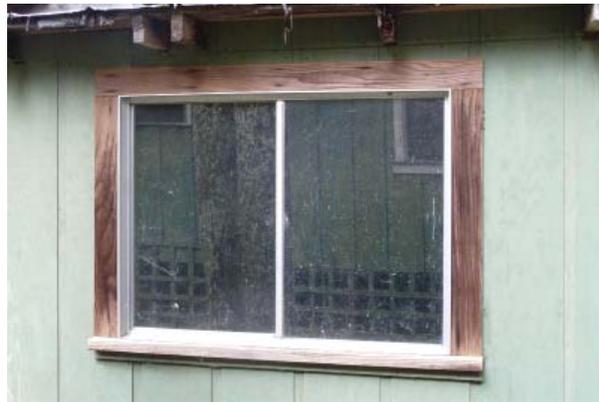
Figure 64. Modern aluminum window on the south elevation.

The two windows on the south elevation are unique to the cabin. The east one is a modern two-light aluminum sash window that slides horizontally (*Fig. 64*). It measures 4'-0" wide by 3'-0" tall and has a $\frac{3}{4}$ " by 4" plank board casing on the exterior that is lintel cut. The sill is part of a 2" by 4" wood board and below the sill is a $\frac{3}{4}$ " by 1 $\frac{1}{2}$ " plank board. The west window on the south elevation is a 36-light fixed wood sash with decorative leaded glass panes, made by the original cabin owner (*Fig. 65*). The window opening measures 4'-6" wide by 1'-4" tall and has plank board casing that wraps all four side of the exterior. The casing measures $\frac{3}{4}$ " by $2\frac{3}{4}$ " and is lintel cut. Unfortunately, after documentation of the cabin by JKOA, this 36-light window was stolen in early 2014.

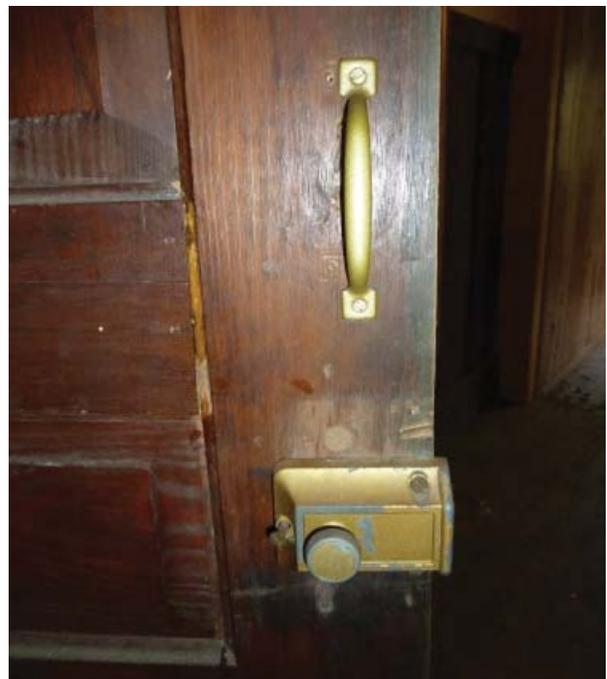
Figure 73. Hardware on the east exterior door.

The east door has its 3" by 4" rimlock intact, but it is missing from the west door (Fig. 73). The east door also has a 4" barrel bolt. The west doorway provides access to the Dining Room (Room 107) and has a board-and-batten door that measures 2'-8" wide by 6'-5" tall by ¾" thick. The boards and battens are made up of ¾" by 5¼" beaded boards that have a 3/16" bead. There are two 4" barrel hinges, a 3¼" by 3¾" rimlock, and a 4" barrel bolt intact on the door. There is another five-horizontal-panel wood door at the west end of the south wall that provides access to the Bathroom (Room 109). The door matches the ones on the north wall, measuring 2'-6" wide by 6'-5" tall by 1¼" thick, and has two 2½" by 2½" three-knuckle hinges. The rimlock is missing. The north, west, and south doors are cased on Room 102 side with wood plank boards that measure 7/8" by 5¾" and are lintel cut. The cased opening to the Living Room Extension (Room 101) at the east end of the south wall measures 5'-6" wide and has no door. It is cased on Room 102 side of the doorway with ¾" by 5½" plank boards.

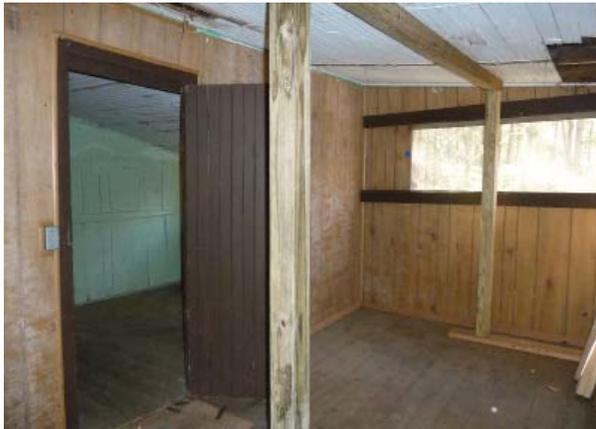
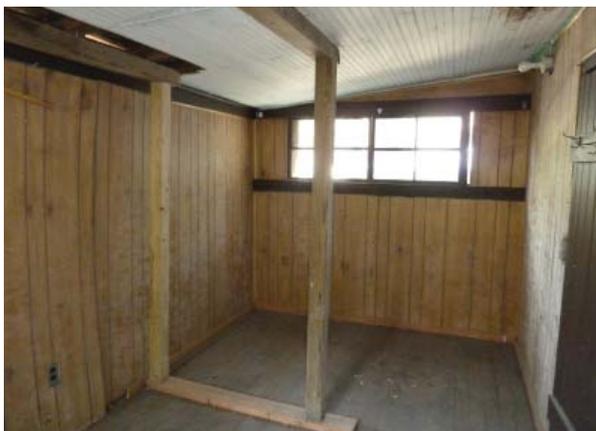
The walls are finished in modern wood-grained veneer paneling measuring 4' by 8' by 1/8" thick. The paneling is in poor condition and is delaminating from the wall surfaces exposing the earlier board-and-batten siding beneath.

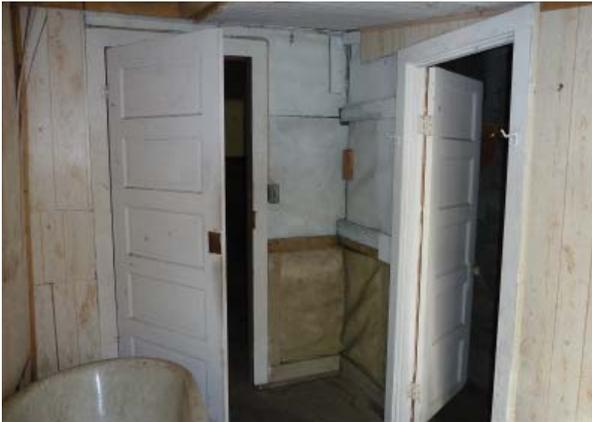
Figure 97. Northeast oblique of Bathroom (Room 109).

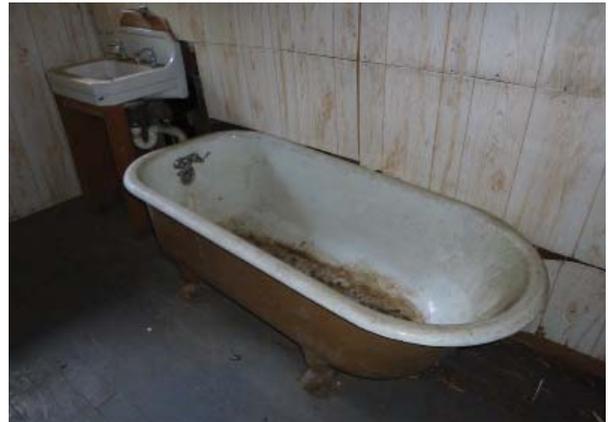
Figure 99. Clawfoot tub in Bathroom (Room 109).
