# Hale Cabin Elkmont Historic District Great Smoky Mountains National Park Historic Structure Report

# Historic Structure Report

March 2016

The Jaeger Company

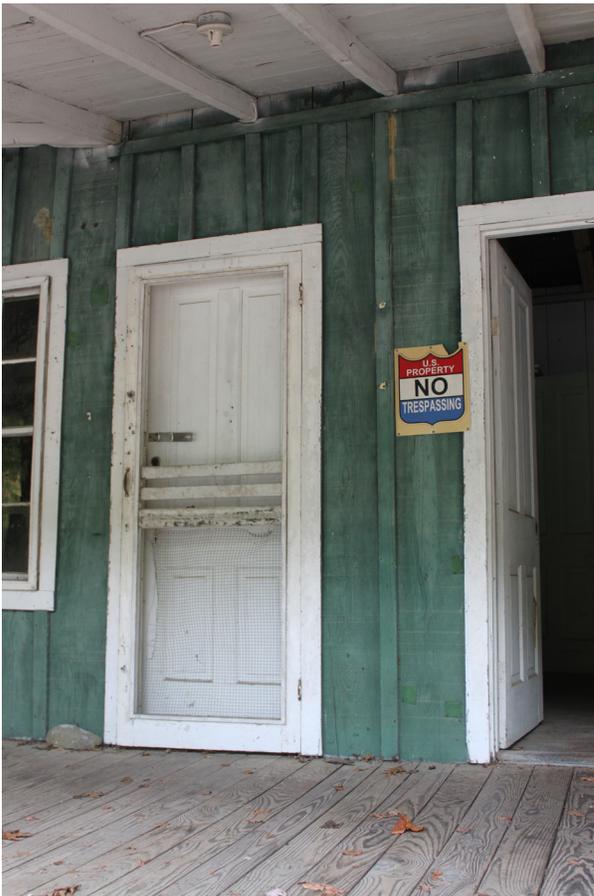
Figure 34: Front entrance doors.

The cabin has two exterior front entrance doors in the west front elevation of the main core. (Figure 34) These wood doors both have four vertical panels – two upper and two lower – typical of

doors within the main core. The northernmost door measures 2'-6 1/4" wide by 6'-6 1/4" tall. It has a screen door with upper and lower screen mesh panels, an exterior handle, and a hook and eye latch. The southernmost door measures 2'-6 1/4" wide by 6'-5 3/4" tall. The southernmost screen door is missing. Both doors retain their metal box lock on the interior with matching catch on the frame, and keyhole escutcheon and knob surround on the exterior, but the doorknobs are missing.

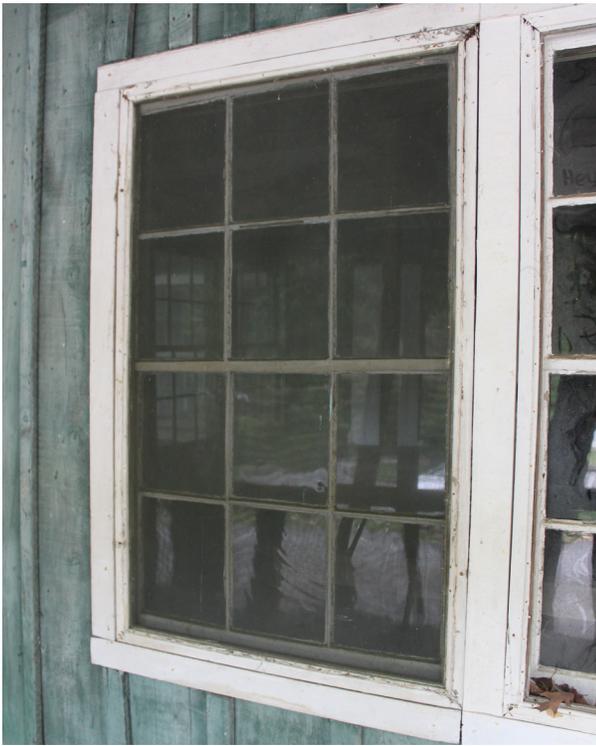
**Figure 35:** Double-hung windows in the west front elevation.

The west front elevation of the main core has one pair of six-over-six double-hung wood windows in Room 101 and one single six-over-six double-hung wood window in Room 102. (Figure 35) These windows are typical of double-hung windows in the main core; they have a muntin profile with a rounded nose. (Figure 36) The pair of windows in Room 101 are two separate double-hung window units placed side by side rather than a pair constructed together. The window opening in Room 101 measures 6' wide by 4'-6 3/8" tall. The upper sash in the northernmost window is a replacement based on the different muntin profile. The window opening in Room 102 measures

2'-10 3/8" by 4'-6 5/8" tall. The exterior window surrounds are 3 1/8" wide tongue-and-groove boards and one 3" wide board. Both windows have wood-frame screens with screen mesh.

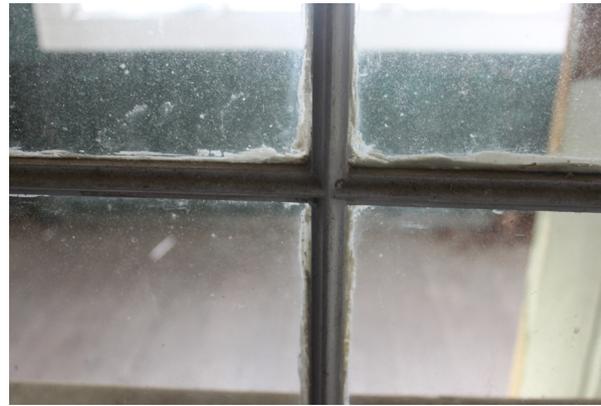
**Figure 36:** Rounded nose muntin typical of windows in the main core.

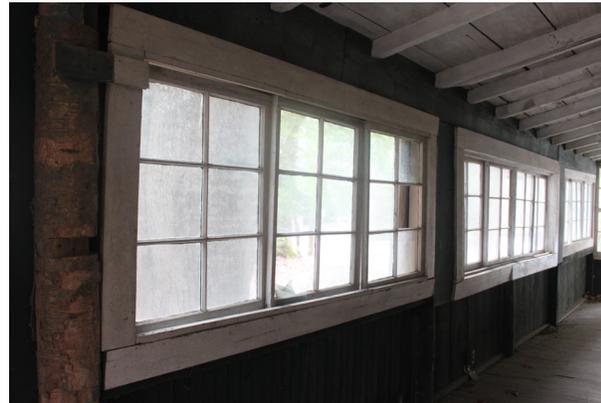
**Figure 37:** Sliding windows in the enclosed porch.

The south side elevation of the enclosed porch contains three groups of sliding windows. (Figure 37) The westernmost group of sliding windows has three six-pane wood sash in a window opening that measures 6'-9" wide by 2'-10 3/4" tall. The middle group of sliding windows has four six-pane wood sashes in a window opening that measures 8' 9 3/4" by 2'-11" tall. The easternmost group of sliding windows has three six-pane wood sash in a window opening that measures 6'-9 1/4" wide by 2'-10 3/4" tall. The exterior window surrounds on these groups of sliding windows are 3 1/2" wide boards.

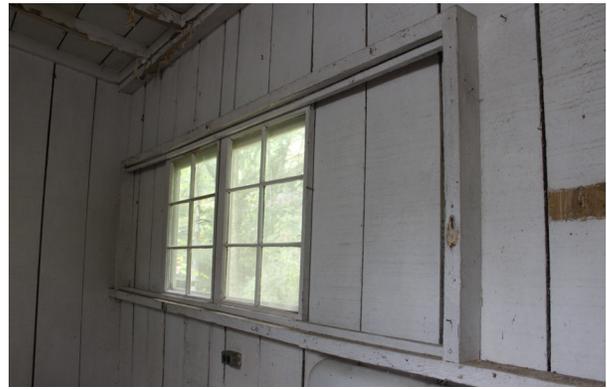
**Figure 38:** Sliding windows with interior frame in the kitchen.

The east elevation of Room 110 has a pair of six-pane sliding wood sash in a window opening measuring 4'-9" wide by 2'-10 1/4" tall. (Figure 38) The exterior surround is approximately 3 1/2" wide. The west elevation of Room 110 rises above the adjacent shed roof of the rear enclosed porch and Room 109 and contains a clerestory window with two six-pane wood sash; one sash is fixed and the other is hinged at the bottom to form a hopper type window. The window opening measures approximately 5'-8" wide and 2'-3" tall. The exterior surround is inaccessible.

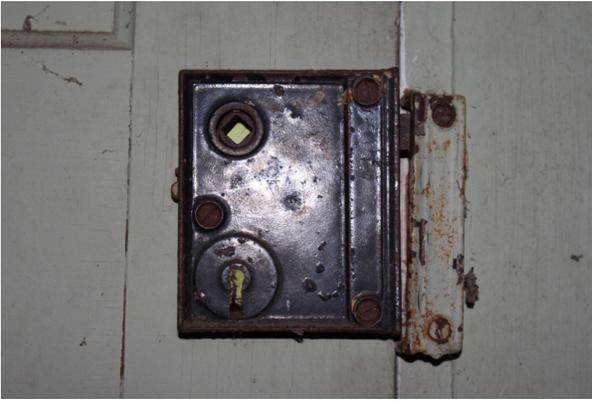
**Doorways**—Four doors lead into Room 101. The front entrance door in the west wall is a four-panel wood door with two upper vertical panels and two lower vertical panels, typical of the doors in the house's main core. The door is framed with no interior casing and has a 5 ½" wood threshold. (See *Exterior Doors.*) (Figure 42)

**Figure 42:** Metal box lock on the front entrance door of Room 101.

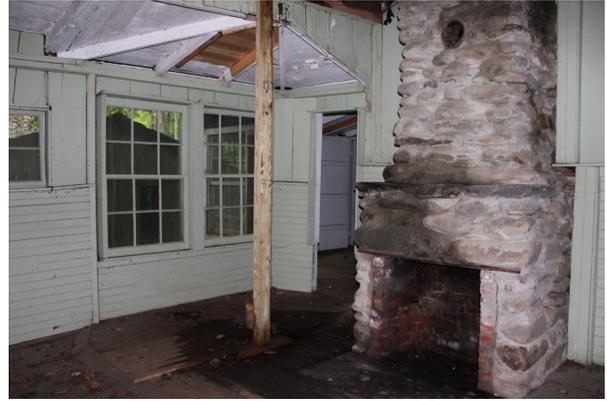
**Figure 43:** Stone fireplace in Room 101.

*Other Features*—The chimney/fireplace on the east wall is constructed of large local fieldstones; these stones are laid flat to form a mantel across the chimney's front. The chimney's neck has an opening for a flue pipe. The firebox is constructed of brick. The flat hearth is level with the floor and is made of small fieldstones set into concrete. (Figure 43) Several wood window sash and sash pieces are stored in Room 101; their origin is unknown.

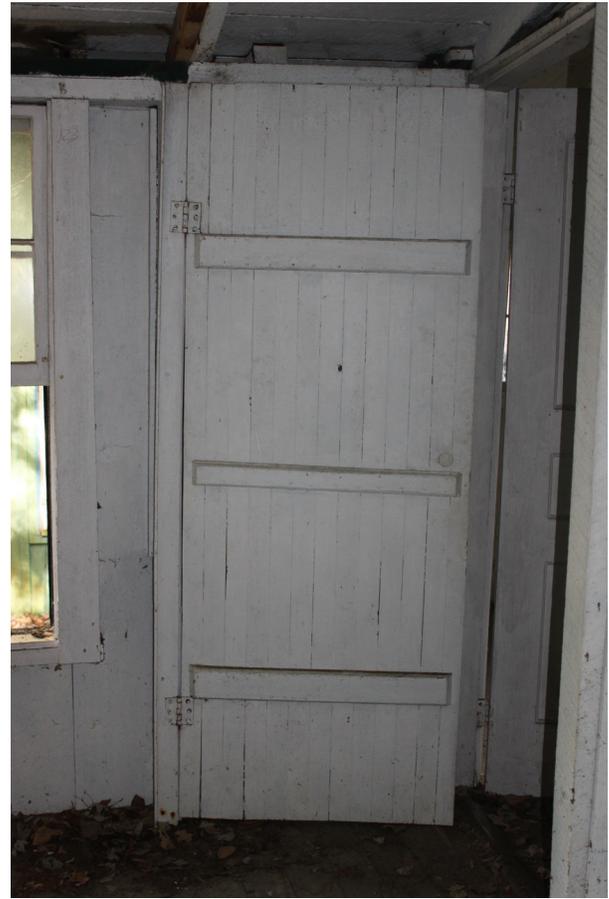
**Figure 56:** Door to Room 107.

**Doorways**—Two doors and two doorways open into Room 106. The door in the north wall leading into Room 107 has a 4” wide wood threshold. The door is constructed of 2 ¼” tongue-and-groove vertical boards; its hardware includes a small wood knob and a hook (missing) and eye latch. (Figure 56) The door in the east wall leading into Room 108 is a five-panel wood door that measures 2’-6 ¼” wide by 6’-5 7/8” tall. The door’s hardware

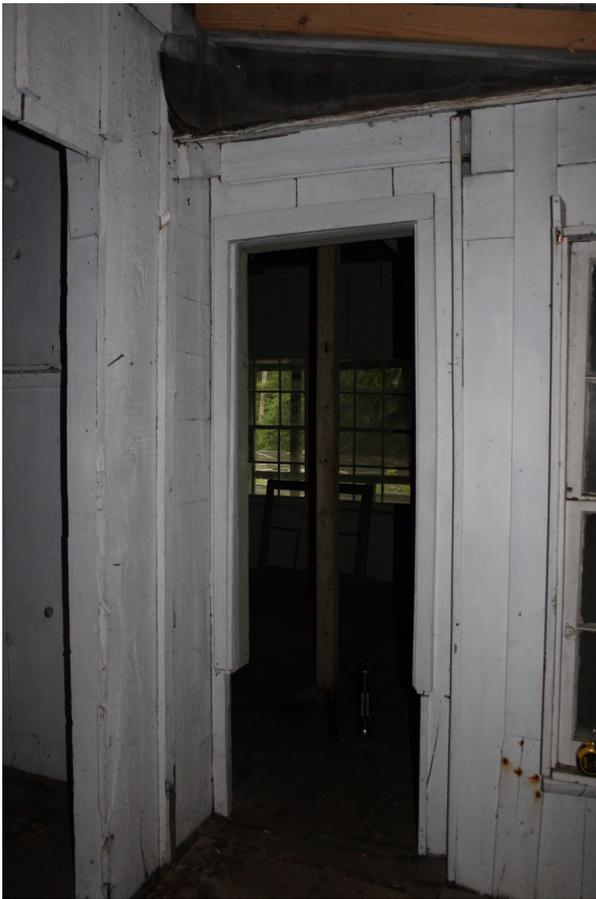
*Other Features*—The original edge of the shed porch roof is visible along the west wall above the doorway into Room 101. The roof is finished with asphalt roofing; wire mesh covers the opening between the two roofs. (Figure 57)

**Figure 57:** Room 106 looking toward Room 101; edge of shed roof visible above door.

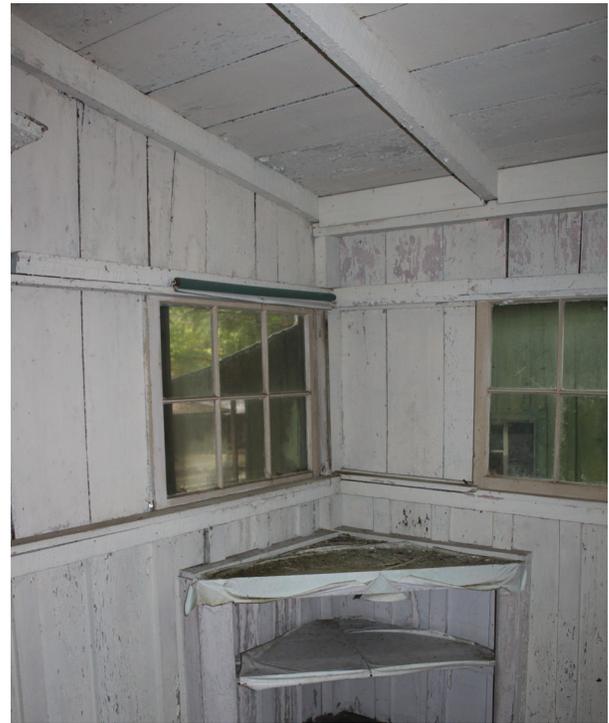
**Figure 60:** Sliding windows in Room 108.

*Windows*—Room 108 has three sets of sliding windows. The west wall has a single six-pane sliding wood sash. The north wall has two six-pane sliding wood sash. These sash slide in a frame built of 2" by 4"s mounted horizontally on the wall with 1 ½" to 3" wood strips attached to form the track. The east wall has two six-pane sliding wood sash that slide behind and in front of each other in a track composed of a 3" wide outer strip and 1" wide inner strip that guide the sash. The windows are framed but have no casings. (Figure 60)

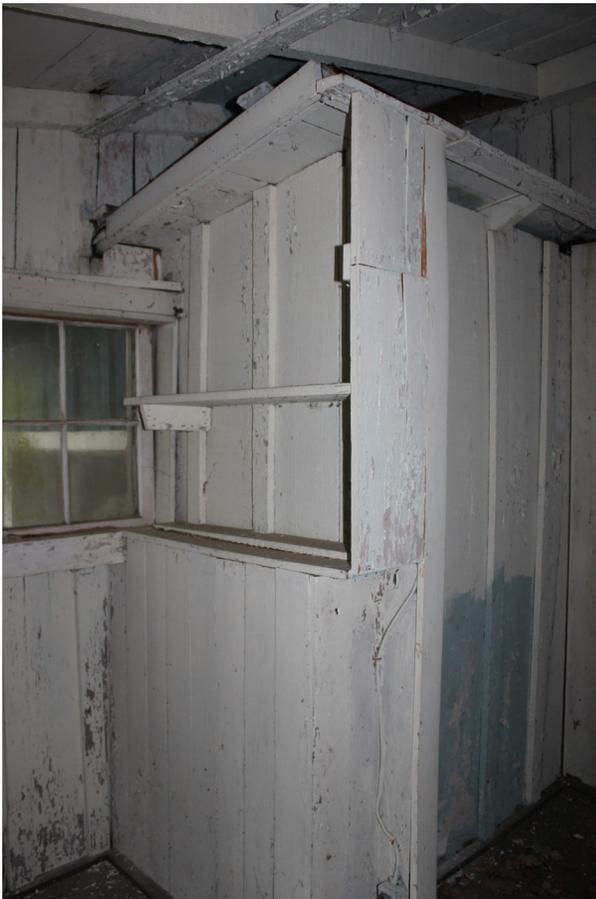
**Figure 61:** Corner and shed roof of Room 111 visible in Room 108.

*Other Features*—A partial wall with shelves above has been constructed on the north side of the Room 111 projection. This wall hides what appears to be a piece of fallen metal gutter or downspout. A portion of the asphalt-shingled shed roof of Room 111 is visible in the southeast corner of the room. (Figure 61) The edge of the shed roof of Room 106 is visible over the door into 106. A pair of angled shelves are built into the northwest corner.

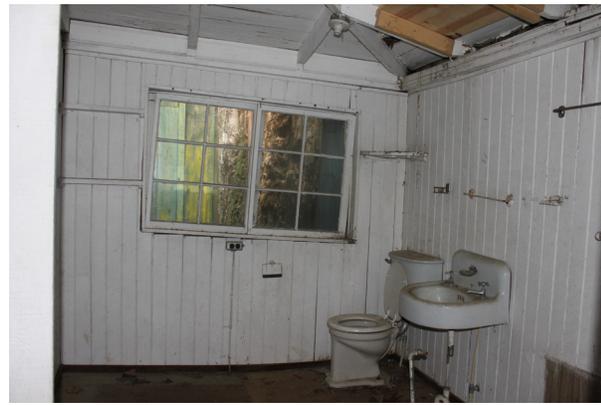
**Figure 62:** Room 109.

The bathroom is located in a portion of the rear enclosed porch of the house. This part of the porch may have originally been open. The room measures approximately 9'-10" by 7'-6". (Figure 62)

*Flooring*—The flooring is 3 ¼" tongue-and-groove wood running east-west. The east half of the flooring has been replaced with 5 ½" boards.

*Ceiling*—The ceiling is the exposed 2" by 4" roof rafters, angled hip rafter, and roof decking of the shed roof. Recent repairs to the ceiling's east side include a spliced rafter. The sloped ceiling measured at the bottom of the angled hip rafter slopes from 8'-5" at the west side to 6'-8 ½" at the east side.

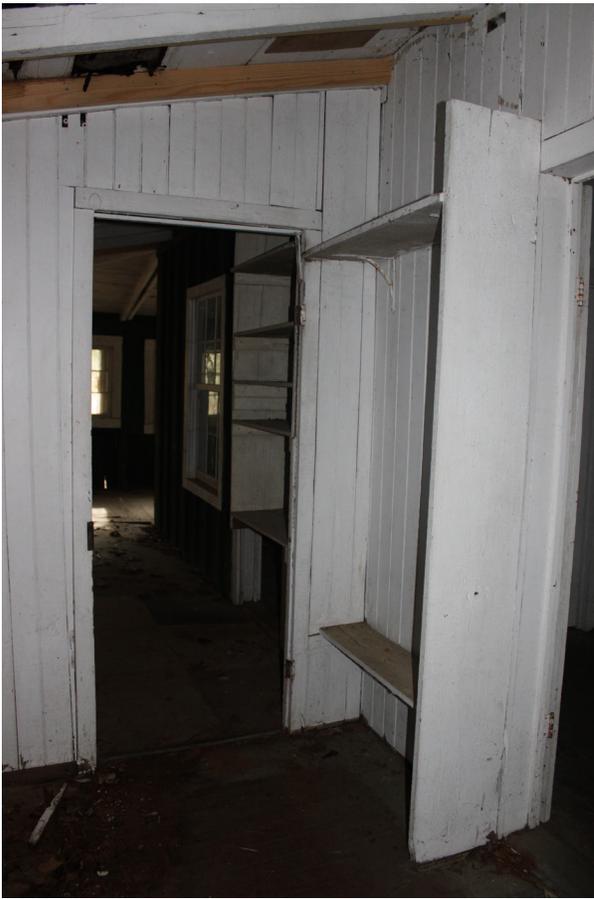
**Figure 63:** Southwest corner of Room 109 with shelves and doorway into rear enclosed porch (left).

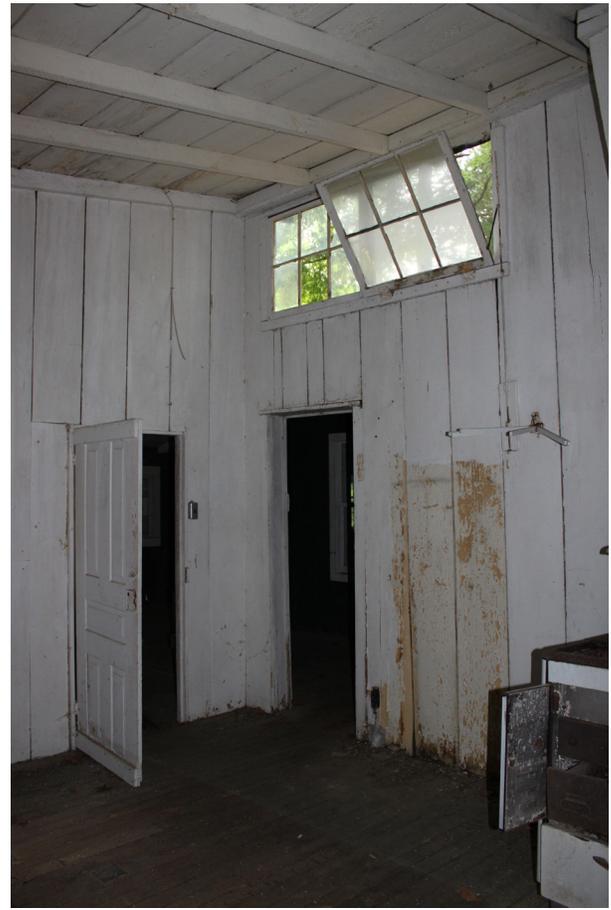
**Figure 64:** Clerestory windows and doors in Room 110.

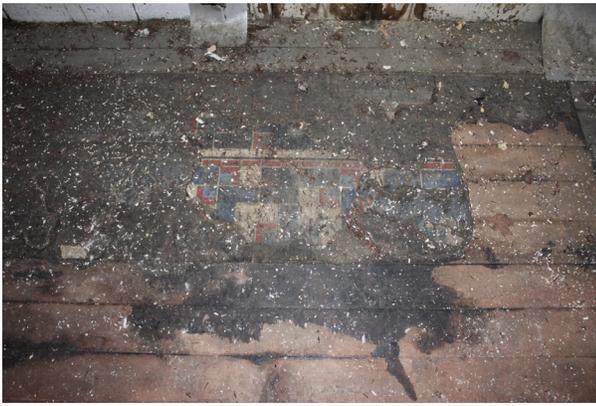
*Flooring*—The flooring is 3 ¼" tongue-and-groove wood running east-west. A definite seam runs down the middle of the floor north to south, and the flooring in the east and west halves are different woods. A linoleum rug once covered the wood flooring; only small remnants of the linoleum remain. The outline of the linoleum rug is visible; the wood flooring has paint around the perimeter of the room outside the rug area. (Figure 65)

**Figure 65:** Tongue-and-groove wood flooring with remnants of linoleum in Room 110.

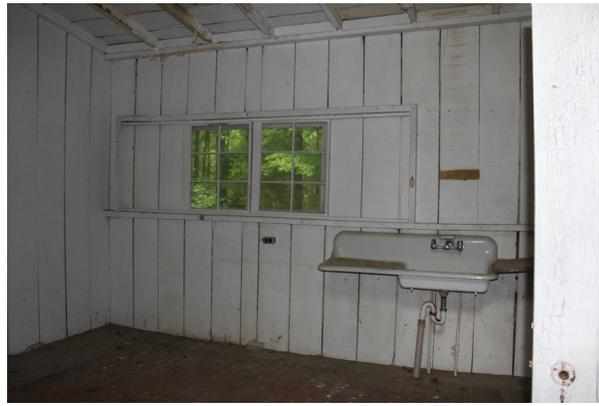
*Windows*—The east wall of Room 110 has a pair of six-pane sliding wood sash that slide within a 2” by 4” frame with a 1” strip that forms the track. The west wall contains a clerestory window with two six-pane wood sash; one sash is hinged at the bottom to form a hopper type window opened with a metal rod attached to the wall. There is a 3” wide casing on the sides and bottom only. (Figure 66)

**Figure 66:** Sliding window and sink in Room 110.

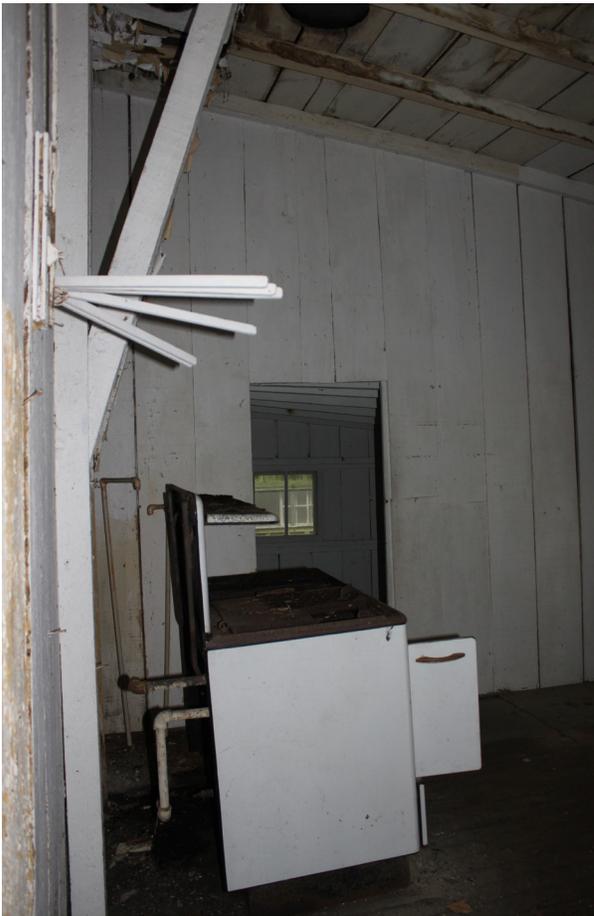
**Figure 67:** “Knox Mealmaster” stove and support for flue in Room 111.

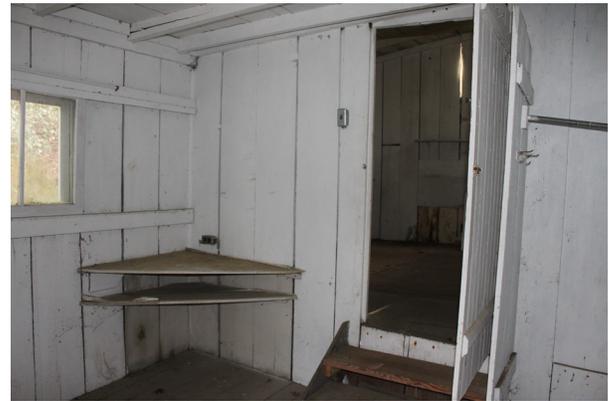
**Figure 68:** Room 111 looking toward kitchen.

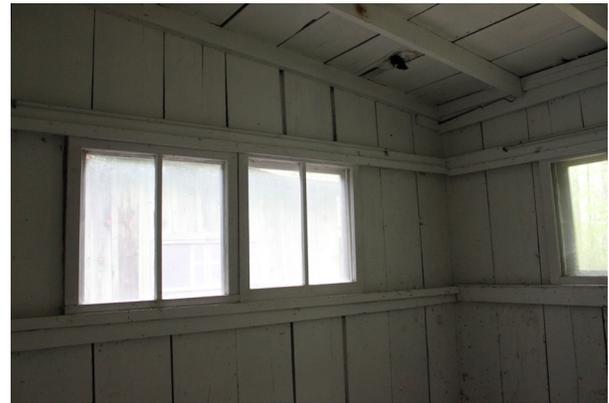
*Windows*—The north and east walls of Room 111 each have two sliding wood sash, with two vertical panes each. The windows slide on a frame of 2” by

**Figure 69:** Sliding windows in Room 111

4”s at top and bottom with a 1” strip that forms a track. (Figure 69)
