**Mayo Cabin and Mayo Servants' Quarters
Elkmont Historic District
Great Smoky Mountains National Park
Historic Structure Report**

Historic Structure Report

Mayo Cabin
LCS#: 264293

Mayo Servants' Quarters
LCS#: 264321

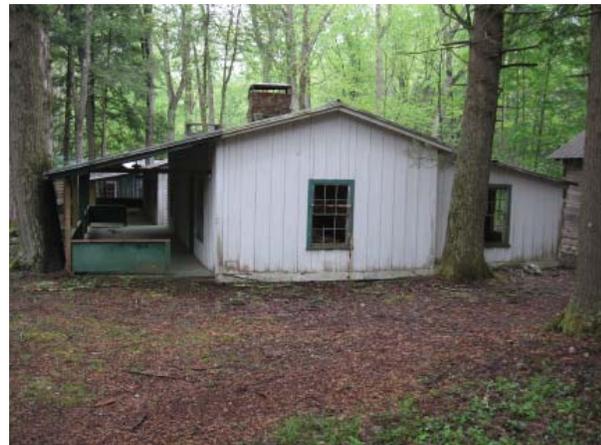
The southeast wing (Room 104) is similar in style to the main block, but exhibits slightly different construction detailing. This room likely was a set-off house of separate design, moved and assembled together with the main block. Or, it conceivably was constructed anew.

Figure 5, South elevation. The shed-roofed southeast wing (Room 104) is at right; offset about 2 feet from the main block.

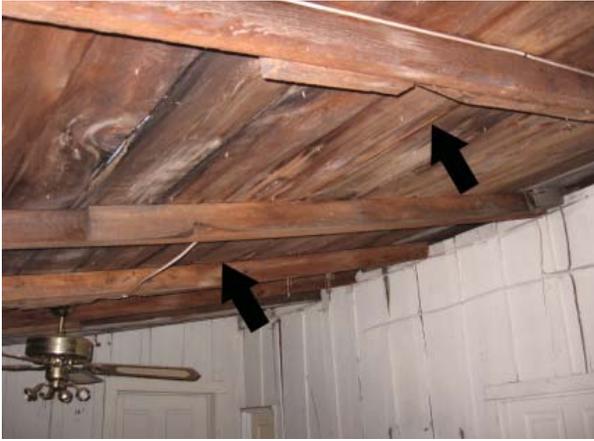
Physical evidence in the roof framing exposed in Room 103 indicates the earlier presence of a narrow room – more likely a porch – along the east wall of the main block; referred to as the “early east porch” (Figure 6). This porch was most likely not part of the original structure, but may have been constructed after the move.

Figure 6, The rafters in Room 103 extend from the east wall of the main block (right). The bird's-mouth cuts in the rafters indicate the presence of an earlier beam or wall.

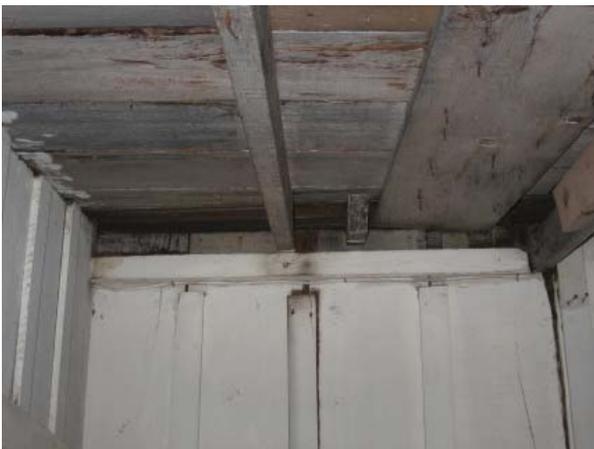
At the south end of Room 103, along the north wall of Room 104, there is evidence of an earlier narrow porch or room; referred to as the “early annex, Room 104” (Figure 6). The roof framing is identical to that of Room 104, and there is evidence of a light-colored wash on the sheathing similar to Room 104. It appears that this small room – possibly an early bathroom accessed from a narrow porch – was removed when Room 103 was expanded and enclosed.

Figure 7, The consistency of the two rafters and roof sheathing north of Room 104 appear to indicate an earlier room or porch.

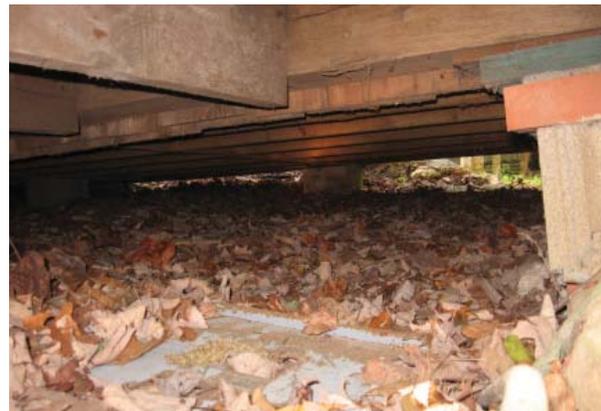
None of the cabin floor framing has a subfloor. The west and east walls of the main block are supported on 8" by 8" hewn sills supported on concrete block piers. The floor system for the main block – Rooms 101 and 102 – consists of 1¾" by 9¾" joists at 24" on center, spanning east-west between the hewn sills. At Rooms 103 and 104, the floor framing consists of 1⅝" by 7½" rough-sawn joists at 16" on center, spanning north-south at 103 and east-west at 104. The entire floor structure at Room 104 is raised 4" above the rest of the house, perhaps due to the presence of a rock outcropping encountered during construction, or possibly due to later repairs.

Figure 11, Floor framing under North Parlor, looking west toward front porch. Note that floor joists toe-nailed into 8" by 8" hewn sill. Vertical board wall structure can be seen on far side of sill.

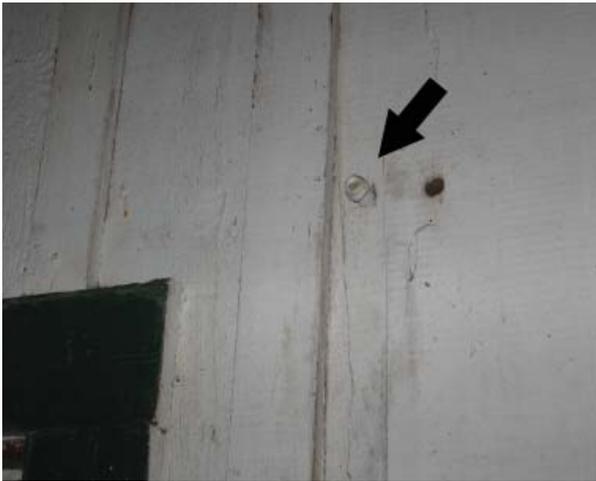
The earliest electrical distribution system for the main block of the cabin appears to have been knob-and-tube wiring. Developed in the 1880s and remaining in use until the 1940s, knob-and-tube wiring utilized ceramic knobs mounted on the surface along with ceramic tubes drilled through framing and walls to separate the hot and neutral wires by 4" to 6", and also insulate the wires away from the structure. Remnants of these porcelain

tubes or sleeves can be seen in several places on the exterior walls where wiring was routed through the structure.

Figure 12, Porcelain tube in west wall is a remnant of early knob-and-tube wiring.

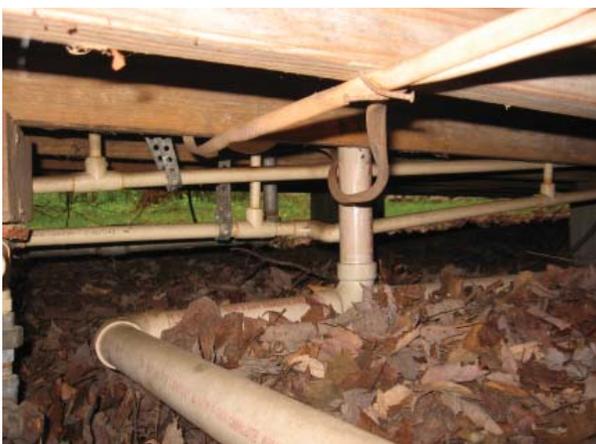
According to interviews with the owners of the cabins at the Appalachian Club Complex, water was provided by a natural spring. The earliest surviving plumbing system consisted of galvanized iron supply and waste piping. Except for some surviving sections, the galvanized piping has been replaced with modern PVC supply and drain lines.

Figure 13, Floor structure and plumbing under Kitchen.

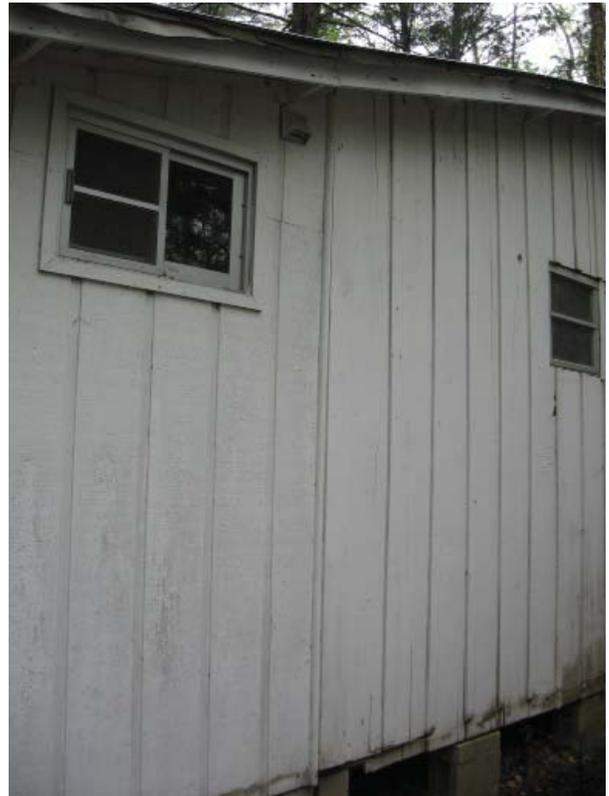
The board-and-batten siding is technically the structural wall. The exposed vertical boards are rough sawn, $\frac{7}{8}$ " in thickness and averaging $11\frac{3}{4}$ " in width. The joints are covered with $\pm \frac{3}{4}$ " by $\pm 2\frac{3}{4}$ " rough-sawn battens (dimensions vary slightly). The only deviation from this material is at the north and east exterior walls of the Room 103, which are clad in modern $\frac{1}{2}$ " thick rough-sawn reverse board-and-batten plywood.

Figure 17, North wall of cabin at juncture of original vertical board siding and modern plywood siding.

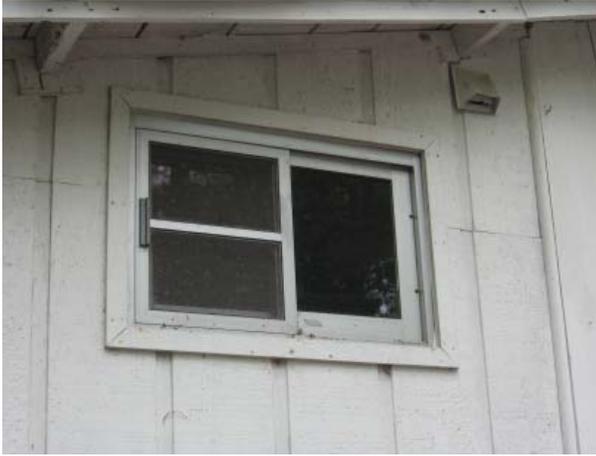
Figure 24, Aluminum replacement window at north wall of bathroom, Room 103A.

In the Bathroom, Room 103A, a double-hung aluminum window measuring 32½" wide by 1'-6" high is turned on its side and trimmed with 2" casing.

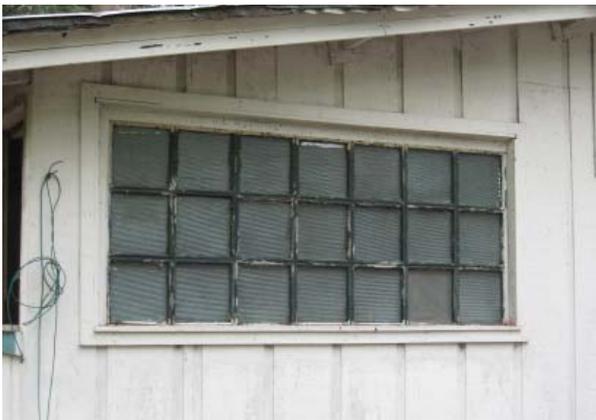
At the kitchen, Room 103, a large, fixed wood sash takes up the entire north wall. The 21-light sash measures 76¾" wide by 34½" high by 1¾" thick. Trimmed with 2" casing, this sash appears to be recycled late-nineteenth or early-twentieth century salvage.

Figure 25, Fixed sash window at north wall of Kitchen.

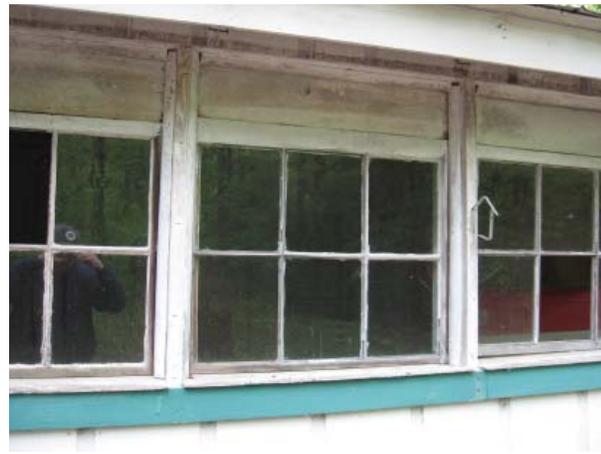
Along the east wall of the kitchen, Room 103, are six, wood awning window sashes ganged together. Each six-light sash measures 34" wide by 27" high, and is joined at the top to a 7" wide filler board, hinged to the frame with two small tee hinges. Narrow strips of wood are fastened across the sash and filler board as reinforcement. The sashes pivot inward and are fastened with a hook-and-eye to the ceiling, allowing the entire wall to be opened up like a porch. The sashes appear to be salvaged from

Figure 26, Awning windows at east wall of Room 103.

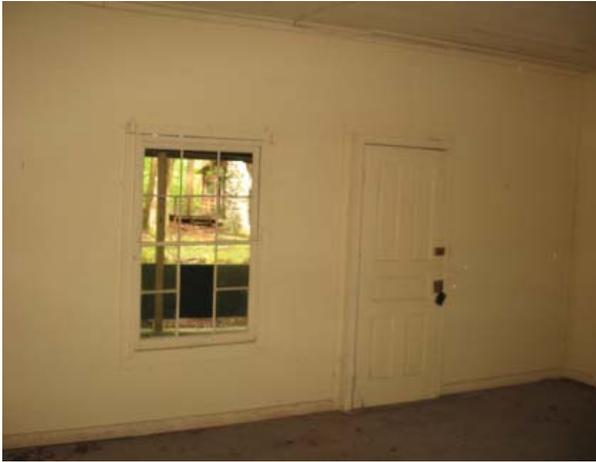
Figure 27, Room 101, view toward west wall.

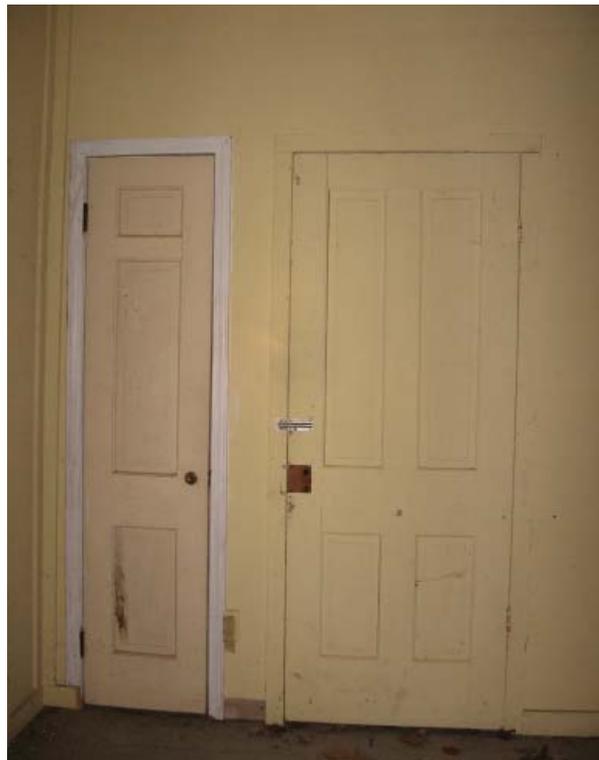
The original interior doors leading into Rooms 102 and 104 are four-panel, both about 30" wide by 78" high by 1⅛" thick and hung on a pair of 3½" five-knuckle steel hinges. Similar to the other four-panel doors in the cabin, the date range of use is from the 1880s through the early 1900s. Lock hardware and knobs are missing on both doors, but appear to have consisted of cast-iron rim locks and keepers similar to the exterior door. At these doors, the casing is ¾" by 2¾" painted wood, installed over the gypsum board finish. The doorway into Room 104 steps up 4 inches.

Figure 28, Room 101, doors leading to Room 103 (left) and 104 (right).

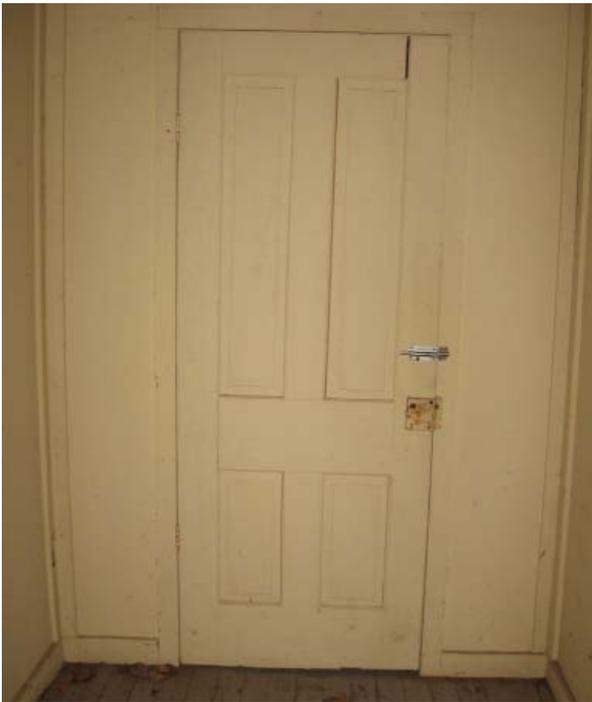
The door into the closet 101A is a modern, flush hollow core construction, 28" wide by 72" high. Physical evidence in closet 101A indicates that the original closet door may have been 24" wide; refer to the description of Room 101A, below. At the northeast corner of the room, a very narrow, modern paneled door measuring about 18" wide by 78" high leads to Room 103. The door appears to have been salvaged from a pair of closet doors.

Figure 29, Room 101, door leading to Room 102.

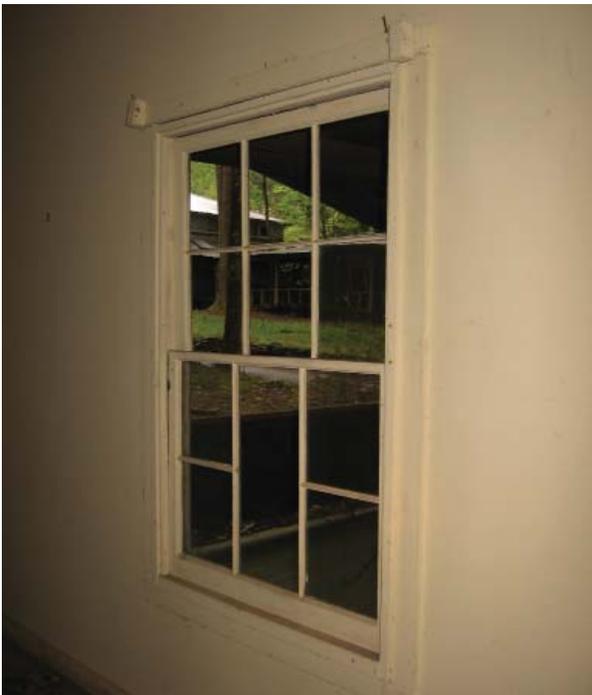
There are two windows opening into Room 101. Both are double-hung, and appear to be original to the cabin. Refer to *Construction Characteristics / Windows*, above. Due to a wall thickness of only 2½", the window frames project over 2½" into the room, and are untrimmed.

Figure 30, Double-hung window at west wall of Room 101.

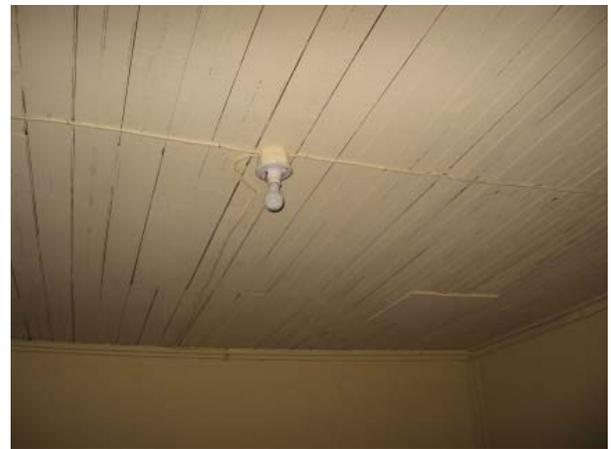
In the center of the ceiling is an un-switched ceramic lamp holder with pull chain. At the ceiling, surface mounted with staples, is a mix of mid-twentieth century cloth-sheathed insulated cable as well as later PVC-sheathed cable. The only other electrical fixture in the room is a receptacle at the south wall.

Figure 31, Beaded board ceiling at Room 101.

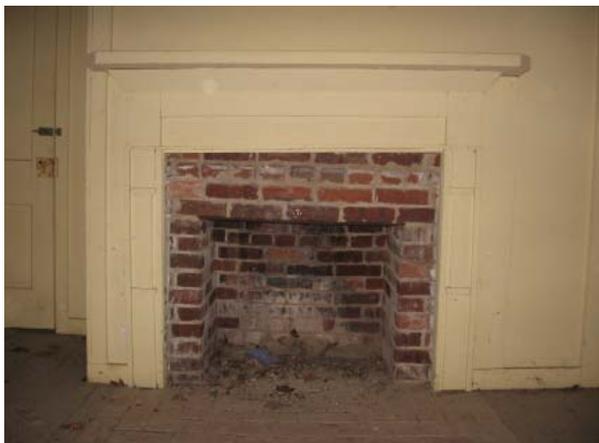
A brick masonry fireplace with wood mantle is centered on the north wall of the room. The firebox, which measures 2'-7½" wide by 2'-2½" high by 1'-6" deep, is spanned by a thick, flat iron lintel. The bricks are early-twentieth century in character, but appear to be salvage and the brickwork is crudely executed. The flush brick hearth measures 4'-6" wide by 2'-0" out from the face of the firebox. The painted wood mantle

measures about 66½" wide by 53" tall, with a projecting shelf.

Figure 32, Fireplace at Room 101.

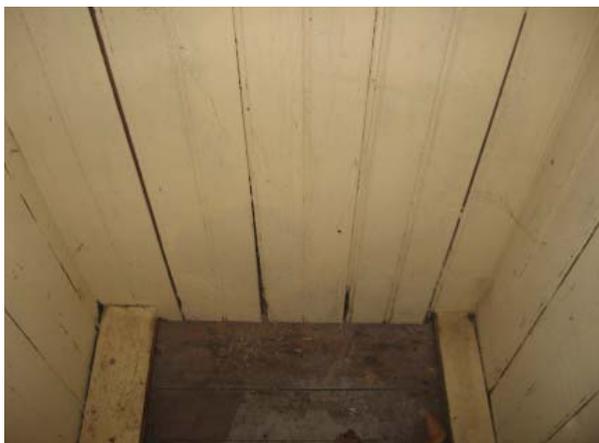
Figure 33, Closet 101A, view toward west. Note beaded board walls.

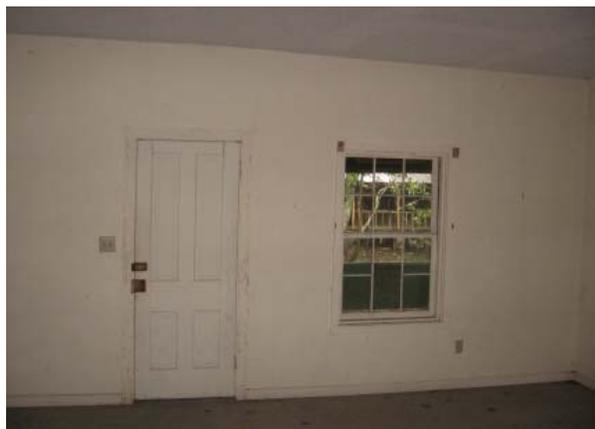
Figure 34, Room 102, view toward west wall.

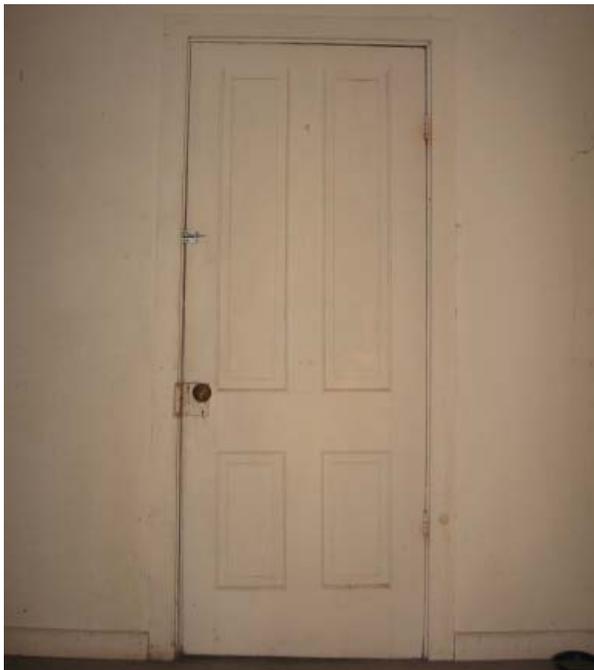
There are three doors opening into Room 102. Leading to the front porch is an original four-panel door; refer to *Construction Characteristics / Exterior Doors*, above. Since the walls have been furred out, the frame does not project into the room as it does in Room 101. The casing is a modern ½" by 3" clamshell profile, and is installed over the gypsum board finish.

Figure 35, Room 102, door D9.

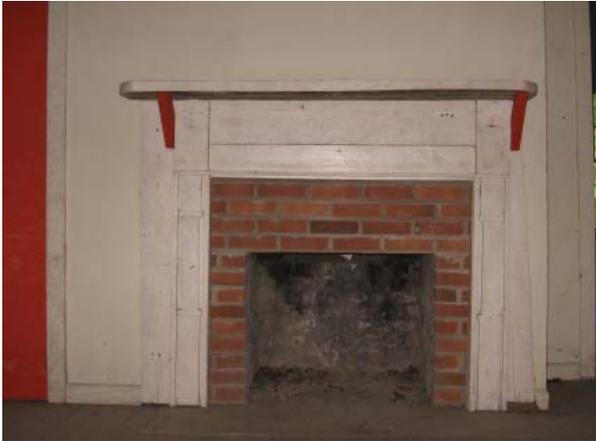
firebox, which measures 2'-7" wide by 2'-1" high by 1'-10" deep, is spanned by a thick, flat iron lintel. The brick inside the firebox displays remnants of an early cement parging. To accommodate the furred out wall surface, the original face bricks appear to have been replaced with modern bricks set with grey cement mortar. The flush hearth of brick pavers measures 4'-10" wide by 1'-8" out from the face of the firebox. The painted wood mantle measures about 66" wide by 53" tall, with a projecting shelf.

Figure 36, Fireplace at Room 102.

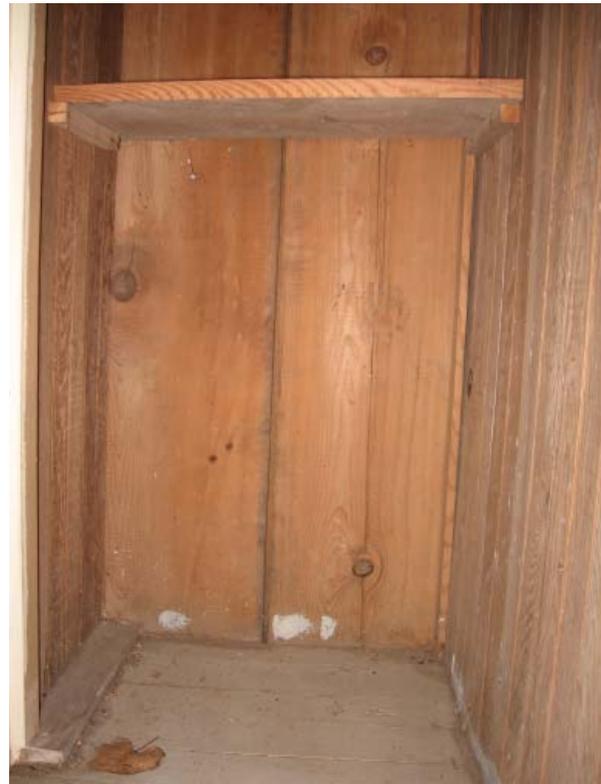
The extant door frame is a modern replacement, installed when Room 101 was finished with gypsum wall board. Above the door head, a 24" wide cutout in the vertical boards indicates a narrow, earlier door.

Figure 37, Closet 102A, view toward east. Note exposed vertical board wall.

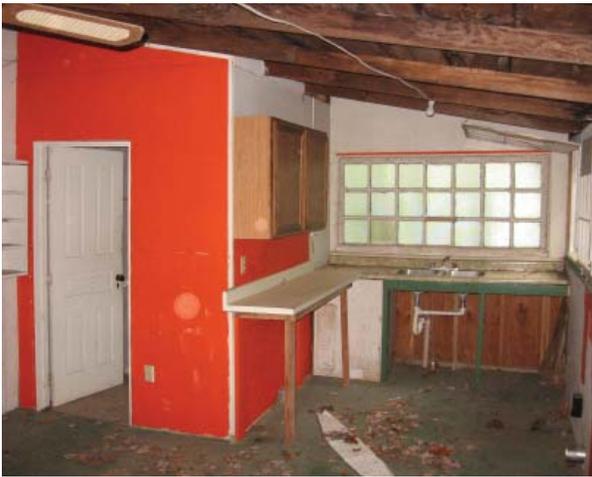
Figure 38, Kitchen, Room 103, view toward north.

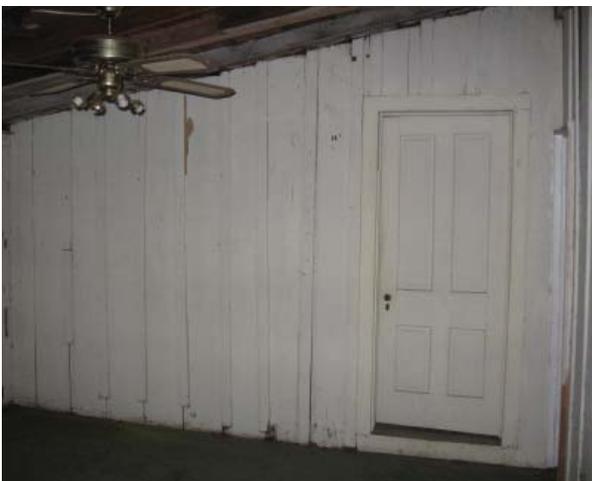
Originally the exterior wall of the main block, the present west wall of the kitchen displays the rough-sawn vertical double-board structure with ¾" by 2¾" battens spaced about 12" on center. The wall separating the Kitchen from Room 104 is of vertical single-board construction with ¾" by 3" battens spaced about 12" on center. At the east and north exterior walls, and at the walls around the bathroom, Room 103A, the present finish is gypsum board.

Figure 39, Kitchen, Room 103, view toward south wall. Door to Room 104 is at right.

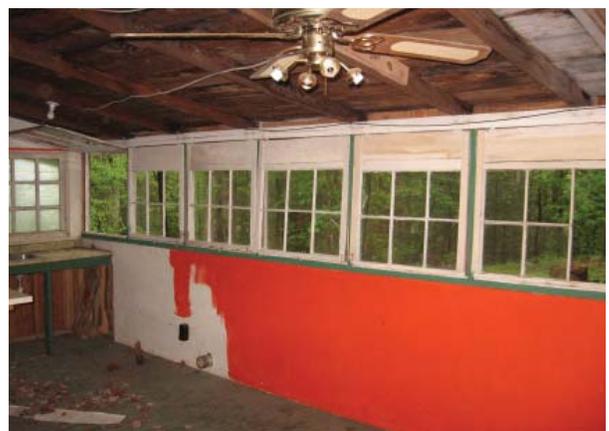
There are two types of windows opening into the Kitchen. Refer to *Construction Characteristics / Windows*, above for description. Both types appear to be salvaged, most likely dating from the expansion of the kitchen in the 1930s. At the north end of the Kitchen, a large, multi-light fixed sash takes up most of the wall. There is no casing around the window opening. The east wall of the kitchen is filled with awning-type sashes. The edges of the window frames are exposed and without casing.

Figure 40, Kitchen, Room 103, view toward east wall.

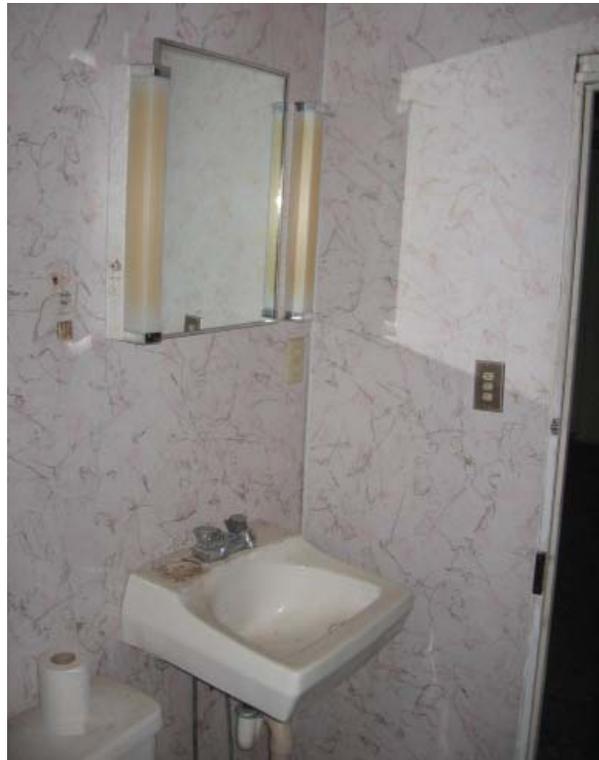
Figure 41, Bathroom, Room 103A, view toward southeast.

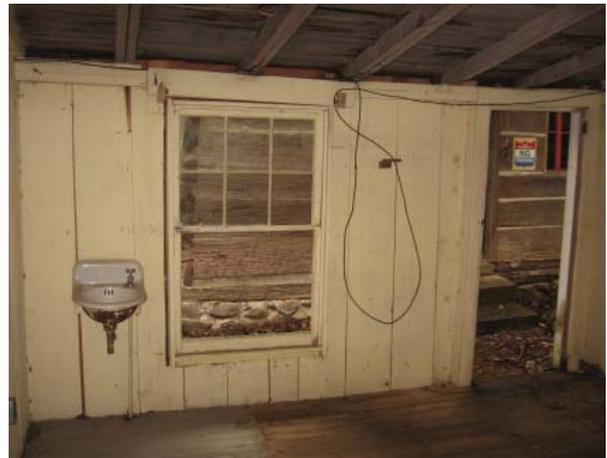
Figure 42, Room 104 view toward east wall.

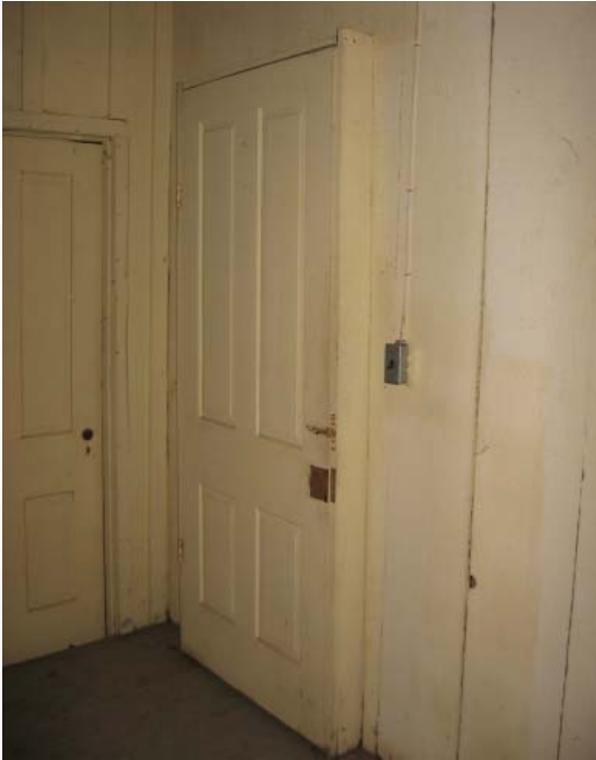
cabin, this door style has a date range of common use from the 1880s into the early 1900s. The door is hung on a pair of 3", three-knuckle steel hinges and is missing all lock hardware, knobs, escutcheons and keeper. Hardware probably consisted of a cast-iron rim lock similar to other doors in the cabin. Due to the wall thickness of only 1½", the door frame projects into the room 4". The edges of the frame are exposed and without casing.

Figure 43, Room 104, door to Room 103.

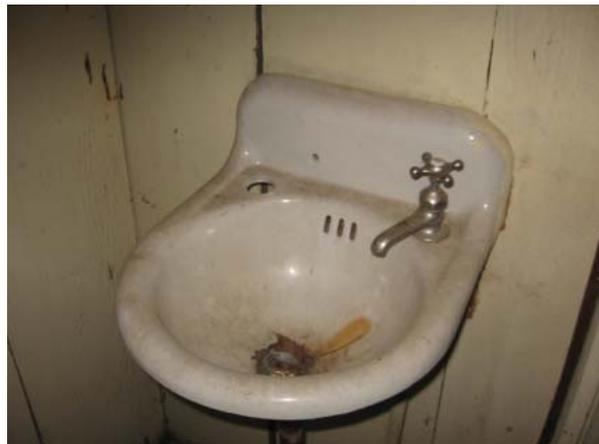
At the northeast corner of the room is a small wall-hung porcelain-glazed cast-iron lavatory with backsplash. The lavatory is 15" wide by 16" deep with a round bowl. A single nickel-plated faucet is connected to a galvanized supply line. The waste line is missing.

Figure 44, Cast-iron lavatory at Room 104.

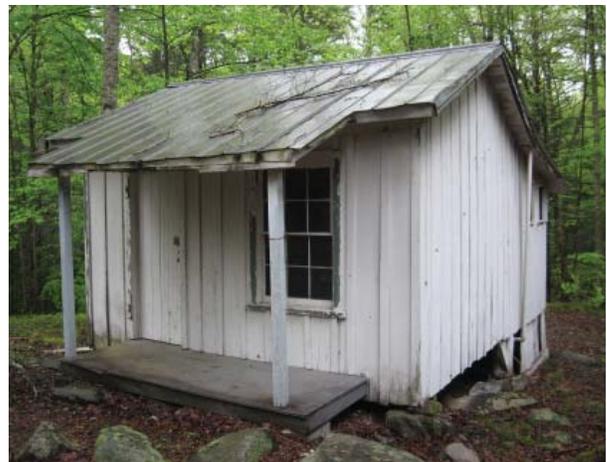
Figure 46, Mayo Cabin Servants' Quarters, southwest oblique.

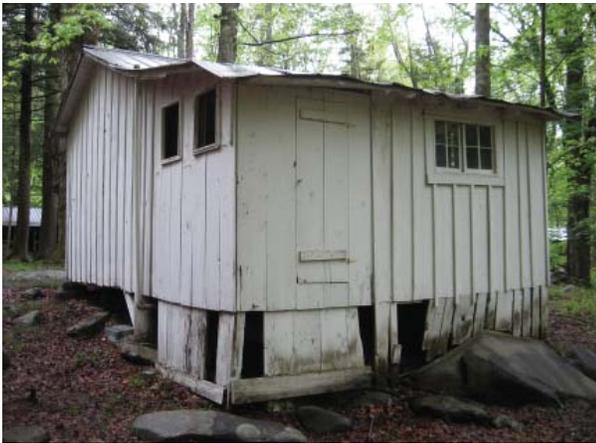
Figure 47, Southeast oblique. The northeast corner (right) bears directly on the rock outcropping. Note the use of locust post piers and wood board underpinning.

its original purpose is unknown but may have allowed additional ventilation into the bathroom at the tub area (Figure 47.)

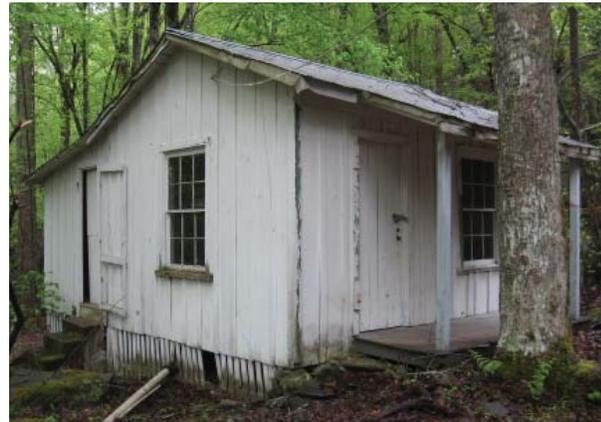
Figure 48, Northwest oblique. Note use of vertical wood slat underpinning.

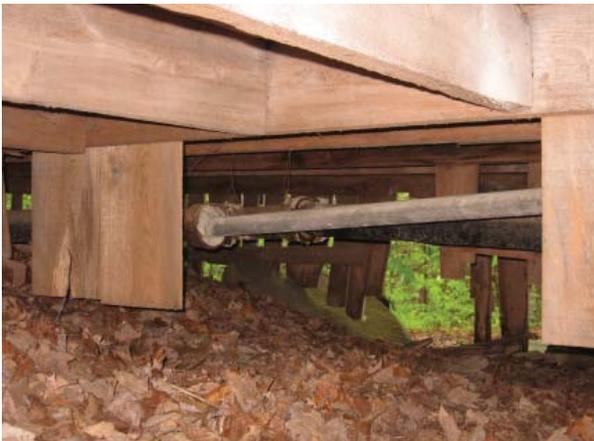
The floor system for Room 101 consists of full 2" by 8" rough-sawn joists spaced 24" on center, clear spanning east-west 12' between 2" by 8" sills. The floor system at the rear shed addition, Rooms 102 and 103, consists of 1½" by 5½" joists spaced 24" on center, clear spanning 14' north-south. The porch floor system consists of nominal 2" by 6" joists, and is a modern replacement.

Figure 50, Crawl space below Room 101, view toward east. Wood slat underpinning and framing for rear addition can be seen in background. The vertical boards in the foreground appear to have been used for shimming out the band joist of the addition from the wall of the original Servants' Quarters. See also Figure 54.

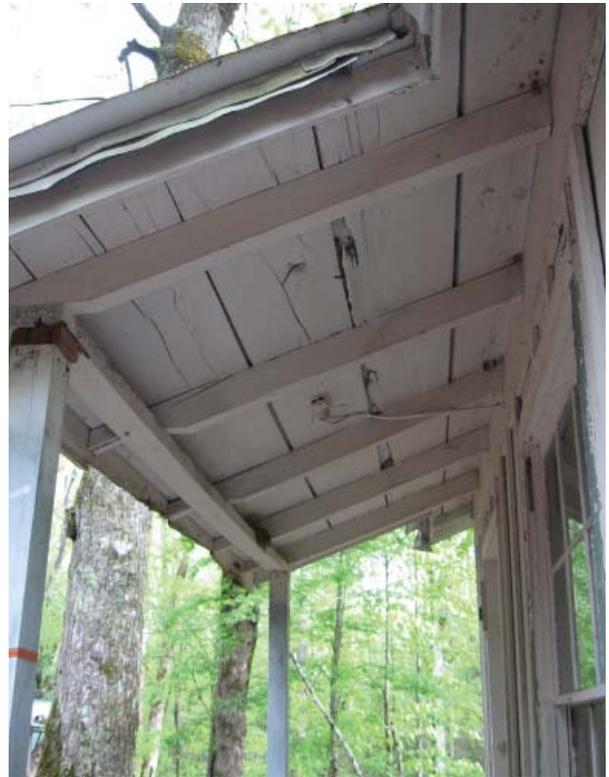
The exposed front porch rafters are true extensions of the main roof framing and consist of 1¾" by 3¾" rafters spaced about 28" on center. The rafters are bird-mouthed at the wall plate, and bear on the double 2" by 4" plate at the porch columns. Roof sheathing is rough-sawn, ⅞" thick and averages 11⅞" in width.

Figure 51, Roof framing at Front Porch.

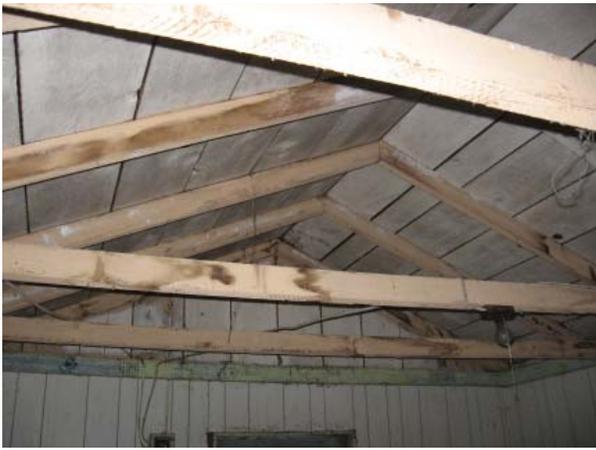
In Room 101, the exposed roof framing consists of 1¾" by 3¾" rough-sawn rafters spaced about 28" on center. Below the rafter bearing are three similarly sized collar beams that span the width of the room. Sheathing boards are ⅞" in thickness and vary in width, averaging 11".

Figure 52, Exposed roof framing in Room 101.

A 2" by 4" bearing plate at the top of the walls fastens the vertical wall boards together. Although not intended as a decorative crown molding, the plate is painted to match other trim in the room (Figure 52)

The ceiling consists of the exposed roof rafters and sheathing. Refer to the section *Construction Characteristics / Roof Framing*, above for more detailed information (Figure 52).

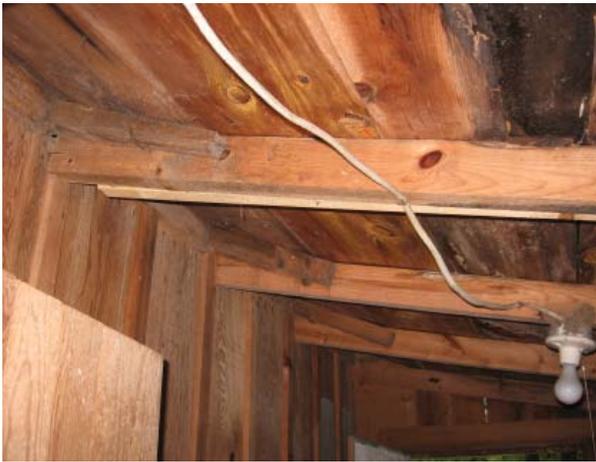
At the rear shed addition, the exposed framing consists of 1 $\frac{5}{8}$ " by 3 $\frac{3}{8}$ " rough-sawn rafters spaced about 28" on center. The rafters are fastened to the rafter extensions of the main room. Sheathing boards are $\frac{7}{8}$ " in thickness and vary in width.

Figure 53, Exposed roof framing in Room 103, bedroom.

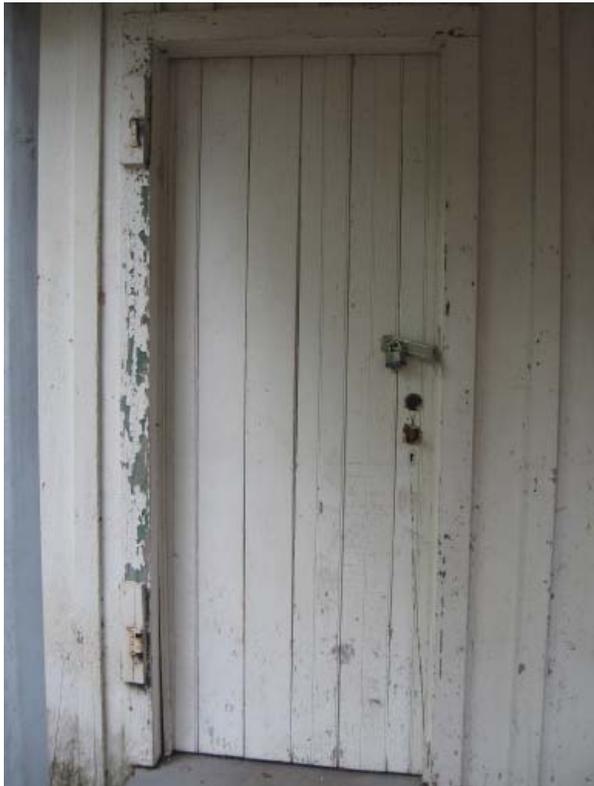
Figure 55, Front door from porch into Room 101.

The entrance door leading from the front porch into Room 101 is of solid wood, vertical tongue-and-groove board construction with horizontal square-edged battens on the interior face. Only on this door, the interior faces of the boards are beaded, and appear to match the size and profile of the ceiling boards used in the Mayo Cabin – $\frac{7}{8}$ " thick by $5\frac{1}{4}$ " wide. The door measures 30" wide

by 79" high by $\frac{7}{8}$ " thick and is hung on a pair of 3", three-knuckle loose-pin hinges. Lock hardware consists of a cast-iron rim lock with steel knobs and escutcheons; the cast-iron keeper is missing. The wood, three-part screen door was mounted on early-twentieth century cast-iron spring hinges, but has been removed and stored in Room 101. Exterior casing is rough-sawn, $\frac{7}{8}$ " by $3\frac{1}{4}$ ".

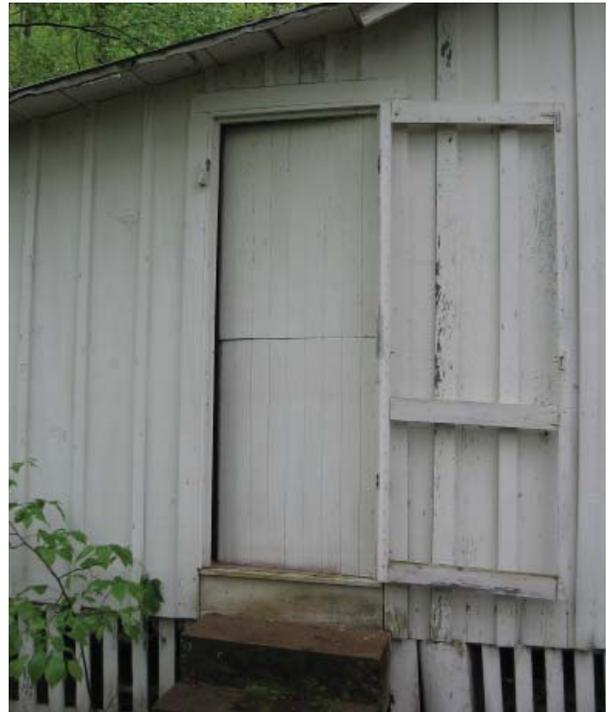
Figure 56, Dutch door opening into Room 103.

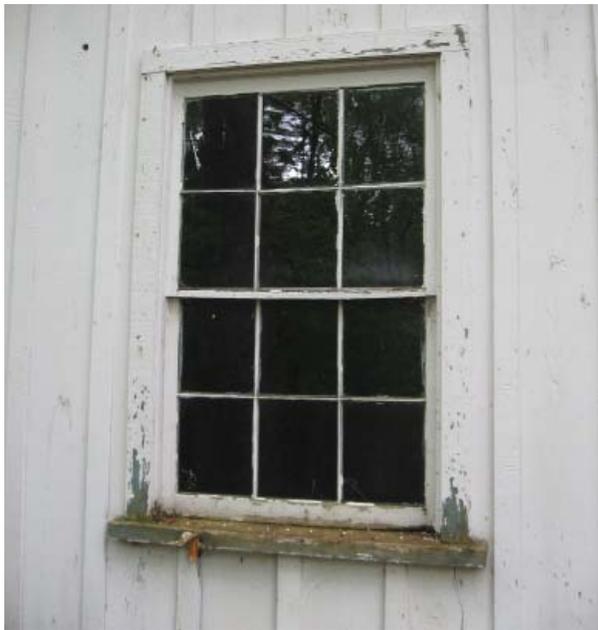
Figure 57, Double-hung window at north wall of Room 101.

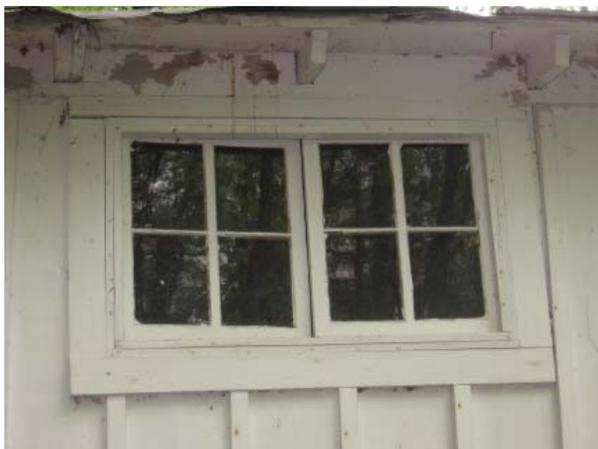
Figure 58, Paired casement windows at Room 103.

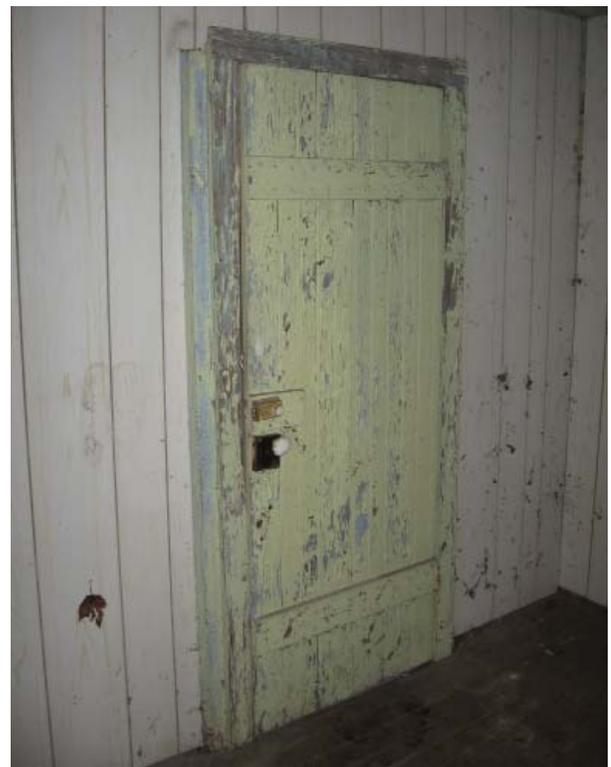
At the north end of the west wall, a tongue-and-groove battened door leads to the front porch; refer to section *Construction Characteristics / Exterior Doors*, above. Since the exterior wall thickness is only 1¾" (including the batten thickness), the door frame projects over 3" into the room. The door frame is anchored to a 3" by 5" structural jamb and trimmed with 7⁄8" by 3¼" painted casing.

Figure 60, Door to front porch, showing projection of frame into Room 101.

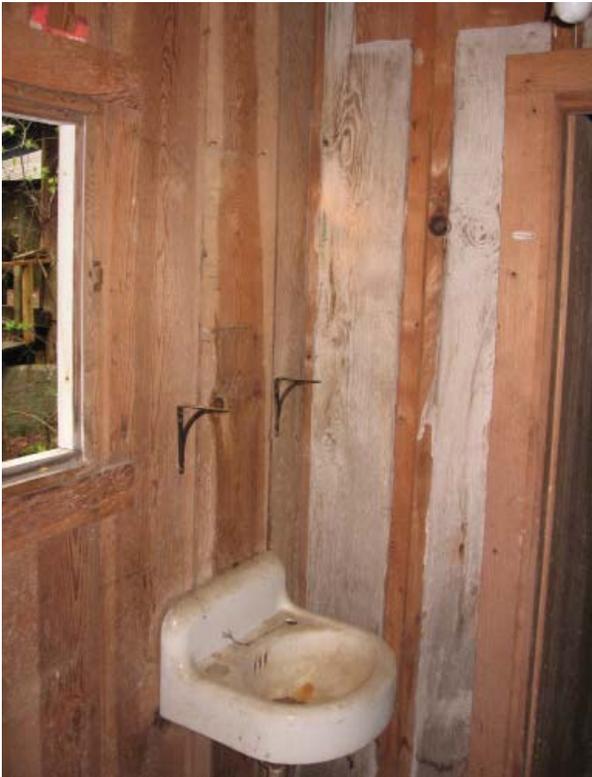
Figure 62, Bathroom, 102, view toward west. Note that battens have been removed on the original exterior east wall of the Servants' Quarters, as seen by the paint lines.

and fascia boards around the edge of the roof are decayed. The plywood covering the porch floor is showing signs of decay. The lack of battens on the exterior walls surrounding Room 102 is allowing blowing rain to enter the building. The section of roof sheathing above the partition between Room 102 and Room 103 and at the southeast corner of Room 102 had been damaged earlier by falling branches, causing leaking which lead to deterioration of the flooring and the bottom edge of the partition. Repairs have been made to the floor, and there is no evidence of recent leaking; however, the roof sheathing and metal roof are damaged and require additional repair.

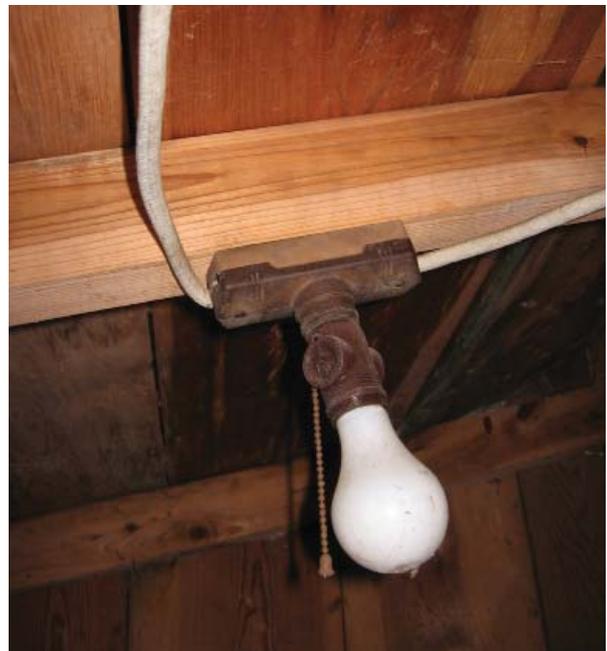
In the center of the ceiling is a mid-twentieth century un-switched Bakelite lamp holder with pull chain. Mid-twentieth century vintage cloth-sheathed insulated cable is surface mounted to the wall surfaces and framing with staples. There are no other electrical receptacles in the room.

Figure 64, Mid-twentieth century Bakelite lamp holder.

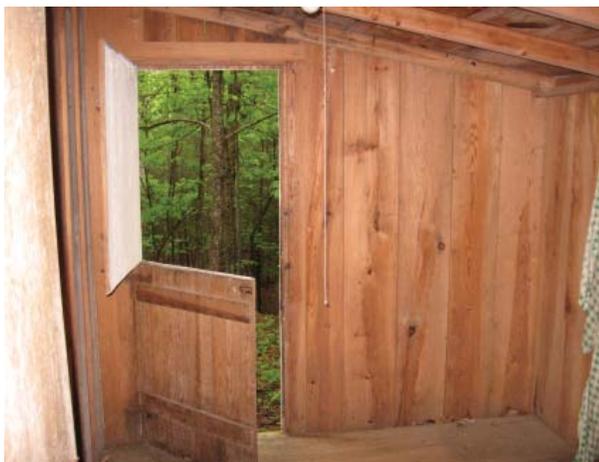
Figure 65, Bedroom, 103, view toward north.

The flooring is tongue-and-groove pine, 3¼" wide, unfinished. The flooring is laid east-west, bearing directly on the floor joists. At the north side of the room, about 16 square feet of water-damaged flooring has been replaced in-kind.

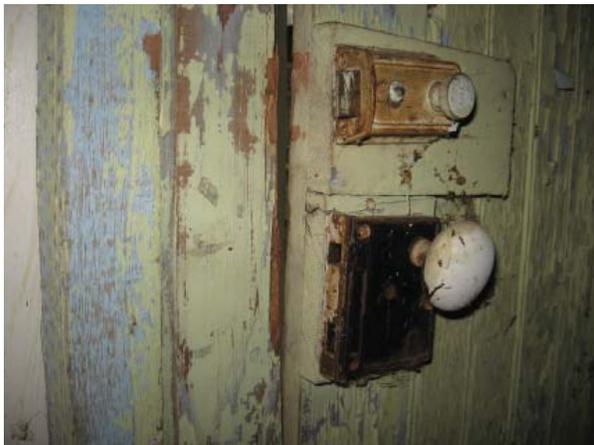
Figure 67, Cast-iron rim lock with steel knobs at front entrance door.
