# Scruggs-Briscoe Cabin Elkmont Historic District Great Smoky Mountains National Park Historic Structure Report

# Historic Structure Report

March 2016

The Jaeger Company

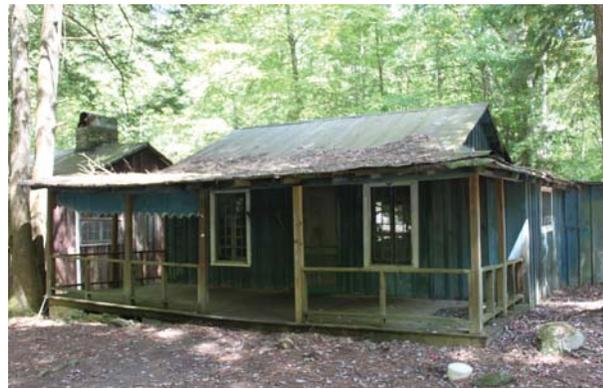
Figure 10: West front and south side elevations.

roof wraps around the southwest corner of the main core and continues along the south side elevation. (Figure 10) Shed roofs that extend from one to another cover the rooms to the east rear of the main core. The rear shed roofs over Rooms 109, 110, and 111 have been recently replaced.

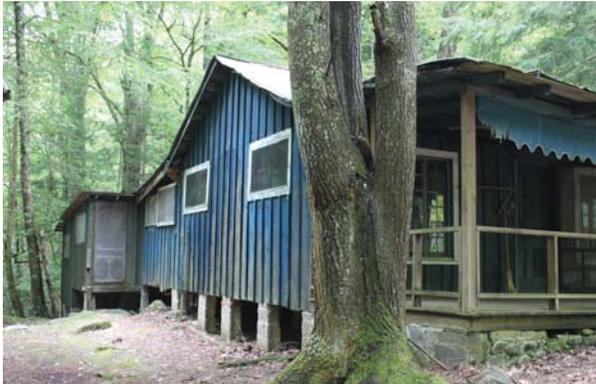
Figure 11: North side elevation.

The exterior of the house is covered with board-and-batten siding that has slight variations depending on when additions and extensions were made. The west front elevation under the front porch has an approximately centered entrance door flanked by casement windows. A rear entrance stoop with shed roof is located on the south side elevation at Room 109. A second rear entrance is located where Room 110 extends from the north side elevation. Steps visible at this entrance in photographs from 1992 and 2001 are now missing. (Figure 11) An interior fieldstone chimney rises out of the northwest corner of Room 109.

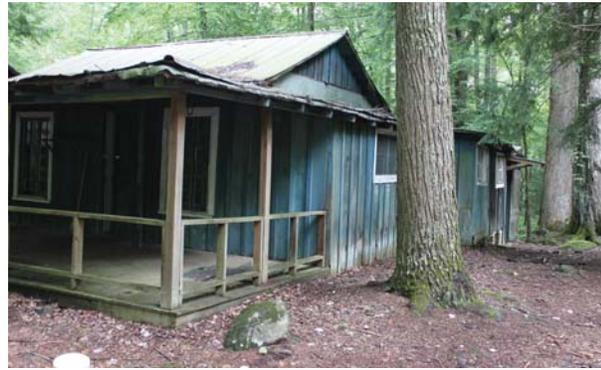
**Figure 14:** Side-gabled and shed roofs.

*Roof Framing*—(See *Roof Plan* in Appendix.) 2" by 4" rafters at 30" on center frame the side gabled roof. The exposed rafter ends are visible under the front porch shed roof and along the rear wall of the main core in Rooms 106, 107, and 108. (Figure 14)

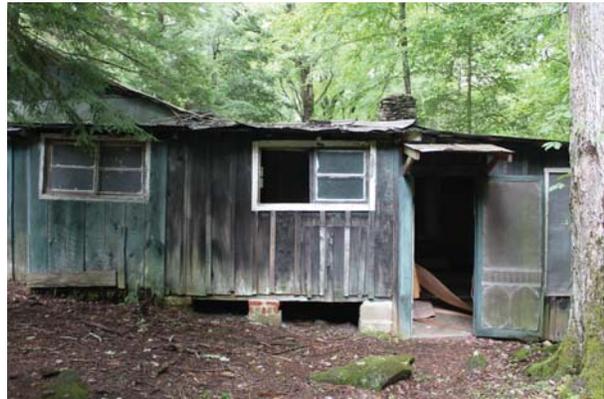
Figure 18: Rear entrance stoop on south side elevation.

A rear entrance stoop is located on the south side elevation at the exterior entrance door to Room 109. The shed roof structure over the doorway has been recently replaced and is constructed with 2” by 4” rafters supported with wood brackets and covered with 5-V metal roofing. The floor of Room 109 is at grade level and there is no step. (Figure 18)

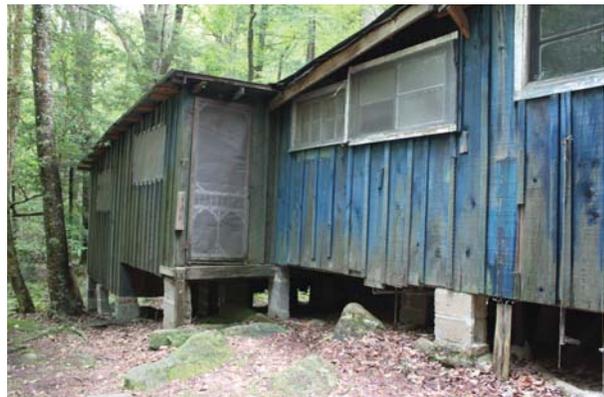
Figure 19: Rear entrance stoop at north side elevation.

A second rear entrance is located where Room 110 extends out from the north side elevation; an exterior entrance door provides access to Room 110. The eave of the shed roof above extends over the doorway to provide shelter. Wood framing members that supported the wood steps remain below the doorway, but the steps are no longer present. (Figure 19)

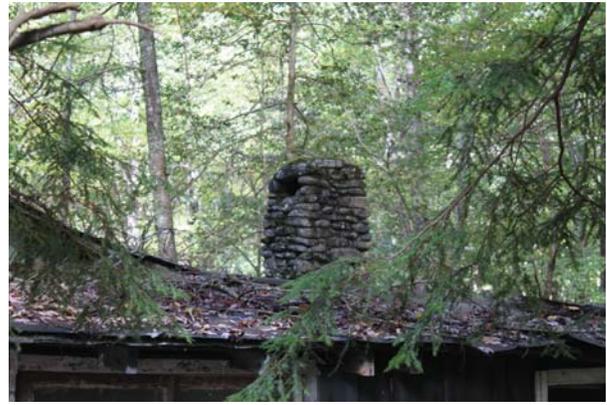
**Figure 20:** Stone chimney.

The house has one chimney located in Room 109. Fieldstones mortared with concrete construct the interior chimney, which sits at an angle in the room's northwest corner. The chimney extends above the shed roof and has an arched fieldstone cap. (*Figure 20*)

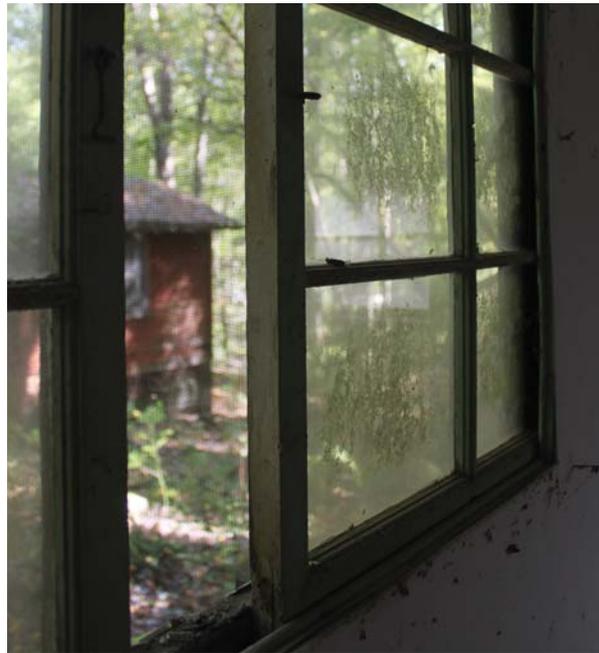
Figure 27: Sliding windows with wall pockets in Room 111.

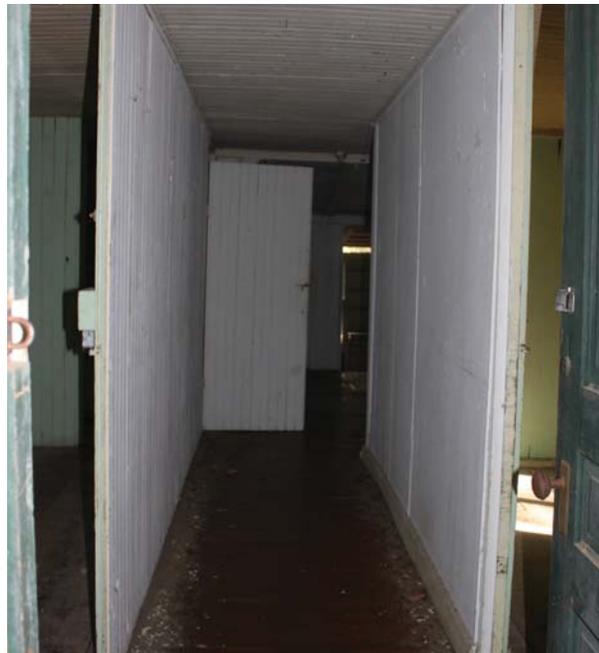
Figure 28: Room 101 - hallway - looking from front entrance door toward rear hallway.

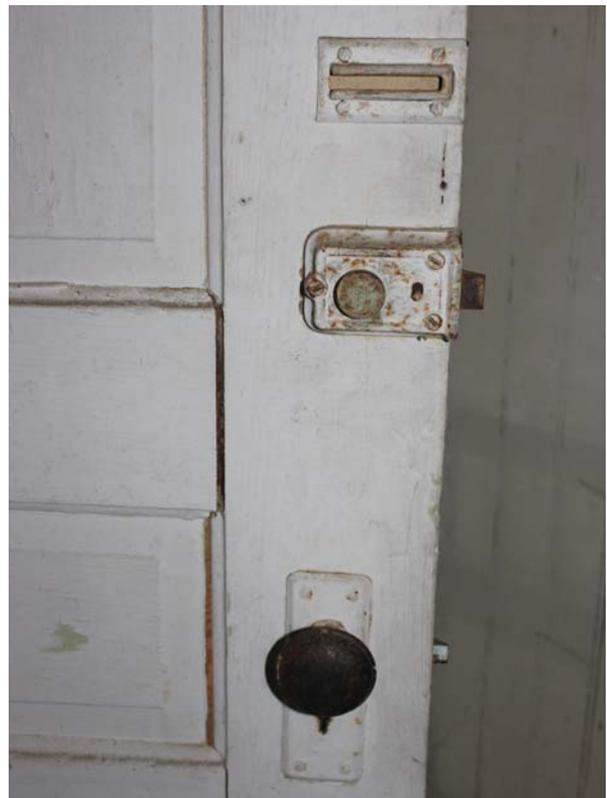
*Doorways*—Three doorways enter into the front hallway, one exterior and two interior. The front exterior entrance door is framed but has no casing. (See *Exterior Doors.*) (Figure 29)

Figure 29: Front entrance door hardware.

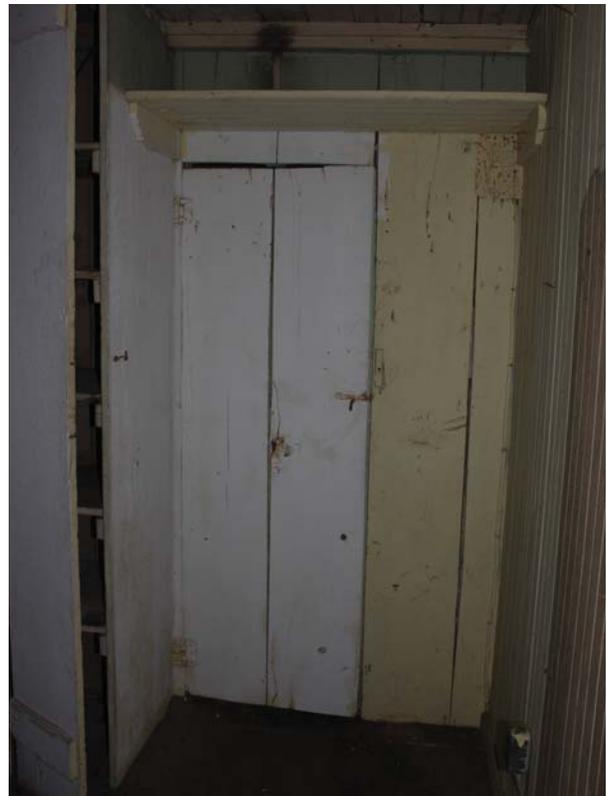
The rear hallway is an extension of the front entrance hallway at the rear of the main core between Rooms 104 and 105. The space measures approximately 9’-1” to the north wall of Room 105 by approximately 5’-6” to the opening into Room 107. (Figure 30)

Figure 30: Room 101a - rear hallway - looking toward Room 105.

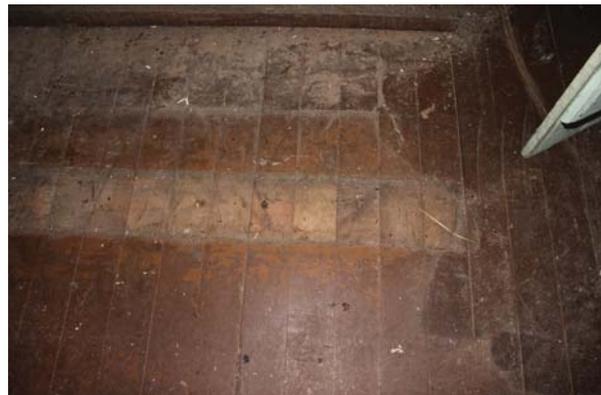
*Flooring*—The flooring is 3 1/4" tongue-and-groove wood flooring extending north-south. The outline of a previous linoleum rug is visible. A ghost outline of a previous partition wall extending east-west approximately 2' from the south wall is visible on the flooring. (Figure 37)

Figure 37: Ghost outline of partition in Room 103.

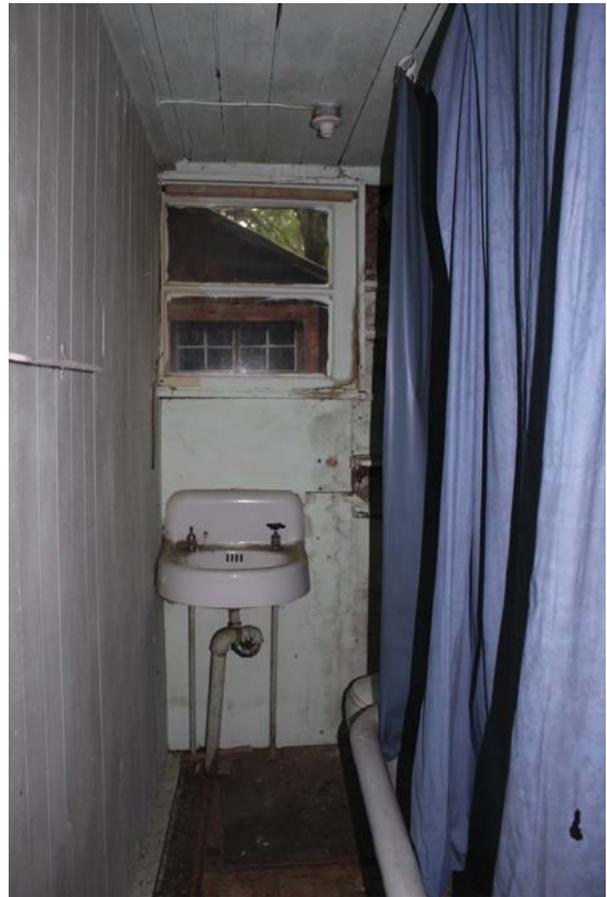
**Figure 39:** Room 104 bathroom, note window shared with Room 103.

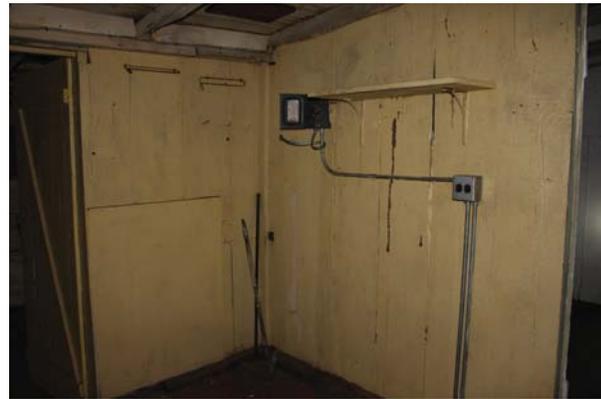
**Figure 49:** Room 108 location of hot water heater.

**Other Features**—Kitchen fixtures include a floor cabinet made of tongue-and-groove boards with a formica-type countertop with backsplash and a stainless steel sink with faucets. The cabinet doors have metal pull knobs and catches; wood shelves are inside the cabinet. Capped galvanized water supply lines and a drain that possibly attached to a hot water heater are located in the southeast corner of the room. (*Figure 49*)

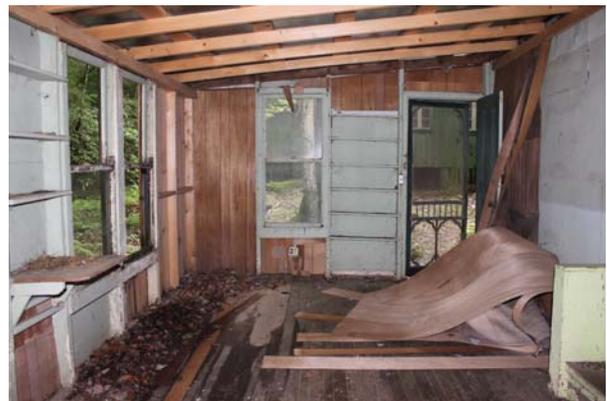
*Walls*—The east and south exterior walls consist of exposed 2" by 4" stud framing with 1/4" gypsum board and 1/8" prefinished wood paneling placed between the studs to cover the wide boards of the exterior board-and-batten siding. New 2" by 4" wall studs and top plate have replaced the framing at the south end of the east wall. (Figure 51)

Figure 51: Room 109 looking south toward exterior door.

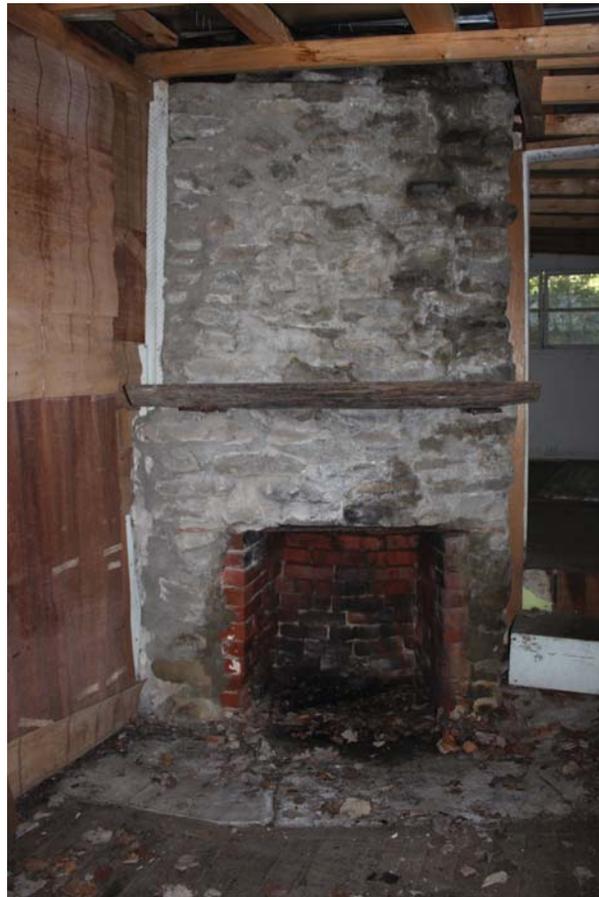
*Other Features*—The chimney/fireplace is constructed of fieldstones mortared with concrete. The firebox is made of brick; a metal lintel supports the masonry above the firebox opening. Metal plates mortared into the masonry support the half log mantel. The concrete hearth is level with the floor and extends from the west wall around to the north wall and adjacent step to Room 110. (Figure 52)

**Figure 52:** Stone chimney/fireplace.

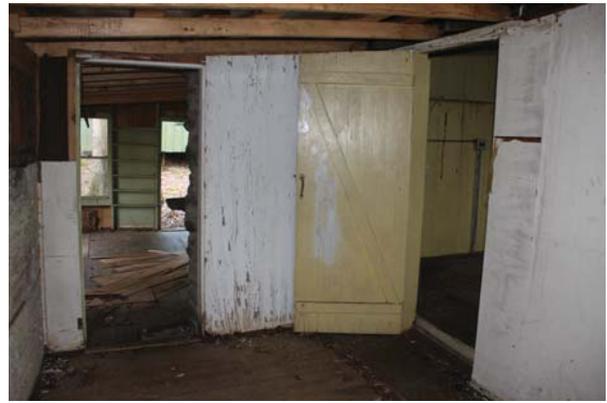
*Doorways*—Room 110 has three doorways that enter it, from the exterior and from Rooms 108 and 109. None of the doorways have casings. The door to Room 109 is off its hinges and stored in Room 110. (See *Exterior Doors, Room 108, and Room 109.*) (Figure 54)

**Figure 54:** South end of Room 110.
