Sneed Cabin

Elkmont Historic District
Great Smoky Mountains National Park

Historic Structure Report

August 2015

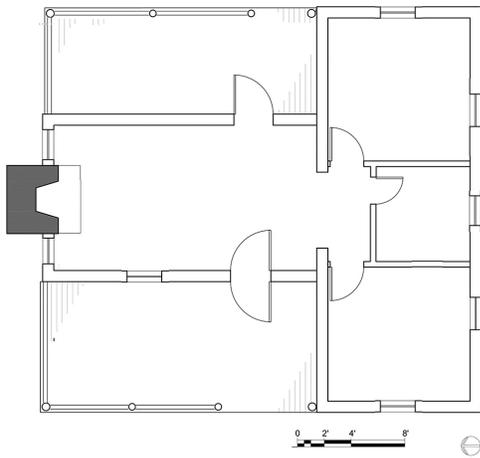
Figure 26. Probable plan of the Fultons' cabin as it was originally constructed, although there remains doubt as to the size and location of the bathroom and even some doubt whether there was a bathroom at all in the original house. The bathroom depicted in this plan reflects the present arrangement.

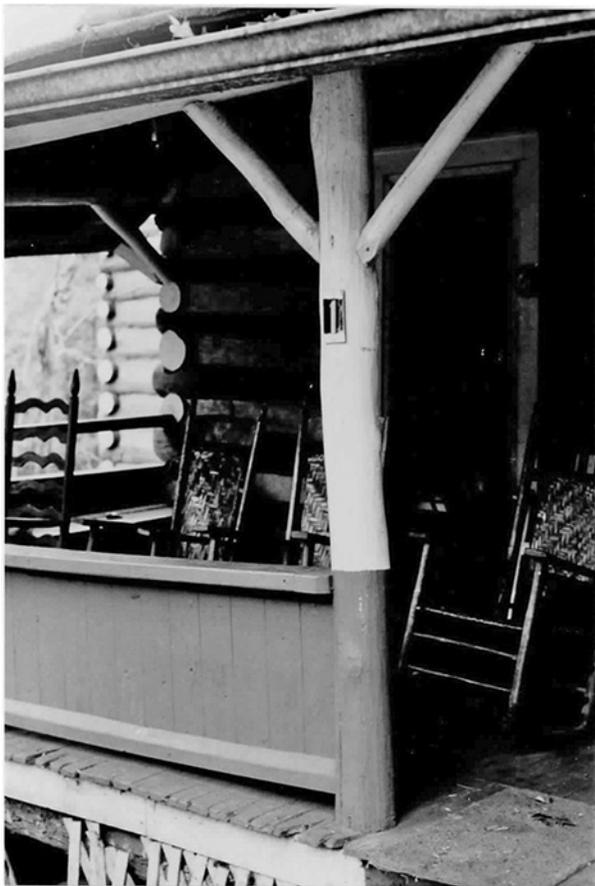
Figure 27. View of original front-porch post and balustrade, 1993. These features were removed in the early twenty-first century. Paint that remains on the logs at the northwest corner of the house suggests that the darker color was green, the lighter, white. (Thomason and Associates)

Shed-roofed porches have been partially rebuilt and, although both have lost their historic paneled balustrades, the two porches were apparently original features of the house. On the front porch, logs were used for posts to support the porch roof, each post having pole braces to the header. Only one original post and none of the braces remain intact. The balustrades visible in later photographs (Figures 27 and 39) appear to have used nominally 2" by 4" or 5" boards to form top rails, which were set about 24" to 28" above the floor. What may have been a nominally 4" by 4" board was shaped to form the bottom rail. Upright between the two rails, tongue-and-groove boards, perhaps 1" by 5", were installed in a rabbet in the bottom rail with something as simple as 1" quarter-round holding them in place at top and bottom.

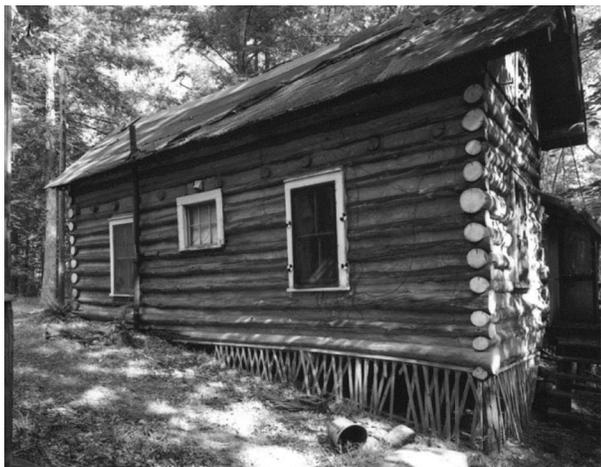
Figure 38. View of south side and part of rear of Sneed Cabin in 2001, with back steps visible at extreme right. (Historic American Buildings Survey)

The historic character of the back porch appears to be at least partially documented in Figure 40, which shows sawn wooden posts across the east side, with screening above tongue-and-groove paneling, similar to that used on the front porch. That enclosure is now missing. The south half of the floor, including joists and flooring, was recently replaced, presumably in conjunction with the roof repairs noted above. The screen door, outside landing, and steps to the ground that were historic features are missing (Figure 38).

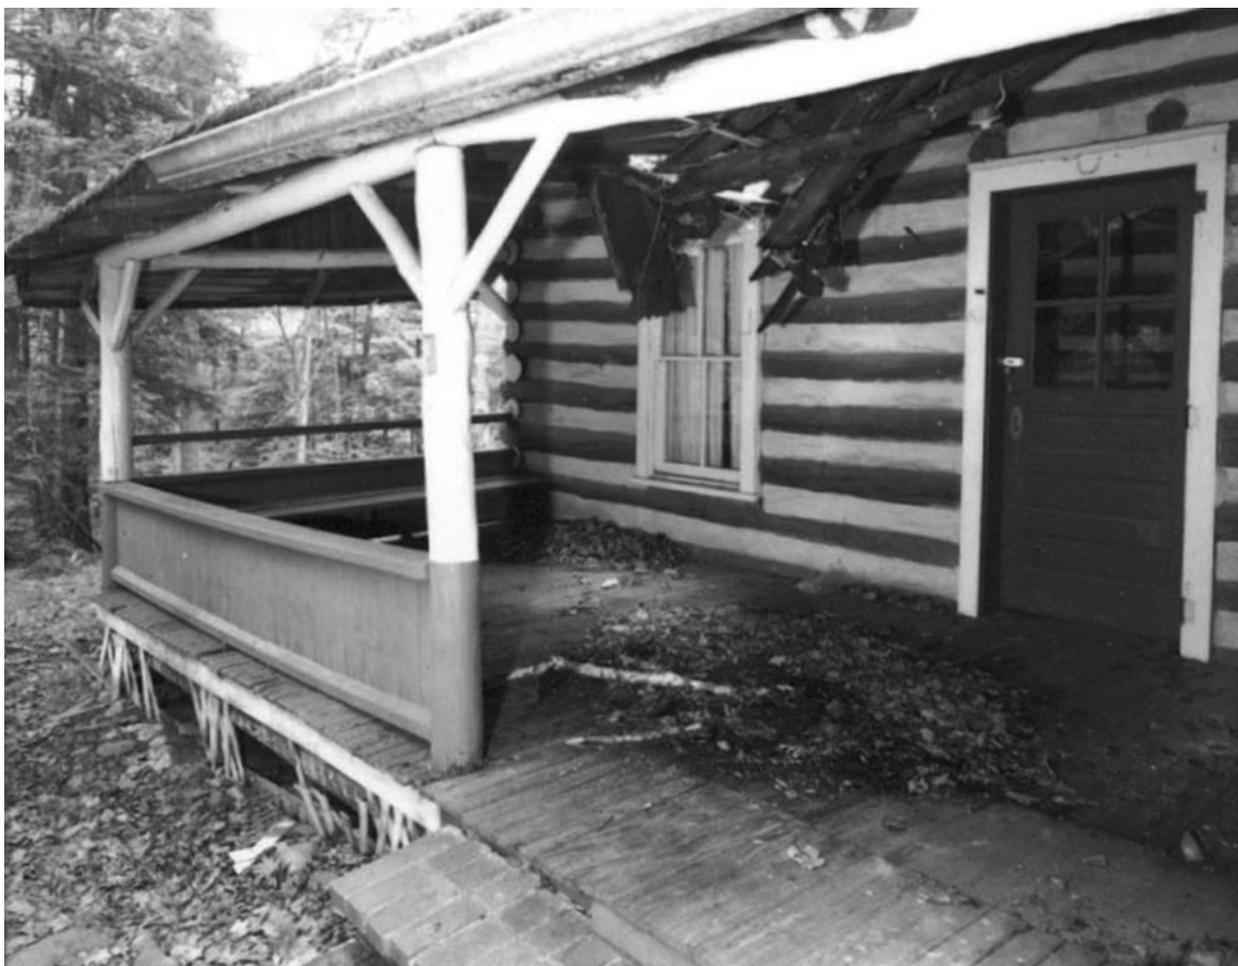
The final features that might be noted, albeit not perhaps historic, are the 6" K-style gutter and the brick steps at the front porch visible in photographs (Figure 39). The gutter appears to have been installed only over the front steps. No downspout is visible in the

Figure 39. View of front porch of Sneed Cabin in 2001. (Historic American Buildings Survey)

that end of the porch. (Figure 39 in previous chapter for details of the original posts and balustrades.) On the back porch, the railing is incomplete, with the paneled balustrade, screen door, landing and stairs to the ground no longer present.

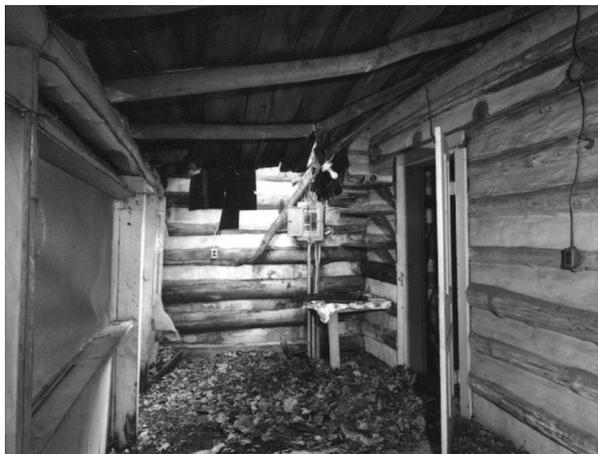
Figure 40. View looking south on back porch in 2001. Note the paneled balustrade at lower left. (Historic American Buildings Survey)

The south wall of the back porch is formed by the log wall of Room 105. Remnants of electrical wiring, most of it Romex, remain on the wall, but the breaker box that once connected them (Figure 40) is now gone. As noted above, significant rotting of the logs has occurred where that equipment was located.

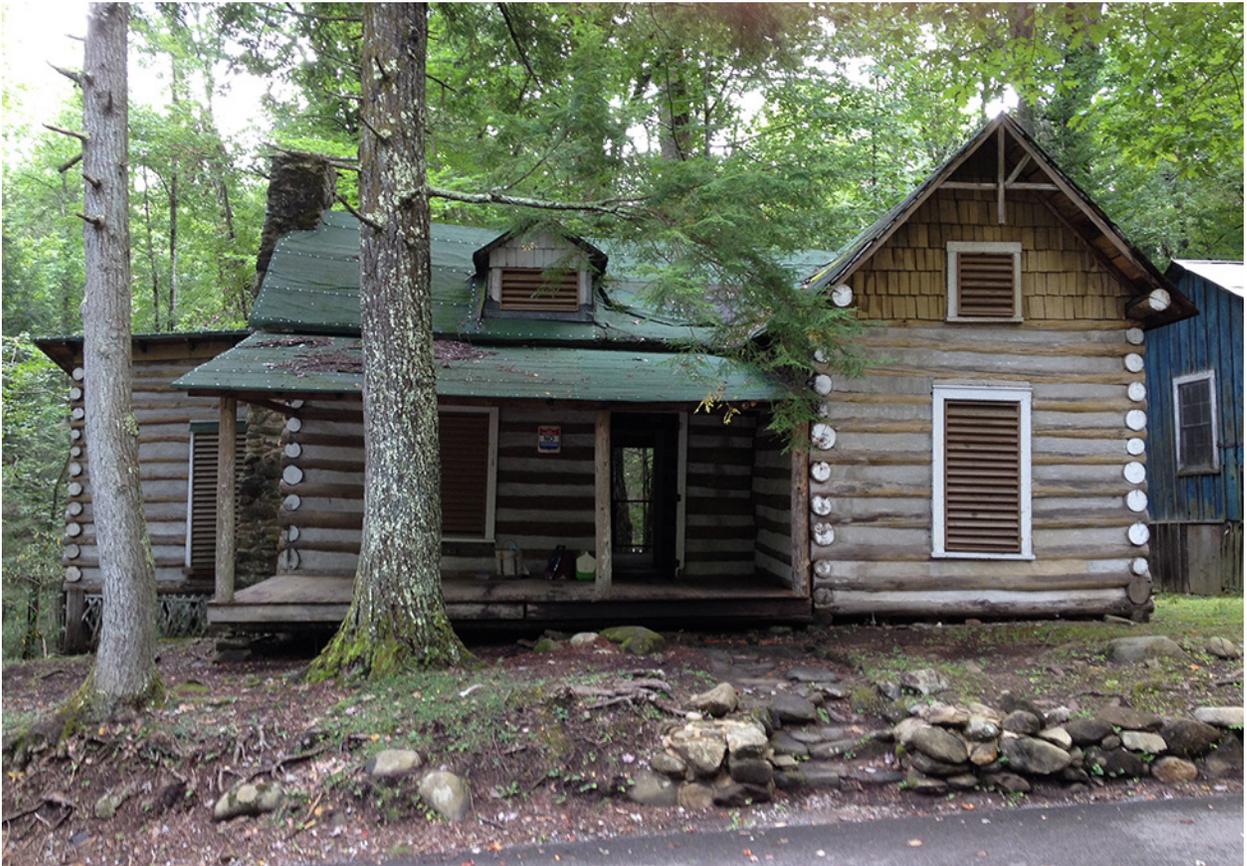
Figure 45. Front (east) elevation of the Sneed Cabin. Unless otherwise indicated, all photographs in this section were taken by JKOA in 2014-2015.

Most of the house's historic fabric remains intact, excepting the front porch balustrades and posts, the wooden steps at the kitchen door and at both porches, and the small awning roof added at the north end of the front porch. Large sections of interior and exterior tongue-and-groove flooring have also been replaced

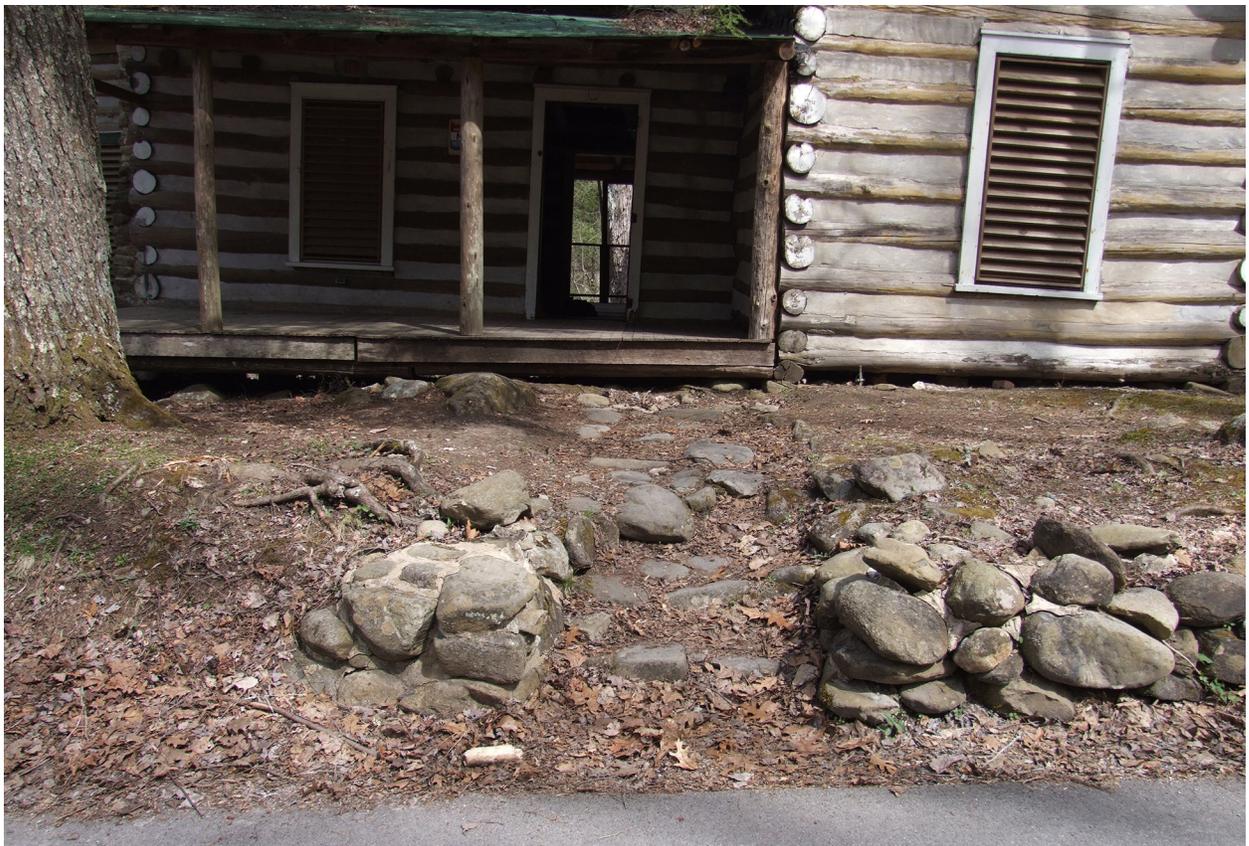
Figure 48. View of river-stone retaining wall, steps, and walkway to front porch.

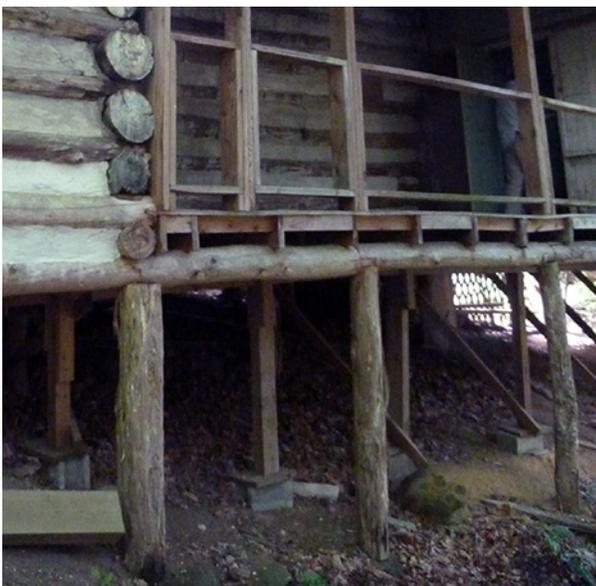
Figure 51. View of locust posts along the outside of the rear porch.

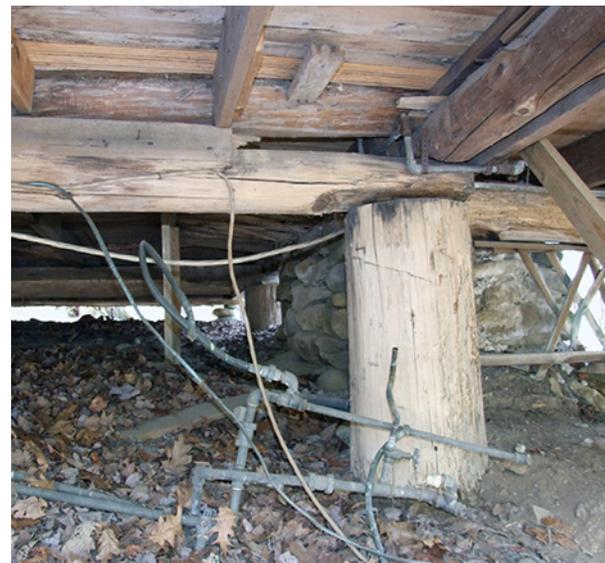
Figure 52. View of one of the largest log posts, supporting the northeast corner of the cabin.

The foundation of the cabin is in fair condition. While some of the posts are locust and resistant to rot and insect damage, many of the posts are in contact with the ground or on unstable footings. The majority of the wood lattice that enclosed the foundation is missing and the remainder is in very poor condition.

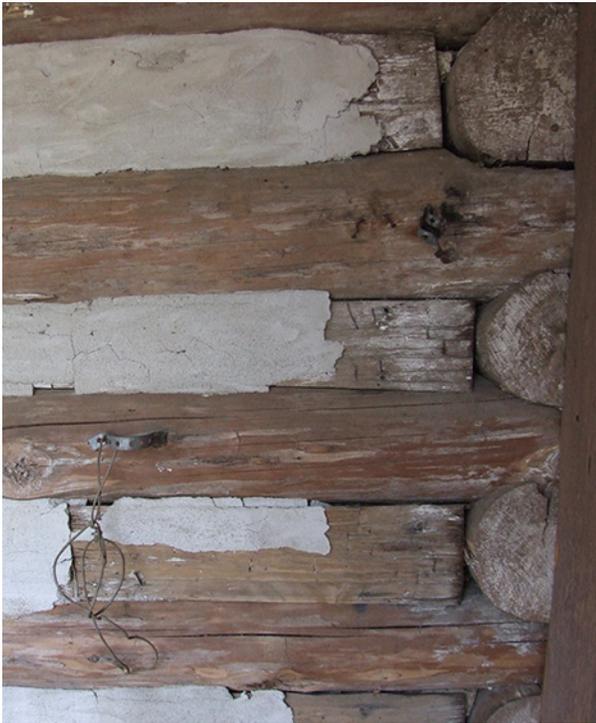
Figure 61. View of typical components of chinking in the log walls.

of cement. Much of the chinking on the interior of the walls of the south log pen appear also to have been heavily repaired. In isolated locations, expanded metal lath has been used for repairs to the chinking.

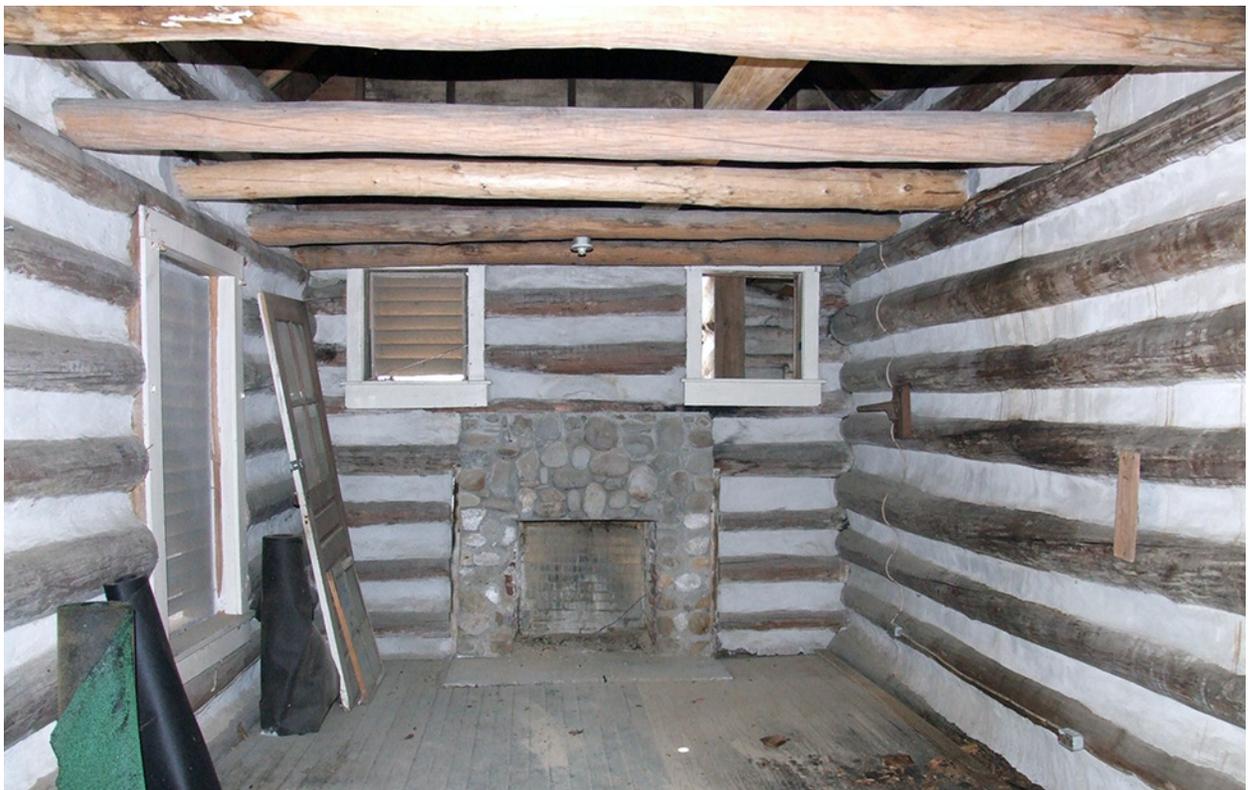
Figure 63. View of the log pen encompassing Room 101, showing log walls and cross beams typical of both pens.

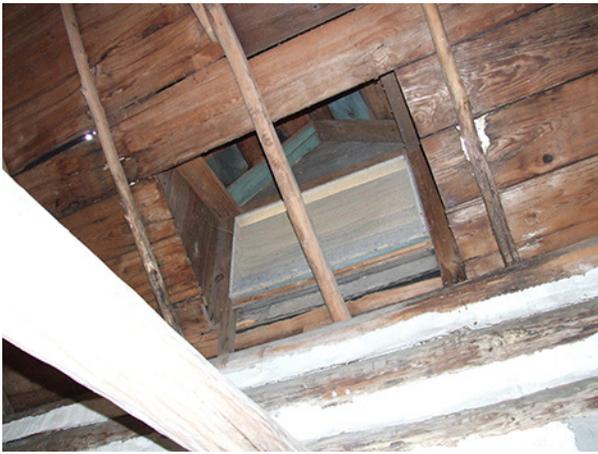
Figure 69. View of roof around west dormer.

There is a major active leak around the dormer on the east side of the house. The entire roof covering is in very poor condition. There are no gutters on the cabin and ground drainage is uncontrolled, keeping areas of the

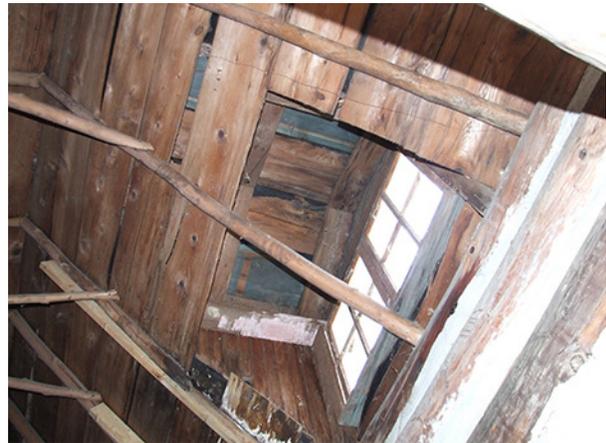
Figure 72. View of underside of east dormer.

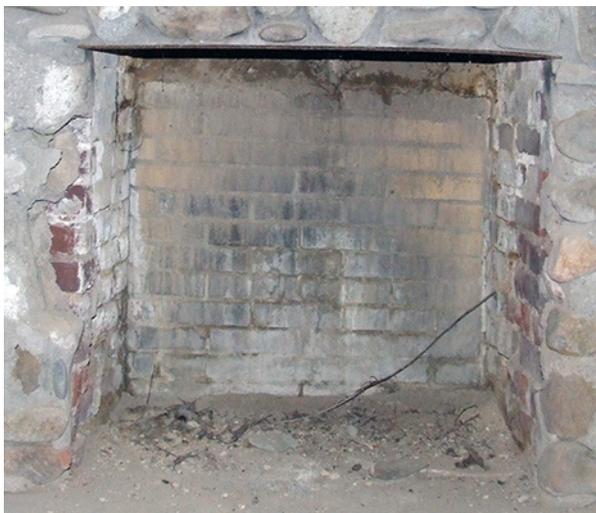
Figure 75. View of the firebox.

The top half of the chimney stack has a slight tilt to the south. A vertical crack running for several feet on the west face of the chimney has been repaired. The metal chimney cap is missing, exposing the interior of the entire chimney stack as well as the firebox to water penetration. The stone veneer is missing from the left cheek wall of the fireplace.

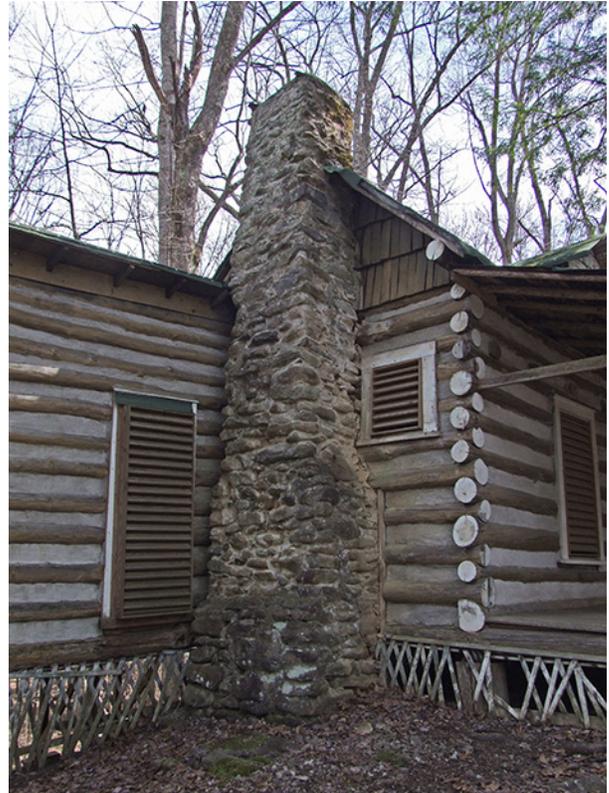
Figure 76. View of Sneed Cabin chimney.

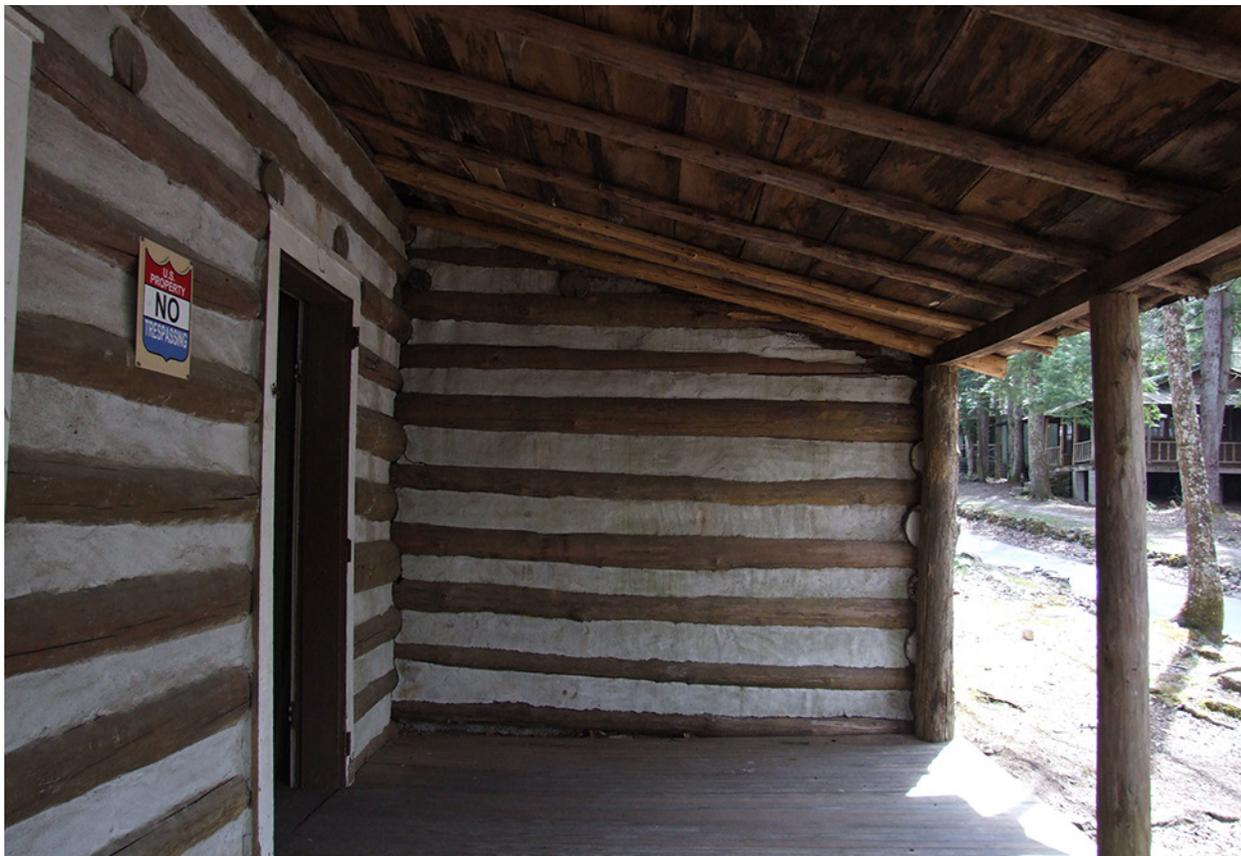
Figure 84. View looking south on front porch.

The paneled balustrades and wooden awning have been removed and all but one of the original log posts have been replaced. Only the post at the northwest corner of Room 103 remains in place.

Although both porches are in sound condition, the historic character of the Sneed Cabin was severely compromised by some of the alterations that occurred during the course of recent repairs. These include removal of the log posts, pole brackets, and paneled balustrades from the front porch, which occurred after 1993. The header for the front-porch rafters is now comprised of two nominally 2" by 4" pieces of lumber set on edge; they appear to have replaced an original log header. At the northeast corner of the front porch, paint has left a "ghost" of the railings at

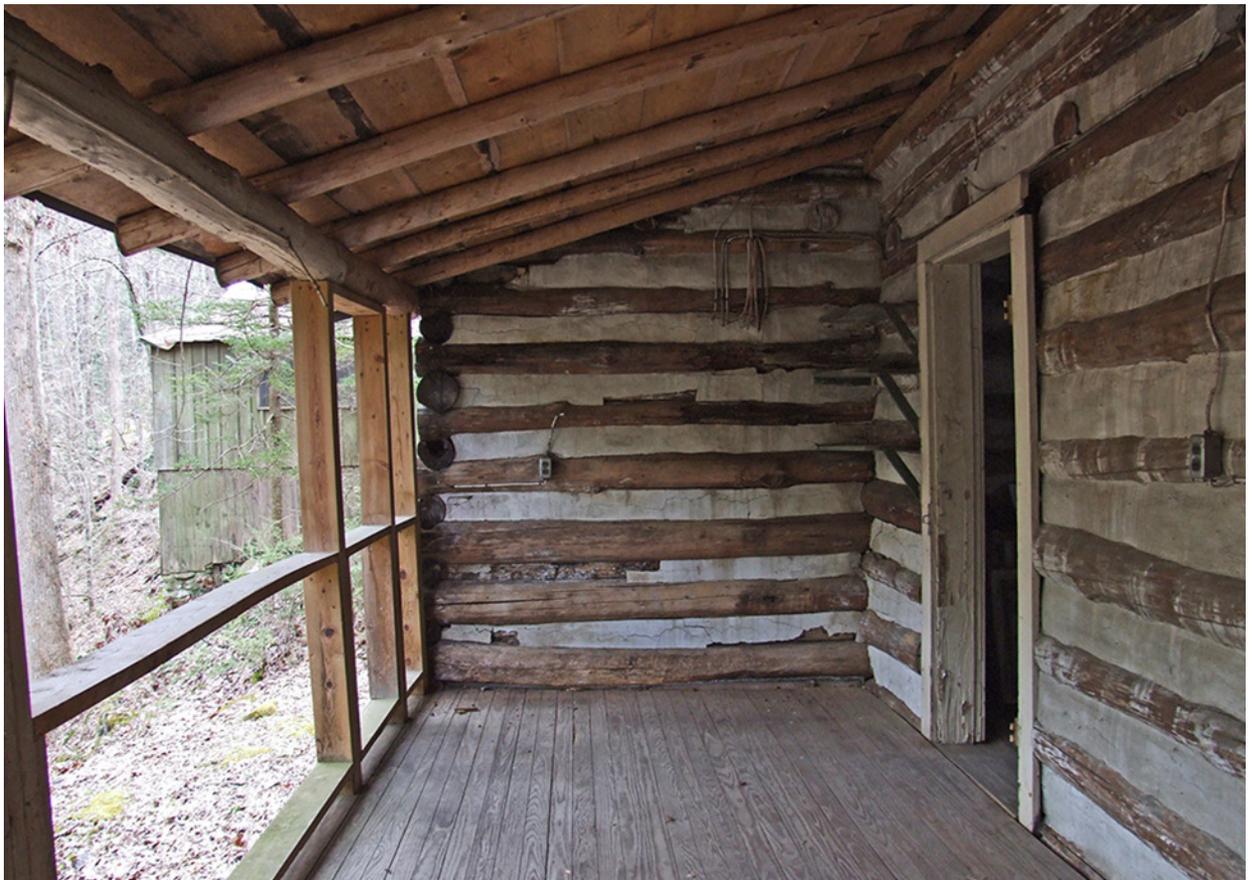
Figure 85. View looking south on back porch.

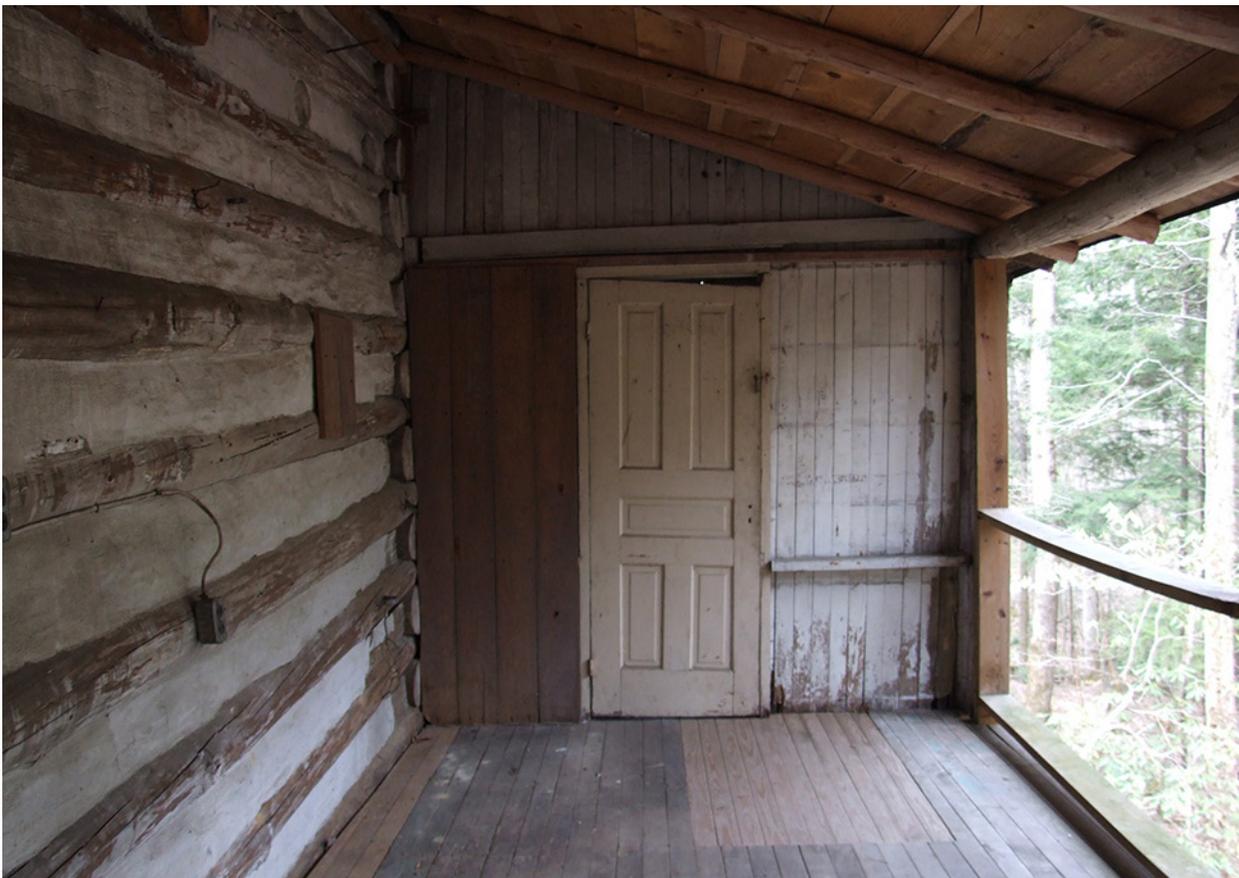
A 7" log header for the rafters of the porch's shed roof is set on nominally 2" by 4" posts. The south end of the header has been replaced; the replacement timber was cut slightly too long for the space, leaving the top of the wall with an outward cant of several inches. Exposed pole rafters, 4" to 6" in diameter set on 24"-28" centers, complete the roof framing. Closed decking uses nominally 1" by 6" boards.

Figure 87. View looking north on back porch.

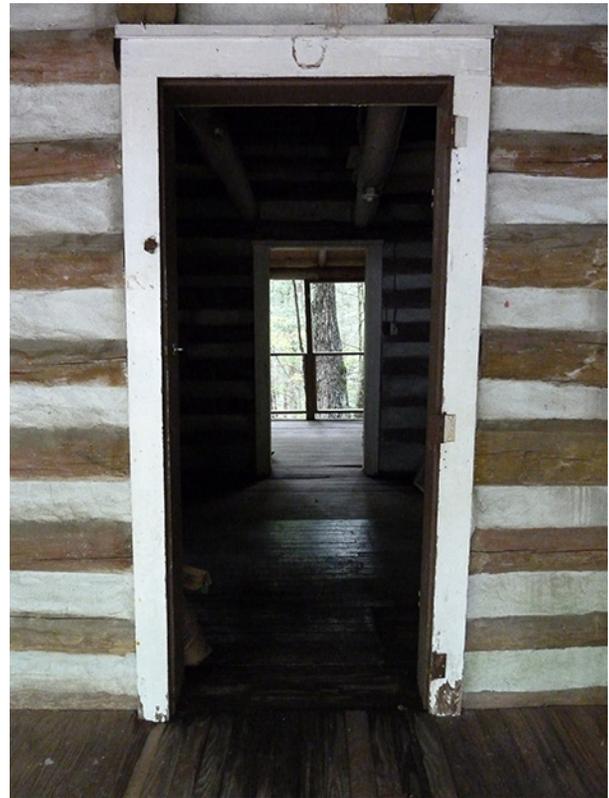
Figure 88. View of front door opening.

completely unsecured. The front door and one screen door remain stored in the cabin, but the back door and the screen door for the front door are missing. Knobs and spindles have disappeared from the front door and from the door at the north end of the back porch. Both of the remaining doors and all casing and trim need minor repairs and repainting.

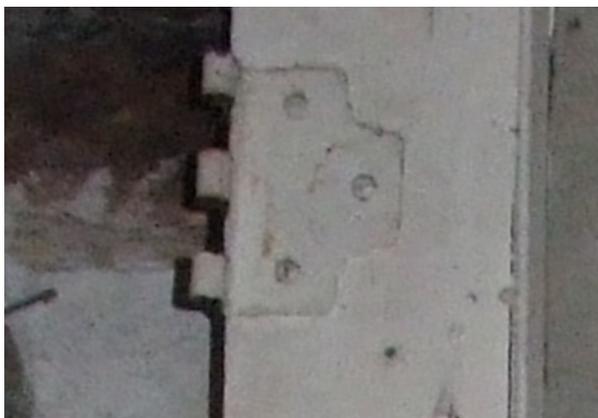
Figure 91. View of the surface-mounted portion of the hinges with which the front door is hung.

The front door opened inward and was hung on a pair of unusual five-knuckle hinges mounted to the south jamb. The two-knuckle jamb portion of the hinge, which remains in place, is a 2" by 4" rectangle mortised into the jamb and attached with three screws. The other half of the hinge is surface-mounted to the interior face of the door, which is apparently how the hinges were designed to be installed. The hinge pins are missing.

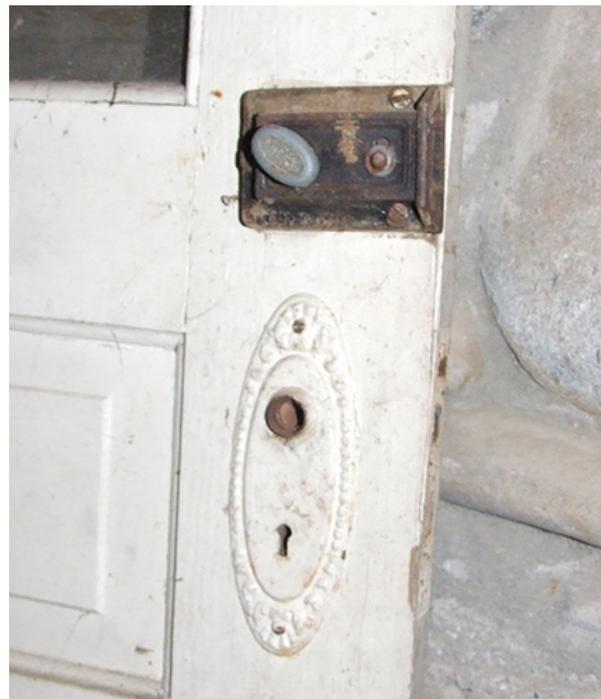
Figure 92. View of escutcheon and rim lock on the inside face of the front door.

The original mortise lock remains on the door along with the stamped-metal escutcheon on the door's interior face. The escutcheon is oval, about 6³/₄" by 2¹/₄", with a raised, flat center oval and a ribbon-and-bead border. The doorknob spindle, knobs, and the escutcheon on the exterior face of the door are missing. The escutcheons most likely matched.

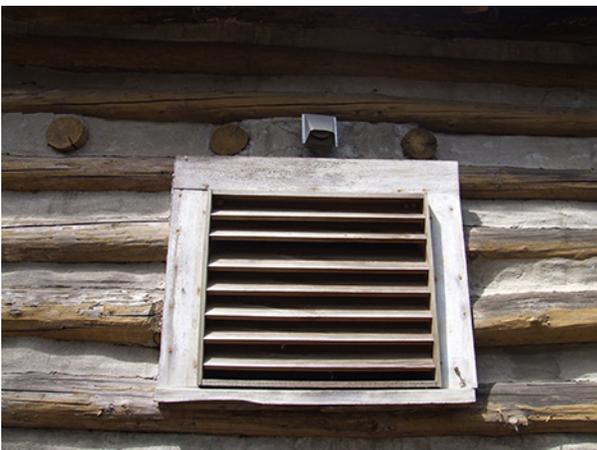
Figure 104. View of exterior of bathroom window.

The present bathroom window is entirely modern, and although there is no physical evidence for window sash in the present opening,

record photographs from the 1990s show the window with a single six-light sash, the only such sash in the house. The present opening measures 2'-8" wide and 2'-3" high and now

has a fixed wooden louver similar to those installed elsewhere on the house. Window casing is 1 $\frac{1}{8}$ " by 4 $\frac{3}{8}$ "; sills are 1 $\frac{1}{2}$ " thick and extend 1" beyond the front face and outside edge of the casing. There is no drip cap.

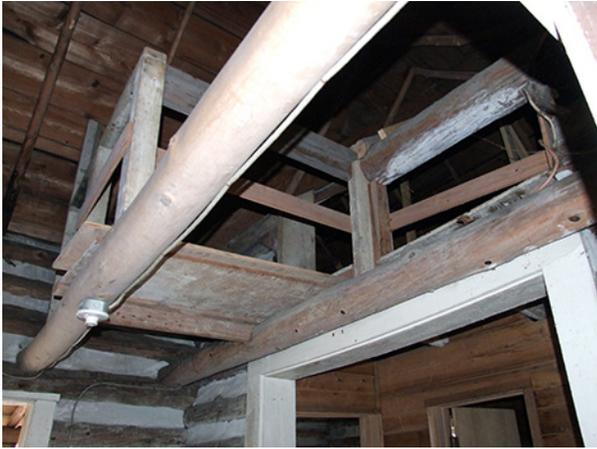
Figure 108. View of landing created in the late twentieth century to provide access to the loft over the south log pen.

Probably in the fourth quarter of the twentieth century, the existing, roughly-framed landing was installed above the southeast portion of the room. Framed with nominally 2" by 4" lumber, it provides access to a loft that was accessed by cutting out the center section of the top two logs of the wall connecting the two pens and simply laying ¾"-thick sheets of plywood across the joists over the south log

pen. Nominally 2" by 4" lumber was also laid across the log joists to provide support for the butt joints between the sheets of plywood. There is no evidence that a staircase was ever built, and a ladder provided access to the loft (Figure 43).

Bathroom fixtures should be removed and waste lines capped to avoid their becoming an attractive nuisance. Similarly, removal of the plywood flooring for the makeshift loft might eliminate another attractive nuisance while reducing the habitat for wild animals inside the house.

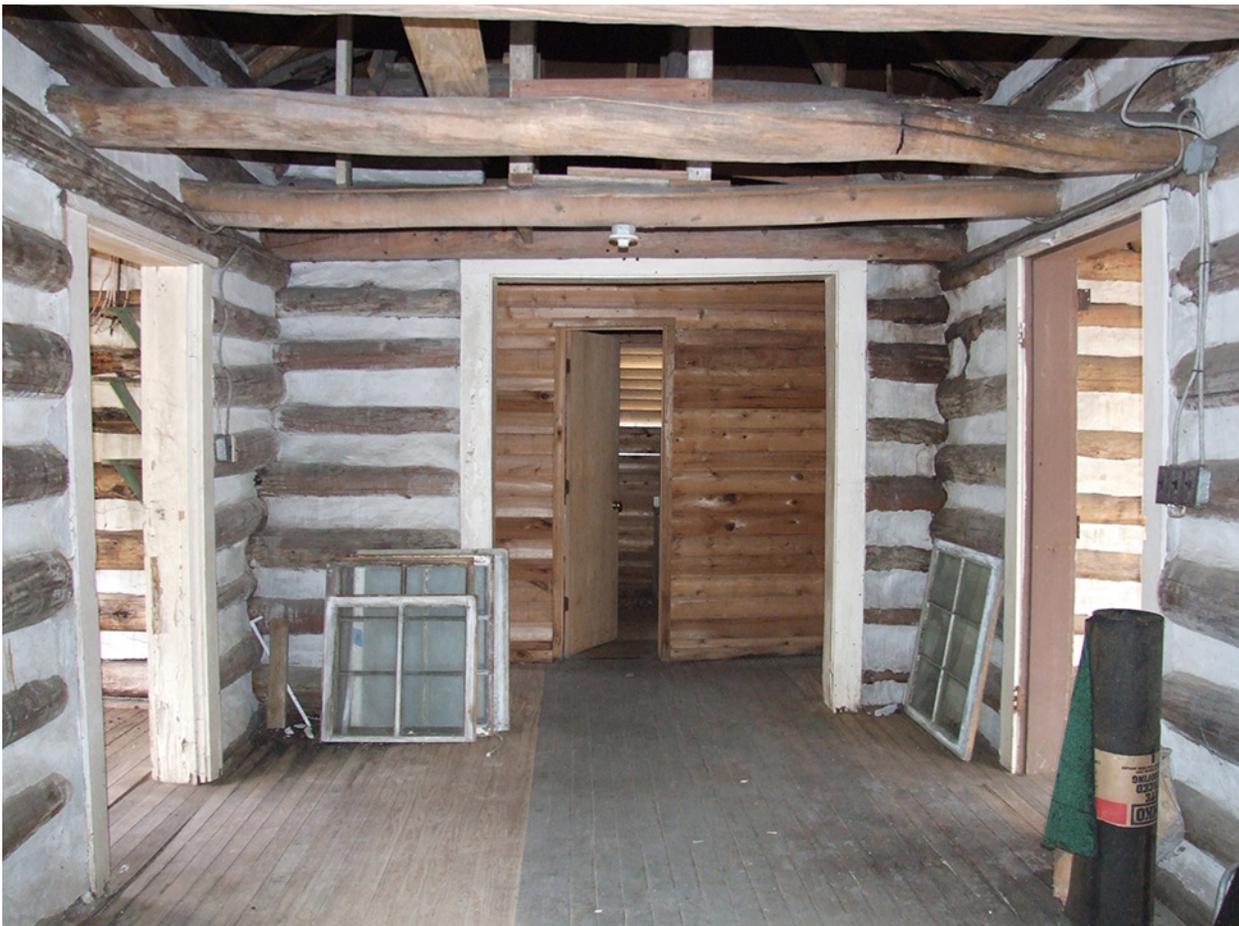
As with the doors, many of the window sash have been removed from their frames but remain in the house. Casing has been removed from one of the kitchen windows, but is still in

Figure 109. View looking south in Room 101.

the room. All of the windows, casing, and trim need minor repair and painting.

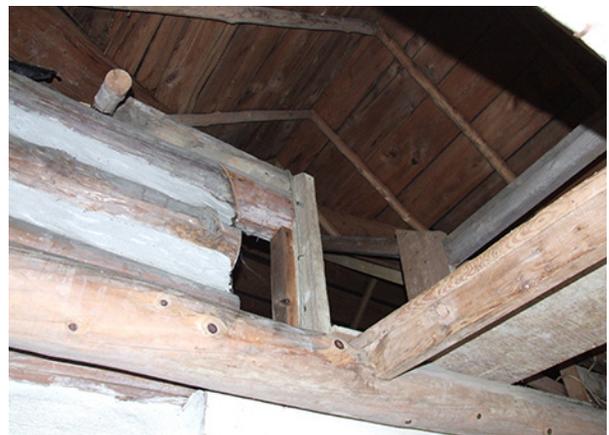
Figure 111. View of opening in log wall created for accessing the loft over the south log pen.

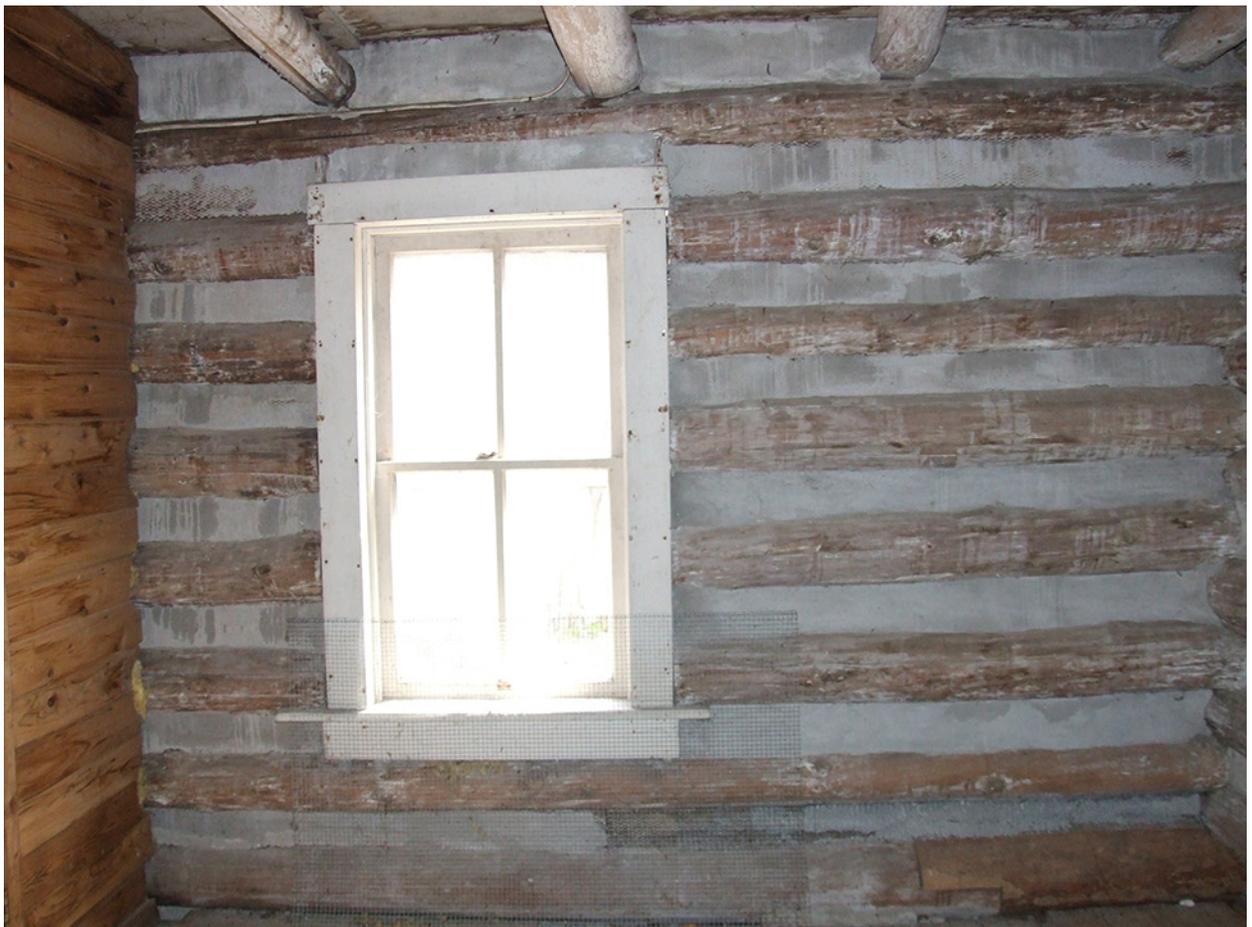
Figure 114. View of south wall of Room 102 and the most intact of the original double-sash windows.

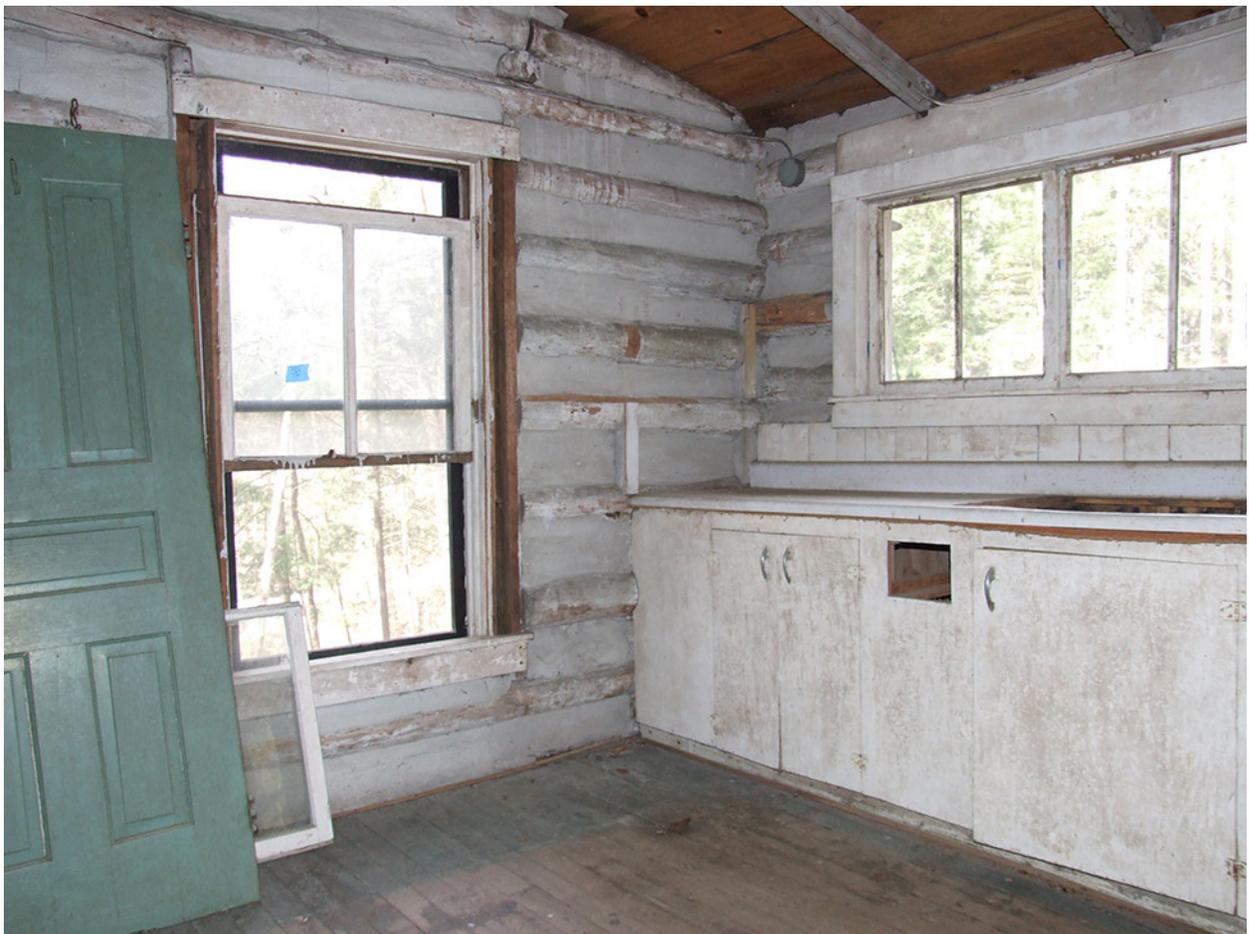
Figure 125. View looking northeast in Room 106. The wooden counter base replaces what was probably a cast-iron, wall-hung sink and drain board in the original kitchen.

Other Features: As noted earlier, a patch in the upper part of the north wall and a corresponding patch in the east face of the chimney mark the location of the original wood- or coal-burning stove. A wooden base cabinet typical of the late twentieth century occupies the entire east side of the room. It is probably contemporaneous with the bathroom remodeling. A double-basin sink has been removed along with the supply and waste lines. Two drawers are also missing.

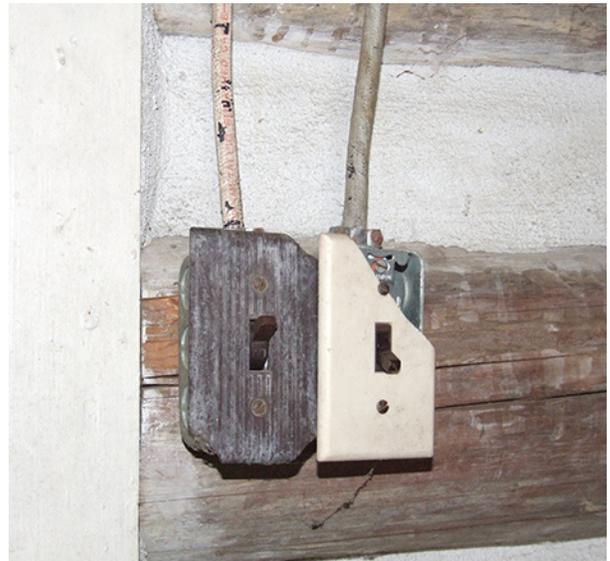
Figure 129. View of two generations of electrical switches and wiring, with the earliest on the left.

There is no evidence in the Sneed Cabin for an early, knob-and-tube wiring system, such as that found in some of the other cabins. The earliest wiring observed has cloth insulation impregnated with fire- and moisture-resistant compounds, typical of the mid-twentieth century. Later wiring is modern Romex wiring with plastic insulation. Two generations of junction boxes are also evident, but both are galvanized steel and similar in design. Two generations of cover plates are present as well, one brown with a striated surface and the other ivory with a smooth surface.

Little rehabilitation of the interior to make it safe for self-guided visitor access would be required. Electrical and water service should not be reinstated, except as necessary for fire protection and security, thereby eliminating a variety of hazards to the historic building.

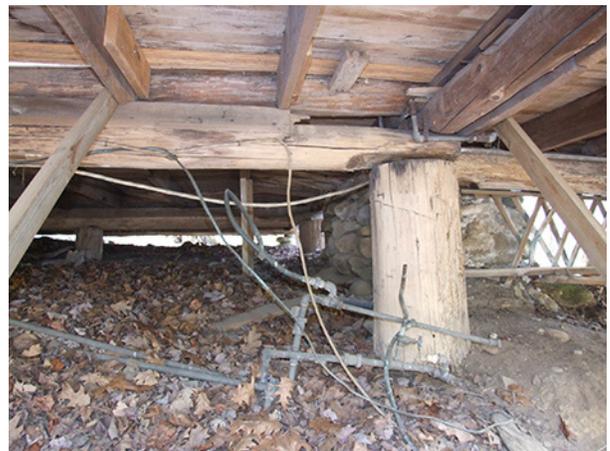
Figure 130. View of what may have been supply lines for propane gas heaters.

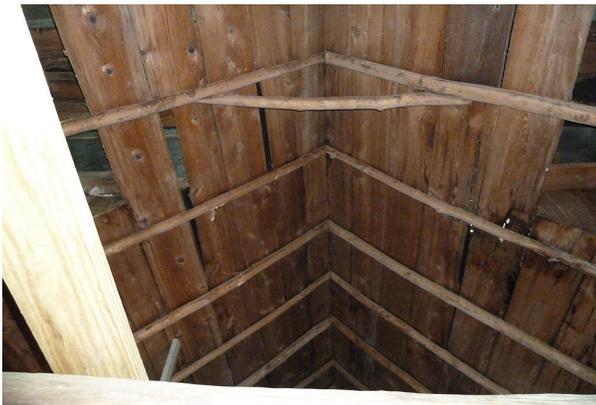
The broken and missing collar ties diminish the roof structure and the cabin's historic character as do the damaged trusses at the

Figure 140. View of pole rafters and collar ties over north log pen.

east and west gables. These features should be repaired in kind.

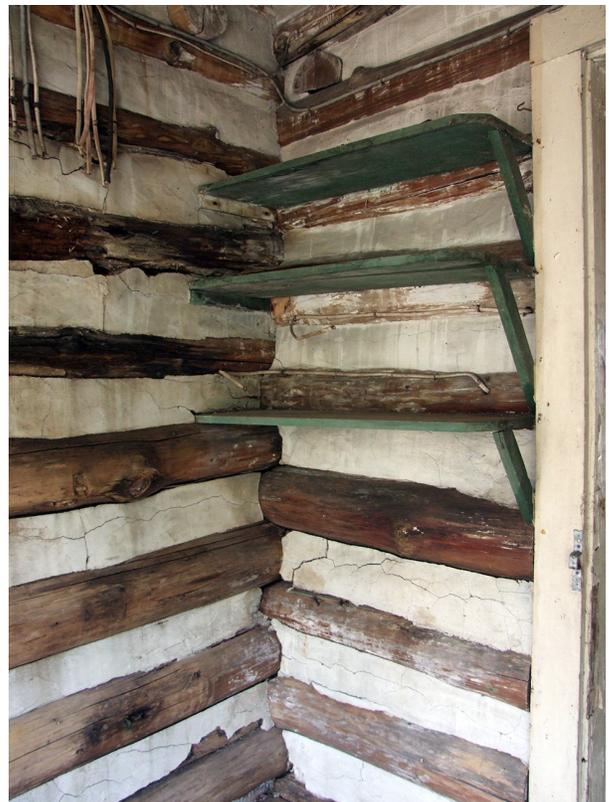
Figure 142. View of shelving and remnants of old wiring at southwest corner of back porch.
