## Battery 234 CRF/BCS Tower

# Historic Structure Report

May 2015

Prepared by:  
Wiss, Janney, Elstner Associates, Inc.  
330 Pfingsten Road  
Northbrook, Illinois 60062

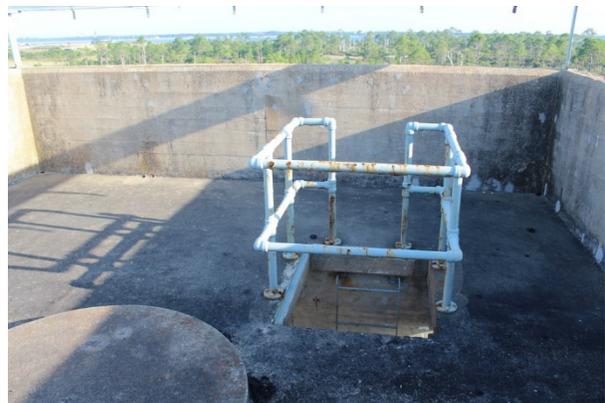
- *Steel repairs.* The contractor’s proposal indicated that “unsafe” portions of the steel structure would be cut out and replaced. This included replacement of the stairway landings with new diamond-pattern steel plate to match the older plate (Figure 17 and Figure 18); replacement of the stairway handrails to match the previous configuration; and the installation of an entirely new 42-inch-high steel pipe guardrail at the upper observation level around the ladder access opening (Figure 19).

**FIGURE 19.** View of the upper observation level, August 2014, showing the steel guardrail and mortar patches installed as part of the 2009 work. Photo by the authors.

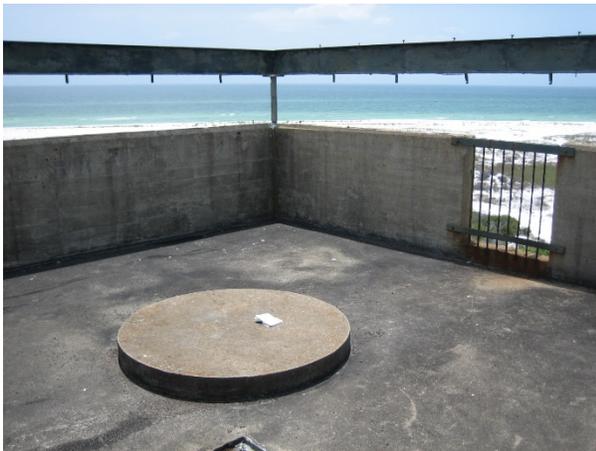
- Replacement of the steel guardrail (“fence”) on the west side of the upper observation level was completed as part of the work (Figure 21). However, given the existing condition of this

**FIGURE 21.** View of the upper observation level, 2008. Replacement of the railing at the west side was proposed. Source: Gulf Islands National Seashore.

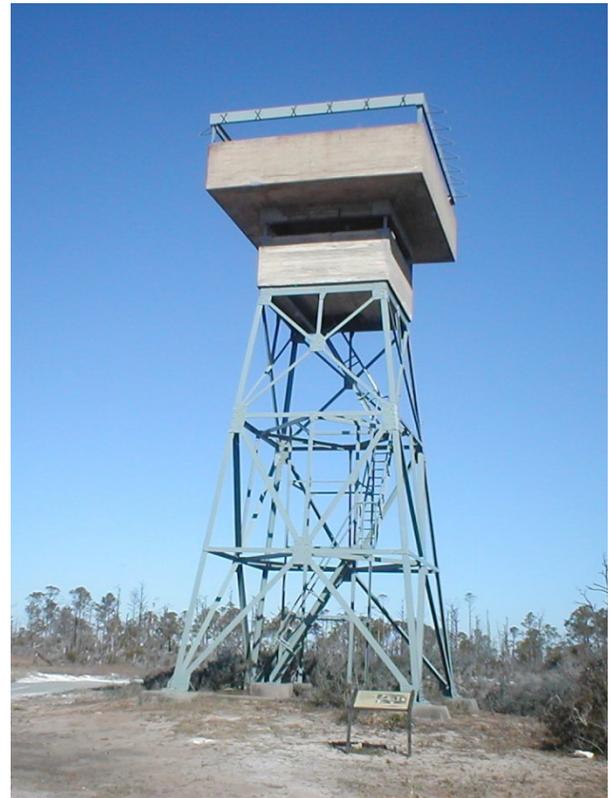
The repair project was completed by February 2009, and the tower was reopened to the public (Figure 23).

**FIGURE 23.** The Battery 234 tower after rehabilitation, February 4, 2009. Source: Gulf Islands National Seashore.

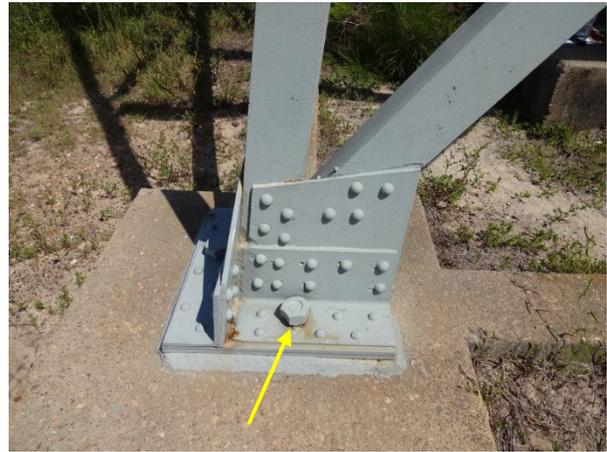
**FIGURE 33.** One of the typical riveted gusset plate-angle assemblies at the base of the tower, anchored to the concrete footing with two anchor bolts (arrow indicates one bolt).

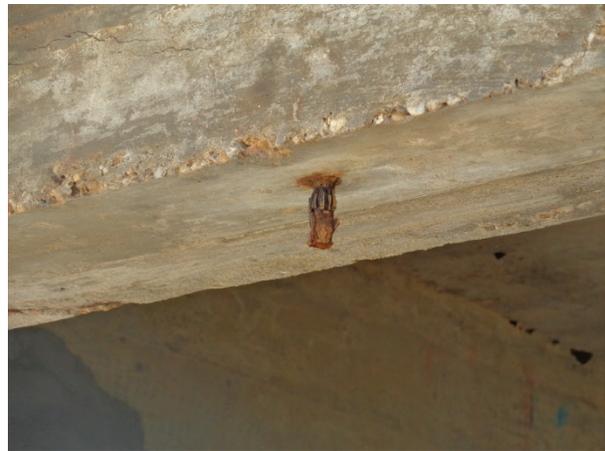
At the lower level of the observation booth, there is a continuous ribbon window opening along the west, south, and east elevations (Figure 55). The opening is approximately 19 inches tall and wraps the corners of the structure. A steel post supports the structure at the southeast and southwest corners of the opening (Figure 56). A single window opening is located at the center of the north elevation (Figure 57). At the window openings, metal dowels, spaced approximately 3 feet apart, are embedded into the concrete at the head (Figure 58). The dowels are severely corroded and appear to have served as anchorage for a previously existing window or screen system.

**FIGURE 58.** Typical anchor for former window or screen system at the lower level window openings.

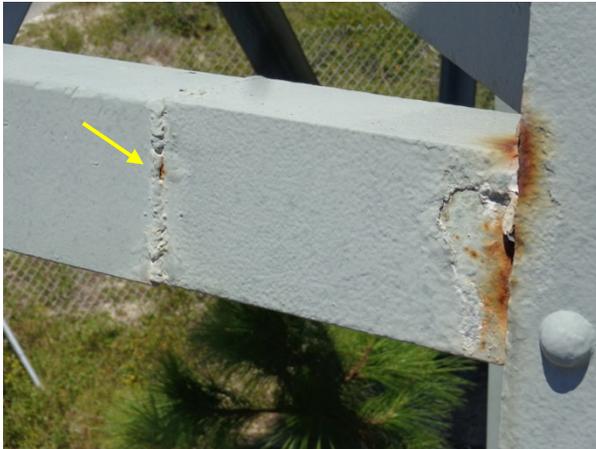
- Evidence of previous repairs to the structure included a spliced horizontal framing member. The repair segment was welded to the original portion of the horizontal brace frame member and painted (Figure 82).

**FIGURE 82.** Welded splice between original member (left) and new horizontal repair segment (right).

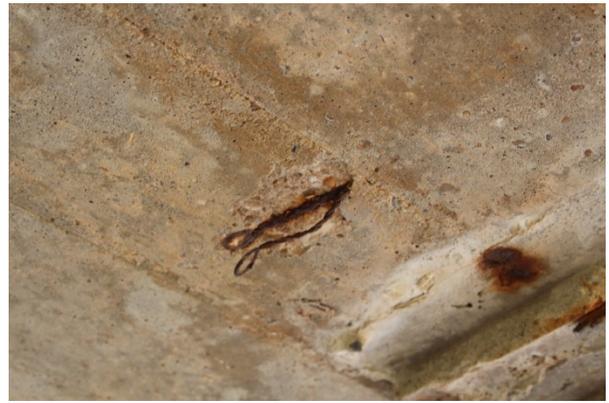
- Metal debris was observed embedded in the surface of the underside of the upper and lower floor slab (Figure 90). The debris consisted of tie wires and small strips of metal. All of the observed debris had surface corrosion and was often associated with small spalls in the concrete. It is assumed that these miscellaneous metal items date to original construction and were used to secure form boards or provide temporary support for embedded reinforcing steel.

**FIGURE 90.** Metal debris from original construction embedded in the concrete.

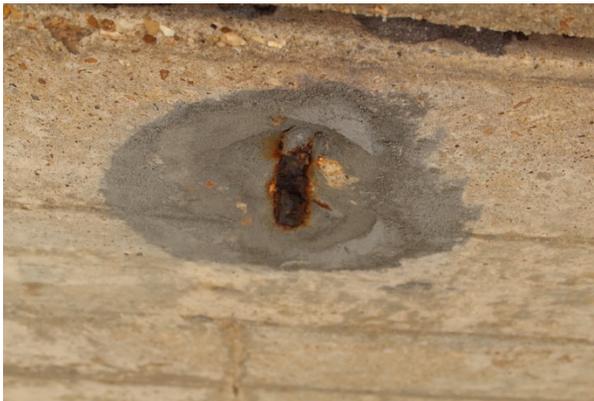
- Previously installed concrete patch repairs were observed at the underside of the upper level overhang. Many of the patch repairs were observed to be debonded, have corrosion staining, or exhibit spalls (Figure 87 through Figure 89). Where patches had failed, the concrete patch was observed to be approximately 1/2 inch deep.

**FIGURE 88.** Corroding reinforcing steel at spalled patch.

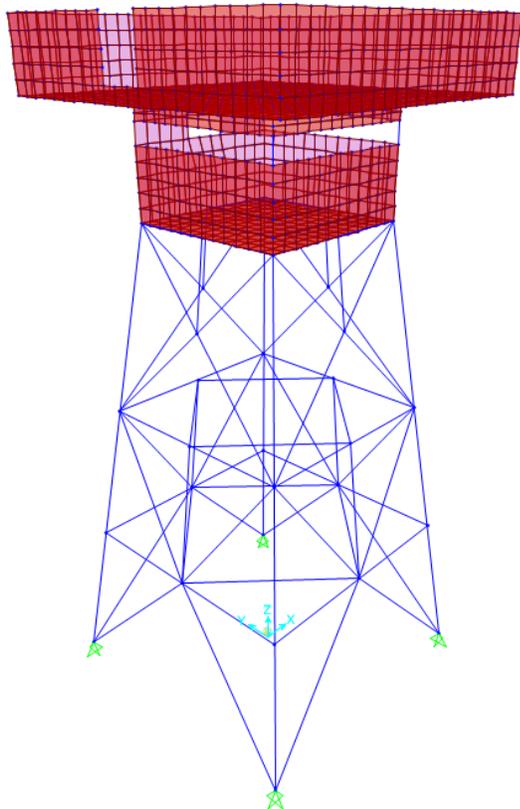
The analysis indicates that the primary framing elements and connections of the tower have adequate design strength to resist current code-required gravity and wind loads. Uplift is minimal under factored-level loads. Typical member and connection demand-to-capacity ratios are on the order of 0.5 to 0.8, indicating some reserve capacity in these elements to accommodate moderate deterioration (less than 20 percent section loss).

**FIGURE 92.** Finite element model of the tower.

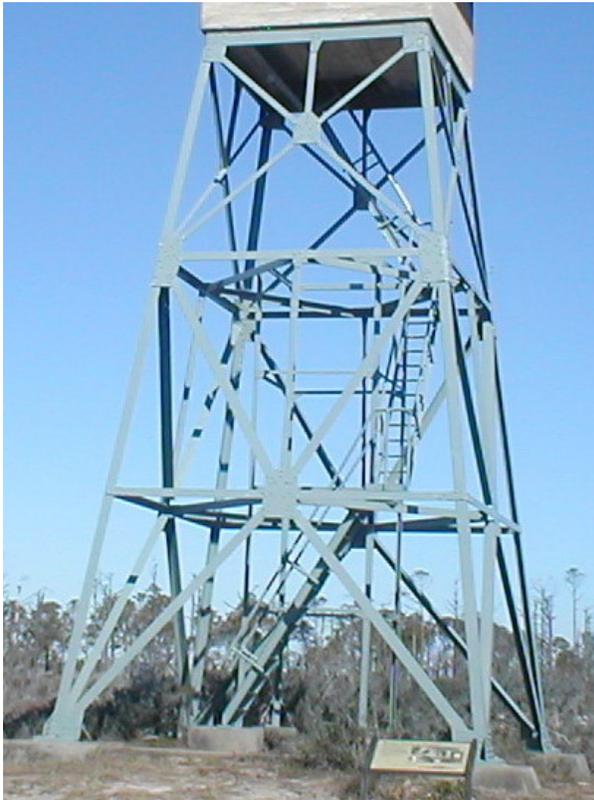
**FIGURE 97.** Detail of the Battery 234 tower after repainting, February 4, 2009. Source: Gulf Islands National Seashore.

The recoating work implemented in 2009 has had a limited service life (for example, compare Figure 97 with Figure 98). Based upon the available information, it appears that the surface preparation work was limited, and that adequate measures to control and mitigate chloride contamination on the surface prior to coating application were not performed. Therefore, the following steps are recommended for comprehensive coating replacement:

- The existing surface coating and rust scale should be removed to bare steel using abrasive blasting in preparation for a new coating system. Because of the windy site and exposure to airborne chloride contaminants, scaffolding or containment of the tower will be necessary during the surface coating removal and preparation process and new coating application. Prior to paint removal, the existing coatings should be sampled to check for potentially hazardous materials. Significant repair work performed at the tower in 1980, after lead was removed from most commercially available paints; however, other traces of original lead-containing paint and/or other potentially hazardous elements may be present in the existing coating. If hazardous materials are present, it may be necessary to first use chemical paint strippers and/or water blasting to removing the coating, followed by abrasive blasting to prepare the steel surface to receive the new coating system.

- Following removal of surface coating and rust scale and prior to application of the new surface coating, the condition of each steel framing member should be assessed. Gusset plates and steel framing members with structurally significant deterioration or section loss should be removed and replaced entirely with new steel. In some cases, it may be possible to remove a deteriorated portion and splice a new steel member to the existing member. Replacement steel should match the existing member sizes and configuration. All connections should be made using new steel rivets. Surfaces of new or existing steel members or gusset plates that will be concealed following installation should be primed and coated prior to installation. Where replacement elements are needed, consideration should be given to the use of hot-dipped galvanized elements or plates.
