John Brown's Fort Building 63

Harpers Ferry National Historical Park Flood / Storm Recovery Project

Condition Assessment Report and Preservation Repairs

February 1998

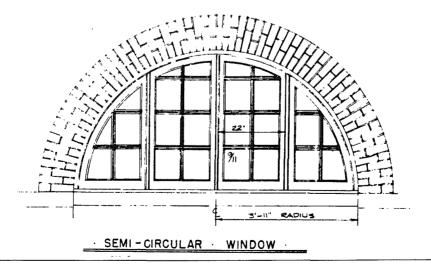
The semi-circular window sash at each bay are divided into four sections (see diagram), and as on the north elevation approximately 50% of the glazing compound has become brittle and cracked which will lead to future deterioration of the window components if not corrected. The only rot noticed on these windows was at the western

end of the eastern window (W108), the bottom rail at this end needs to be replaced. It was also interesting to note that the wood sills for these windows (WT106,WT107,WT108), which appear to be replacements (ca. 1976), do not have a drip edge cut into the underneath side which would help to keep water from running back under the sill and to the building.
