Condition Assessment and Treatment Plan for Libbey Memorial Physical Medicine Center

P R E - D E S I G N S E R V I C E S

June 30, 2022
NPS PMIS # 318915
NPS TIC #128-180181

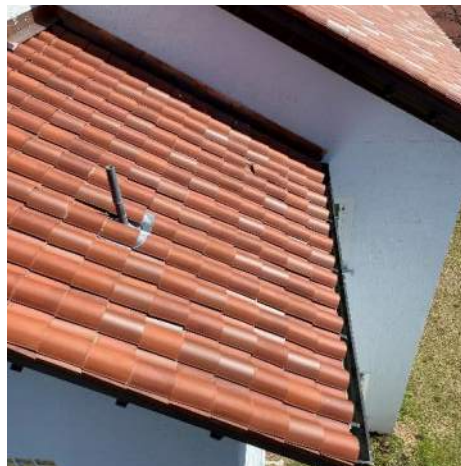
XAE.8– Damaged clay tile.

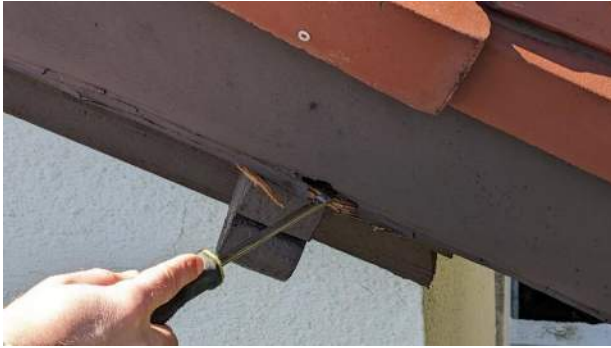
XAE.10 – Damaged wood at soffit and eave.

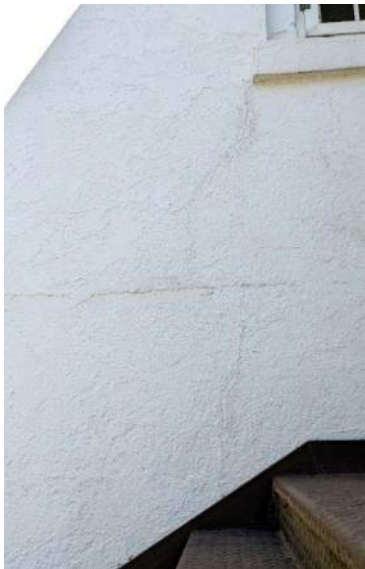
XAE.11 – Cracking at exterior wall paint and stucco.

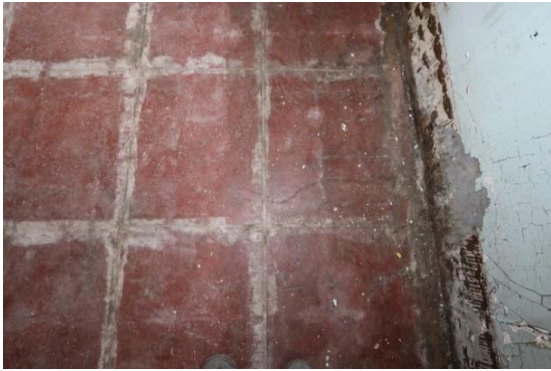
XAI.6 – Office 102. Concrete floor.

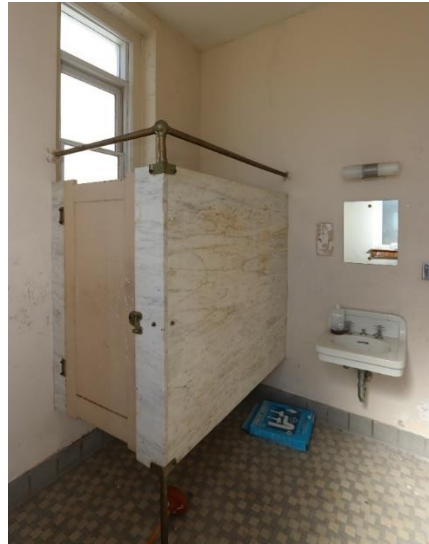
XAI.9 – Toilet 104. Historic marble partition.

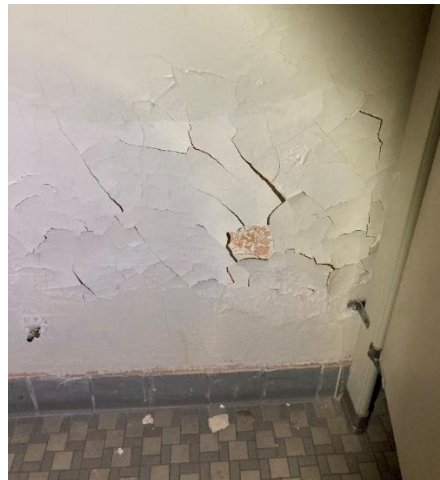
XAI.11 – Toilet 105. Cracked wall plaster and paint.

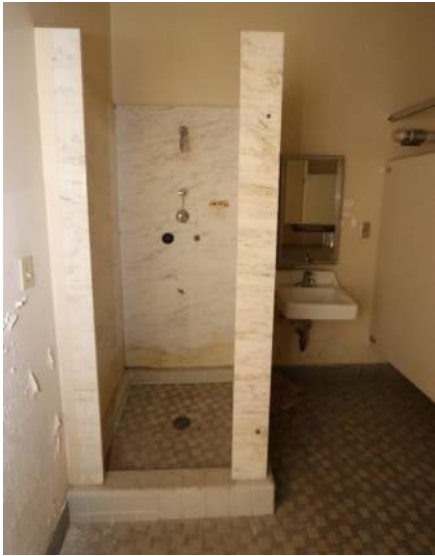
XAI.12 – Toilet 105. Marble shower partition.

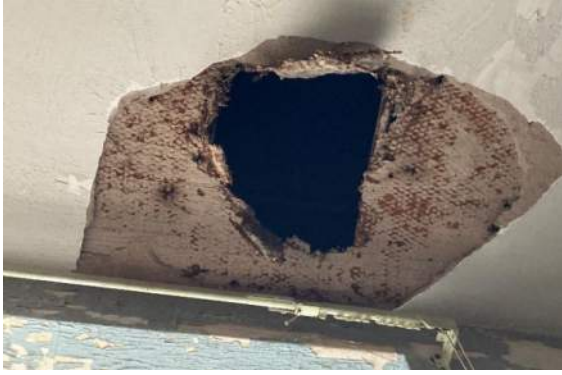
XAI.19 – Office 109. Damaged plaster at ceiling.

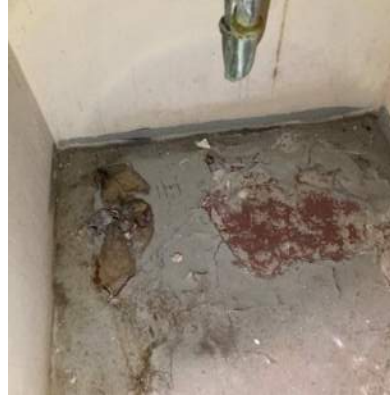
XAI.22 – Toilet 110. Damaged paint at flooring

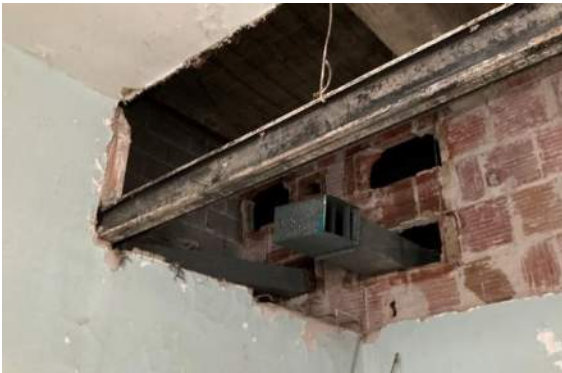
XAI.20 – Office 109. Exposed clay tile wall.

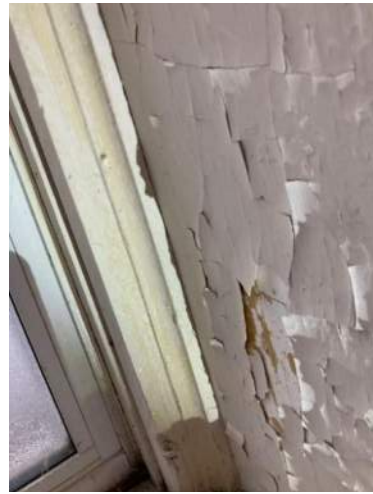
XAI.23 – Toilet 111. Damaged plaster and paint at window jamb.

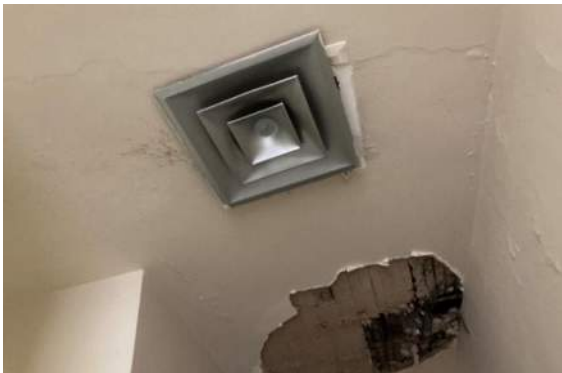
XAI.21 – Toilet 110. Damaged plaster at the ceiling

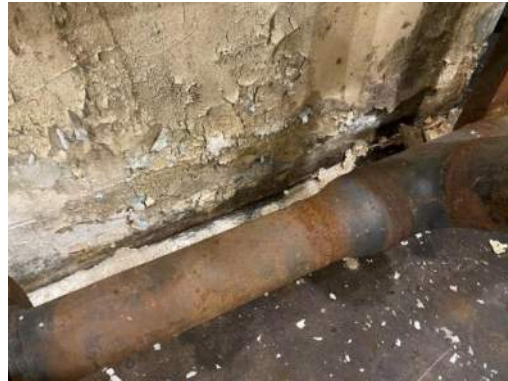
XAI.29 – Mechanical 115. Deteriorated plaster wall.

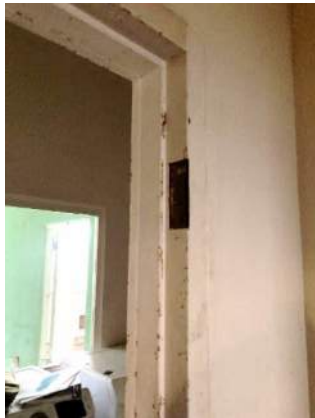
XAI.26 – Room 113. Deteriorated metal door frame.

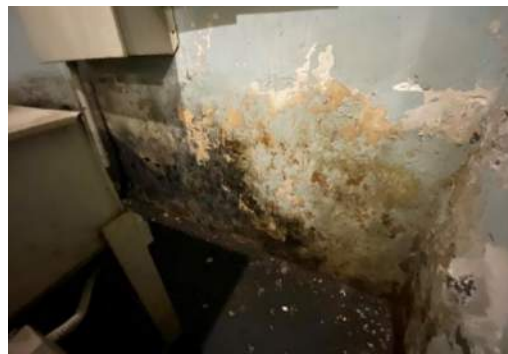
XAI.30 – Mechanical 115. Deteriorated plaster wall.

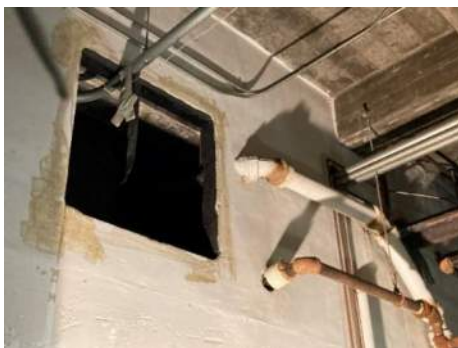
XAI.27 – Mechanical 114. Hole cut into wall.

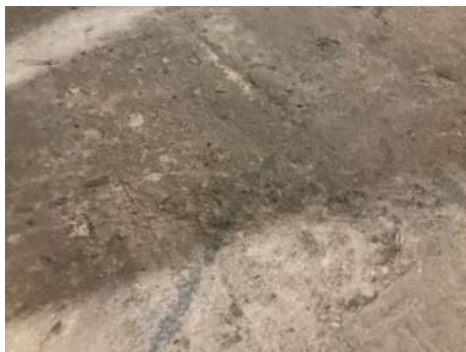
XAI.28 – Mechanical 114. Pitted concrete floor.

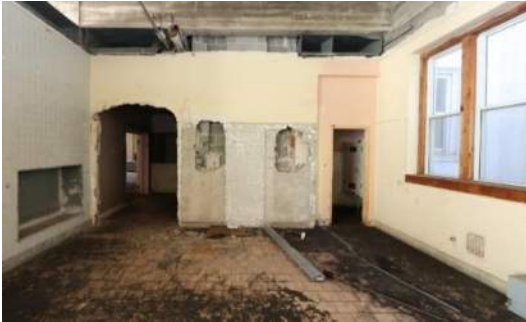
XAI.33 – Pool Room 117. Damaged flooring and walls, looking west.

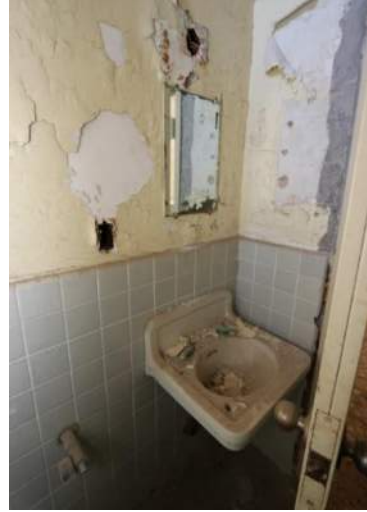
XAI.36 – Toilet 118. Damaged plaster walls.

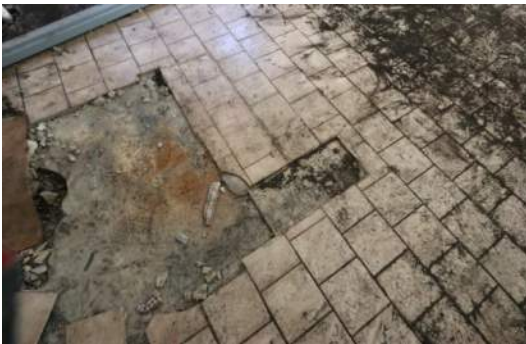
XAI.34 – Pool Room 117. Damaged floor tiles

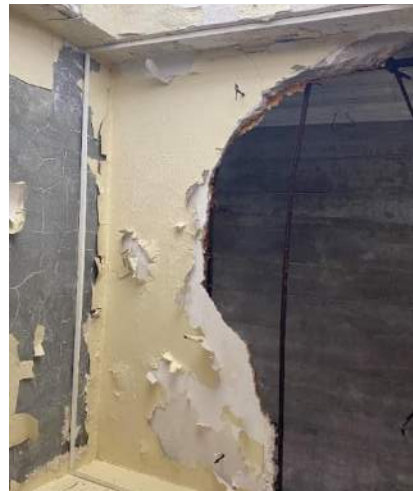
XAI.37 – Toilet 118. Damaged plaster ceiling.

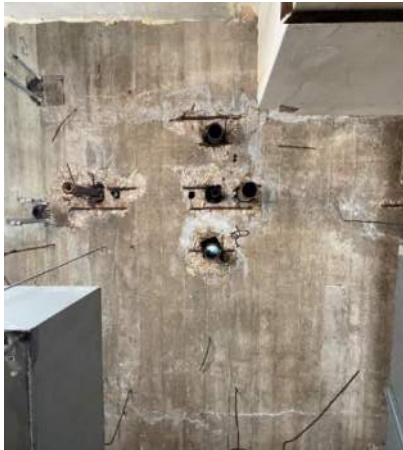
XAI.38 – Mechanical 119. Exposed concrete ceiling.

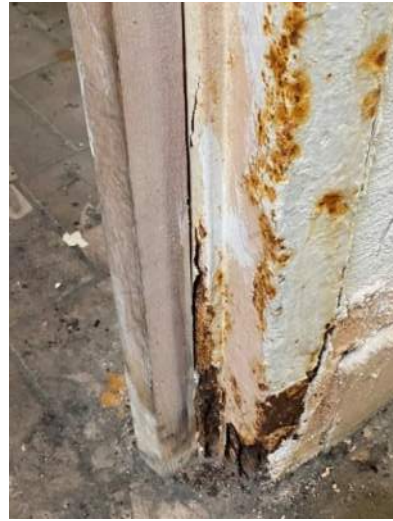
XAI.41 – Toilet 120. Damage at door frame.

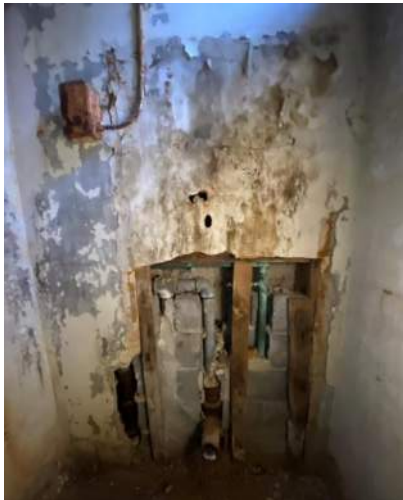
XAI.39 – Mechanical 119. Damaged plaster wall.

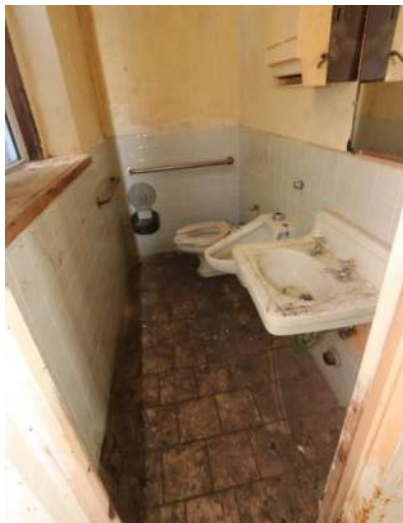
XAI.40 – Toilet 120. Looking east.

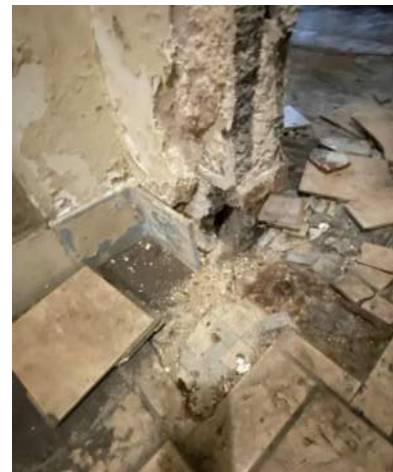
XAI.43 – Hallway East 121. Damaged Floor

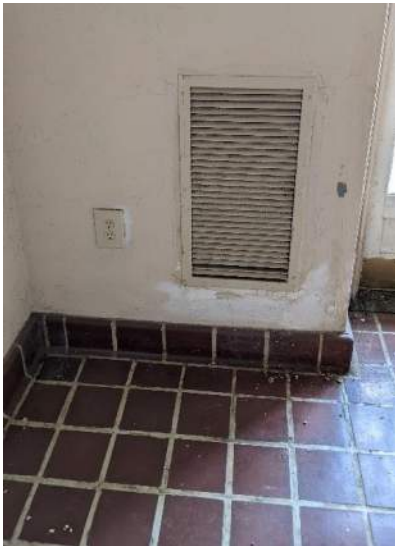
XAI.45 – Lobby 200. Damaged plaster wall and dirty louver and quarry tile and base.

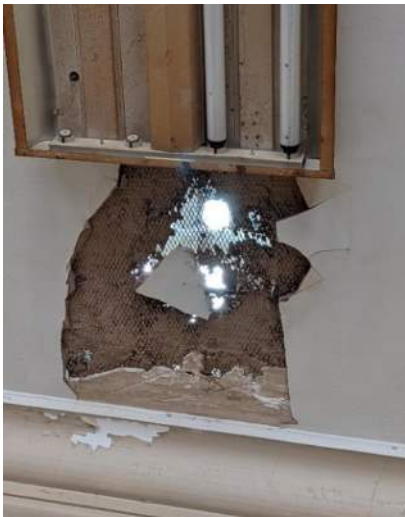
XAI.46 – Lobby 200. Damaged plaster and lighting in ceiling.

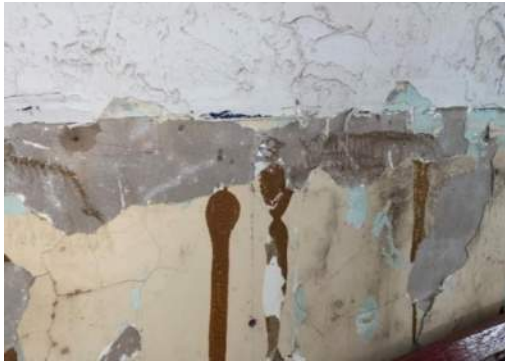
XAI.50 – Room 202. Damaged plaster.

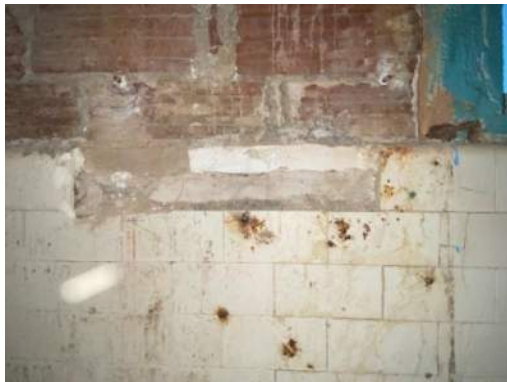
XAI.52 – Pool Room 203. Damaged tiles.

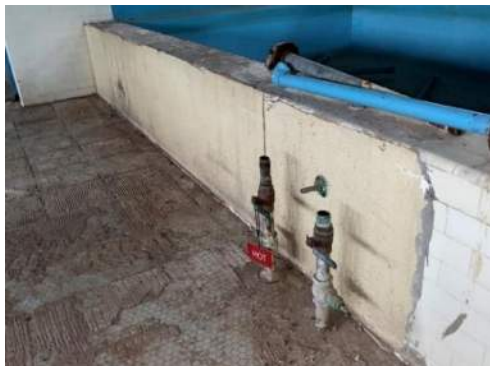
XAI.53 – Pool Room 203. Damaged wall and floor tile.

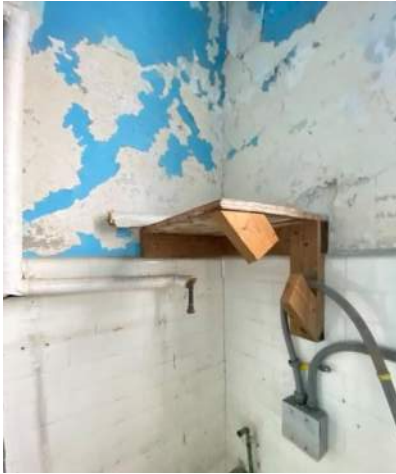
XAI.57 – Toilet 205. Damaged plaster and abandoned pipes.

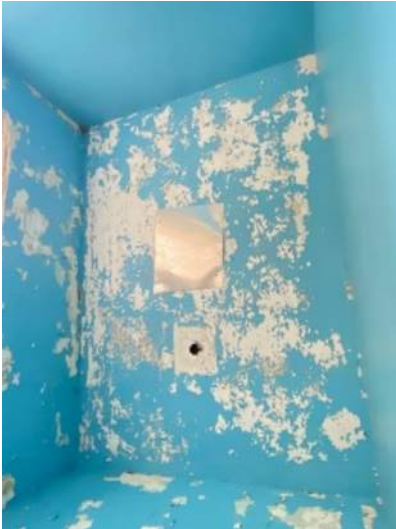
XAI.58 – Toilet 206. Damaged ceiling plaster.

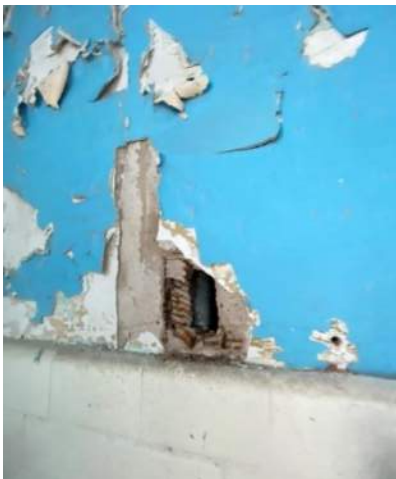
XAI.59 – Toilet 206. Damaged wall plaster.

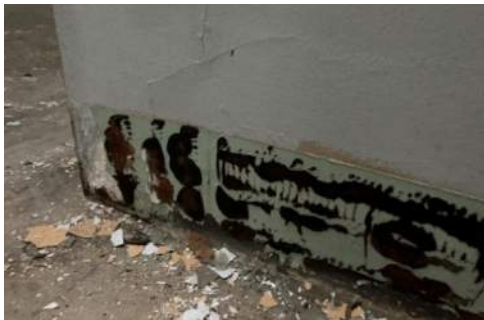
XAI.64 – Hallway 209. Missing wall base.

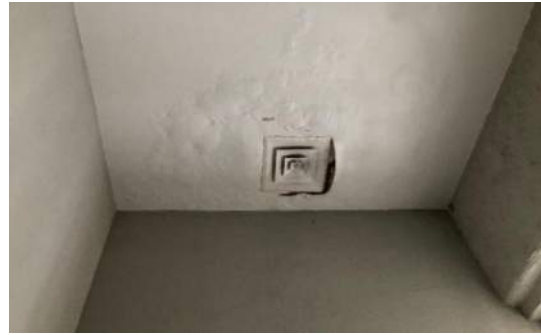
XAI.66 – Toilet 210. Damaged ceiling plaster.

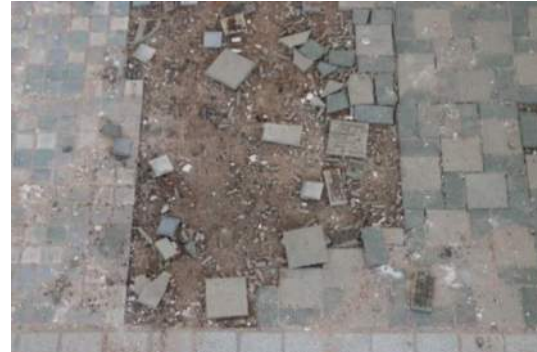
XAI.68 – Treatment Room 211. Damaged floor tile.

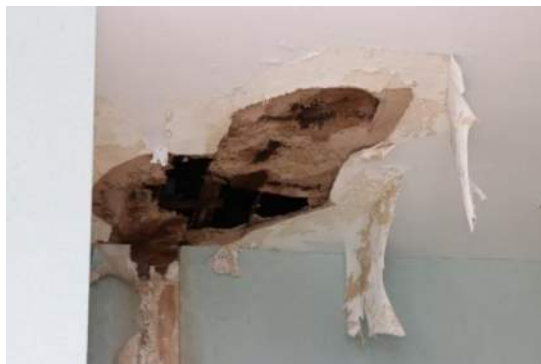
XAI.69 – Treatment Room 211. Damaged ceiling plaster.

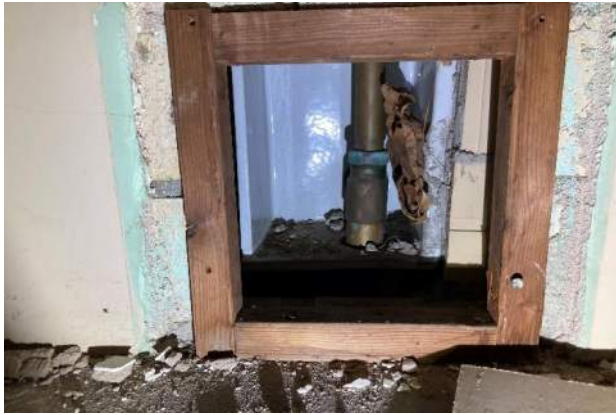
XAI.70 – Closet 212. Utility access at base of wall.

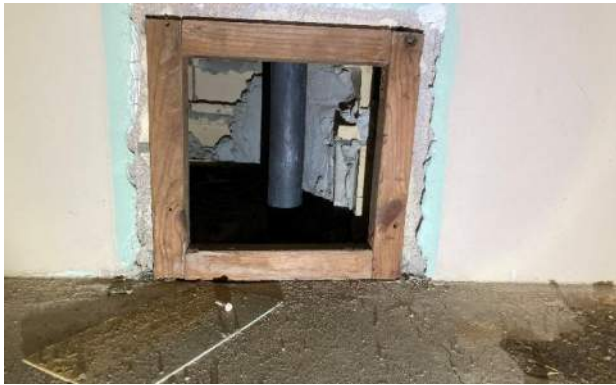
XAI.71 – Closet 213. Utility access at base of wall.

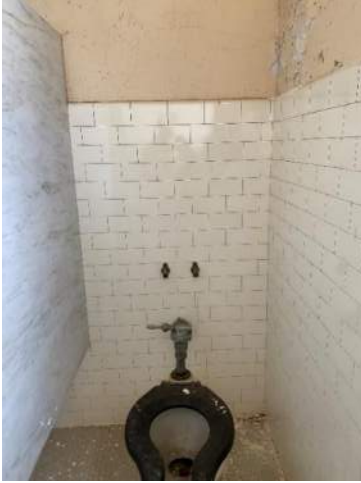
XAI.81 – Toilet 219. Damaged plaster and tiled walls, and plumbing.

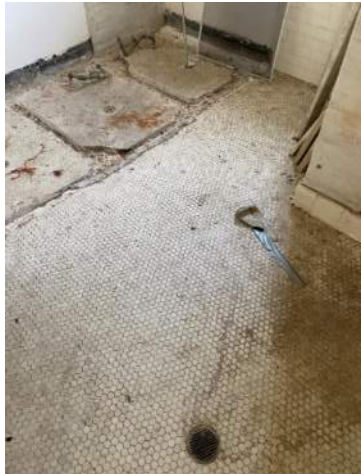
XAI.82 – Shower 220. Damaged tile flooring.

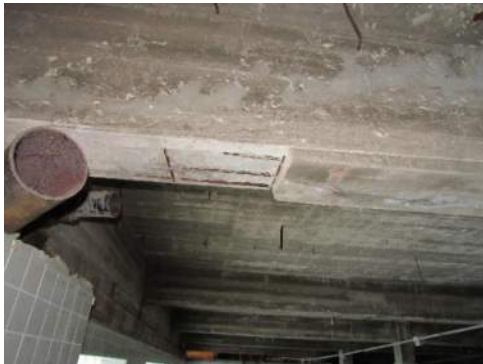
The 2009 HSR investigated this beam construction in depth. A petrographic analysis was performed for the lower strata, revealing that the material is a low strength grout slurry that was likely used in the bottom of the concrete forms to hold up the steel reinforcement. It was allowed to set prior to subsequent concrete pours, creating a poor bond between the two materials. This construction has implications on the load carrying capacity of the system as well as hazards for the occupants below. Areas where this condition were apparent were documented and included in the treatment checklist for repair.

S.1 – Typical overhead beam repair due to original construction.

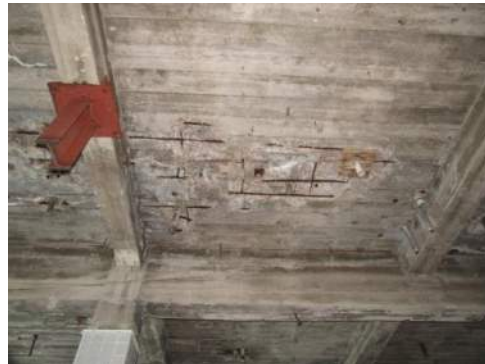
S.2 – Typical overhead slab repair area due to corrosion of reinforcing steel.

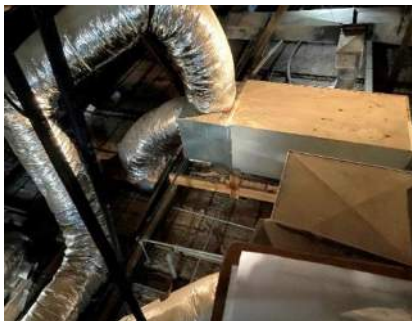
The existing exhaust systems have been abandoned.

XM.1 Abandoned Blower Coil Unit

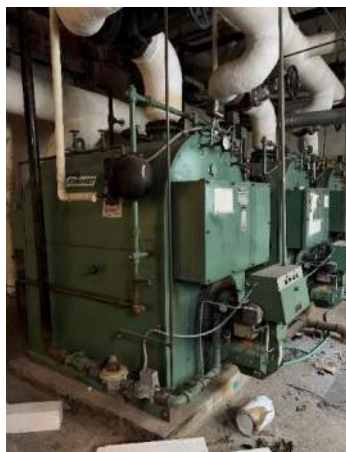
The building is not currently heated. The building was heated by steam boilers connected to steam zone heating coils. The boilers were replaced around 1987 and therefore, past their typical life span as are the steam coils that date prior to 1987. Much of the steam piping has been demoed.

XM.2 Existing Steam Boilers

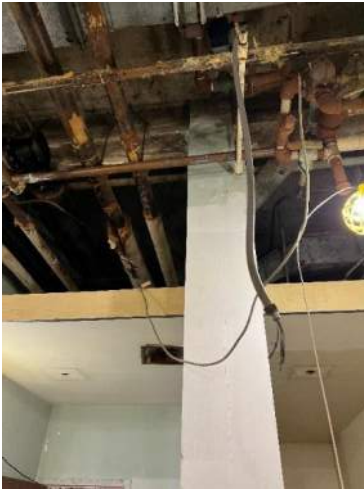
XM.4 Existing Piping

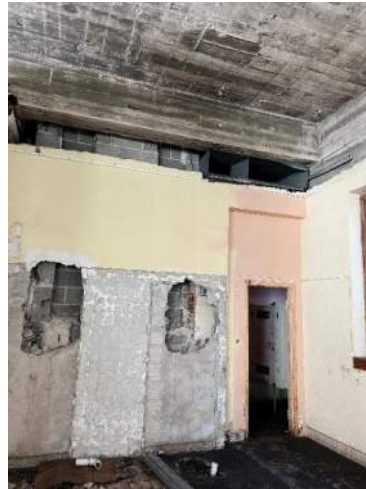
XM.6 Demolded Ductwork

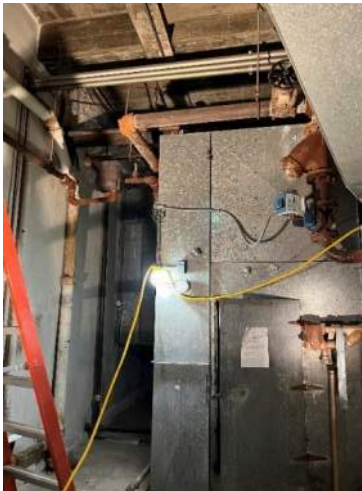
Libbey Memorial PMC has an existing air handling unit located in the basement that appears to have been installed in 1956 with some modifications, such as a fan replacement, occurring after that. The unit provided heating and ventilation only, and as stated above, no central cooling was provided except for the abandoned bower coil. Ductwork is distributed from the AHU in the first floor ceiling plenum and the attic. The majority of the ductwork is original to the 1956 HVAC improvements and a large amount has been demoed in preparation for tenant leasing.

XM.5 Existing Air Handling Unit

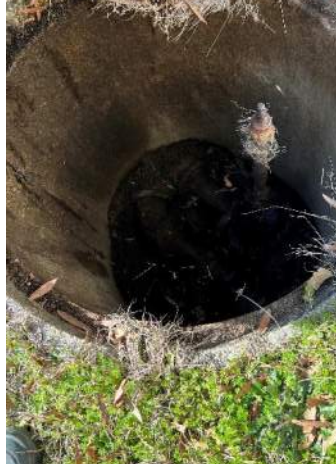
XP.4 Pool Drain Exterior Gate Valve

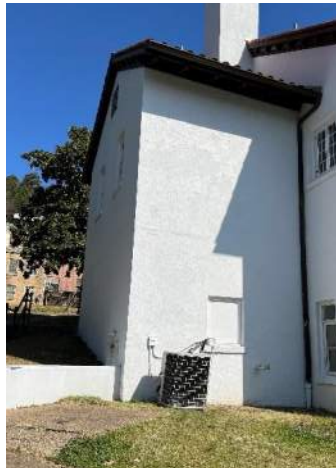
XP.5 Abandoned Gas Service

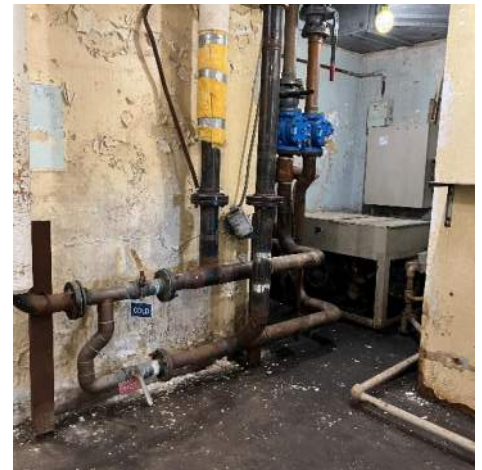
XP.8 Thermal Water Service & Piping

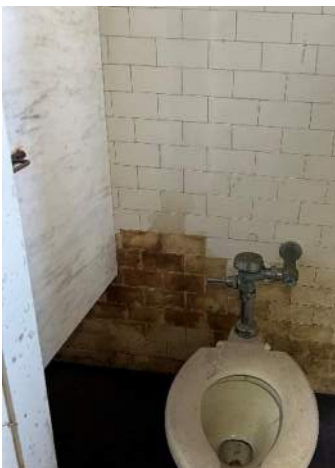
XP.3 Plumbing Fixture

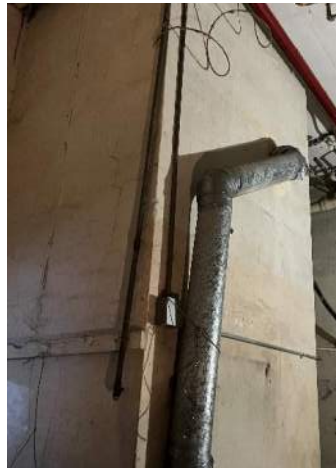
XP.6 Existing Gas Piping

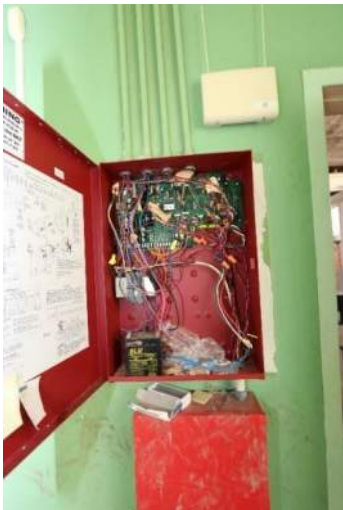
The building has an existing fire alarm system in limited areas. The existing system is not functional. All existing fire alarm devices and associated wiring should be removed.

XE.1 Existing Fire Alarm System

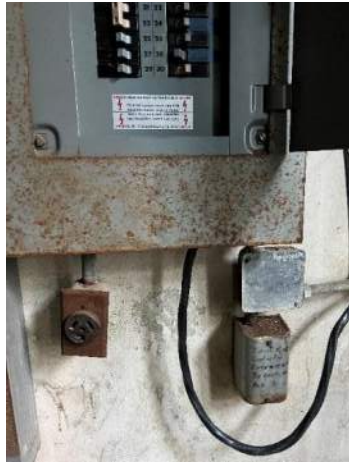
XE.7 Rust on Electrical Equipment

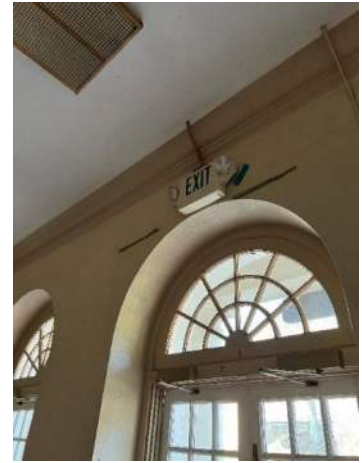
XE.10 emergency Light Fixtures

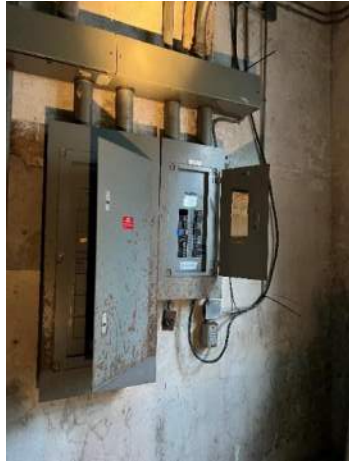
XE.8 Rust on electrical Equipment

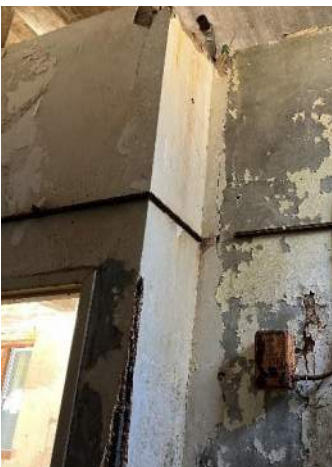
It is recommended to remove all existing conduit and branch circuits. A large percentage of the existing conduit system is damaged and therefore unusable. Special consideration will need to be given to routing for all new conduits. In some cases, it may be necessary to use surface raceway. All new conduit and raceway should be carefully routed to coordinate with and maintain the historical nature of building.

XE.6 Existing Conduit System

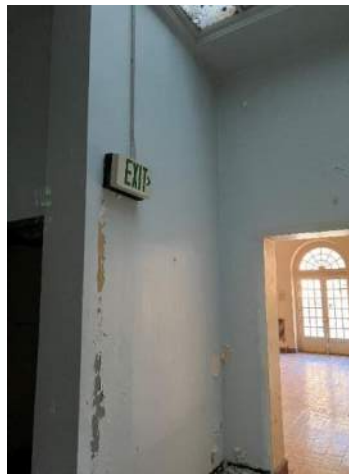
XE.9 Exit Sign

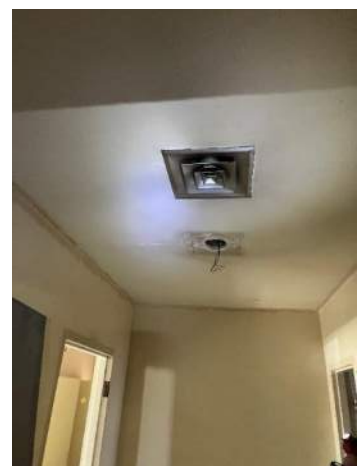
XE.12 Open Wiring

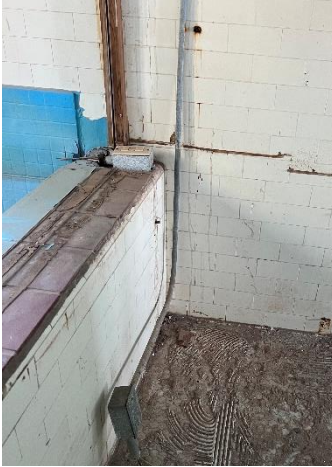
XE.13 Open Wiring

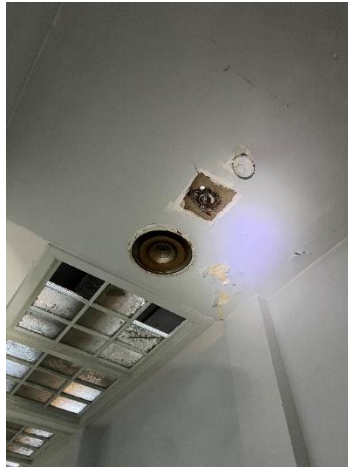
XE.16 Missing Light Fixtures

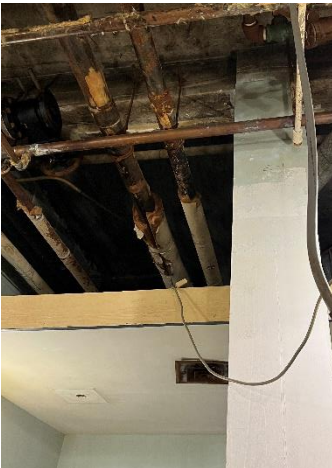
XE.14 Open Wiring

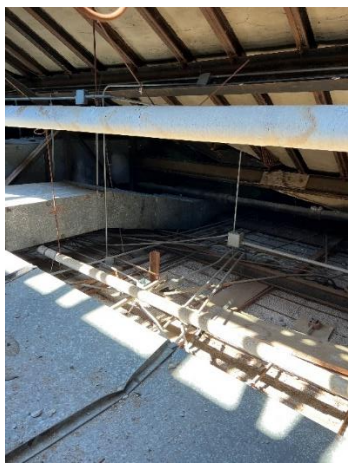
XE.17 Missing Knock Outs

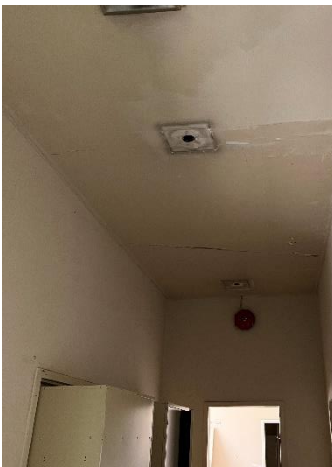
XE.15 Missing Light Fixtures

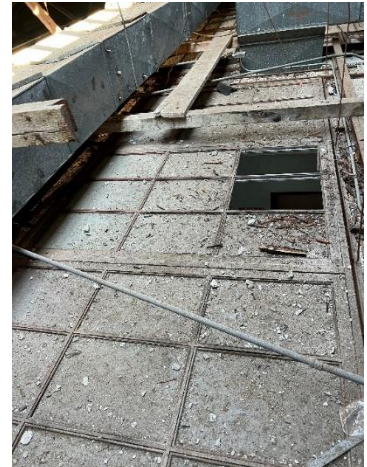
XE.21 Conduit above Lay Lite
System

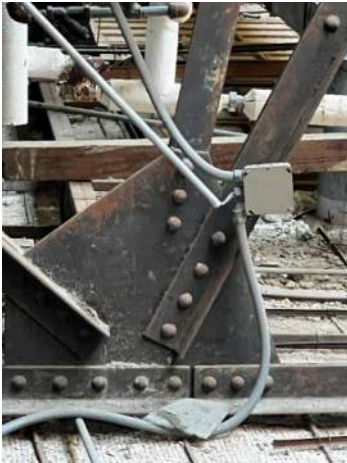
XE.22 Broken Conduit System

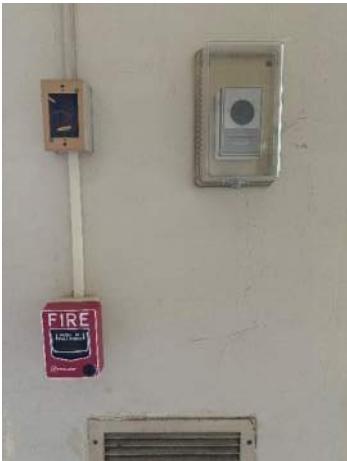
XE.23 Missing Fire Alarm Device

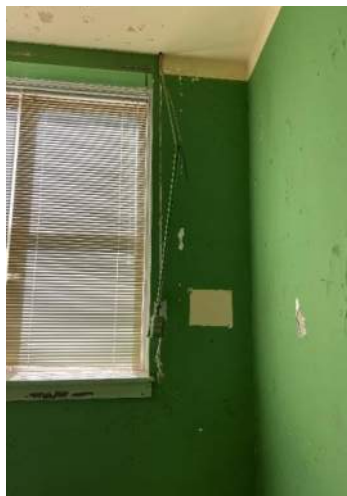
XE.24 Damaged Conduit System

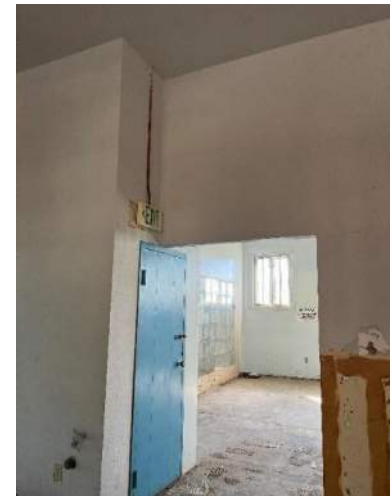
XE.30 Existing Exit Sign
