Superior Bathhouse

Historic Structure Report

National Park • Arkansas

prepared by
Chamberlin Architects
Grand Junction Colorado

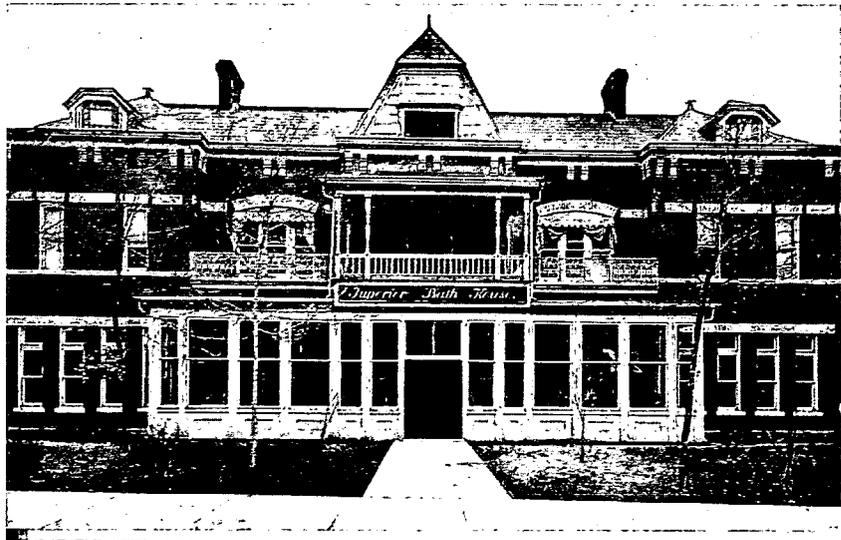
Figure CLA-1: Postcard of the original Superior bathhouse in the 1890s shows elm trees and ornamental plantings set in turf. Note narrow sidewalk and lack of clipped hedge. (HOSP Archives)

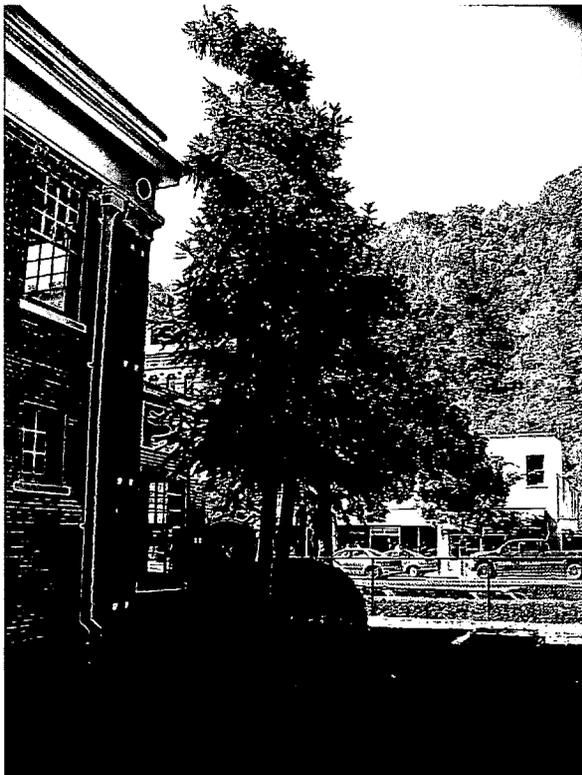
As to vegetation, much has been lost or altered over the years. The elms that ran parallel to the Magnolia Promenade was removed and replaced with American hollies – also now removed. Although most foundation plantings have been removed from Superior's landscape, a few remain along its northern side. The clipped hedge that outlines the bathhouse lawn is now composed of Chinese holly (*Ilex cornuta*), which is different from the original species (Chinese privet). Generally, this does not pose a problem because the evolution of vegetation on Bathhouse Row has been somewhat haphazard without the benefit of an

Figures CLA-3, 4: Superior's vegetation retains some of its historic character, such as these ornamental plantings at the building's northwest and northeast corner of the building. (Shapins Associates, 2003)

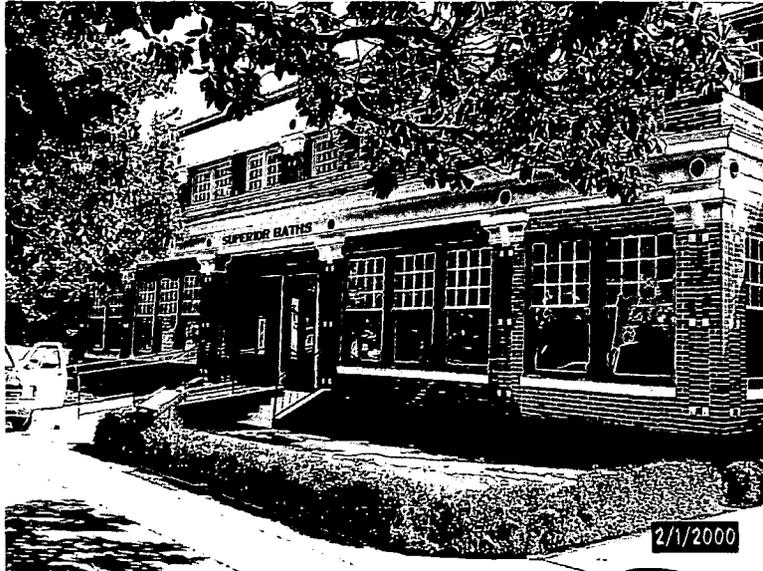
This new ramp will extend along the southern side of the building front, and will be constructed in the style of that building. This change will interrupt the strict symmetry of the building façade, and being a dominant landscape feature it will affect the landscape's formal feeling. The sloping ramp will also create a distraction from the building's dominant lines, and its will create a non-historic design element on the façade.

Figure CLA-7: Location of proposed universal access ramp would alter the facade's strict symmetry. (NPS, 2000)

It will change the size and scale of the front lawn against which the building is seen, because Superior's front lawn is narrower than many of the other bathhouses. However, the landscape's spatial organization, circulation, topography, land use patterns, and small scale features will be essentially unaltered.

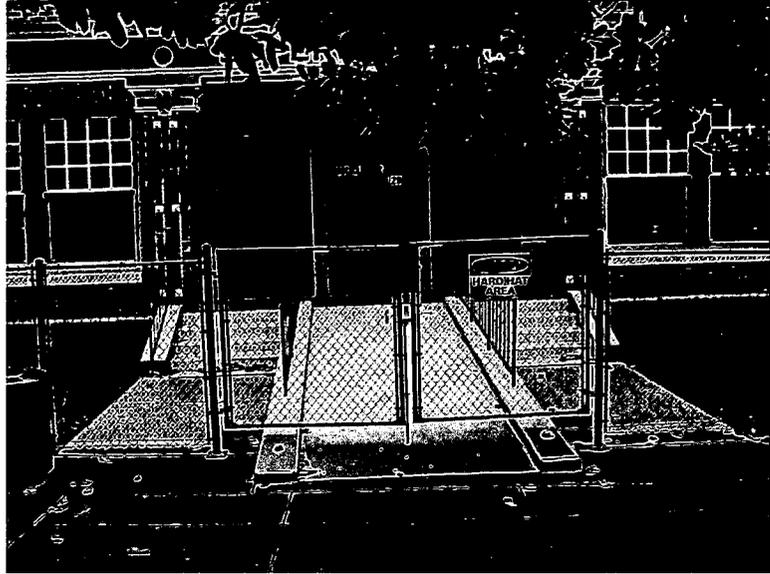
Figure CLA-8: Original entry's stairs and ramp emphasize the facade's symmetry. (Shapins Associates, 2003)

The entry staircase on the southern side of the existing entry ramp will be modified to accommodate the new universal access ramp. Specifically, the stairs will be removed and rebuilt to accommodate a landing for that ramp. To accomplish this, they will be shifted out toward the Magnolia Promenade sidewalk, yet again interrupting the formal, symmetrical landscape and building entry experience. As stated in the universal access ramp discussion, the feeling of symmetry to the building entry should be maintained. This could be accomplished through vegetation restoration, or through architectural modification to the northern staircase. In any case, the reconstructed staircase should match the original construction profiles.

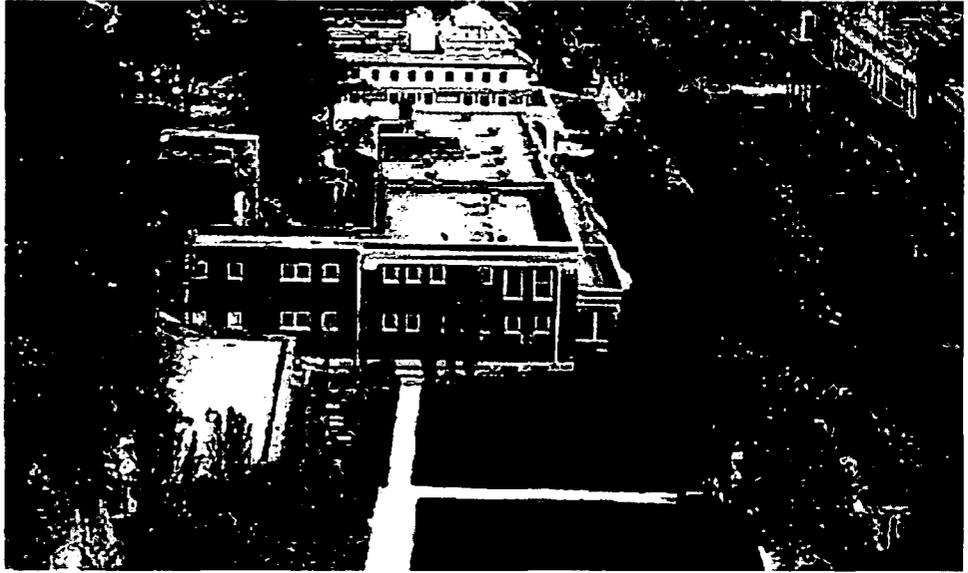
1B-5: The current Superior Bathhouse with cooling towers intact to the east of the building. c. 1920-37. Photo courtesy of Hot Springs National Park Archives.

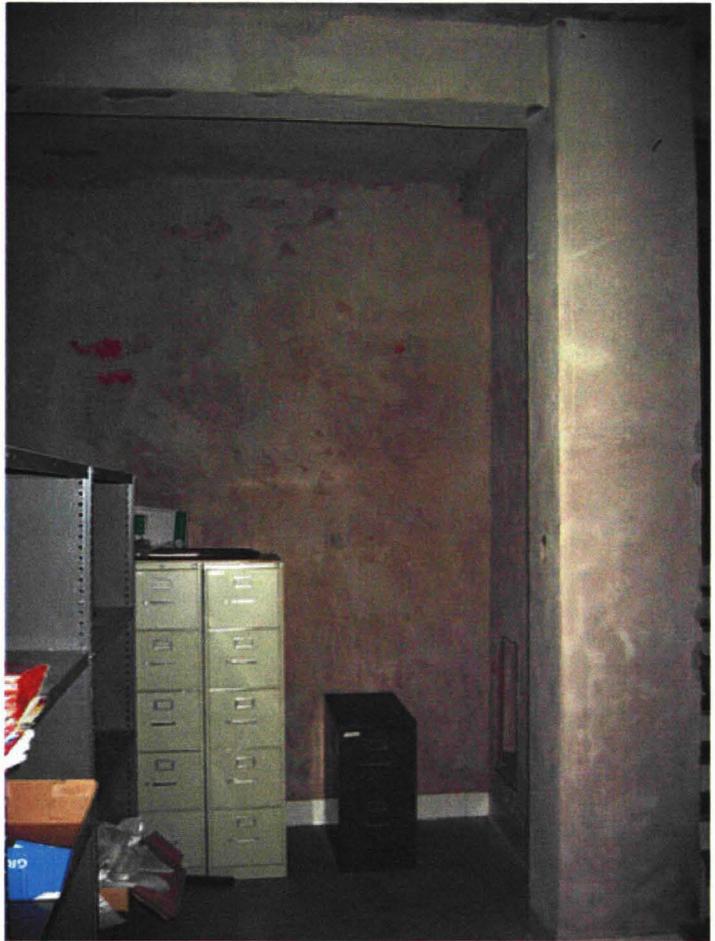
1C-112: Room 111, Women's Dressing. Note ceiling deterioration. Window: 136 (blocked).
Chamberlin. 11/03

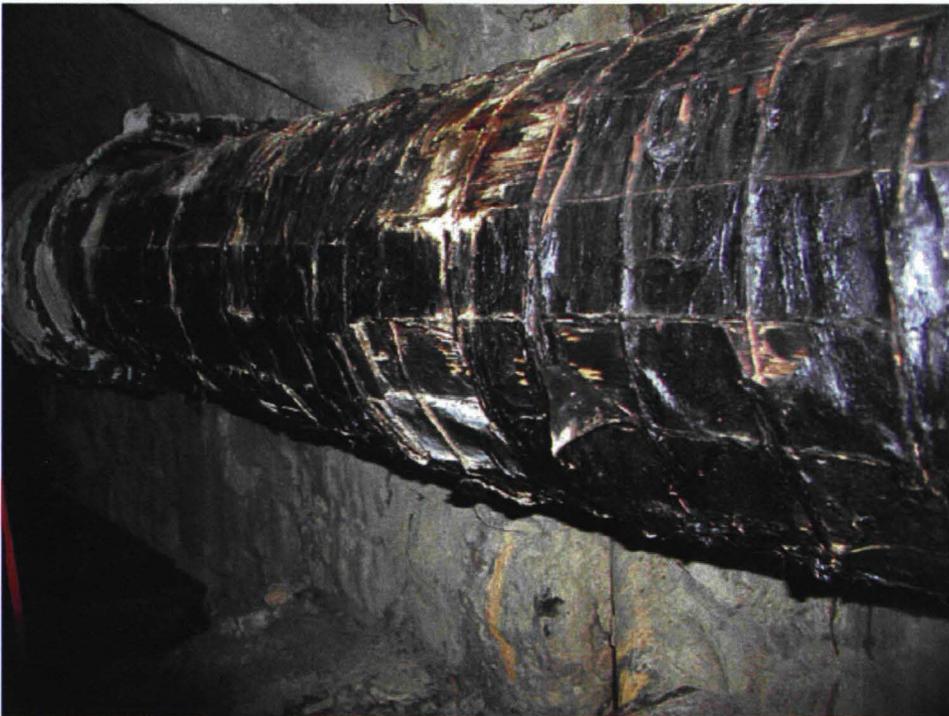
tunnel floor and east sidewall. The iron pipe is mostly covered by an outer wood stave pipe in poor condition and wrapping of roofing tar impregnated cloth material. The latter is discontinuous. The extent of the pipes' problems were not the primary subject of the investigation.

CA-5: The Creek Arch. The hot springs collection pipe.

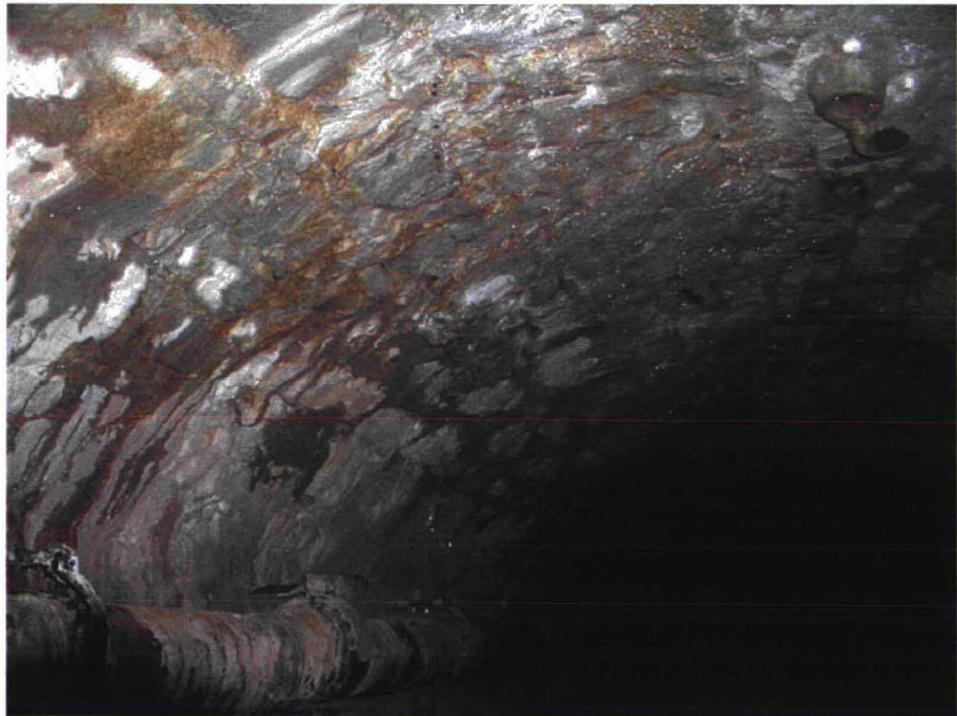
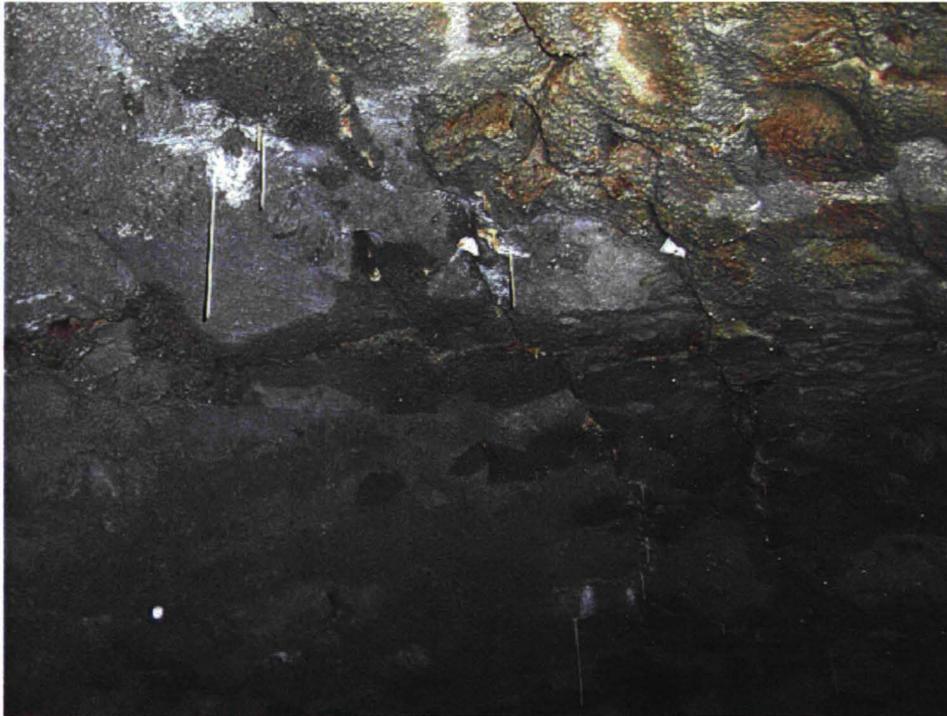
6. Hot springs water flows enter in two ways, by pipes and by seepage. Examples of the piped flows included the drainage from the fountains, from sump pumps in the basements, and from the Buckstaff. Seepage can be seen coming through both the walls and the arched roof. Defining these flows as hot springs water is both the heat of the water and the deposits, calcium carbonate principally. Unfortunately these deposits obscure the condition of the masonry beneath.

CA-8: The Creek Arch. A building up of stalactites from the arch surface. This is evidence of a steady drip.

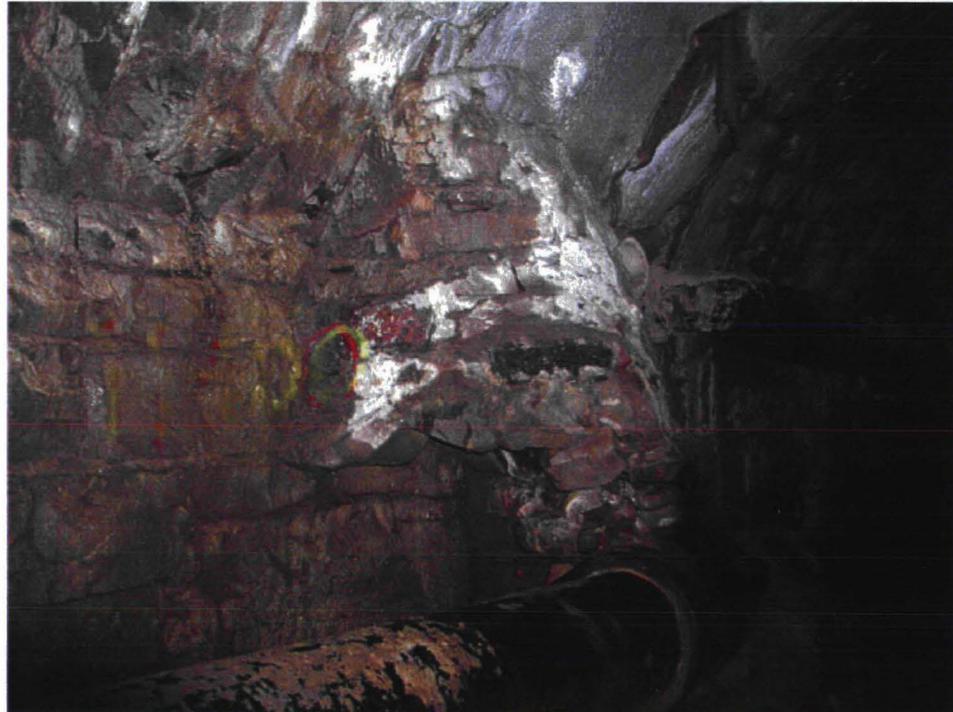
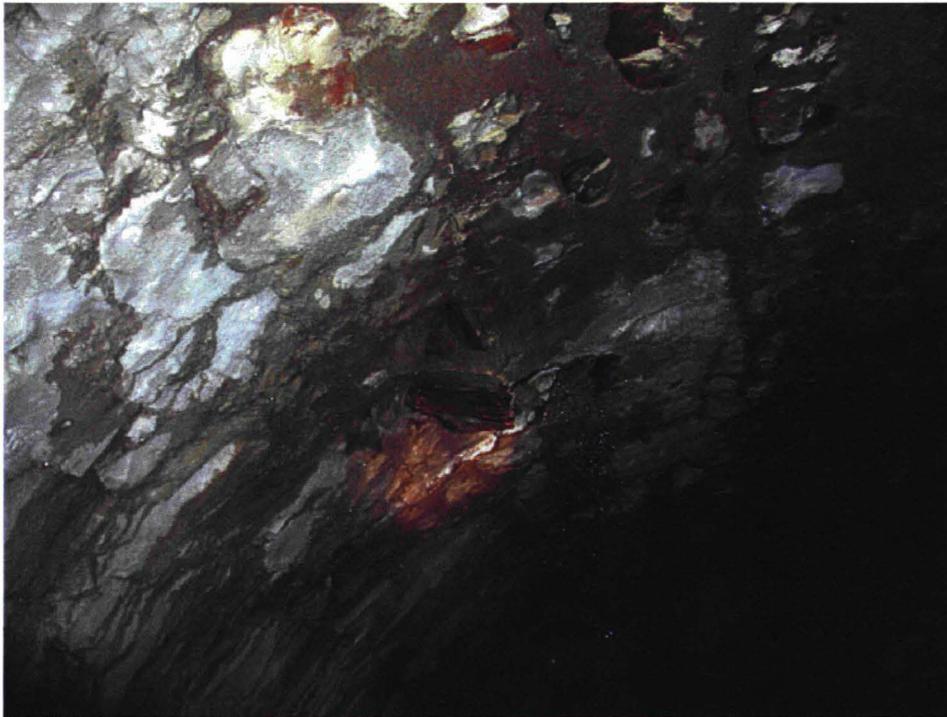
CA-12: The
Creek Arch. Fallen
rock in roof of the
arch.
