Harry S Truman National Historic Site

Truman Home HS-01
Truman Carriage House HS-02

Historic Structures Report

Architectural Data Section
Existing Condition Drawings

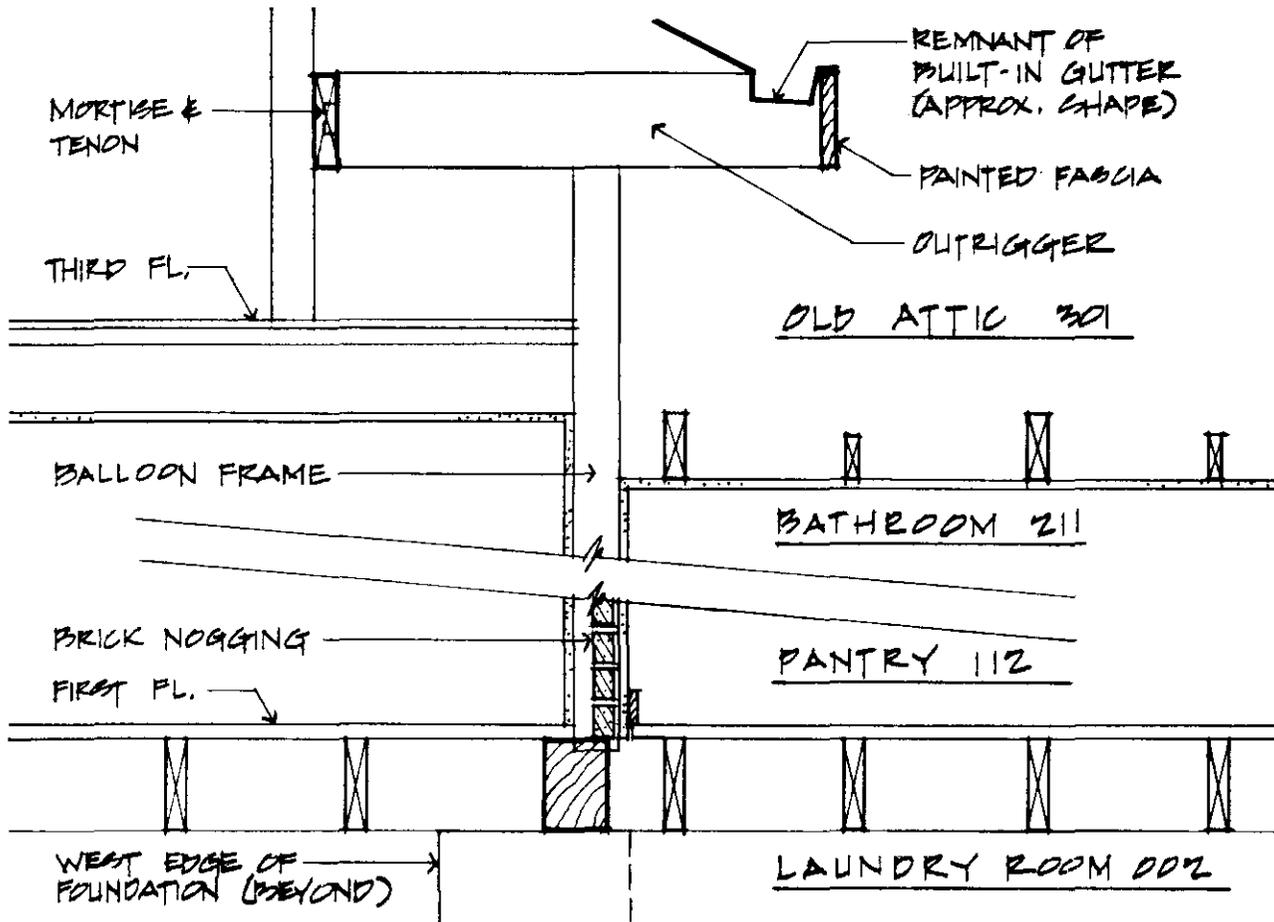
Resembling the massing of a two-story American I-House, the 1867 structure is shown with a medium-hip roof. Recent investigation at the west end of the old attic (301) revealed extant framing of a hip roof with painted fascia board and remnants of a built-in sheet metal gutter. Thus, the east wall of Truman dressing room (209) and hall (208) was originally an exterior wall. The smaller kitchen wing (kitchen 113, pantry 112, butler's pantry 111) is shown with a shallow-pitched, gable roof. A September, 1986 physical investigation revealed that the kitchen wing (113) was balloon framed at the floor joists, north wall. In addition, there is evidence of an intermediate kitchen partition. Presumably, the kitchen wing was constructed as a one-story or one-and-one-half story addition with the roof altered to its existing height and configuration in the remodeling of 1885. (See Fig. 1.2.)

Fig. 1.2 Truman Home. Construction detail of connection between main house and kitchen wing. Credit: Doug Wasama

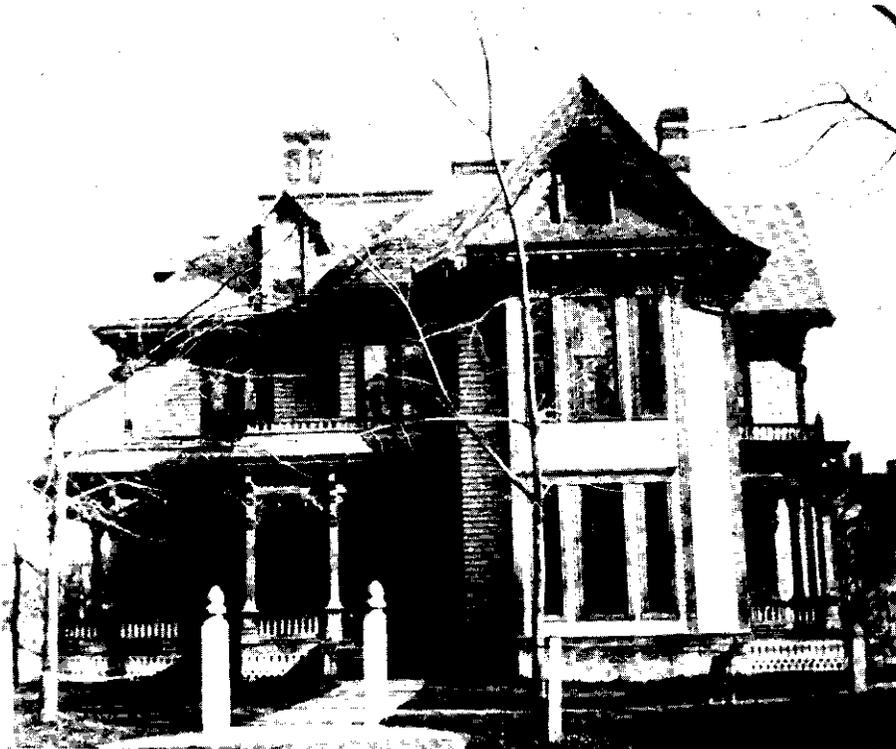
Fig. 1.4 Truman Home, c. 1900. West elevation (looking east). One of a series of the earliest extant photographs of the structure. Note the absence of the roof line decorative grillwork as shown in the 1886 Independence Sentinel. Credit: HSTL

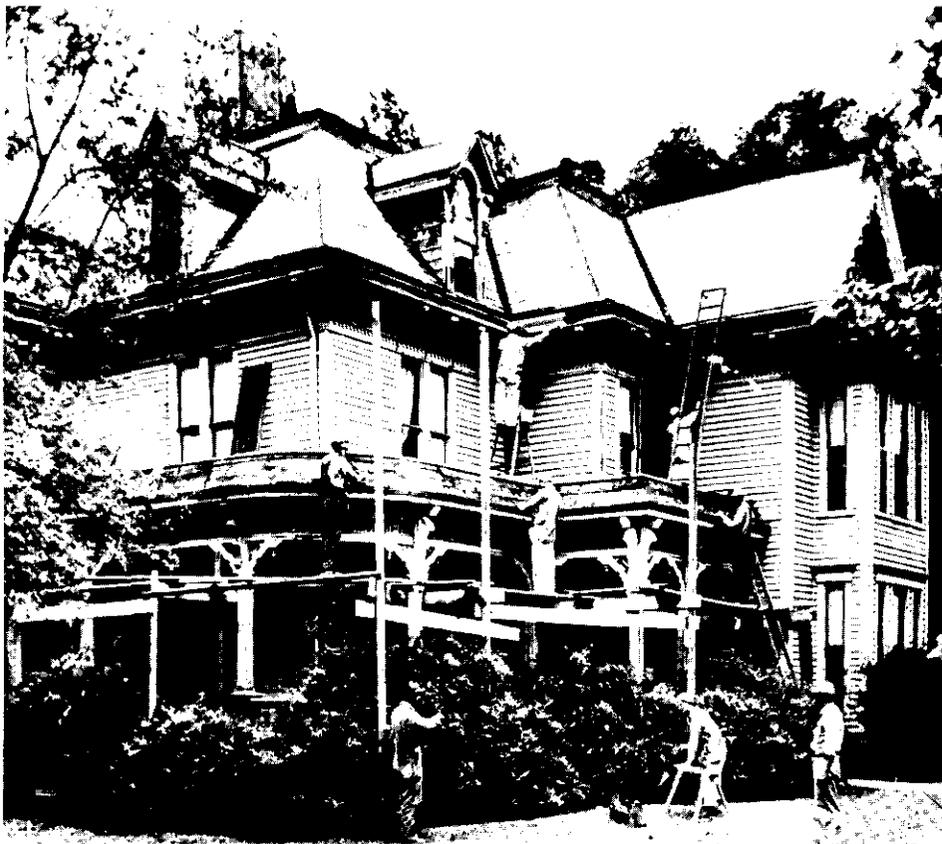
Concerned about the appearance of her family home, Bess Truman made arrangements to begin exterior renovation of "The Summer White House" as it was then called. (See Figs. 1.10 and 1.11.) Work at 219 North Delaware included replacing rotted millwork and slate shingles, covering the worn, grey exterior with white paint, and trim areas with Kentucky green.²¹ The second floor bath (211) was also remodeled with a new blue porcelain tub, stool, and sink.

Fig. 1.10 Truman Home, May 21, 1945. West elevation (looking southeast). Workers begin renovation. Credit: HSTL

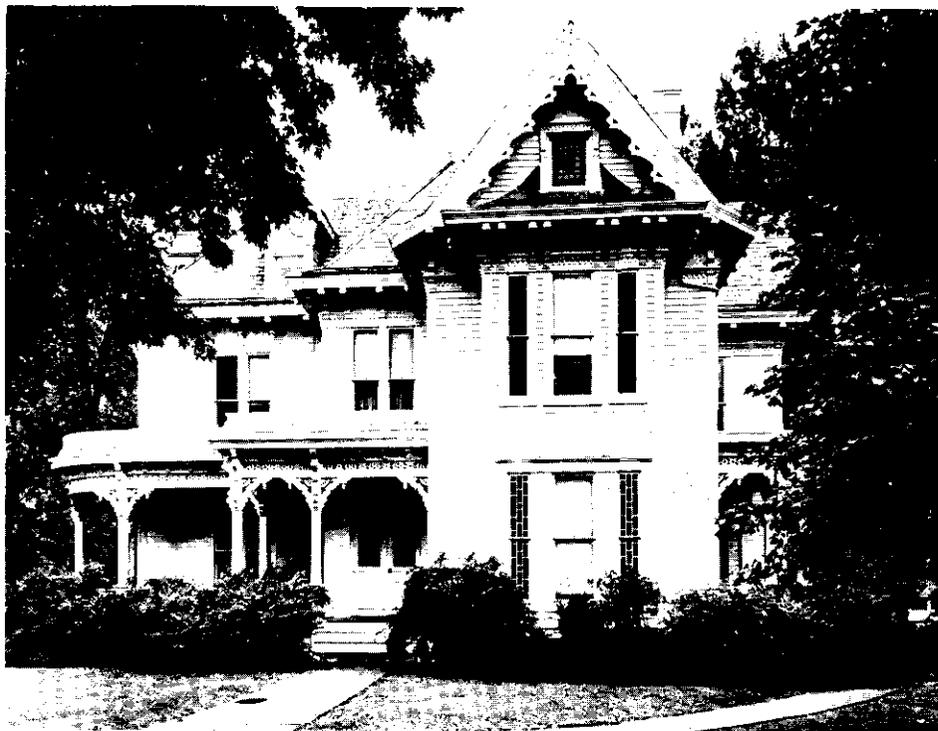
Fig. 1.11 Truman Home, June 27, 1945. West elevation (looking east). After 1945 renovation. Credit: HSTL

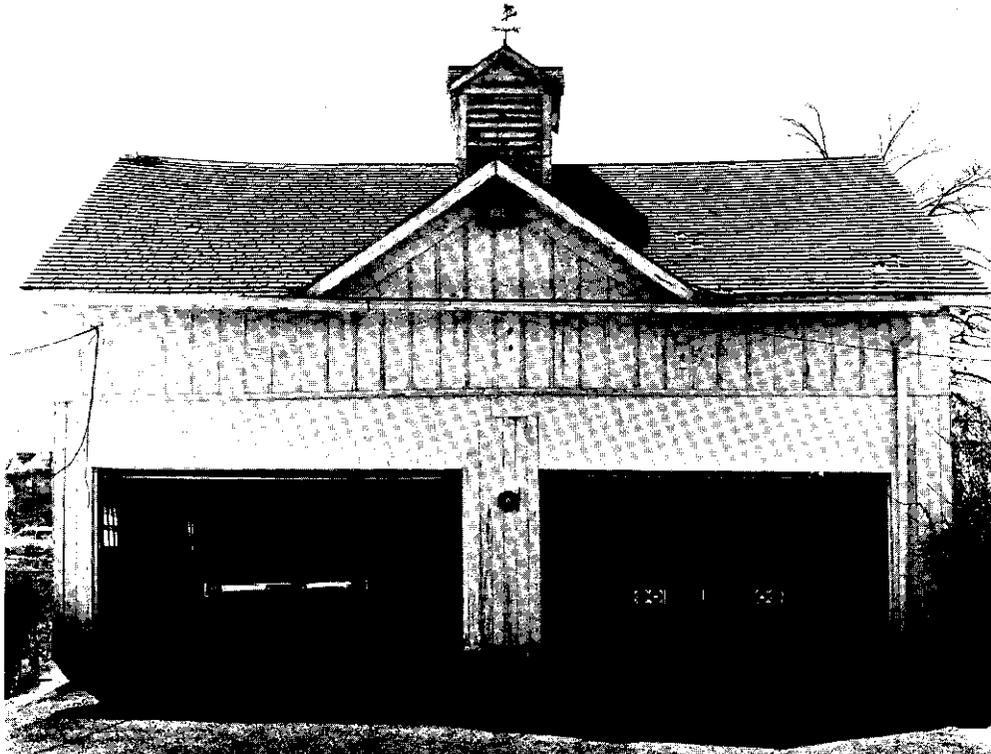
This white, 1-1/2 story, heavy timber framed structure with a shallow limestone foundation, measures approximately 24 x 32 feet. Its date of construction is unknown, but probably dates to the late 1860s or 1870s. The barn was adapted as a garage before 1914 to house the Gates' automobile.¹ The gable roof is sheathed in dip stained wooden shingles and crowned with a louvered square cupola at the center of the ridge. A gablet is centered on each roof leaf at the eave line. The south gablet features two loft doors. Loft doors also exist at the main gable ends. Two six-pane fixed windows and two shuttered openings mark the east and west facades respectively at the ground floor. The structure has a concrete slab floor. Overhead rolling garage doors enclose the two-car bays. Vertical board and batten siding is the predominant sheathing material. (See Figs. 3.1-3.4.)

Fig. 3.1 Truman Carriage House, Fall 1985. North elevation (looking south). Credit: Zoom Studios

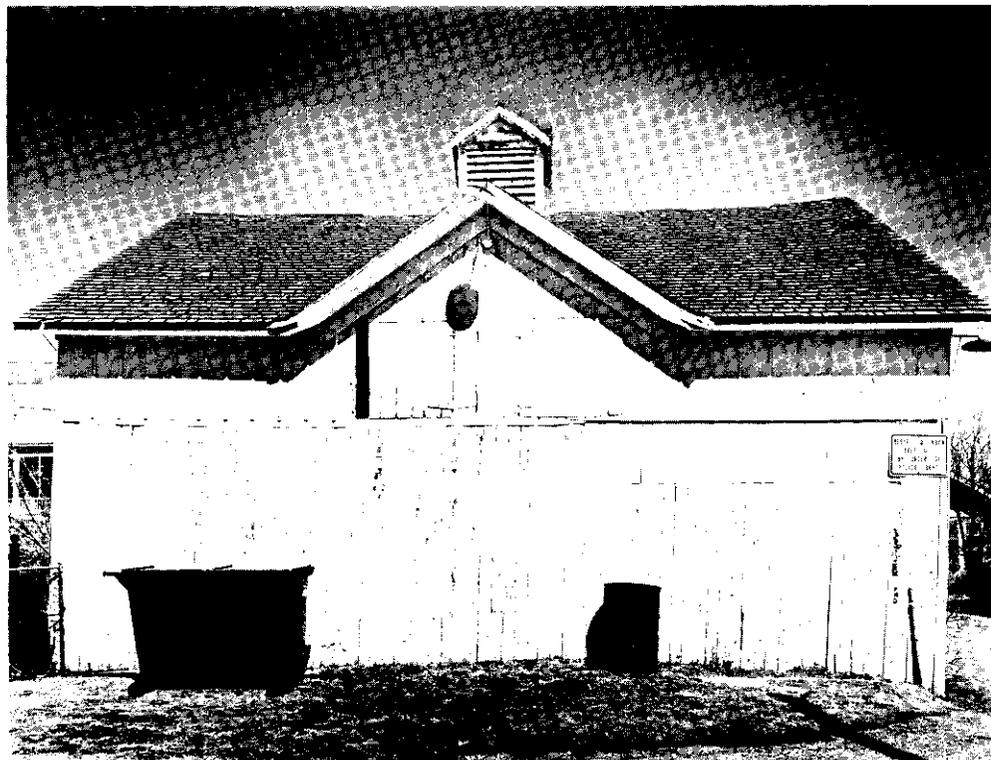
Drainage around the structure is generally very poor. At the south elevation adjacent to the alley, soil and gravel has been built up to obtain positive drainage away from the Carriage house. Unfortunately, the exterior grade now rises above the interior grade of the concrete floor slab. This has led to severe deterioration of the siding, foundation sill and structural post bases. It appears that the exterior grade has been raised at least 20 inches along the south elevation with

Fig. 3.2 Truman Carriage House, Fall 1985. South elevation (looking north). Credit: Zoom Studios

No gutter exists on the south elevation. Lack of proper roof drainage and site grading which is sloped towards the south wall instead of away from it has caused the lower ends of the siding to decay. A gutter and downspout should be installed on this elevation and the site regraded to facilitate drainage away from the building.

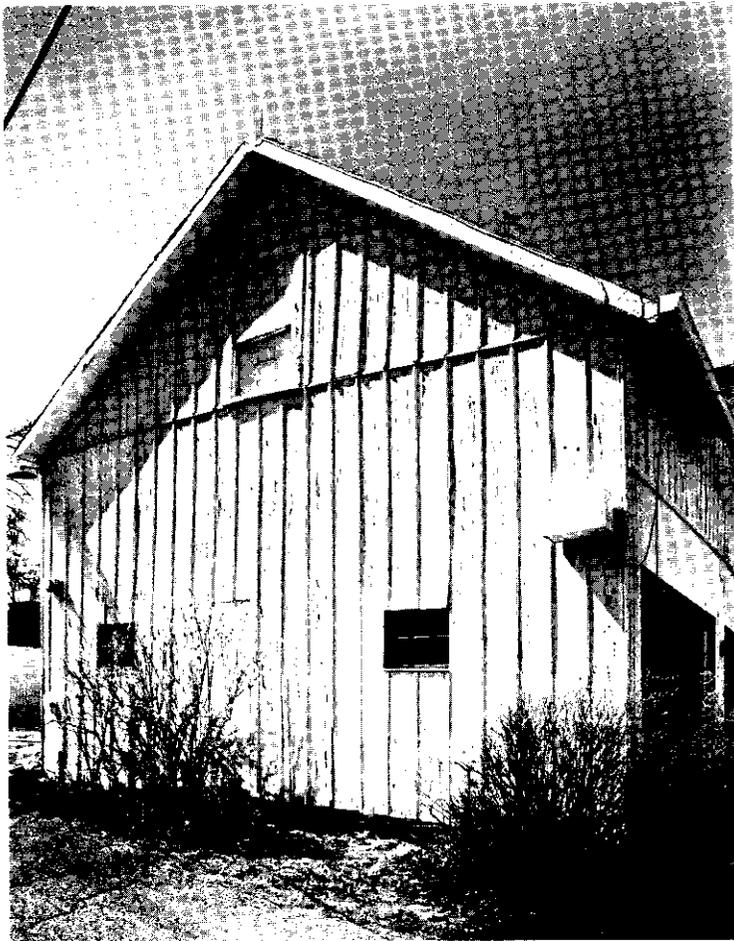
The grade along the east elevation is approximately 1 foot below the top of the foundation wall. Moisture problems are not apparent; there is a slight slope away from the building towards the driveway.²

The siding on the east elevation exhibits numerous open joints and missing or non-original battens. Relative to the west elevation, it is in poor condition. The edge is not in direct contact with the soil and is in sound condition.

Fig. 3.3 Truman Carriage House, Fall 1985. East elevation (looking west).
Credit: Zoom Studios

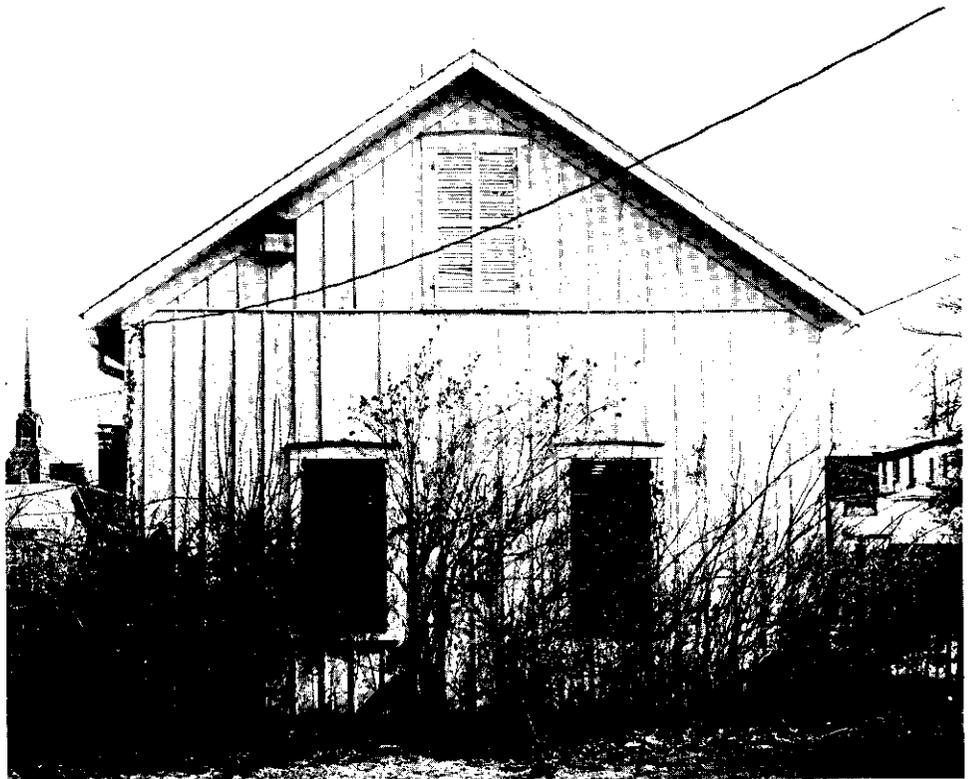
The west elevation shares some of the same problems as the south elevation. The soil has been built-up 2 inches above the top of the foundation wall. Tall, thick bushes along the west elevation have compounded moisture problems by reducing ventilation and sun exposure. The only downspout on the building drains rain water at the northwest corner. Negative slope causes water to pond in this area.

Fig. 3.4 Truman Carriage House, Fall 1985. West elevation (looking east).
Credit: Zoom Studios

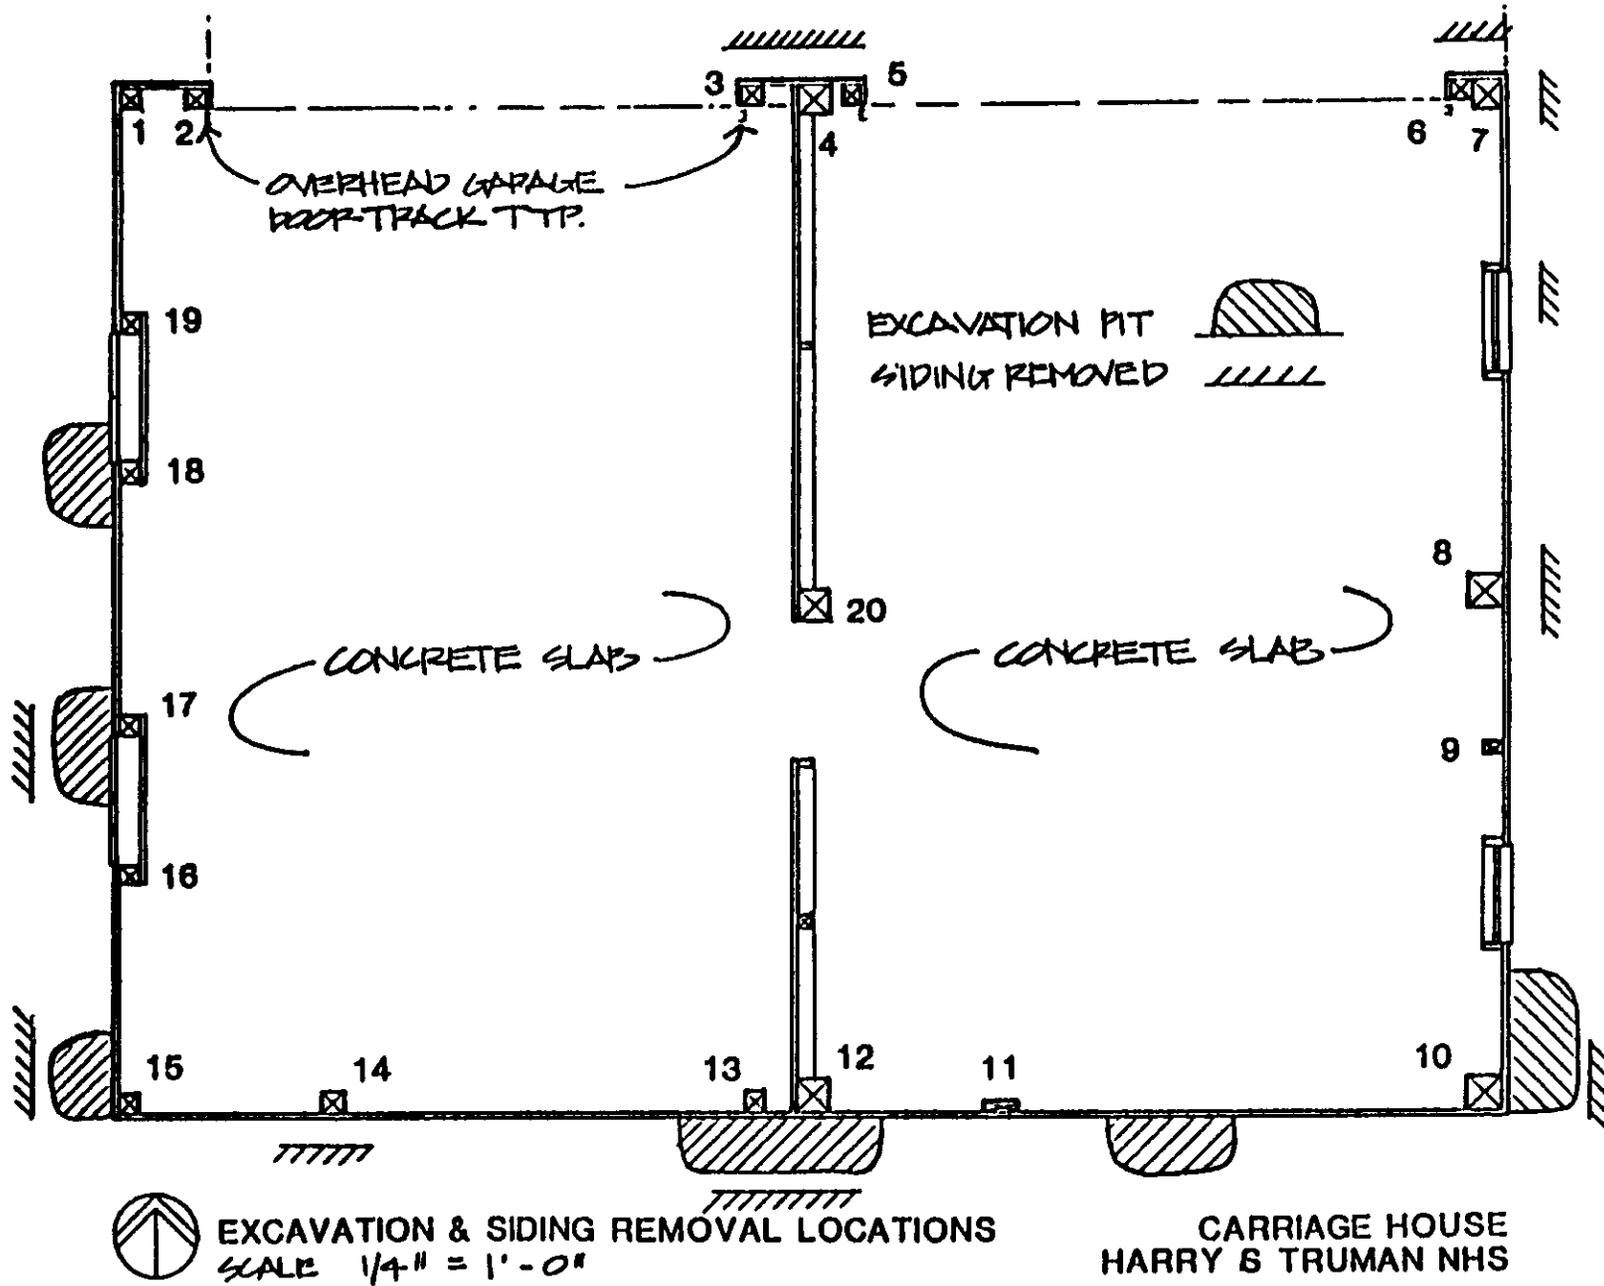
Appendix G. (b) Post Location Key. PIR(IIS-02).

MARK	DIMENSIONS	BEARING CONDITION				DETAIL	NOTES
		GOOD	FAIR	POOR	VERY POOR		
1	6x6				●		NFB, NSB
2	6x6				●		NFB, NSB
3	5 1/2 x 5 3/4				●		NSB, ROT
4	9x9 HH				●		NSB, ROT
5	5 1/2 x 5 3/4				●		NSB, ROT
6	5 1/2 x 5 3/4				●	5	NSB, ROT
7	9x9 HH			●		5	NSB, ROT
8	8 1/2 x 8 1/2 HH		●			4	NSB, ROT, T
9	4x4						NE
10	8 1/2 x 8 1/2 HH				●		NSB, ROT, T
11	2x8						NE
12	8 1/2 x 8 1/2 HH				●	2,3	NSB, ROT
13	5 1/2 x 5 3/4				●	3	NSB, ROT
14	5 1/2 x 5 3/4				●		NSB, ROT
15	5 1/2 x 5 3/4			●		1	ROT, T
16	4x4						NE
17	5 1/2 x 5 3/4			●		1	NSB, ROT
18	5 1/2 x 5 3/4			●		1	NSB, ROT
19	4x4						NE
20	9x9 HH				●		NSB(?), ROT
