HISTORIC STRUCTURE REPORT

FURE'S CABIN

BAY OF ISLANDS, NAKNEK LAKE

KATMAI NATIONAL PARK & PRESERVE

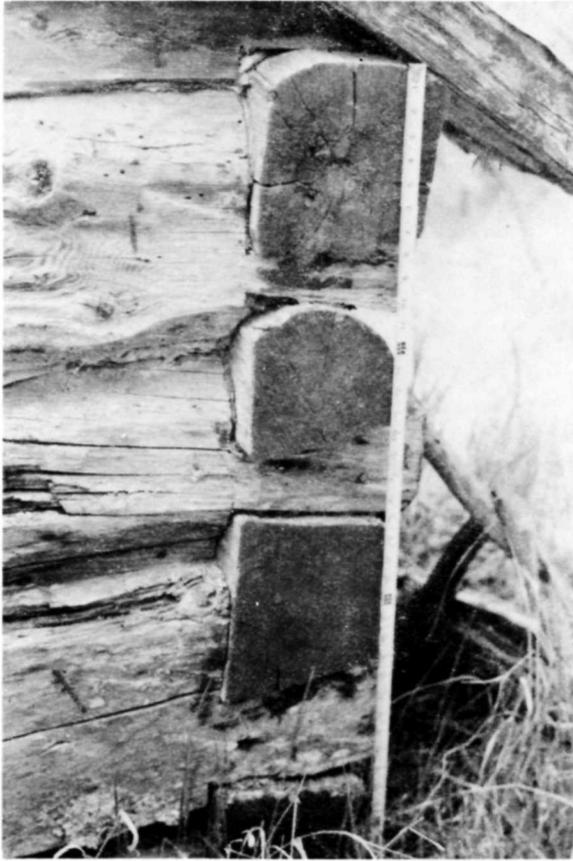
Photograph 8
North Elevation
6/82 D. Snow

The existing condition of the sill logs is obvious because they have been in constant contact with the soil since the cabin was constructed. There is uniform dry rot primarily below the grade. This problem is compounded at the north elevation and the north end of the west elevation because the structure is built into the hillside. At least three courses of these wall logs, above the floor level, are in direct contact with soil at their exterior face.

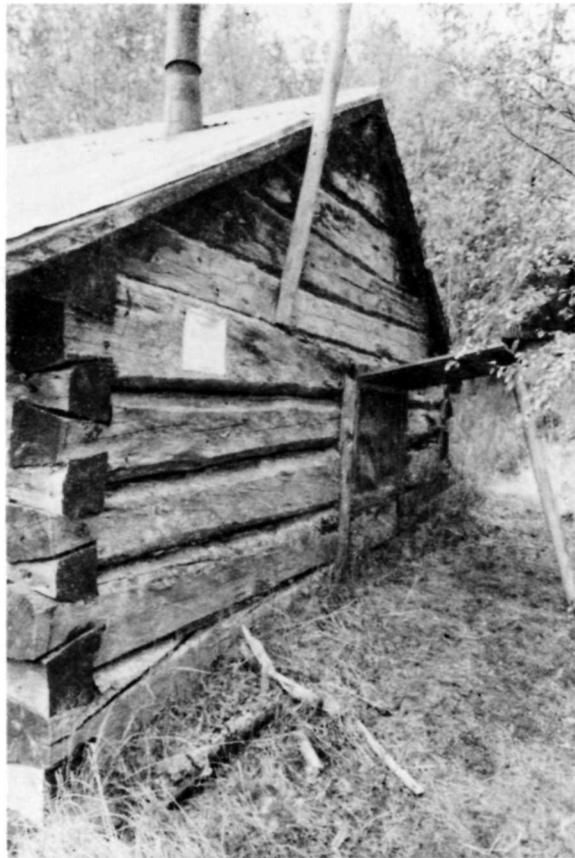
Photograph 9
West Elevation with Window Shuttered
6/28/83 D.C. Anderson

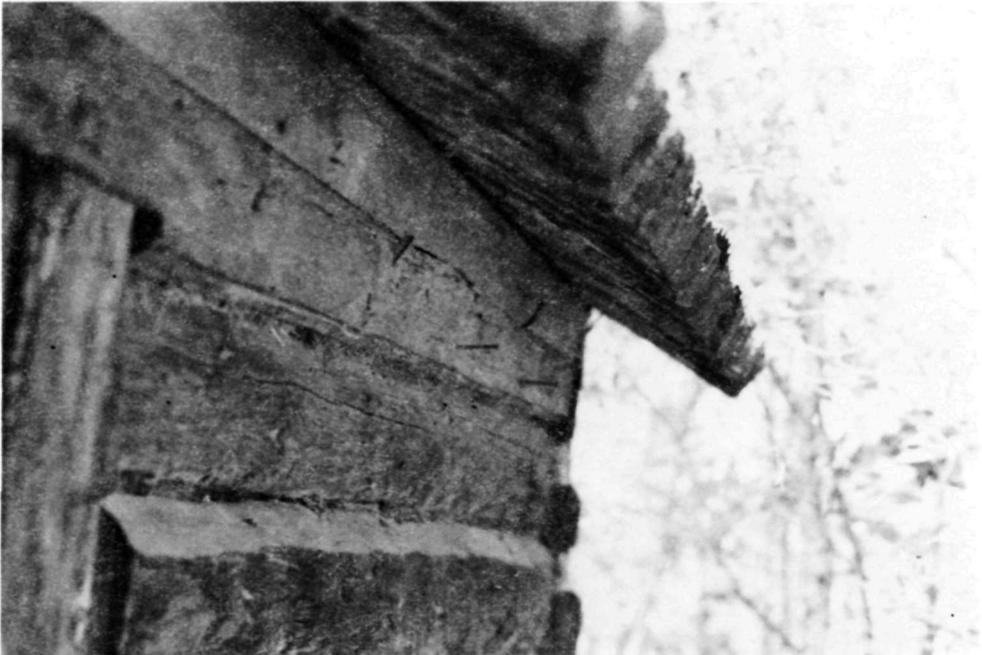
The roof planks are sheathed with corrugated metal at the exterior. There are signs of rot at the butts of many of the planks because the corrugated metal does not uniformly cover the last inch of the plank. Water running off the roof is being soaked up into the end-grain and causing damage. It should be noted that the end-grain of the roof planks and the corrugated metal have all been treated historically with what appears to be red paint, similar to that found on wall corners.

Photograph 11
Roof Planks Ends at East
Elevation
6/28/83 D.C. Anderson

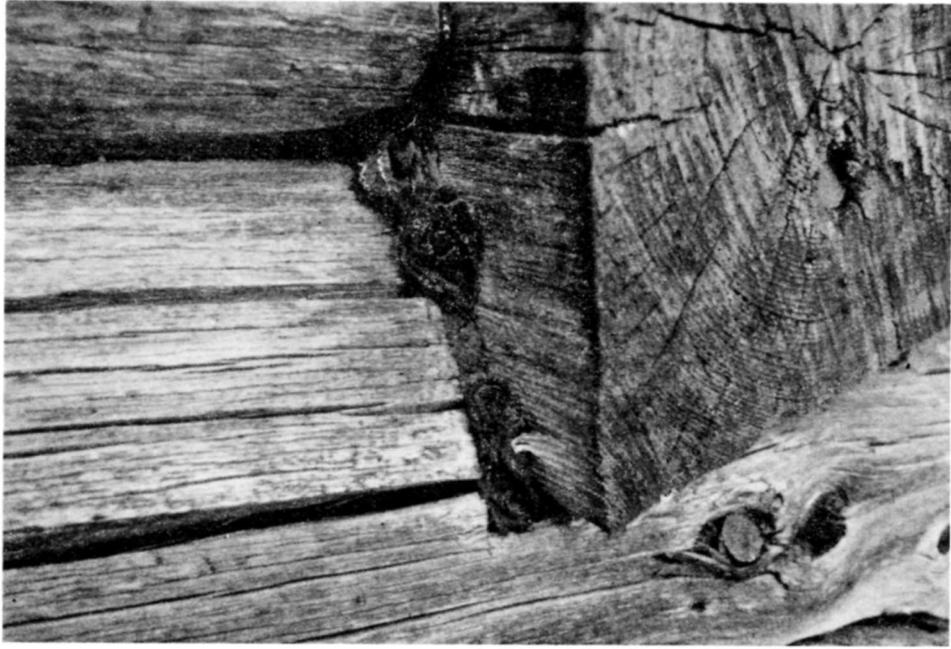
Photograph 44
Northeast Corner: Note
Rotted Sill Log
6/82 D. Snow
