Historic Fire Station No. 6 Martin Luther King, Jr. National Historical Park

Historic Structure Report

August 2019
Cultural Resources, Partnerships and Science Division
Southeast Region

Prepared by:
Panamerican Consultants, Inc.
2390 Clinton Street
Buffalo, New York 14227-1735

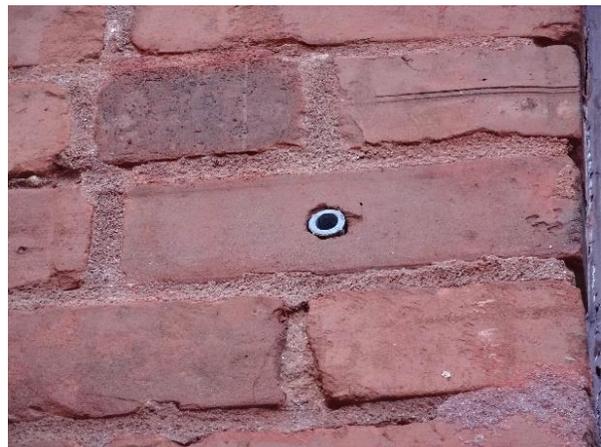
- Embedded anchors were observed in the brick (Figure 54), and some former anchor locations were patched with a cementitious patch material (Figure 55). Typically, the anchors did not exhibit any corrosion. It is likely they were associated with a previous canopy system that was removed in 1995.

FIGURE 54. Embedded anchor in brick masonry wall.

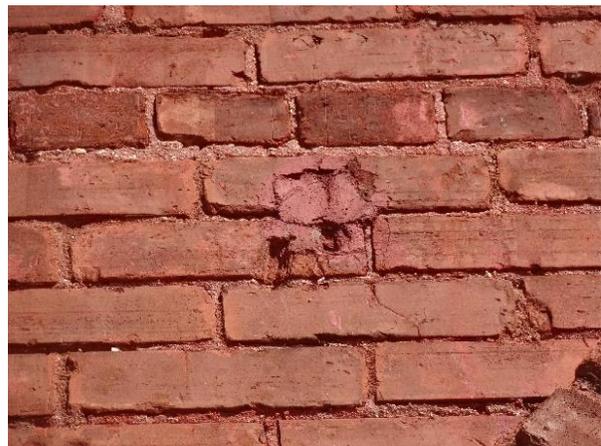
FIGURE 55. Cementitious patch at previous anchor location.

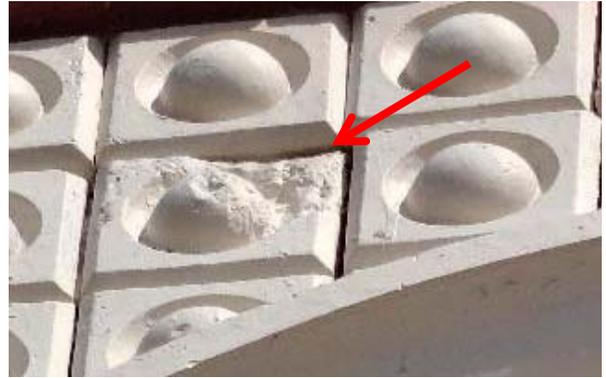
- Small spalls were observed at approximately four hemispherical projections on the terra cotta dedication year plaque. The spalls were typically 1/2 inch deep and had been encapsulated with a white surface coating (Figure 66). No untreated spalling was observed.

FIGURE 66. Spalls in the terra cotta.

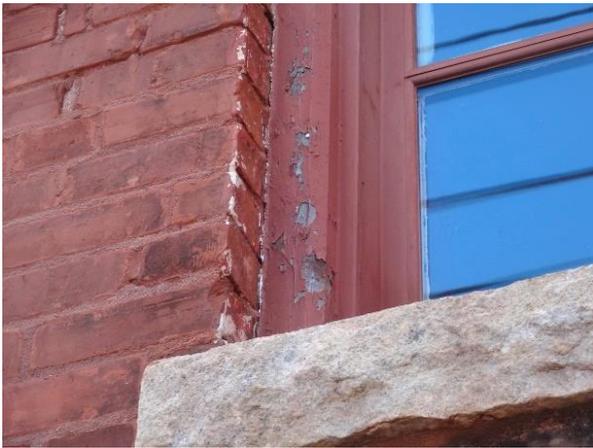
- Peeling, debonded, and cracked paint was observed at many of the window units (Figure 76). The distress was typically observed at the bottom of window jambs and at sills where checks and knots in the wood were present. At some areas, the paint had fallen off and the underlying wood was exposed to view. The wood at these locations appeared weathered.

FIGURE 76. Debonded and peeling paint at window frame.

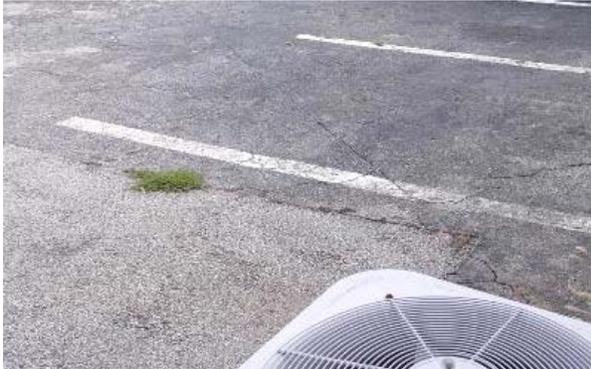
- Cracking was observed at the asphalt-paved surface lot east of the building at street level (Figure 80). At many locations, the cracking included biological growth.
- Deteriorated paint was observed at the fiberglass door at the personnel entrance on the west elevation (Figure 81).
- Pest infestations were observed at the head of window and door openings (Figure 82). The infestation included what appeared to be mud dauber and yellow jacket nests and spider webs. No evidence of termite infestation was observed.

FIGURE 80. Cracking and biological growth at asphalt-paved surface lot.

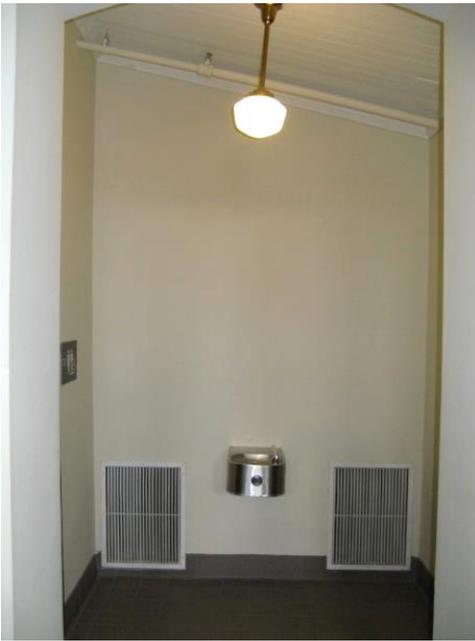
FIGURE 110. Overall view of toilet vestibule.

Fire-suppression piping overhead follows the slope of the ceiling and is exposed to view. A single light fixture matching those in the museum space is mounted in the vestibule ceiling. The brass rod connecting the fixture base to the globe receiver appears to be fixed in a perpendicular relationship to the sloped ceiling and may be deflecting due to the weight of the globe.

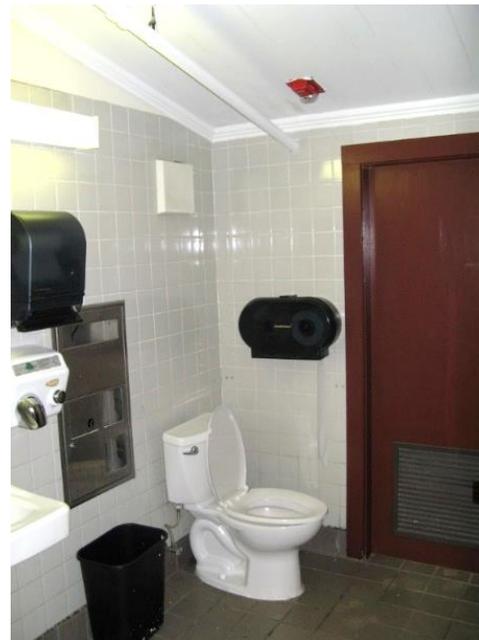
FIGURE 111. Overall view of west toilet.

The unisex west restroom is not ABAAS compliant. A door on the west wall provides access to the west HVAC equipment room (Figure 111). The east unisex restroom is intended to be ABAAS compliant and labeled as such in the vestibule. The room has a chair-height toilet with an elongated bowl, wall-mounted grab bars and a toilet paper dispenser within the ABAAS reach range (Figure 112). As referenced in the 1999 condition assessment, the flush valve is mounted on the wall side of the toilet.¹³⁷ Additional study is required to determine whether the restroom meets the most current standards of the ABAAS for floor clearance requirements and pipe protection at the fixtures.

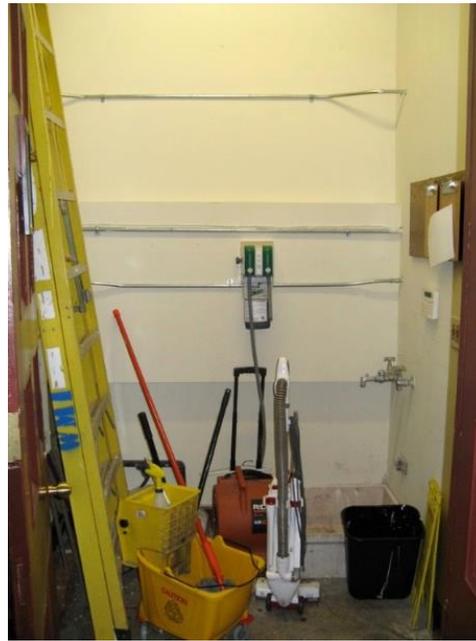
FIGURE 113. Overall view of janitor closet.

The janitor's closet has a fiberglass floor sink in the southwest corner with a wall-mounted faucet and soap dispenser (Figure 113). There is no wall protection at the sides of the mop sink and no mop hook. A plywood panel with metal hooks is attached to the wall above the mop sink and above a digital control panel

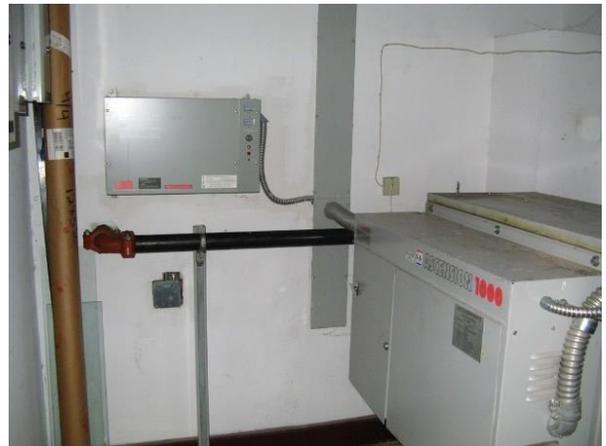
The elevator's hydraulic control system is housed in a machine room occupying the southeast corner of the first floor (Figure 117). The fire ratings of the shaft and the elevator controls room are not labelled or recorded in available documentation. It is likely that the wood ceiling assembly at the underside of the hose room does not meet the contemporary fire code separation requirements for a hydraulic elevator machine room. The presence of a sump pump and oil separator could not be determined at the time of the site visit.

FIGURE 117. Elevator controls.

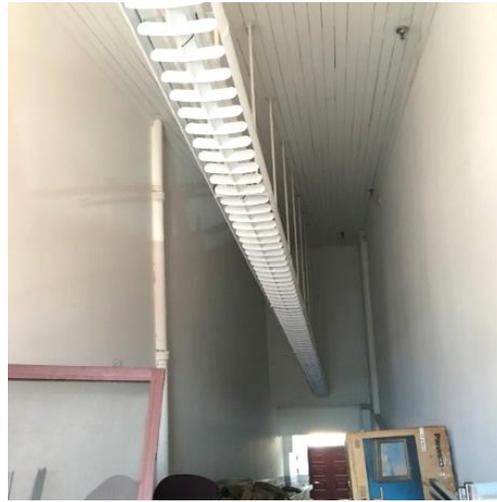
There are several steps in the ceiling and walls on the western end of the hose room concealing mechanical equipment and electrical conduit (Figure 125). A continuous, suspended fluorescent light fixture runs along the full length of the hose room ceiling.

FIGURE 125. Hose room ceiling.

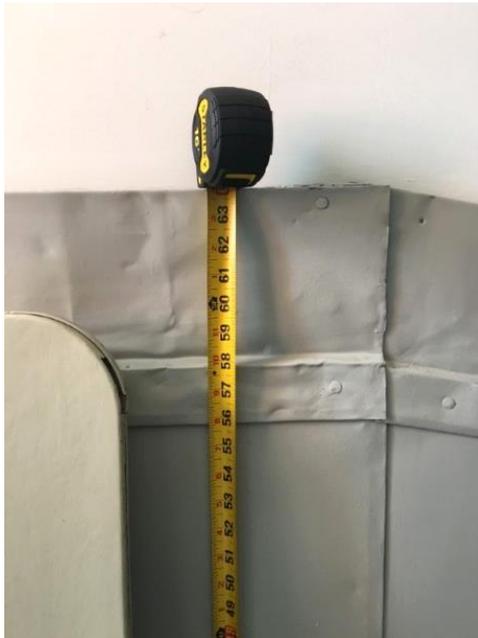
Finishes in the room consist of a beaded board ceiling and crown molding painted white. Walls are finished with gypsum board furred off the original masonry and painted a cream color that matches the first-floor rooms. The sloping floor is covered by lapped sheet-metal panels with cleated flat seams that turn up the walls to a height of 4 feet 8 inches. The metal wainscot is terminated with an 8-inch-high hemmed cap (Figure 124). The paint finish on the metal panels is in good condition at the walls but worn at the floor. It is

unclear whether the worn condition is the result of an intentional reproduction of a historic condition or if it is the result of normal wear since the rehabilitation work was completed.

FIGURE 124. Detail at top of metal wainscot panel.

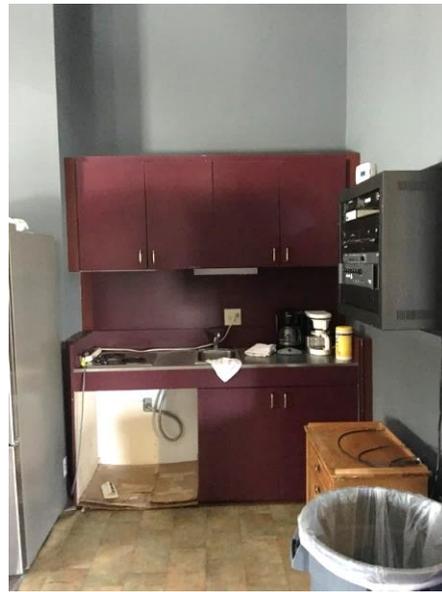
FIGURE 128. Overall view of kitchenette.

Second Floor – Kitchenette. The kitchenette area is defined by a small area of vinyl flooring within the larger area of carpet that covers most of the second floor. The built-in kitchenette unit consists of a two-section base and wall cabinet with dark red plastic laminate and chrome wire pulls (Figure 128). The stainless-steel countertop incorporates a two-burner electric cooktop and a small stainless steel, drop-in bar sink. Above the

sink, a toggle switch controlling an under-cabinet light fixture and a ground fault interrupter (GFI) receptacle are installed in the backsplash behind an ivory faceplate. A missing under-counter refrigerator on the left side of the base cabinet was replaced by a full-size refrigerator adjacent to the kitchenette unit (Figure 129). The full-size refrigerator is plugged into an outlet power strip on the countertop. The cord from the power strip runs across the electric cooktop and the countertop to the receptacle above the sink.

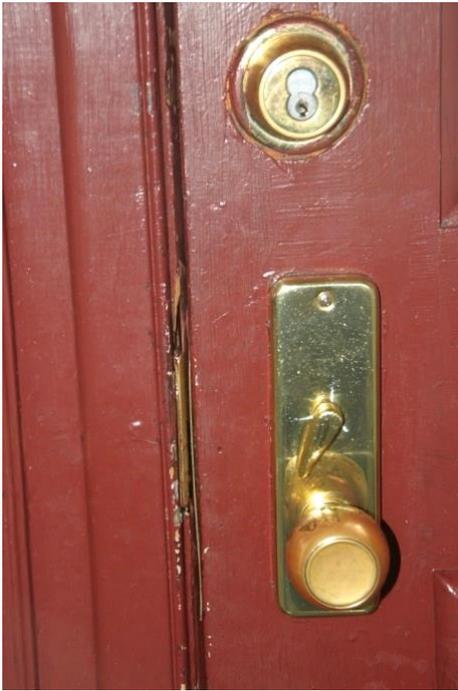
- There is a deadbolt lock on the west egress door that is keyed on the interior (Figure 143). When the deadbolt is locked, it will prevent egress in the event of an emergency, particularly if the east egress door is blocked.

FIGURE 143. Deadbolt at interior of egress door.

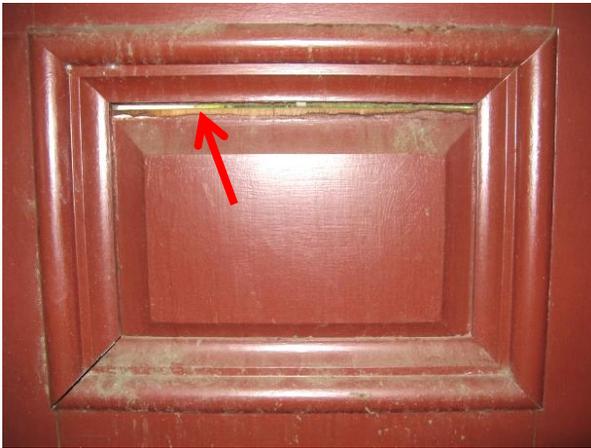
- The lower panels on the pair of doors at the base of the inclined hose room have separated from the rail. Daylight gaps were observed (Figure 144).
- The interiors of windows were mostly in good condition. Moisture infiltration was noted at some locations. At many second-floor windows, the lower sash did not seat properly at the sill, and it appeared that foam strips were inserted at the base of the sash tracks. The result is that lower sash cannot be completely lowered and the windows cannot be secured with locks at the meeting rails (Figure 145 and Figure 146). No information was available to indicate the intended purpose of the foam inserts or to confirm when they were installed in the sash tracks.

FIGURE 144. Panel separation at exterior door.

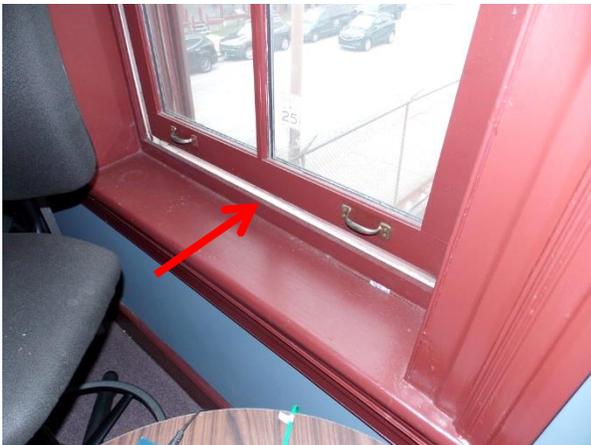
FIGURE 145. Typical gap at bottom of lower sash.

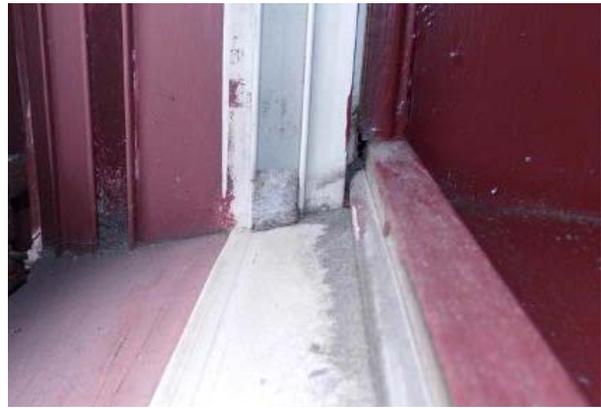
FIGURE 146. Foam insert at sash track.

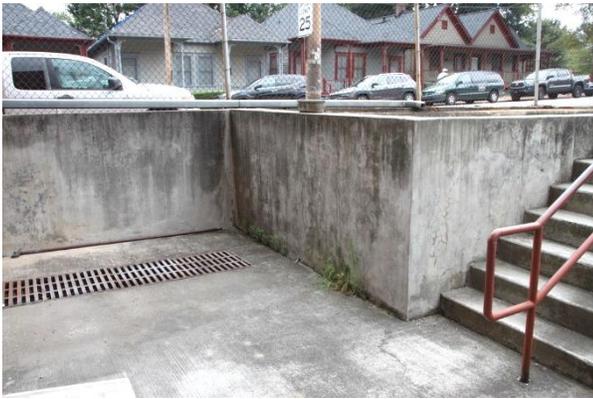
- There are several issues of concern relating to the accessibility of the second, east exit from the first floor. Currently there is no completely accessible path from the interior of the building to a public way. The historic door at this location is very large and the force required to open it may exceed the maximum opening force stipulated by the ABAAS. The threshold at the door is raised approximately six inches above the concrete surface at the recessed court on the east side of the fire station. Within the court, the only path of egress is up a flight of concrete steps to the parking lot and sidewalk level along Auburn Avenue. There is only a center grip rail at the steps, and no ramp is provided as an accessible route. The concrete retaining walls around the recessed court and the returns along the sides of the steps exceed the 30-inch minimum height, above which a compliant guardrail is required for compliance with the IBC (Figure 148). At both the court level and the sidewalk and parking lot level, the linear drain inlets do not have heel-proof grates as required when drains are in walking surfaces in a public area. These issues should be addressed and considered along with the interpretive considerations for the historic landscape. Currently, it appears that the only historic condition of significance along the east facade is the presence of the pair of historic vehicular doors. The Historic Landscape Report (HLR) produced in 1995 refers to designs for an acceptable treatment for the rear yard of the fire station.¹³⁹ The current installation does not reflect the proposed drawings included in the HLR.

FIGURE 148. Retaining wall condition at east exit. Note the absence of guardrails along the tops of the walls and only a center handrail.

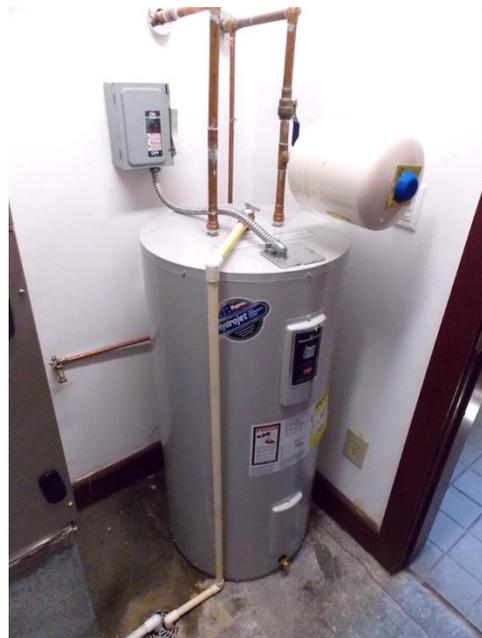
FIGURE 152. 50-gallon electric water heater at second-floor mechanical room.

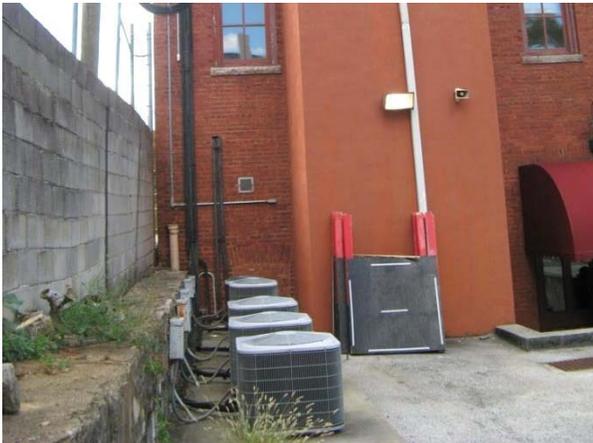
Four air-cooled condensing units are located outside east of the elevator tower along the south property line (Figure 154). The units sit on a raised concrete pad. Each unit has an electrical disconnect mounted to the stone retaining wall behind it. Electrical supply conduit and refrigerant lines run horizontally along the wall before turning up the face of the building at the southeast corner. Some refrigerant lines lacked insulation after passing through the exterior wall.

FIGURE 154. Condensing units at east side of building.

The condensing units appear to be in good condition; however, no information was available to document their ages or maintenance histories.
