# Reid-Zachary House 497 Auburn Avenue

Martin Luther King, Jr.  
National Historical Park

## Historic Structure Report

2018

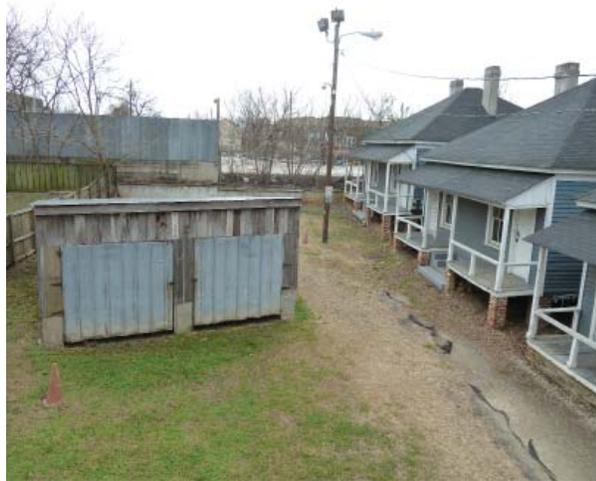
**Figure B29.** All landscaping elements were removed from the back yard in the 1999-2000 project, including vegetation for shade and delineation, and the fence and gate determined to be of high integrity to the period of significance. The fence was typical of those in Auburn Avenue yards during King's time there and, in 1995, one of only two left in the neighborhood.

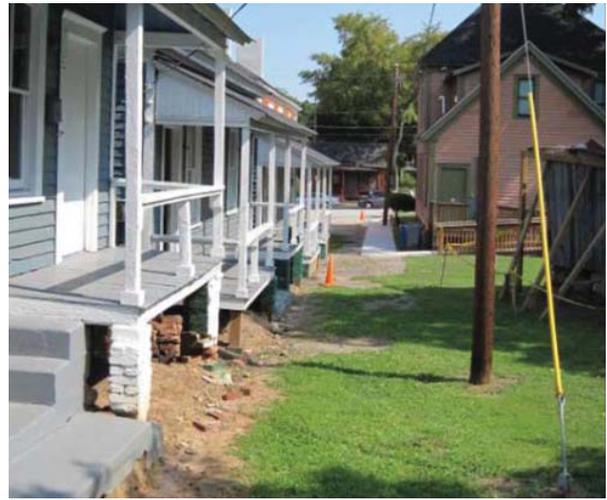
Figure B33. Same view in 2010 long after NPS removed trees and other landscape features. (MALU collection)

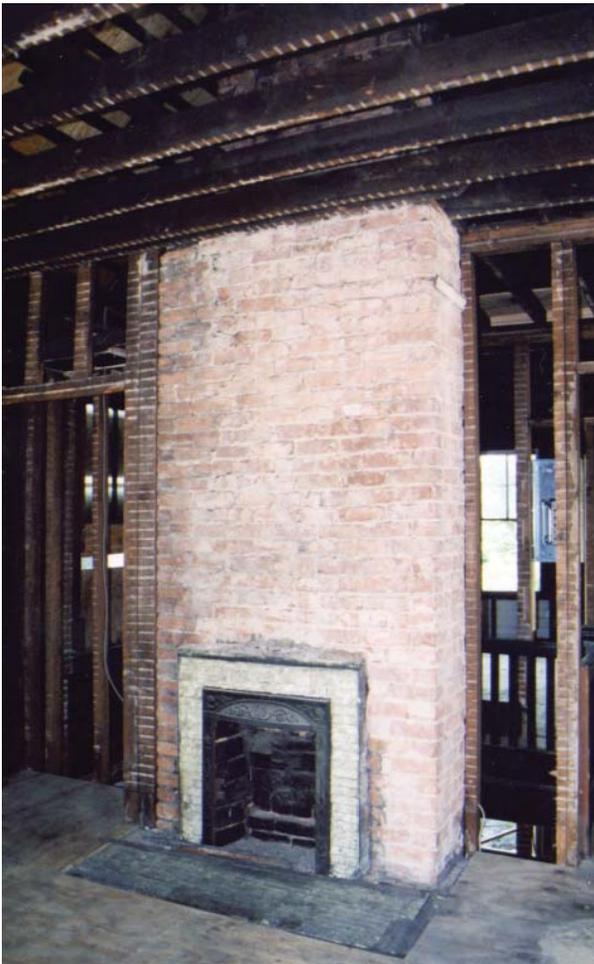
**Figure B36.** Chimney in northeast bedroom during work. The mantel, decorative tiles on the hearth, and plaster were removed; only the cast-iron firebox surround and the surrounding tiles were kept. A mantel of different design was later installed. (MALU collection of 2005-2010 photographs)

iron insert and tile surround are the only remaining historic features (*Fig. B36*).<sup>108</sup>

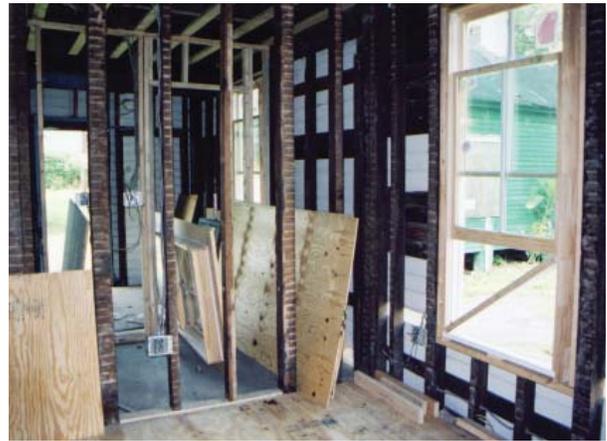
**Figure B37.** Looking south-southwest towards the back of the house; at the left is the back door. This and other photographs show the stacks of new windows that replaced original windows, as noted in the CAR. A new window unit, including sash, surround, sill etc., is in place in the west wall (right) (MALU collection of 2005-2010 photographs)

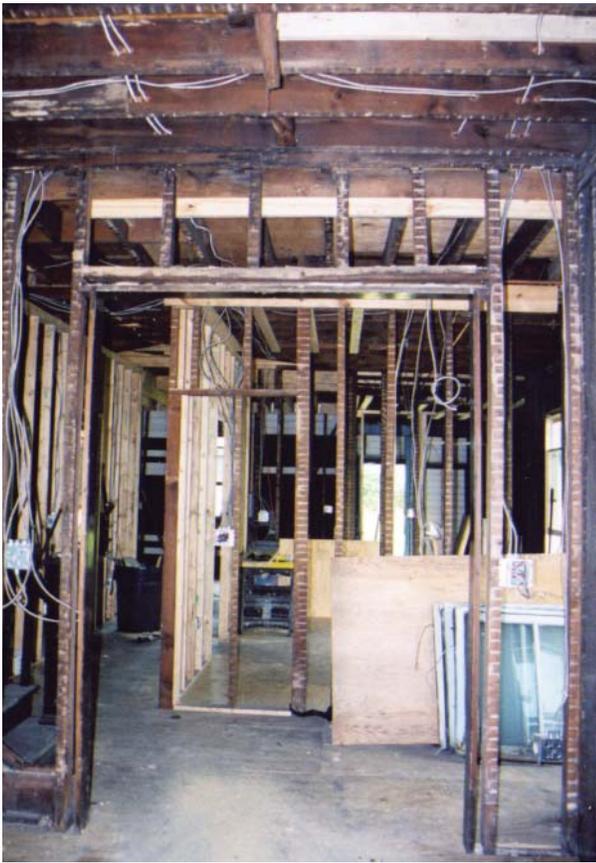
**Figure B38.** Looking south from the front hall; one of several photographs showing the extent of removal of original fabric, including all trimwork, plaster and lath walls and ceilings, and doors. The CAR noted that the pocket doors and front door were retained. (MALU collection of 2005-2010 photographs)

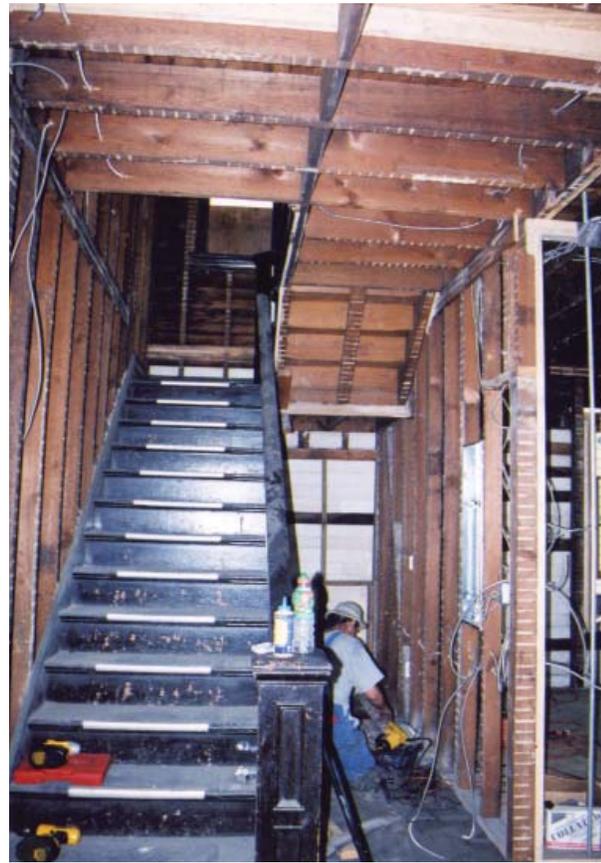
**Figure B39.** Looking east toward the Birth Home; the bathroom added by Henry James at the end of the stair hall and beneath the stairs has been removed; the window remains, but would later be removed with the ghostmark evidence of the earlier door. (MALU collection of 2005-2010 photographs)

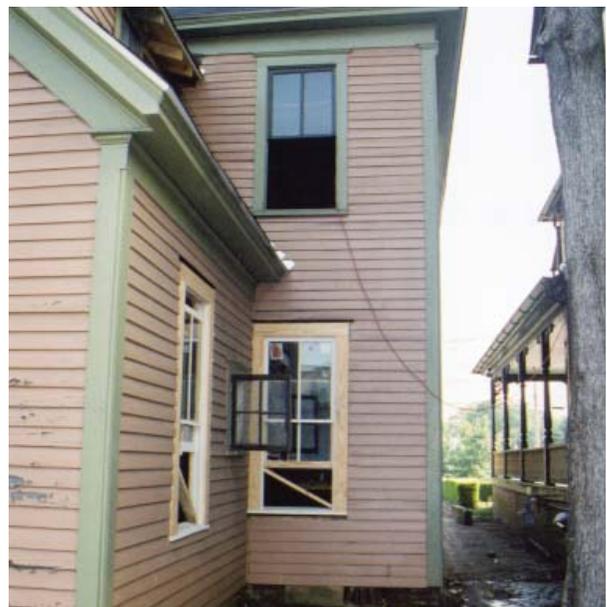
Concurrent with the interior rehabilitation, work resumed on the exterior, focusing mainly on fenestration and accessibility. On the east wall of the rear ell, a casement window, possibly not original, was removed (*Fig. B42*). An original double-sash window on the south wall was either replaced with a smaller window or shortened. The original four-over-four-light, double-sash window at the second-floor gable end was either replaced with, or modified to, a one-over-one-light, double-sash window of the same dimensions. The four-light casement dormer windows were replaced with single-light, fixed sash windows of the same dimension (*Figs. B40-B41*).

**Figure B42.** New windows being installed in south and east back walls. The open casement window between them was later removed. (MALU collection)

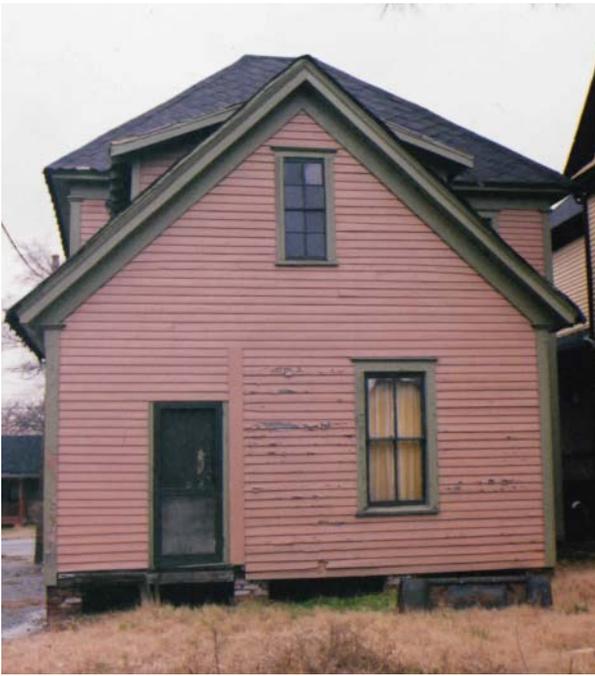
More general work to the house included stabilizing and rebuilding over 100 square feet of masonry (probably foundation piers and infill walls); replacing 500 square feet of siding; repairing the front door and threshold; repairing/replacing damaged window trim, drip molding, and sills; repairing 48 window sash and replacing four; and replacing damaged sections of soffit, corner boards, and skirt boards. The exterior of the house was painted. At the back where the shed additions had been removed, the two back doors were removed (*Fig. B43*).

**Figure B43.** The back of the ell as it was left in 2000. Two doors were removed and a new doorway, seen above, was added just to the right of the earlier door. Of interest is the vertical board probably showing the location of the west wall of the original ca. 1900 ell before the Reids' widening. (MALU collection)

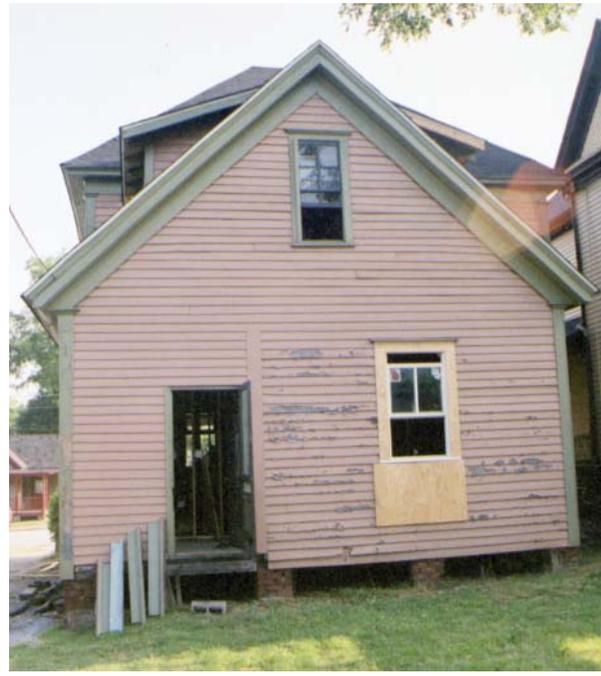
**Figure B44.** The back of the ell during the 2005-2010 work, showing the window being shortened. The surround and sash were replaced with new materials. The door remains in the location selected in the 1999-2000 work. (MALU)

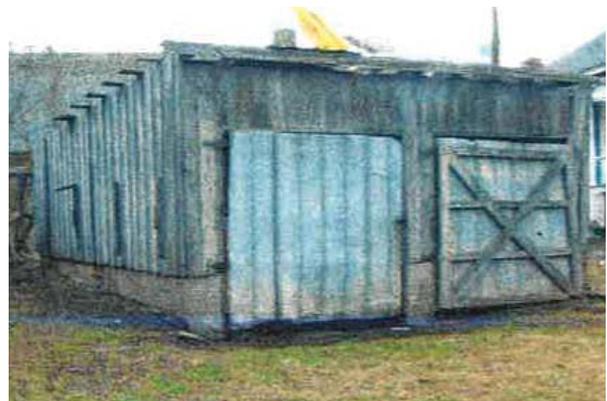
The CAR noted that lumber, attached vertically to the lower half of the east elevation, may have supported an earlier attached shed or structure

Figure B47. Lumber and supports on the east side, probably for an earlier shed attachment. (CAR, p. 84)

(*Fig. B47*). The nearby fence at the property line of the Birth Home had been replaced, so no evidence of any corresponding supports on the earlier fence could be found.<sup>116</sup>

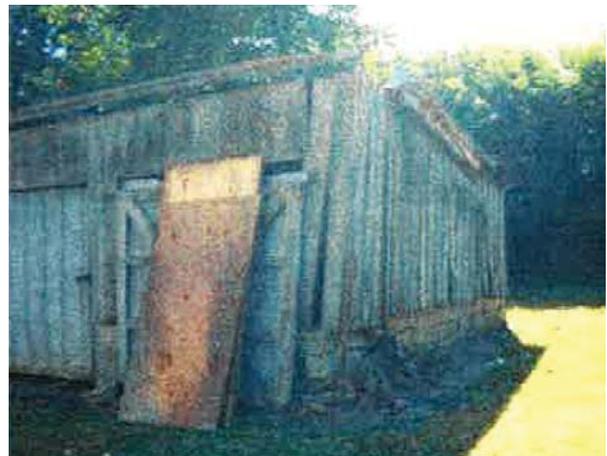
Figure B48. Door resting on ground with exterior metal surface facing inward. (CAR, p. 83)

The shed/garage was in poor condition; the northwest foundation was near collapse, and about half of the corrugated metal roof covering was missing, exposing the rafters. One door was propped with its bottom edge on the ground.<sup>117</sup> The building was left untouched during the work on the house and later when elements of the landscape were destroyed. Nevertheless, although the 2008 CAR called for study and preservation, a work project was undertaken in 2011.<sup>118</sup> Comparisons of the building with 1990s and 2008 photographs and descriptions show that the structure was braced, then disassembled and repaired with new and salvaged materials (*Figs. B50-B52*).<sup>119</sup>

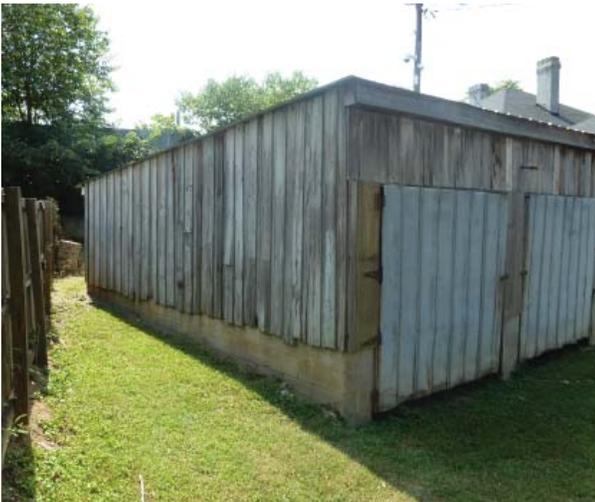
**Figure B50.** Garage after the project. East side shows salvaged boards of staggered lengths. Board-and-batten and flush siding were removed. Photographed 2016.

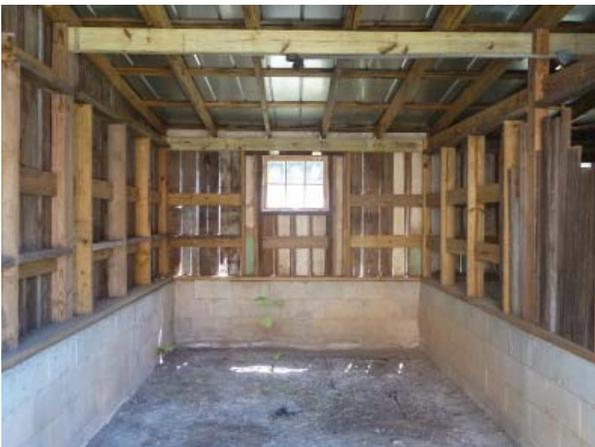
**Figure B51.** Garage interior, showing new materials and loss of shelving. Photographed 2016.

horizontal, and the sash turned ninety degrees from its earlier orientation (*Fig. B51*). The early six-light sash seems to have been heavily repaired. The four-light sash in the east window was replaced with a six-light sash that appears to have been salvaged.

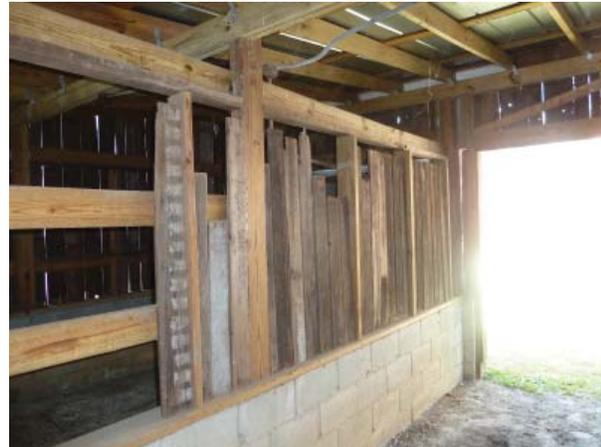
**Figure B52.** Garage interior partition of mixed salvaged pieces. Photographed 2016.

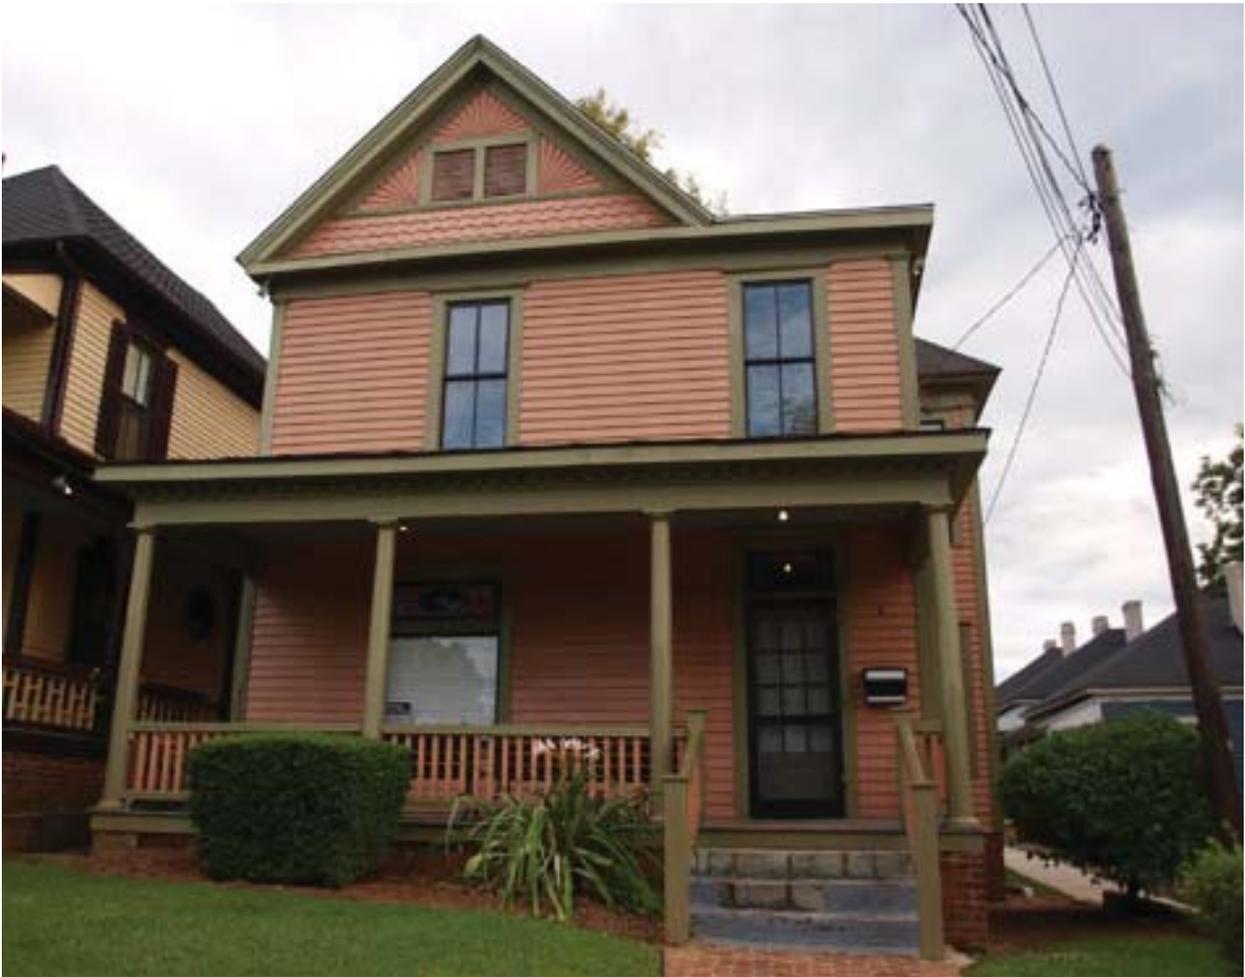
Wood newel posts and handrails were introduced to the front porch steps to improve safety (*Fig. B52*). Some hardware on the front door and all hardware on the screen door was replaced, and an acrylic panel was added to the screen door. The brick walkway leading to the stairs was relaid in a combination running/stack pattern with no edging, although the well-documented original walkway had been in a herringbone pattern with a sawtooth edging (*Figs. B17 & B52*). Presumably, the cast iron railings at the steps to the sidewalk were added at this time.

**Figure B53.** Front of house in 2012 showing introduction of railing on front steps. The herringbone brick walkway and sawtooth edging noted in the Cultural Landscape Report has been replaced with a brick walk of combination running/stack pattern without edging. (MALU collection)

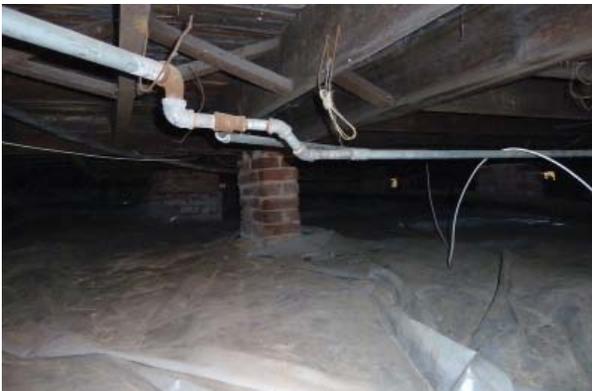
Figure C10. Original elements of first-floor framing visible in north half of crawl space. Note the foundation of the front chimney in the background.

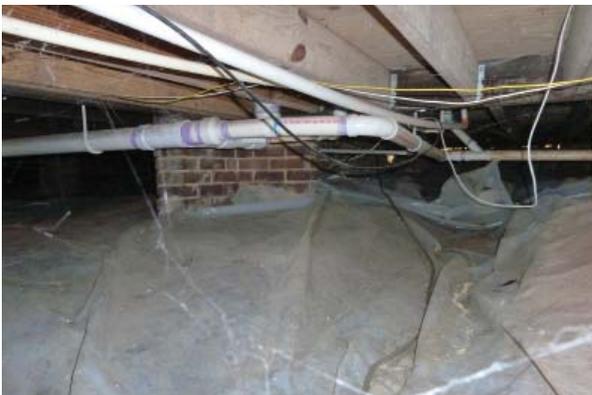
Figure C11. Modern replacement elements of first-floor framing visible in south half of crawl space. Note original L-shaped pier under the northwest corner of the original rear ell and the modern PVC drain lines for the former first-floor bathroom added during the 2005-2010 rehabilitation.

First-floor framing is visible from the crawl space. Much of the original framing has been replaced, likely because of fire damage and subsequent water infiltration as well as the alterations made during the 2005-2010 interior rehabilitation. The remaining original framing is concentrated near the north side of the house, which has seen the least change and would have been least affected by the fire. Floor joists here are nominal 2x8s running between doubled 2x8 girders resting on brick piers.<sup>131</sup> Between the joists is 2x4, X-type blocking. Floor decking is composed of individual boards nominally 6" wide. Replacement framing consists of modern 2x8 joists hung with metal joist hangers from girders of doubled modern 2x8s. There is no blocking, and floor decking is modern plywood (Figs. C10-11).

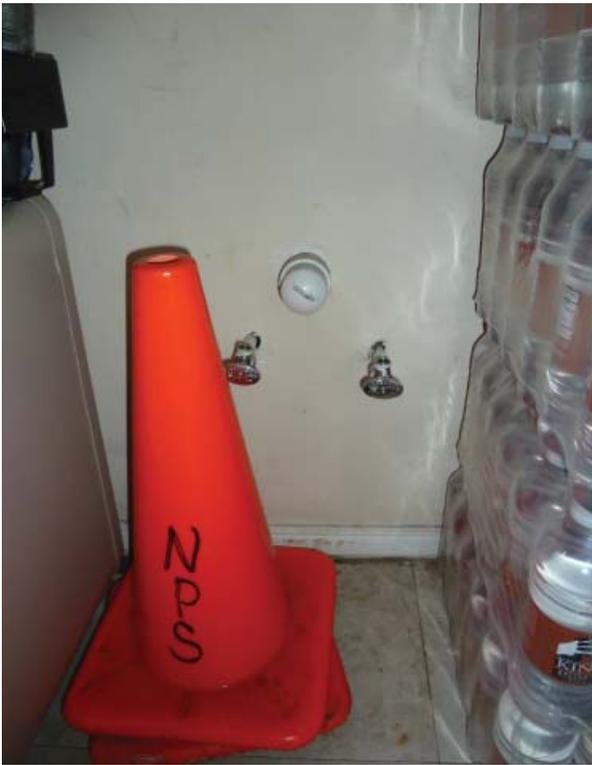
Figure C21. Remaining plumbing supply and drain lines on east wall of Room 109A.

At an unknown later date, the plumbing fixtures were removed from Room 109A, and the room was used for storage. The supply and waste lines are still in place (Fig. C21).

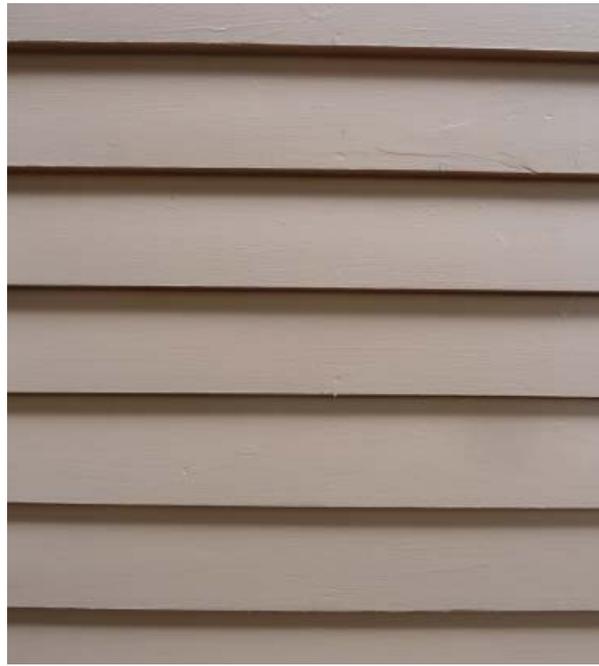
All siding and trim are painted. The house exterior is clad with tapered weatherboards ranging in exposure from about 4 1/2" to 5" and with a maximum thickness of 1/2" at the exposed end. Photos taken during the two phases of rehabilitation indicate that much of the siding was replaced in kind (Fig. C26).

Figure C26. Tapered weatherboard siding.

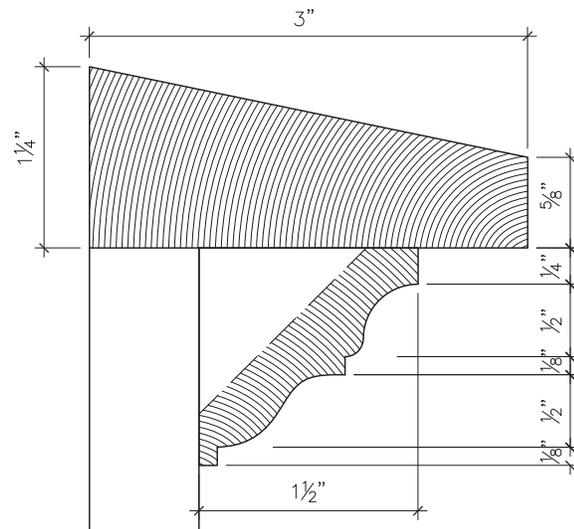
Figure C34. Original drip edge and decorative molding.

mitered crown molding was added to a couple of first floor windows on the main block (Figs. C34-35). A modern, non-matching replacement 1 5/8"-tall backband molding is present only on the rear ell (Fig. C36). The molding under the drip edges of the ell's east first-floor window and second-floor south window and the east and south first-floor windows of the main block is missing. The dormer windows probably never had this detail.

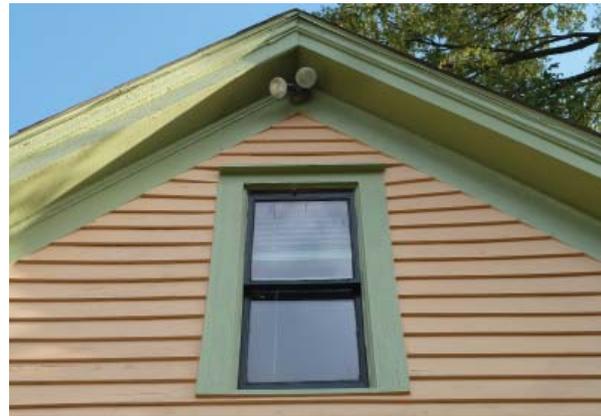
Figure C41. Modified/modern one-over-one, double-sash second-floor window on north wall of rear ell.

At the second-floor level of the ell's gable end is a one-over-one-light, wood, double-sash window measuring 1'-11" wide by 4'-2" tall (*Fig. C41*). While the opening probably dates to the expansion, photographs show it originally held a four-over-four-light, double-sash window, which was repaired during the 1999-2000 rehabilitation and then either modified or replaced with the current window during the 2005-2010 rehabilitation.

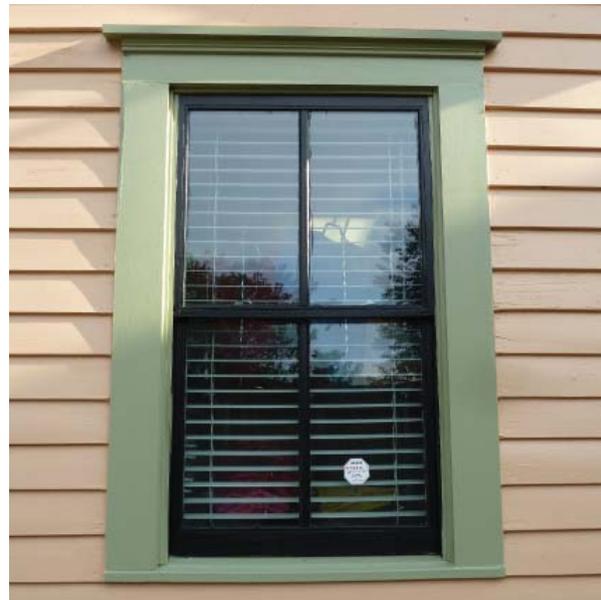
Figure C42. Modern four, fixed-sash first-floor window on north wall of rear ell.

The first-floor level of the ell's gable end has a two-over-two-light, wood, double-sash window measuring 1'-11" wide by 4'-2" tall (Fig. C42). Photographs of this wall show a 1'-11"-wide by 6'-2"-tall window matching those original to the main block, and physical investigation further indicates that it is probably the original south wall of the original ell, and the taller window was original. It was repaired during the 1999-2000 rehabilitation and replaced with the current four-light fixed-sash window during the 2005-2010 rehabilitation.

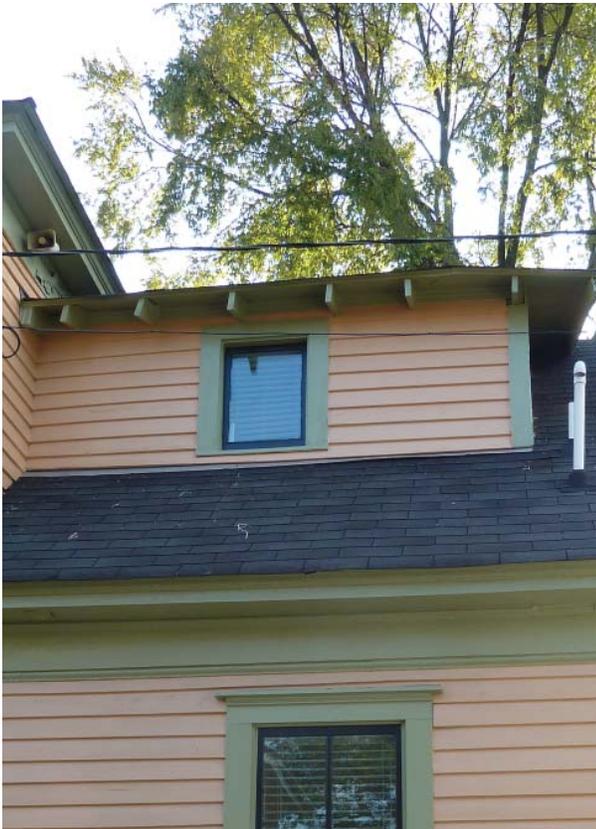
Figure C40. Original four-light fixed-sash dormer window of rear ell.

On the rear ell, each of the two dormers have a four-light, wood, fixed-sash window measuring 2'-0" wide by 2'-7" tall (*Fig. C40*). They were likely installed when the ell was expanded. Photographs show they were once operable-casement sash but were modified to be fixed and possibly rebuilt during rehabilitation work.

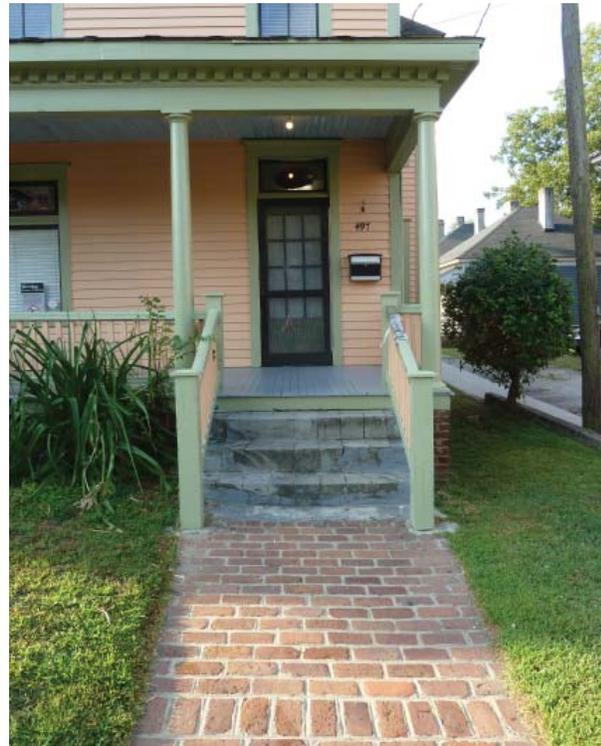
Figure C48. Steps leading to front porch.

Three steps constructed of CMUs lead to the front porch. They were once stuccoed and painted, but these finishes have eroded, and the CMUs are clearly visible. The first riser is only 6½” tall; the other two are 8” tall, but the distance between the top step and the porch floor is 6½”. The treads range in depth from 10” to 1’-1”, and the top step is skewed slightly to the west. While early, these steps are likely not original (*Figs. C48-49*).

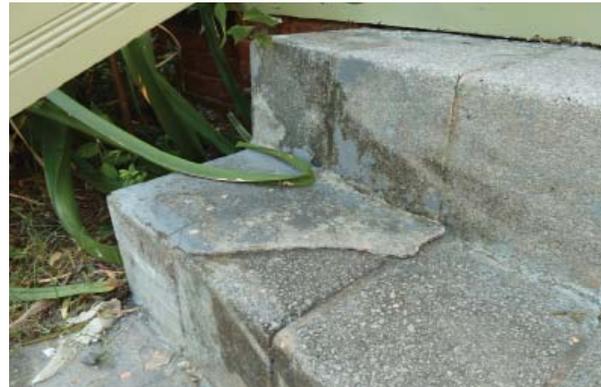
Figure C49. Exposed CMUs of front steps under deteriorated painted stucco coating.

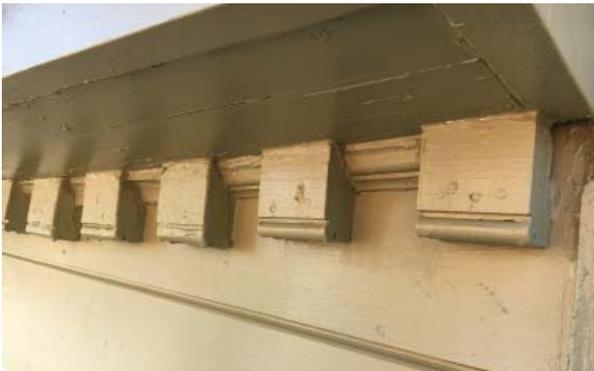
Figure C52. Mismatched dentils at front porch bed molding.

The porch roof is supported by four, more or less equally spaced Tuscan-style columns (a more austere Doric order) and a relatively unadorned entablature. The simple, round columns have a 7½" diameter shaft that tapers as it rises. Detailing on the columns is plain. Capitals are composed of a rounded echinus band molding and square abacus, while bases have only a rounded torus band molding and square plinth. The entablature has a composite bed molding, made of a 1x6 plank with a molded cap set below, and dentils with an incised three-quarter convex molding. Between the dentils is a 1¾"-tall simple convex molding in 3½"-long segments. Several non-matching replacement

dentils and a non-matching replacement 1½” molding were added during the 1999-2000 exterior rehabilitation (Figs. C51-56).

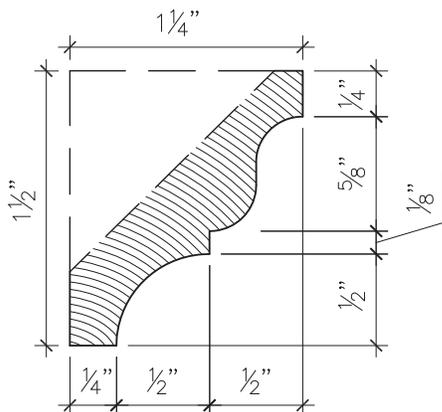
Figure C56. Non-matching replacement front porch bed molding.

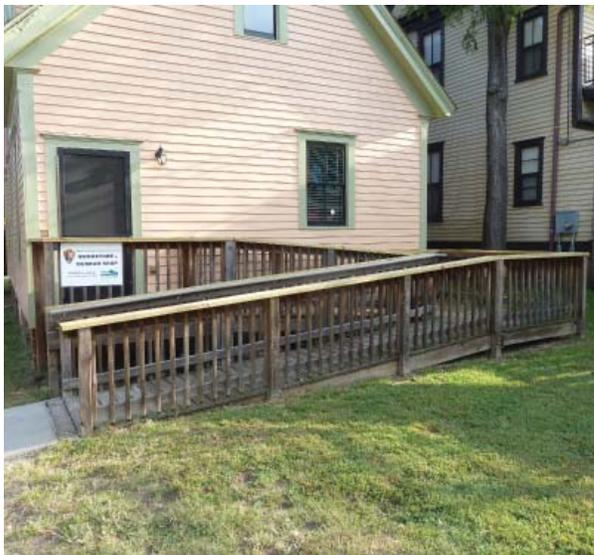
A wheelchair-accessible ramp to the back door was constructed between 2007 and 2010. It is framed with 4x4 posts and 2x8 rim joists. Deck boards and handrails measure 2x6. Balusters measuring 1¼" square are attached to 2x4 top and bottom rails. The ramp has two sloped runs and can be reached by a concrete sidewalk at the west property line (*Fig. C67*).

Signage at the street indicates that the rear entrance is handicapped accessible. Although the ramp is accessible, the rear doorway is just shy of the 3'-0" ADA requirement, and neither the door nor the storm door have an automatic opener.

Figure C67. Modern handicapped accessible ramp at rear of house.

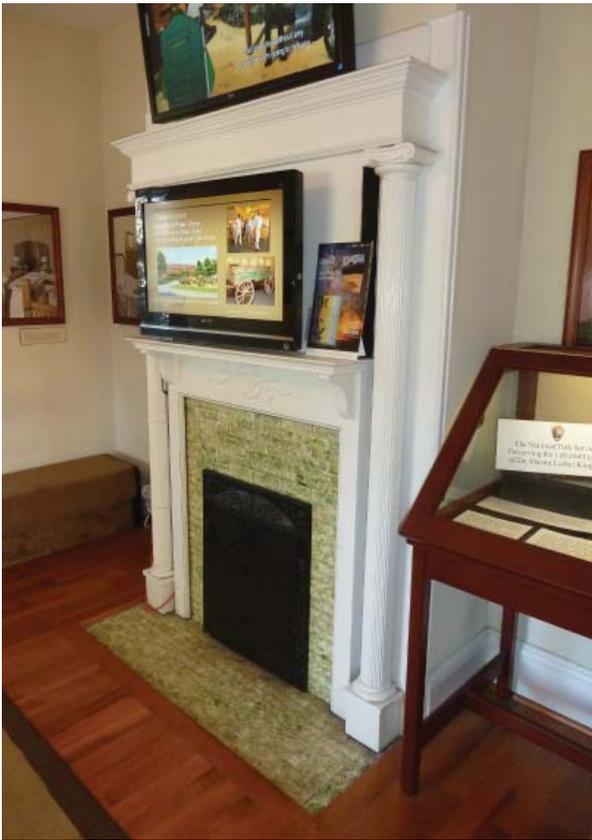
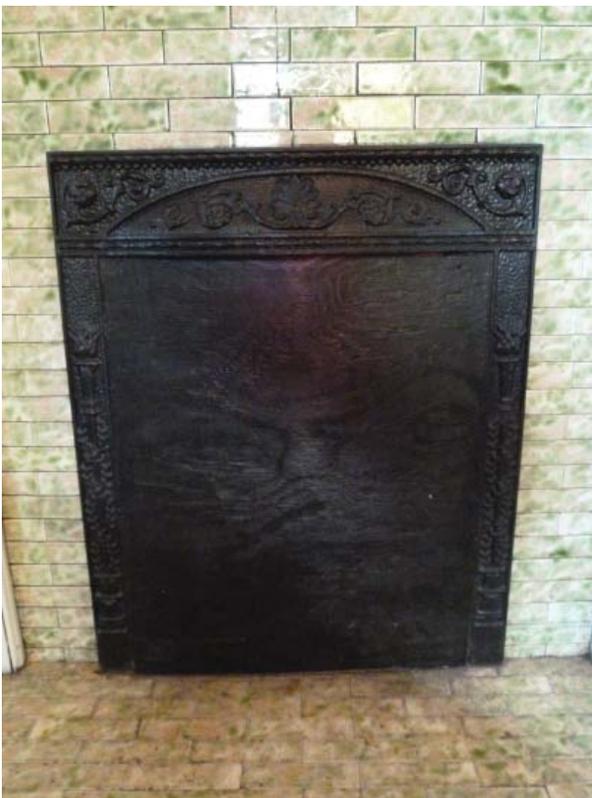
The house was designed so that all the main rooms had a fireplace for heat. The remaining chimney serves fireplaces in Rooms 101 and 201 but is damaged and inoperable. Documentary sources note that the house was outfitted with a mechanical heating system of insufficient capacity sometime prior to 1993.

Figure C86. Original fireplace in Room 101.

Figure C87. Decorative cast iron coal-burning firebox insert in Room 101.

A fireplace with a decorative cast iron coal-burning insert projects about 1'-7" into the room. The hearth measures 1'-6" deep by 4'-9" wide and is laid in faux green onyx glazed tile. A bracketed wood mantel measuring 9¾" deep by 3'-9¾" wide is attached to a built-up wood surround with matching tile. On either side of the mantel are fluted Ionic columns 4" in diameter surmounted by a simple entablature with a crown molding. Originally, a mirror was affixed above the mantel and below the entablature, but now the space is used as a mount for a television. All elements of the fireplace are original except for the hearth tile, which was replaced during the 2005-2010 interior rehabilitation. The fireplace is not operable (*Figs. C86-87*).

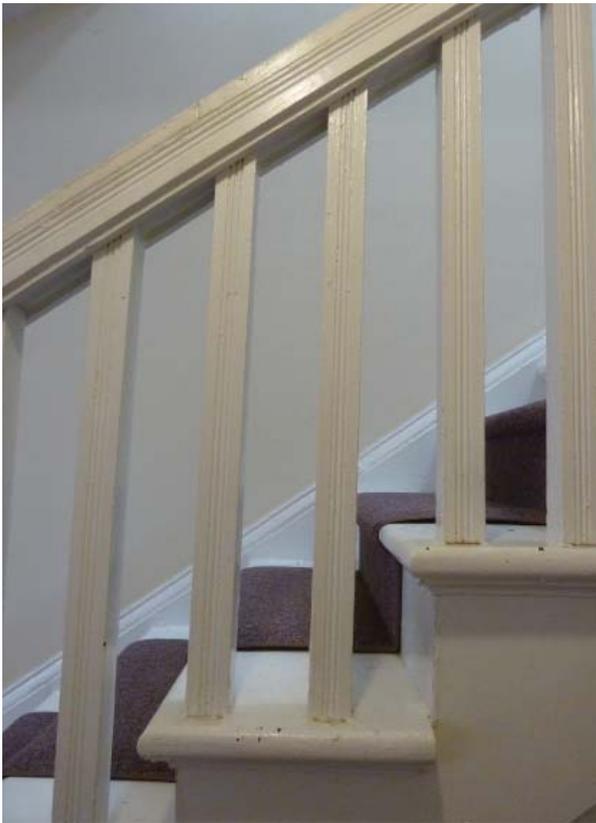
Figure C93. Original Handrail and balusters of staircase. Note the incised double reed detail is identical to the original balusters of front porch.

The balustrade is similar to that of the front porch. The handrail measures  $3\frac{1}{2}$ " square and has a rounded top and a triple-reed detail on the sides. The balusters measure  $1\frac{3}{4}$ " square and have a double-reed detail on the two exposed faces (Fig. C93).

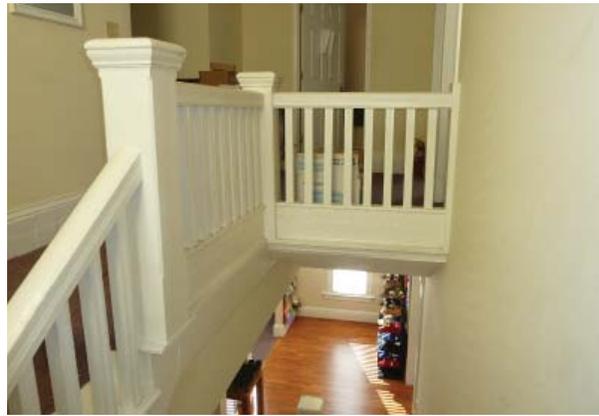
Figure C94. Newel posts at top of stairs.

newel posts at second-floor level are  $3'-1\frac{3}{4}$ " tall (Fig. C94). The newel post at the landing is rotated 45 degrees and measures 3'-5" tall (Fig. C95).

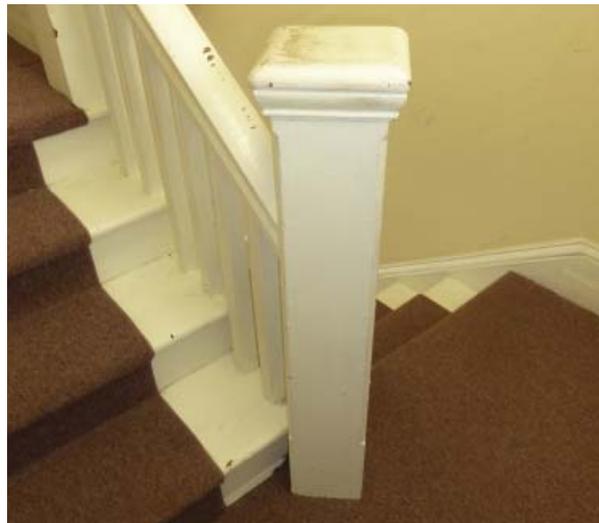
Figure C95. Newel post at stair landing.

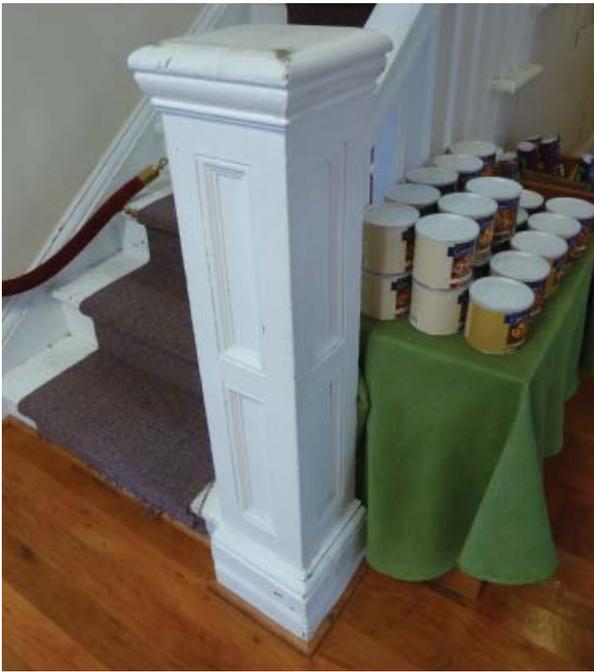
The newel post at first-floor level is  $7\frac{3}{4}$ " wide north-south by  $7\frac{5}{8}$ " wide east-west and  $3'-7\frac{1}{2}$ " tall. It is built-up, not solid; each face has two panels with molded sticking (Fig. C96). The cap design is the same as that of the other newel posts but measures  $9\frac{3}{4}$ " square. At the base is baseboard typical of the house.

Figure C96. Newel post at bottom of stairs.

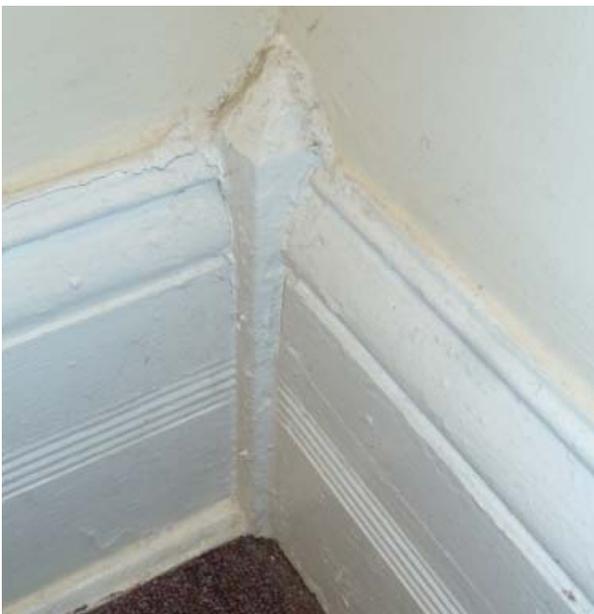
Oddly, the angled baseboards along the stair runs are identical to the baseboards typical of the house but without the incised quadruple-reed detail. Another unique detail is the use of  $1\frac{1}{2}$ " by 1" blocking in the corners of the baseboard at the landing. The blocking has a pyramidal top that rises  $1\frac{1}{2}$ " above the baseboard (Fig. C97). Photos from the 2005-2010 interior rehabilitation indicate that all the staircase elements are original.

Figure C97. Baseboard corner blocking at stair landing.

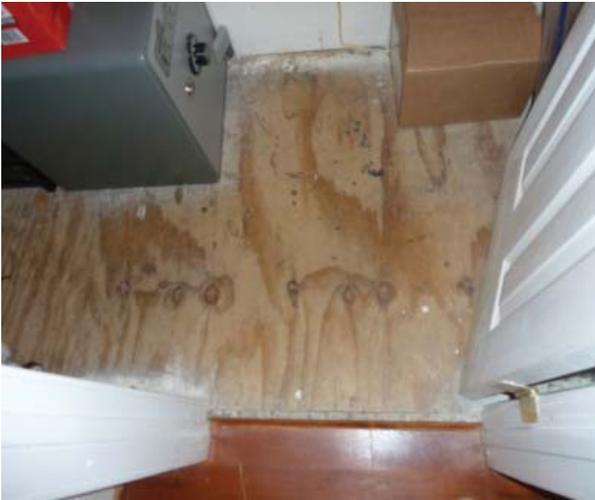
The plywood floor sheathing is exposed (*Fig. C101*).

Figure C101. Plywood flooring of Room 104.

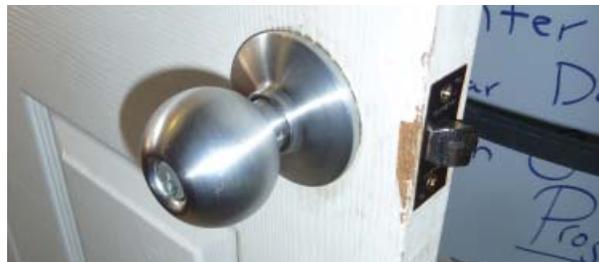
Figure C103. Typical door hardware of modern replacement interior doors.

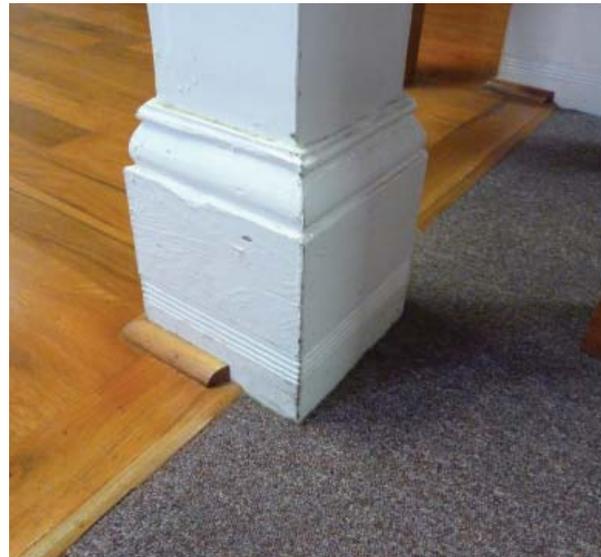
Figure C108. Typical threshold between laminated wood floorboards and carpet.

wall. The southernmost measures 3'-5" wide; the middle, 3'-7" wide; and the northern, 5'-1" wide. All three are 8'-4" tall and separated by structural columns with baseboard typical of the house and quarter-round crown molding (*Fig. C108*).

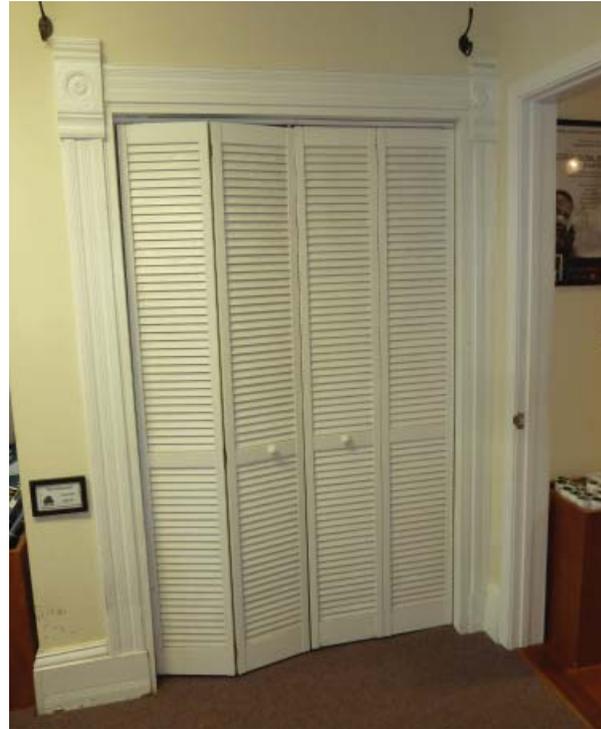
a set of 1"-thick, modern, louvered bi-fold doors (*Fig. C113*).

Figure C113. Modern louvered bi-fold doors of mechanical closet in Room 108.

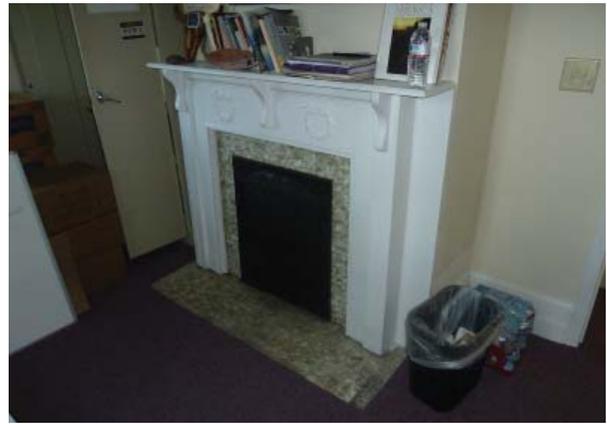
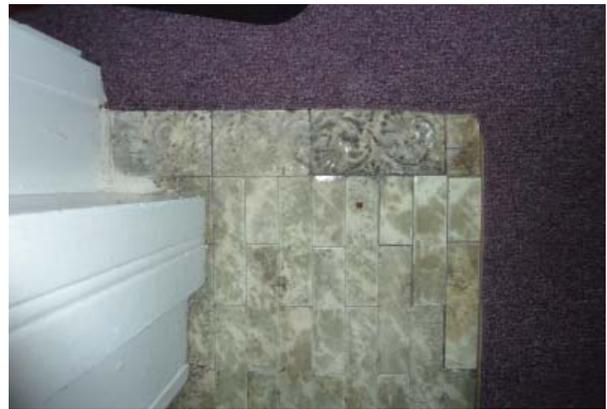
Figure C120. Fireplace in Room 201

Figure C121. Tile hearth in Room 201.

A fireplace projects about 1'-7" into the room. The hearth measures 1'-6" deep by 4'-9" wide and is laid in faux green onyx glazed tile. A decorative cast-iron coal-burning insert remains in place. While the tile surround and cast-iron insert are original, the bracketed wood mantel, 9<sup>3</sup>/<sub>4</sub>" deep by 3'-9<sup>3</sup>/<sub>4</sub>" wide, and attached to a built-up wood surround with a matching tile inlay, was installed during the 2005-2010 interior rehabilitation. The fireplace is not operable (*Figs. C120-121*).

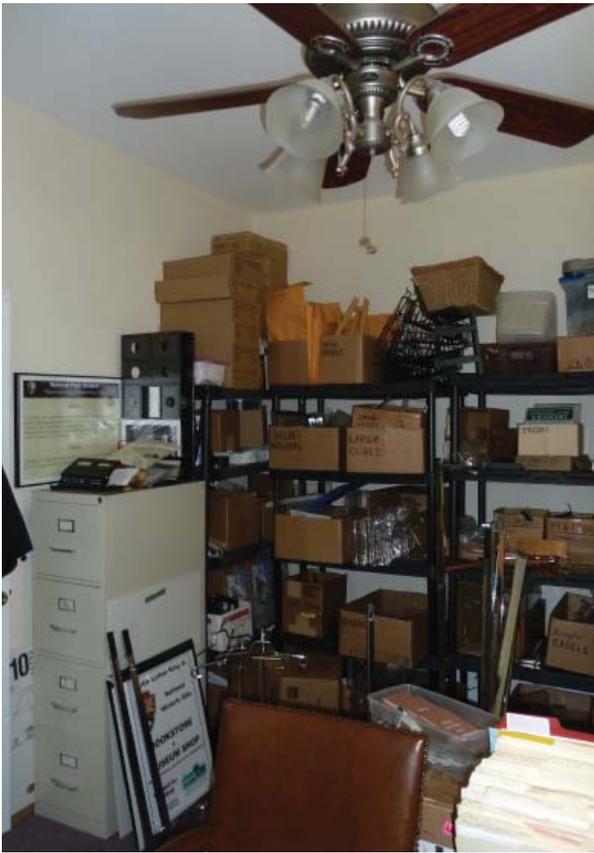
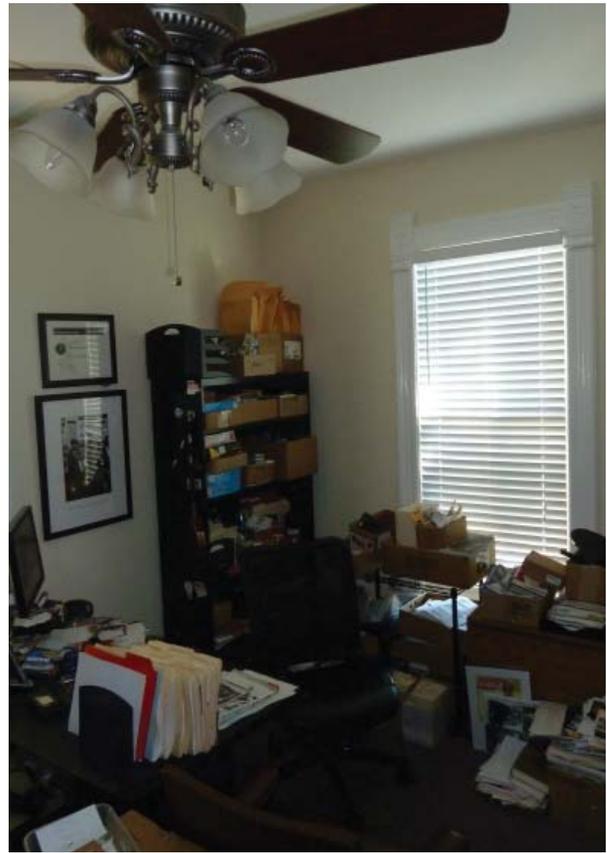
Figure C128. Northwest oblique of Room 205.

Figure C129. Southeast oblique of Room 205.

accommodate the addition of Room 206 during the 2005-2010 interior rehabilitation (*Figs. C128-129*).

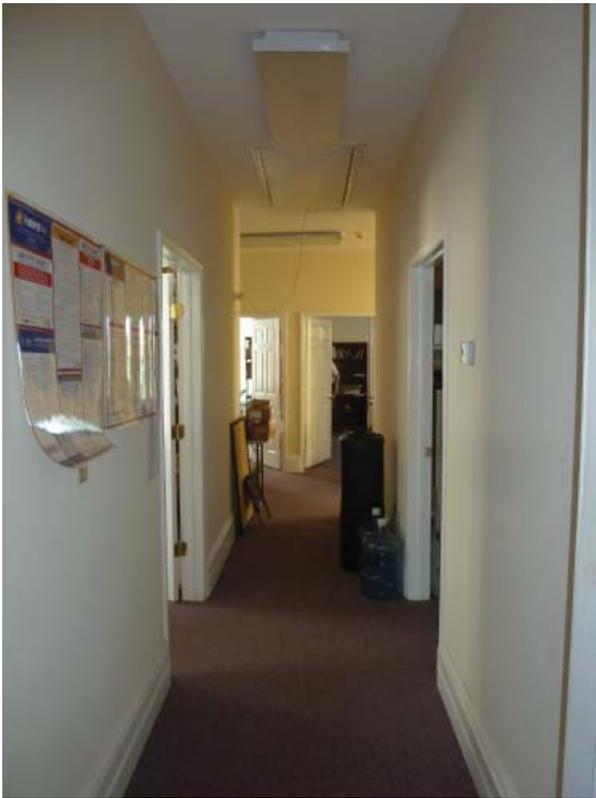
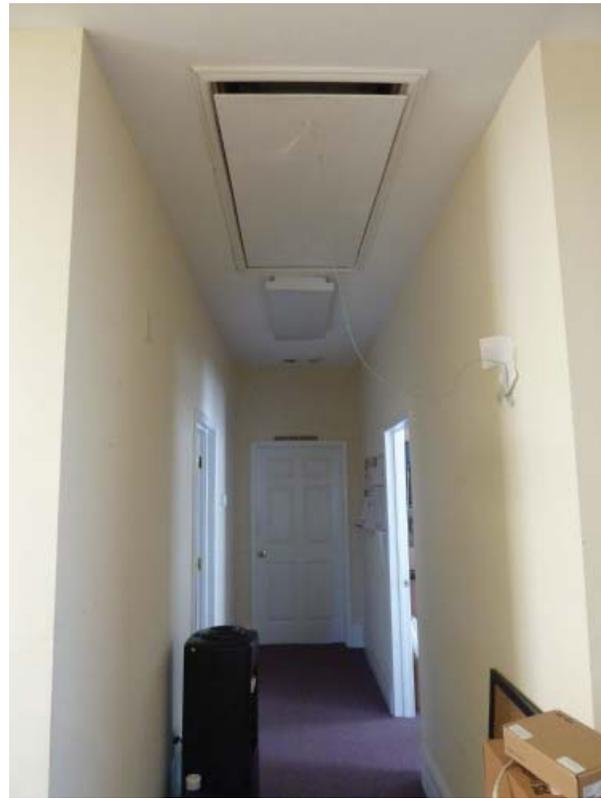
Figure C130. Room 206 looking north.

portion of the main block. It was added during the 2005-2010 interior rehabilitation (*Figs. C130-131*).

Figure C131. Room 206 looking south

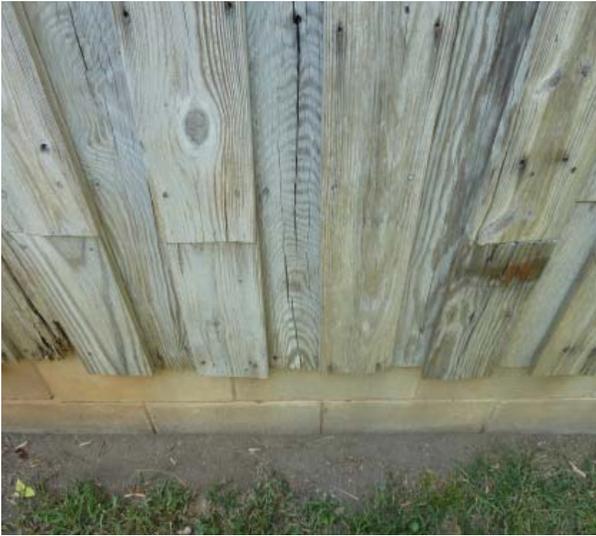
Figure C141. Salvaged siding of shed/garage.

The shed/garage is undeniably important as the only remaining outbuilding among the MALU properties, an important site feature of what was determined in 1995 to be one of the most intact and well documented back yards in the district. It was disassembled and repaired in 2011. Important and documented character-defining features were removed at this time. Going forward, it is imperative that all remaining historic and salvage material be preserved.

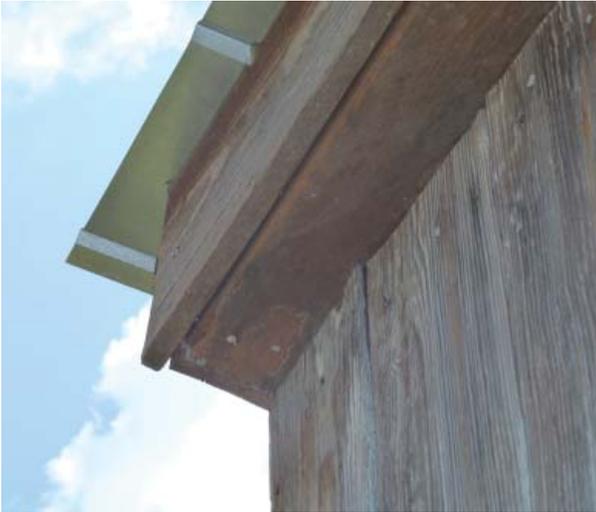
Figure C142. Soffit detail of shed/garage.

Historic photographs show soffits on all four sides of the roof. When the roof was rebuilt, only the soffits on the front and the back facades were retained, leaving the siding on the other two elevations unnecessarily exposed to potential water damage.

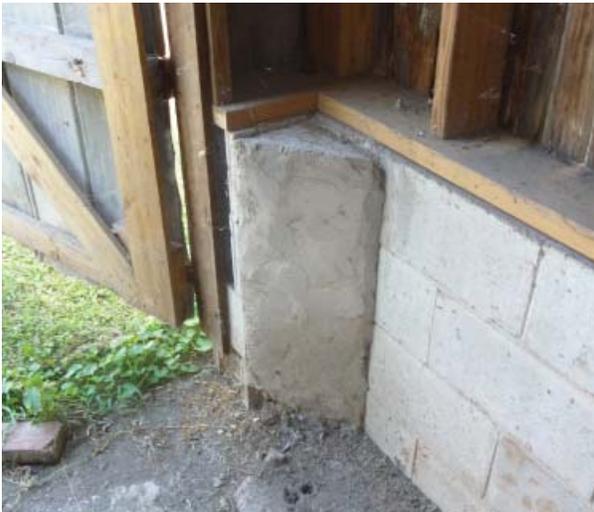
Figure C148. Added concrete structural brace.
