# Reid-Zachary House 497 Auburn Avenue

Martin Luther King, Jr.  
National Historical Park

## Historic Structure Report

2018

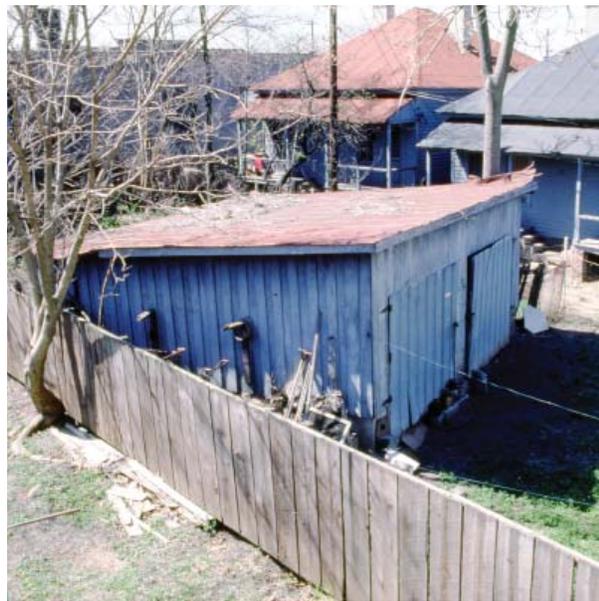
Figure 11-4. Shed/garage viewed from the northeast prior to reconstruction.

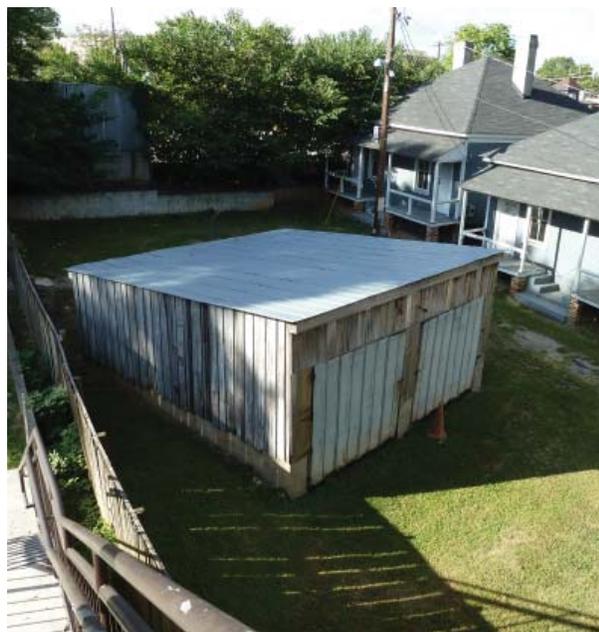
Figure 11-5. Shed/garage viewed from the northeast after reconstruction.
