503 Auburn Avenue, NE Historic Structure Report

503 Auburn Avenue, NE
Martin Luther King, Jr. National Historical Park
Atlanta, Georgia

Historic Structure Report

September 2019

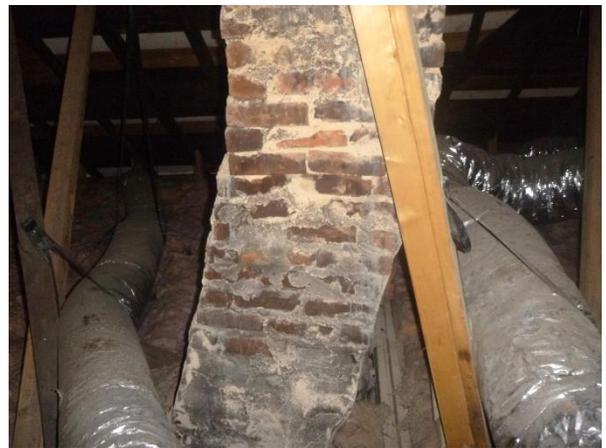
- One of the chimneys on the west elevation was constructed in an unusual curved configuration (Figure 85). From the attic space, the chimney was constructed to shift significantly to the west over a several courses of brick. It appears that the chimney was constructed in this form to position it away from the roof ridge.

FIGURE 85. Curved configuration of masonry chimney in the attic.

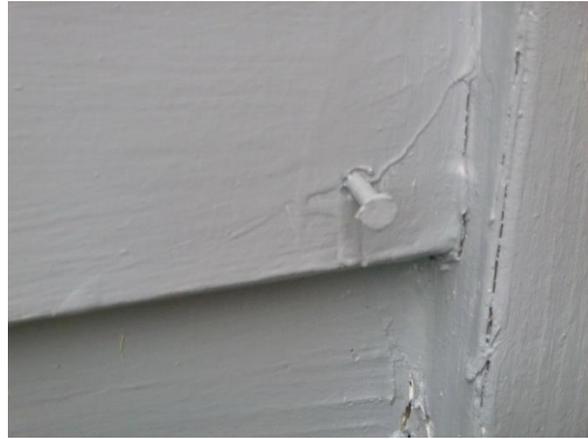
FIGURE 98. "Walking out" of nails at horizontal siding

- The walking out of nails was observed at the wood siding (Figure 98). The walking out of nails was most pronounced at the lower portion of the building at the south elevation and near the end of boards. The nail heads were projecting approximately 1/2 inch from the face of the wall.

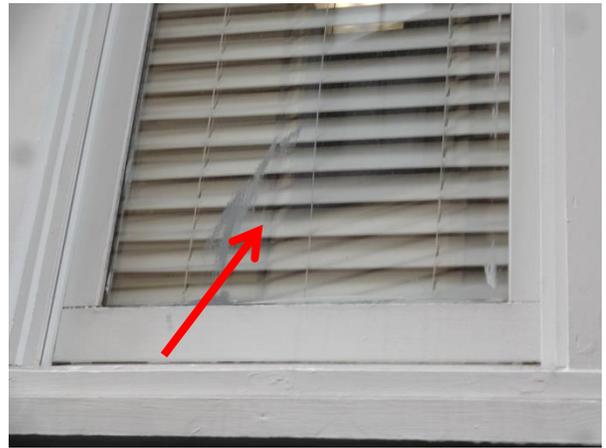
- In general, the windows are in good condition. Minor distress conditions were observed at some window sash and exterior projecting molding.
- Gaps were observed between the window sash and the frame at three window openings: one at each of the south, north, and west elevations (Figure 99 and Figure 100). The gaps were typically 1/8 inch wide and indicate that the sash or the frame is not plumb. A cold air draft could be felt at the gaps in the window system.
- Broken glazing was observed at one window opening on the north elevation (Figure 101). The upper corner of the glass was cracked but remained in place.
- Paint was observed on the glass of many of the window sash (Figure 102). Full brush strokes of white paint were observed on the glass, indicating that the paint was accidentally applied during previous repainting of the windows.

FIGURE 102. Paint on glass.

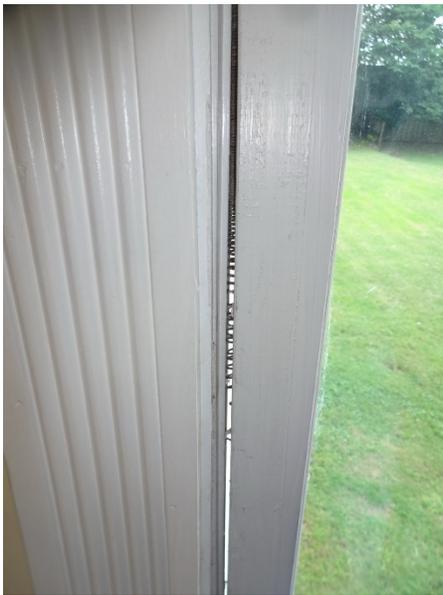
FIGURE 100. Gap between window sash and frame.

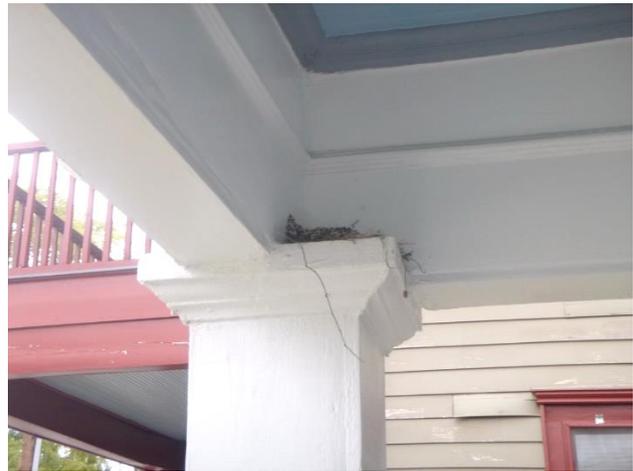
- Pest infestations were observed at one exterior projecting window molding and at the soffit of the porch (Figure 105 and Figure 106). The infestation included small circular insect holes, measuring approximately 3/8 inch in diameter, at the underside of the projecting window molding. At the porch, there was a bird's nest. No evidence of termite infestation was observed.

FIGURE 106. Bird's nest at porch.

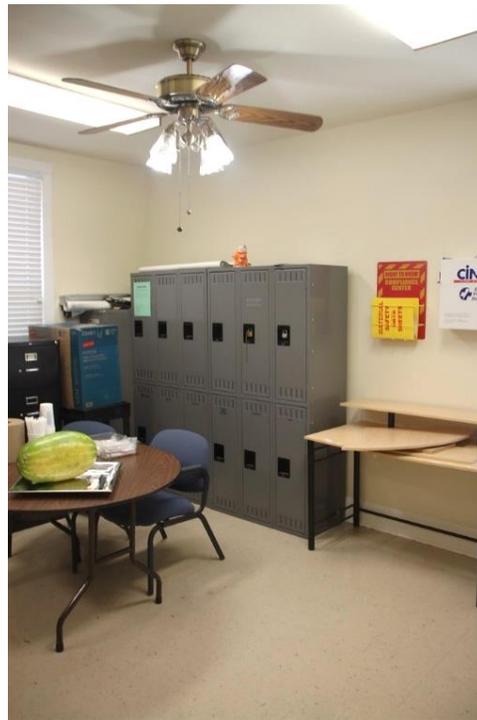
FIGURE 118. VCT flooring in the break room.

- Vinyl composition tile is a floor covering that has been widely used in different formulations since the 1930s. It is inexpensive and easy to install, and it is available in a wide range of colors and patterns. The 12-inch-by-12-inch, tan, marbled tile in the break room and work room is in satisfactory condition, but does require periodic cleaning, waxing, and buffing to maintain a neat appearance. It can chip and crack when impacted and moving heavy furniture and equipment over it can scratch and mar the surface.

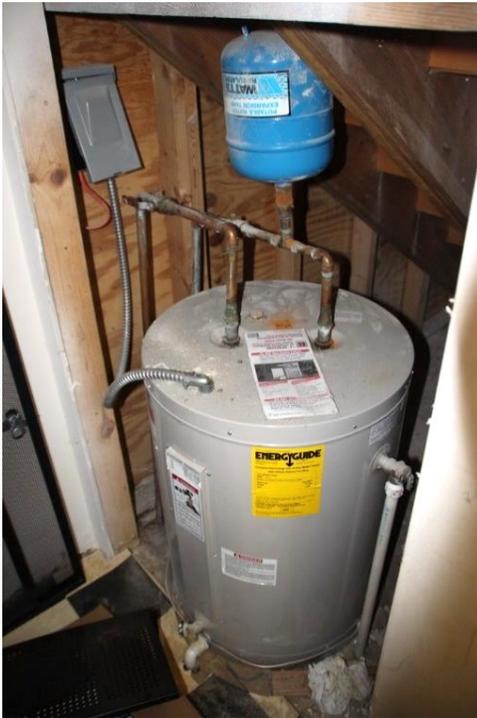
Electronic Equipment Room. The electronic equipment room is actually the space beneath the stair. It was likely created during the renovation project in the early 2000s, because it does not appear on the 1993 as-built drawings. The walls and the sloped ceiling are finished with painted gypsum board, and the painted wood baseboards are identical to those throughout the house. Sheet vinyl, with a large, black-and-white checkerboard pattern, covers the floor (Figure 136). At the rear of the space, head room is low beneath the stair landing where most of the electronic equipment is located, including a server and the telecommunication board (Figure 137). A water heater is also tucked beneath the first-floor stair run in unusually close proximity to the electronic equipment (Figure 138).

FIGURE 138. Electric hot water heater in the server / IT space under the stair.

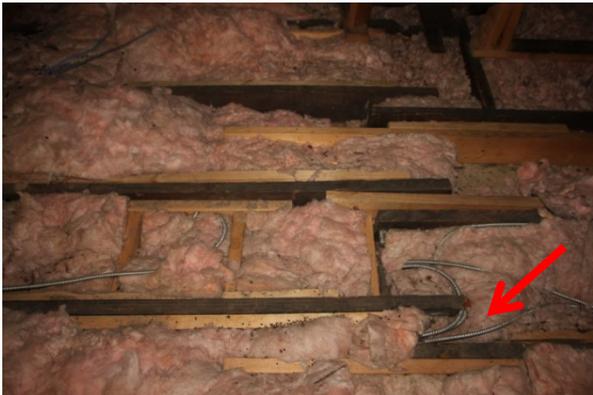
In the attic, thermal insulation is achieved primarily by blown-in fiberglass insulation that covers the ceiling joists; however, some paper-faced fiberglass batts were also observed (Figure 145).

FIGURE 145. Fiberglass insulation between ceiling joists. Also note the metal-clad electrical cables.

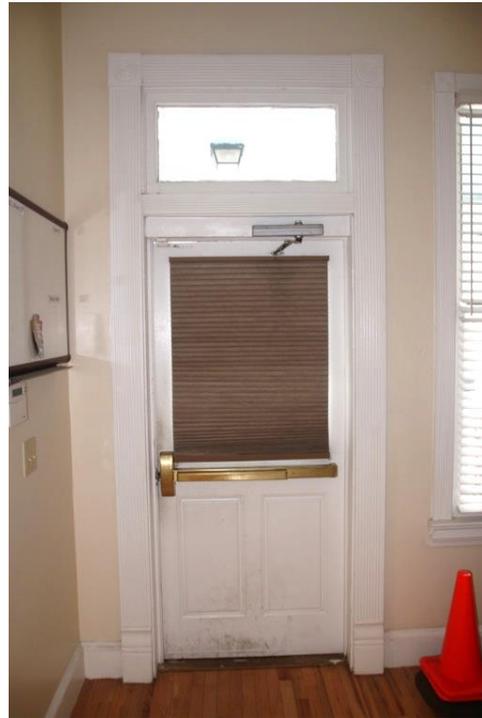
- Painted cased openings and door and window trim are consistent throughout the house but are mostly not original. Trim at the front entry door may be original, because it is very similar to historic wood trim found in other homes from this period on the Birth Home block (Figure 146). Some window trim in the foyer, the director's office, and the meeting room may also be original, particularly the decorative apron trim (Figure 147), which is repeated in the meeting room chair rail. Park records suggest that cyclical interior painting may have been done in 2015, and the condition of the woodwork and trim makes that likely. Besides the effects of normal wear and tear, the trim is generally in good condition.

FIGURE 146. Original trim at the front entry door.

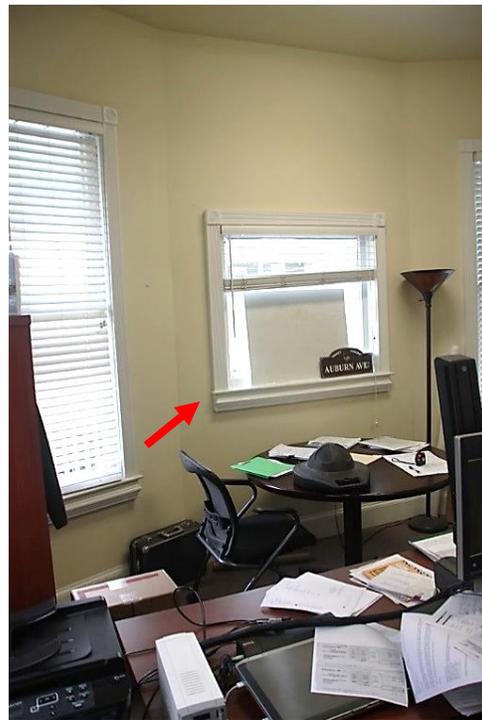
FIGURE 147. Decorative apron trim at bay window in chief's office.

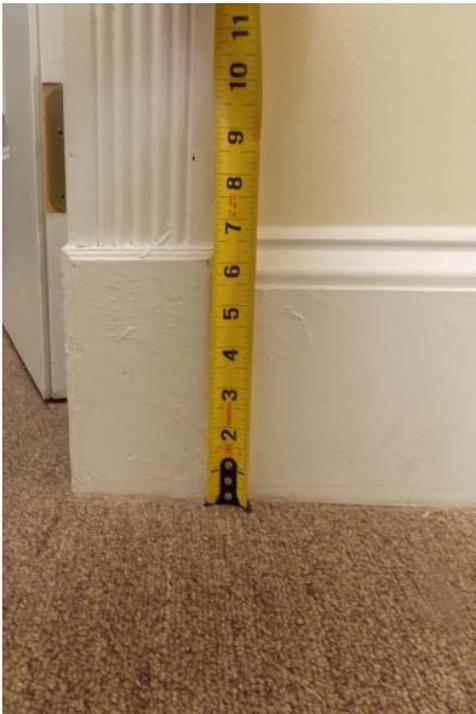
- Baseboards are consistent throughout the house and are not historic (Figure 148). If there was an original base shoe, it was removed when wall-to-wall carpet was installed. Non-original, quarter-round base shoe is present in those rooms that have VCT flooring. Not surprisingly, baseboards and base shoe have been painted several times but are subjected to scratching and abrasion that have accumulated over time.

FIGURE 148. Non-original baseboards.

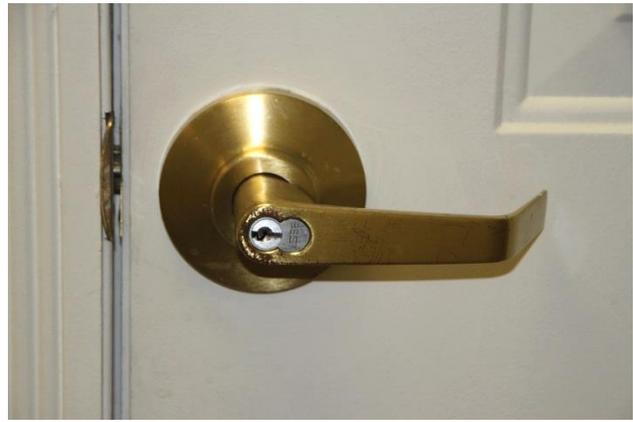
- The brass finish on the door hardware is tarnished and scratched, and brass hinges and strike plates are marred by excess paint (Figure 149 and Figure 150).

FIGURE 149. Tarnished and scratched brass finish on door hardware.

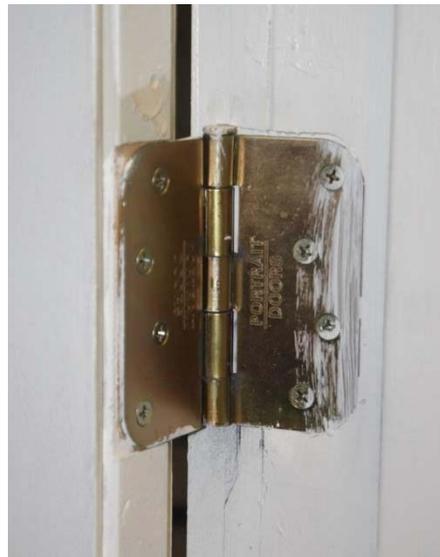
FIGURE 150. Paint on brass hinges.

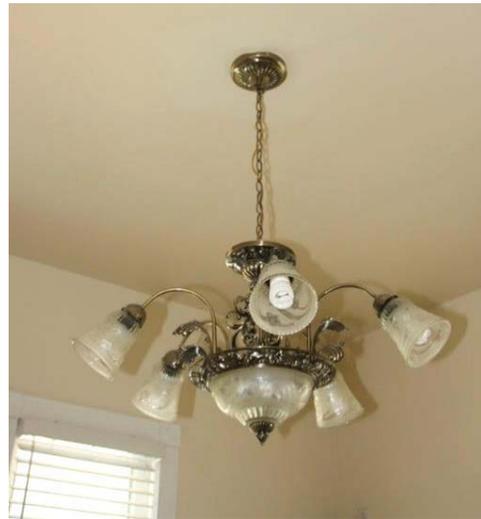
FIGURE 177. Non-original, vintage-style light fixture. Note incongruous compact fluorescent light bulb.

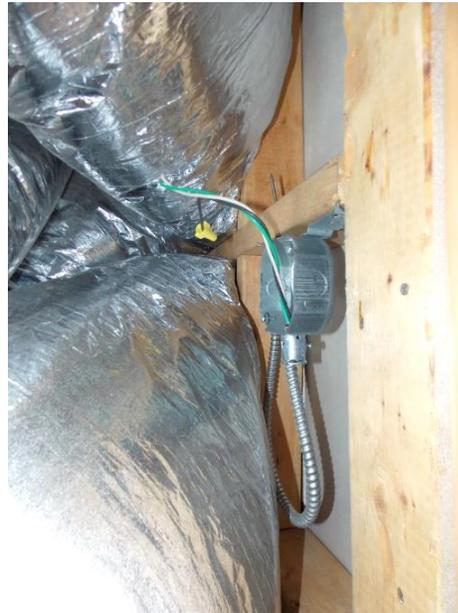
It is assumed that when the electrical system and electrical devices (receptacle, switches, fixtures, etc.) were last updated about fifteen years ago they complied with the requirements of the building code. For example, visible wiring in the attic and mechanical spaces is metal-clad (MC) cable (Figure 179), but some observed conditions did not have MC cable or conduit (Figure 180 and Figure 181).

FIGURE 181. Open junction and unshielded wires.

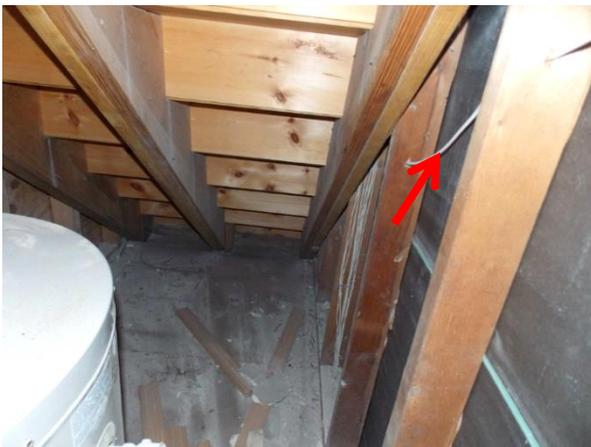
FIGURE 180. Insulated electrical wire not in conduit.

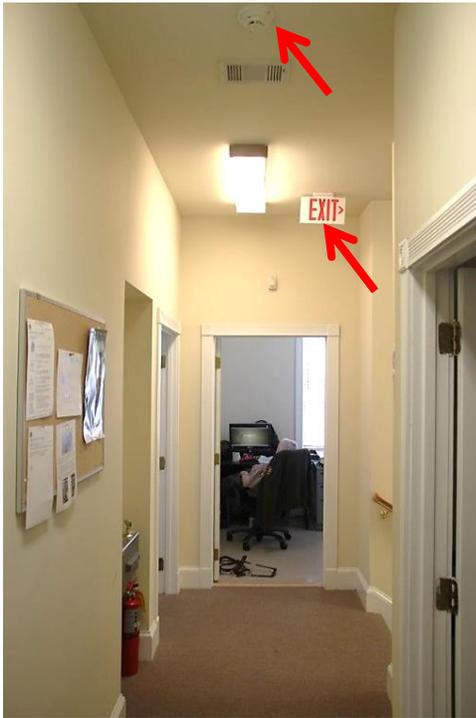
Life safety systems include electrically powered, ionization-type smoke and fire detectors, emergency lights, and lighted exit signs. However, the building is not sprinklered (Figure 184 and Figure 185).

FIGURE 184. Ceiling-mounted smoke and fire detector and illuminated exit sign on the second floor.

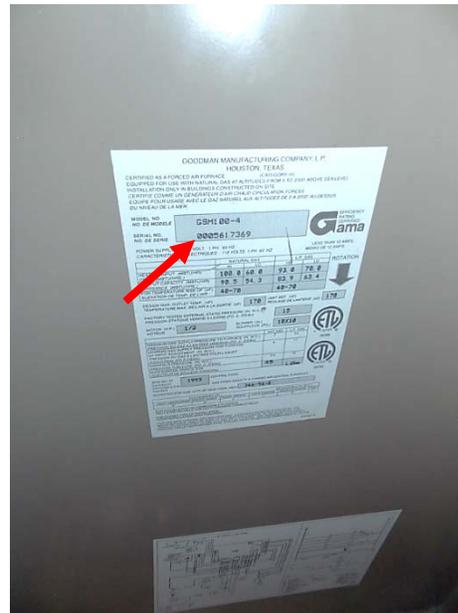
- The house at 503 Auburn Avenue is heated and cooled by two Dx split-systems, with blower coil unit, gas heat, and outdoor condensing unit. According to the serial number on the unit that serves the first floor, it was manufactured in May 2000, and was most likely installed when the house was renovated in the early 2000s (Figure 188). Park records show periodic maintenance of HVAC units in 2008, 2010, and 2015. A date of manufacture or date of installation for the unit in the attic was not discernable, but facility management data for 2012 includes the cost to replace nine HVAC units. The unit that serves the second floor of 503 Auburn Avenue may be only five or six years old, if it was one of the nine new units. During the on-site visit for this report, no problems with the HVAC systems were mentioned by the park staff. Performing cyclic preventative maintenance will continue to extend the operation of both HVAC units.

FIGURE 188. The first four digits of the serial number of Goodman equipment indicate the year and month when the unit is manufactured. The first-floor unit was made in May 2000.

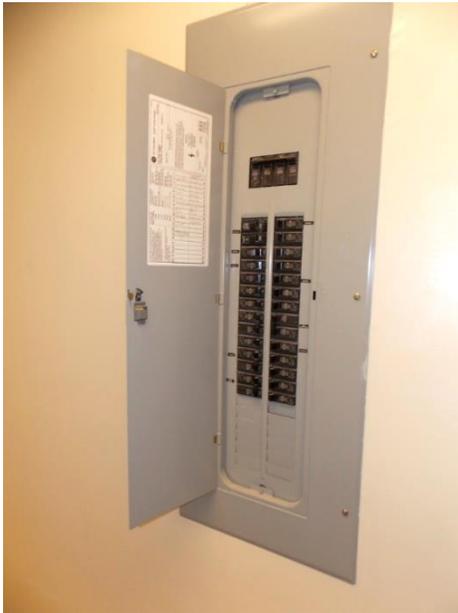
- It is reasonable to assume that the existing electrical system was installed in compliance with the current electrical / building code in the early 2000s. Substantial changes to the building or a change in occupancy classification may require upgrades to bring the building and the electrical systems into compliance with present codes.
- The main and secondary electrical panels have the ample capacity and space for more circuit breakers (Figure 189).
- The server space beneath the dog-leg stair contains a host of electrical and electronic devices and equipment along with a hot water heater. The stair is constructed of combustible materials and is not a fire-rated assembly. In addition, the open stair is the only means of egress from the second floor.

FIGURE 189. Main electrical panel on the first floor.
