506 Auburn Avenue, NE Historic Structure Report

Martin Luther King, Jr. National Historical Park

Atlanta, Georgia

Historic Structure Report

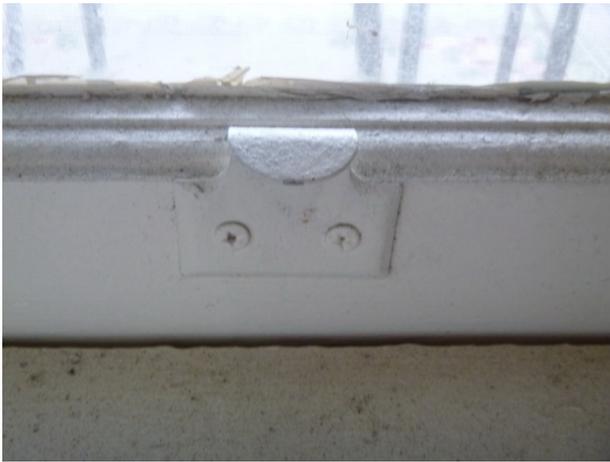
Typical hardware includes brass window lift hooks at the lower sash, a brass latch at the meeting rail, and rope sash cords with pulleys set in sash pockets (Figure 55 through Figure 57). At all locations, the rope sash cords and pulleys have been painted or altered and are no longer operable. A vinyl shade is mounted to the interior trim of each window (Figure 58).

FIGURE 55. Brass window lift at bottom window sash has been painted white.

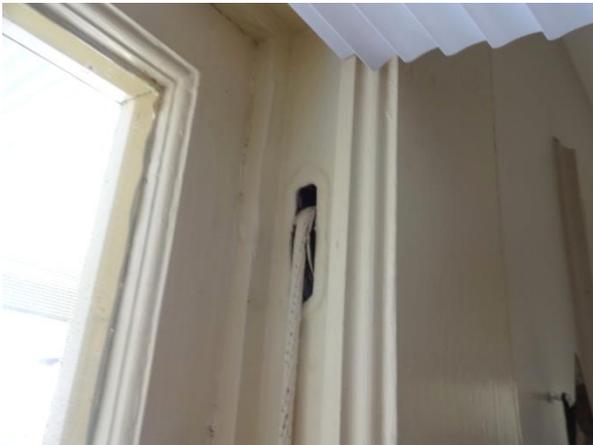
FIGURE 57. Typical sash cord and pulley.

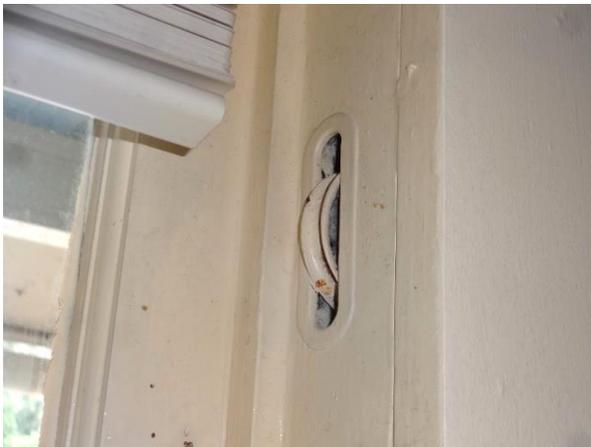
The windows have sash pockets with the pulleys, an indication that the existing windows have been modified from a previously existing operable sash (Figure 61). The rope sash cords are no longer present.

FIGURE 61. Sash cord pulley at fixed window indicates that the window was operational at one time.

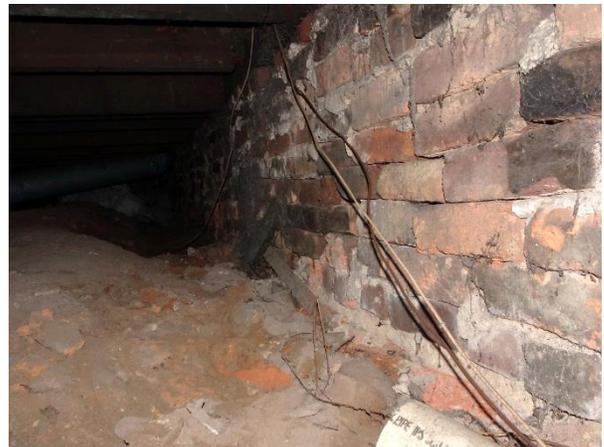
- Open, eroded, and deteriorated mortar joints were observed at the brick foundation wall at the perimeter of the building (Figure 71 and Figure 72). The distress was observed at the interior face of the foundation wall, as viewed from the crawl space, and at the base of the foundation wall, at grade. At open joints, the mortar was missing; however, the mortar setting bed appeared to be intact. Erosion and deterioration at joints consisted of loss of some of the mortar and bond separation between the brick and mortar.

FIGURE 71. Overall erosion of mortar joints as viewed from crawl space.

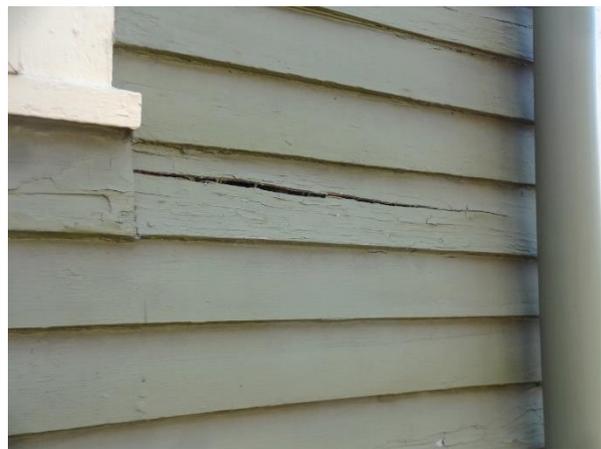
- Mild to moderate decay and deterioration was observed at some wood siding and trim (Figure 82). Typical distress included decay as well as checking and splitting of wood near the end grain and along the bottom edge. The distress was most significant near downspouts.

FIGURE 82. Checked wood siding. Note check is located near end of board and adjacent to downspout.

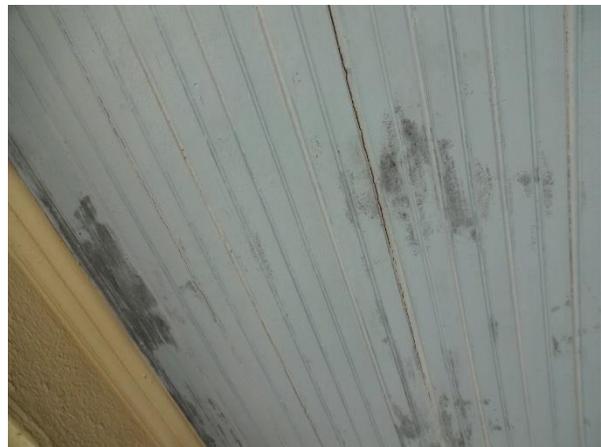
- Biological growth was observed at the wood at the west end of the ceiling of the south porch at both floor levels, floor boards at the north porch, and some exterior faces of doors (Figure 83 through Figure 85). The growth had a splotchy appearance and was black in color.

FIGURE 83. Biological growth at the ceiling of the south porch.

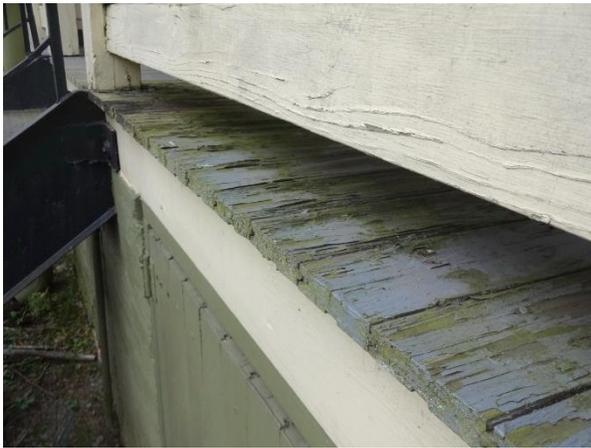
FIGURE 84. Biological growth along the ends of decking boards at the north porch.

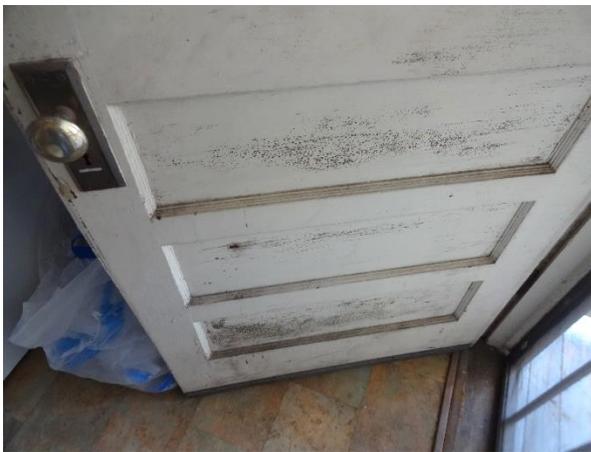
FIGURE 85. Biological growth at the exterior face of one north elevation door.

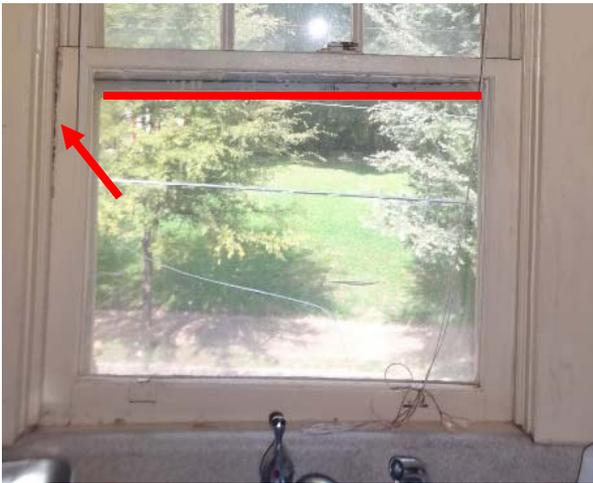
- Uneven window sash were observed at a few locations. Some of the sash appeared not to be set plumb within the window opening (Figure 91). There were small gaps along one edge of the sash.

FIGURE 91. Window that is out of plumb and has a small gap between the frame and sash. This window is located at second floor unit B, in the kitchen.

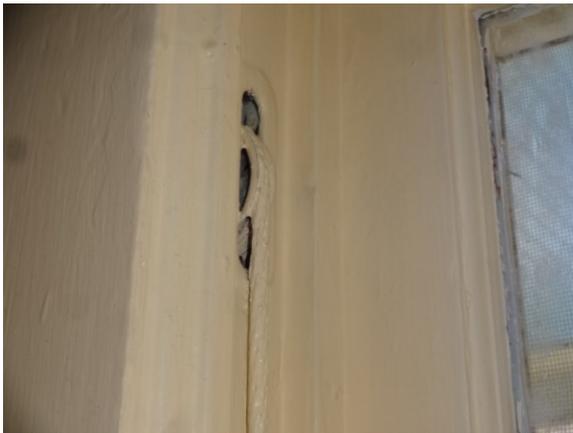
- Some rope cords at double-hung window pockets are missing or have been cut and the windows are no longer operational (Figure 93). At most locations, the pulley and cord remain but the rope may have been painted over (Figure 94).
- Displaced window screens were observed at a few window openings (Figure 95). Where displaced, large gaps measuring approximately 1 inch wide were observed between the screen sash and the window frame.
- Paint was observed on the glass of many of the window sash (Figure 96). Brush strokes of yellow paint were observed at the exterior face of the glass, indicating that the paint was

FIGURE 94. Rope sash cord at double-hung windows that has been painted over and is no longer operable.

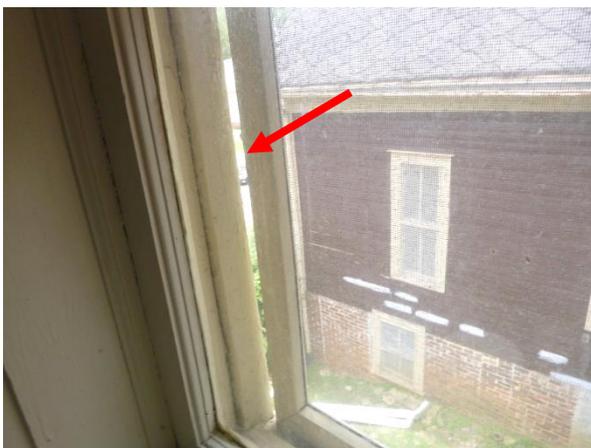
FIGURE 95. Displaced window sash.

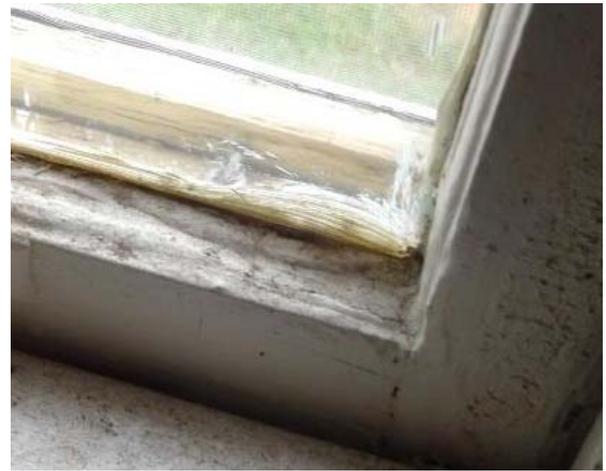
FIGURE 96. Paint on exterior face of glass at window.

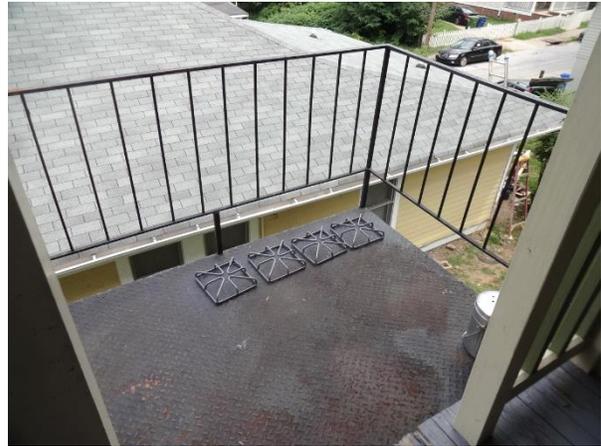
- Mild surface corrosion was observed at the metal stair treads and stair landings (Figure 99). The corrosion was most significant at high-traffic areas along the walking path and at the edges of the landings.
- Guano was observed at the wood siding above a first-floor window opening on the east elevation (Figure 100). The area of distress was in close proximity to a telephone wire.

FIGURE 99. Metal stair landing at second floor of north elevation.

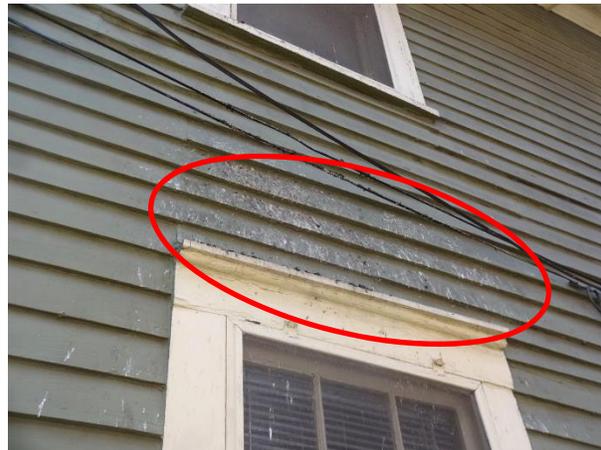
FIGURE 100. Guano on the siding above one window opening. Note the adjacent telephone line.

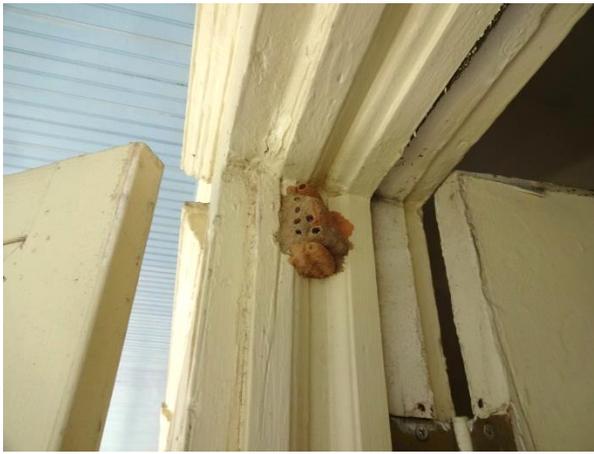
- Pest infestations were observed at one south porch door opening, at the perimeter of the ceilings at the north and south porches, and at roof eaves (Figure 101). The infestation included what appeared to be a mud dauber nest.

FIGURE 101. Mud dauber nest at south elevation door opening.

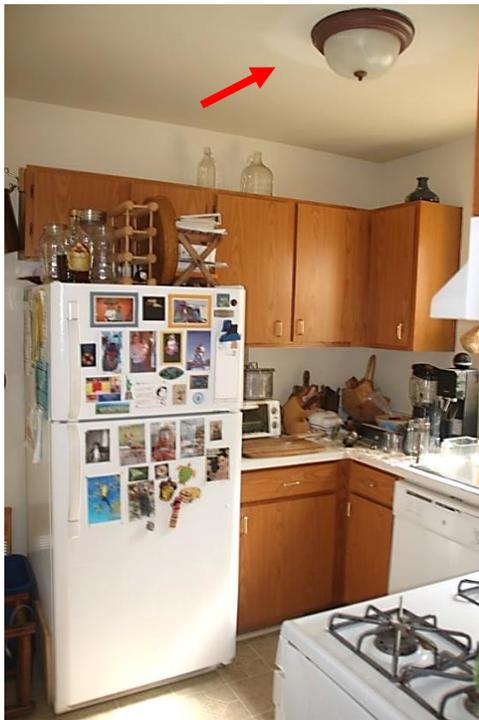
The walls and ceilings of all four apartments are painted a ubiquitous, light tan color. There is some discoloration of the paint around a few ceiling fans and light fixtures, perhaps due to mismatched touch-up paint (Figure 102). Flaws on the ceilings and walls are more obvious because of semi-gloss paint that was used. It was probably applied because it is more durable and washable than paint with a flat finish (Figure 103).

FIGURE 102. Mismatched paint around the light fixture.

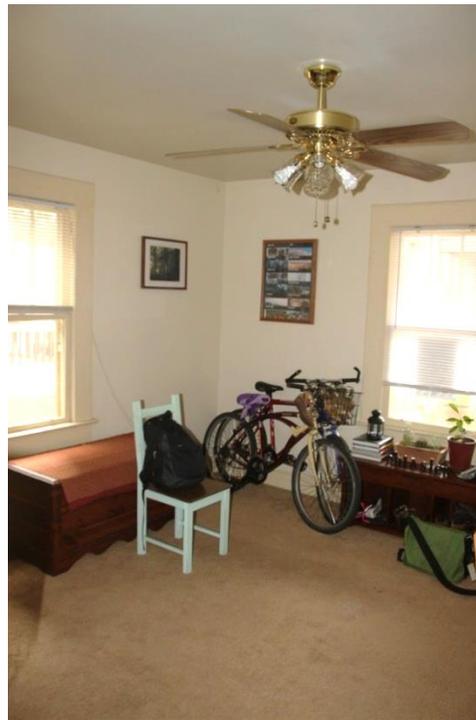
FIGURE 104. Typical medium-tan colored carpet.

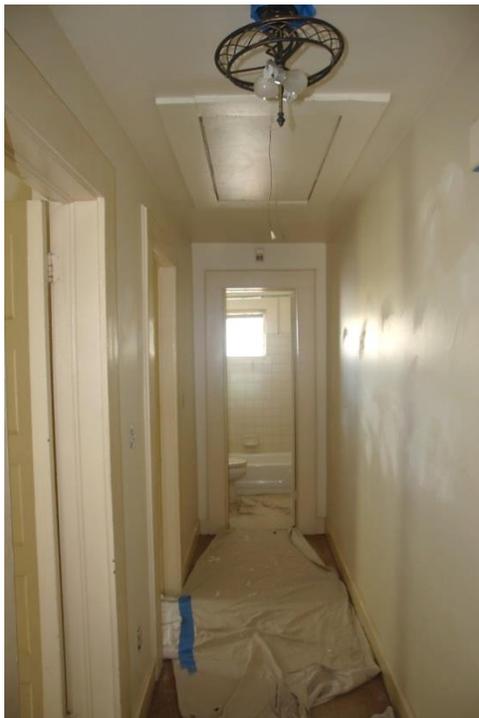
FIGURE 103. Note the sheen of the semi-gloss paint in this hallway.

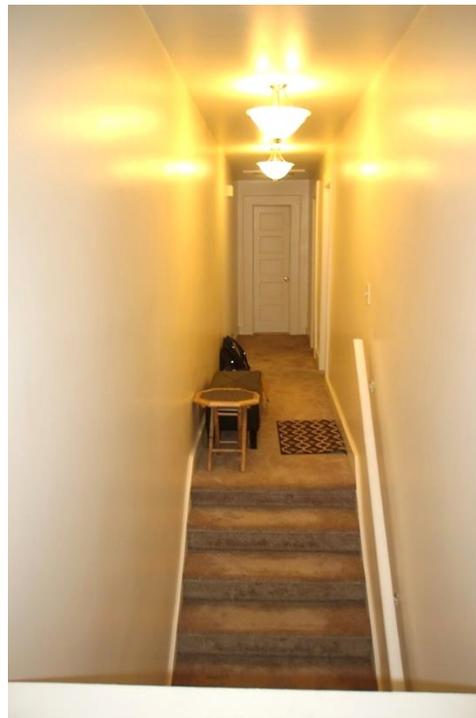
FIGURE 105. Fully carpeted stair in one of the second-floor apartments.

- Original flooring was covered in 1994 with other flooring materials that have subsequently been replaced with new flooring, such as carpet, sheet vinyl, and ceramic tile.
- The ceramic tile in the bathrooms is durable and suitable for wet areas. It has performed well with periodic cleaning.
- Newer sheet-vinyl flooring is also relatively durable, and it is holding up well. However, moving heavy furniture and equipment over it can scratch and mar the surface. The older sheet vinyl in unit B, for example, should be monitored for wear and replaced when necessary.
- Carpet is the resilient flooring material in the building. Generally, it is soiled and showing signs of wear.
- Carpet on stairs is particularly vulnerable to premature deterioration. This is the case at 506 Auburn Avenue. When wear and

deterioration occur, and the carpet becomes loose, it can be a hazard on stairs.

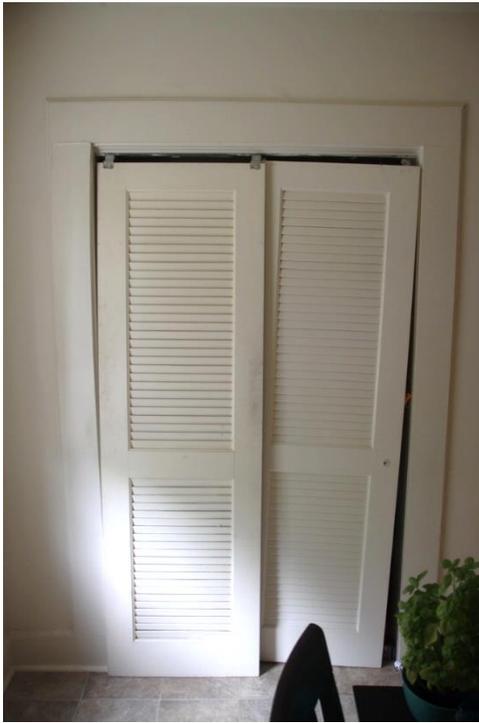
FIGURE 120. Typical louvered sliding door.

- The hinged doors are fair condition, and the majority is functional.
- The louvered bi-fold and louvered sliding doors are less sturdy, and some of them are not operating properly. The sliding doors are disengaged from the overhead tracks, and bi-fold doors have become misaligned, so they either remain open or in a partially closed position.
- Generally, door hardware (locksets, latch sets, deadbolts, and hinges) is functional. The polished brass finish on the mismatched, knob-type door hardware is scratched and tarnished, and brass hinges and strike plates are marred by excess paint.
- Door knobs are not in compliance with the regulations of the revised Architectural Barriers Act (ABA) and Americans with Disabilities Act (ADA). However, historic properties can, in some circumstances, receive waivers from strict compliance, but probably none of the locksets and latch sets is historic.

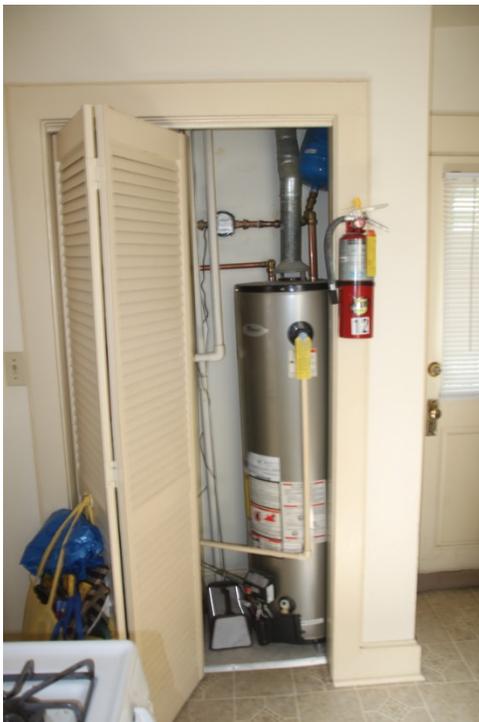
FIGURE 121. Typical louvered bi-fold door at water heater closet.

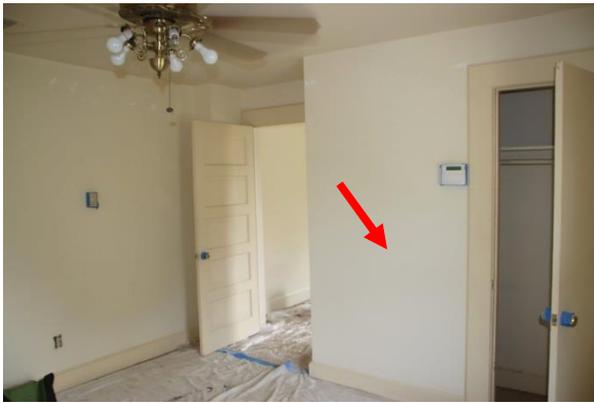
FIGURE 127. Gypsum board wall covering one side of back-to-back fireplaces in unit B.

- Only four fireplaces—one in each unit—are visible. They are in good condition except for the missing coal grates and cast-iron registers at the firebox. A couple of registers are missing pieces.
- Further destructive investigation will be needed to determine whether the opposite sides of the back-to-back fireplaces remain behind the gypsum board wall, if consideration is given to restoring the original fireplaces.

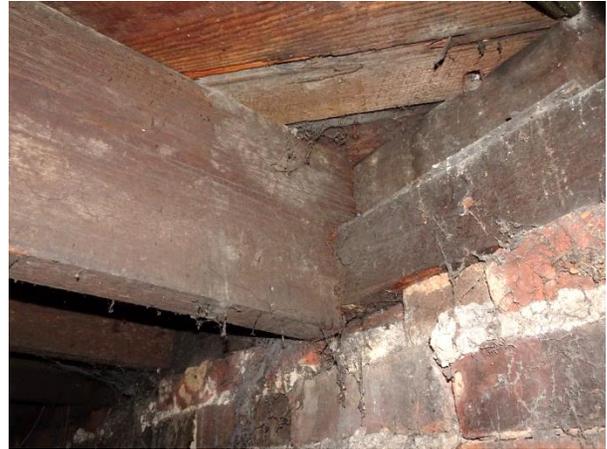
FIGURE 131. Floor beam with 2x4 ledger and 2x10 floor joist.

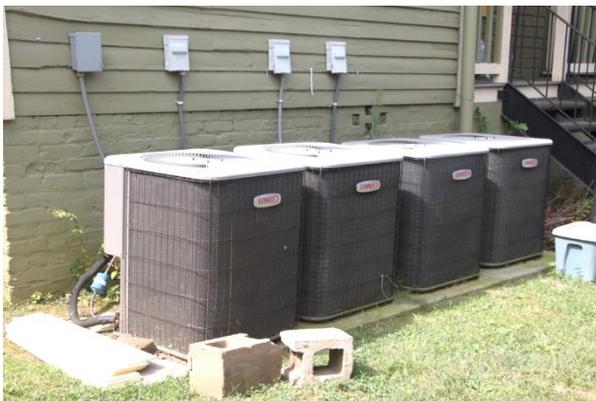
FIGURE 147. Closely grouped condensing units at northeast corner of the building.

recommended clearance (refer to Figure 147). Over time, this could diminish the efficient operation of this equipment.

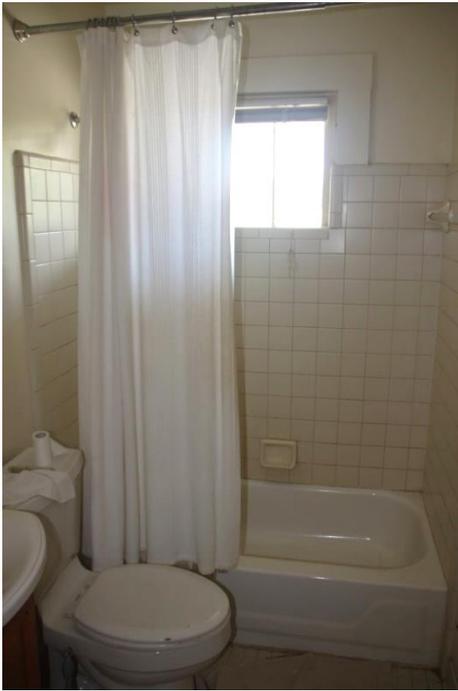
FIGURE 150. Typical bathroom.

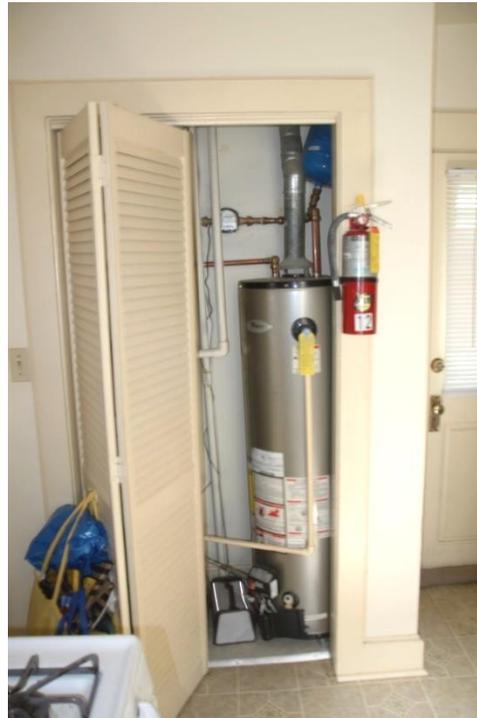
Old galvanized and cast-iron piping was replaced with PVC (polyvinyl chloride) for potable water, drain and waste lines. Schedule 40 PVC pipe is code-approved for most sanitary waste systems because of long-term performance and ease of installation. Current PVC waste lines are routed in the crawl space and, from there, to the public sanitary sewer system in Auburn Avenue (Figure 151). Domestic water is provided by the City of Atlanta through a meter on Auburn Avenue. Each apartment has a 40-gallon gas water heater located in a small kitchen closet that backs up to the bathroom. No records were found to document when the current water heaters were installed (Figure 152).

FIGURE 152. Kitchen closet with gas water heater.

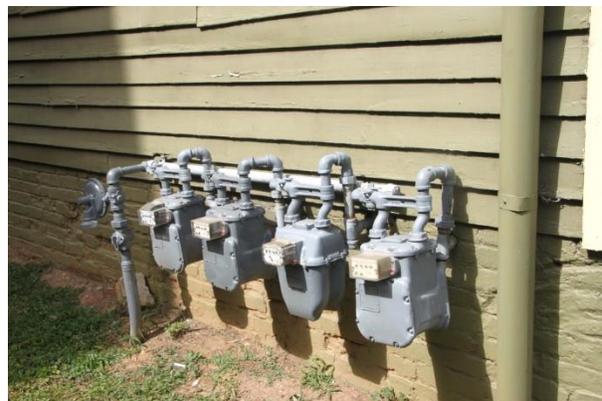
Natural gas is used to heat the building, to produce hot water, and for cooking. There is a gas meter for each apartment and the four of them are ganged together at the north end of the east facade (Figure 153). Black steel gas pipes run in the crawl space from the meters to the various appliances and equipment above.

FIGURE 153. Gas meters mounted on the east wall.

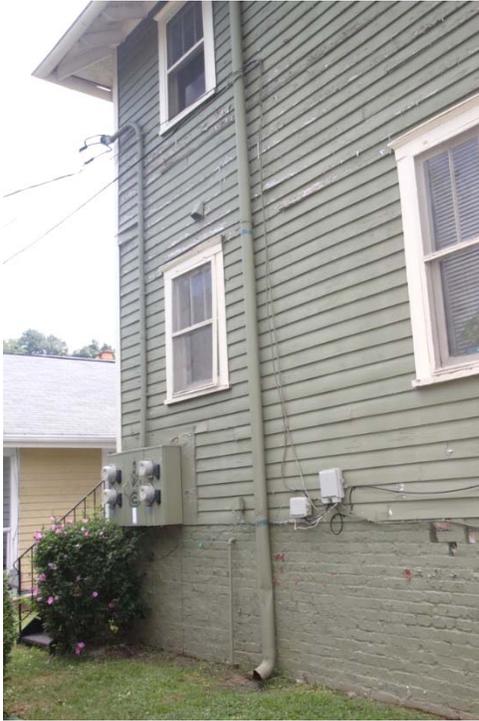
Electrical Systems. According to park records, the electrical system was updated and upgraded as part of the rehabilitation project in 1994. Electrical service comes from a power pole on Hogue Street to a weather head, conduit, and grouped-meter base at the northwest corner of the house (Figure 154). Each living unit is metered separately, and a

FIGURE 154. Electric service enters the building at the northwest corner.

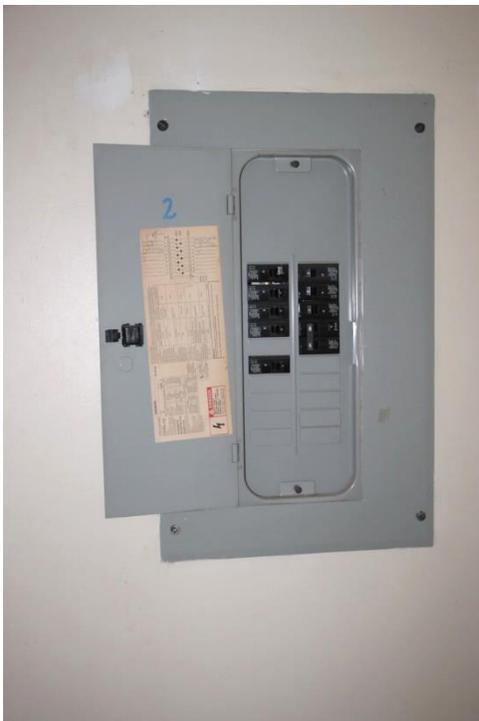
breaker panel for each unit is on the north wall of the kitchen next to the rear door (Figure 155).

FIGURE 155. Typical breaker panel for each apartment.

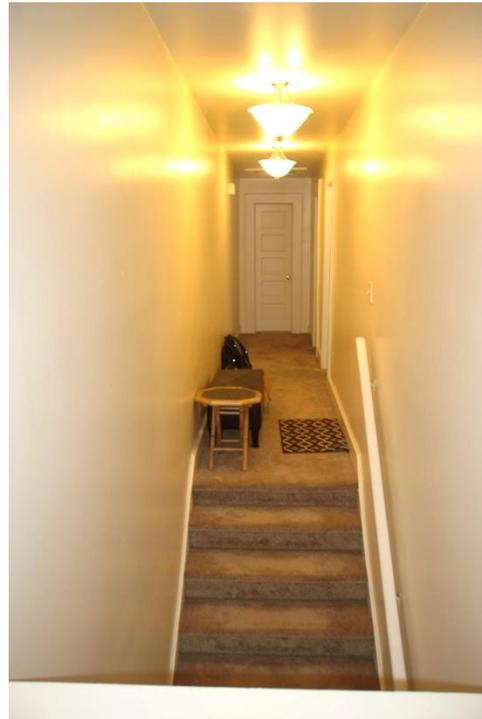
FIGURE 156. Traditional pendant light fixtures in second-floor unit C.

- The assortment of light fixtures and ceiling fans in the apartments has a traditional or vintage style, but they may not accurately represent fixtures from the early 1930s when the building was constructed. In addition, some of them are damaged or have missing bulbs (refer to Figure 156, Figure 157, Figure 158, and Figure 159).
- Future electrical upgrades should be done after a code compliance assessment is completed by a licensed professional.

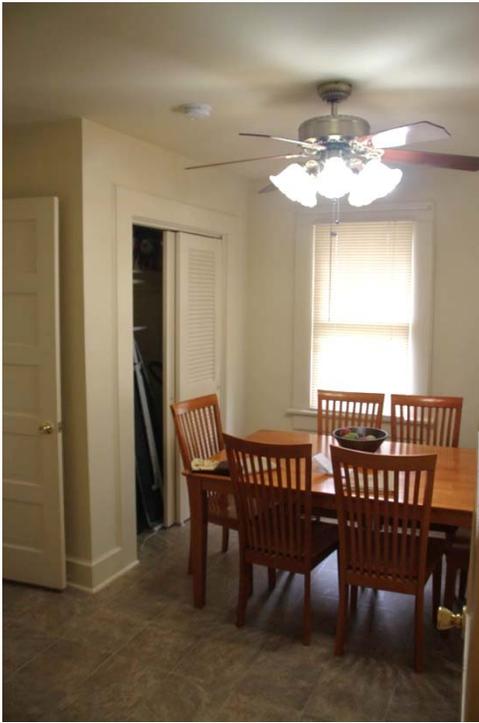
FIGURE 157. Ceiling fan with light kit.

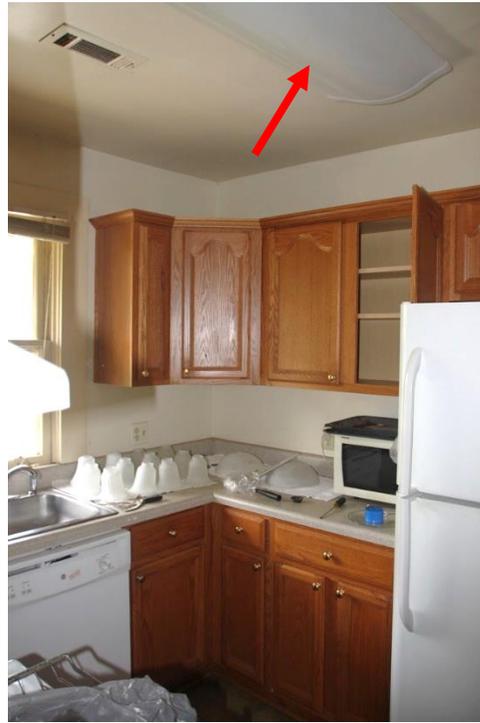
The 1994 rehabilitation work included the installation of new receptacles, switches, and light fixtures. Currently, an assortment of ordinary light fixtures and ceiling fans in the apartments have a traditional or vintage style, but they may not accurately represent fixtures from the early 1930s when the building was constructed (Figure 156, Figure 157, and Figure 158). In contrast to the traditional-style fixtures elsewhere in the apartments, the kitchens in units A, B, and C have modern, surface-mounted, 1-foot-by-4-foot, fluorescent fixtures with wraparound plastic lenses (Figure 159).

FIGURE 159. Modern, surface-mounted, 1-foot-by-4-foot, fluorescent fixture in unit B kitchen.

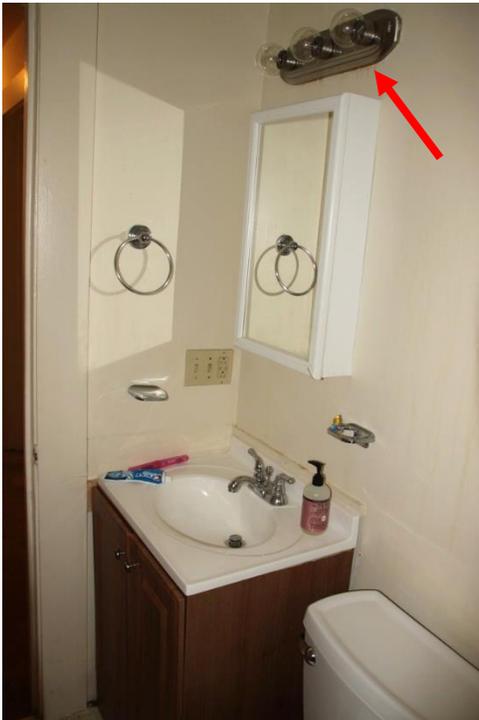
FIGURE 158. A traditional-style light fixture above the vanity.

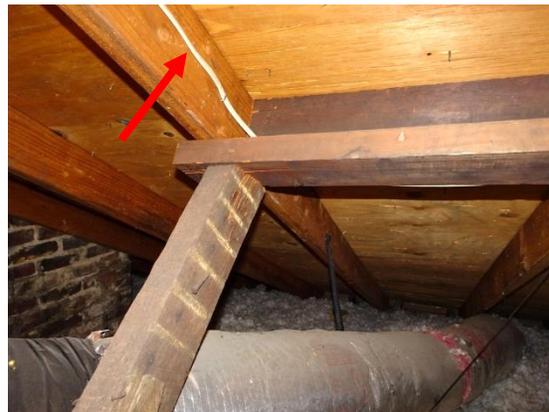
It is assumed that when the electrical system and electrical devices (receptacle, switches, fixtures, etc.) were last updated they complied with the requirements of the building code. Some visible wiring in the attic and mechanical spaces is non-metallic clad (NM) cable (Figure 160), which conforms to the current International Building / Electrical Code for multi-unit residential buildings. However, observations of concealed wiring and electrical system components for the purpose of determining compliance with current codes were beyond the scope of this report.

FIGURE 160. NM electrical cable in the attic.

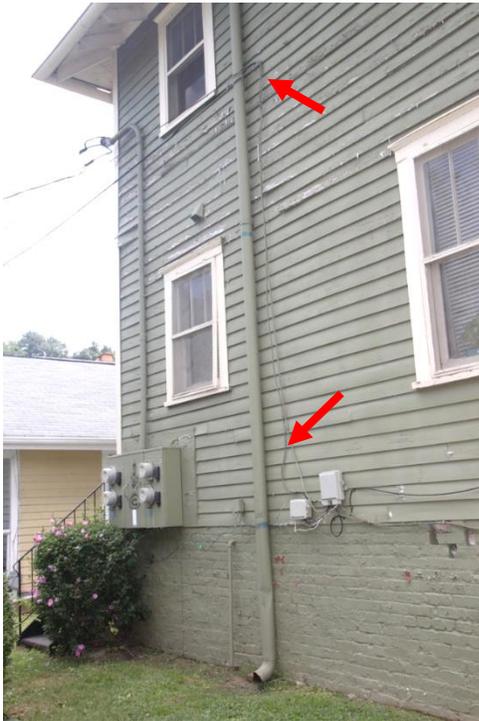
Systems. Cable television, communication, and data service comes from a line on Hogue Street to the northwest corner of the building. From that point, cables drop down to weather-resistant junction boxes, and from there to locations along the west wall where the cables penetrate the wood siding and enter the building and the two apartments on the west side (Figure 161 and Figure 162). Units C and D receive cable television, communication, and data through cable that enters the building on the east wall from a line along Auburn Avenue (Figure 163). Data jacks and

FIGURE 161. Television and internet cabling running down the west side of the building.

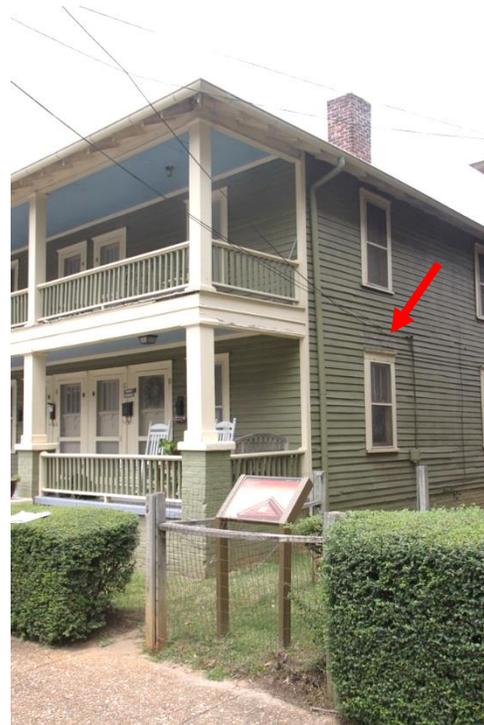
FIGURE 163. TV and internet cable from Auburn Avenue.

- Haphazard and destructive penetrations through the exterior envelope of the building damaged wood siding and brick foundation walls. Left unsealed, the holes allow air and moisture to into the wall which can result in deterioration of the siding and other wood components of the wall. Moisture and humid

air also contribute to organic growth (refer to Figure 162 and Figure 163).

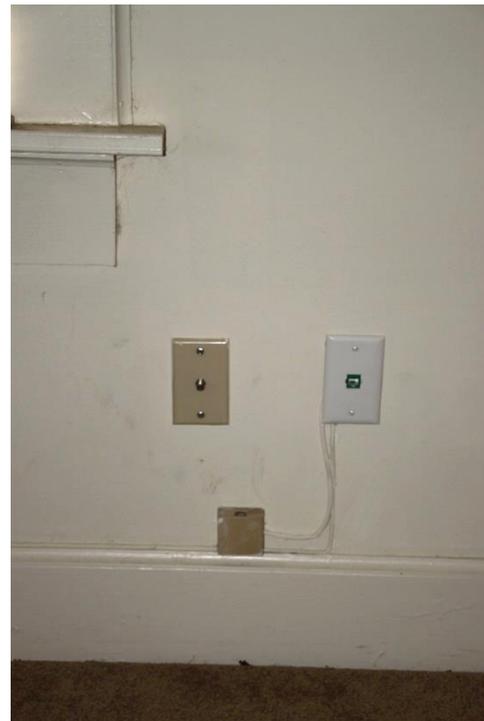
FIGURE 164. Co-axial cable connection (left) and data jack (right) inside one of the apartments.

- Messy data, television, and communication cables and wires detract from the appearance of the building and are incongruous with the historic period of original construction.
- Some wiring runs are exposed along the baseboard to a jack or a device. This is unsightly, and the wires are unprotected (Figure 164).

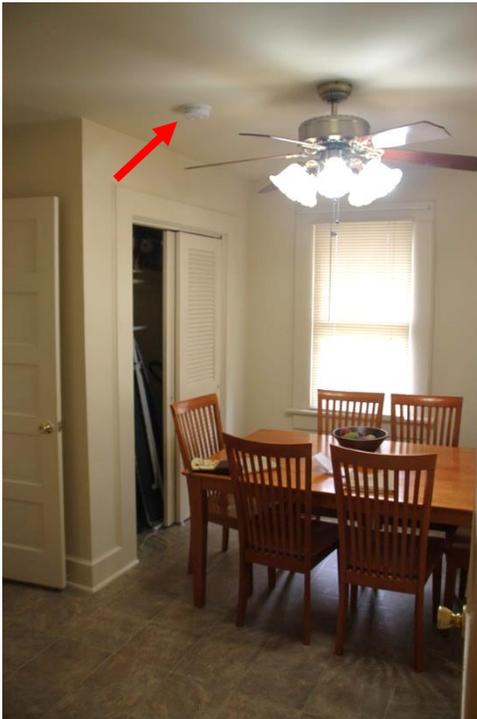
Fire Protection and Security. Notification of smoke and fire is provided by ceiling-mounted detectors with alarms that are in each room of the living units. These detectors appear to be battery operated, but may be direct wired (Figure 165 and Figure 166).

FIGURE 165. Smoke and fire detector in unit C.

- Some ceiling-mounted smoke and fire detectors appear relatively new, but others are older. They may be battery operated or wired, but they should be checked regularly for proper operation as recommended by the manufacturer and local fire officials (refer to Figure 165 and Figure 166).
- Means of egress from the building must conform to the requirements of the adopted building code and National Fire Protection Association (NFPA) 101: Life Safety Code (LSC).
- Although motion sensors and alarm horns are in the building, they may not work. There were no keypads near entry doors for arming and disarming a security system, so it is assumed that the units do not have active security systems (refer to Figure 167 and Figure 168).

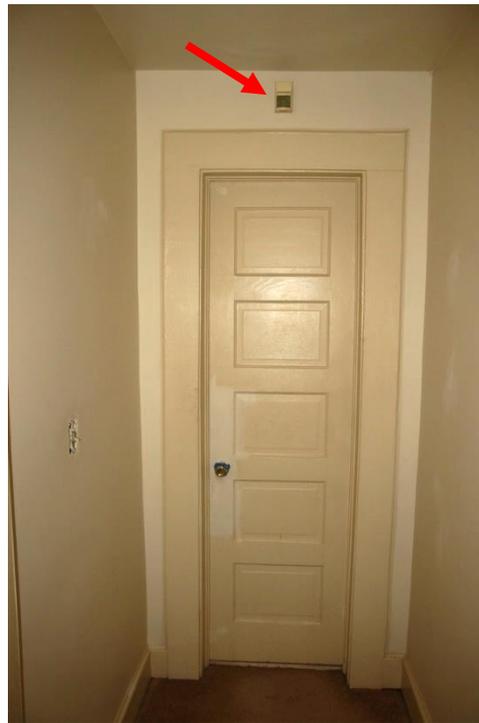
Some motion sensors and horn alarms were present in the units, but they appeared to be old (Figure 167 and Figure 168). Key pads for arming and disarming a security system were not apparent, so the old-looking devices may not be functional.

FIGURE 167. Motion detector above the door.

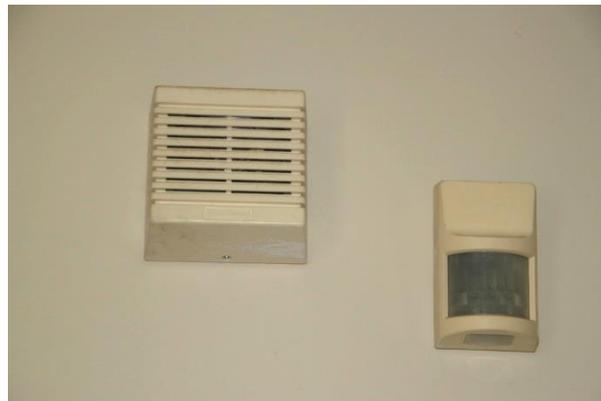
FIGURE 168. Old motion sensor on the right and alarm horn on the left.

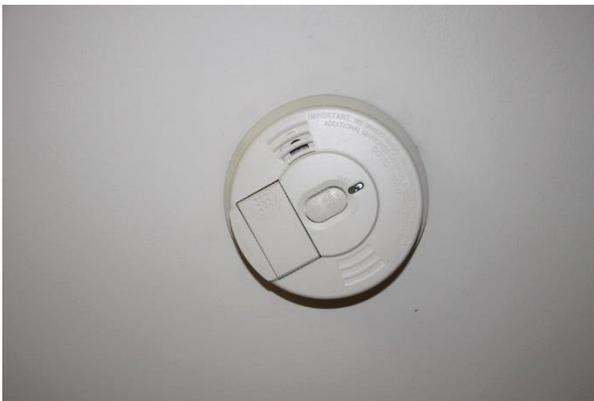
FIGURE 166. Ceiling-mounted smoke and fire detector.

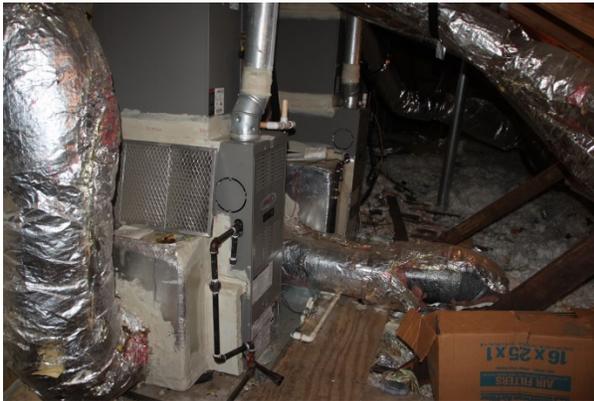
- Each apartment in the multi-unit structure is heated and cooled by a Dx split-system, with blower coil unit, gas heat, and outdoor condensing unit. According to the serial numbers on the units in the attic that serve the second-floor apartments, they were manufactured in 2008 (Figure 169).

All four systems are slightly less than ten years old. Park records of periodic maintenance of HVAC units at 506 Auburn Avenue are minimal, but information about regular maintenance for other structures in the park indicates that these four HVAC units receive cyclical maintenance. During the on-site visit for this report, no problems with the HVAC systems were mentioned by the park staff. Performing cyclic preventative maintenance will continue to extend the operation of the HVAC equipment.

FIGURE 169. Dx split-system heating and cooling systems in the attic above unit B.
