510 Auburn Avenue, NE Historic Structure Report

510 Auburn Avenue, NE
Martin Luther King, Jr. National Historical Park
Atlanta, Georgia

Historic Structure Report

September 2019

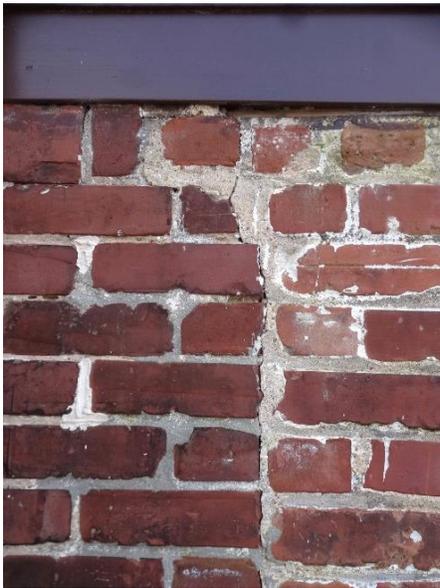
- Cracked and open mortar joints were observed at the joint between the brick foundation piers and brick infill (Figure 92). The cracking was most pronounced at the north elevation of the one-story extension, followed the vertical joint, and was approximately 1/16 inch wide.

FIGURE 92. Cracked and open mortar joint between brick foundation piers and brick infill.

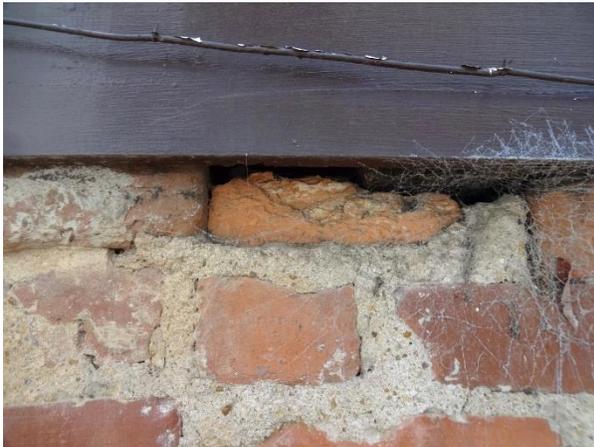
- Spalled bricks were observed at a few locations at the top of the brick infill of the foundation wall (Figure 93). Typically, the spalling included one or two brick units. The spalling was most pronounced at the north extension foundation.

FIGURE 93. Spalled brick unit at top of foundation wall.

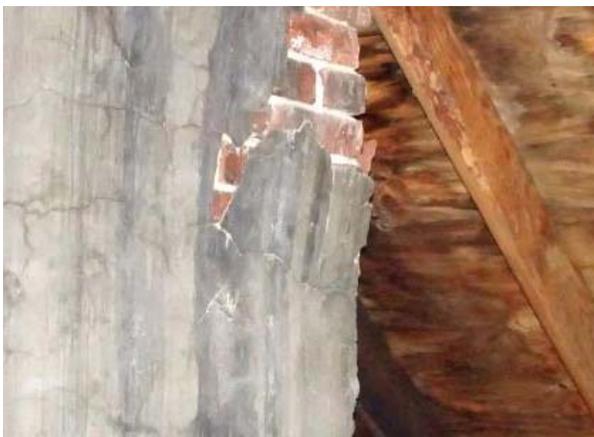
- Mild delamination was observed of the cementitious parge coating at the brick masonry chimneys (Figure 94). The chimney at the west-facing slope of the main building had large areas where the parge coating was

cracked or had fallen away and was missing. Where cracked, the parge coating would move when touched. The distress was observed from the attic space at an interior portion of the chimney.

FIGURE 94. Delaminated parge coating at chimney.

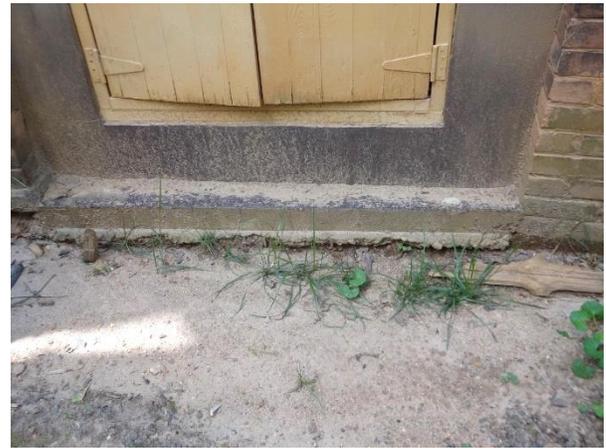
- Mild erosion was observed at the concrete footing, specifically near the crawl space entrance at the north end of the east elevation and at the west side of the porch foundation (Figure 95). At these locations, the soil appears to be undercutting the footing. The site at these locations is sloped slightly to the north.

FIGURE 95. Undercutting of the concrete footing due to soil erosion.

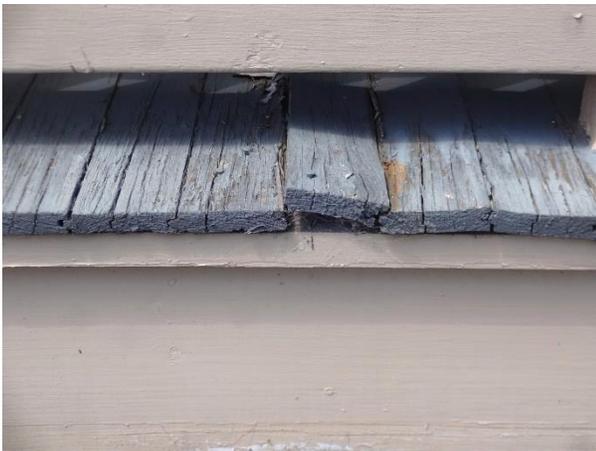
- Cupping was observed at approximately 50 percent of the decking boards at the south porch. At some locations, the cupping was severe and included disengagement of the tongue-and-groove between the boards, resulting in buckling (Figure 97). This is a potential tripping hazard. Mild cupping was also observed at many deck boards. Where observed, the individual boards were slightly cupped in profile. These did not appear to be a tripping hazard (Figure 98).

FIGURE 97. Buckling at south porch deck boards.

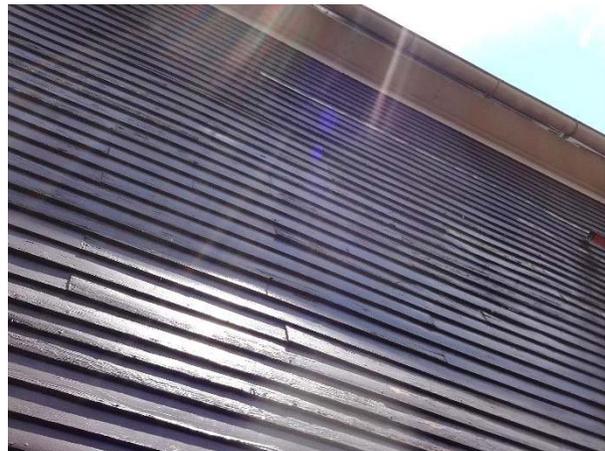
- Bowing and displacement was observed at the wood siding at localized areas. The area of bowing was typically located at the west elevation and consisted of gaps between fasteners where the lower portion of cladding boards separated from the adjacent cladding boards (Figure 100). The gap was approximately 1/4 inch to 3/8 inch wide. The gaps were not covered by the paint coating. Displacement was observed at the ends of siding boards, where boards had come loose, creating a gap between the wall and the siding (Figure 101). At the fascia, some of the boards had displaced downward approximately 1 inch and were no longer aligned with the adjacent fascia (Figure 102). The displaced fascia boards also show evidence of deterioration.

FIGURE 100. Bowed and displaced wood siding. Note the ends of many boards are displaced and protrude from the plane of the wall.

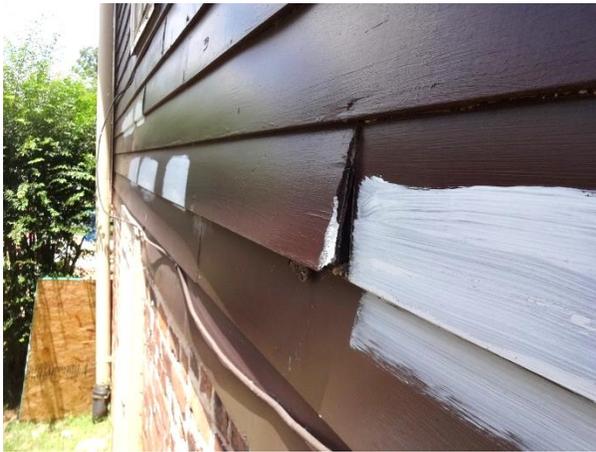
FIGURE 101. Displacement at the end of a wood siding board.

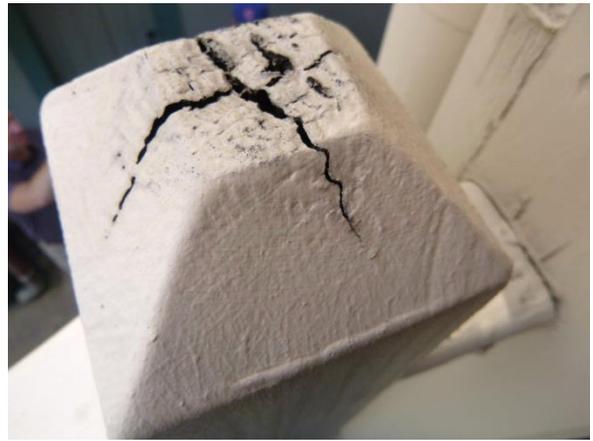
wood was observed at the top of the northeast porch handrail (Figure 108).

FIGURE 108. Checking and splitting of wood at northeast porch handrail.

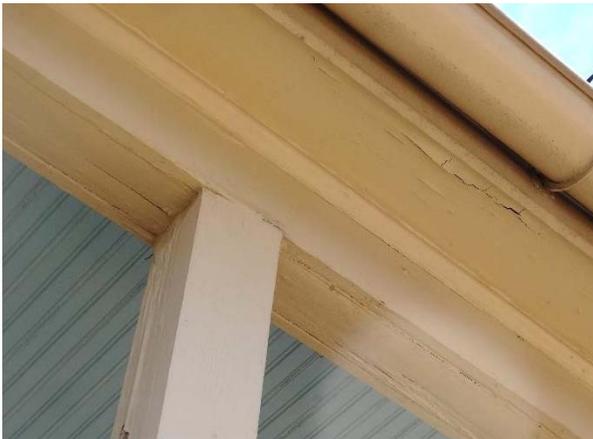
- Moderate decay and deterioration was observed at some wood siding, trim, porch box beams, and fascia (Figure 103 through Figure 106). Typical distress included checking and splitting of wood near the end grain and along the bottom edge. Deterioration of siding was most pronounced at the east and west elevations. Checking was observed at the south porch box beam below the location of severe distress to the porch roof. Deterioration of fascia boards was most pronounced near gutters. Where deteriorated, the wood was friable.
- Moderate deterioration of the wood was observed at the wood guardrail of the south porch (Figure 107). The wood at the top rail and base of the porch posts had deteriorated and was friable when probed. Splitting of the

FIGURE 106. Deterioration such as checking and peeling paint at porch box beam

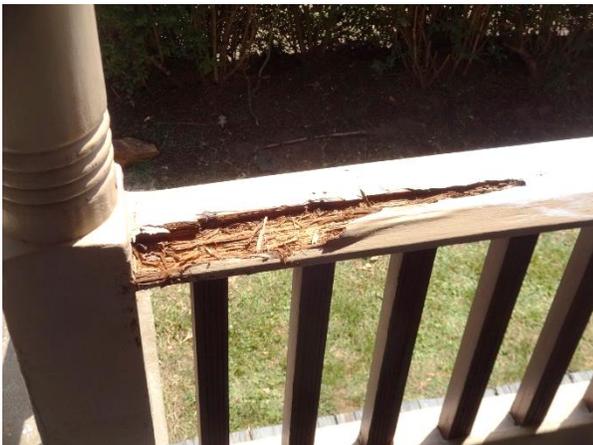
FIGURE 107. Deterioration and decay of wood at south porch balustrade.

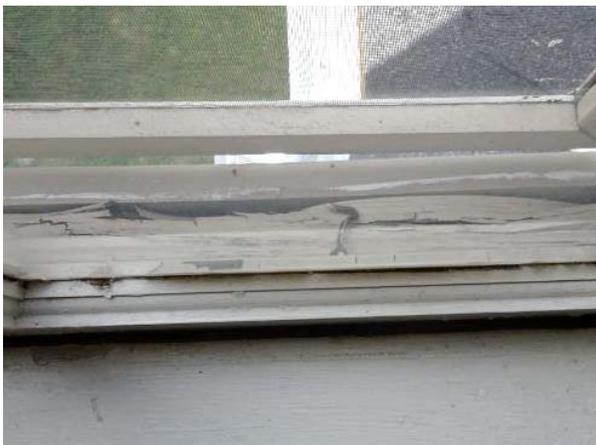
- In general, the windows are in good condition. Minor distress conditions were observed at some window sash and window sills.
- Deterioration of the wood sills and casing was observed. The distress included splitting and evidence of deterioration of the wood (Figure 110). The most pronounced distress was located at the bottom end of vertical window casings and at the top surface and ends of sills.
- Some rope cords at double-hung window pockets have been cut and the windows are no longer operational (Figure 111).
- Unevenly set window sash were observed at a few locations. Some of the sash appeared not

FIGURE 110. Deterioration of wood at the exterior sill.

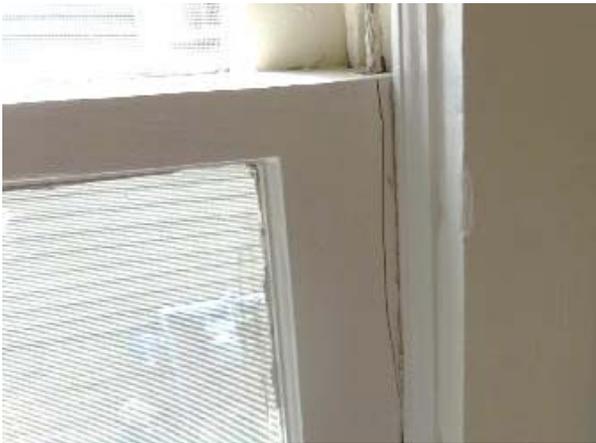
FIGURE 114. Crack along sash pocket at lower sash.

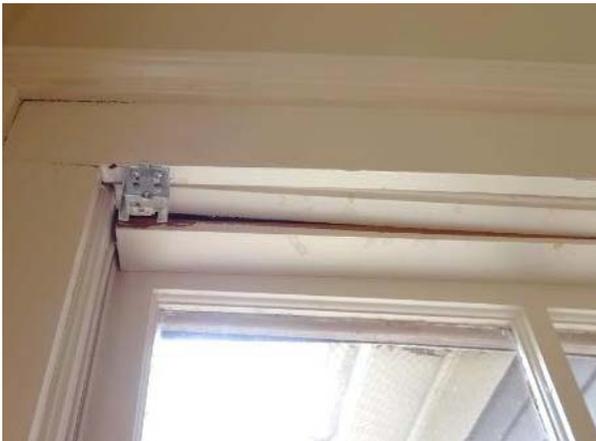
- Displaced interior header trim was observed at one window location (Figure 115). Where observed, wood trim was loose and displaced approximately 1-1/4 inches.

FIGURE 115. Displaced interior window trim.

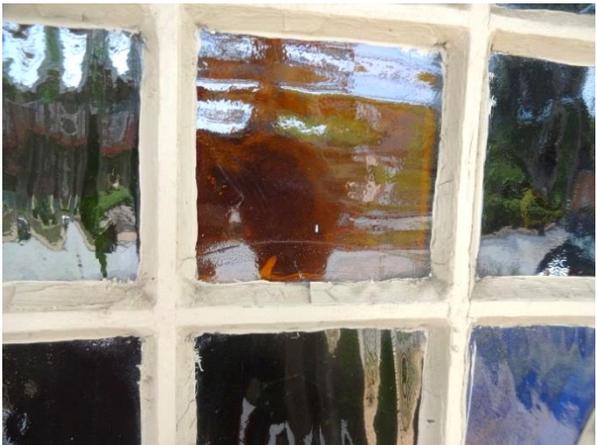
- Broken glazing was observed at the fixed stained glass window on the south elevation (Figure 116). The cracks were located at two tinted glass lights and extended across the glass.

FIGURE 116. Cracked tinted glass light at character-defining diamond-shaped window in front hall.

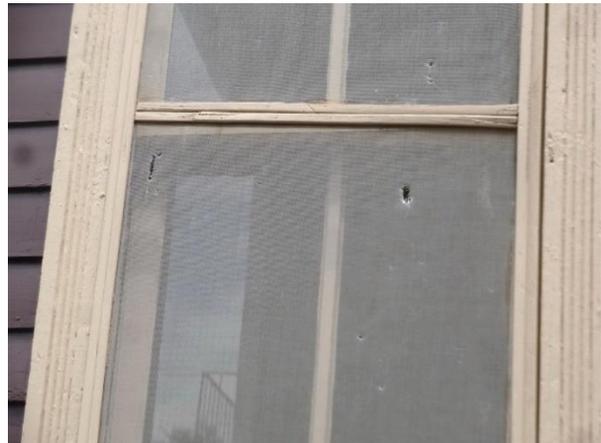
- Torn screens were observed at a few windows (Figure 117). The holes were approximately 1 inch wide, and were mostly located at first-floor windows. Some windows had multiple holes.

FIGURE 117. Window screen sash with tears in window screen.

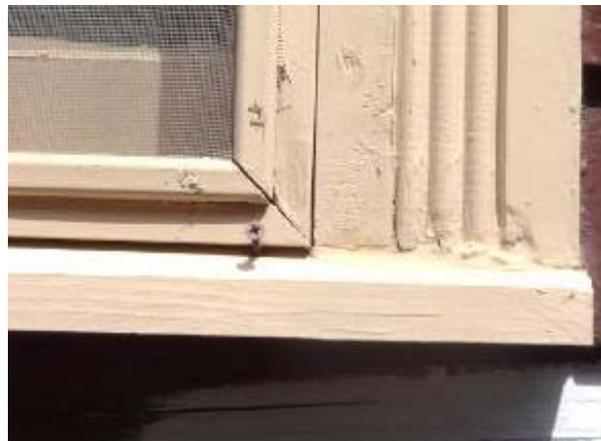
FIGURE 118. At some locations a screw secures the lower portion of the window screen sash.

- At some locations, the bottom of the window screens is secured with a screw rather than the typical hook and eye system (Figure 118). Typically the sill at these windows had evidence of deterioration.

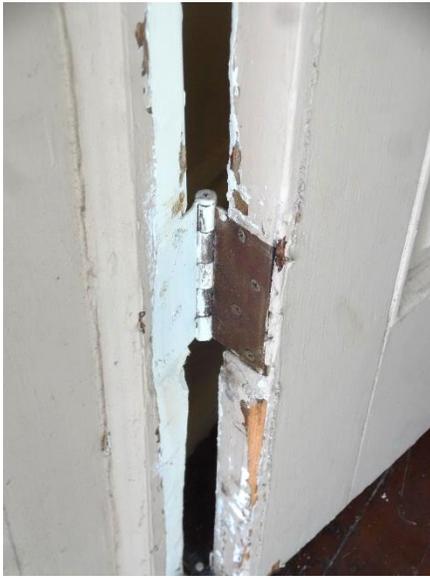
- The doors are in good condition, with the exception of peeling paint.
- Peeling paint was observed at the exterior face of the doors (Figure 119). The distress consisted of deboned, chipped, and peeling paint at the door casing and along the edges of the door leaf.

FIGURE 119. Chipped and peeling paint along the edge of the main entrance door.

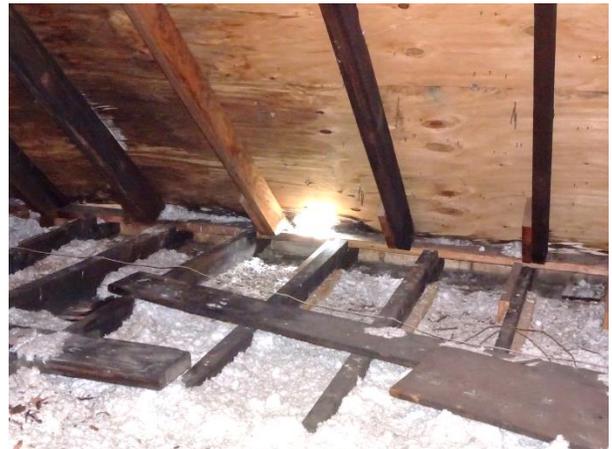
- Large holes were observed in the roof system. One hole was located at the base of the roof sheathing along the east-facing slope of the main building roof. The hole was approximately 12 inches wide. The surrounding plywood sheathing had moisture staining and evidence of mold and biological growth. A large hole was also observed at the

FIGURE 121. Hole in the east-facing roof slope of the main building roof.

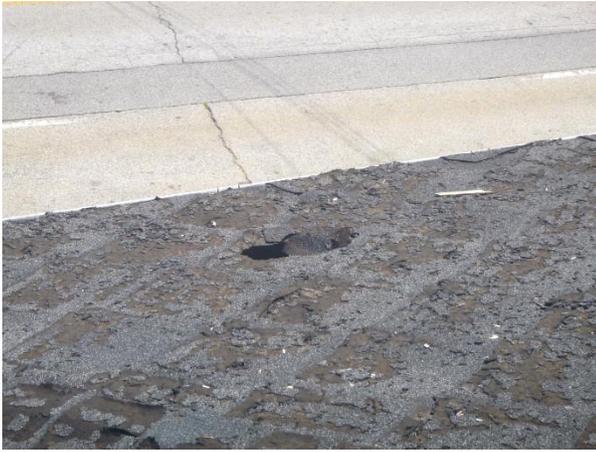
south porch hip roof (Figure 122). The hole was observed from the exterior and was located at the south end of the roof, above the porch stair. The hole was approximately 12 inches in diameter and the asphalt shingles had torn and were no longer present.

FIGURE 122. Hole in the hip roof at the south porch.

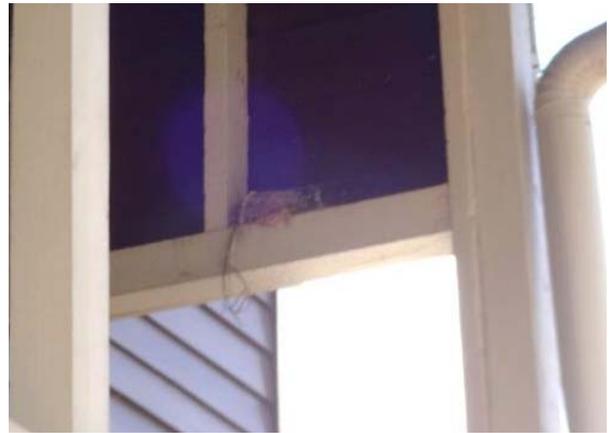
- Pest infestations were observed at the shed roof framing of the northeast porch (Figure 129). The infestation included a small bird's nest set within the roof framing members.

FIGURE 129. Bird's nest at northeast porch roof framing.

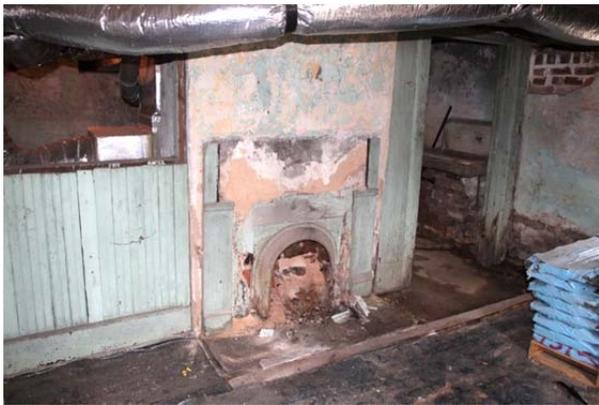
There is a section of a wall adjacent to the fireplace that has wood bead board on wood studs. The bead board is also painted green (Figure 169). Exposed joists of the floor above have marks from wood lath indicating that the ceiling was also plaster; although, none of it remains. Fiberglass batt insulation fills the spaces between joist, and round, insulated ducts are strapped to the joists as they run across the ceiling.

FIGURE 169. Bead board wood partition and door opening flanking the fireplace.

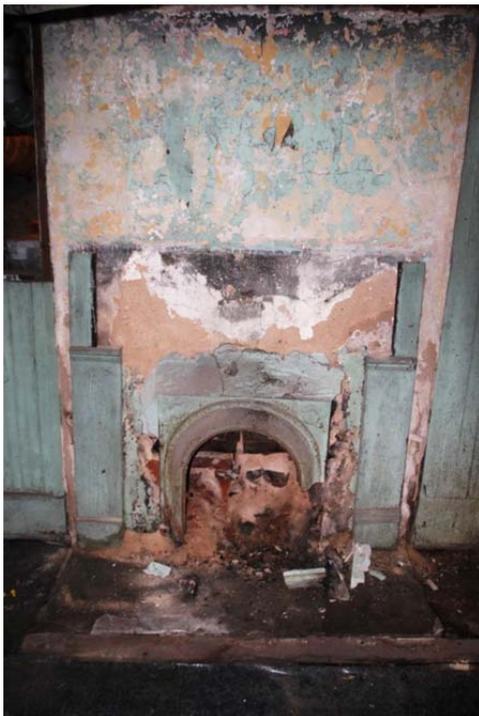
FIGURE 170. Fireplace between the two basement rooms.

Between the two rooms is a coal-burning fireplace flanked by wood-framed walls (mentioned above) that extend east and west across the width of the basement. The brick chimney is plastered, and there are remnants of a wood mantelpiece and a Portland cement hearth. The firebox was filled in with brick at some point in time (Figure 170).

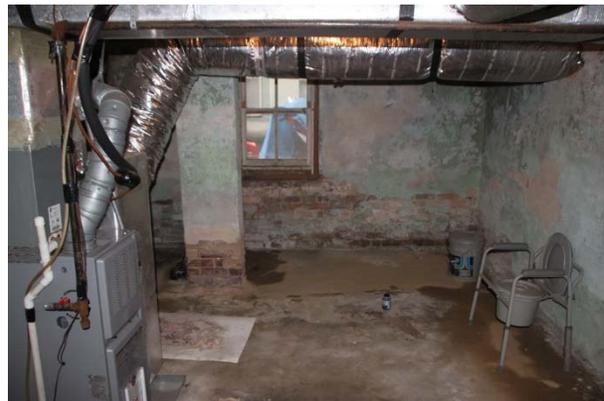
The south room has plastered masonry walls, on the east, south, and west, and a rough concrete floor. Most of the plaster has spalled off the lower sections of the walls, probably because of moisture migrating through the masonry foundation walls that are at or below grade. And, there are water stains and standing water on the floor (Figure 171).

FIGURE 171. South basement room looking east.

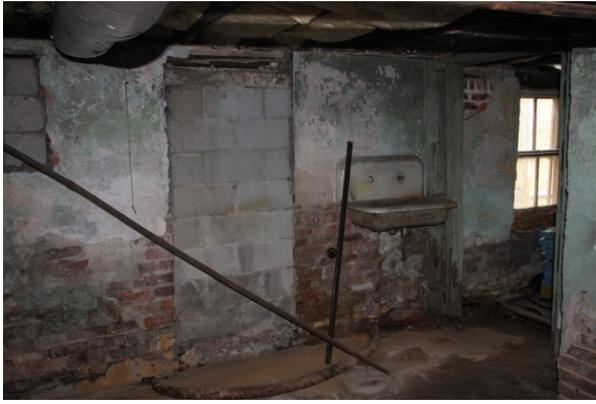
Just inside the door between the two basement rooms is a wall-hung, porcelain enameled, cast-iron sink. To the left of the sink are two openings in the brick foundation wall that were infilled with CMU. It appears that one was a door and the other a window (Figure 172).

FIGURE 172. West basement wall with wall-hung sink and infilled door and window openings.

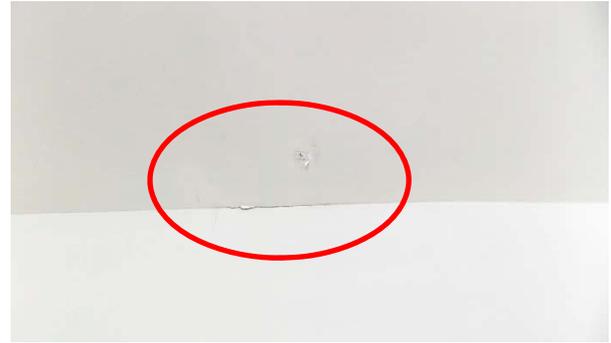
FIGURE 173. Gypsum board ceiling damage from roof leaks—fracture in wall-to-ceiling joint, paint blister and staining.

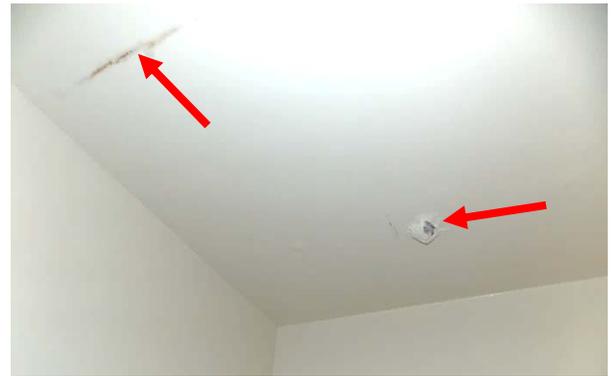
FIGURE 174. Bathroom: gypsum board ceiling damage from roof leaks—paint blister and linear staining along joint line and ceiling joist.

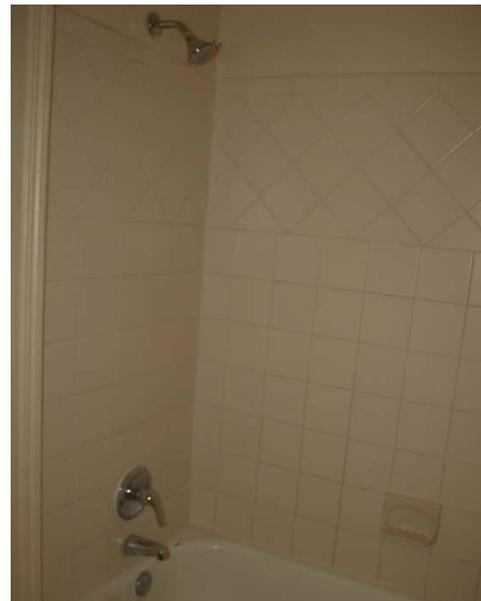
- Gypsum board walls are in good condition. No significant cracks at joints or extensive delamination of joint compound at fastener heads is evident. The last confirmed cyclic painting occurred in 2014. However, exterior repairs and painting were in progress during the site visit for this report in August 2017. The house was vacant, and the interior was clean. The good condition of painted surfaces inside the house suggests that the interior walls and trim were recently painted.
- Ceilings had water stains and damage from roof leaks (refer to the exterior condition assessment above for a description of the deteriorated roof) (Figure 173 and Figure 174).
- The ceramic tile bathtub surround in the second-floor bathroom is durable and requires little maintenance. It is in good condition (Figure 175).

FIGURE 175. Ceramic tile surround at bathtub/shower in second-floor bath.

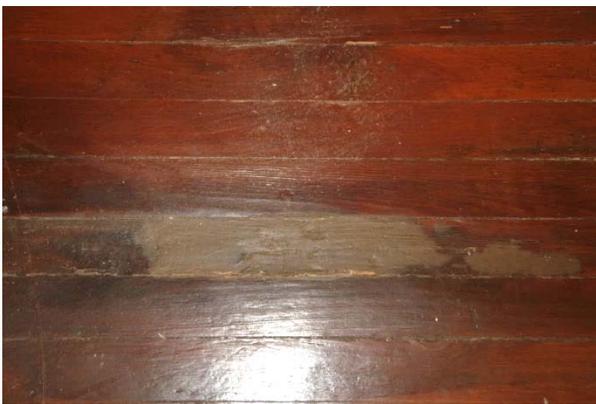
- Generally, the carpet is in satisfactory condition. It did not show signs of prolonged use or wear, and it may have been recently cleaned.
- Original, hardwood strip flooring on the first floor is another hard-wearing material. It has a natural, high-gloss finish that is in fair condition because it is subjected to the highest use and traffic. Cyclical maintenance should continue in order preserve this historic feature. Plan for repairs and refinishing in the near term to fix areas of degradation and foster longevity (Figure 176 and Figure 177).

FIGURE 176. Degradation of hardwood flooring.

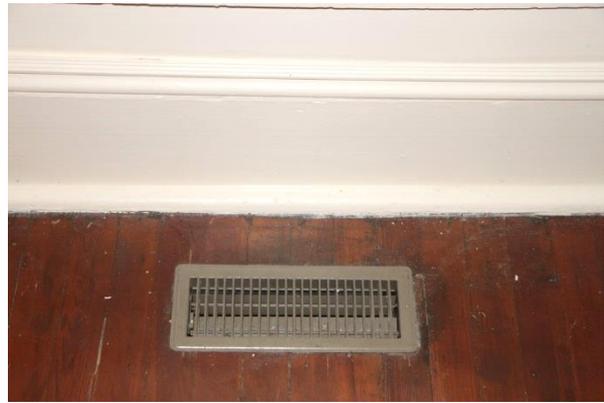
FIGURE 177. Degradation of hardwood flooring around floor register.

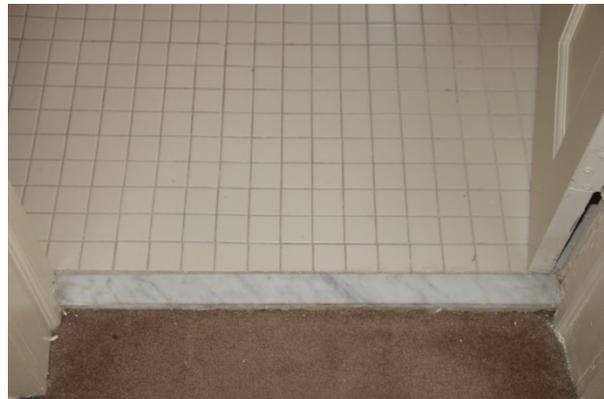
- Ceramic mosaic tile floor was installed in wet areas like the powder room and bath (Figure 178). No major cracks or delamination were observed, and these floors have also held up well since they were put in. Because installation was done over a wood substrate, the type of waterproof membrane applied to the substrate will affect the long-term performance of these tile floors. Maintaining stiffness of the floor framing will also aid long-term performance.

FIGURE 178. Typical ceramic mosaic tile flooring installed in first-floor powder room and second-floor bath.

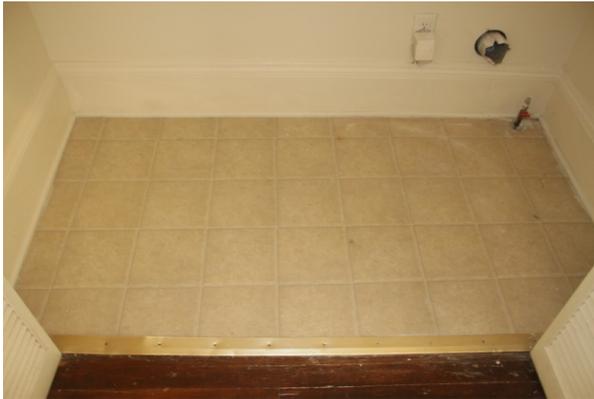
- Sheet vinyl is a floor covering that has been widely used in different formulations since the 1930s. It is inexpensive and easy to install, and it is available in a wide range of colors and patterns. The tan-color, square tile pattern in the kitchen, laundry, and water-heater closet is in good condition, but it requires periodic cleaning to maintain a neat appearance. It can crack and tear when impacted and moving

heavy furniture and equipment like appliances over it can scratch and mar the surface (Figure 179).

FIGURE 179. Ordinary sheet vinyl flooring in the laundry closet.

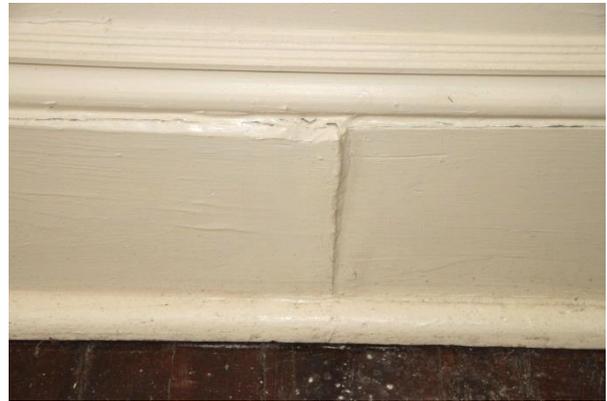
rather than repaired properly (Figure 180 and Figure 181). Baseboards have several layers of paint and scarring, scratches, and abrasions that have accumulated over time.

FIGURE 181. Misaligned joint in baseboard that was caulked and painted.

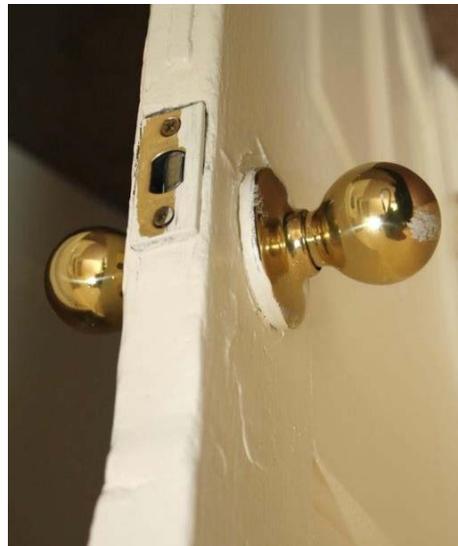
- Generally, door hardware (locksets, latch sets, deadbolts, and hinges) is functional but not in good condition. Doorknobs are not in compliance with the regulations of the revised Architectural Barriers Act (ABA) and Americans with Disabilities Act (ADA). However, historic properties can, in some circumstances, receive waivers from strict compliance; although, none of the locksets and latch sets are historic.
- The brass finish on the door hardware is tarnished and scratched, and brass hinges and strike plates are marred by excess paint (Figure 182, Figure 183, Figure 184, and Figure 185).

FIGURE 184. Excess paint on brass door hardware.

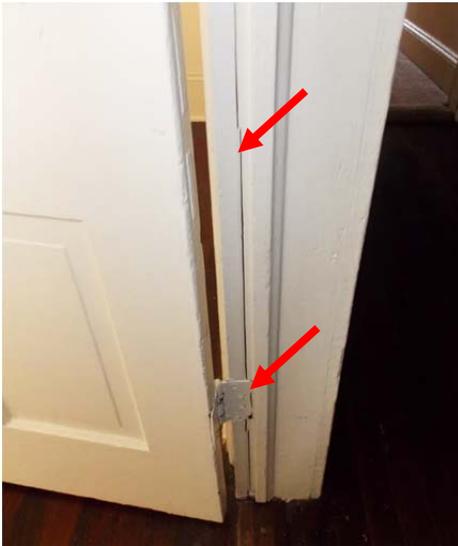
FIGURE 185. Multiple coats of paint on brass hinge. Also note split door jamb.

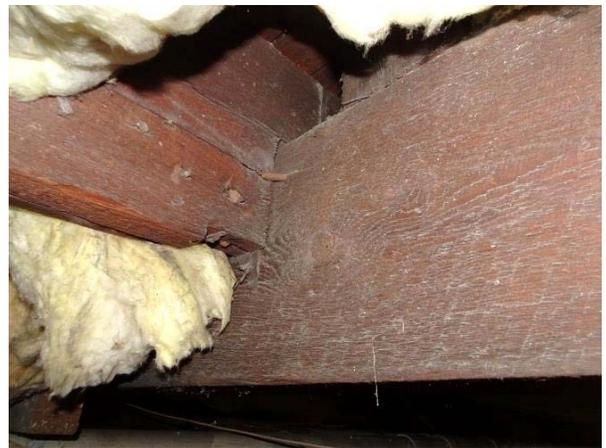
FIGURE 187. Notched floor joist at wood floor beam.

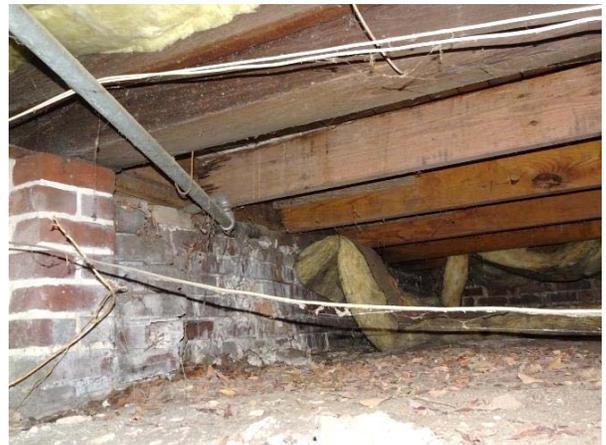
FIGURE 188. Non-original wood floor joists at north end of building.

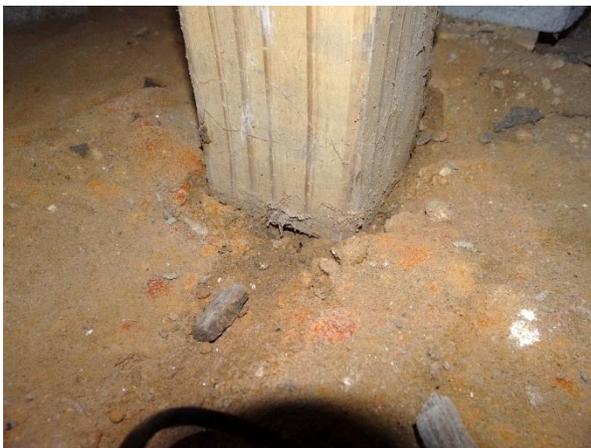
- Some of the supplemental wood foundation posts did not fully extend to the concrete footing (Figure 192). Where observed, the posts appeared to stop approximately 1/2 inch above the footing. The area was filled with dirt and gravel.

FIGURE 192. Base of wood post framing does not meet concrete footing.

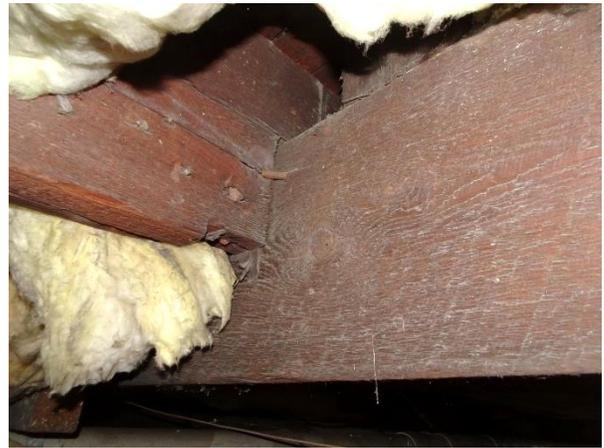
- Small checks and horizontal cracks were observed at the center of a few of the floor joists (Figure 193). The cracks were approximately 1/16 inch wide, were located at the mid-height, and extended approximately 1 foot from the end of the beam.

FIGURE 193. Small check in the wood at the end of the joint.

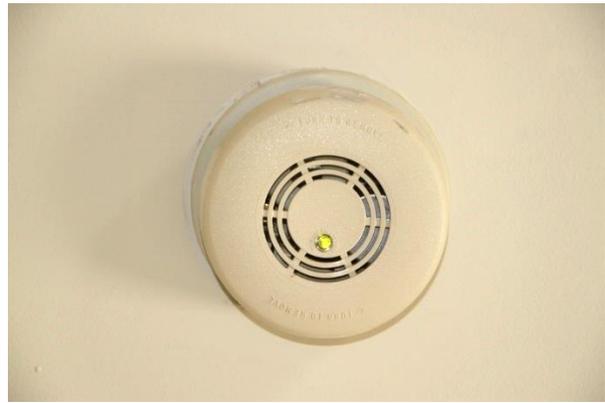
FIGURE 215. Ceiling-mounted smoke and fire detector.

- Fire protection is limited to electrically powered, ionization-type detectors mounted on ceilings. At the time 510 Auburn Avenue was surveyed, operation of the smoke and fire detectors could not be determined. Records of installation, periodic maintenance, and detector replacement were not available. A portable fire extinguisher was purchased and placed in the kitchen under the sink in 2012, according to facility management data.

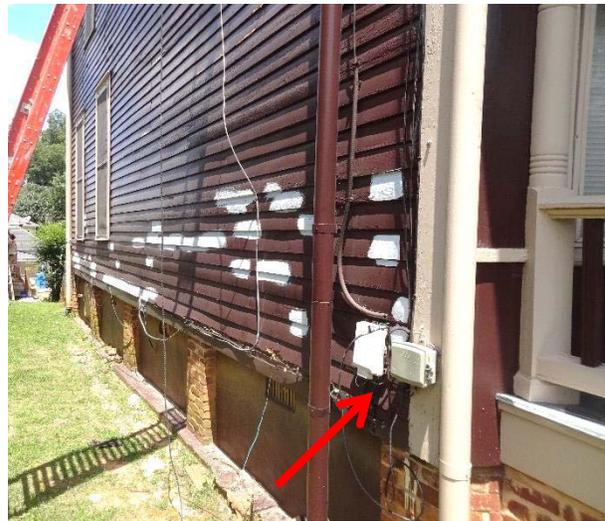
Data, Television, and Communication Systems. Cable television, communication, and data service comes from a line on Auburn Avenue to the southwest corner of the house. From that point, cables drop down to weather-resistant junction boxes and from there to locations along the west wall where the cables penetrate the wood siding and enter the building (Figure 216). Co-axial cable is exposed and haphazardly attached to the siding before it goes the exterior walls (Figure 217).

FIGURE 216. Data, cable television, and communications service drops down to weather-resistant junction boxes at the southeast corner of the house.

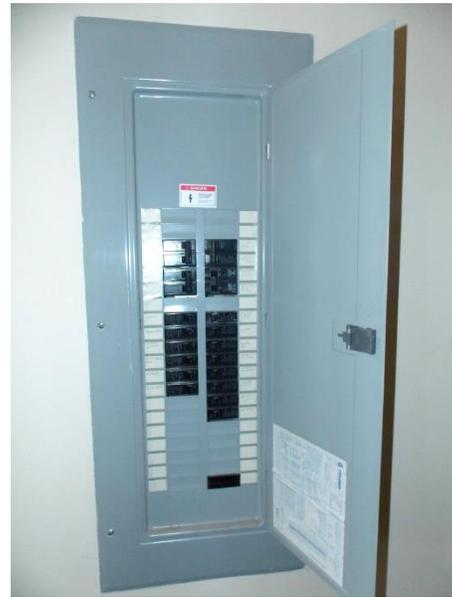
- The main electrical panel has sufficient capacity and space for more circuit breakers (Figure 218).

FIGURE 218. Main electrical panel on the first floor.

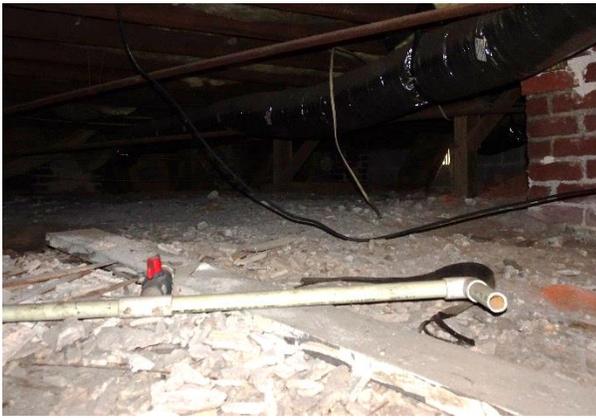
- Plumbing in the house was completely replaced in 1994. It appears that PVC piping was used for domestic water lines instead of copper. Copper is a proven, long-lasting material for domestic water piping, and it is the preferred standard. PVC and copper must be insulated to prevent freezing. Observation in the crawl space did reveal abandoned PVC pipe with an attached valve lying on the ground, but other PVC water lines were not visible. It could not be determined if water pipes in the crawl space are insulated. Further investigation may be necessary if problems arise (Figure 219).
- The hot water heater is plumbed with PVC pipes (Figure 220).

FIGURE 219. Abandoned section of PVC water pipe with red-handled valve attached.

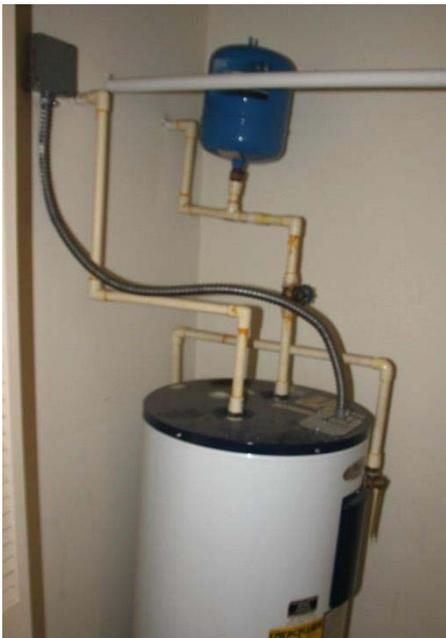
FIGURE 220. PVC water piping at the water heater.

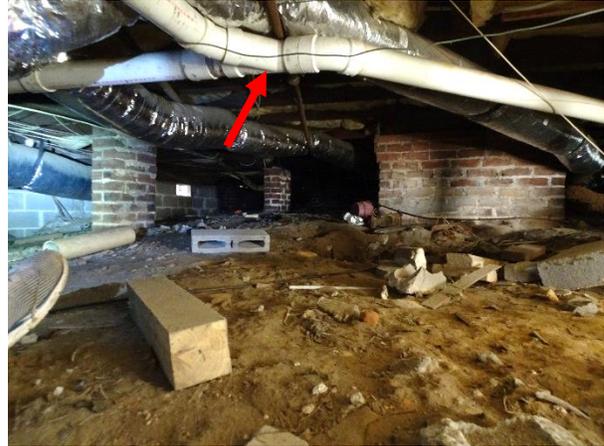
- Sanitary waste lines in the house and in the crawl space are PVC. The main waste line exits the crawl space at the west side of the house and ties into the public sewer line in Auburn Avenue (Figure 221). Schedule 40 PVC pipe is code-approved for most sanitary waste systems because of long-term performance and ease of installation.
- From a city water meter along Auburn Avenue, the main domestic water line enters the crawl space and runs horizontally and then vertically to a 40-gallon gas water heater in a closet under the stair. From there, hot and cold water are distributed to the kitchen, the laundry, the powder room, and the bath on

FIGURE 221. PVC waste line in the crawl space.

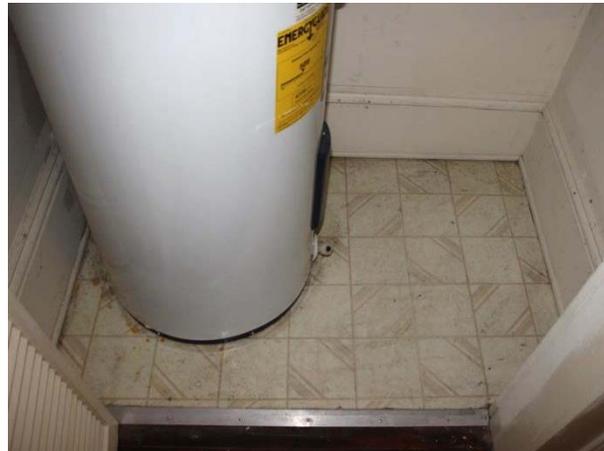
the second floor. The water heater is in serviceable condition, but it does not have an insulation jacket, and there is no drain pan (Figure 222). For tank-type water heaters, current building and plumbing codes require drain pans with a drain line to the outside.

FIGURE 222. Water heater without a drain pan.
