518 Auburn Avenue, NE Historic Structure Report

518 Auburn Avenue, NE
Martin Luther King, Jr. National Historical Park
Atlanta, Georgia

Historic Structure Report

August 2019

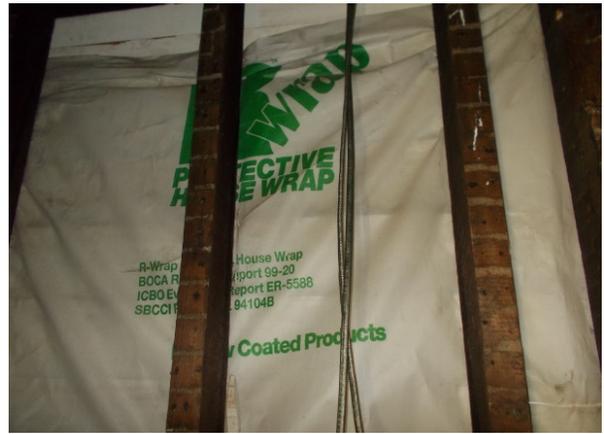
Much of the exterior siding, trim, and ornamental woodwork appears to have been replaced or removed and reinstalled as part of exterior stabilization and alterations performed in 1994.¹¹⁸ During that time, it is likely that the building wrap, a weather-resistive barrier (WRB), located between the cladding and stud framing, was installed (Figure 31). Differences in the kind and type of building wrap used suggest that the cladding and WRB at the north elevation were installed as part of a post-1994 alteration (Figure 32).¹¹⁹

FIGURE 31. Evidence of non-original building wrap installed behind non-original wood siding.

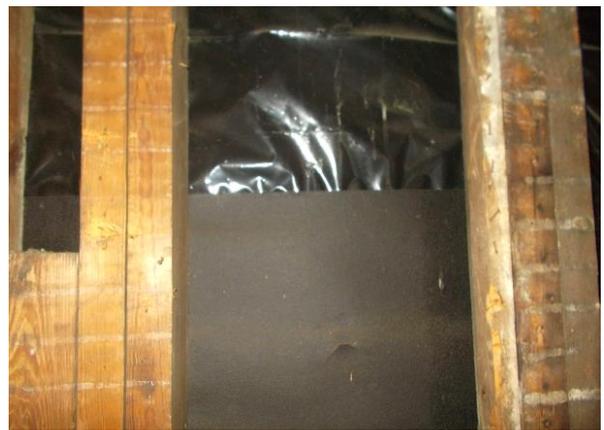
FIGURE 32. A different vintage of non-original, vapor impermeable building wrap observed in the building.

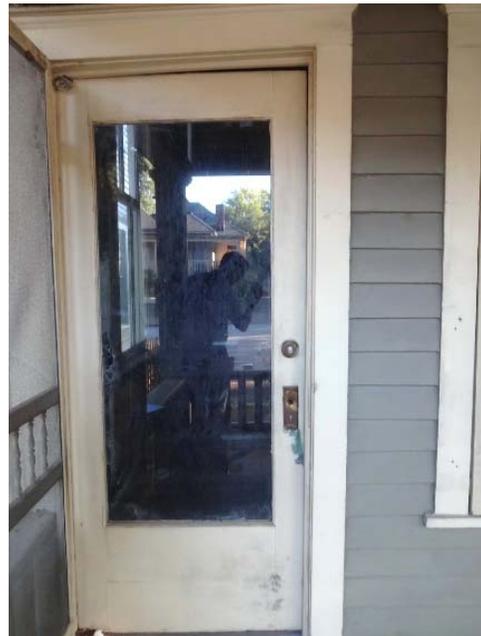
FIGURE 40. Entrance door at west end of south entrance porch. Note wood trim at jambs and header and single-light glazing.

- The two exterior doors are in fair condition and are not original to the building. Both are secured with deadbolts. There are no knobs on these doors (refer to Figure 40 and Figure 41).
- Many interior doors are original and appear to be in good condition. Some, particularly the doors from the central hall to the second-floor rooms, have undergone a great deal of abuse and have been fitted with multiple locking hasps and deadbolts (refer to Figure 93 and Figure 94). There is an assortment of door hardware, mostly on the second floor, and it is questionable whether the mortise latchsets can be successfully restored. Escutcheons at original latchsets appear consistent and could be refurbished. Most knobs and splines have been removed, so many doors will require non-original replacement hardware (Figure 151).
- Makeshift fabric coverings remain on a few second-floor doors (Figure 152).

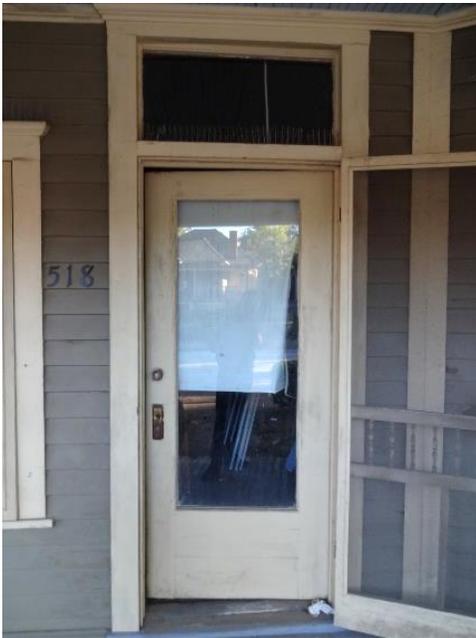
FIGURE 41. Main entrance door at south elevation. Note single-light transom.

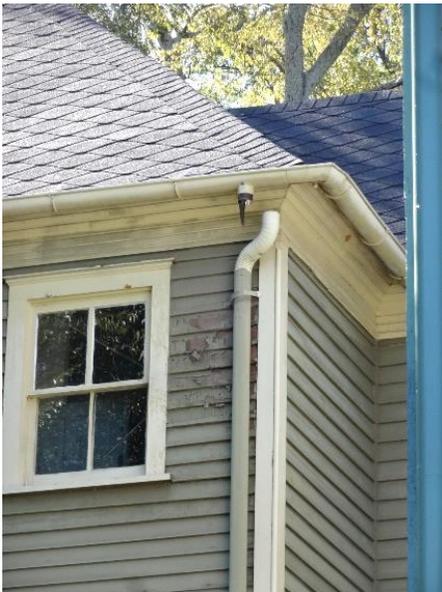
FIGURE 55. Gutter and downspout assembly along roof edge.

- In general, the roof is in good condition; gutters and downspouts were connected and secure at the time of the survey except for the downspout at the northwest corner of the house. It was not connected to the gutter (refer to Figure 55). During rainy weather, water flows out of the gutter at this location and runs down the side of the building. There was no other evidence or report of water leakage.
- Loose and displaced downspout straps were observed at a few locations on the north elevation (Figure 78). Despite the straps being loose, the downspout remained in place.
- Loose or missing gutter brackets were observed at a few locations (Figure 79). The condition was typically associated with areas of distress where the wood fascia and soffit had deteriorated to the point that it could no longer support the bracket.

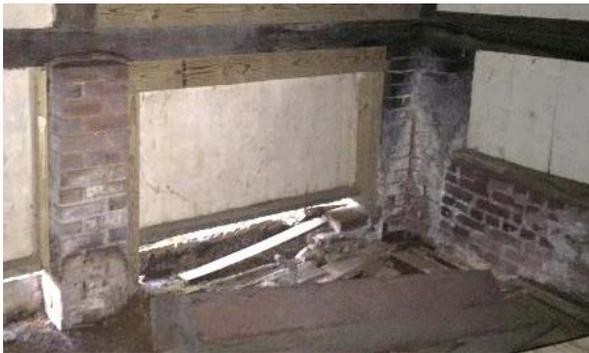
- Efflorescence and evidence of rising dampness was observed at the original brick piers. The efflorescence was typically located at the bottom 20 inches of the piers and at the full height of some masonry wall infill (Figure 57). At some locations, the efflorescence was severe and was associated with deterioration of the brick.

FIGURE 57. Brick foundation piers with efflorescence.

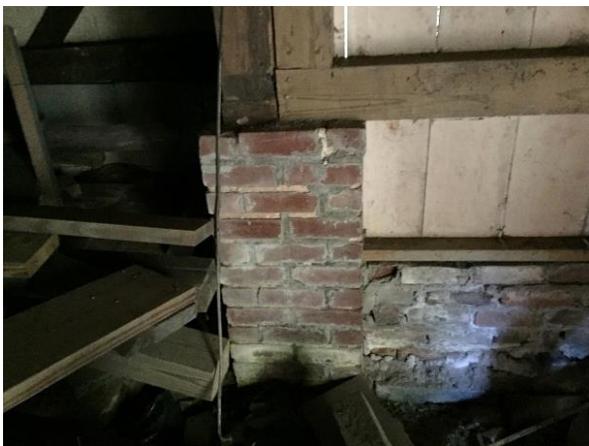
- Spalled and deteriorated brick was observed at some brick piers and was most pronounced at piers along the west elevation of the building (Figure 58). Some of the piers were rebuilt with CMU (Figure 59).

FIGURE 58. Deteriorated brick at brick foundation piers.

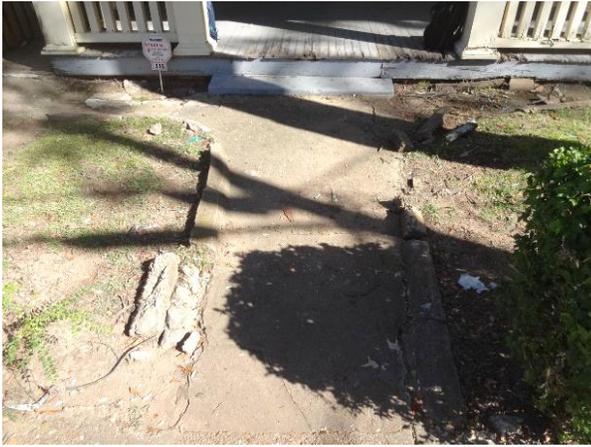
- Deterioration and cracking were observed at the concrete walk and drainage gutter that extends from the public sidewalk to the front porch (Figure 61). The distress includes hairline cracking that extends perpendicular across the full width of the walk and drainage gutter, deterioration of the perimeter curb along the walk, and deterioration of localized areas of concrete. At one location, the concrete walk has been repaired with new concrete.

FIGURE 61. Cracking of concrete at main sidewalk.

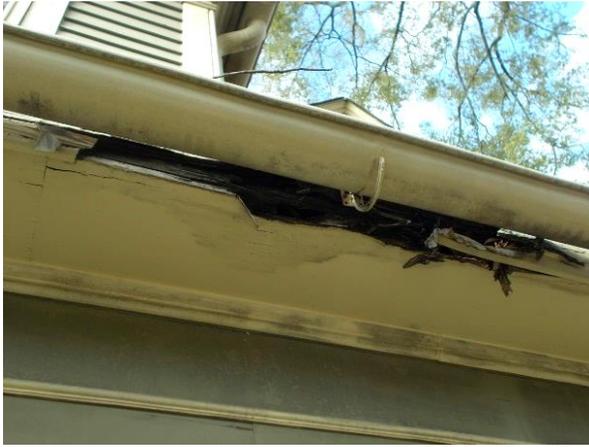
- Moderate to severe decay and deterioration were observed at various elements of the front porch. The deterioration was most pronounced at the porch fascia and eave adjacent to gutters and downspouts, at caps and bases of porch columns, porch balustrades, and at the porch flooring and floor framing (Figure 62 through Figure 64). The distress consisted of splitting or splintering wood that appeared wet and felt soft when probed. The deterioration was typically accompanied by peeling paint, corrosion of anchorage, and biological growth. At some locations, the wood was friable and fell apart when touched. In general, the deterioration appeared related to the presence of moisture. At some locations, such as at column bases, balustrades, and floor boards, the deteriorated wood was removed and either repaired with a wood dutchman or replaced with new (Figure 65 and Figure 66).

FIGURE 62. Wood deterioration at soffit, adjacent to gutter.

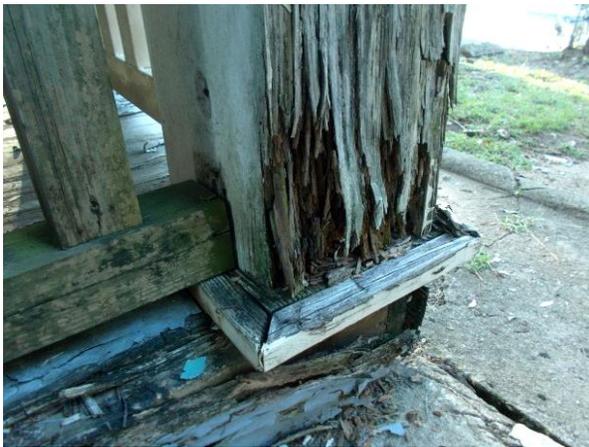
FIGURE 63. Wood deterioration at balustrade column base.

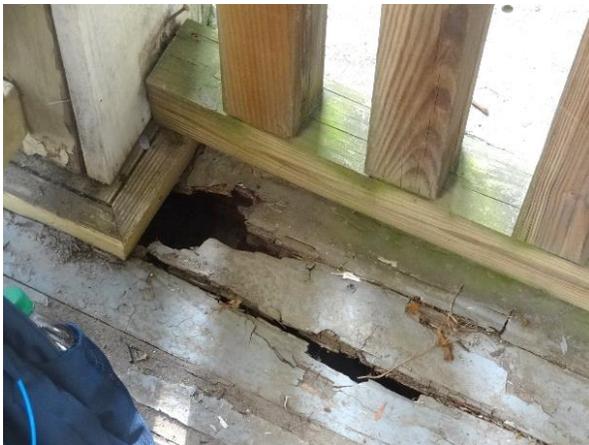
FIGURE 64. Deteriorated wood floor boards.

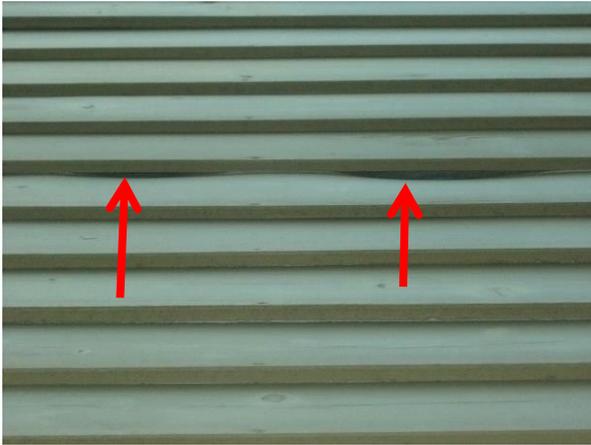
- Mild to moderate decay and deterioration were observed at some wood siding, trim, and roof eave (Figure 67). The deterioration was most pronounced at the north elevation. Typical distress included checking and splitting of wood near the end grain and along the bottom edge.

FIGURE 67. Deterioration of wood at trim board.

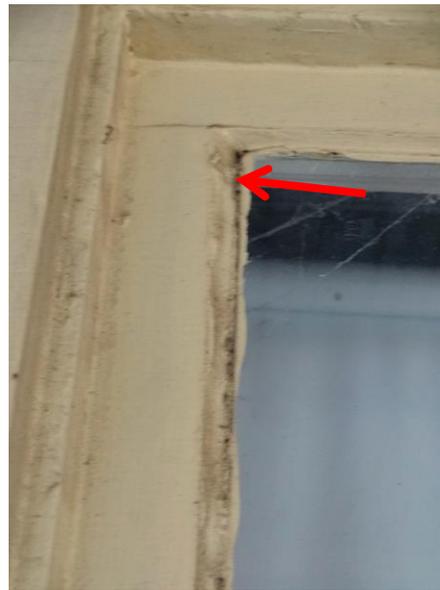
- Discontinuous glazing was observed at the fixed windows unit on the south elevation as well as at windows on the east elevation (Figure 75). The condition resulted in gaps, measuring 1/8-inch wide, which extended a couple inches along the edge of the sash. Despite the gap, the glazing appeared to be secure.

FIGURE 75. Glazing at fixed window does not extend to glazing stop. Arrow indicates edge of glass.

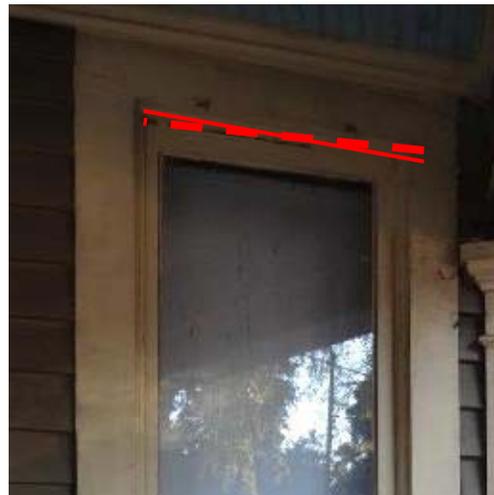
- A displaced window sash was observed at one octagonal bay window on the south elevation (Figure 76). The displacement was located at the upper sash and was evidenced by a gap, measuring approximately 1/4-inch wide, between the sash and frame.

FIGURE 76. Top of sash (dashed line) at window opening (solid line) is displaced.

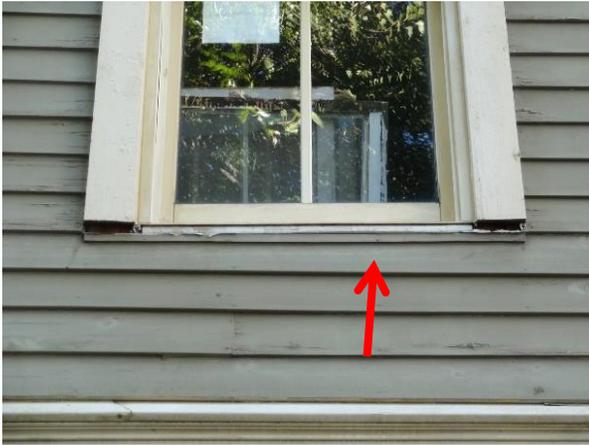
- A window with a missing sill was identified at the first-floor level of the north elevation (Figure 77). The entire length of the sill was missing, and the underlying building wrap was exposed to view.

FIGURE 77. Missing sill at north window.

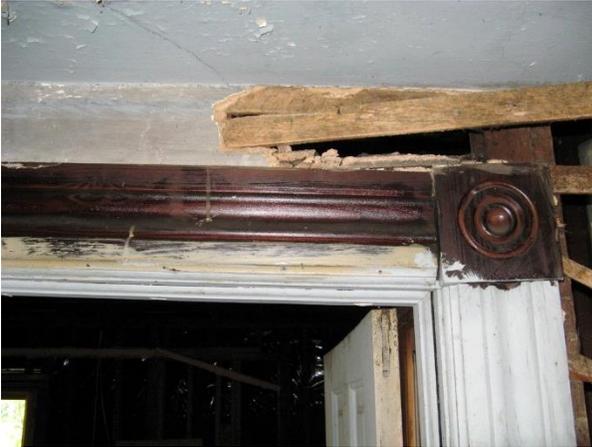
Interior Finishes. Most of the interior finishes remaining in the house are original to the building. Wood trim and millwork appears to have been originally stained and later painted with opaque finishes that are now peeling and in poor condition (Figure 83). Coatings on trim elements vary in age, type, color and sheen from room to room. Isolated portions of plaster remain which may provide evidence of historic paint colors.

FIGURE 83. Original stained finish at door casing and rosette and later white paint finish.

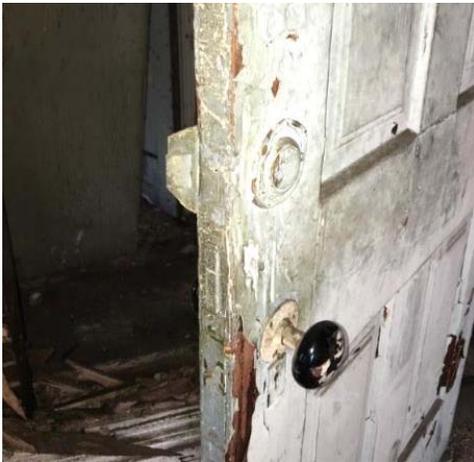
Interior doors are consistently four raised-panel stile and rail doors. Some may be original to the house, and most are in suitable condition for refurbishment. Several doors, particularly those at the second-floor rooms, show significant wear and damage specifically from surface applied hardware.

FIGURE 94. Typical poor condition of the doors and hardware on the second floor.

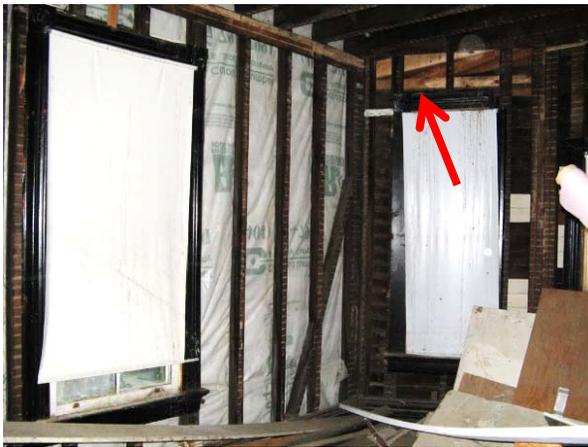
FIGURE 103. Overall view of first-floor living room and the single window to the left in the east wall. Arrow indicates the open stud cavity and the porch attic beyond.

the porch (south) wall, indicating that the siding on the porch wall was probably not completely removed. In addition, the attic space above the porch ceiling is open to the balloon-framed wall cavity of the living room (refer to Figure 103). This condition provides a path for detrimental warm humid air to bypass the recently added air and moisture barrier on the east wall and enter the building.

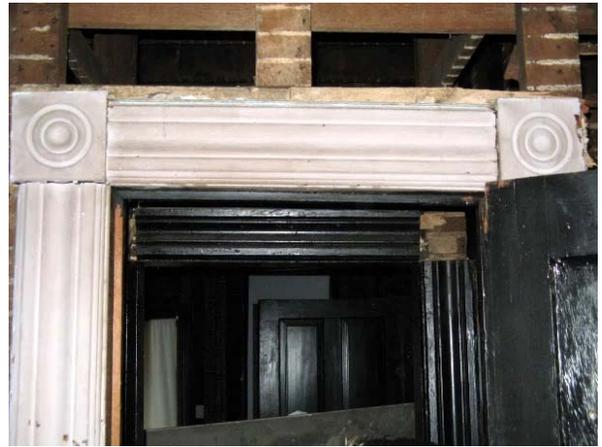
The plaster and wood lath that was on the walls and ceilings was removed completely from the bedroom and the two adjoining closets. Trim elements and doors remain and are consistent with others on the first floor; although, they have several layers of opaque paint over the original dark stained finish (Figure 107). The top coat on all moldings and millwork in the bedroom is a greyish pink. No evidence of a picture rail or crown molding was found in the bedroom.

FIGURE 107. Detail of closet door at first-floor north bedroom.

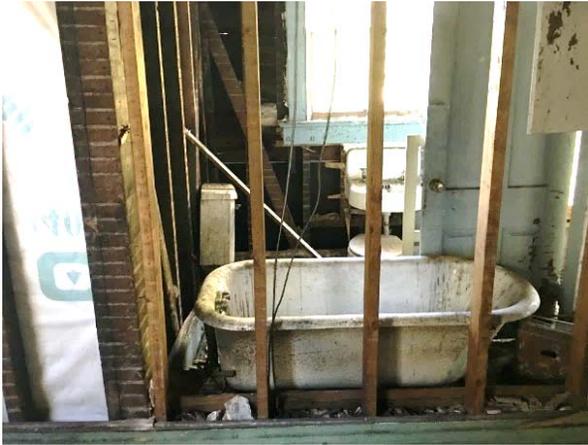
FIGURE 108. View of second-floor bathroom from the west bedroom. First-floor bathroom was likely similar.

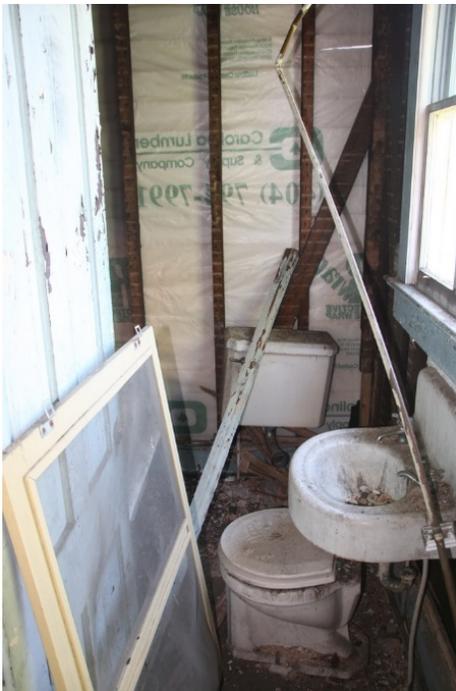
FIGURE 109. View of second-floor bathroom from the hall.

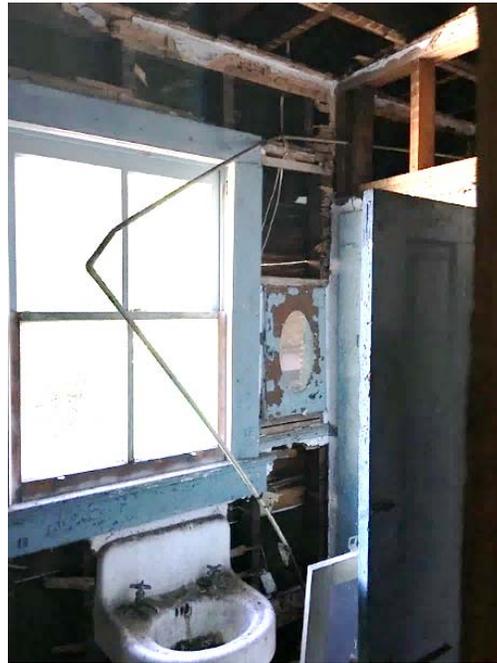
There is a small one-over-one window in the west wall of the first-floor bathroom and a larger two-over-two window in the north wall of the second-floor bathroom (Figure 110). The original window locations and their relationship to the demolished rear stair are not certain. Visual evidence on the exterior suggests that an original window at the first-floor level may have been removed and the opening filled in.

FIGURE 110. Recessed medicine cabinet with mirrored door, lavatory and window in the second-floor bathroom.

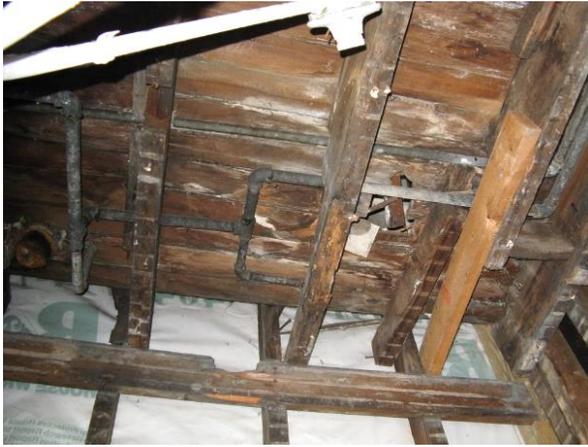
Flooring in the upstairs bathroom is sheet vinyl over tongue-and-groove wood which is rotten beneath the water closet. Floor framing below the bathroom appears to have been repaired during the 1990s stabilization project (Figure 111). The first-floor bathroom was largely inaccessible at the time of the site visit due to stacks of discarded building materials.

FIGURE 111. Underside of rotten floor boards below second-floor bathroom. Note spliced floor joist and abandoned drain piping from bathtub (left) and water closet (right).

- Flooring in the bathrooms is in poor condition and requires replacement.

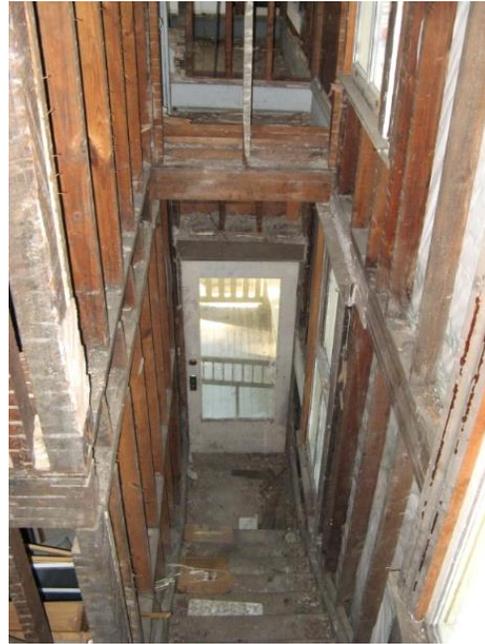
The west exterior wall and infill of the interior walls around the stair are platform-framed with a built-up perimeter beam between the first- and second-floor framing and no rim joist (Figure 112 and Figure 113).

FIGURE 112. Overall view of stair looking south. Extant electrical panel is to the left of the door.

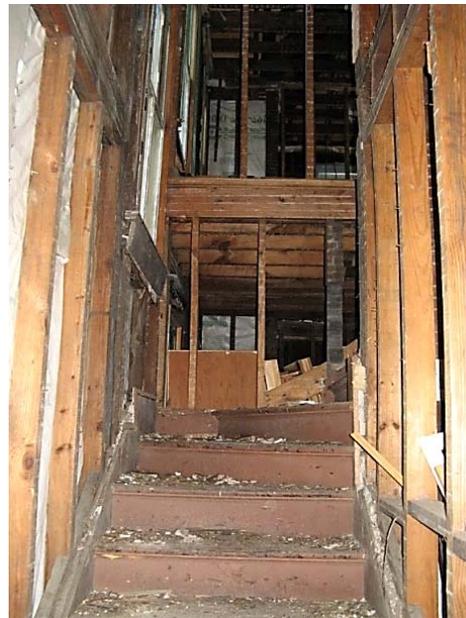
FIGURE 113. Overall view of stair looking north from base of stair.

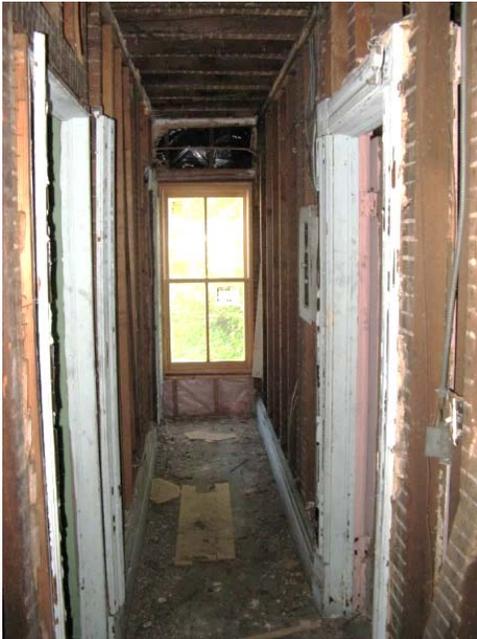
Second Floor – Hall. The second floor of the building was used as a rooming house, possibly as early as the late 1930s. The three rented rooms on the second floor were accessed from the front porch by the new stair described above. By 1949, the second-floor boarders most likely shared a common parlor and bathroom on the west side of the central hall and a kitchen in the north wing (Figure 114). The kitchen, a partially enclosed

FIGURE 114. Overall view at second-floor hall, looking north.

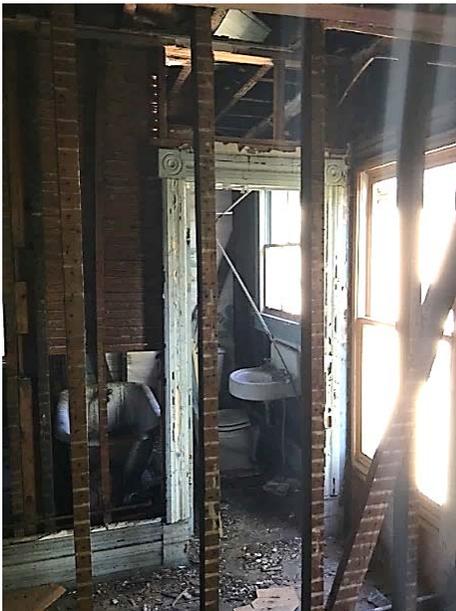
porch and a rear stair in the north were removed during the 1993–1994 stabilization. Similar to the floor below, the door opening from the hall to the north wing was infilled with a two-over-two wood window unit and wood framing.¹³² The interior of this window is unfinished, and there is no trim (Figure 115 and refer to Figure 114).

FIGURE 115. View through north end of the hall to the bathroom door. Contemporary infill window is to the right.

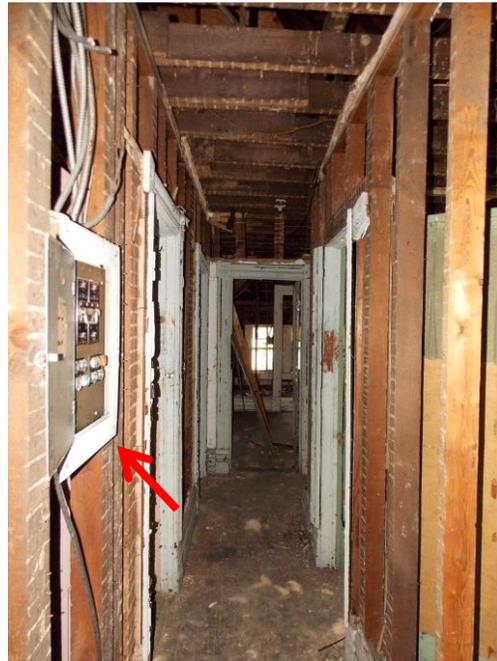
FIGURE 116. Overall view at the second-floor hall, looking south towards the front of the house. Note an electrical panel on the left.

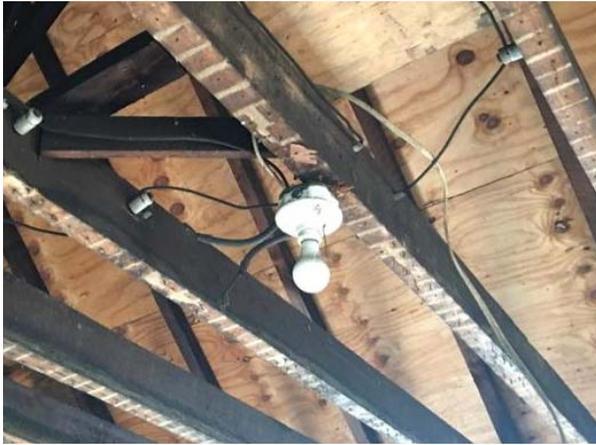
Single bulb, porcelain light fixtures are aligned in the center of the ceiling along the hall (Figure 117). There is flexible, metal electrical cable at these fixtures which indicates that they were installed about the time the front stair, the southwest bedroom, and the extant electrical panel were added (refer to Figure 116).

FIGURE 117. Ceiling-mounted, porcelain light fixture on the second floor.

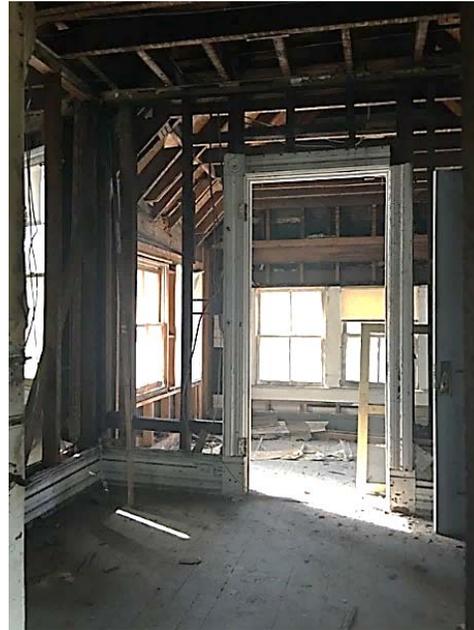
The living room occupies the space directly above the first-floor foyer. It was originally a bedroom (Figure 118). With the expansion of rooms along the original west and south facades, the nearly square living room is now completely internal, with no widows. Only the chimney from a demolished fireplace remains precariously suspended in the attic from ceiling joists just to the north of the stair. It may have originally served this room. No evidence of the original fireplace, hearth or continuation of the chimney below the attic remains (Figure 119).

FIGURE 118. View looking south into the second-floor bedroom beyond from the living room.

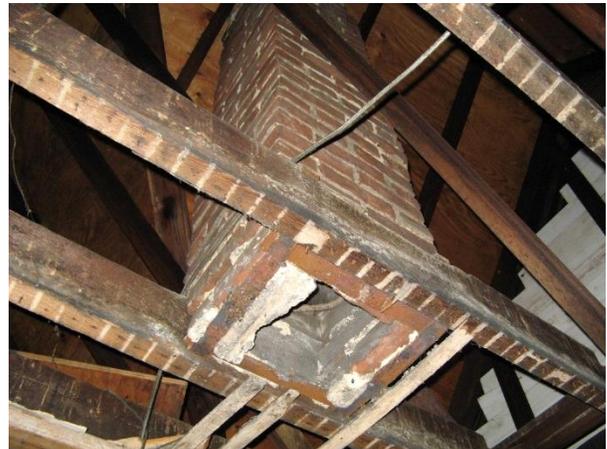
FIGURE 119. Chimney supported only by second-floor ceiling joists and metal straps.

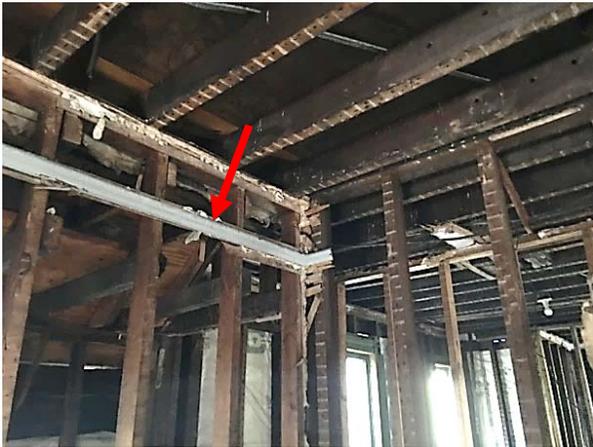
FIGURE 120. Partial picture rail in the second-floor living room.

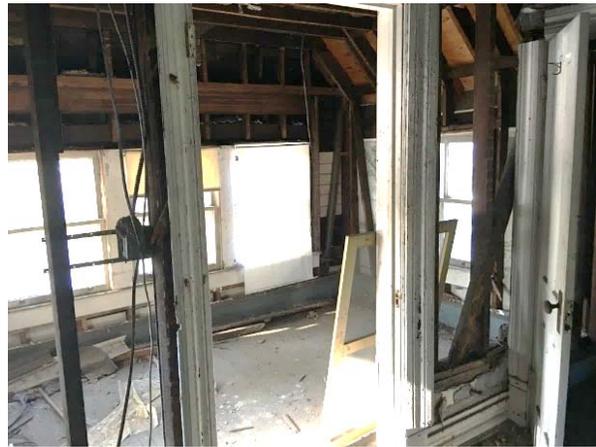
FIGURE 121. View of the southwest bedroom addition from the living room. A door for the closet above the stair is to the right.

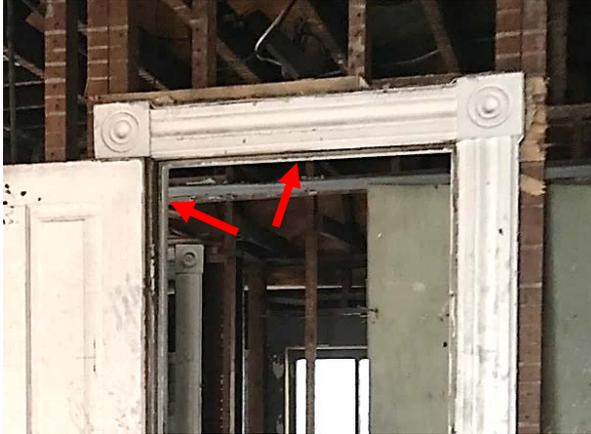
An original door and frame remain in the east wall between the living room and the southeast bedroom which has the octagonal bay. Some existing door hardware suggests that this door was secured during the time when boarders occupied the upper floor. Paint on each side of the door and frame does not appear to continue onto the jamb faces, indicating that the most recent coats were applied with the door closed and probably locked (Figure 123).

FIGURE 123. Original door between second-floor living room and bedroom. Note lack of white paint on the jamb and head faces.

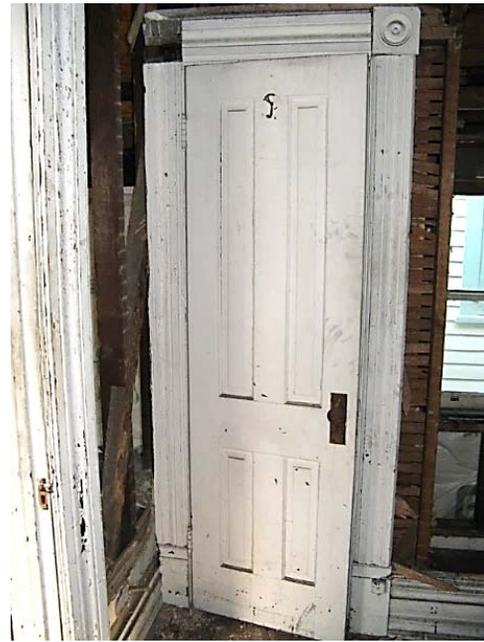
Although the head and jamb casing have the same profile as those at the original doors, the plinth blocks are significantly different at the non-original doors of the southwest bedroom (refer to Figure 118) and closet (Figure 124). The door between the bedroom and the living area was missing leaving only the door frame and trim.

FIGURE 124. Door to the closet built in above the stair at the second-floor living room.

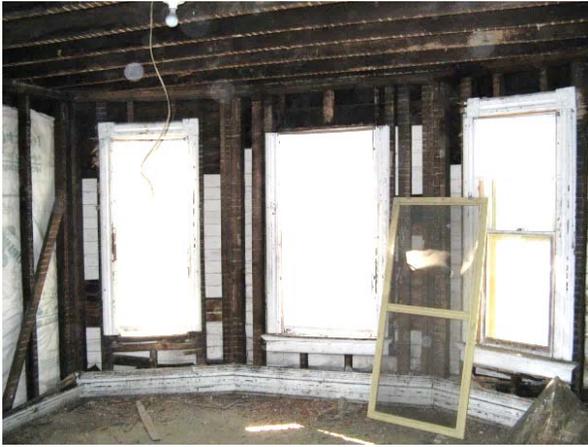
Second Floor – Southeast Bedroom. The southeast bedroom remains in its original configuration. Located directly above the first-floor living room, both rooms have a projected octagonal bay accented on the south facade by the main cross-gable of the roof. Three one-over-one double-hung windows provide views to Auburn Avenue (Figure 125). A fourth, two-over-two, window is located in the east wall. The four windows contain segments of casing trim, stools, aprons, and rosette corner blocks matching other original windows to the home; however, only the window trim on the west side of the octagonal bay is intact. The center window is missing the head casing and corner blocks, and the east window of the octagonal bay and the window in the east wall are missing sills and aprons. Non-original, vinyl roll-up shades cover the south-facing windows (refer to Figure 125).

FIGURE 125. Overall view of octagonal bay in the second-floor southeast bedroom. These windows facing Auburn Avenue have roll-up shades.

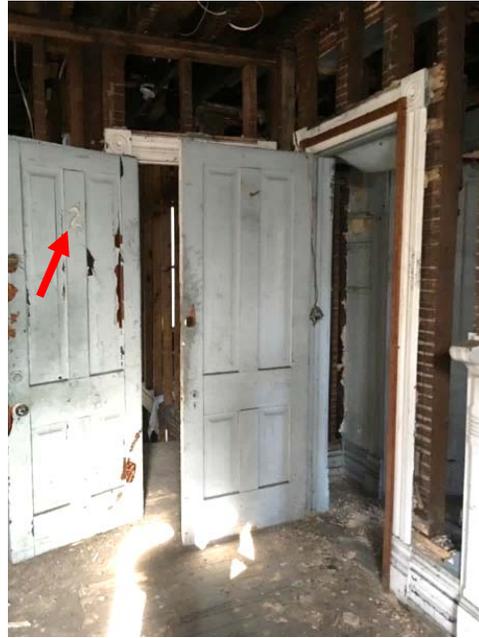
Door knobs and other components of the latch are missing from the south door of the closet, and a hole remains where a mortised deadbolt was also removed. A stained wood strip is attached to the outside face of the closet door trim used to hang a

FIGURE 126. The non-original entrance door (left) and closet door (right) at the northwest corner of the second-floor south bedroom. Note the number “2” on the door’s center stile.

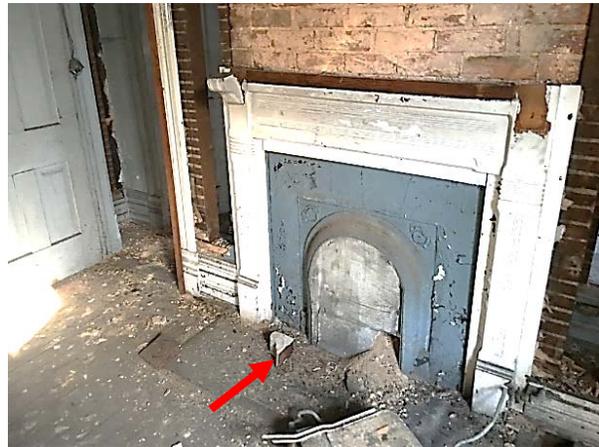
FIGURE 127. Fireplace and surround in the second-floor southeast bedroom. The right-side shelf bracket lies on the hearth.

The decorative wood fireplace surround in the southeast bedroom remains nearly complete (refer to Figure 127). The construction and detailing match the complete unit remaining in the northeast bedroom. The mantel shelf is missing, and one shelf bracket lies on the hearth below. The cast-iron register and plastered firebox surround have been painted a blue-grey. The register is missing its front grille and the firebox has been infilled with unpainted portland cement plaster on brick infill. A gas-fired space heater is located on the portland cement plaster hearth. The

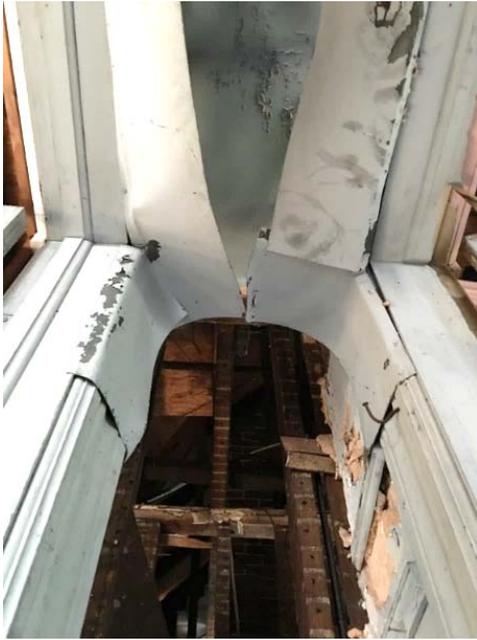
FIGURE 128. Painted sheet-metal soffit inside the west closet between the southeast and northeast bedrooms.

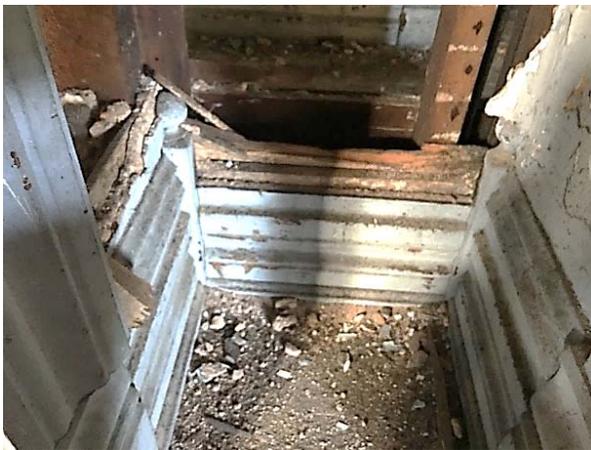
Much like the first-floor room below, closets flank the fireplace which is in the center of the north wall (Figure 127). The west closet has back-to-back doors allowing communicating access, through the closet, to the northeast bedroom. The plaster ceiling and a portion of the wall remain near the top of the closet. Inside the closet there is an unusual sub-ceiling consisting of a pair of sheet-metal arches that form a concave soffit above the two doors (Figure 128). The purpose of this metal soffit is not known, and it does not occur in the other closet or anywhere else in the house. Original door casings and baseboards in the closet are painted light blue (Figure 129).

FIGURE 129. Detail of baseboard with corner block and finial inside the west closet.

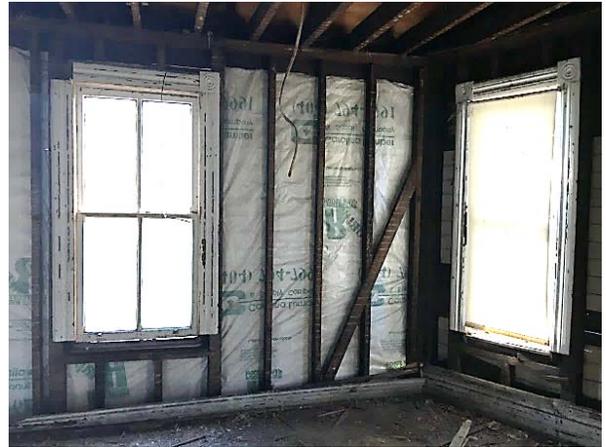
It appears that lap siding on the east exterior wall was completely removed and replaced by new exterior siding over an air and moisture barrier. There is no wall sheathing behind the air and moisture barrier. Wood lap siding is attached directly to the vertical framing members. The siding on the south octagonal bay appears to have been partially replaced without an air and moisture barrier (Figure 130).

FIGURE 130. View of the east windows in the second-floor southeast bedroom.

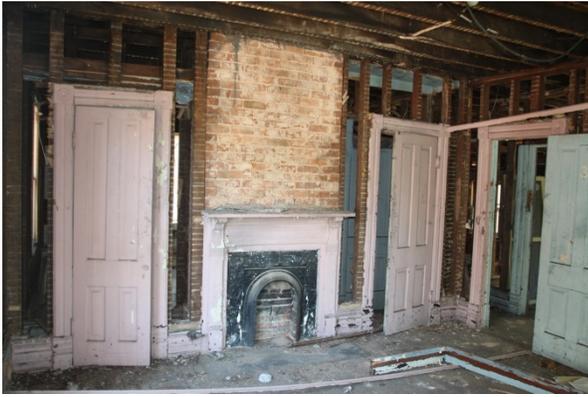
FIGURE 131. View of the south wall in the northeast bedroom.

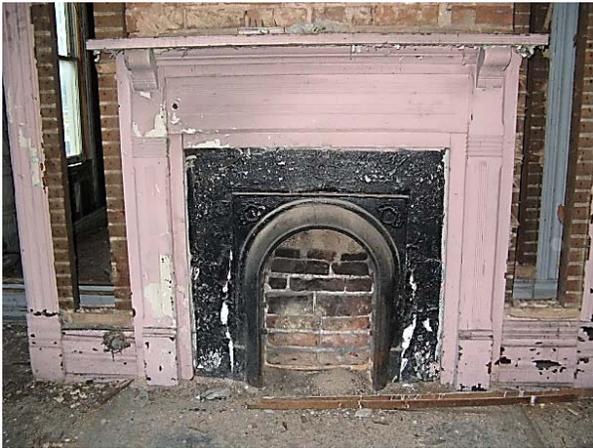
The wood mantel in this bedroom is intact and matches the one in the southeast bedroom on the opposite side of the fireplace (Figure 131 and Figure 132). A coal register, without a front grille, is set in a painted plaster surround. The black paint on the plaster is heavily blistered and flaking. The firebox is filled in with unfinished common brick. The mantelpiece is complete and in good condition even though the original dark-stained and varnished wood is now covered with peeling pink paint. The single mantel shelf has a grooved perimeter edge, and it is supported by a single shelf bracket at each end. The entablature and pilasters have a similar five-groove face pattern.

FIGURE 132. Intact fireplace in northeast bedroom on the second floor.

- Wooden mantelpieces should be retained, repaired and refinished. They are significant, character-defining features (refer to Figure 132).
- Glazed encaustic tile surrounding the firebox in the northeast bedroom on the first floor appears to be in sound condition and suitable for restoration (Figure 143). It should be used as a reference for restoring tile surrounds at the other remaining fireplaces.

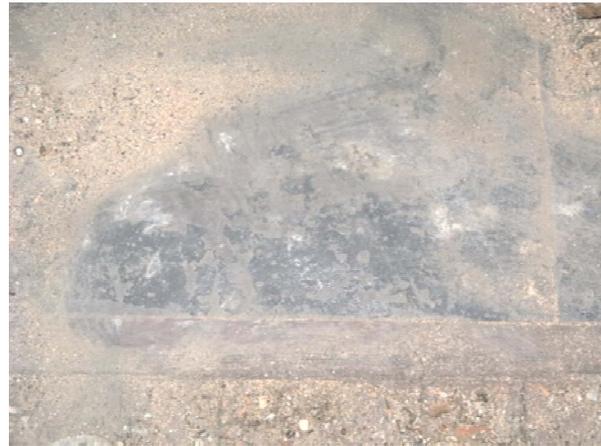
The hearth also appears to be intact. Despite being heavily soiled, it is likely a good representation of the typical original hearth in the home (Figure 133). Portland cement plaster applied over brick surrounds the firebox and the cast-iron register. A gas valve was installed through the

FIGURE 133. Surface of the portland cement plaster hearth in the northeast bedroom.

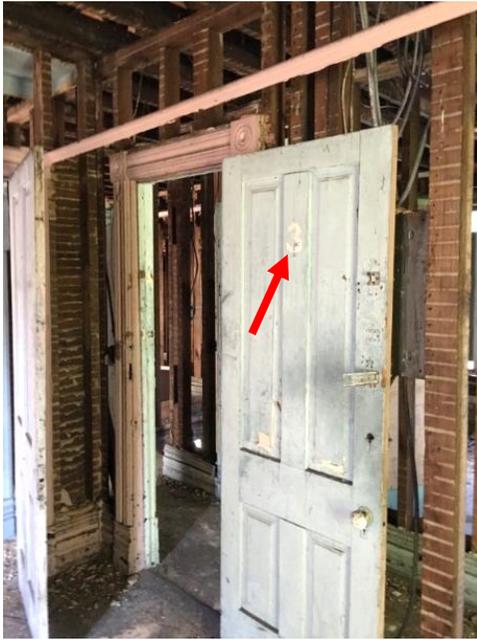
The door from the hall into this bedroom appears to be in its original location. On the hall side, it is labeled with the number “3” (Figure 134). Oddly, it appears that it was secured with a surface-mounted deadbolt on the interior side as well as with a padlock and hasp on the hall side.

FIGURE 134. Door from second-floor hall to northeast bedroom. Note the number “3” on the door’s center stile.

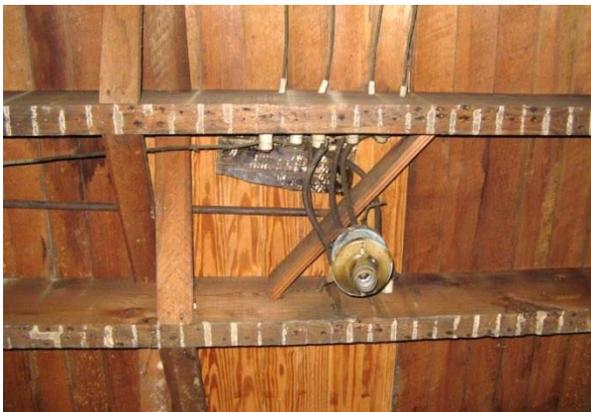
Similar to the other bedrooms, a single-bulb, porcelain light fixture is located in the center of the ceiling where knob and tube wiring is present (Figure 135).

FIGURE 135. Common ceiling-mounted, single-bulb porcelain light fixture and knob and tube wiring.

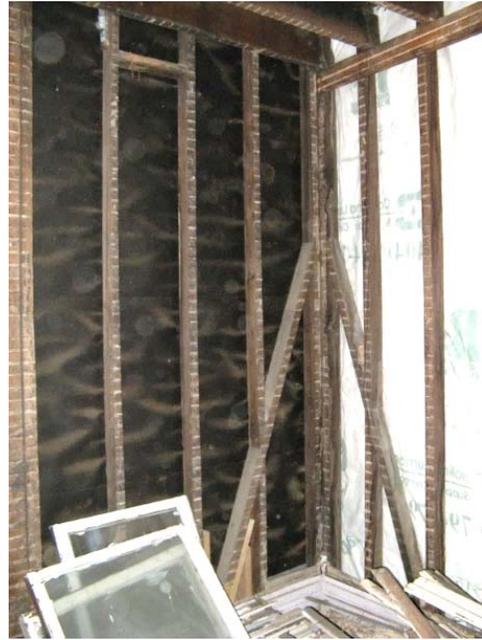
New siding was installed on the exterior of the north wall over common, black plastic sheeting that presumably serves as an air and moisture barrier. Behind the wood lap siding, different materials were apparently applied to the exterior walls as air and moisture barriers, and seams and gaps in these materials were not properly sealed (Figure 136).

FIGURE 136. Northeast corner of second floor, air and moisture barriers change from white building wrap on the east elevation to black plastic sheeting on the north elevation.

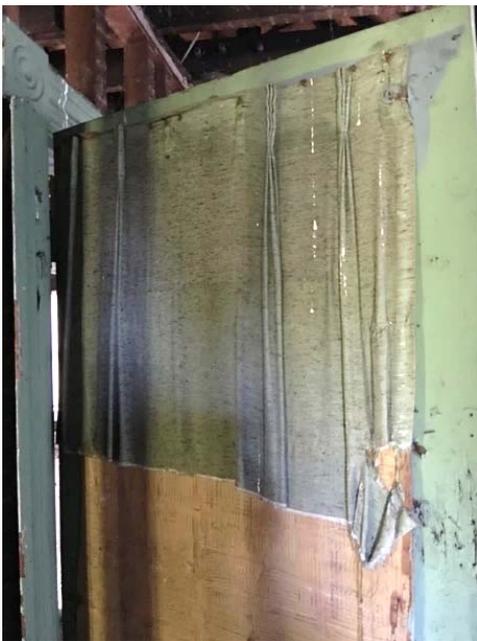
FIGURE 138. Fabric drapery and plywood covering west parlor door lights.

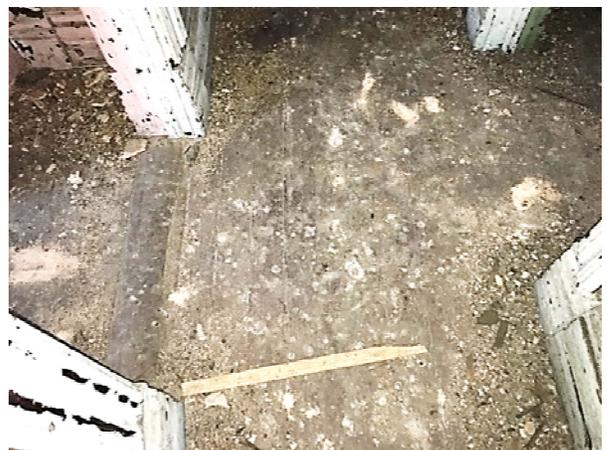
FIGURE 141. Typical condition of wood flooring.

placement of building materials and miscellaneous furnishings throughout the house. Hardwood floors will first require appropriate cleaning to document original stains and finishes and then careful refinishing (Figure 141).

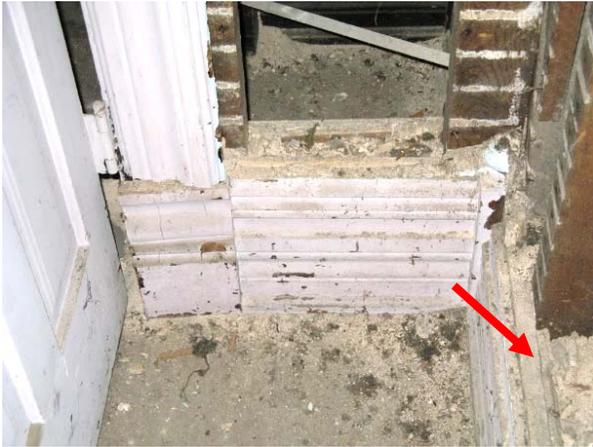
FIGURE 142. Typical baseboard condition and inside corner block with finial. The arrow indicates original plaster remaining behind the baseboard.

- Baseboards are in fair condition throughout the house, but they are suitable for repair and refinishing. Some pieces are missing and will require replacement in kind. In most places, the plaster and lathe have only been removed to the top of the baseboard cap, but baseboards may have to be carefully removed and reinstalled after the new wall finish is applied. (Figure 142). Existing baseboards and inside corner blocks should be salvaged for reuse.

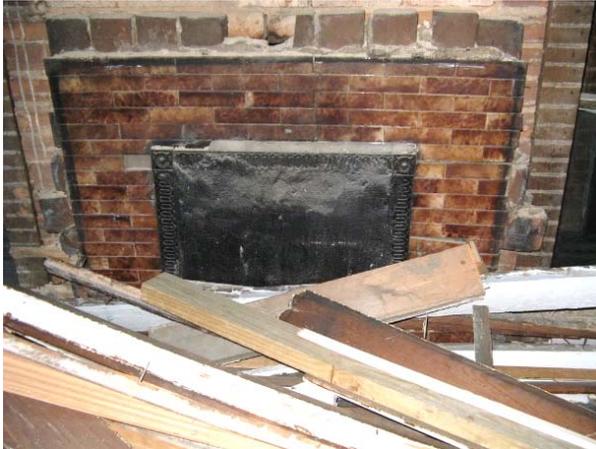
FIGURE 143. Glazed encaustic tile surround at first-floor northeast bedroom.

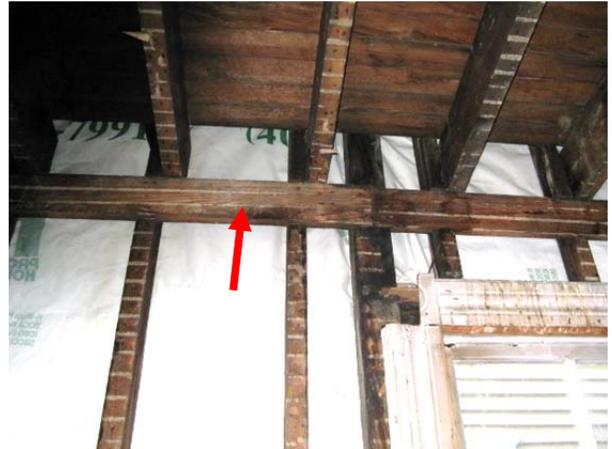
- The balloon frame construction of the exterior walls consists of a 2x4 ribbon joists supporting the floor joists (Figure 146). (Structural concerns are included in the following structural assessment section). However, there is no blocking to provide fire stops at the wall cavity between the floors. The ceiling space between the joists will be exposed to the wall cavity where the floor joists frame into the exterior walls. A similar condition occurs where the porch framing is exposed to the wall cavity (refer to Figure 102). Consideration should be given to installing a mechanical system designed to avoid negative interior pressure that will draw moisture from the exterior wall cavity into the ceiling cavity where the dew point temperature of surfaces will result in condensation and moisture damage to sensitive interior finishes. This has occurred in the Birth Home.

FIGURE 146. Balloon framing at the second floor. This condition consists of a ribbon joist nailed to the face of the wall studs that supports the floor joists above.

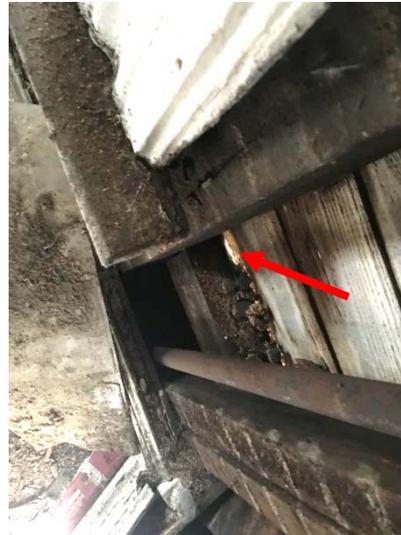
- The siding in some places appears to be separated or split (Figure 147). Moisture entering the wall cavity at these locations could cause an increase in humidity in the wall cavity where the air and moisture barrier is not continuous or has gaps as described above. Moisture entering the wall could collect in the wall cavity and cause framing members, window and door frames, or other building components to deteriorate.

FIGURE 147. Typical framing condition at second-floor level (looking down into the wall cavity). Here, a gas pipe rises in the wall cavity, and daylight gap can be seen at joints and at splits in the exterior siding.

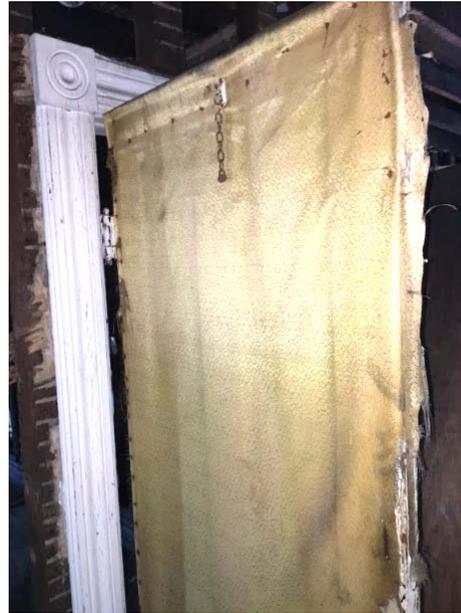
FIGURE 152. Fabric drapery covering door lights.

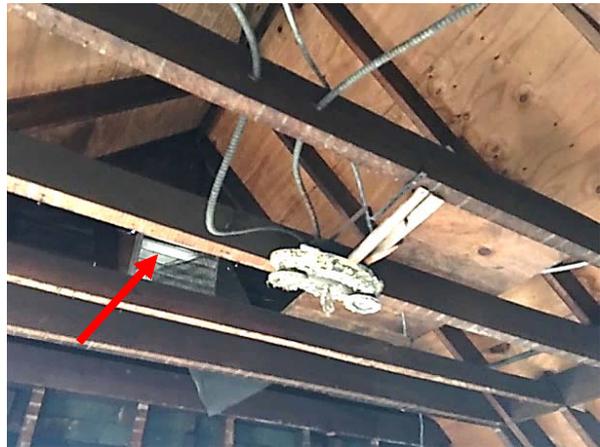
FIGURE 154. Insect and rodent screen dislodged at interior of gable vent.

- Insect and rodent screens have been dislodged on the interior of some attic louvers (Figure 154). The screens should be replaced or reinstalled.
- There is currently only one means of egress from each floor, and the first floor is elevated nearly the height of a full story above grade at the rear (Figure 155). There is no interior communicating stair between the floors. A stair at the rear (north) of the home will likely be required to provide egress from the first- and second-floor levels to grade when the house is rehabilitated and occupied.

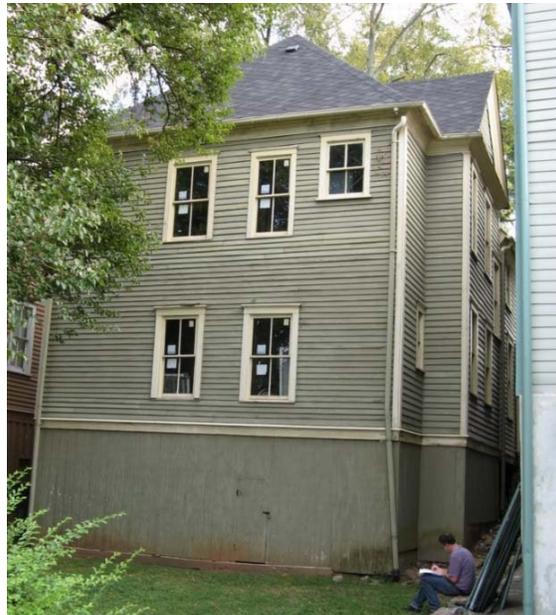
FIGURE 155. New windows in north wall at the previous location of doors to kitchen and rear stair in the demolished north wing.

- Currently, door openings on the north elevation have been infilled with windows (refer to Figure 155). If the building is to be rehabilitated for residential use, consideration is needed as to how best to include a kitchen while meeting the interpretive goals for the house and the park.

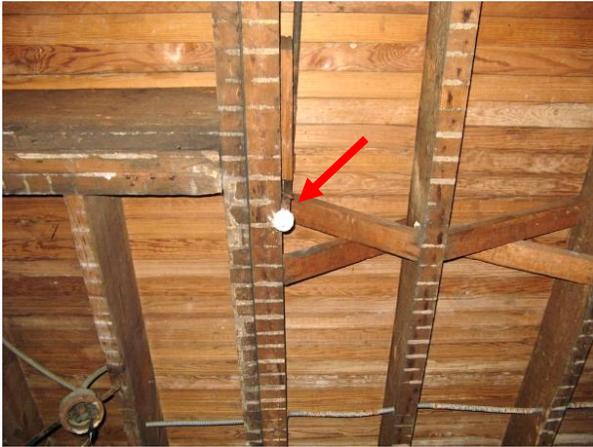
FIGURE 158. Gas fitting for pendant fixture in the current west room on the first floor. Note location of later electrical junction box with flexible metallic conduit in the lower left. The locations reflect the shift of the center of the ceiling before and after the original stair was removed.
