518 Auburn Avenue, NE Historic Structure Report

518 Auburn Avenue, NE
Martin Luther King, Jr. National Historical Park
Atlanta, Georgia

Historic Structure Report

August 2019

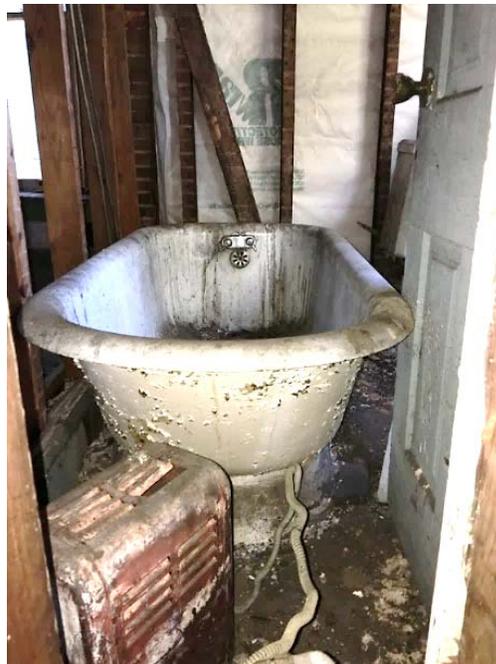
FIGURE 169. Gas space heater and bathtub in the second-floor bathroom.

- There is no central HVAC system in the house. The present gas systems do not comply with current codes and must be replaced.
- The house does not have power, and the electrical systems in the building are old and non-functional. New service from the grid on Auburn Avenue and a complete new electrical system is necessary to meet current codes.
