535 Auburn Avenue, NE Historic Structure Report

535 Auburn Avenue, NE
Martin Luther King, Jr. National Historical Park
Atlanta, Georgia

Historic Structure Report

August 2019

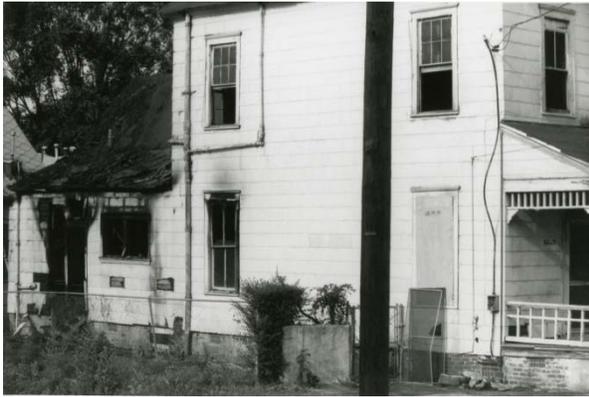
In 1992, the house underwent exterior stabilization. The following year, in 1993, during a rehabilitation project, a kitchen in the rear wing caught fire, which almost destroyed the kitchen wing and caused serious damage to the main house and the roof. The NPS began work almost immediately to continue the rehabilitation. The house interior underwent rehabilitation again in 2003.

FIGURE 10. 535 Auburn Avenue showing fire damage, circa 1993. (Source: MALU, Series 8 Image Collection, circa 1940s-2006 - 535 Auburn Ave Restoration Harper House, undated Box 2, Folder 4068)

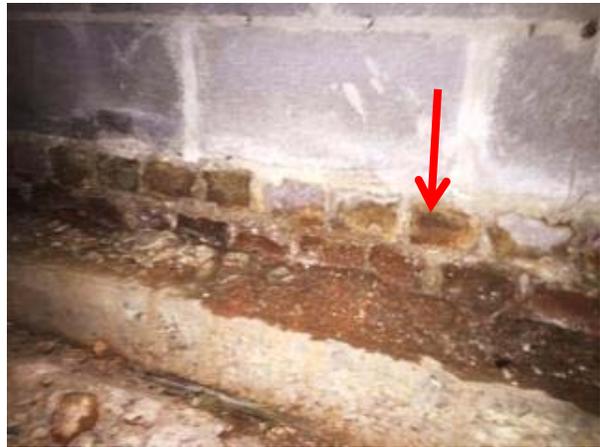
It appears that the original foundation was constructed of brick; however, the foundation has undergone extensive repairs and is now mostly non-original CMU. The continuous foundation wall consists of a base of original brick masonry, set at or below grade, upon which are four courses of open-cell CMU (Figure 21 and Figure 22). At

FIGURE 21. Continuous brick foundation wall at perimeter of building.

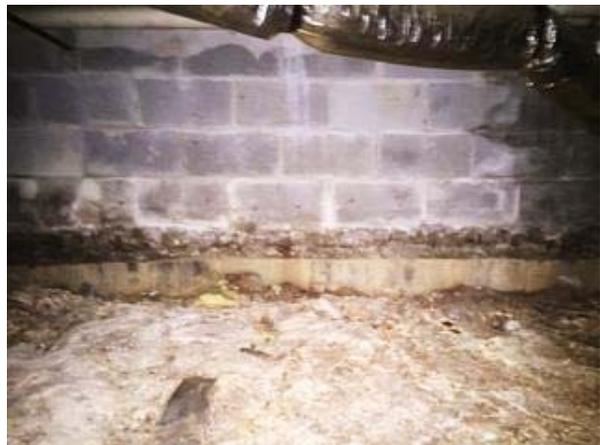
FIGURE 22. Four courses of CMU constructed on top of brick foundation wall.

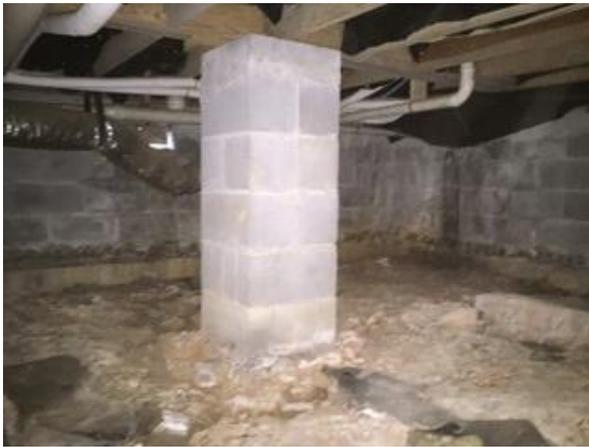
FIGURE 24. Non-original CMU foundation piers.

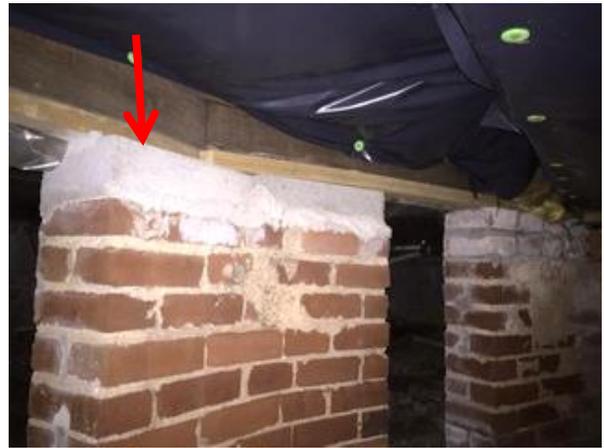
Masonry foundation piers, spaced 8 to 10 feet apart, support the floor beam and chimneys. The piers include original 8-inch-by-16-inch brick piers as well as non-original 16-inch-square piers (Figure 24 and Figure 25). Some of the original brick piers have been partially repaired with CMU or non-original brick (Figure 26).

FIGURE 26. CMU repairs at original brick foundation piers.

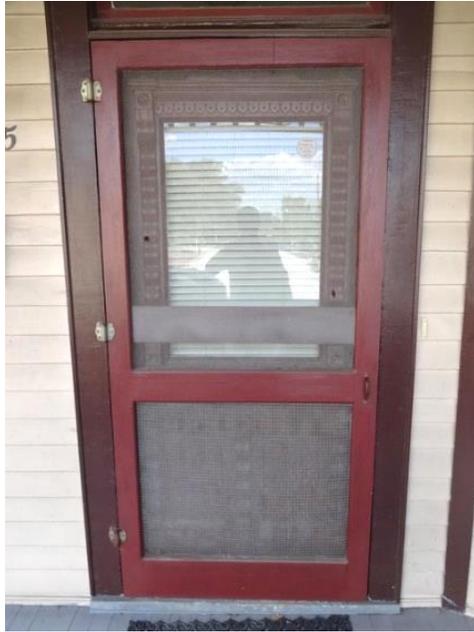
The screen doors at both door openings are non-original (Figure 39). The doors have an intermediate rail that divides the door into an upper and lower half and has mesh screening. Doors are mounted to the exterior face of the wood trim with spring-loaded self-closing hinges and have a metal handle. The door frame and handle are painted brown.

FIGURE 39. Non-original screen door at the front entrance.

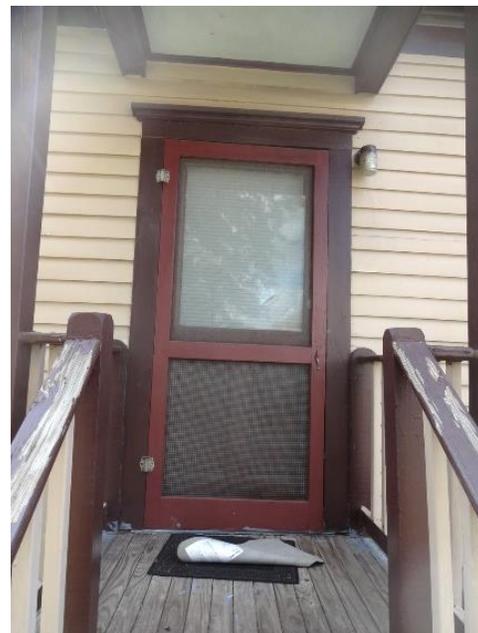
The rear door is non-original to the structure and is accessed from the rear stoop. In addition to the trim and screen door, the entrance has a half-glazed two-panel wood door, painted dark brown (Figure 42). The wood panels are beveled and located at the bottom half of the door. The upper half of the door consists of a single-light clear glass window. A venetian blind is mounted to the interior face of the door. Adjacent to the door is a wall-mounted light fixture with twist-on glass shade.

FIGURE 42. Non-original rear door.

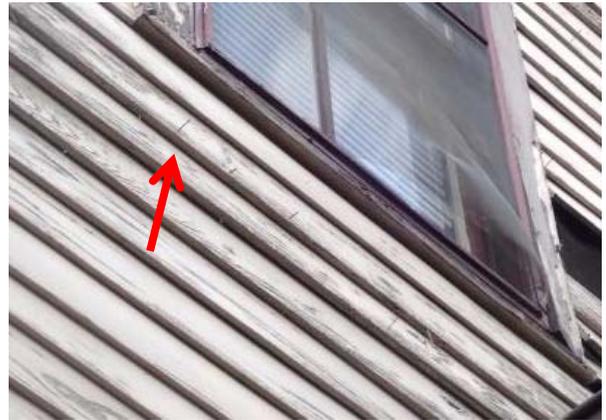
FIGURE 72. "Walking out" of nails at horizontal siding

- The walking out of nails was observed at the wood siding and applied wood ornament (Figure 72). At a few locations, nails were observed to be walking out and were no longer sunk into the wood nor providing an attachment to the underlying structure. At some locations, the nail head was projecting 1-1/2 inches from the face of the wall.
- Bowing was observed at approximately three of the balustrade bottom rails. The bowing consisted of a 1/2-inch sag at the center of the wood member.
- Divots and checks were observed at the face of the posts (Figure 73). The distress consisted of 1/2-inch deep irregular divots in the wood. At some locations, the divots had been painted over. The divots were typically located at the lower portion of the post and aligned with the balustrade.

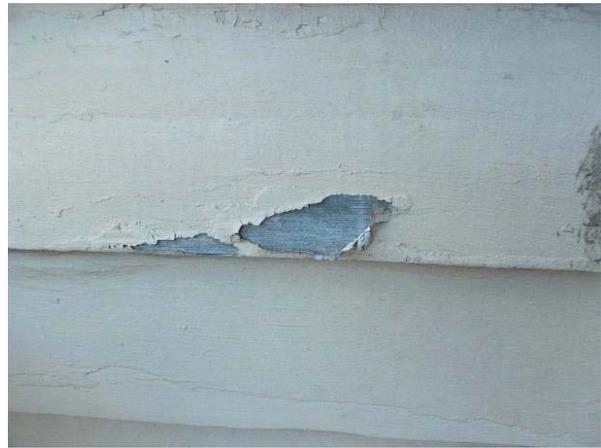
- Cracking, debonding, and peeling paint was observed at wood siding, trim, porch, and decorative elements (Figure 74 and Figure 75). For the siding, the distress was most pronounced at the main two-story portion of the building, specifically at the upper level of the south elevation and at the end gable on the north elevation. Peeling paint was also noted at various components of the front porch and at windows. The paint failure may be related to poor surface preparation.

FIGURE 74. Peeling paint at wood siding.

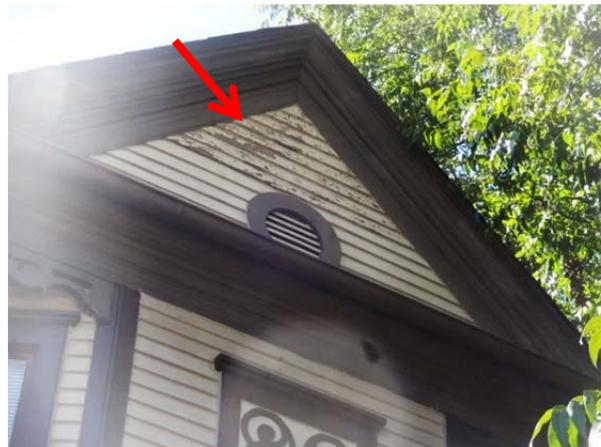
FIGURE 75. Peeling paint at end gable horizontal siding.

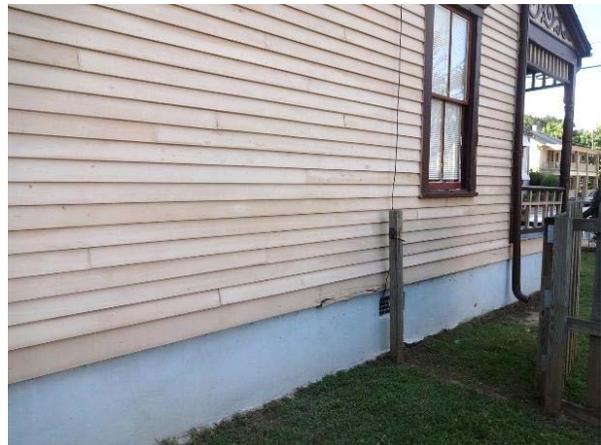
- Bleaching and discoloration of the paint coating was observed at multiple locations (Figure 76). The distress was typically located at knot holes in the wood siding or at areas where the wood was observed to be more tightly grained. In general, wood where this condition was observed appeared to be non-original replacement boards.

FIGURE 76. Bleaching and discoloration of paint at horizontal siding.

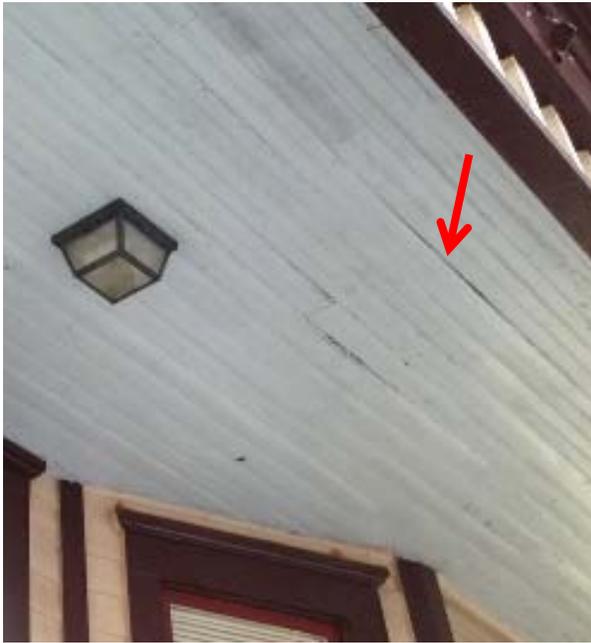
- Open joints were observed between some of the ceiling boards (Figure 77). Where present, the joints were typically 1/8-inch wide and the paint coating was cracked.

FIGURE 77. Opening joints between ceiling boards.

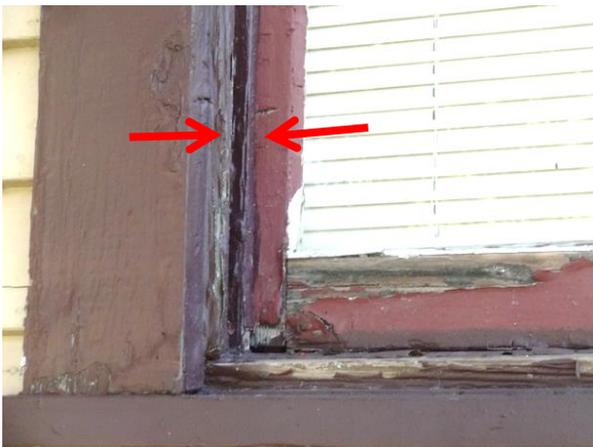
- Gaps were observed between the window sash and the frame (Figure 80). A cold air draft could be felt at the gaps in the window system. The gaps indicate that the sash or the frame are not plumb.

FIGURE 80. Gap between the window sash and frame.

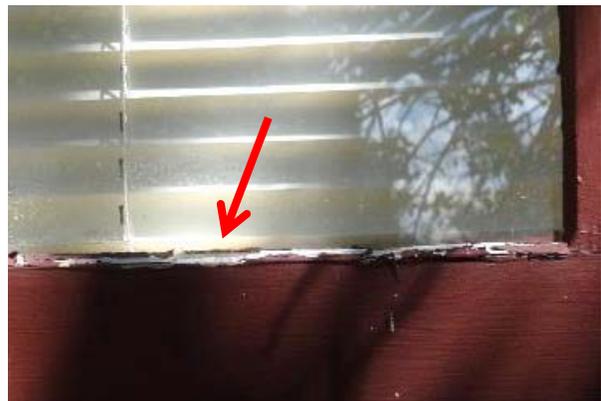
- Missing or deteriorated glazing putty was observed at many of the windows (Figure 83). At many locations, the glazing putty had been painted. Where the paint was loose or had been removed, the putty was observed to be cracked, deteriorated, or completely missing. Typically, the area of distress was a few inches long. Where missing, the edge of the window glazing was exposed to view.

FIGURE 83. Deteriorated glazing putty at window.

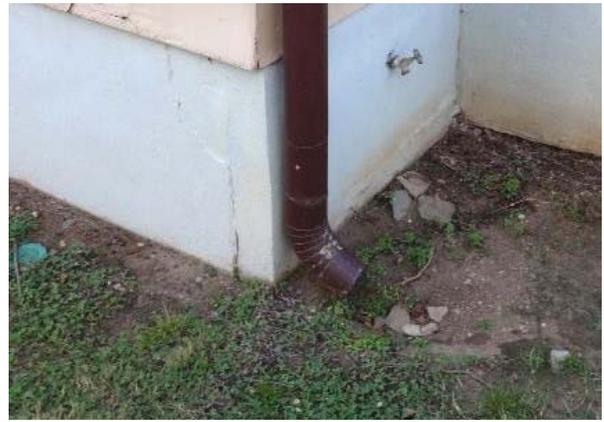
- In general, the roof is in good condition. Distress conditions were associated with gutters and downspouts.
- A disconnected downspout was observed at one location on the southeast corner of the building (Figure 85). The two straps and anchorage keeping the downspout vertical and tied to the wood trim were both removed. The downspout extended at an angle from the building.
- Depressions were observed at the soil below many of the downspouts (Figure 86). The depressions were approximately three inches deep. There were no splash pads present.

FIGURE 86. Depression in the soil adjacent to the building at the downspout.

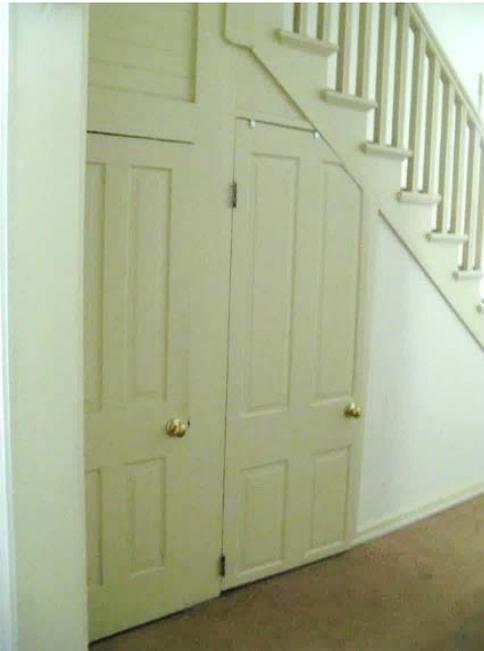
unequal height, four-panel doors conceals storage space beneath the ascending stair (Figure 103). These two doors are not original and are poorly modified, standard height doors made to fit under the slope of the stair stringer.

FIGURE 103. Non-original doors at storage closet beneath central stair.

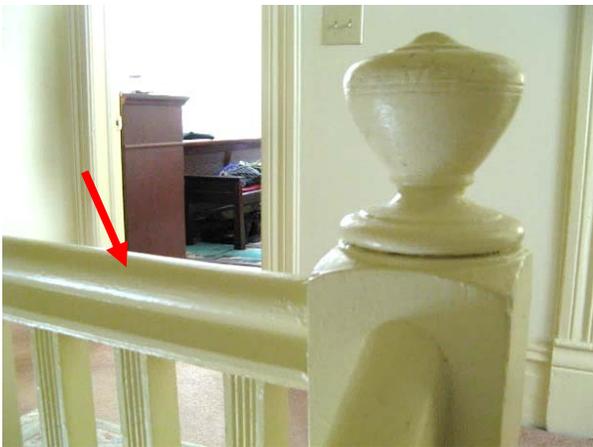
The handrail has two fluted balusters at each tread that are 1-3/4 inches square and match balusters found at the front porch. The top rail appears to be a traditional milled piece that was probably readily available from local millwork shops or lumber yards. The top portion is a smooth oval shape which flattens near the bottom where it transitions to a rectangular cross section with vertical edges that are milled with a convex curve. The lower portion of the handrail is the same width as the balusters that support it. This stair rail is consistent as it rises to the newel post at the second floor, where the top rail changes to a very different shape as it continues along the edge of the upstairs hall and terminates at the north wall of the bathroom. On the hall side, the top rail has a plain, flat face that is rounded at the top edge (Figure 105), while the face on the opposite side is milled with a compound curve (Figure 106). Only the mantelpiece in the living room has the same compound curve profile.

FIGURE 106. Odd handrail at second floor hall.

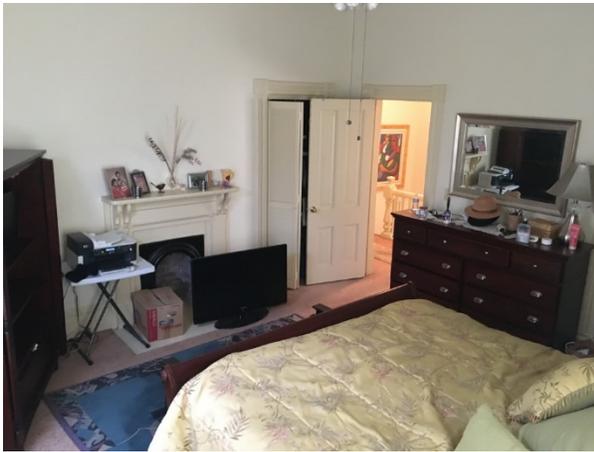
FIGURE 109. Southwest bedroom on the second floor.

A second bedroom is in the southwest quadrant of the upper floor (Figure 109). The door from the hall in the east wall was labeled as existing on the 1992 drawings and may be original.¹²⁵ On the north wall is a shallow, coal-burning fireplace that backs up to the one in the front bedroom. It has a cast-iron register missing its arched-top front grille. The brick firebox is surrounded by a painted wood mantelpiece with details similar to the mantelpiece in the other bedroom (Figure 110 and Figure 111). The hearth appears to be Portland cement plaster painted to match the color of the mantelpiece; however, fireplaces in both upstairs bedrooms are not functional. The west and south walls in this room each have a two-over-two double-hung window, both of which are in fair condition. An air draft could be felt, and light comes through gaps in the window system. The

gaps indicate that the sash or the frame is not plumb and proper weather stripping is lacking. On the exterior, these windows are exhibiting deterioration that is contributing to the lack of weathertightness.

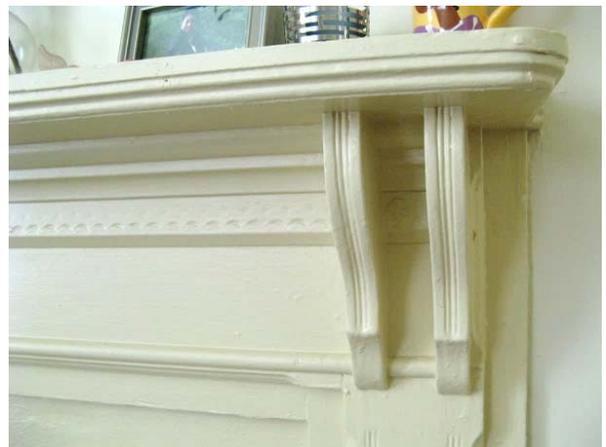
FIGURE 111. Detail of fireplace in the southwest bedroom, second floor.

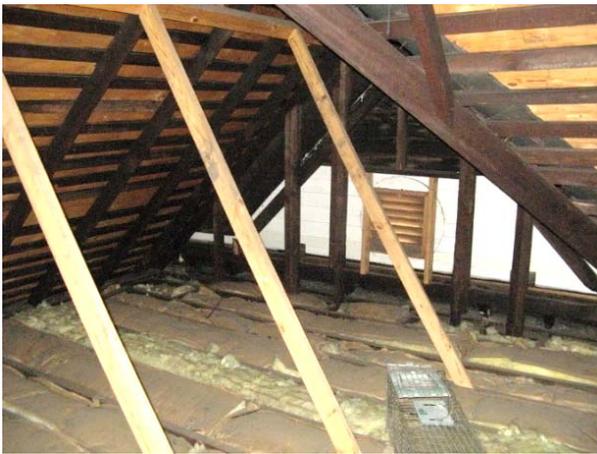
The attic of the two-story portion of the house can be accessed by a pull-down folding ladder in the ceiling of the second-floor hall. The roof is stick framed, and the dark patina of original structural members make them distinguishable from the newer, more recent wood braces and plywood roof deck added when the roof was replaced with asphalt shingles in 1993 (Figure 117). Roof replacement included installing 1/2-inch thick plywood continuously over the original wood strapping. Wooden shingles, which are no longer extant, were fastened to these nailing strips that are clearly visible in the attic running over and perpendicular to the roof rafters. A brick chimney extends through the attic and penetrates the roof on the west side. Mortar in the chimney has deteriorated and some joints in the masonry appear to have very little if any remaining mortar (Figure 118). Insulation is provided by fiberglass batts placed between ceiling joists; however, some of the batts have been disturbed resulting in a loss of effective insulation.

FIGURE 117. Attic in two-story portion of 535 Auburn Avenue.

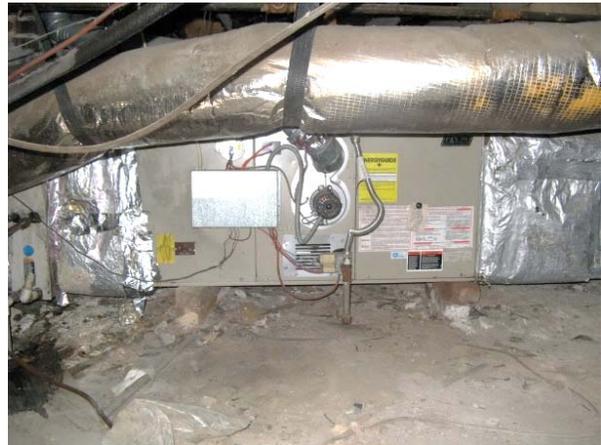
Mechanical and Electrical Systems. The house is heated and cooled by two split systems. One is in the crawl space under the house. The other one is in the attic, and it serves the upper floor. A gas-fired furnace and fan unit was installed in the attic with insulated ducts running from the unit through the attic to ceiling registers. A return air grille for the second floor is in the ceiling of the stair hall. Heating and air conditioning for the first floor is supplied by a gas-fired furnace and fan unit located in the crawl space. It is supported on bricks barely a few inches above the soil (Figure 119), and a small electric

FIGURE 119. Horizontal flow Dx-type HVAC unit in the crawl space.

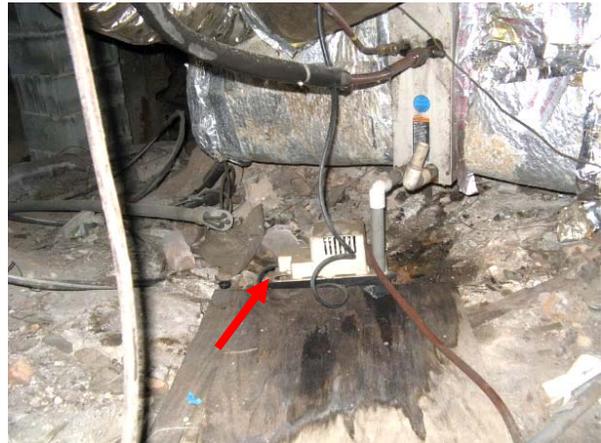
pump removes condensate from the crawl space (Figure 120). Insulated ducts carry heated or cooled air to floor registers, and the return air register is in the floor of the main hall adjacent to the stair. Condensing units for both split systems are located at grade on the west side of the house just south of the access door to the crawl space.

FIGURE 120. Condensate sump pump adjacent to HVAC unit in crawl space.

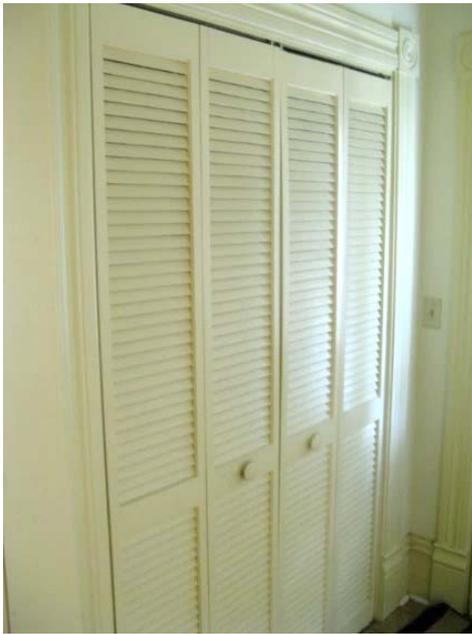
- Several existing interior doors were replaced during the rehabilitation project in the early 1990s, particularly those in the single-story rear addition that was damaged by fire. Architectural drawings indicate that the current exterior door and screen door at the east porch, the bathroom door, and bedroom door were new in 1993. They are replicas of the four-panel, stile-and-rail doors they replaced. On the second floor, doors to the bathroom and office are also four-panel, stile-and-rail replacements. Closet doors and the laundry room door are wood, stile-and-rail louvered doors and louvered bi-fold doors installed in 1993 (Figure 124). These newer doors are in reasonably good condition requiring only fresh paint.

FIGURE 124. Non-original louvered bi-fold doors at closet in rear hall.

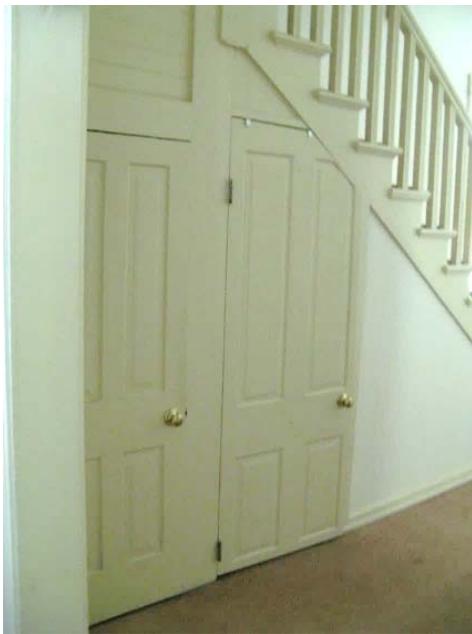
- The two doors at the storage closet in the main hall beneath the stair date from the early 1990s. Both four-panel doors were oddly modified to fit the trapezoidal shapes of the openings under the slope of the stair stringer (Figure 125). Both doors appear to be functional.

FIGURE 125. Standard-height, non-original four-panel doors poorly cut to fit below main stair.

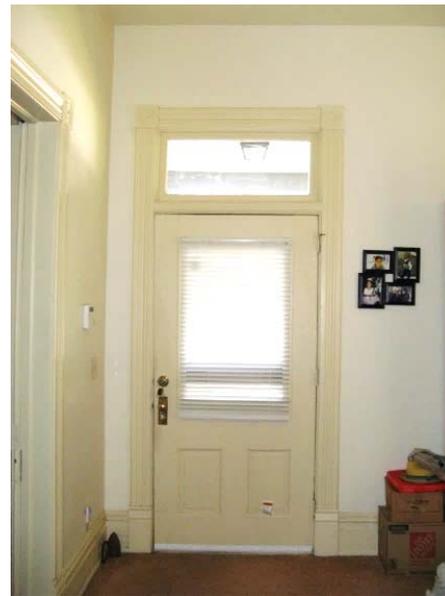
- The front door is unique and appears to be an original defining feature. The interior face of this stile-and-rail door has two raised panels below a single clear glass light (Figure 126). It is painted an off-white color that matches the color of other interior doors and trim. The round brass doorknob and escutcheon with keyhole are tarnished but operational. They may be original, but the deadbolt lock above it is a more recent addition. On the interior, the doorknob is not original. This unique Victorian door is in good condition.

FIGURE 126. Interior side of front door.

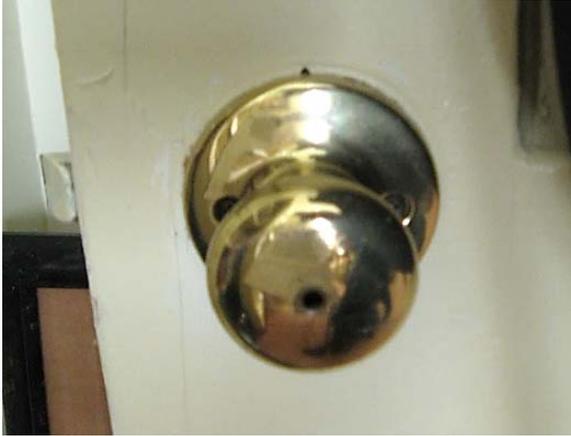
- Generally, door hardware (locksets, latch sets, deadbolts, and doorknobs) is in functional condition. Only the lockset on the front entry door has components that appear to be original as noted in the paragraph above. Other hardware in the house is contemporary and is largely polished brass (Figure 127). There are a few different, modern styles of doorknobs, which probably indicate that not all of the hardware was replaced or repaired at the same time (Figure 128).
- Painted cased openings and door trim (Figure 129 and Figure 130) are consistent throughout the house. Painted window trim is also the same throughout (Figure 131). Beside the effects of wear and tear and multiple coats of paint applied over time the trim is generally in

FIGURE 127. Polished brass interior doorknob.

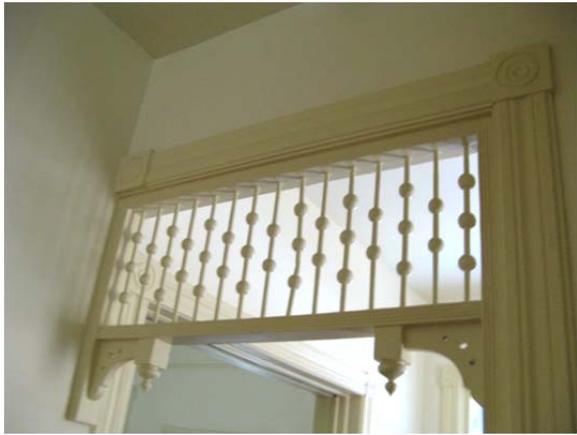
- Another character-defining feature associated with the Queen Anne Style is the spindlework in the transom of the cased opening in the foyer (Figure 132). This rectangular grille, supported on each end by brackets, has fifteen thin vertical spindles with alternating knob-like beads. It appears to be an original architectural element, and it is in very good condition.

FIGURE 132. Queen Anne Style spindlework transom grille.

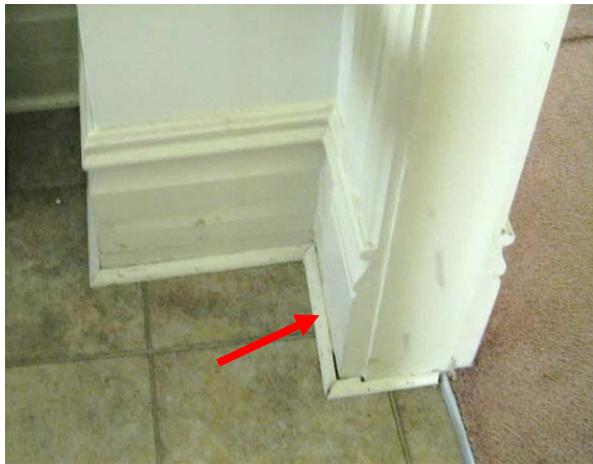
- Baseboards are consistent throughout the house and most are original. The original base shoe was likely removed in the kitchen and rear hall and replaced with common quarter round molding when sheet-vinyl flooring was installed (Figure 133). Not surprisingly, baseboards have several layers of paint and extensive scarring, scratches and abrasions that have accumulated over time (Figure 134).

FIGURE 133. Common quarter round molding as base shoe.

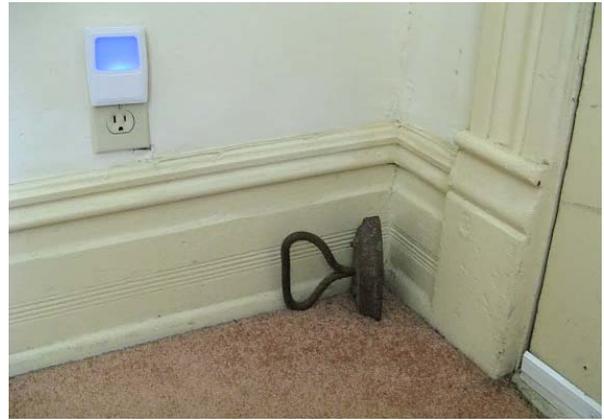
FIGURE 134. Typical condition of baseboards.

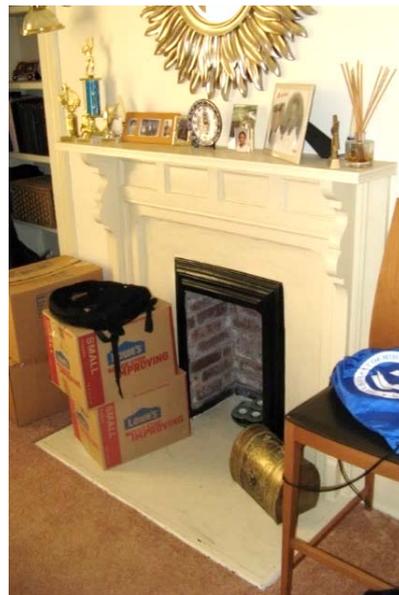
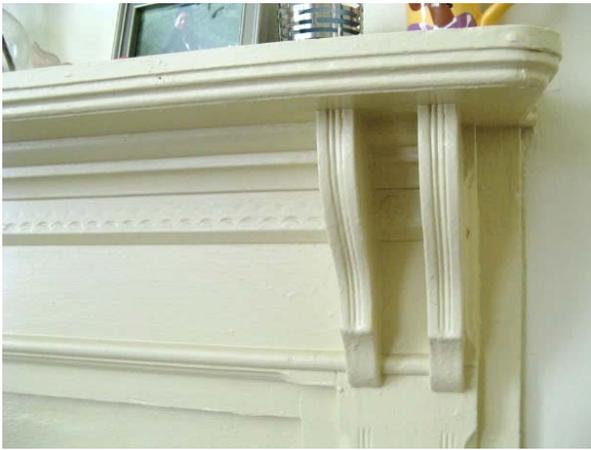
- The four fireplaces (no longer functional) and their mantelpieces are significant original features, and each one is slightly different. Mantelpieces are relatively simple designs with a mantelshelf supported by a single bracket or a pair of brackets on each end (Figure 135 and Figure 136) except for the mantelpiece in the living room. At this location, the mantelshelf is supported by 7-inch-wide fluted side pieces flanking the firebox and an identical 7-inch horizontal spandrel below the shelf (Figure 137). The living room mantelpiece is the only one with an overmantel. The other three mantelpieces are differentiated by design and the application of decorative moldings and ornamental details. Mantelpieces and fireplaces are in very good condition.

FIGURE 135. Dining room fireplace.

FIGURE 136. Mantelpiece detail at southwest bedroom, second floor.

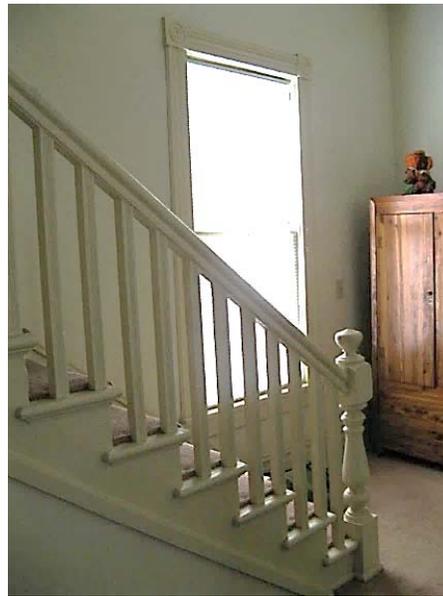
cross section with vertical edges that are milled with a convex curve. The stair rail begins with a turned newel post at the first riser, ascends to a square newel at the turn and then to another matching turned newel post at the second-floor landing. From that point, the railing continues along the upstairs hall ending at a wall at the south end. All the components of the stair are painted the same off-white color as other interior woodwork (Figure 138). No major repairs are needed currently.

FIGURE 138. Central stair.

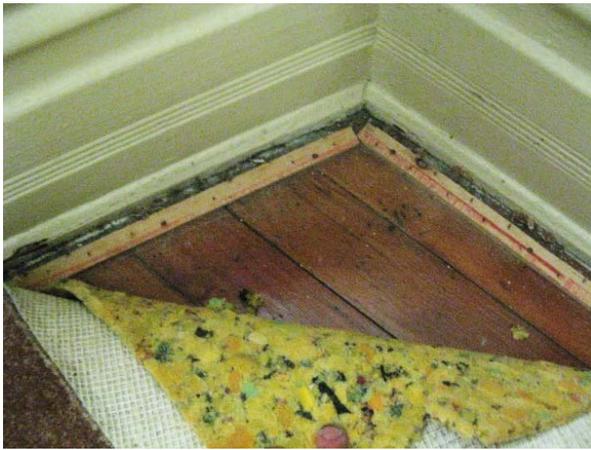
- Floors in most first- and second-floor rooms have wall-to-wall carpet except for the kitchen (sheet vinyl), bathrooms (ceramic tile), and the laundry (sheet vinyl). Generally, the carpet is soiled and worn from normal use. There is original hardwood flooring beneath the carpet that could be refinished (Figure 139). However, it was not possible to discern the full extent of hardwood flooring or its overall condition.
- Sheet-vinyl floor covering in the kitchen and laundry are in serviceable condition currently.
- Ceramic tile floors and tile base in bathrooms were installed in the early 1990s. Only minor staining of grout joints was observed.

FIGURE 139. Original hardwood flooring beneath wall-to-wall carpet.

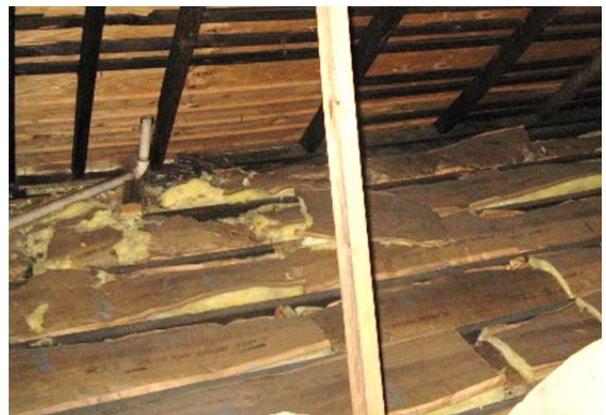
The second-floor ceiling is constructed of 2x6 joists spaced 16 inches on center. The joist pockets are filled with batt insulation (Figure 141).

FIGURE 141. Overview of second-floor ceiling framing showing 2x6 ceiling joists with batt insulation at joist pocket.

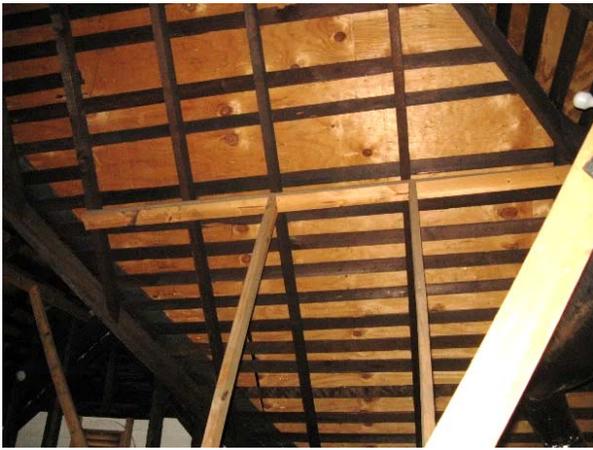
The roof at the main two-story portion of the house is constructed of actual 2x4 rafters spaced 30 inches on center with a 1x6 ridge beams. On top of the framing is 1x4 tongue-and-groove nailers, spaced approximately 8 inches apart and overlaid with 3/4-inch plywood (Figure 142). It appears that approximately half of the tongue-and-groove sheathing boards were removed when the plywood sheathing was installed. In addition to the plywood sheathing, other non-original supplemental bracing includes 2x4 diagonal cross bracing, spaced 32 inches on center. The diagonal bracing extends from the ceiling joints to a non-original wood plate, consisting of doubled 2x4s, that spans across the midpoint of the rafters (Figure 143). There is no cross bracing at the end gable.

FIGURE 142. Ceiling framing including 2x4 rafters and 1x4 sheathing overlaid with plywood.

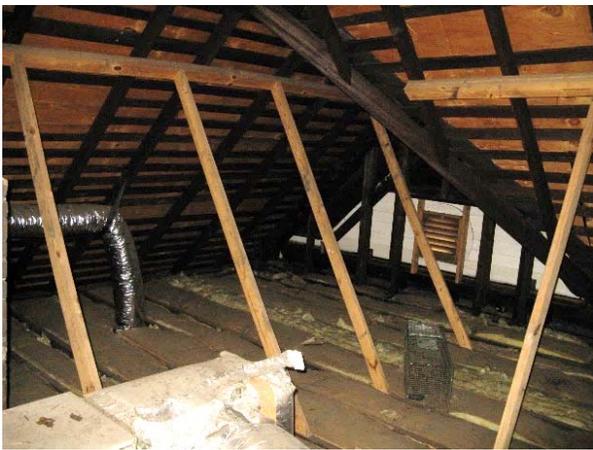
FIGURE 143. Diagonal 2x4 bracing extending from ceiling joists to roof rafters.

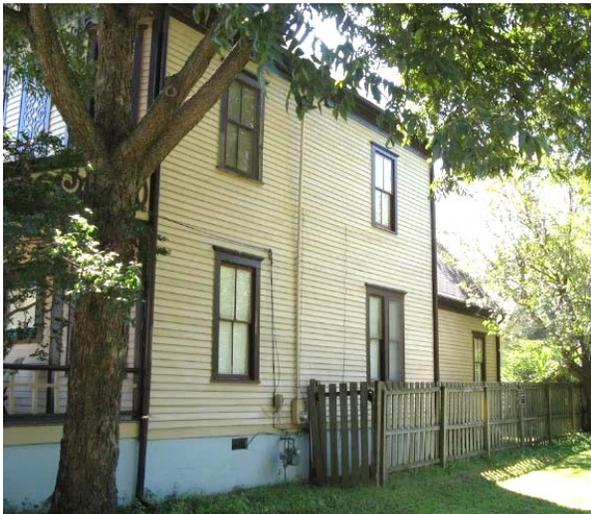
Electrical. Single-phase electrical service comes from a power pole on Auburn Avenue to a weather head and meter base on the west side of the house (Figure 145). A 200-amp electrical panel is positioned in the east wall of the rear hall just south of the laundry room door. According to the architectural drawings, a new weather head, meter base, entrance cable and main electrical panel were newly installed as part of the 1993 rehabilitation project. These drawings also indicate locations for new interior and exterior light fixtures, a doorbell, telephone jacks, smoke detectors, and various electrical devices such as receptacles and switches. It is not known if all new wiring and electrical devices were installed in 1993 or if the drawings also indicated some locations of existing electrical fixtures and devices. The electrical service and main panel are approximately twenty-four years old, and it is likely that wiring, most electrical fixtures and devices are the same age. If so, then the electrical system may not be in compliance with current building codes.

FIGURE 145. Electric power, gas, and telecommunications connections on the west side of 535 Auburn Avenue.

Wiring for telecommunication and internet services enters the house through a weather resistant junction box adjacent to the electrical meter on the west wall of the house.

The house has natural gas service. A gas meter is set near the foundation wall adjacent to the electric meter and the telecommunications service box on the west side of the house (refer to Figure 145). Gas is delivered through black steel pipes in the crawl space and wall cavities to two gas-fired heaters, a water heater, a stove, and a clothes dryer.

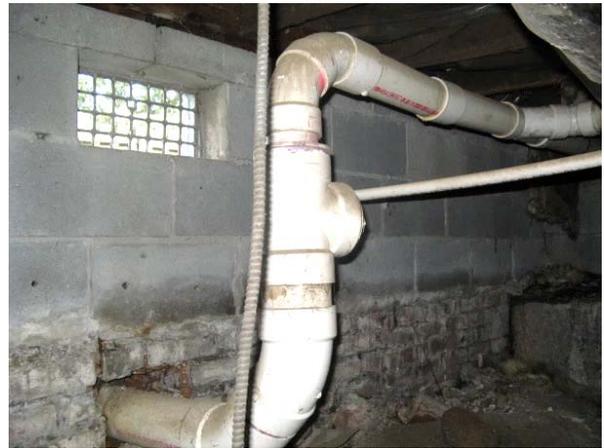
so it was not possible to see if the lines are copper or PVC. Sanitary waste lines are PVC (Figure 146). In the crawl space under the house the main sanitary waste line is connected to the kitchen waste line and to waste lines from both bathrooms and the laundry. It is assumed that the main line exits from the crawl space through the east side of the foundation, turns north and ties into the public sewer line in Auburn Avenue.

FIGURE 146. Main PVC sanitary waste line exiting the crawl space.
