Three Double-Shotgun Houses 493ABC Auburn Avenue

Martin Luther King, Jr. National Historic Site

Historic Structures Report

May 2017

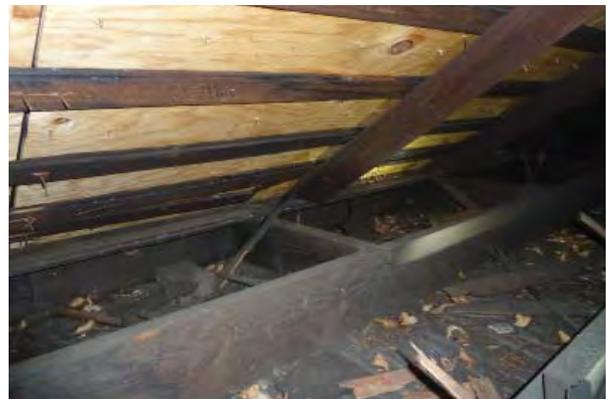
Figure B14. Wood shingles from original roof remain scattered on the attic floor, and nailers above are sized and spaced for wood shingles. Photographed 2016.

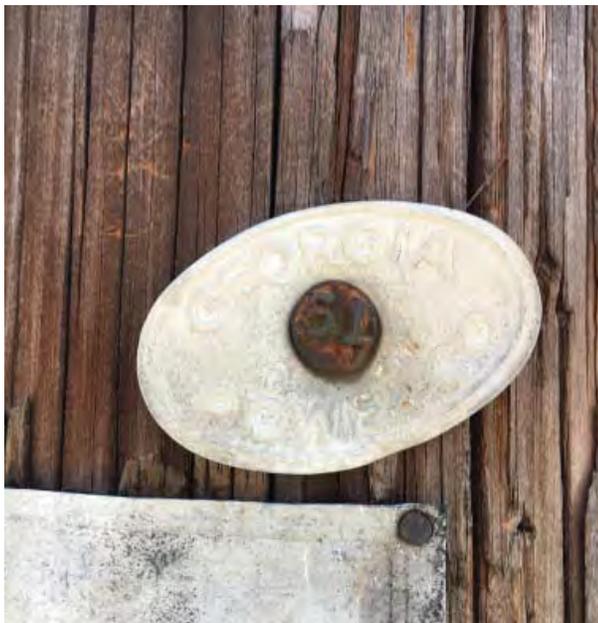
Figure B15. Identification tag and 1951 date nail on northernmost of the two poles installed in the alley under an electrical easement of the same date. Photographed 2016.

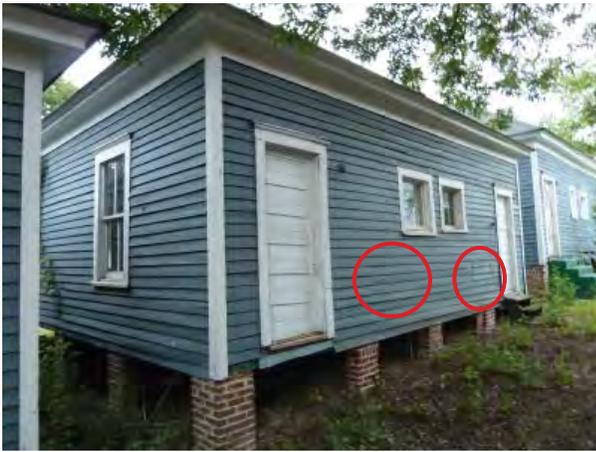
and a smaller window installed, closer to the adjoining unit, to light the bathroom. While most changes are similar in all units, the “new” rear windows appear salvaged, of different sizes and design even when next to each other in the same building (*Figs. B20-B21*).

Figure B20. Original windows nearer the doors were removed for installation of a bathroom window for each unit. The new windows appear to be salvaged and do not match. Seams in the siding show the original rear window location, circled in red.

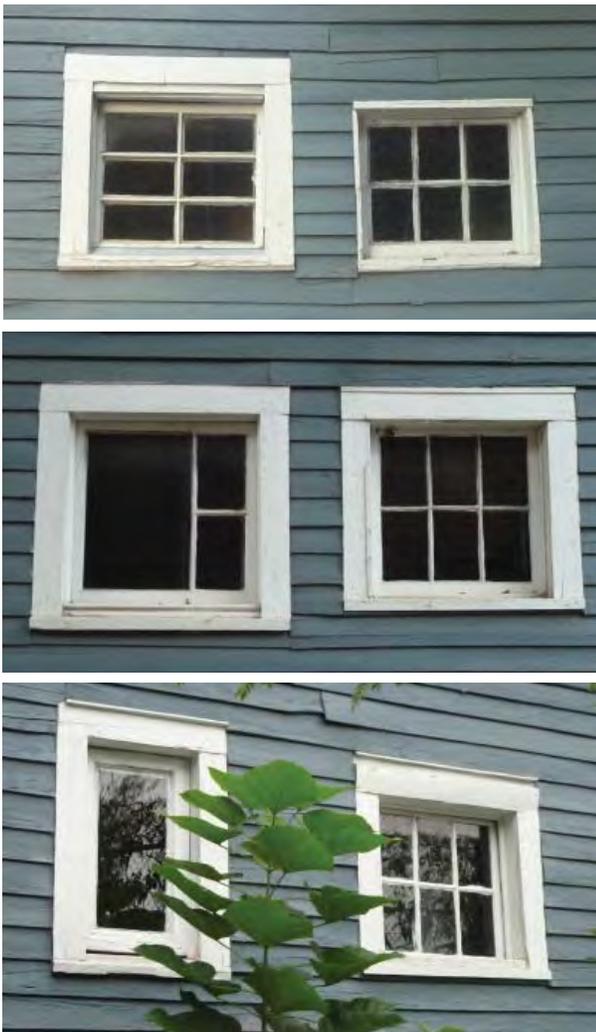
Figure B21. Unmatched single sash salvaged from the double-hung sash of other buildings. Above are the pairs from Buildings A (top), B (middle), and C (bottom).

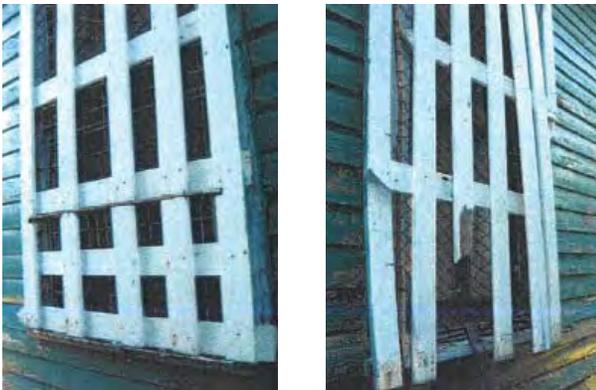
Figure B28. Metal grills and wood lattice for tenant security remained on Building B when photographed in 2008. (Condition Assessment Report, p. 56)

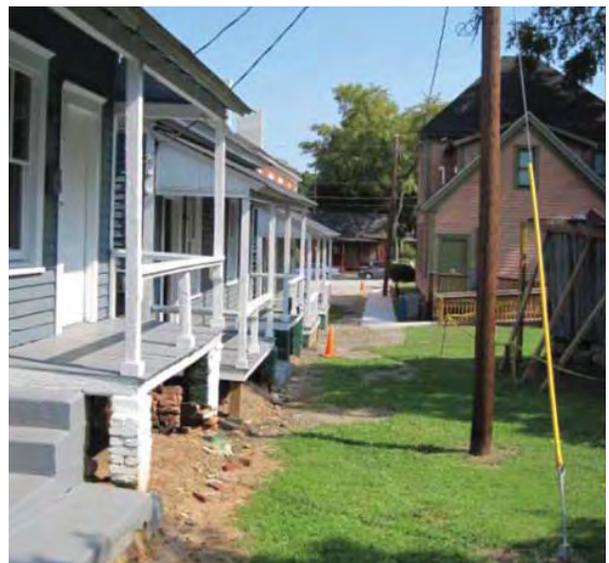
The CAR shows that by 2008, although the shotguns showed little change from 1995, the surrounding landscape had been significantly altered and many features previously identified as significant were now absent. For example, trees that shaded the houses were gone. All gates and fencing had been removed from front, side, and rear, as well as the clotheslines in the back yards and the garden between Building A and the apartment house, all of which reflected the activities and needs of the residents during the buildings' time of use (*Figs. B37-B38*).

Figure B38. Same view in 2010 long after landscape features had been removed.

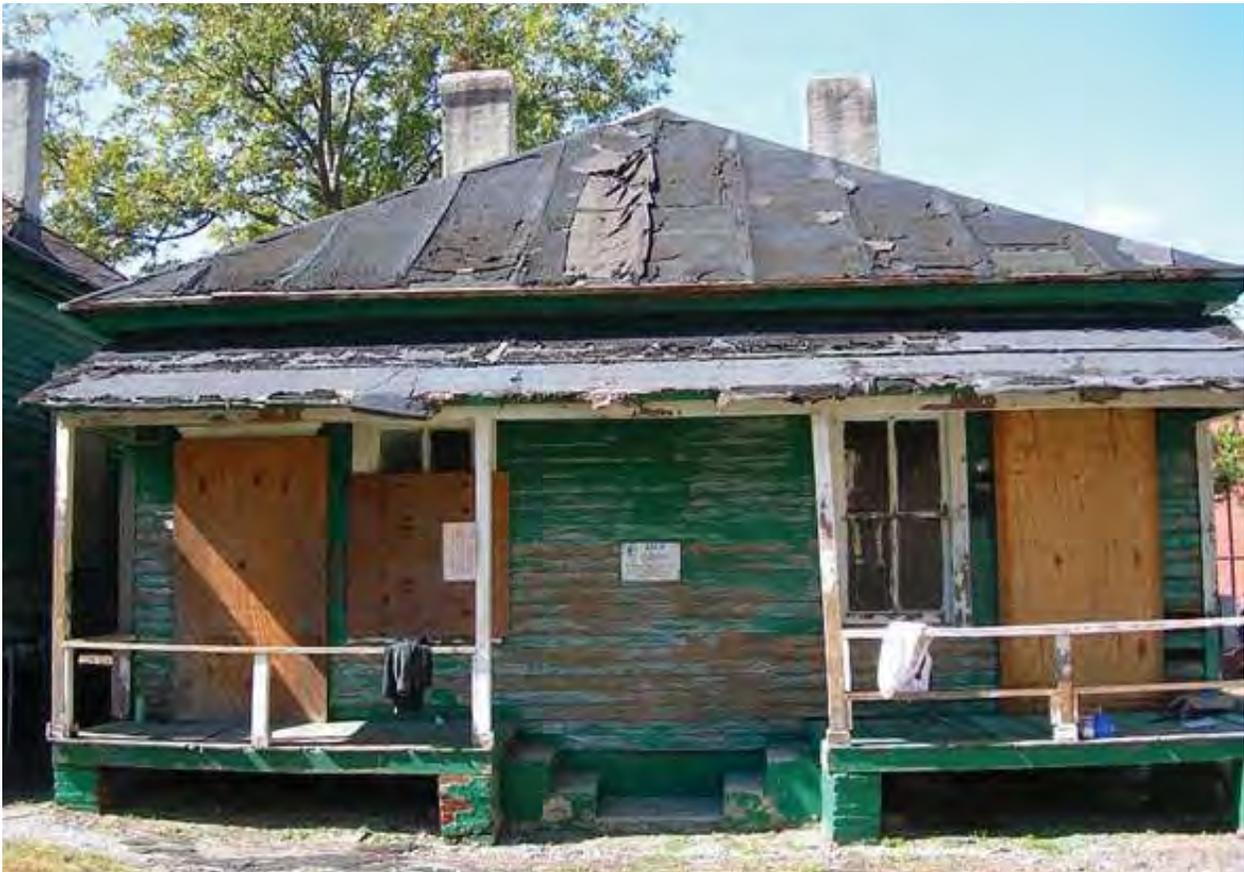
Figure B39. Building A exterior in October 2008. (CAR, p. 42)

The CAR notes that the porch of Unit 2 was not square to the building; the lower tread of the back steps at Unit 2 was missing; window glazing was deteriorated or missing and some glazing was plastic.

While condition assessments for the CAR were underway in 2008, the Park Service made significant exterior repairs to stabilize the buildings and secure them against weather. The final report therefore lists the work completed by NPS on each building by June 2009. All roofs, including the roll roofing still present, were replaced with composition shingles, siding was repaired, chimneys flashed and perhaps re-parged, porches repaired, and the buildings painted. No interior repairs were made. The CAR lists the additional work specific to each building:

- New composition shingle roofing; no gutters.
- Metal chimney flashing installed.
- Siding repaired.
- Porch flooring repaired.
- Building painted.

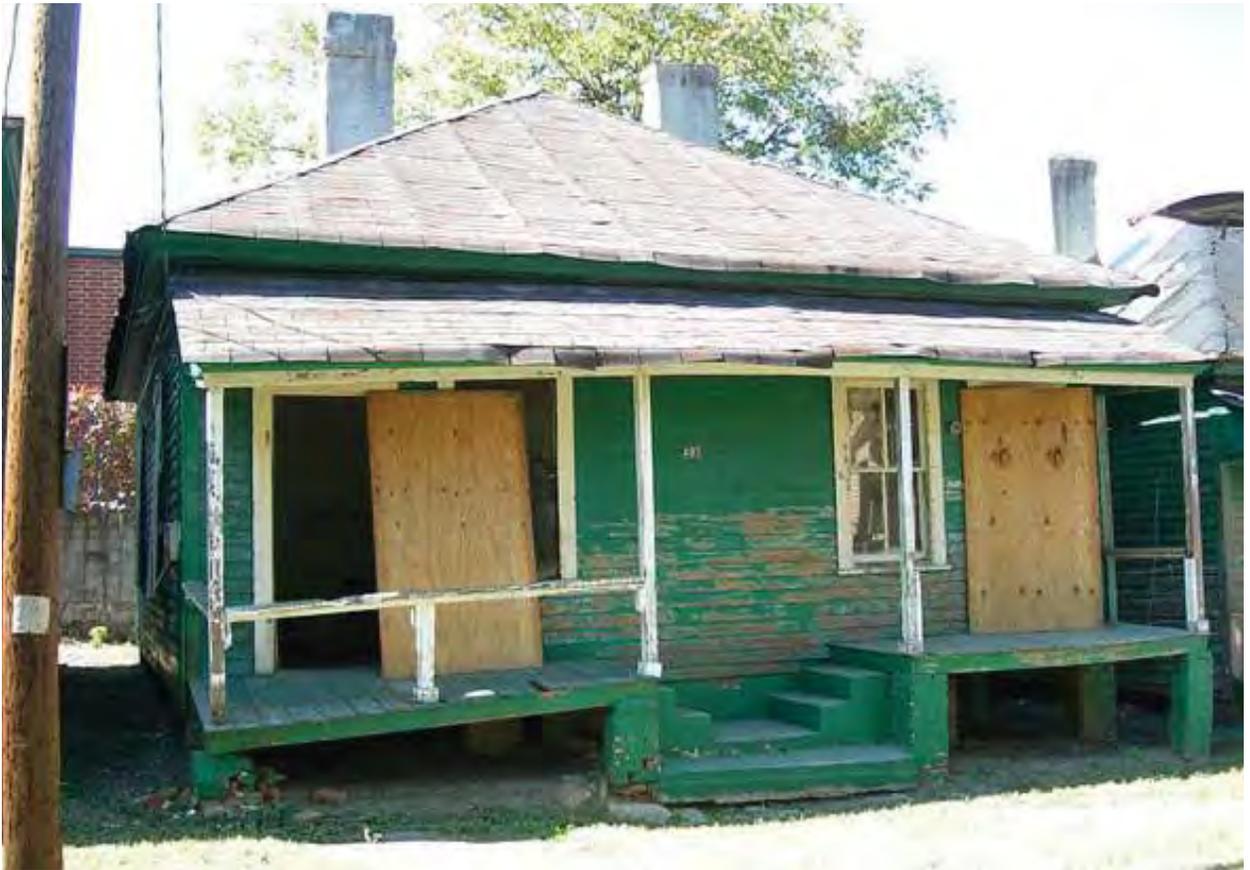
The CAR notes that the west window sill on the north elevation sloped to the interior, encouraging rot; the rear wood steps were missing at Unit 3 and badly deteriorated at Unit 4; window glazing was deteriorated or missing; and the jamb molding was detached on one window.

Figure B40. Building B exterior in October 2008. (CAR, p. 42)

- New composition shingle roof; no gutters.
- Metal chimney flashing installed.
- Siding repaired; non-matching replacement siding in some areas.
- Porch flooring repaired; missing porch rail reconstructed.
- Building painted.

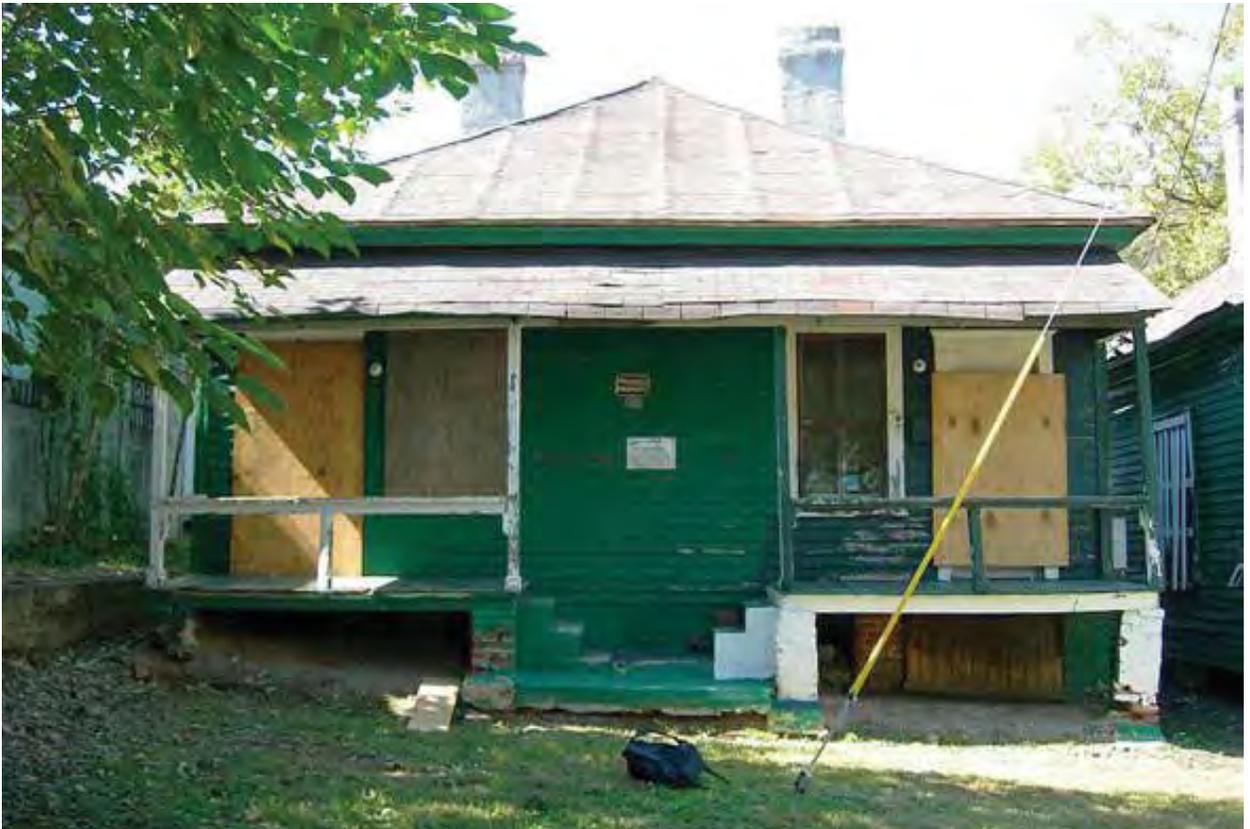
Figure B41. Building C exterior in October 2008. (CAR, p. 42)

The CAR notes that the porch posts were out of plumb; the CMU rear steps of Unit 5 and wood steps of Unit 6 were in poor condition; window glazing was deteriorated or missing; sill and sash of north window and sill of south window of west (rear) elevation were rotted; and the west window on the south elevation was missing.⁹⁷

- New composition shingle roof, no gutters.
- Metal chimney flashing installed.
- Rotted soffit crown repaired.
- Siding repaired, had been heavily deteriorated on south side and portions previously replaced.
- Porch flooring repaired.
- Building painted.

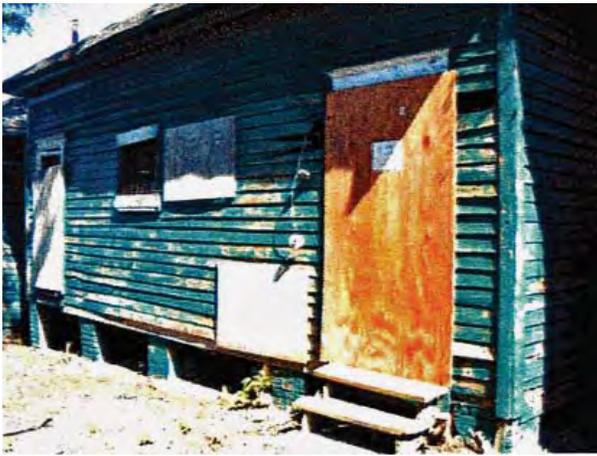
Figure B42. Condition of a west elevation in 2008. (CAR, p. 56)

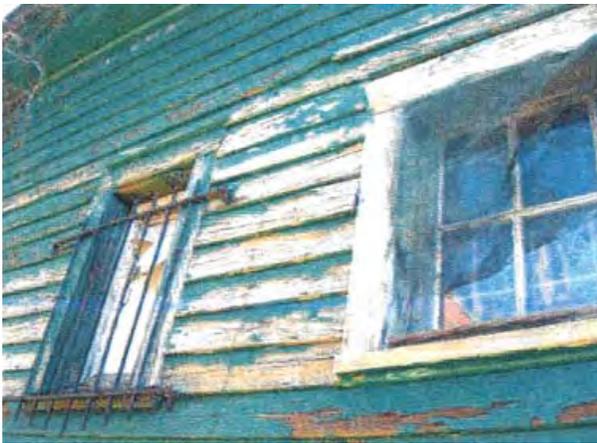
Figure B43. Condition of rear windows in 2008. (CAR, p. 65)

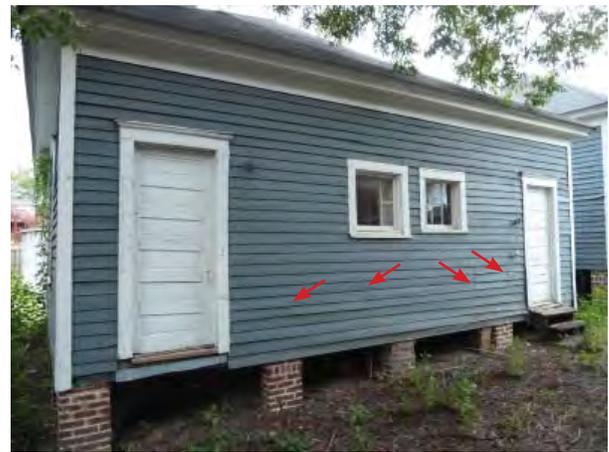
Figure C41. Patches in weatherboard siding indicate original window openings.

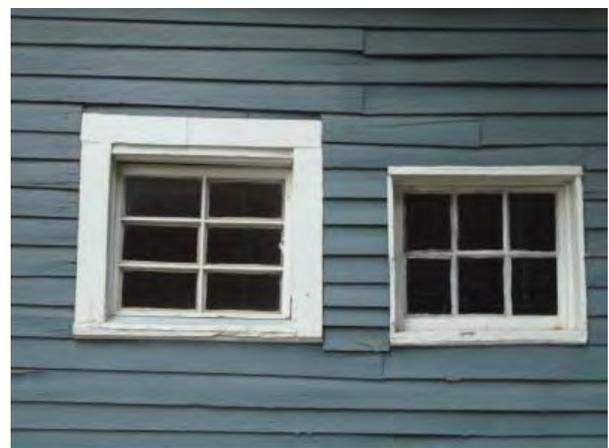
Figure C42. Mismatched 1960s west-elevation windows salvaged from other buildings.

The sash installed in the new bathroom window openings were salvaged from other buildings and the design and size varies among units (Fig. C42). All were originally one sash of a double-sash

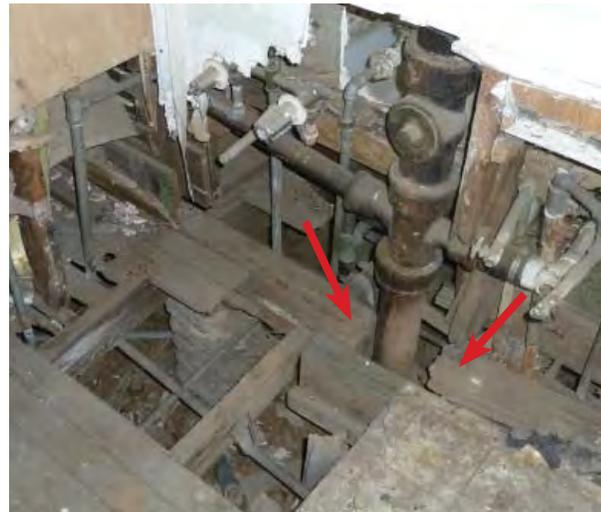
Figure C44. Severed girder and partially dismantled foundation pier to install plumbing.

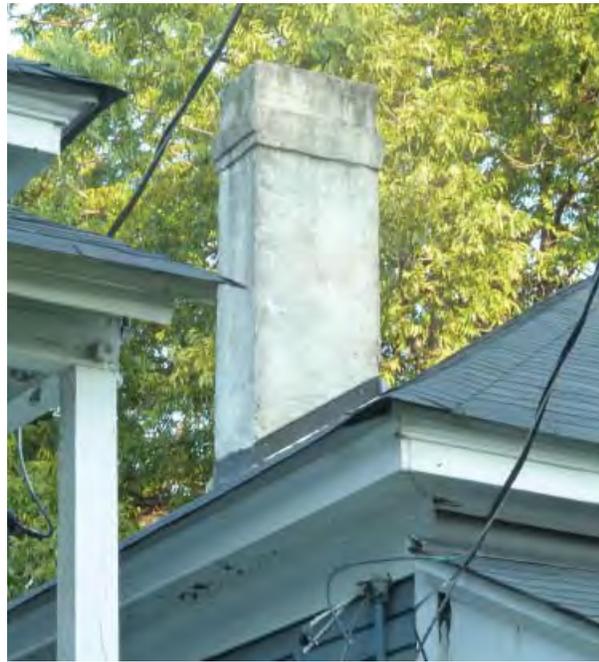
The cement parging that coats the exterior of the chimneys appears to be an added feature, perhaps to address problems of deteriorating mortar joints or water infiltration. When the application first occurred is not known.

Figure C47. Typical composition shingle roofing, aluminum flashing, and stuccoed chimney.

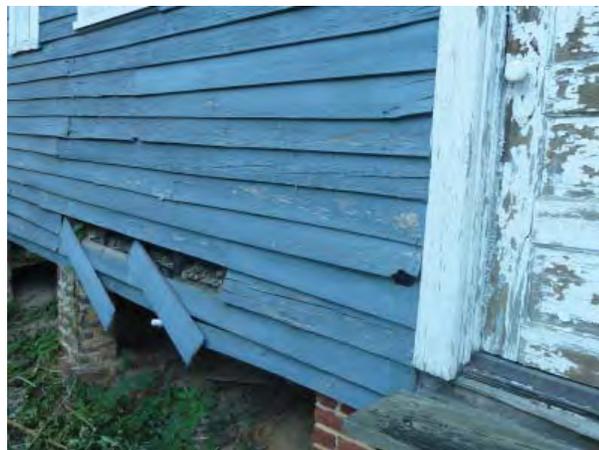
A sizable amount of weatherboard siding is cupping and checking. The failed siding appears to be replacements, similar to the original in size and shape. The cause may be attributable to the quality of the material.

Figure C48. Cupping, twisting and checking of weatherboard siding.

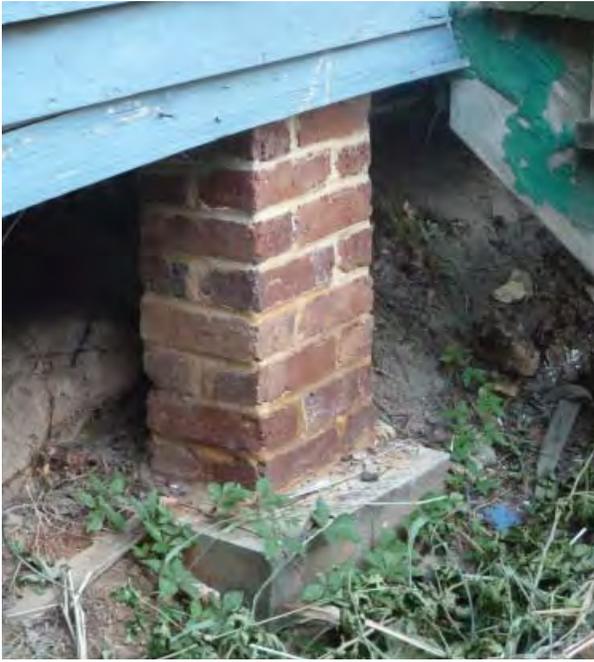
The original brick piers were constructed in accordance with a grid plan, and at some locations it appears there were brick footings as well. Some piers have been repaired or replaced and some have a recently installed concrete footing.

Figure C49. Brick pier with modern concrete footing.

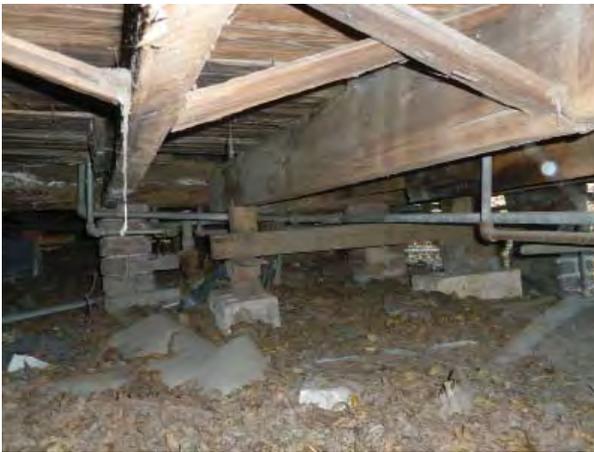
Figure C50. Irregular supplemental support. Extensive rot in flooring and floor framing in Building C attributable to both leaking pipes and failed roofing.

Rot attributable to leaking water pipes has caused extensive damages in Building C, in particular.

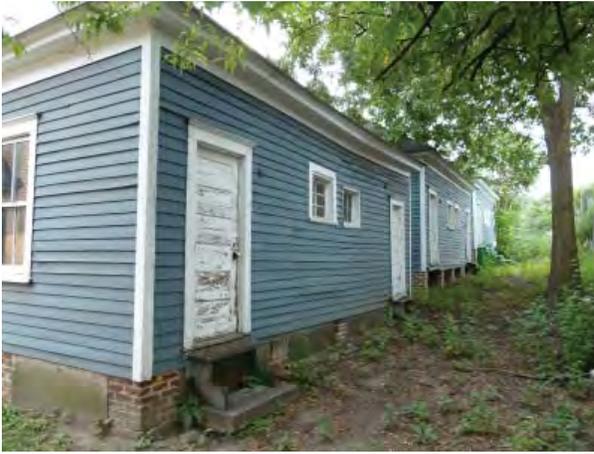
Figure C60. Building A northwest oblique. Checking, twisting, and warping of siding. Missing treads at entrance. Deteriorated thresholds.

A sizable number of weatherboards are checking, twisting or warping and cannot be salvaged. Many appear to be modern replacement boards (*Fig. C60*).

At this building only, the spaces between the piers are covered with sheets of plywood (*Fig. C60*).

Both sets of back stairs are modern replacements in need of extensive repair if not replacement. The thresholds of the two back doorways are also in need of repair (*Fig. C60*).

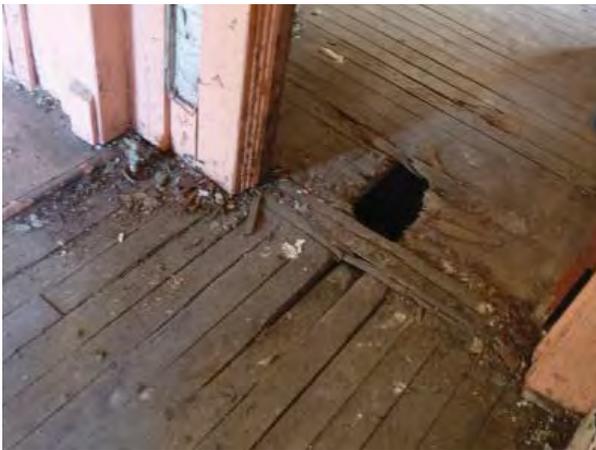
Figure C65. Damaged flooring from roof leaks.

The original wood flooring is mostly intact though there is severe damage from prolonged roof leaks near the doorway to Room 102-A. Nevertheless, the floor is a candidate for repair and preservation.

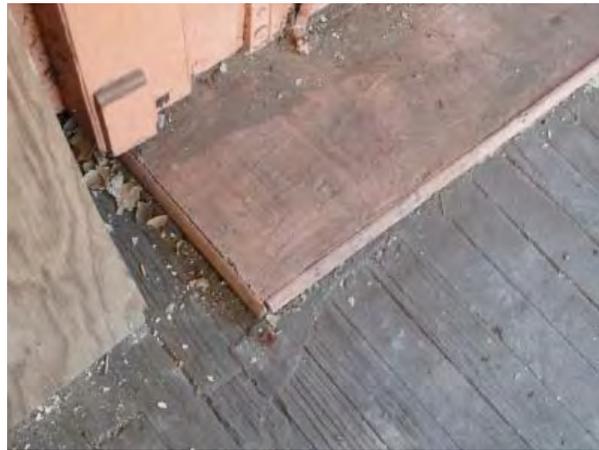
Figure C66. Hearth with replacement trim. Remnant of sheet flooring over cupped wood flooring.

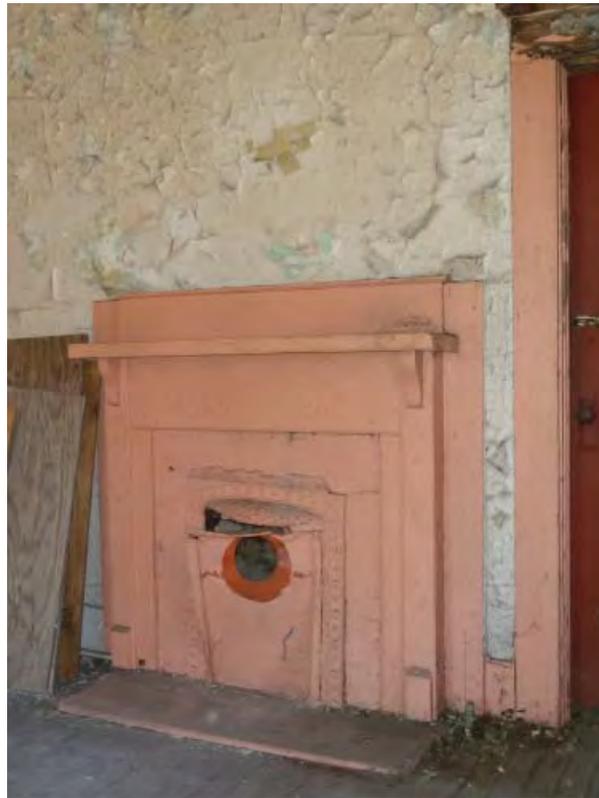
Figure C67. Fireplace mantel and hearth.

The fireplace mantel, metal surround and hearth with replacement trim are largely intact and are good candidates for repair and preservation. The coal grate has been removed and the coal grate opening has been covered by a metal panel with an opening for a later 6" diameter metal flue; the coal grate is a good candidate for repair and preservation (*Fig. C67*).

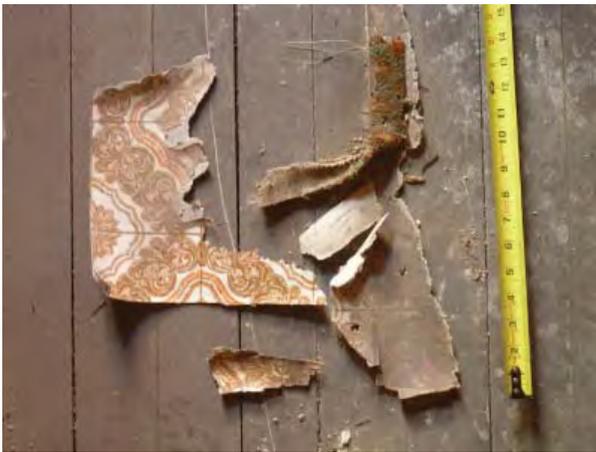
Figure C71. Remnants of modern carpeting over sheet flooring on top of second layer of wood flooring.

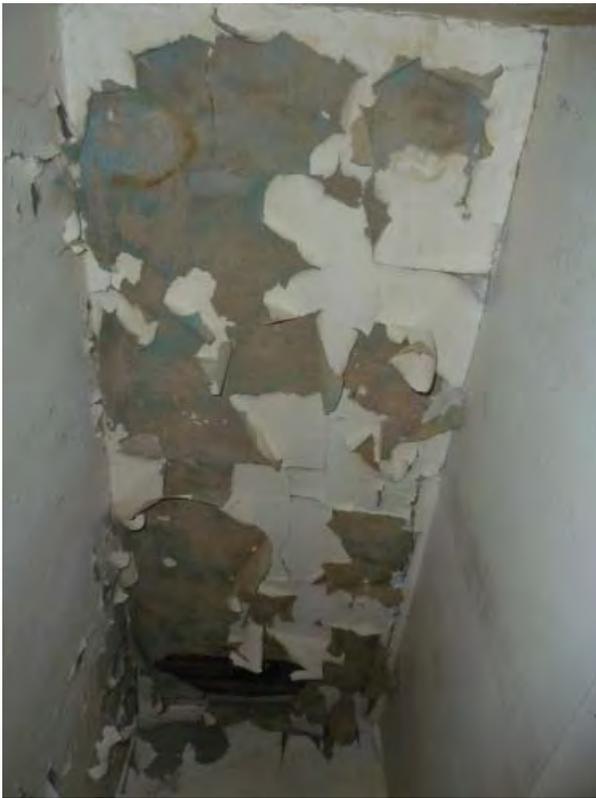
Figure C75. Ceiling looking north.

A large portion of plaster appears to remain on the two original walls and original ceiling that form this room. There is some localized plaster loss, primarily from former roof leaks. The principal area of loss is a section of ceiling at the north end of this room above where the water heater was located and through which its metal flue vented. Wood lath that remains should be retained if sound and reused in replastering. Given the apparently long period of time of water infiltration, there may be unseen water damage to plaster still in place. Nonetheless, the areas of both plaster loss and damage are candidates for consolidation, infill repair and preservation (*Fig. C75*).

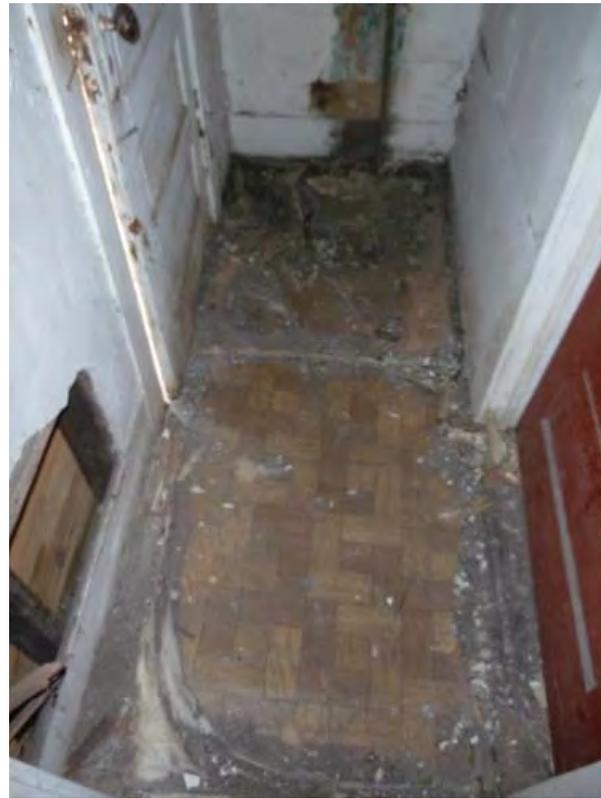
There are remnants of multiple layers of sheet flooring applied on top of the original wood flooring. The condition of the original wood flooring is not known (*Fig. C76*).

Figure C76. Floor looking north.

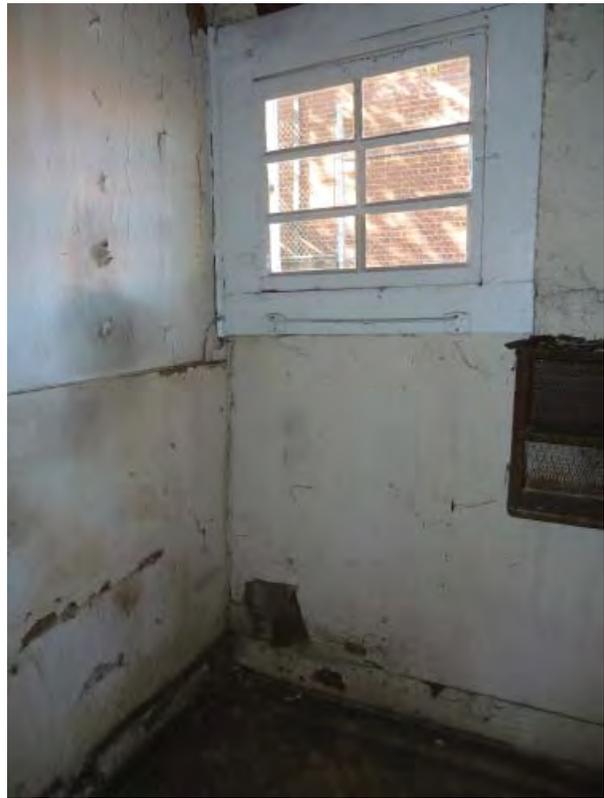
A section of original baseboard remains along the south wall, but the shoe molding is missing. A section of the typical wood floor boards serves as baseboard along the north wall with $\frac{3}{4}$ " half-round trim serving as shoe molding. A section of $\frac{3}{4}$ " trim is on the south wall without a baseboard (*Fig. C80*).

Figure C80. Southwest oblique of Room 102-C.

turned perpendicular to its intended orientation and hinged on its south jamb. The sash as installed measures 2'-4" wide by 2'-2" tall. The two T-hinges measure 2½" by 4". A wire toilet-paper holder is on the east side of the door (*Fig. C80*).

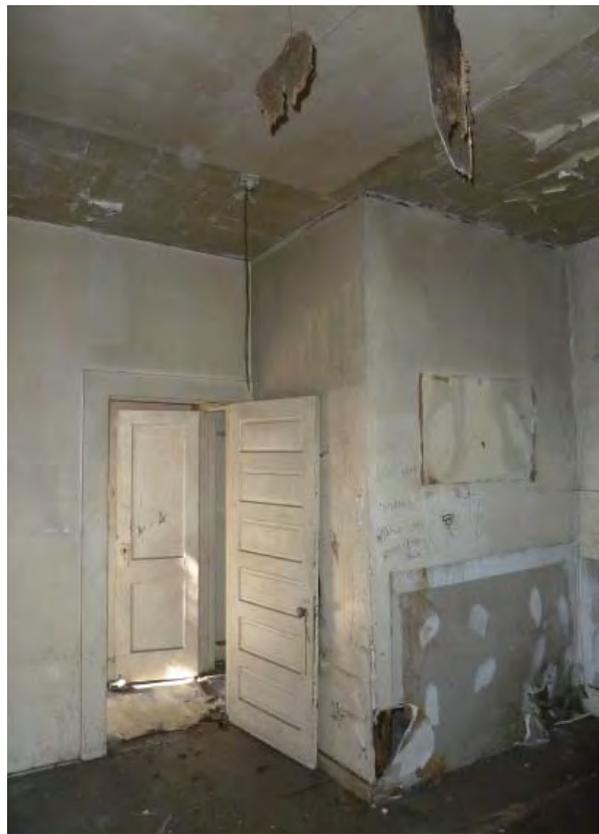
Figure C85. Northwest oblique of Room 102-A.

Sheets of plywood are applied to the floor. The condition of the original tongue-and-groove wood flooring is unknown (Fig. C85).

The 1960s doorway that leads to Room 102-B, the Back Hall, is one of the original six-panel doors. It retains its original hardware except for its hinges which now are modern 3" five-knuckle steel butt hinges (Fig. C85).

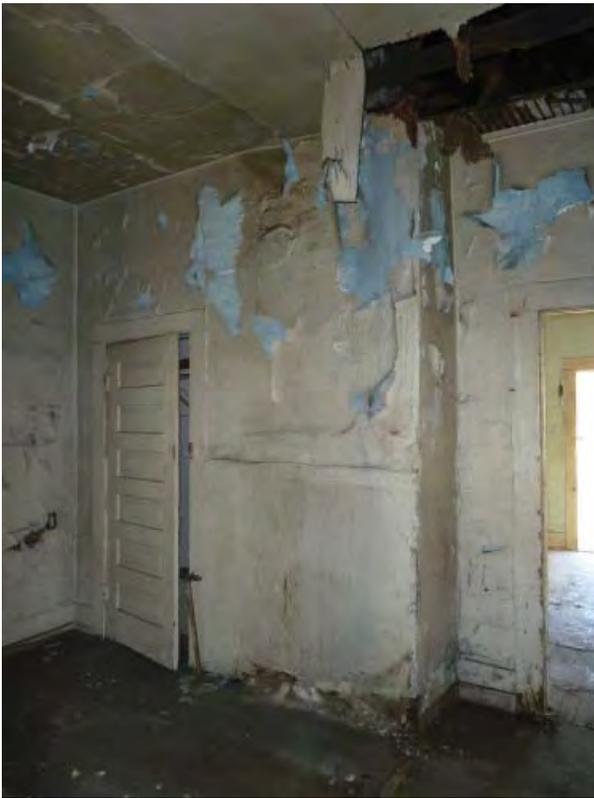
Figure C87. Northeast oblique of Room 102-A.

North of the original fireplace is an original closet (Fig. C87). The interior retains its original plastered walls and ceiling; they are good candidates for preservation. The original baseboards inside the closet are also intact and are good candidates for preservation. The door to the closet is original and retains its original hinges; all merit preservation. The small original rim lock of the interior face and wood handle of the room face are missing. A small wood swivel latch

The original fireplace mantel and coal grate have been removed; the base of the chimney including the firebox has been covered with a painted sheet of plywood. An added 6" diameter clay pipe in the chimney breast for a flue connection has been infilled with mortar. The hearth with trim remains intact (Fig. C87).

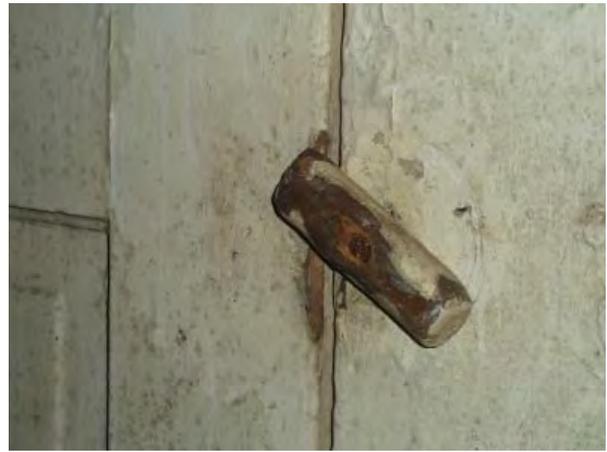
Figure C88. Wooden swivel latch of closet door.

measuring 1¼" wide by 3¾" long by 1" thick has been added to the room face (Fig. C88).

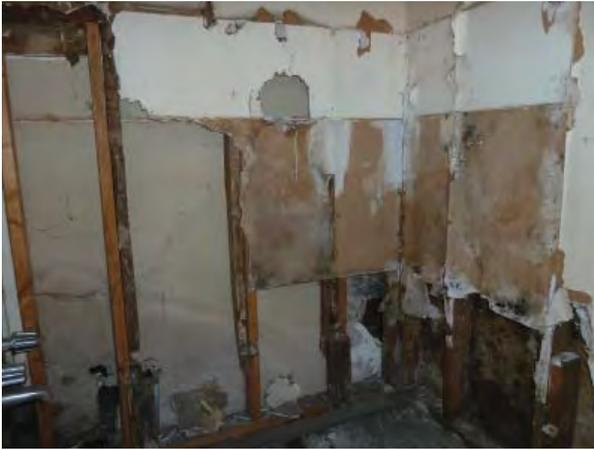
Figure C91. Southwest oblique of Room 102-C. Ghost marks of lavatory in foreground.

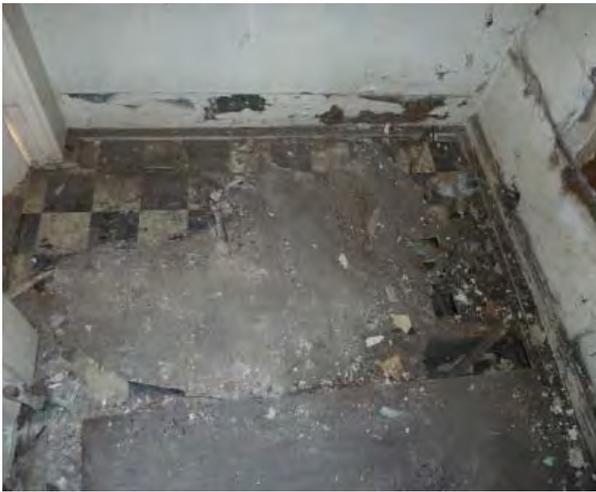
There are remnants of multiple layers of sheet flooring applied on top of the original wood flooring.

Figure C93. Multiple layers of sheet flooring atop wood floors.

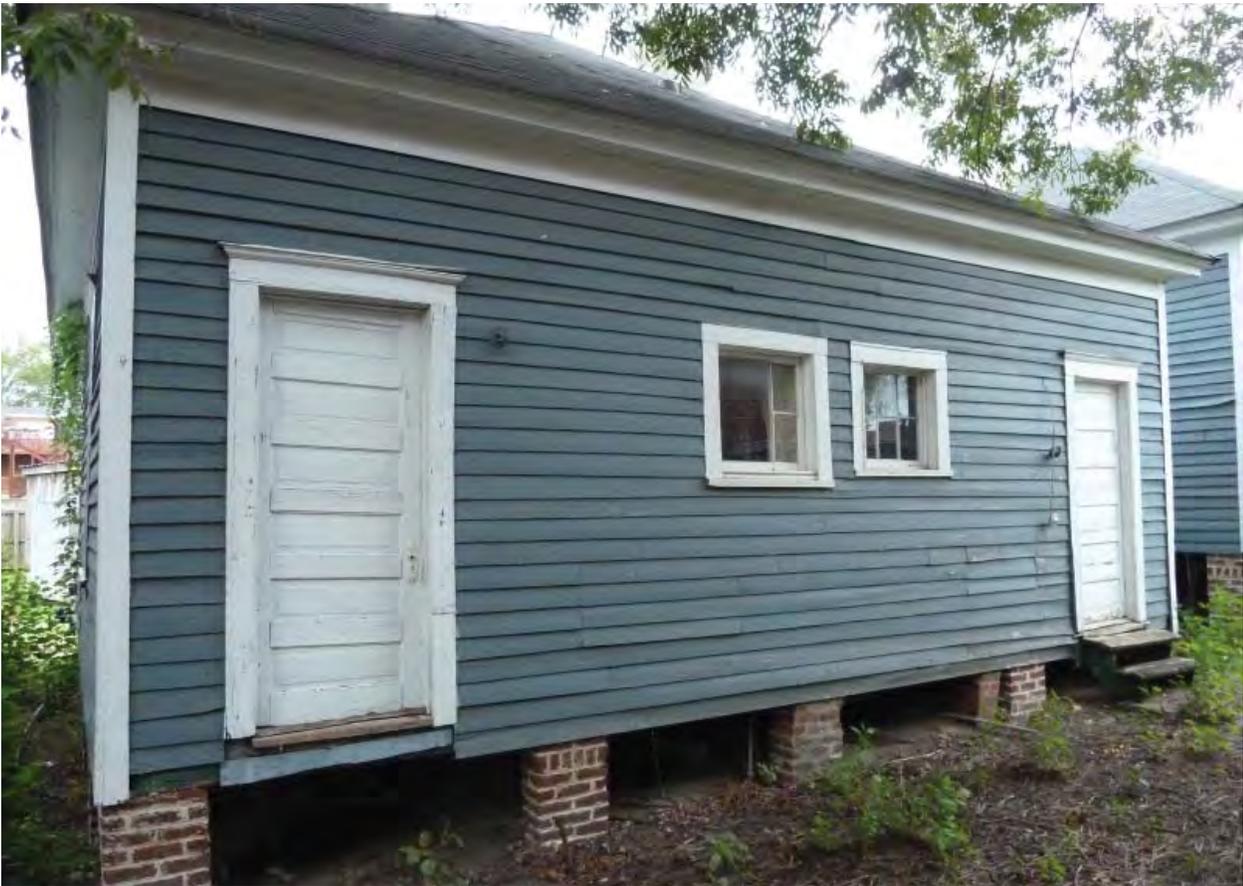
Figure C96. Northwest oblique. Both rear doors are original and retain most of their original hardware.

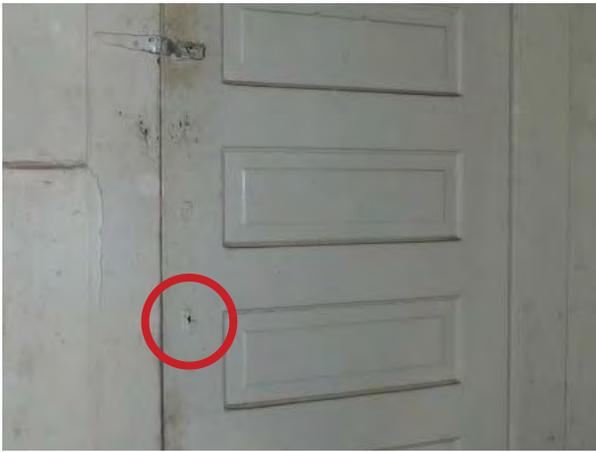
Figure C108. Original key escutcheon (only extant example) on original closet door.

The original baseboards inside the closet are intact and are good candidates for preservation. The door to the closet is original and retains its original hinges; all merits preservation. The small original rim lock of the interior face is missing, though the ghost of the original remains. The original key escutcheon remains, the only one of the six closet doors; its preservation is important (*Fig. C108*). Modern hardware includes a 7" zinc hasp for padlock.

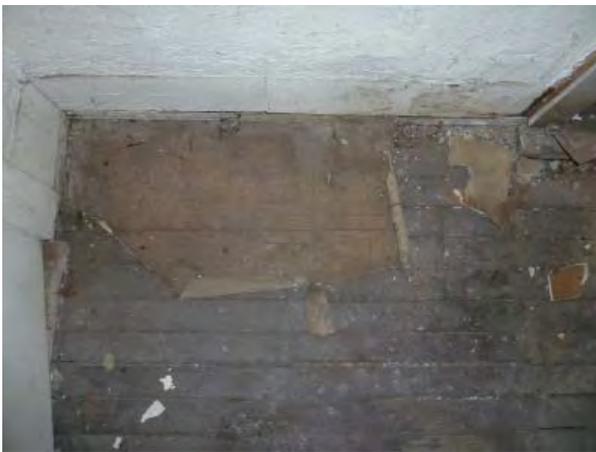
Figure C109. Multiple layers of sheet flooring over water-damaged original wood flooring.

The original wood flooring is intact but exhibits cupping, a condition created from excessive and prolonged wetting, apparently caused by roof leaks. Remnants of multiple layers of sheet flooring cover the wood floor.

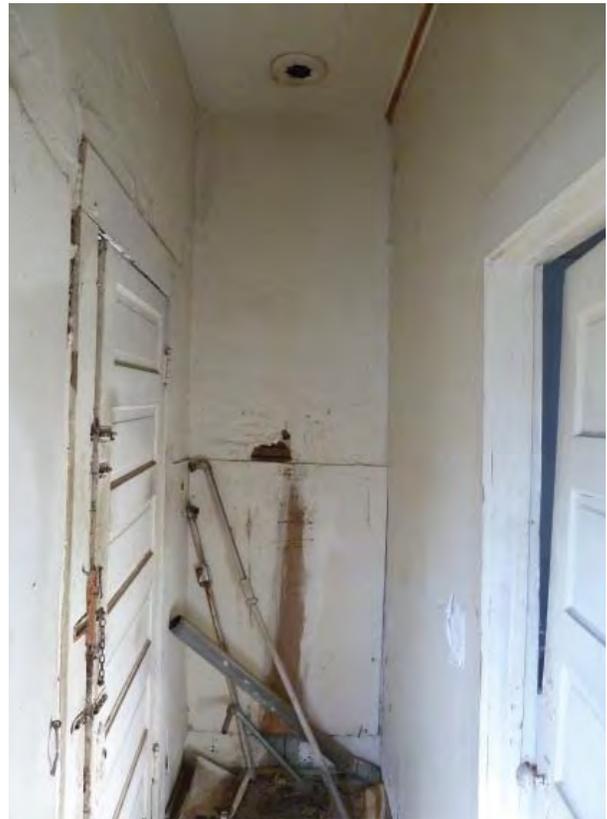
Figure C111. Room 102-B looking north. Note pipes for hot water heater and flue collar on the ceiling.

The water heater is missing from the north end of the room. Two galvanized water pipes remain

as well as a steel gas line. A metal flue escutcheon with 6" diameter opening is immediately above in the plastered ceiling.

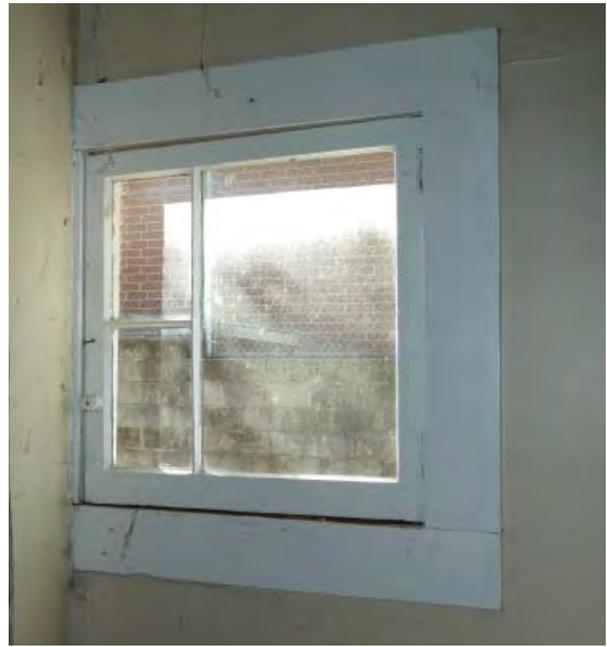
Figure C117. Window sash salvaged from another building.

A small window was added to the original west wall when the bathroom was created. The six-light wood sash is one section of a double-hung window salvaged from another building. Several muntins are missing and not replaced when reglazed, giving the appearance of one large glass and two small ones. The sash is turned perpendicular to its intended orientation and hinged on its north jamb. The sash as installed measures 2'-6" wide by 2'-7"

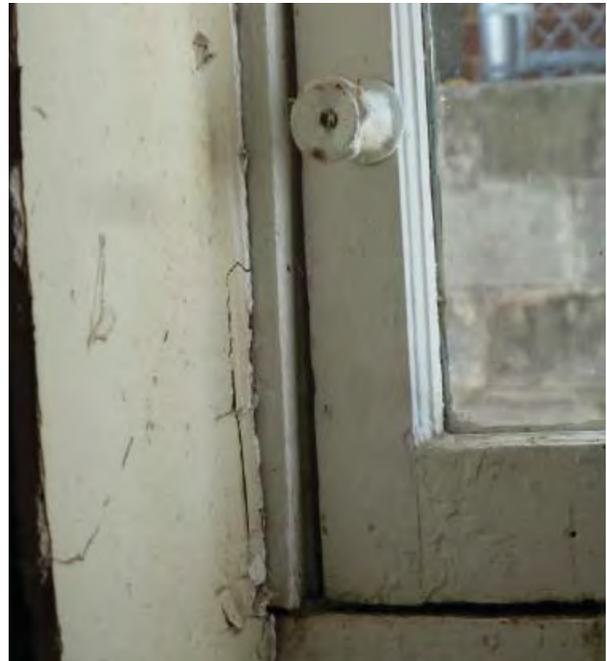
Figure C118. Thread spool used for window handle.

tall, and is hung on two ball-pin, 2½", five-knuckle, butt hinges. A 1½" diameter wooden thread spool that serves as a handle (Fig. C118).

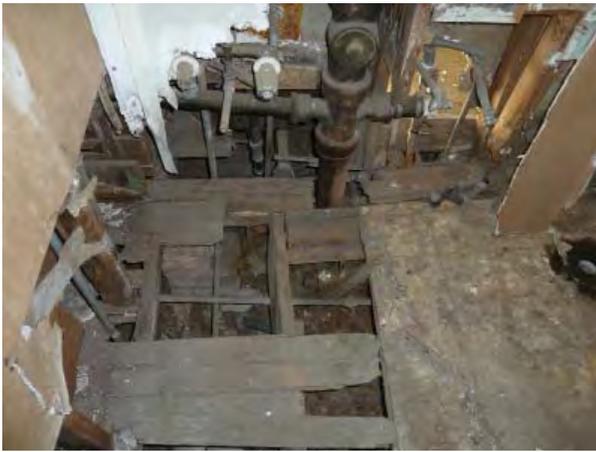
There are remnants of sheet flooring applied on top of replacement plywood flooring (*Fig. C119*).

Figure C119. During bathroom installation, brick pier partially dismantled for water supply lines and girder severed for drain line.

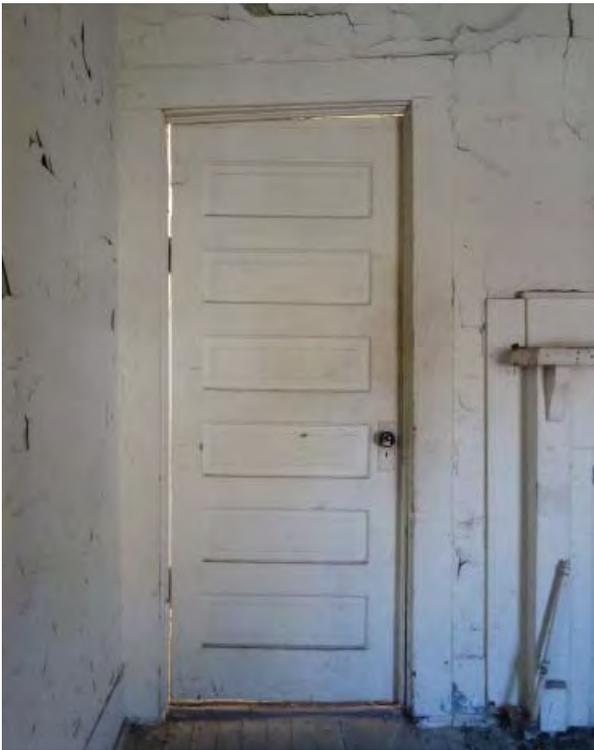
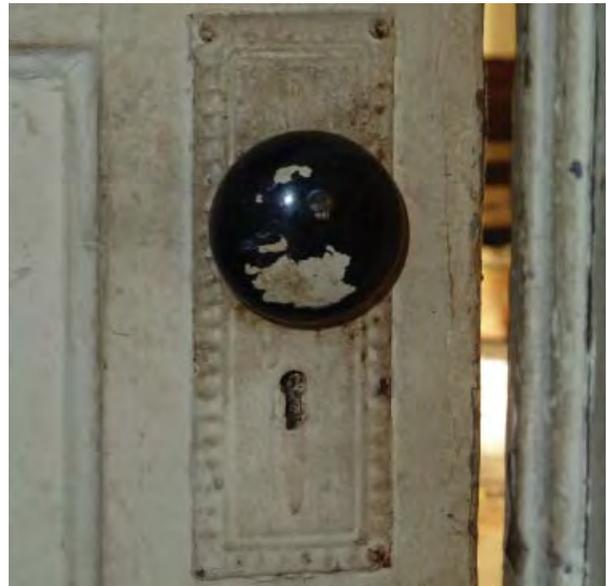
Figure C122. Original six-panel door to Room 102-A retains original hardware.

The original six-panel door of the front entrance has been replaced with a five-panel door. The door of the doorway to Room 102-A retains its original six-panel door, both decorative ball-pin hinges and both embossed escutcheons. The original embossed doorknobs have been replaced with black mineral knobs. Both doorways retain their original casing (*Figs. C122-C123*).

Figure C123. Original interior-door doorknob and escutcheon.

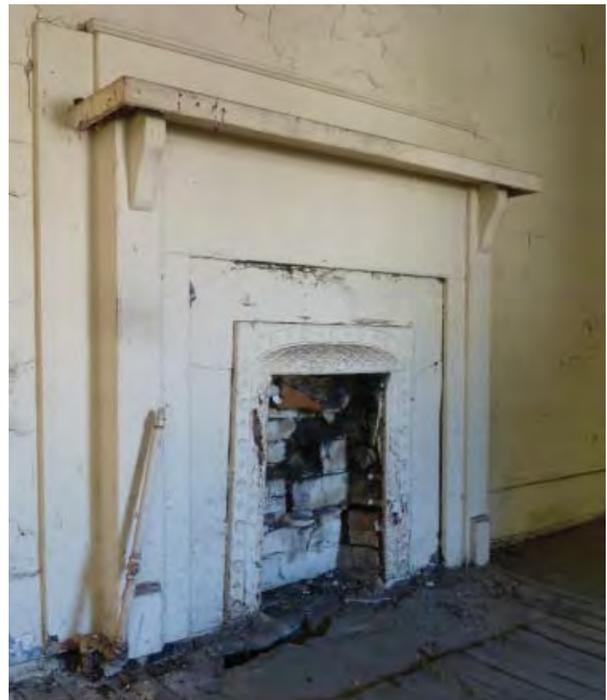
The mantel is intact and is a good candidate for preservation. The original coal grate surround is present but the grate has been removed; all are candidates for repair and preservation (*Fig. C124*).

Figure C124. Fireplace mantel.

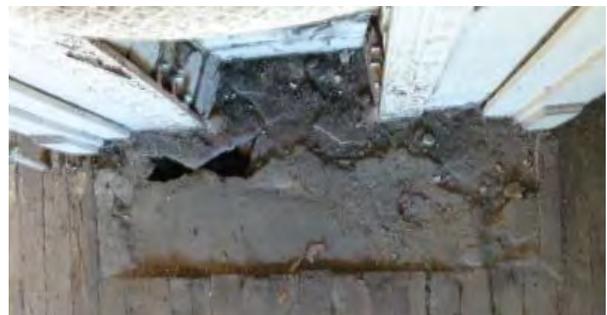
The original poured cement hearth is damaged and missing a section of its clam shell style trim board. Both hearth and trim boards are good candidates for repair and preservation (*Fig. C124-125*).

Figure C125. Damaged cement hearth and clam-shell trim are candidates for repair.

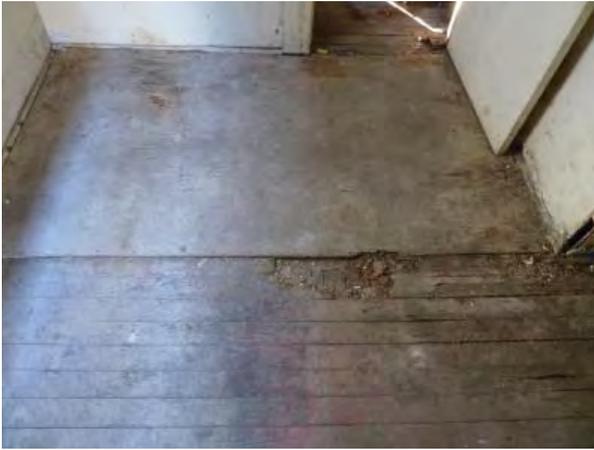
Figure C129. Multiple layers of flooring due to roof leaks.

A second layer of the typical wood flooring has been added on top of the original flooring and runs north-south, perpendicular to the direction of the original flooring. At the west end of the room is a third (plywood) covering due to roof leaks (Fig. C129).

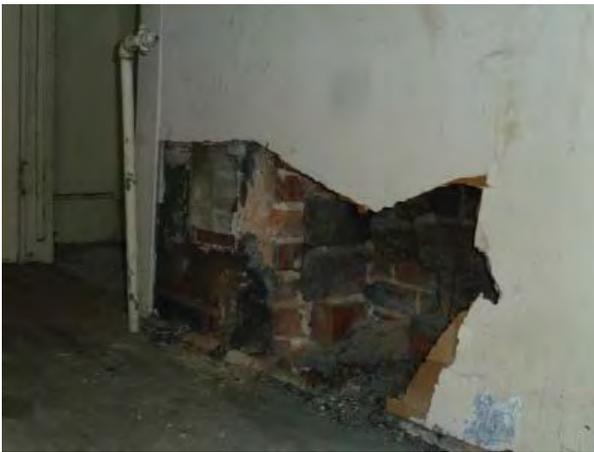
Figure C130. Partially collapsed firebox. Hearth covered over with added flooring.

The original fireplace mantel and coal grate have been removed; the base of the chimney has been covered with a gypsum board panel, now damaged, to hide a partially collapsed firebox (Fig. C130). Hearth is presumably beneath the added wood flooring and its condition is unknown. A 6" diameter opening in the chimney for a connecting flue has been patched with mortar.

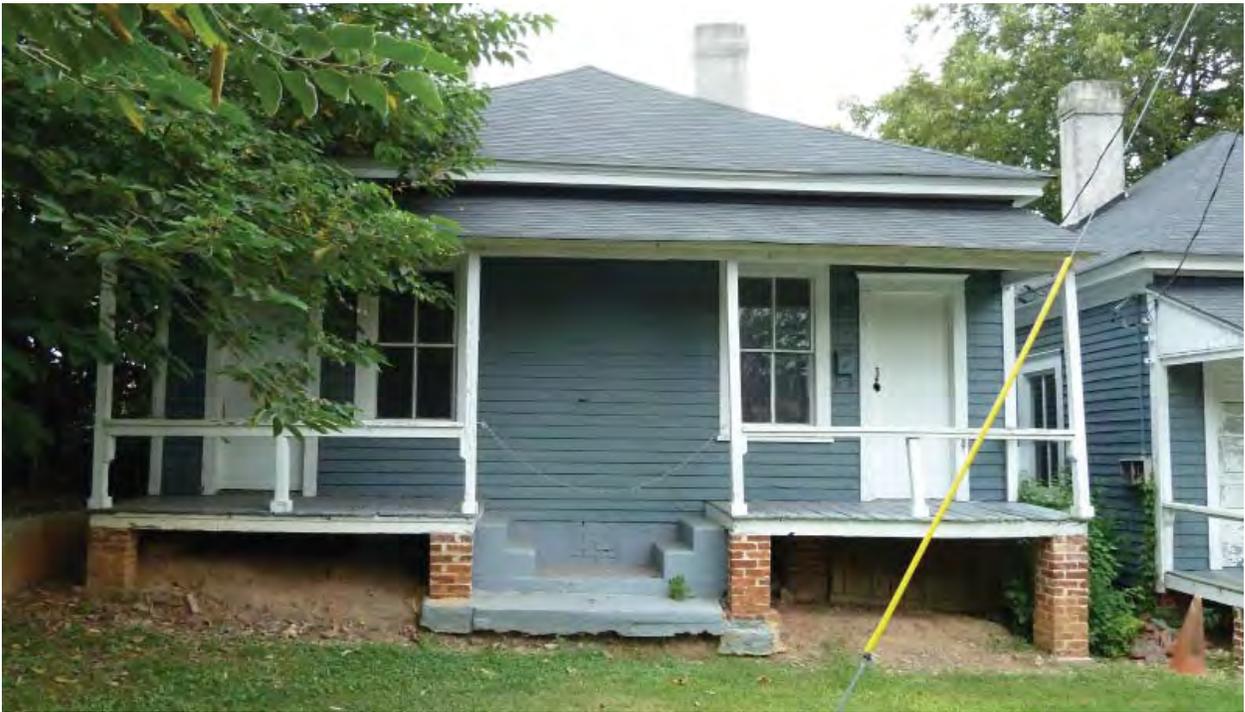
Figure C140. East (front) elevation of building C.

The north chimney appears to have had several extra courses added above the corbelling. The application of a cement stucco to both chimneys appears to have been a late-twentieth century occurrence and it is unclear why the chimneys were parged. The parging is crudely executed, in contrast to the high quality of early craftsmanship executed elsewhere (*Fig. C140 & C146*).
