Three Double-Shotgun Houses 493ABC Auburn Avenue

Martin Luther King, Jr. National Historic Site

Historic Structures Report

May 2017

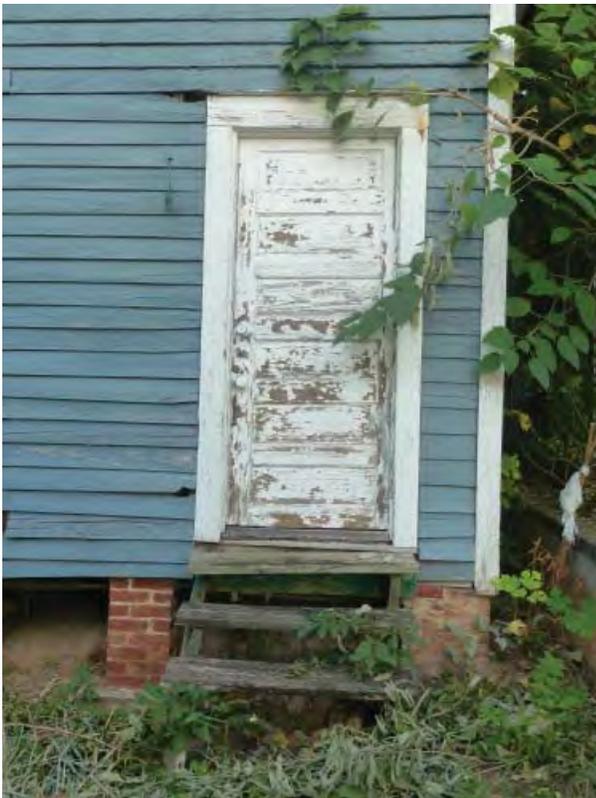
None of the four exterior doorways have been modified, although only one original door remains, the back door to Unit 6. The door retains all of its hardware including decorative hinges, both embossed escutcheons and both embossed doorknobs. This door is a good candidate for preservation. The other three are replacement slab doors. Each reuses the decorative hinges of the original door (*Fig. C142*).

Figure C142. Original Exterior door retains all its original hardware.

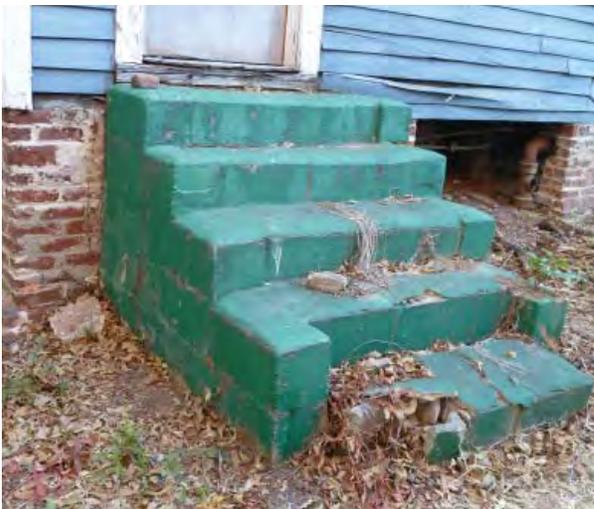
At the back of the building, the south set of open-stringer wood stairs is intact but in poor condition and unstable. The north set (Unit 5) has been replaced with steps constructed of parged CMUs, which are separating. The thresholds of both back doorways, especially the north threshold, are in need of repair (*Fig. C142*).

Figure C145. North rear entrance steps constructed of CMUs.

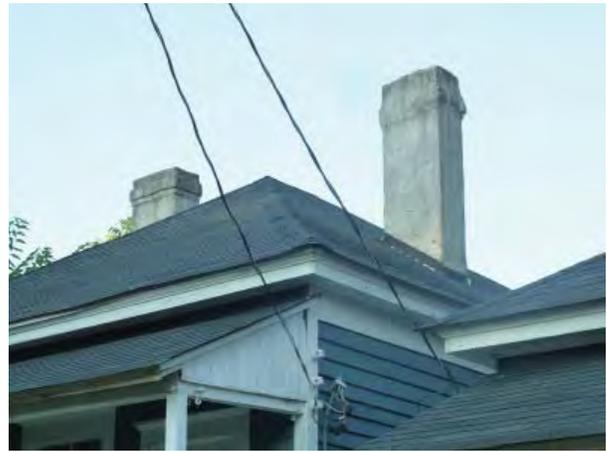
The new composition shingle roof and flashing appear to be working well (*Fig. C146*).

The north chimney appears to have had several extra courses added above the corbelling. The application of a cement stucco to both chimneys appears to have been a late-twentieth century occurrence and it is unclear why the chimneys were parged. The parging is crudely executed, in contrast to the high quality of early craftsmanship executed elsewhere (*Fig. C140 & C146*).

Figure C146. Chimneys, roofing, and flashing.

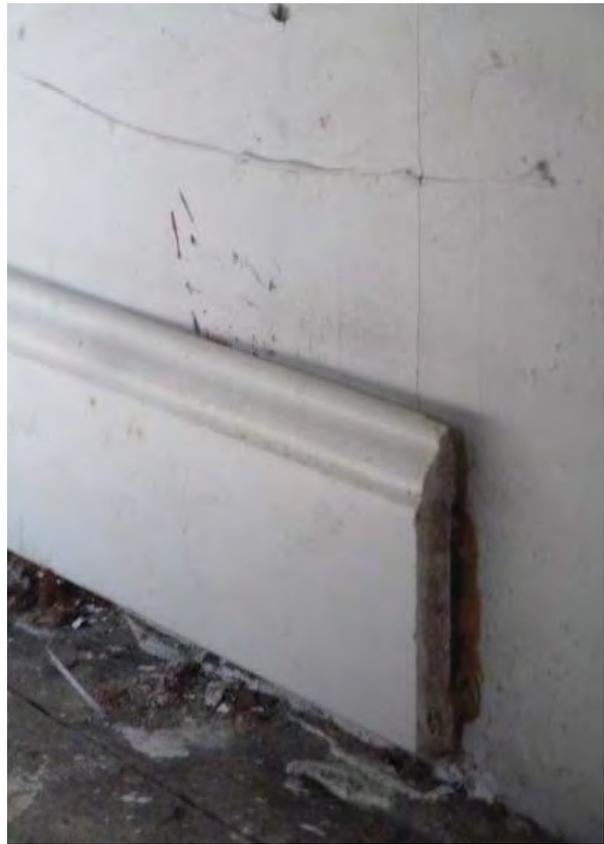
At the north wall is a much smaller modern replacement board/cap combination measuring just $\frac{3}{8}$ " thick by $3\frac{1}{4}$ " tall (*Fig. C149*).

Figure C149. Modern composite baseboard/cap combination molding.

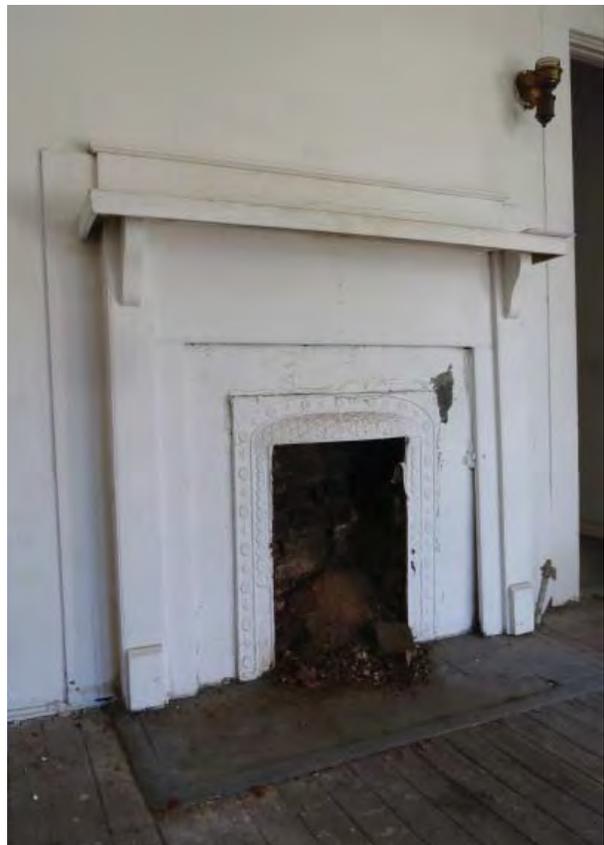
Figure C150. Fireplace mantel and hearth.

The fireplace mantel is intact and is a good candidate for preservation. The coal grate surround is in place but the grate has been removed and the masonry firebox has partially collapsed. All are good candidates for repair and preservation (*Fig. C150*).

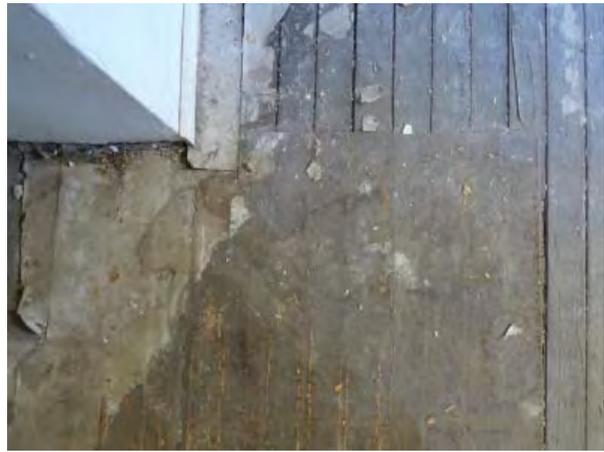
Figure C156. Diverse flooring materials of Room 102-A.

The original wood flooring appears to be intact beneath remnants of sheet flooring, but exhibits extensive cupping, a condition that can occur from excessive wetting (*Fig. C156*).

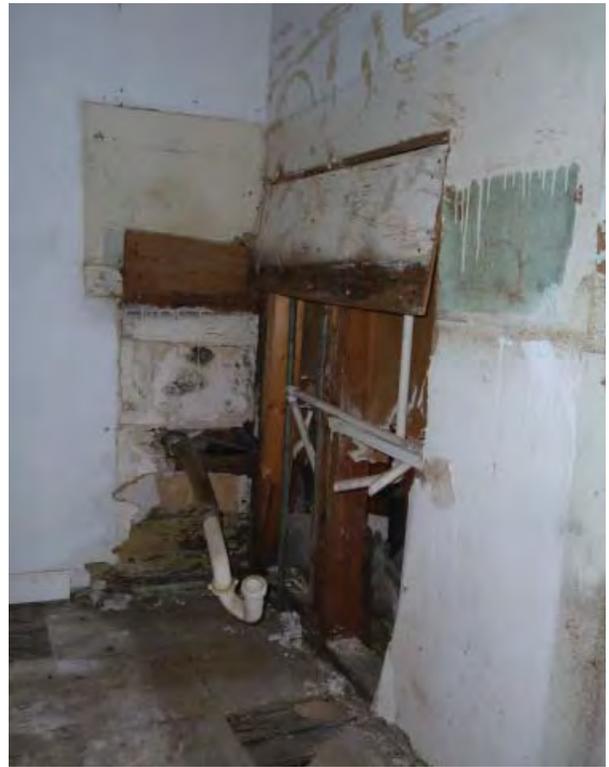
Figure C160. PVC water supply and drain lines.

A PVC drain line for a sink is on the south (party) wall (Fig. C160).

Two PVC water supply lines are at the west wall shared with Room 102-C, the Bathroom (Fig. C160).

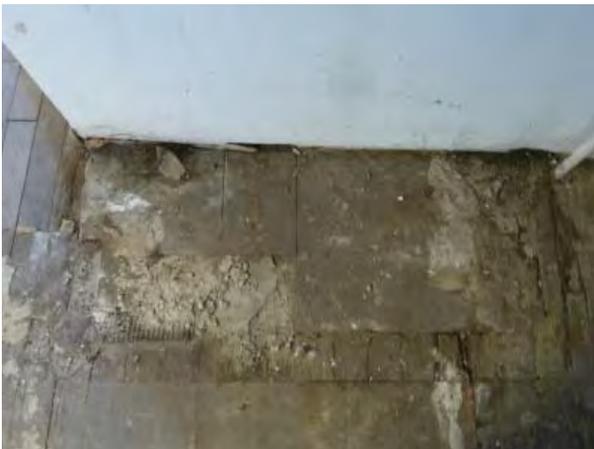
Figure C159. Deteriorated cement hearth with hardware cloth reinforcement exposed.

The poured-in-place cement hearth is deteriorating, exposing the hardware cloth used as reinforcement (Fig. C159).

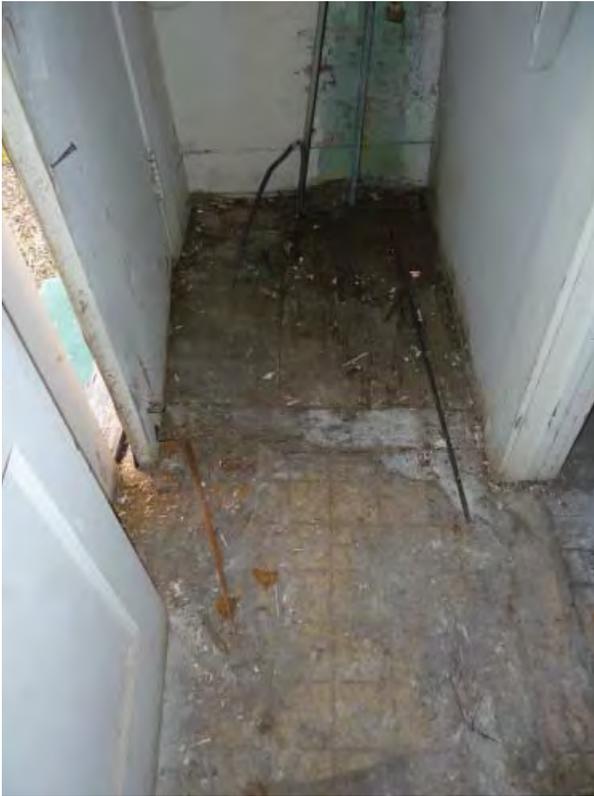
Remnants of multiple layers of sheet flooring applied to plywood are on top of original wood flooring.

Figure C163. Multiple layers of sheet flooring over plywood on top of the original wood flooring.

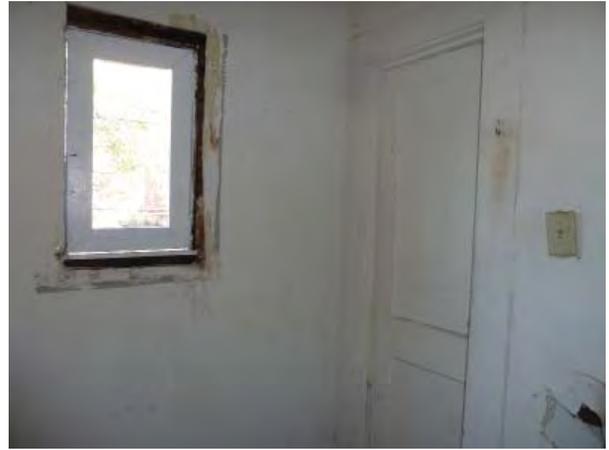
Figure C164. Northwest oblique of Room 102-C.

A small, single-light sash window was added to the original west wall when the bathroom was created. The sash measures 1'-6" wide by 2'-7" tall. It is hinged on the north jamb with two ball-pin, 2½", five-knuckle, ball-pin, butt hinges. The casing is missing (*Fig. C164*).

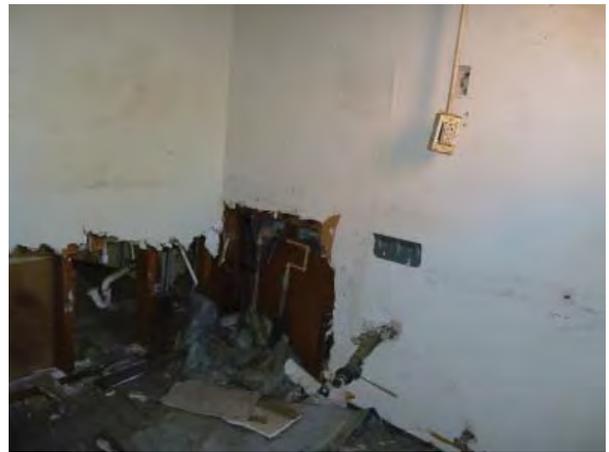
Figure C165. Southeast oblique of Room 102-C.

A drop-in type bathtub that was along the east wall is missing. The chrome and plastic faucet handles and both galvanized and PVC piping remain (*Fig. C165*).

The lavatory, which was mounted on the south wall, is also missing. The chrome pipe shut-off valves remain (*Fig. C165*).

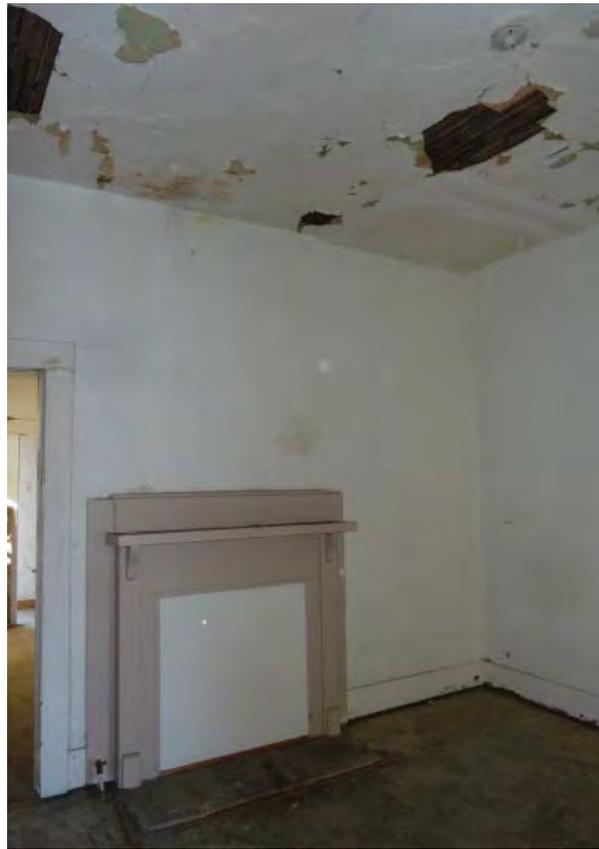
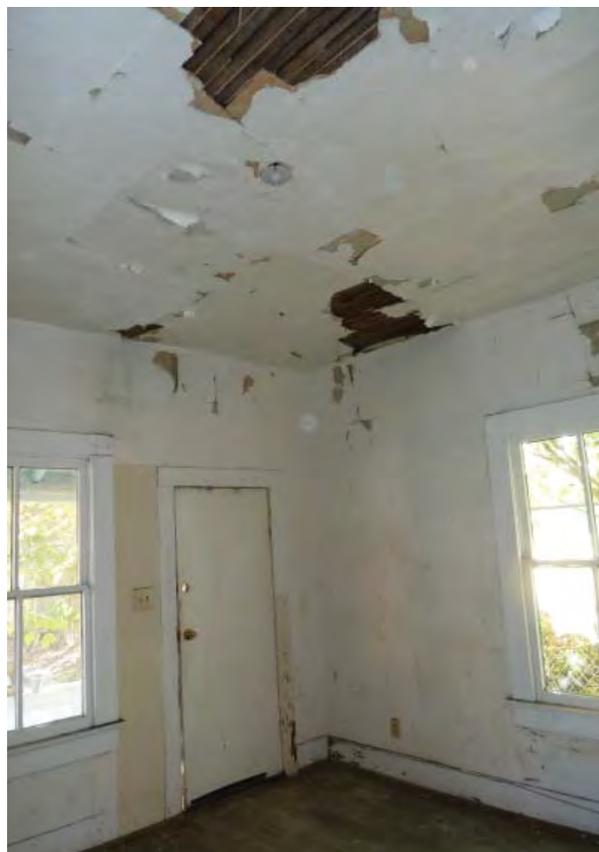
Much of the original plaster appears to remain on the walls and ceiling although there are several

areas with significant loss, primarily on the ceilings, due to former roof leaks (*Figs. C166-C167*).

There may also be unseen damage to plaster due to the apparently long period of water infiltration from roof leaks. Nonetheless, these areas of damage or loss are good candidates for consolidation, infill repair and preservation.

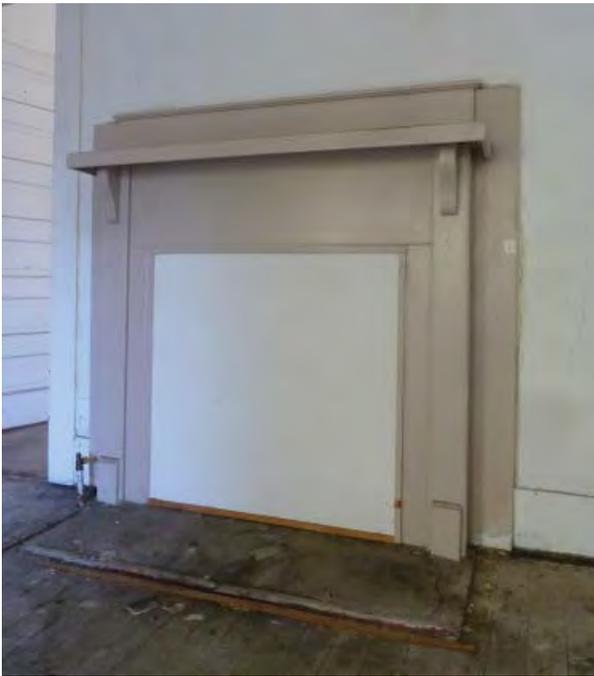
Figure C168. Fireplace mantel and hearth.

Wood lath remains in most areas of plaster loss and should be evaluated at the time of repair for retention and reuse in replastering (*Fig. C168*).

The fireplace mantel is intact and is a good candidate for preservation. The coal grate and surround are missing; the firebox has been infilled and plastered (*Fig. C168*).

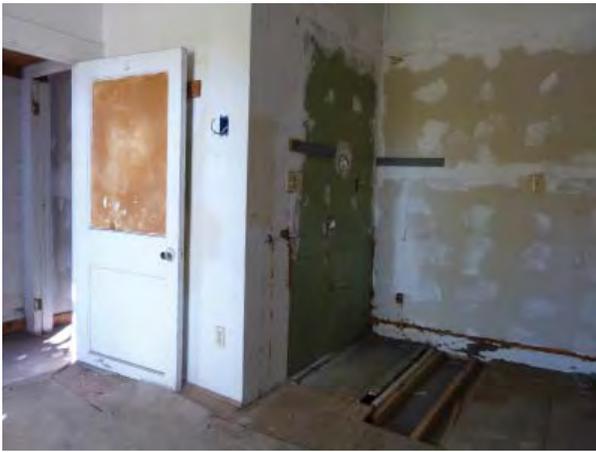
Figure C170. Northwest oblique of Room 102-A.

Original plaster along the party wall was damaged when plumbing was installed. Repairs were made using gypsum board panels though the work is unfinished. Whether some of the panels were applied over existing plaster is not clear (Fig. C170).

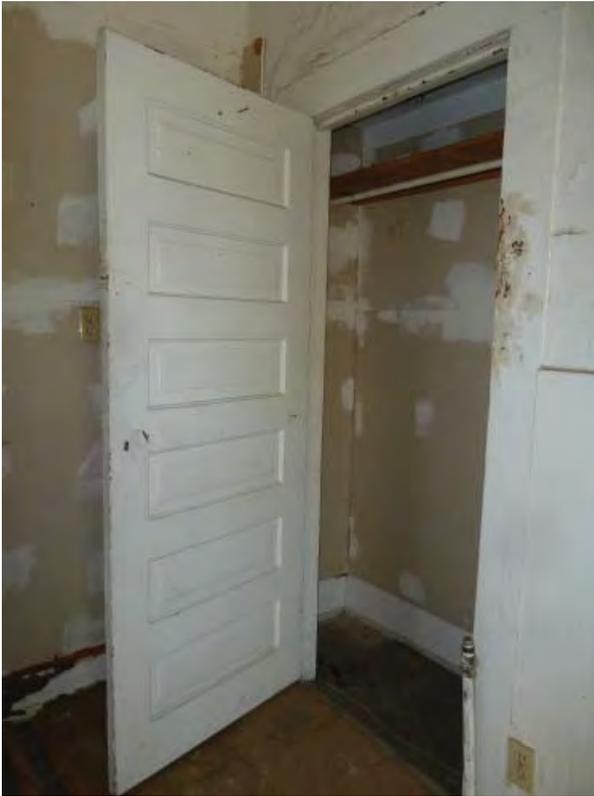
North of the fireplace is an original closet. Gypsum board panels were apparently being applied to its walls and ceiling when the work stopped. The original baseboards and shoe moldings inside the closet remain intact and are good candidates for preservation (Fig. C171 & C173).

Figure C173. Original closet with new gypsum board panels.

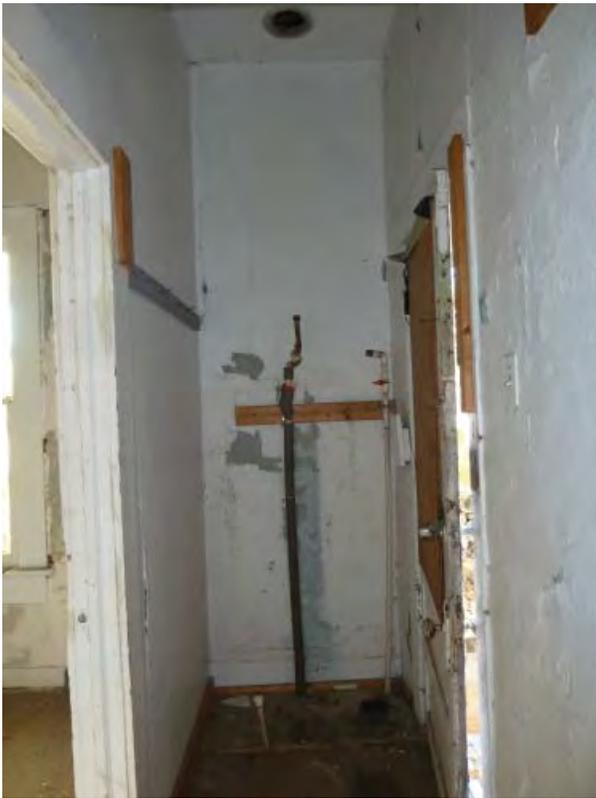
Figure C174. Room 102-B looking south to water heater alcove.

The plaster of the two original (south and west) walls and ceiling appears to be largely intact, except for the opening at the south end of this room above the water heater through which a metal flue vented.

Given the apparently long period of time of water infiltration, there may be unseen water damage to the plaster. Even if damaged, the plaster is a good candidate for consolidation and preservation.

A 6" diameter hole in the ceiling above the water pipes accommodated a water heater flue (*Fig. C174*).

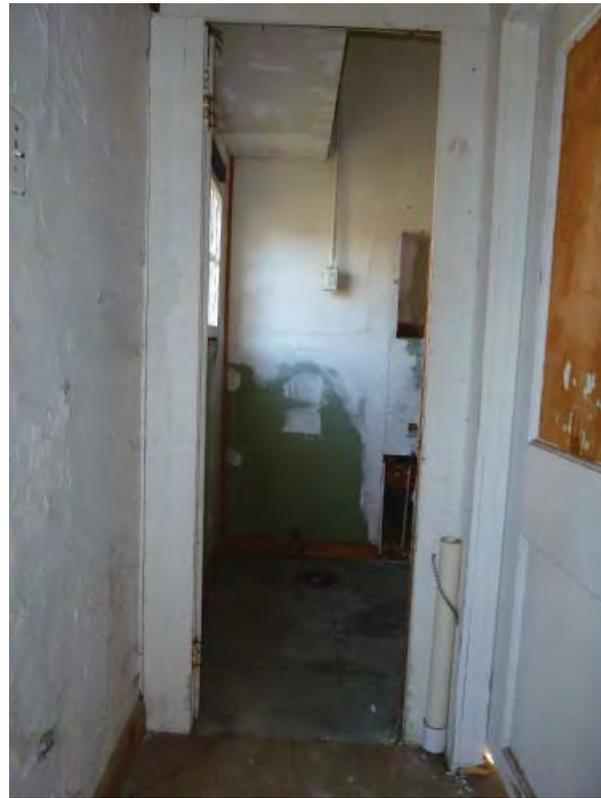
Figure C175. Room 102-B looking north to bathroom.

The 1960s north wall contains the doorway that leads to the Bathroom, Room 102-C. The 2'-0" by 6'-8" door is missing.

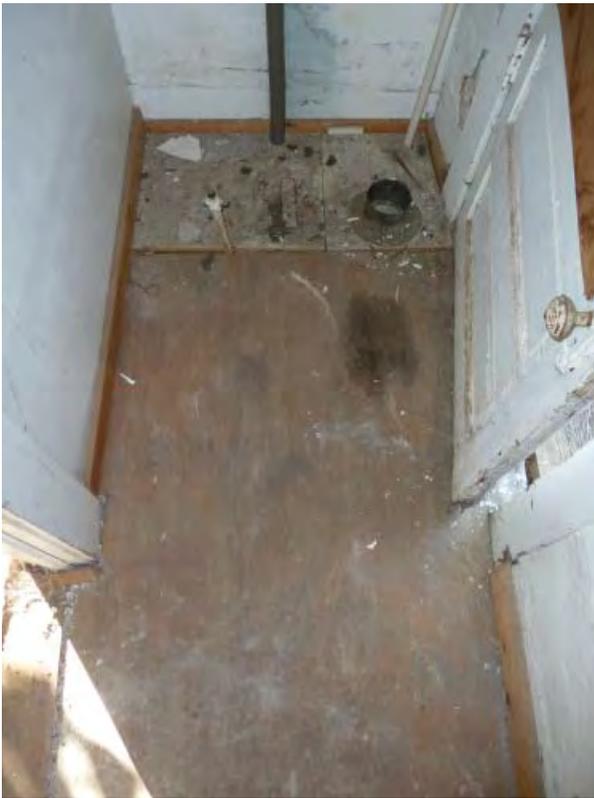
Plywood has been added as flooring, apparently to raise the floor level closer to the height of Room 102-A and to prepare a base for carpeting. Presumably, the original wood flooring remains intact below (*Fig. C176*).

Figure C176. Plywood added to raise level of slumping floor.

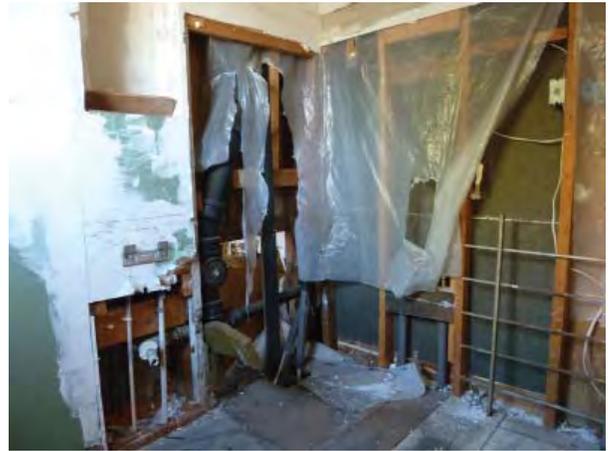
Figure C177. Northeast oblique of Room 102-C.

The lavatory, which was mounted on the north wall between the tub and toilet, is also missing. The PVC supply pipes, installed as part of the remodeling, are also present (Fig. C177).

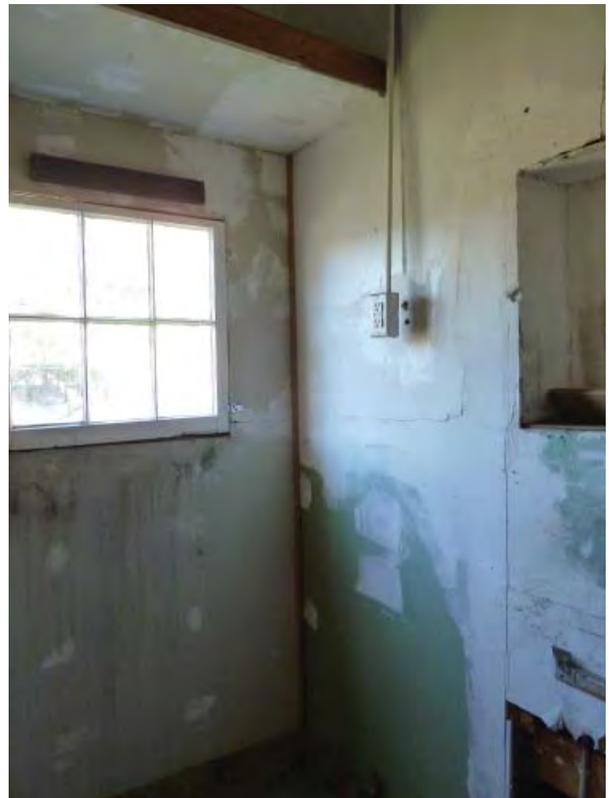
Original plaster does remain on the ceiling. There is a small section of ceiling plaster loss. Wood lath that remains should be retained if sound and reused in replastering. Given the apparently long

Figure C178. Northwest oblique of Room 102-C.

period of time of water infiltration, there may be unseen water damage to plaster still in place. Nonetheless, the areas of both plaster loss and damage are good candidates for consolidation, infill repair and preservation.

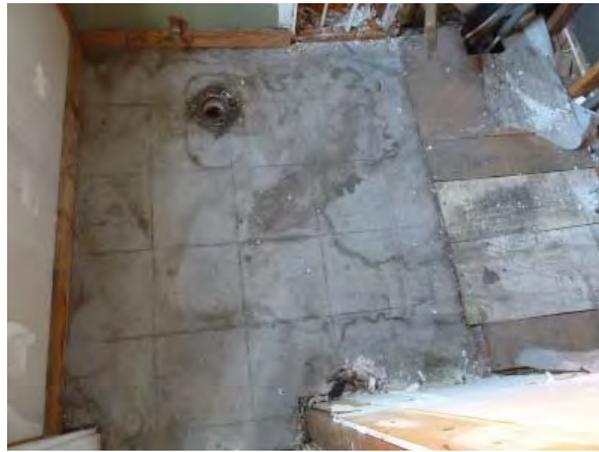
There are remnants of 12" by 12" vinyl tile flooring (Fig. C180).

Figure C180. Synthetic tile flooring.

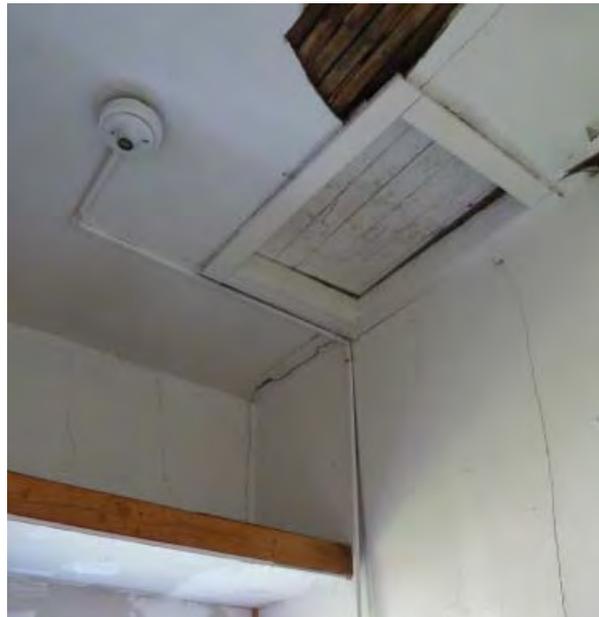
There is a ceiling hatch close to the north wall. The casing and board hatch are made of ¾" by ¾" plank and v-groove boards.

Figure C181. Ceiling hatch and partially constructed shelf along west wall.

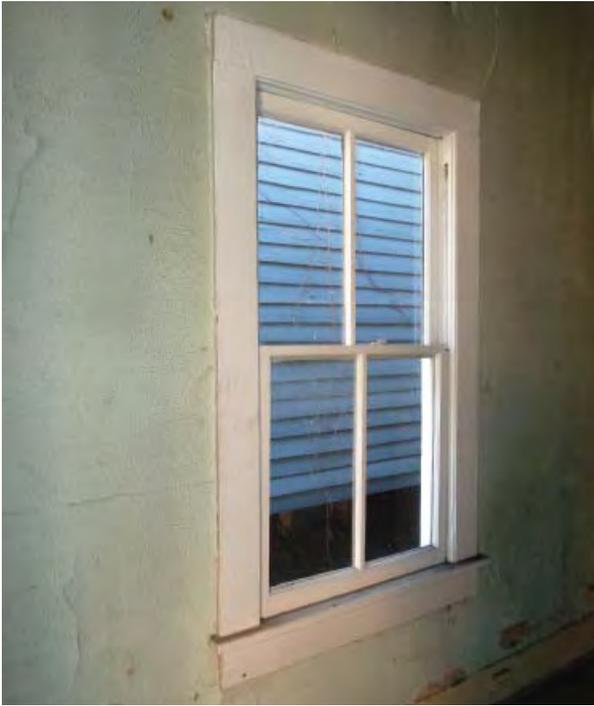
Figure II-3. Typical window design.

- Remove all sash on the west elevation (added in the 1960s) and reinstall a reproduction of

the original double-hung sash window and window hardware. Return all other sash to working order.
