Historic Structures Report
PART III
ON
DOGAN HOUSE
Manassas National Battlefield Park
Architectural Data Section

Prepared by
Orville W. Carroll
June 1962

HISTORIC STRUCTURES REPORT

DOGAN HOUSE

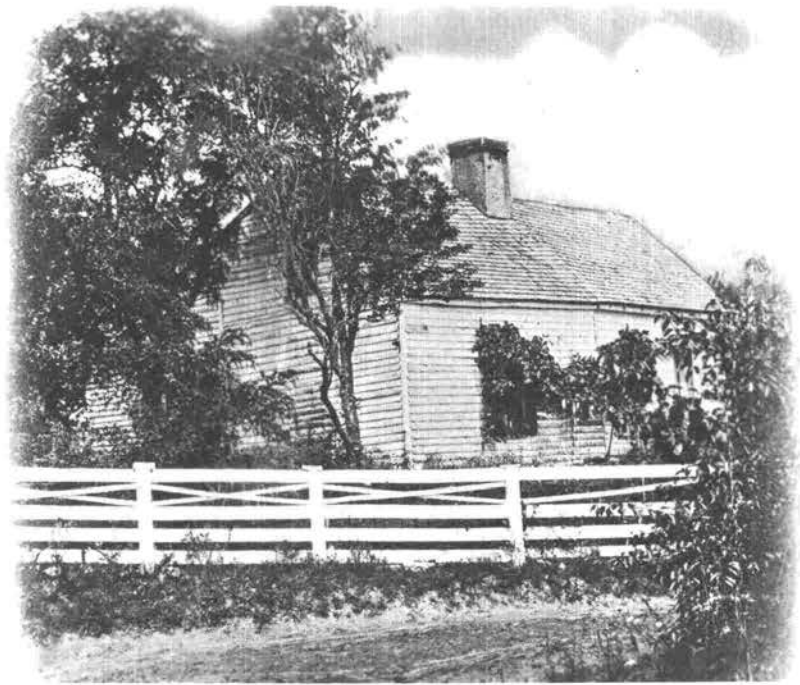
ILLUSTRATION NO. 3

VIEW FROM SOUTHEAST

By the mid-1930's the Dogan House had reached a rapid stage of deterioration. The old house went through a series of various uses such as carpenter shop, chicken house and tenant house. At one time, the Dogan's had planned to convert the house into a "tea-room."

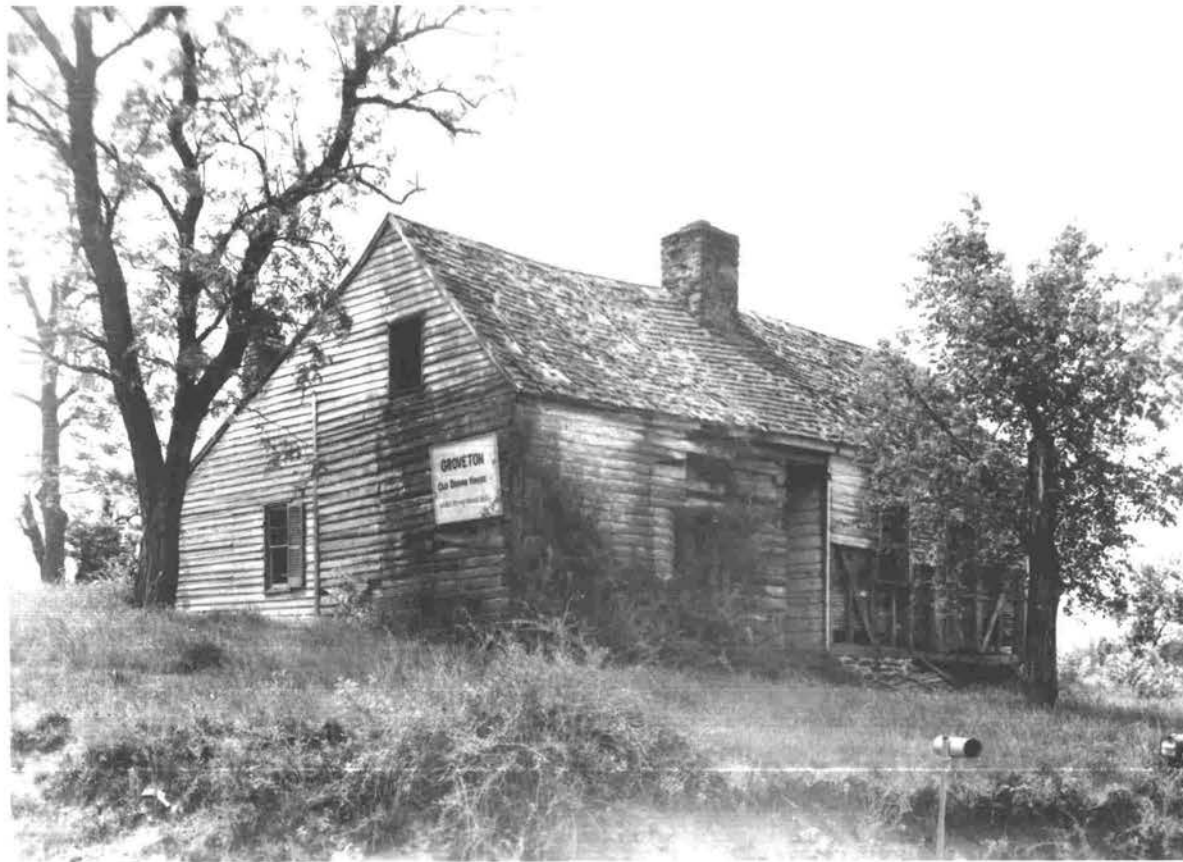
ILLUSTRATION NO. 4

VIEW FROM NORTHWEST

In 1947, the Prince William County Chamber of Commerce purchased the Dogan House and 4914 square feet of land from W. H. Dogan. In 1948, the FWCCC supervised the stabilization of the house by Raymond Cross, carpenter. During this time, the west addition was removed as shown by this photograph. The house was officially deeded to the NPS in 1949.

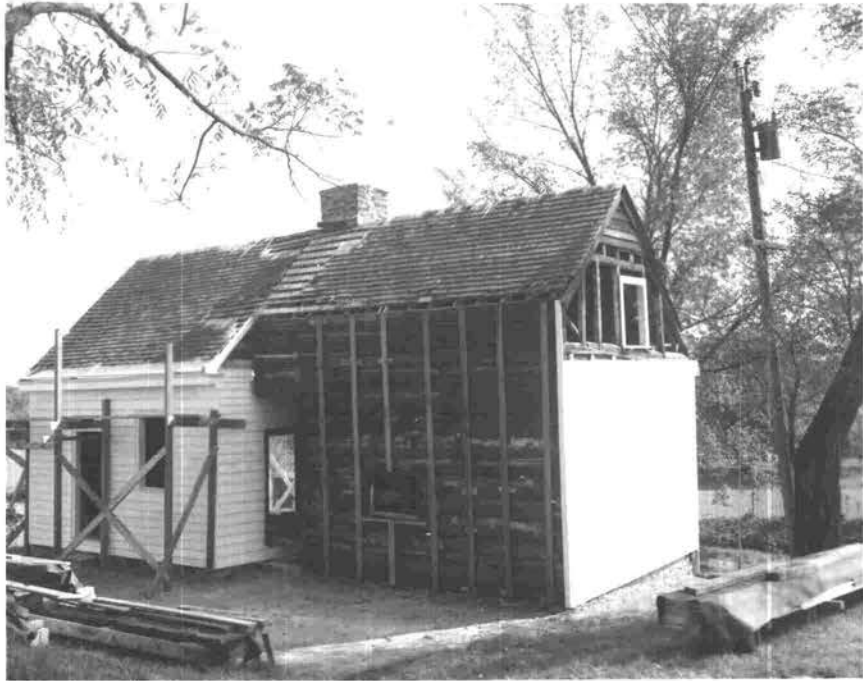
ILLUSTRATION NO. 15

SOUTHEAST VIEW

The historic scene of the Dogan House has now almost become obscure by the introduction of utility poles, steps, mailboxes, the lowering of the adjacent roadbeds and the establishment of a cemetery to the west. The Dogan House is all that remains of the old Groveton Village.

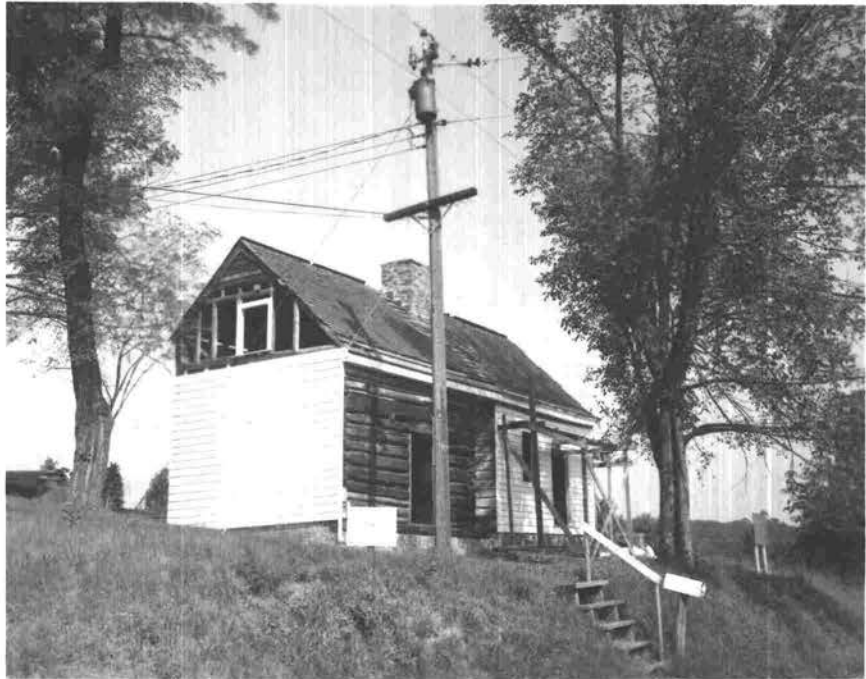
ILLUSTRATION NO. 16

NORTHEAST VIEW

View from the northeast showing the extent of the restoration work, August 27. We were fortunate in finding one window and door frame intact as well as two cornerboards and the cornice (in part) on the east wall of the frame addition. A more accurate restoration might have been possible if the building had not undergone two stabilization jobs in 1948 and 1950. The door opening in the log cabin was proven authentic when a rifle ball was found lodged in the door frame.

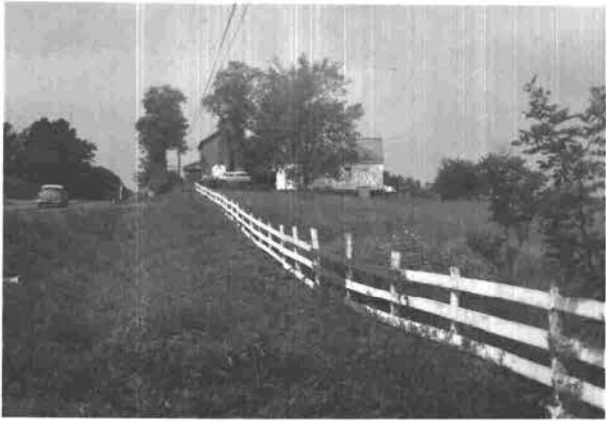
ILLUSTRATION NO. 21

VIEW FROM SOUTHEAST

A view taken from a similar angle as
Illustration No. 2. The restoration of the Dogan
House represents a start in the overall reconstruc-
tion of the Groveton Village setting of 1861.

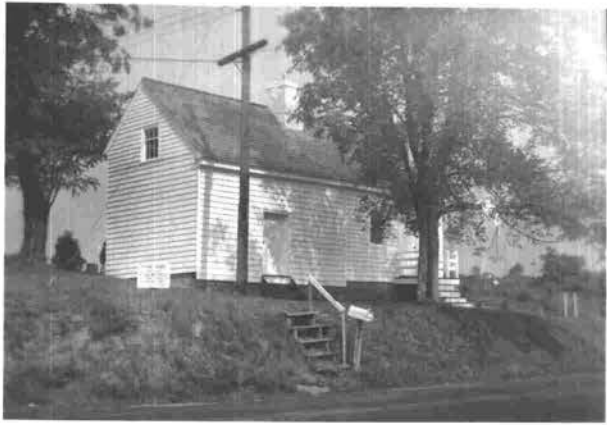
ILLUSTRATION NO. 22

VIEW FROM NORTHEAST

This view shows the exterior finish of the
Dogan House with its final coat of "whitewash" paint.

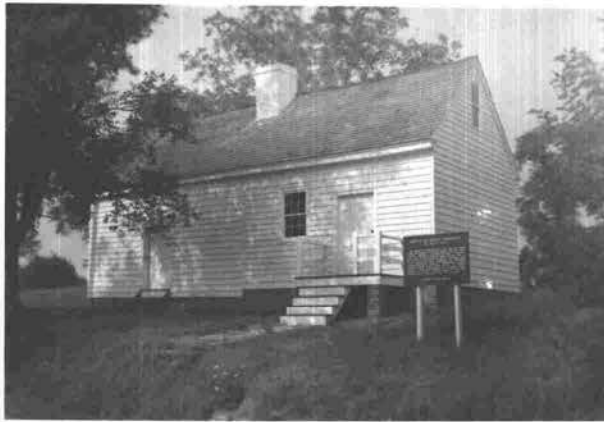
ILLUSTRATION NO. 23

VIEW FROM NORTHWEST

An original door and window frame was found in the west wall of the frame addition covered over during the 1881-82 remodeling. The two openings are shown in this view, restored to their original positions. Both openings are identical to the door and window positions in the opposite wall.

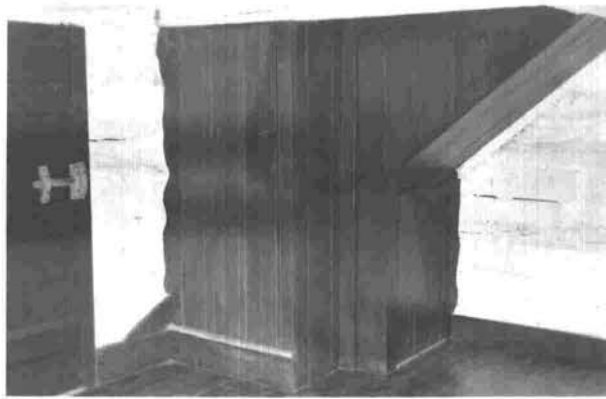
ILLUSTRATION NO. 28

INTERIOR, LOG CABIN
