CONDITION ASSESSMENT and PRESERVATION PLAN
for
Various Structures

Manzanar National Historic Site

DECEMBER 31, 2000

Mark L. Mortier
Historical Architect

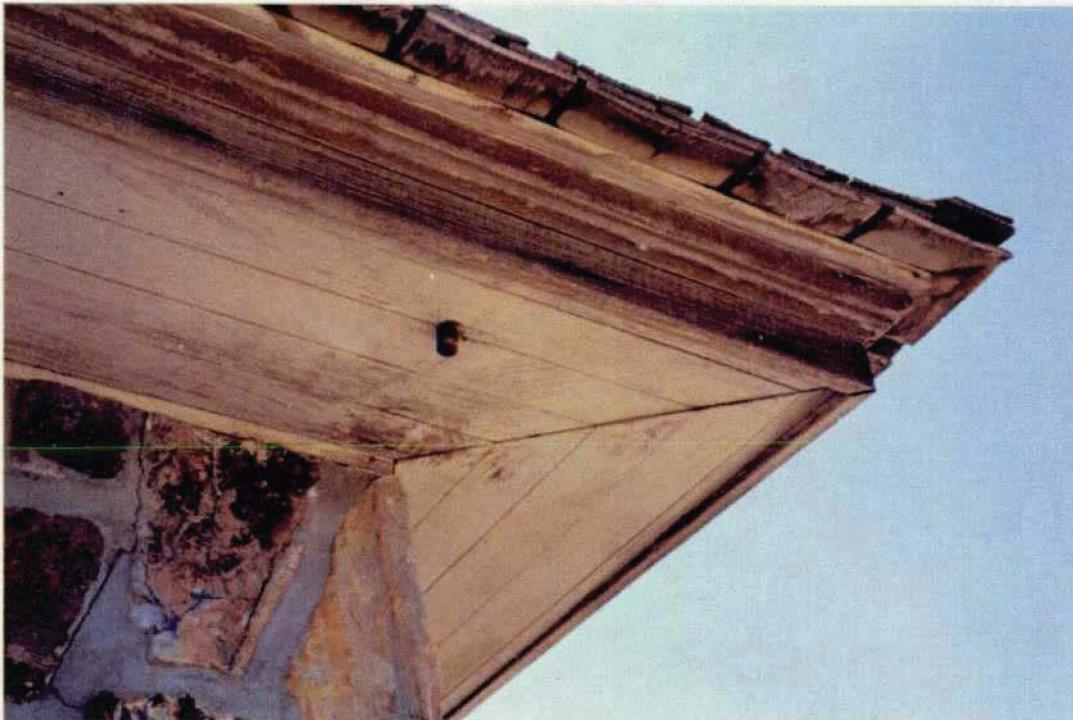
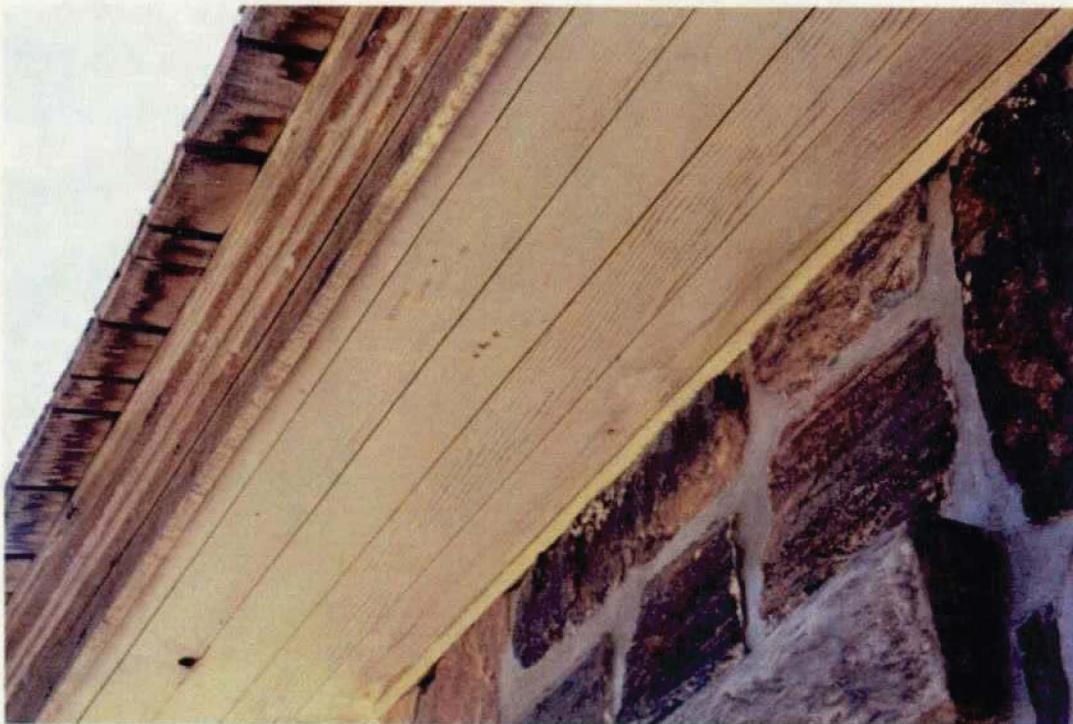
Exterior Trim: The exterior trim is in fair to poor condition. It is weathered, warped, cracked, and dried out.

Detail at Military Sentry Post Roof Overhang

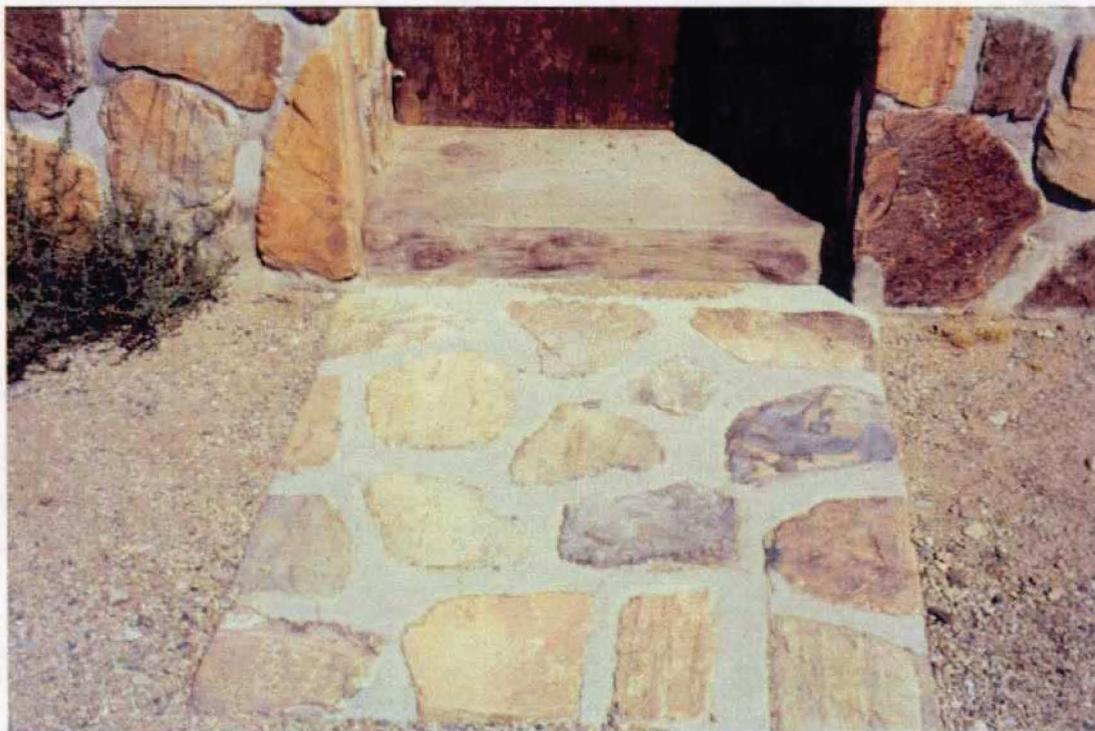
Detail at Military Sentry Post Stone Stoop

The grade at the stoop in the east has eroded and has exposed the sides and bottom of the stoop.

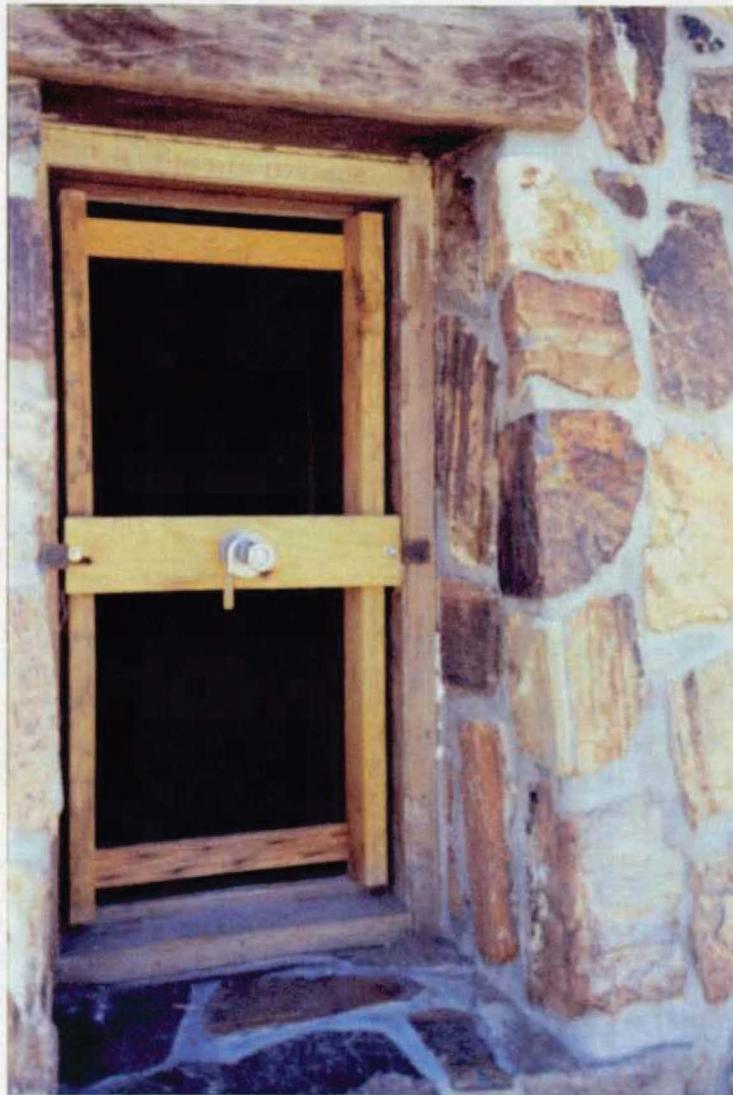
Overall, the building is in fair to good condition. It was mothballed in 1992, but adequate provisions were not made for ventilation, prevention of insect infestation, or to provide access to the interior. The roof was also repaired in 1992, by replacing damaged or missing shingles.

Detail at Military Sentry Post Mothballed Window
