CONDITION ASSESSMENT REPORT
SPRUCE TREE HOUSE ALCOVE
SANDSTONE ARCH
MESA VERDE NATIONAL PARK
MESA VERDE, CO

James A. Mason, Ph.D., P.E.
Structural, Geotechnical, and Preservation Engineer
Vanishing Treasures Program
National Park Service
Mesa Verde National Park, Colorado
January 19, 2016

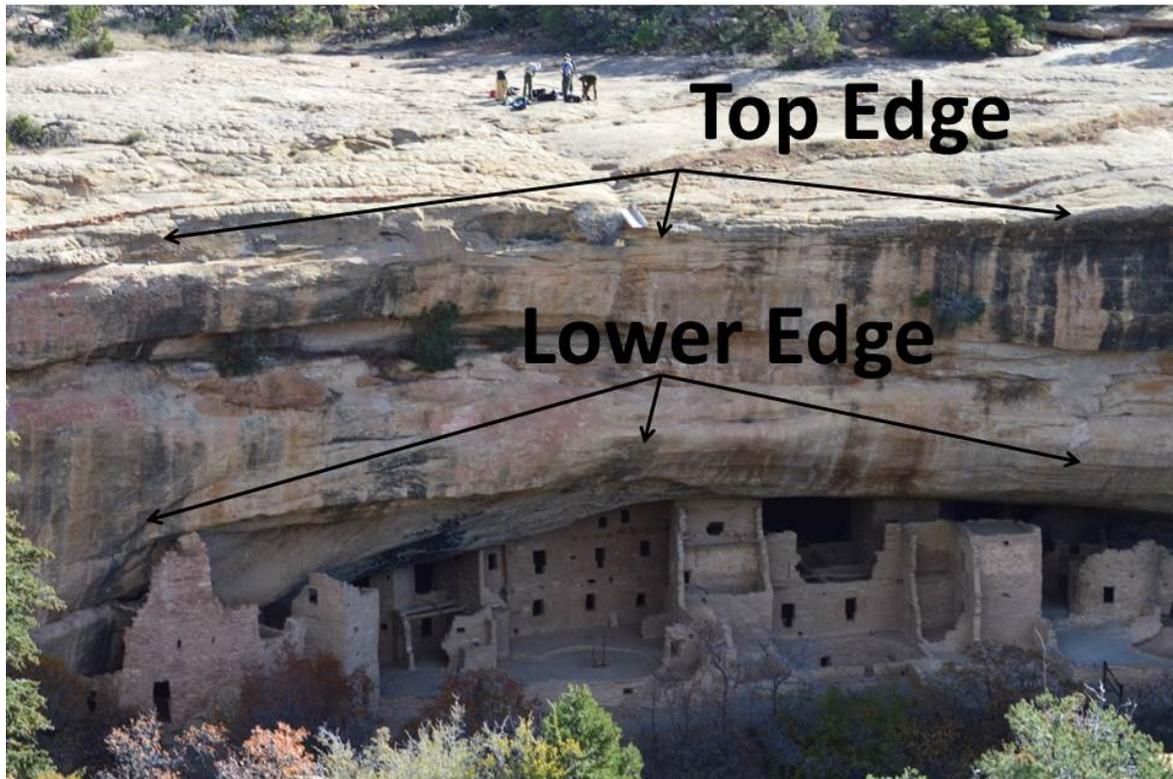
A scaling operation was conducted in early November 2015 by the NPS Climbing Team. See Figure 11. These professional climbers took two days establishing anchorage under the top edge of the alcove roof. The alcove roof top edge extends approximately 15 feet past the alcove lower edge. The majority of the suspect spall material was in-between the upper and lower edges. Thus, they had to install rock climber bolts under the top edge as restraint points to safely hang off the rock face while cleaning loose material. Numerous rappel drops were

made to install these devices because of the extremely limited access. Once the bolts and carabiners were installed, the climbers could progress across the rock ledges and methodically and safely remove the loose spall material, which had presented a hazard to people below. Still it was acknowledged that another scaling session is required to remove more material.

Figure 11. NPS Climbing Team preparing for initial placement of climbing anchors.
(photo: Mason, 2015)

The confirmation of rock anchor locations was completed in the office with high definition photographs. The rest of the objectives were completed in the field. Potential small rock spall hazards that could be reached by the climbers were removed. The large sliver will require pinning with rock bolts to prevent it from falling. The abutments were photographed and will

be included into the proposed detailed numeric analyses. The rock joint material was confirmed to be composed of silt. The grout plug was intact, but loose in several locations.
