JOHN NELSON HOUSE AND BARN

Minute Man National Historical Site
Lincoln, Massachusetts

**DOCUMENTATION of PHYSICAL
EVIDENCE 2009-10**

Prepared By:
James J. Lee III
Architectural Conservator
Historic Architecture Program
Northeast Region, National Park Service
Lowell, Massachusetts

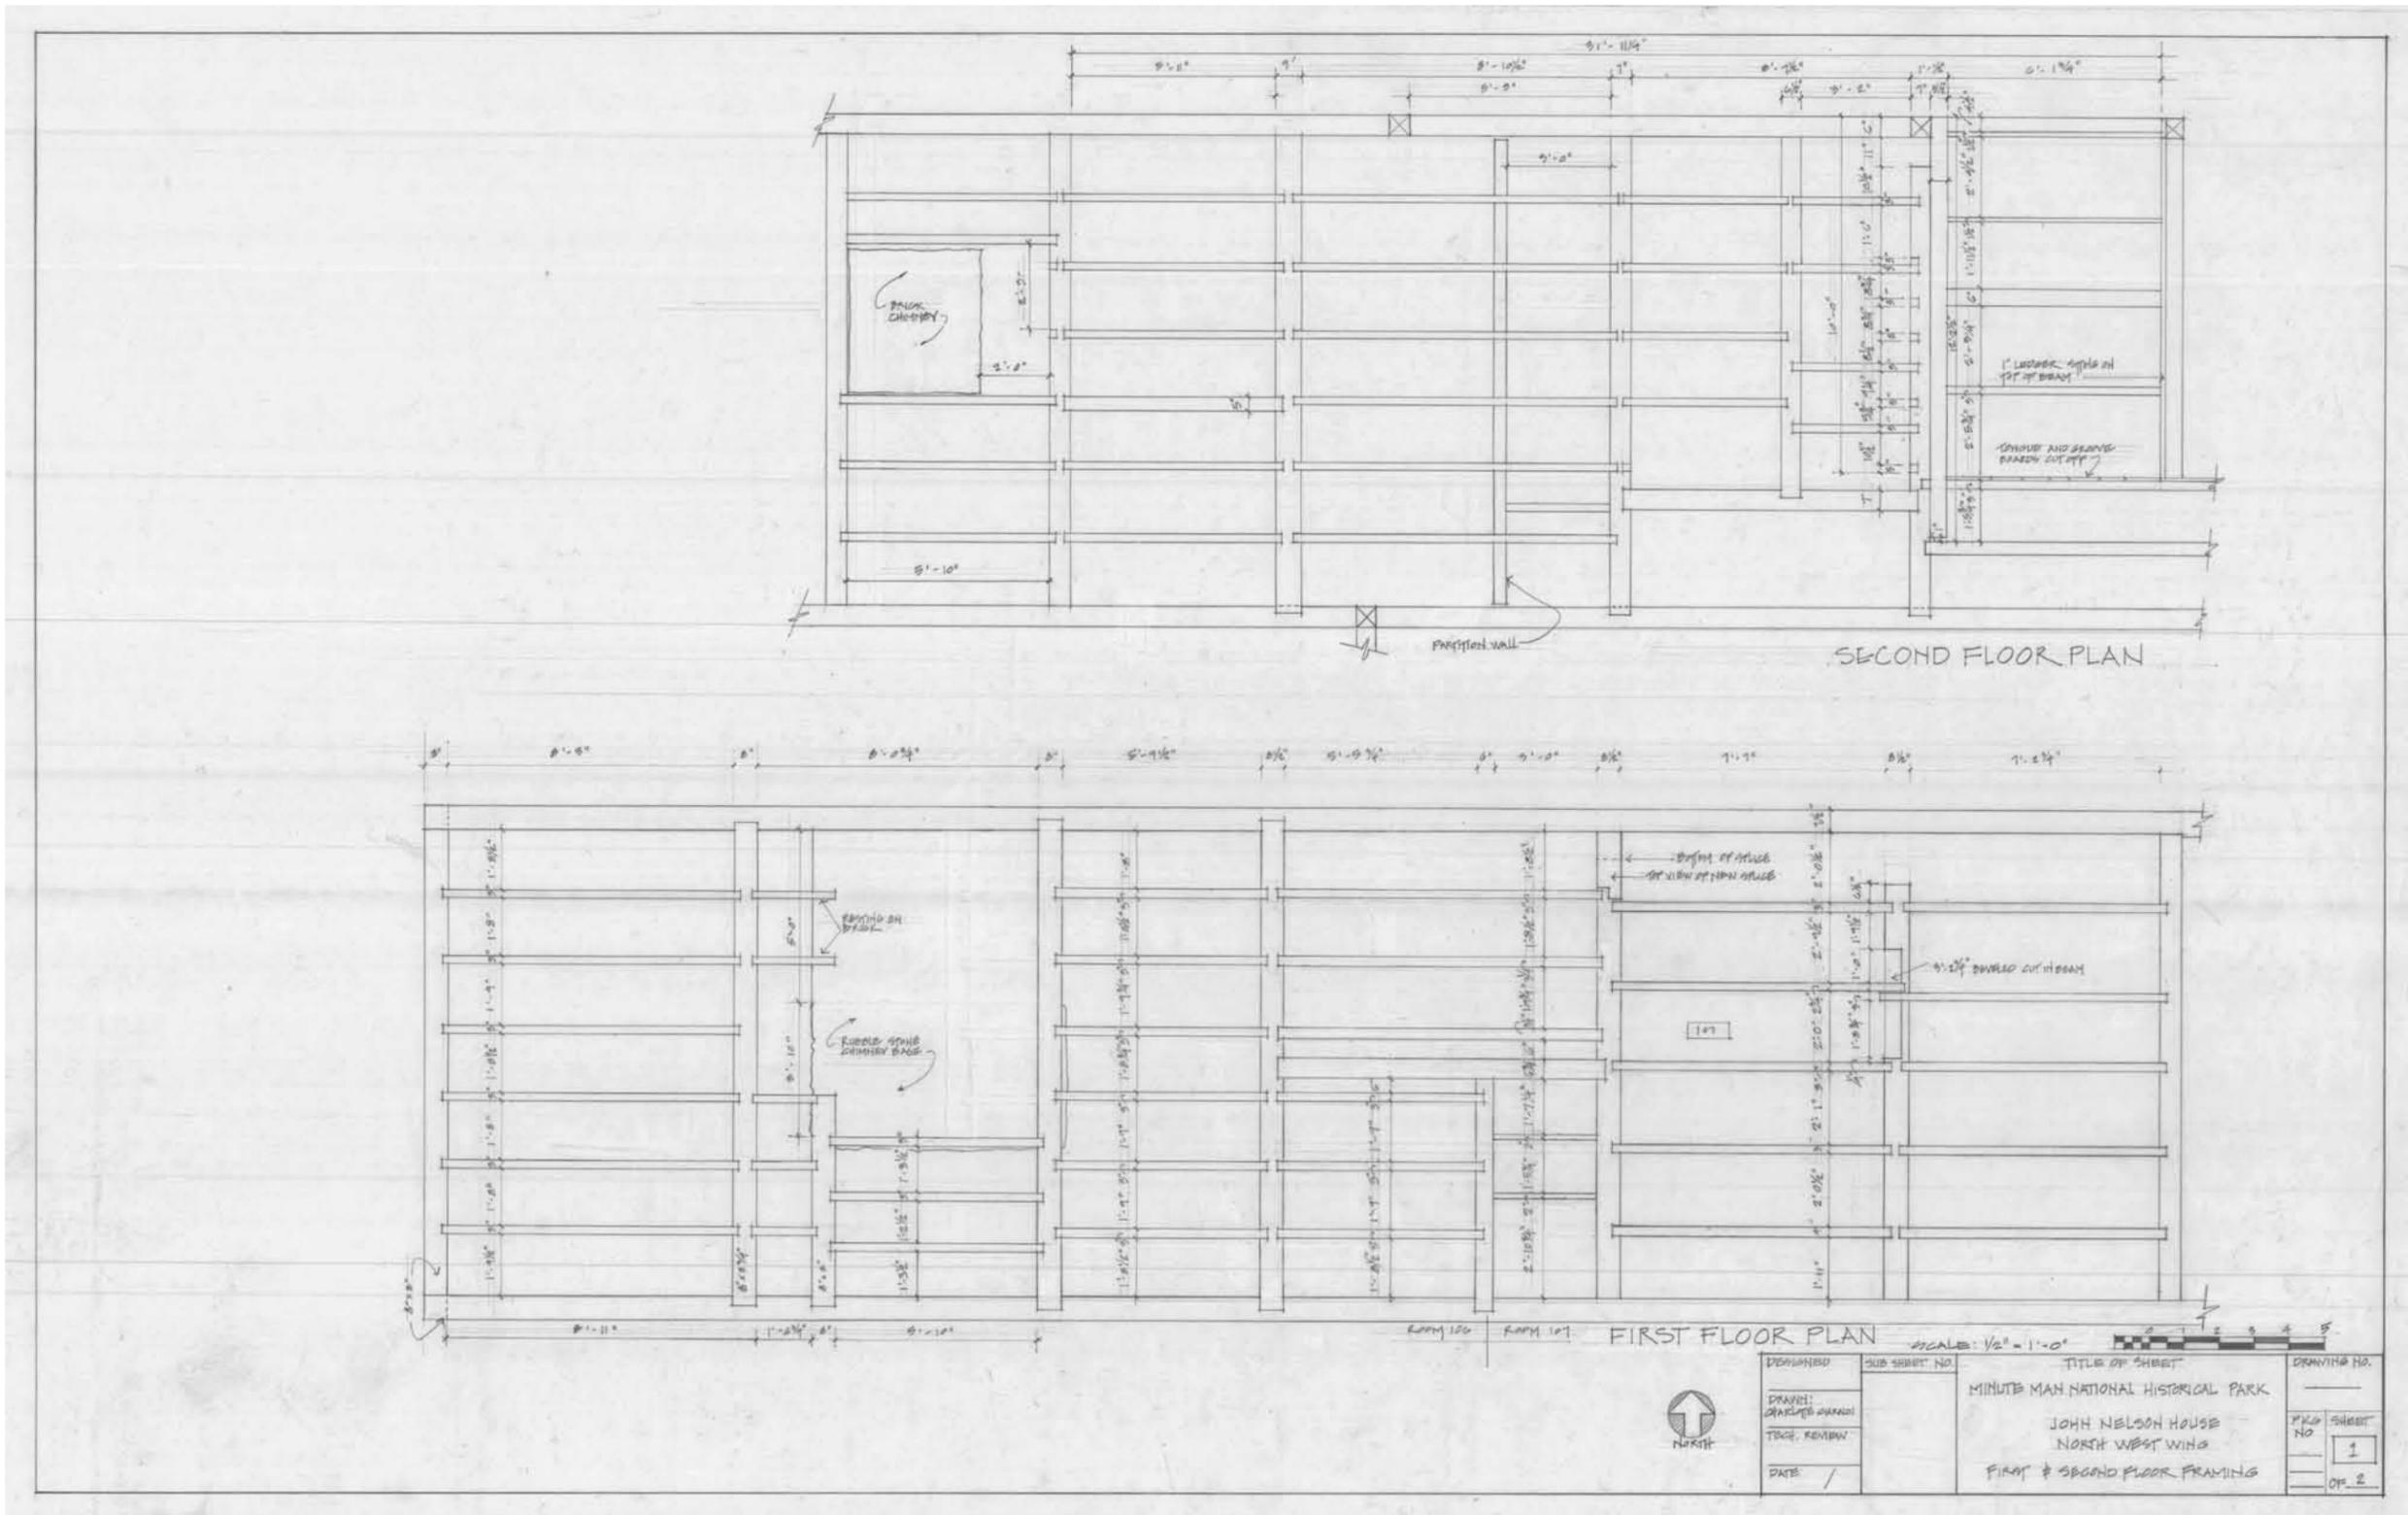
Drawing 1. Minute Man National Historical Park, John Nelson House, Northwest Wing, First and Second Floor Framing, C. Ciaraldi, 12/2010.

Significant portion of the framing had been previously repaired and much of it required repair during the current rehabilitation. The lower walls were a combination of undersized 4-inch-by-6-inch replacement sills, deteriorated studs with scabbed on sistering, and deteriorated posts (fig. 13); the upper walls were framed with 2-inch-by-4-inch lumber, and the roof was framed with 2-inch-by-6-inch rafters and ridge. The floor in Room 109 was

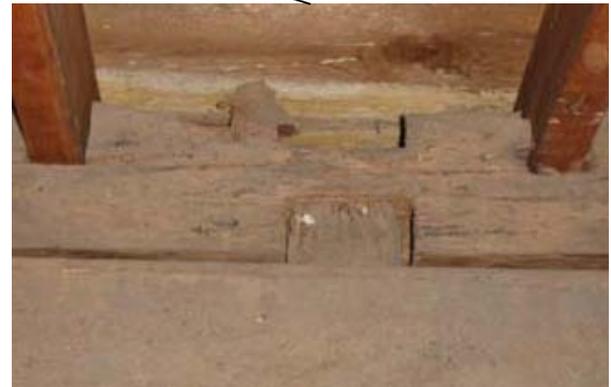
The second story north and east girts of the eighteenth-century structure were documented and the physical evidence indicated that the portion of the building had been larger. The extant ceiling joists are mortised into south face of the north girt and there are corresponding open mortises on the north side of the timber (figs. 10a and 10b). That evidence suggested that the structure had at least an additional bay north of the present north wall. Open mortises on the east-end girt indicated where the timbers framing the roof were located and open mortises on the east face suggested some portion of the structure extended east (fig. 11). There was no further evidence that indicated the extent of the extensions to the building.

Figure 10b. John Nelson House, eighteenth-century structure, Room 209, north girt with mortised joist and corresponding open mortise, 2010.

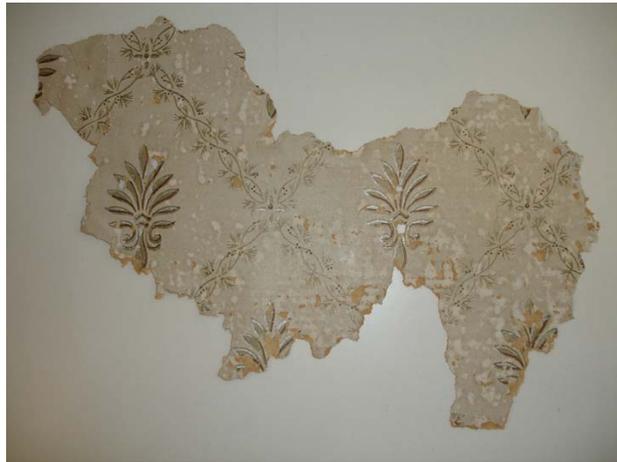
Figure 14b. John Nelson House, Room 102, wallpaper removed from west wall.

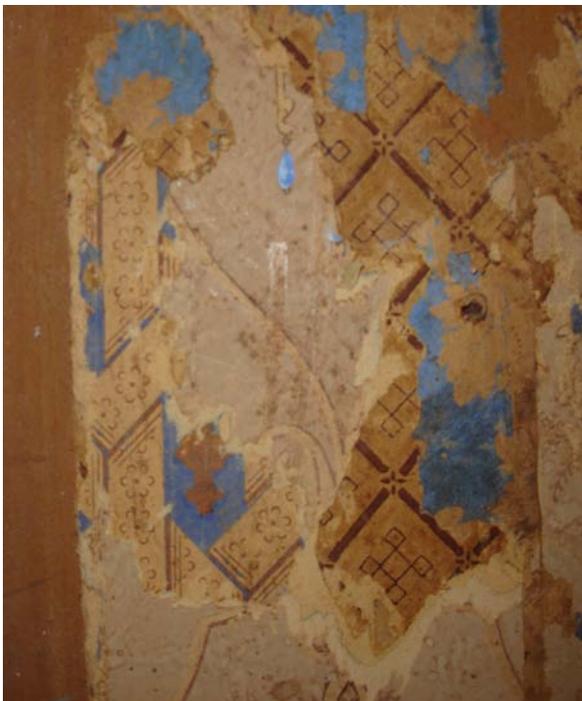
Figure 18. John Nelson House, Room 107, wallpaper remnants (layers 2 and 3).

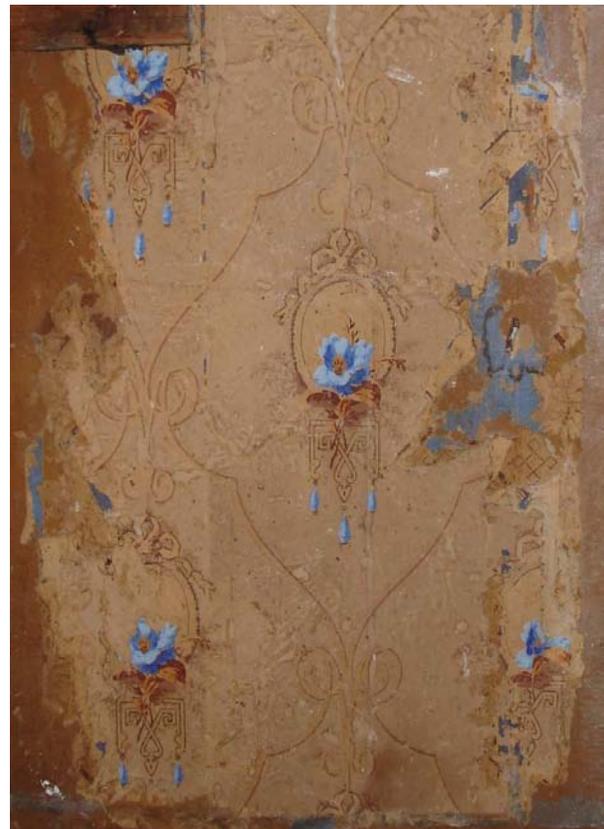
Figure 19. John Nelson House, Room 107, fourth layer of wallpaper (layer 4).

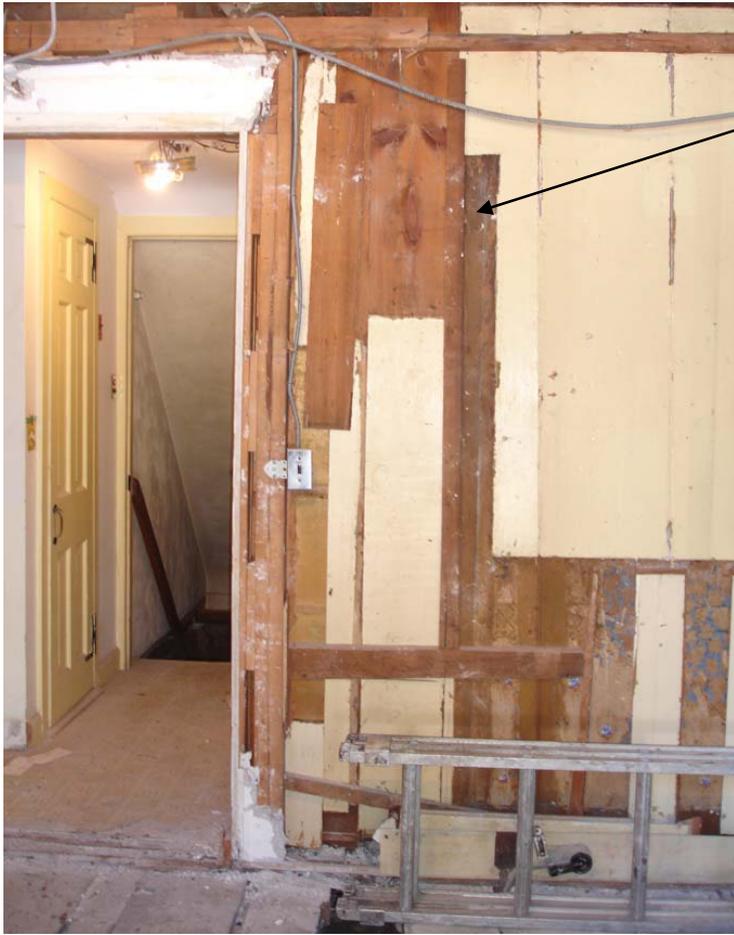
Examination of the south vertical board wall indicated that the staircase to the second story had been altered. At the east end of the board wall was evidence of an earlier doorway from the staircase (fig. 20). Further examination of the staircase determined that the bottom of the staircase had been constructed with winder stairs that turned north and landed in Room 107. The alterations had straightened the staircase and closed off the doorway.

Figure 20. John Nelson House, Room 107 south vertical board wall, showing scars of earlier opening to winder staircase.

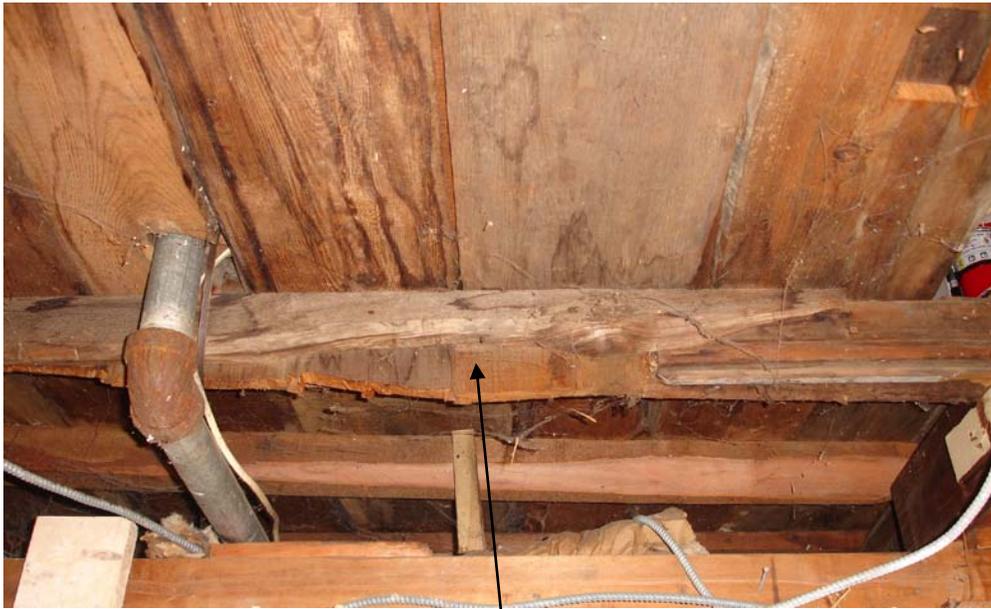
Near the southeast corner of Room 107 was evidence of a vertical board wall that had extended east-west about three-and-half feet north of the 1808 block of the house. The vertical boards had been cut off near the ceiling and only the ends remained attached to the framing (fig. 21). The location of the board wall suggested a hallway extended along north wall of the main block, perhaps as access to the basement at one time. The presence of the wall also supported the evidence that the finish and framing in the bay north of that wall was a later alteration (see previous section “Structural Elements”).

Figure 21. John Nelson House, Room 107, remains of vertical board wall near southeast corner.

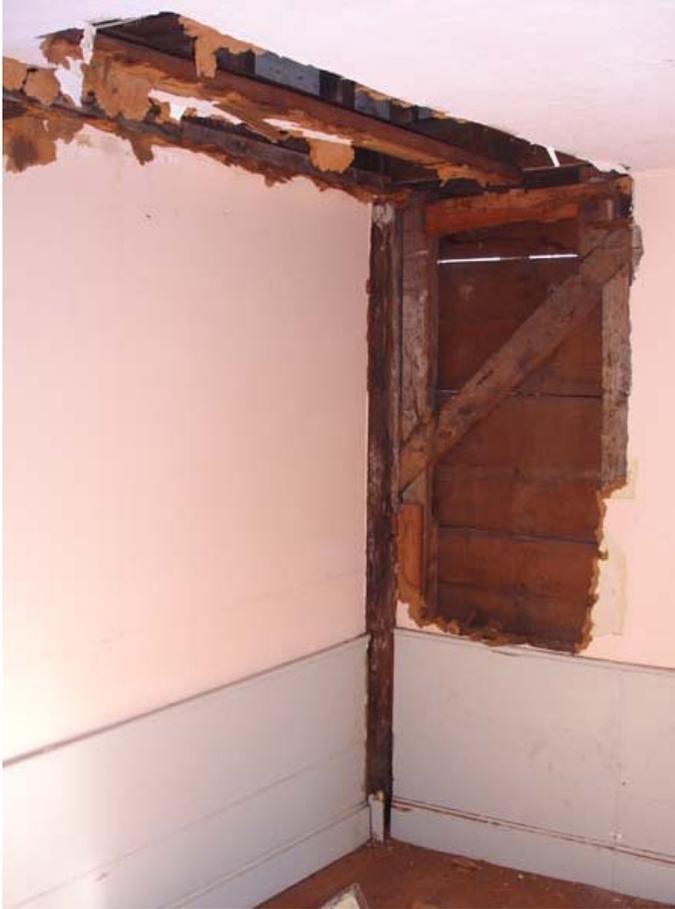
The building materials in Room 108 were not significantly altered during the rehabilitation of the John Nelson House. Removal of particle board in the northeast corner of the room did confirm the presence of an earlier staircase in that corner (fig. 23). Tucked in the ceiling at the west end of the staircase opening was the bowl of a clay pipe (fig. 24). Since the ceiling materials were accordion lath and plaster that were consistent with the 1808 main block, it appears that the clay pipe bowl was deposited sometime after the early nineteenth-century alterations.

Figure 23. John Nelson House, Room 108, northeast corner location of earlier staircase.

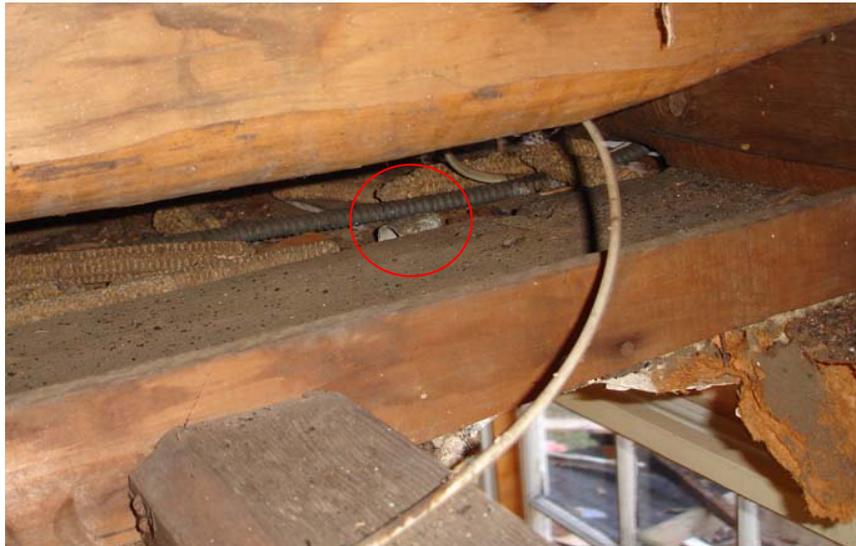
Figure 24. John Nelson House, Room 108, location of clay pipe bowl in ceiling near staircase header.

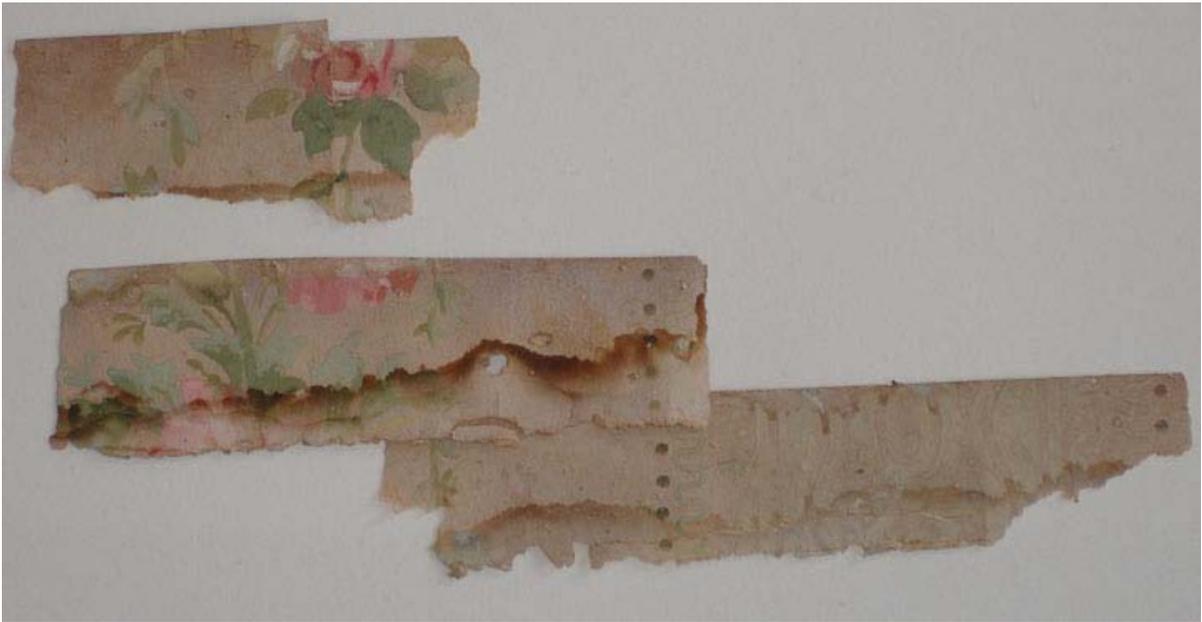
Remnants of wallpaper were removed from Room 202 and Room 207. The wallpaper in Room 207 was machine printed on a wood pulp paper. It included a floral pattern with pink roses and green vines and an alternating pattern with faint green design that included medallions between undulating stripes (fig. 25).

Figure 25. John Nelson House, Room 207, wallpaper remnant.

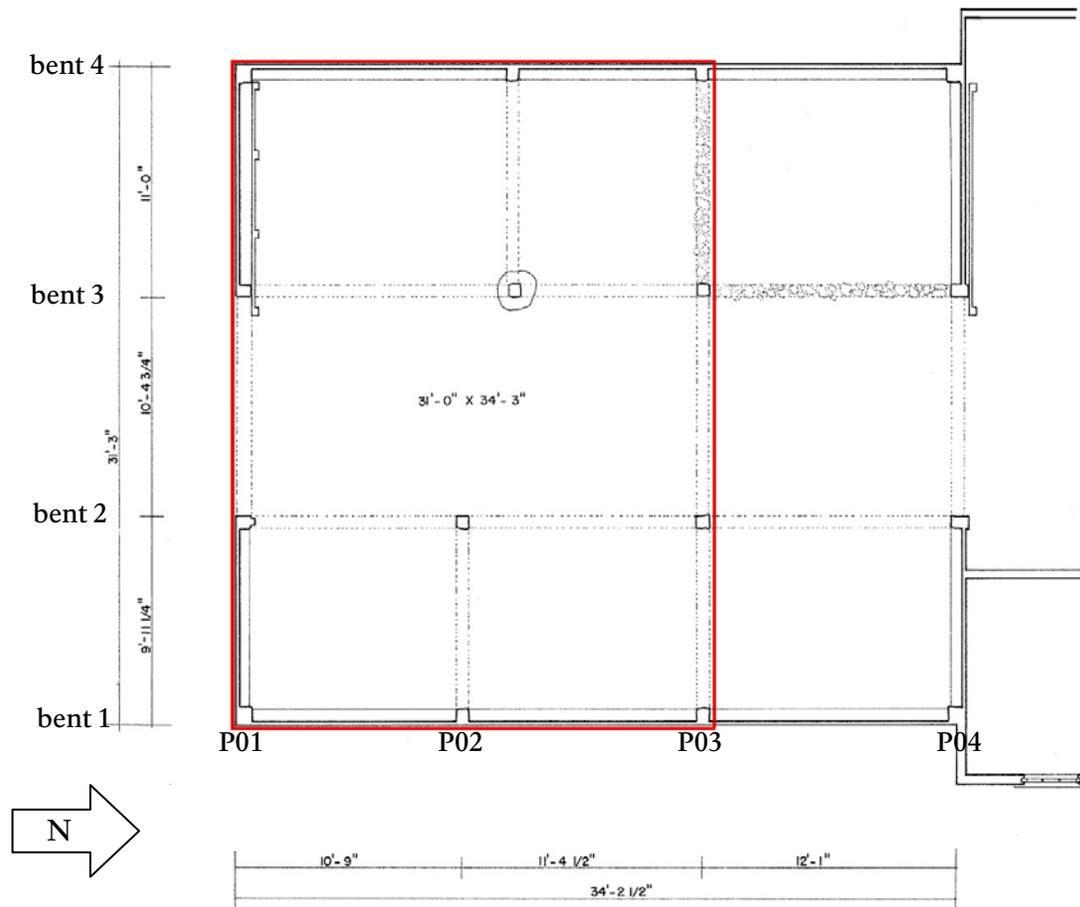
Preliminary observations determined that the historic core of the John Nelson Barn had been three bays long (east-west) and two bays wide (north-south), with the gables on the east and west elevations, and the main doorway on the south elevation. It appeared that the historic barn had been constructed with four bents (east-west, fig. 27) that created the bays, including a center drive-up bay (fig. 27). This was similar to the current configuration of the main block, but smaller.

The previous research indicated that the barn was added to in circa 1836, based on an increase in the assessed value of the barn. The physical evidence suggested that this addition included raising the roof of the main block of the barn to its current height and adding a section three bays long and one bay wide to the north side of the historic barn. The expanded barn resembled the current configuration of the main block of the barn (fig. 27).

Figure 27. John Nelson Barn, main block with red outline indicating historic core of barn with labeled bents and posts. Plan copied from HABS drawing (not to scale).

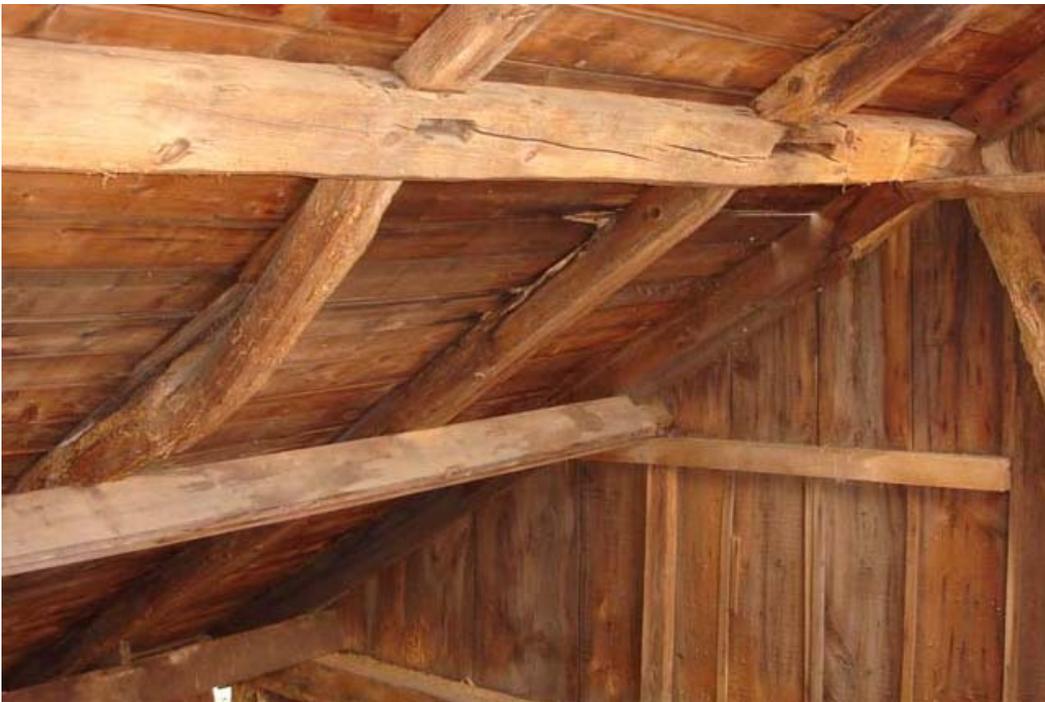
The historic configuration of the barn was evident from certain extant framing members. On the south slope of the roof what is now an intermediate purlin (about two-thirds of the way to the current ridge) was determined to be the ridge of the historic barn. It is a five sided continuous timber with continuous rafters extending to the south plate and open mortises on the north side where historically rafters would have extended to the north plate (figs. 28 and 29). There are also wind braces from some rafters to the south side of the historic ridge, and again, corresponding open mortises on the north side (fig. 28). In addition, the framing of the south wall is similar to the intermediate north section of framing, suggesting that it was historically the north wall. This was most evident in the construction of the plate. On the south wall the plate overhangs the posts of each bent and is tenoned into girts that also extend beyond the posts (fig. 30). The north intermediate section of framing is framed in the same manner (fig. 31). That framing did not seem appropriate for an interior section of framing, but when compared to the south wall it became evident that it was historically framed as the north wall of the barn. That framing also aligned with, and supported the

Figure 29. John Nelson Barn, historic 5-sided ridge with open mortises.

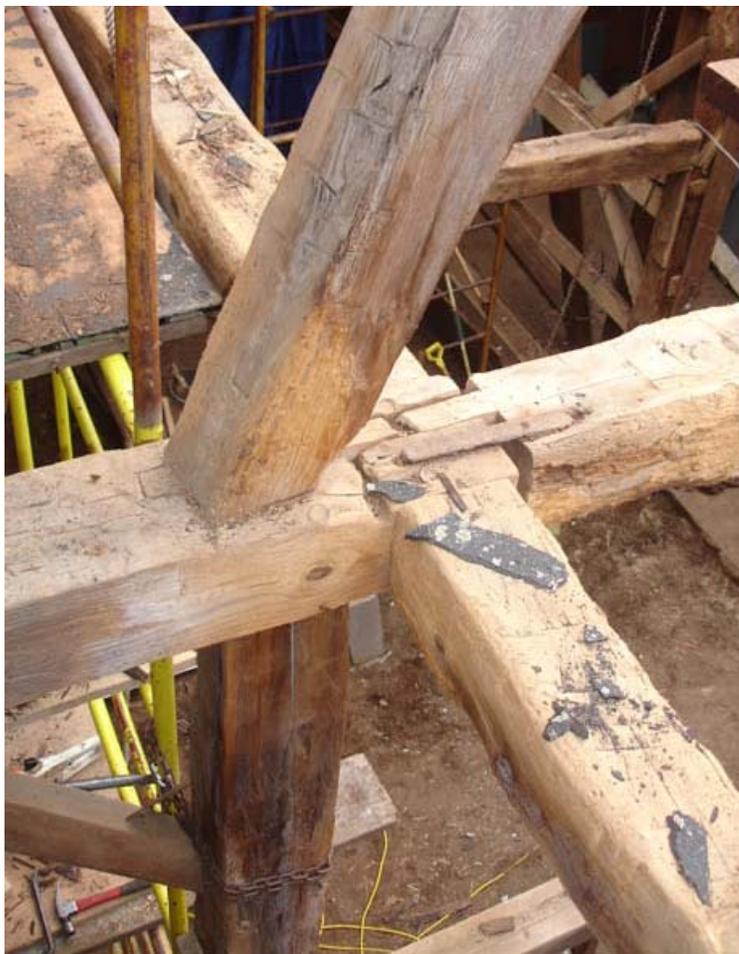
Figure 31. John Nelson Barn, showing overhanging girt and earlier north plate above P03, bent 2.

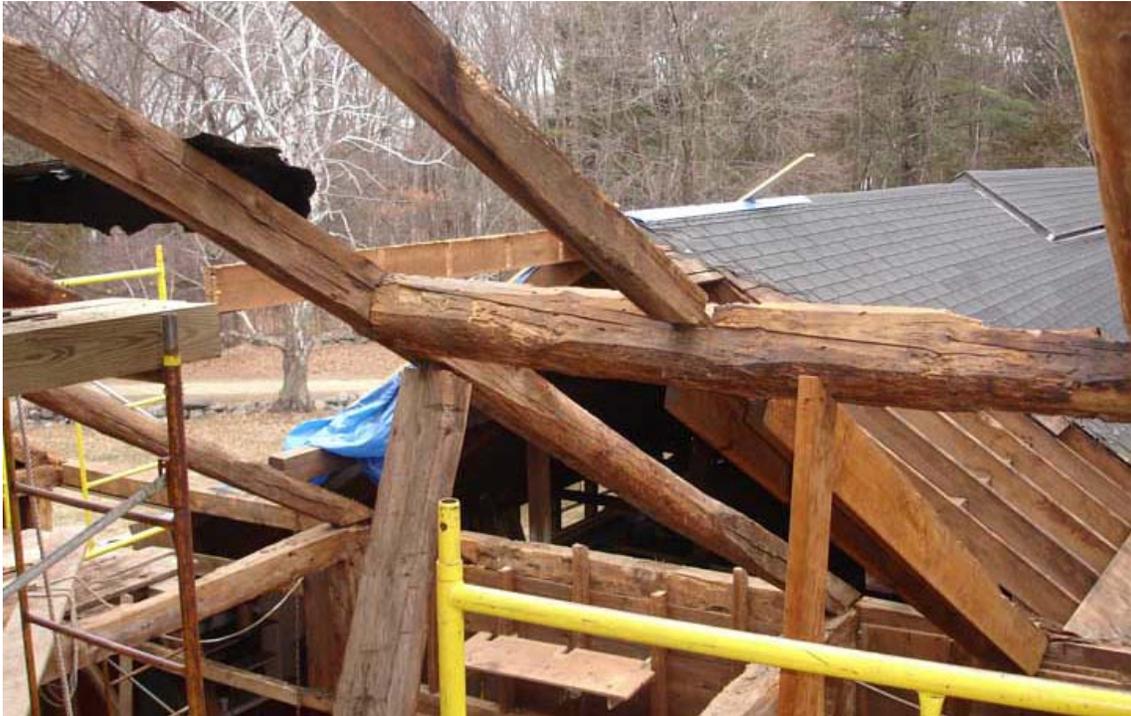
The framing of the roof was indicative of the circa 1836 addition to the barn. On the south slope of the roof rafters spanned from the historic ridge up to the new five-sided ridge. The north slope of the roof was framed with continuous primary rafters at each of the four bents with principle purlins spanning the rafters at about two-thirds of the way to the ridge (fig. 32). Secondary rafters extended from the ridge to the purlins and from the purlins to the north plate. Though similar to the south slope framing, the north slope was different in that there are primary rafters at each bent, where as the framing of the historic barn roof precluded having continuous rafters from the new ridge to the south plate without reframing the south slope.

Figure 32. John Nelson Barn, north roof with continuous rafter and purlin.

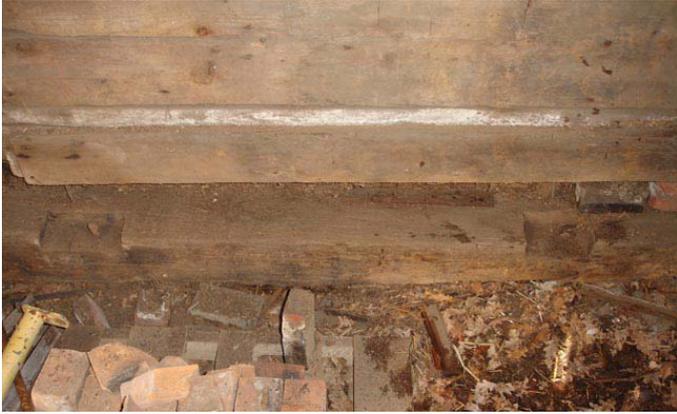
Figure 34. John Nelson Barn, southwest bay, open mortises in sill.

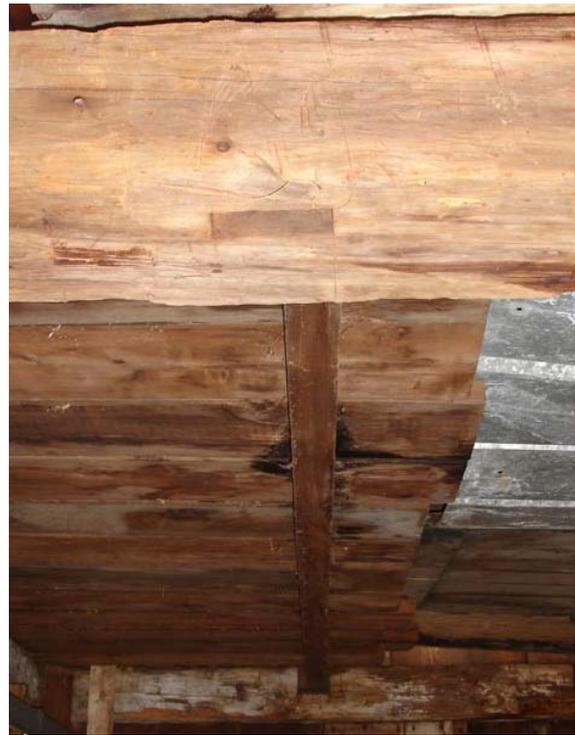
Figure 35. John Nelson Barn, southwest bay, open stud mortise in beam.

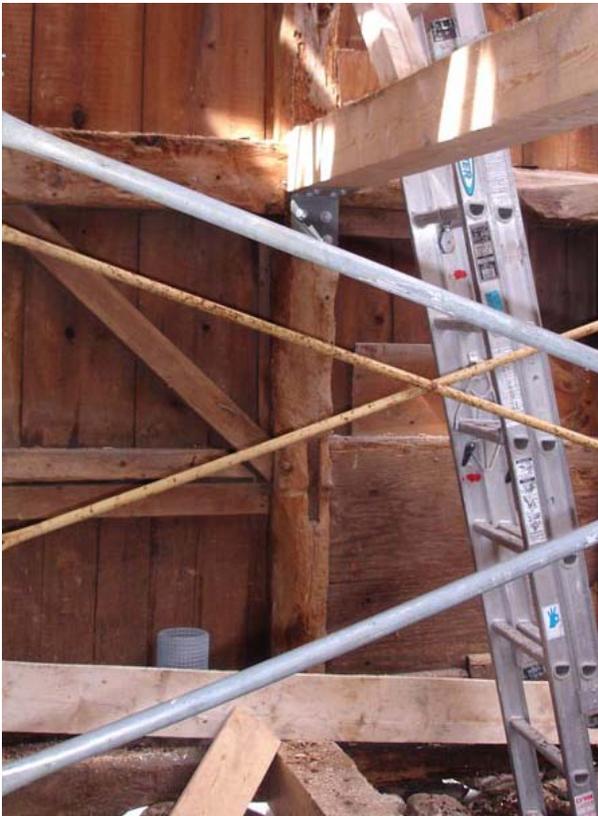
Figure 36. John Nelson Barn, west wall, P03, bent 4, open mortise and extant framing.

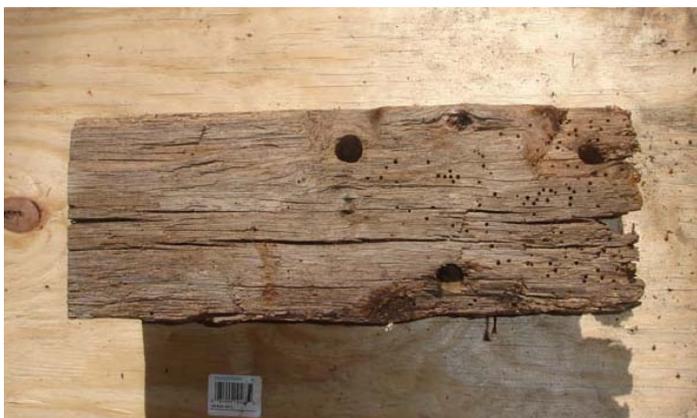
Figure 37. John Nelson Barn, bottom section of P01, bent 3 removed, showing holes with chiseled ends, possibly for earlier pintles.

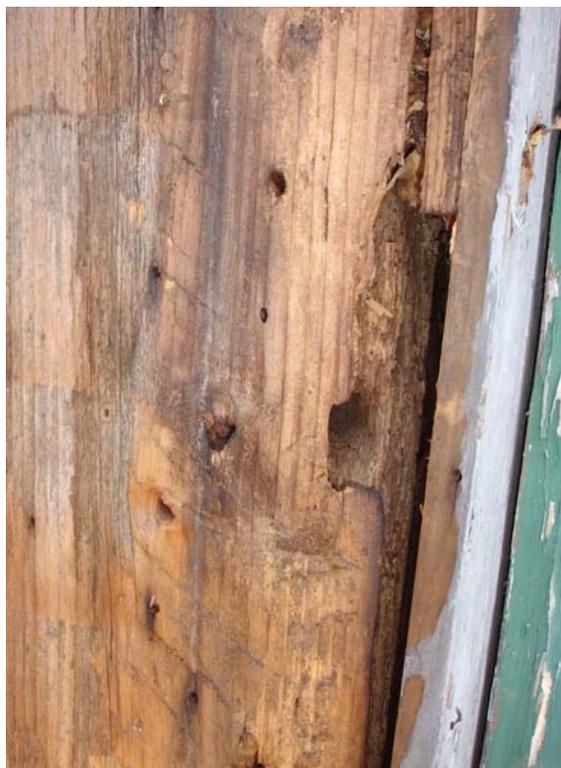
Figure 38. John Nelson Barn, top of P01, bent 3, showing hole possibly for earlier pindle.

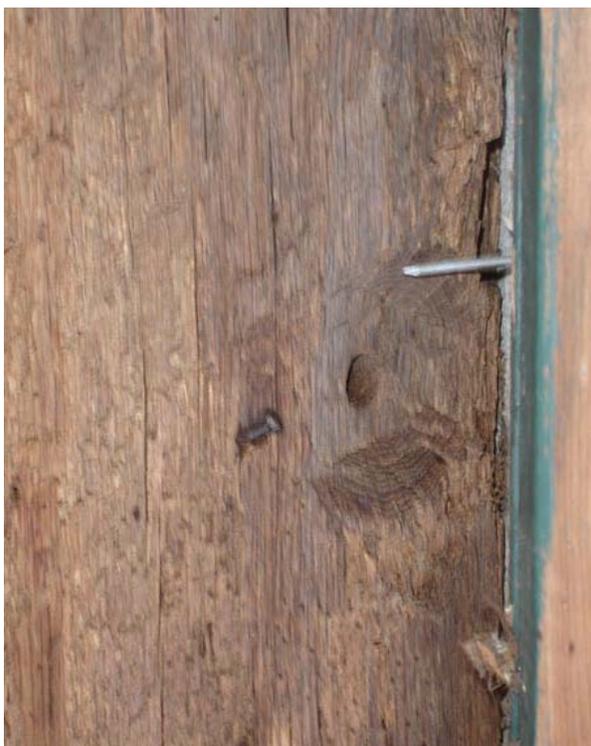
Figure 39. John Nelson Barn, top of P01, bent 3 interior, showing hole with chiseled end, possibly for earlier pindle.

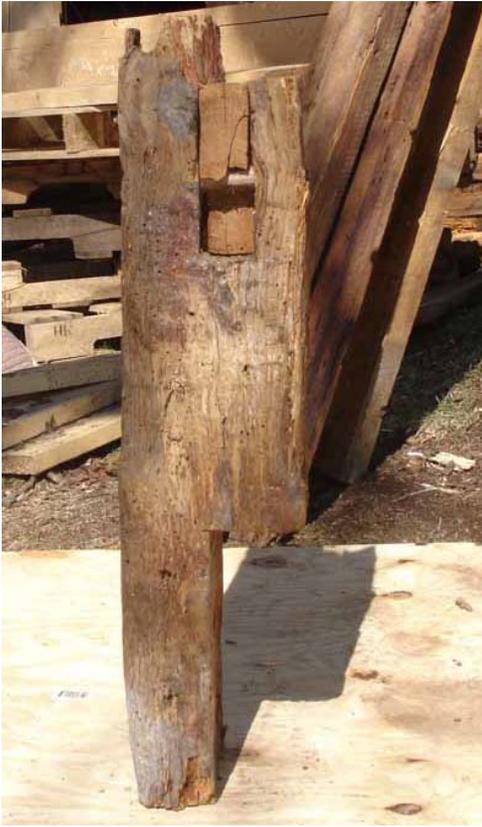
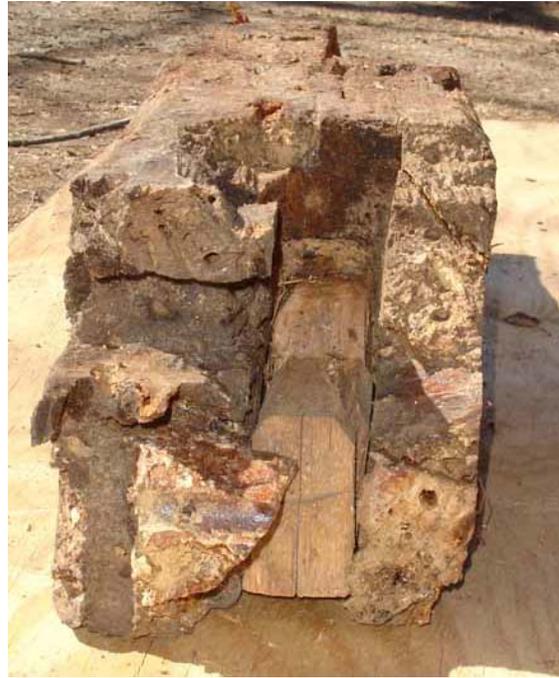
Figure 42a and 42b. John Nelson Barn, remnant of P02, bent 2 showing open mortises.

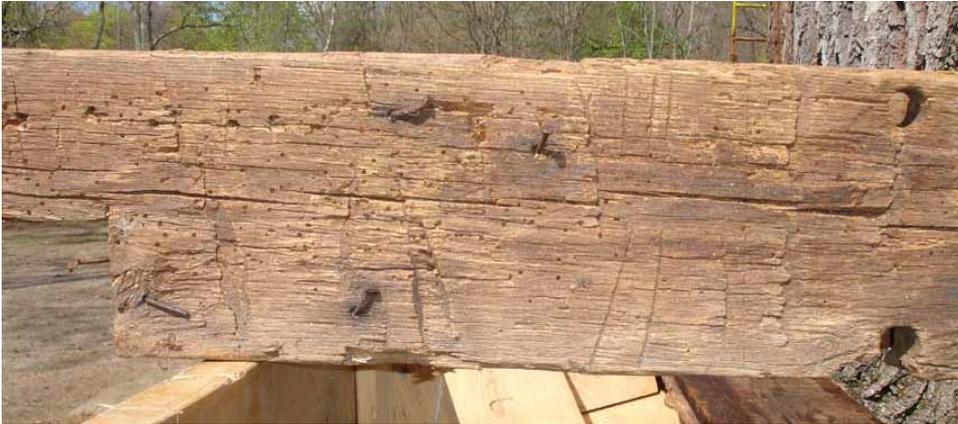
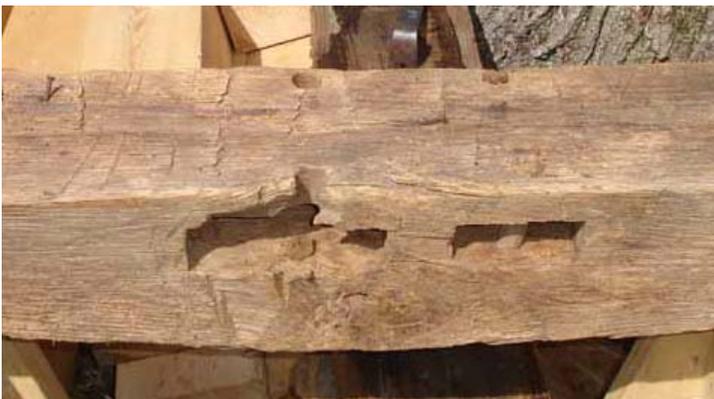
Figure 43a and 43b. John Nelson Barn, piece of P02, bent 3 showing open mortises, scribe marks, and half-lap joint.

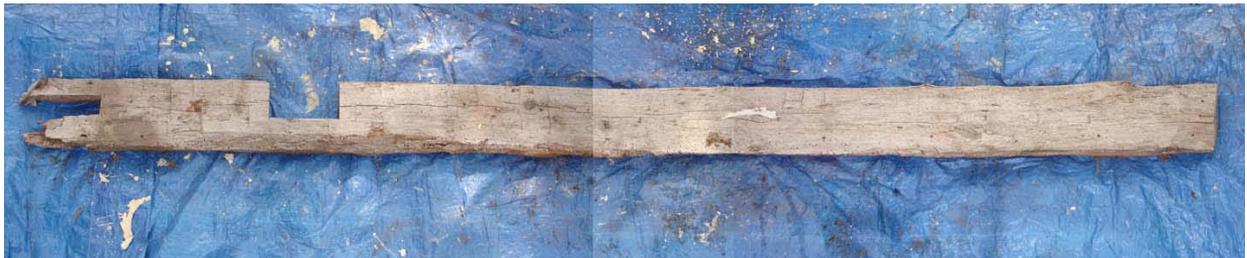
Figure 47. John Nelson Barn, hewn timber, possibly oak; 7 ¼ inches wide 11 feet 4 inches long; 8-inch-by-4-inch pocket; 8-inch-by-2-inch open mortise with single peg hole; regular pattern of nailing along “top” edge; cut nails observed.

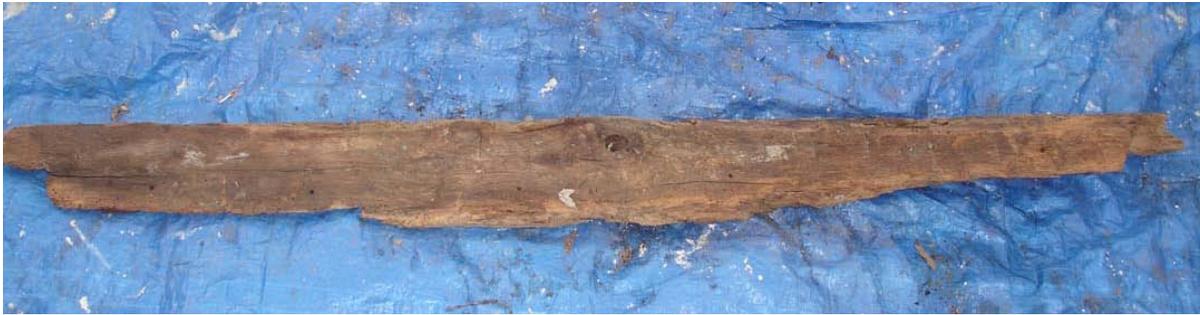
Figure 49. John Nelson Barn, hewn timber; 6½ inches wide by 6 feet 2 inches long; open pockets at both ends; evidence of cut nails.

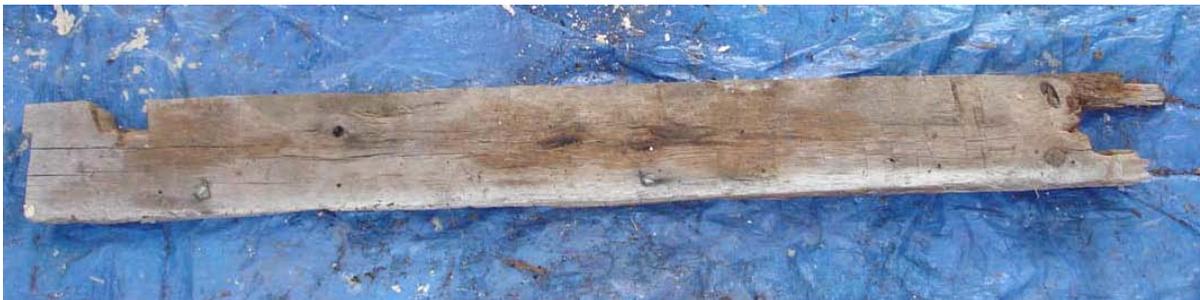
Figure 50. John Nelson Barn, hewn timber, possibly oak; 8 inches wide by 6 feet 6 inches long; irregular notch at one end (left); 5 inch "cheek" at one end (right).

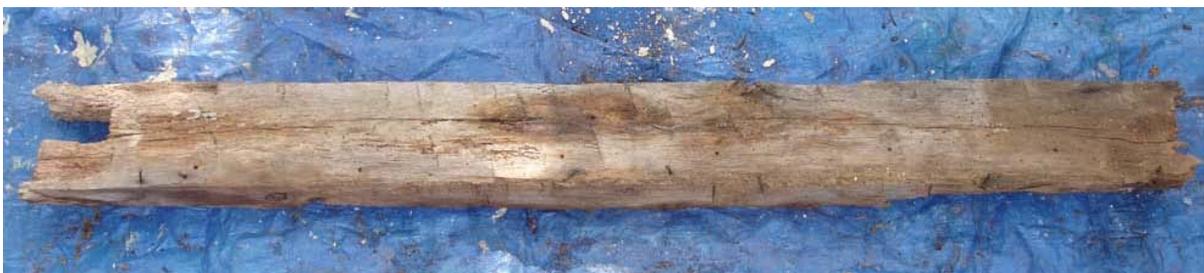
Figure 51. John Nelson Barn, hewn timber; 7½ inches wide by 6 feet 3 inches long; 2½ inch wide open mortise at one end (left); possible open mortise at other end (right); evidence of cut and wire nails.

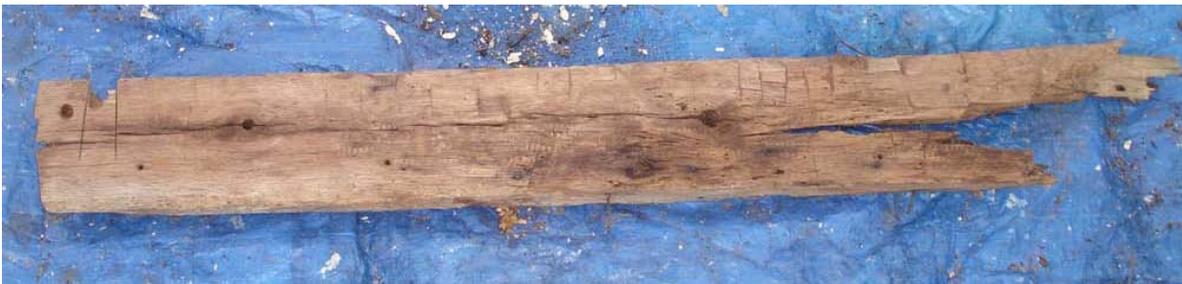
Figure 53. John Nelson Barn, hewn timber; 7 inches wide by 5 feet long; irregular notch at one end (left); evidence of cut and wire nails.

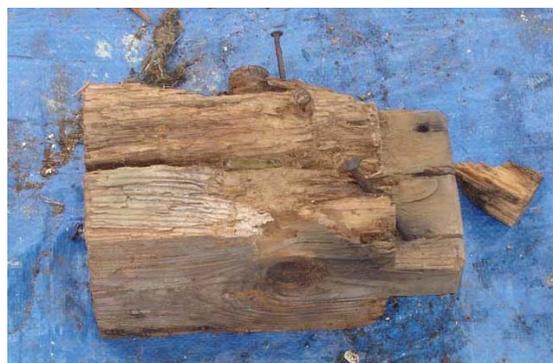
Figure 54. John Nelson Barn, end of timber; 5 inches wide by 9½ inches long; 4½ inch tenon on end; evidence of wire nails.

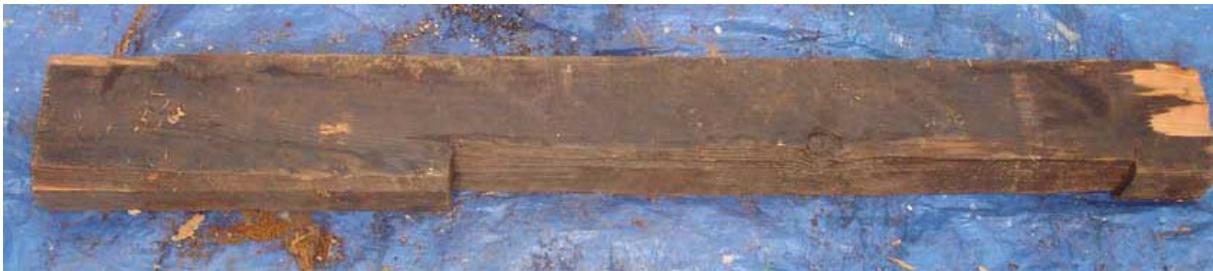
Figure 56. John Nelson Barn, sawn timber; 7½ inches by 3¾ inches by 5 feet 2½ inches long; large notched section 3 feet long and varied in depth.

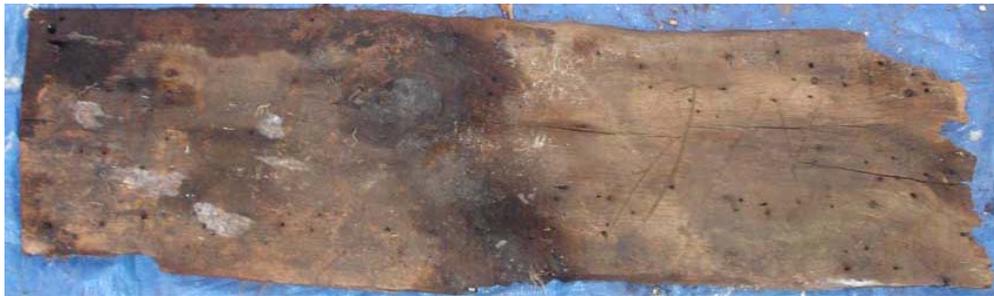
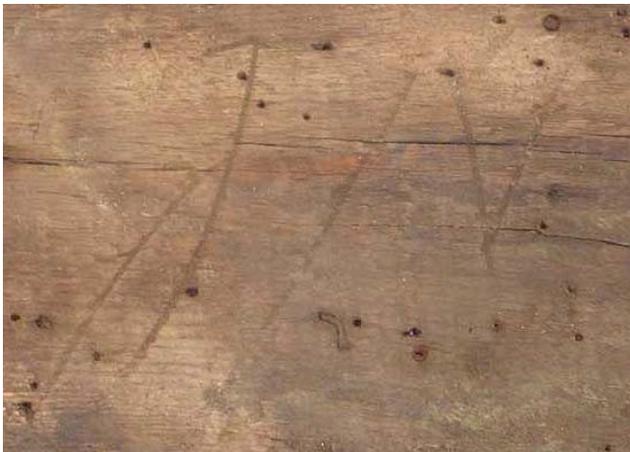
Figure 57. John Nelson Barn, south upper wall sheathing board, approximately 15 inches wide (sheathing ranged from 12-19 inches wide); evidence of cut nails for shingle cladding; scribe marks appear to be “J N.”

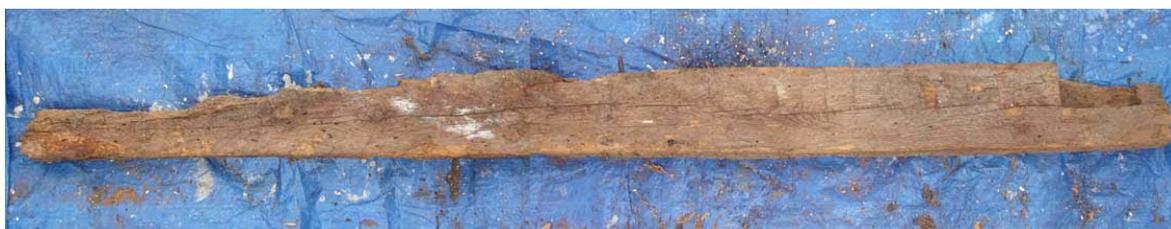
Figure 59. John Nelson Barn, hewn timber; 7½ inches by 4 inches by 8 feet 5 inches long; 7½ inch by 3 inch pocket at one end (right); iron rod in “top.”

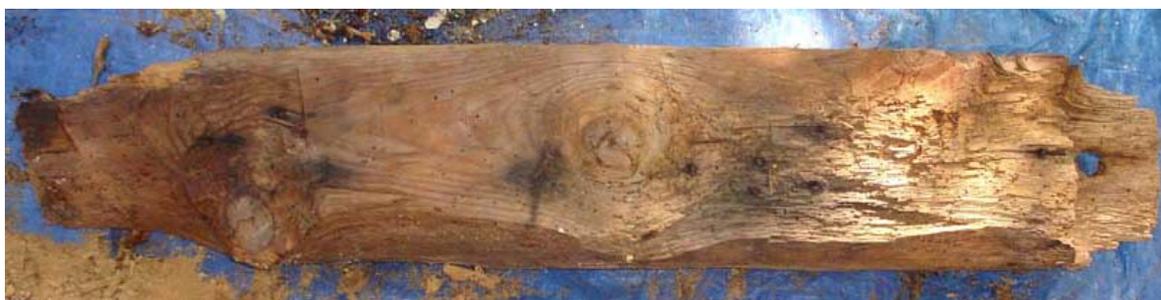
Figure 60. John Nelson Barn, 7 inches wide by 3 feet 1 inch long; 3½ inch full tenon at one end; evidence of cut nails.

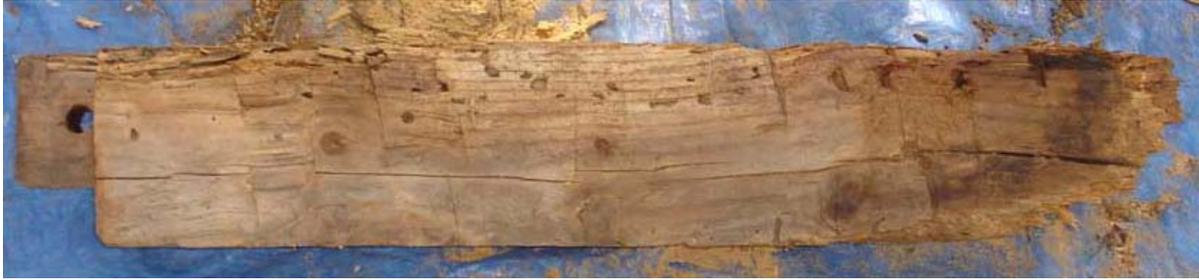
Figure 61. John Nelson Barn, hewn timber; 7 inches by 6³/₄ inches by 3 feet 4 inches long; 4-inch partial tenon at one end.

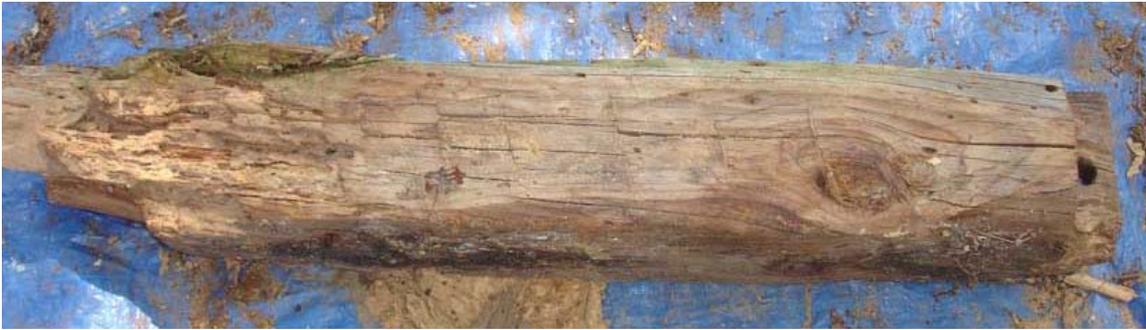
Figure 62. John Nelson Barn, hewn timber; 6¹/₄ inches by 6¹/₂ inches by 3 feet 5 inches long; 2¹/₂ inch deep full tenon at one end.

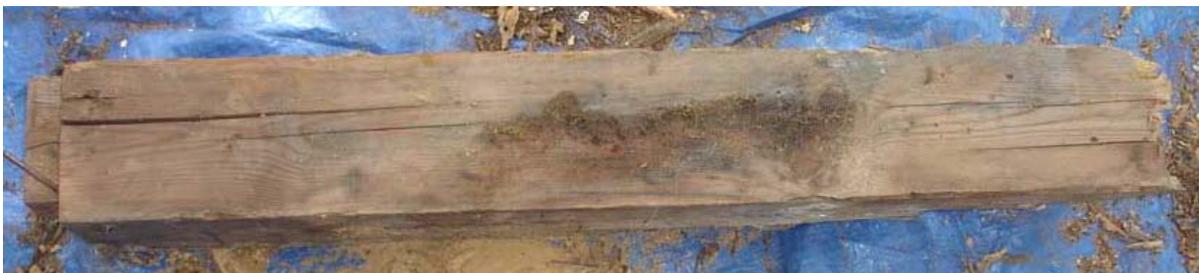
Figure 63. John Nelson Barn, sawn timber; 5¹/₂ inches wide by 3 feet 5 inches long; 4¹/₂ inch tenon at one end; wire nails/spikes at tenon.
