JOHN NELSON HOUSE AND BARN

Minute Man National Historical Site
Lincoln, Massachusetts

**DOCUMENTATION of PHYSICAL
EVIDENCE 2009-10**

Prepared By:
James J. Lee III
Architectural Conservator
Historic Architecture Program
Northeast Region, National Park Service
Lowell, Massachusetts

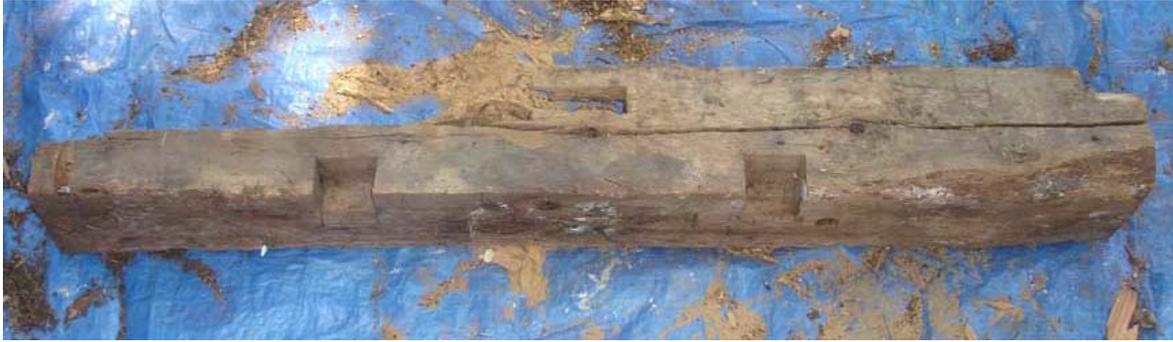
Figure 64. John Nelson Barn, hewn timber; 8 inches wide by 5 feet 2 inches long; two 3½-inch-by-2-inch pockets approximately 2 feet on-center; of-center open mortise on “top” face; 3½ inch cheek at one end; evidence of cut nails.

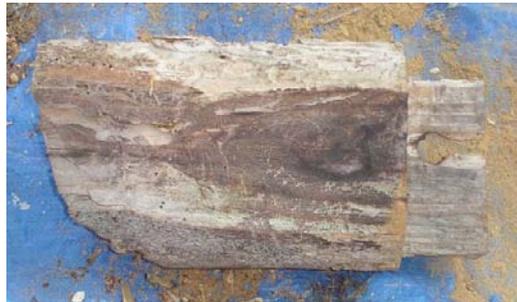
Figure 65. John Nelson Barn, end of timber; 6½ inches wide; 3 inch tenon.

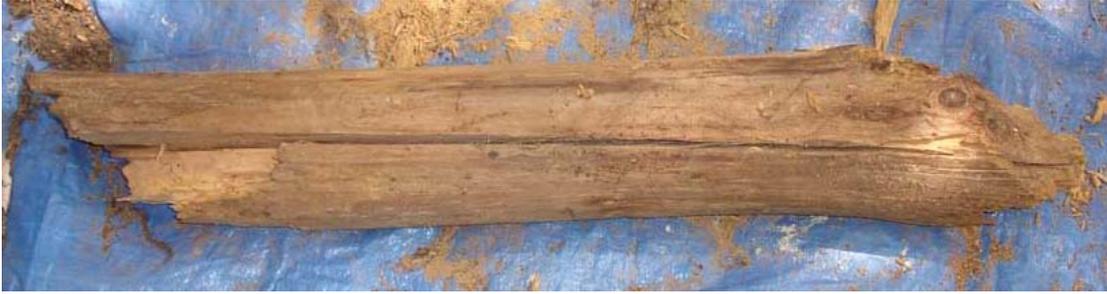
Figure 70. John Nelson Barn, waned edge timber remnant, possibly rafter; 3½ inches by 4½ inches by 2 feet 8 inches; chiseled at end, possibly for joining to ridge.

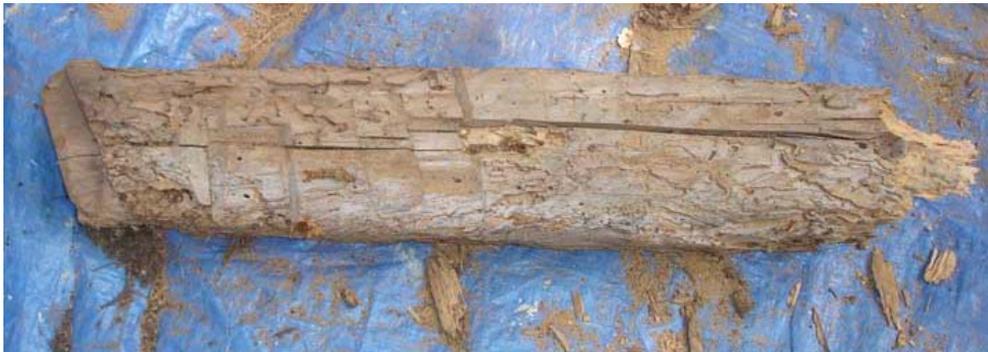
Figure 71. John Nelson Barn, waned edge timber remnant; 5½ inches by 5¼ inches by 2 feet 8 inches; angled tenon suggesting it was a brace.

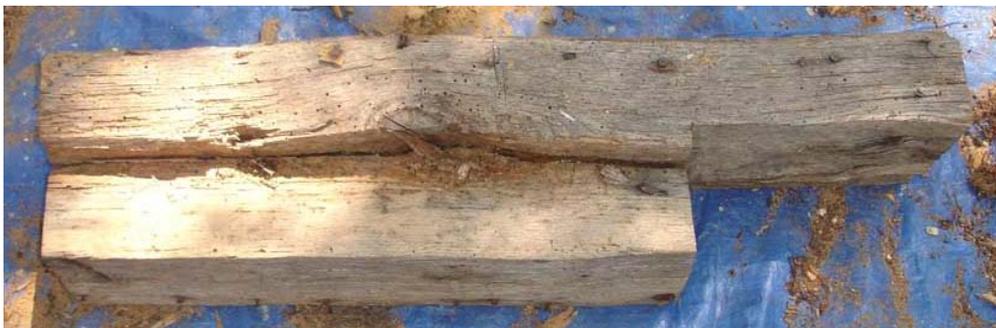
Figure 72. John Nelson Barn, possibly oak timber remnant; may have been part of an earlier repair; 7¾ by 7½ inches wide by 2 feet 8 inches long; 10 inch half-lap at end; chiseled out edge.

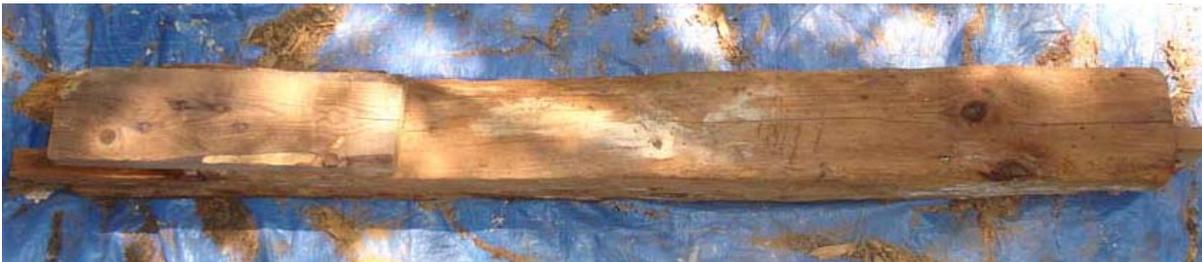
Figure 75. John Nelson Barn, waned edge timber remnant, possibly hewn; 7 inches by 7½ inches by 6 feet long; full offset tenon with 4 inch cheek; 4-inch-by-2-inch mortise near broken end (left); 2-inch-by-6-inch cleat fastened with wire nails (left).

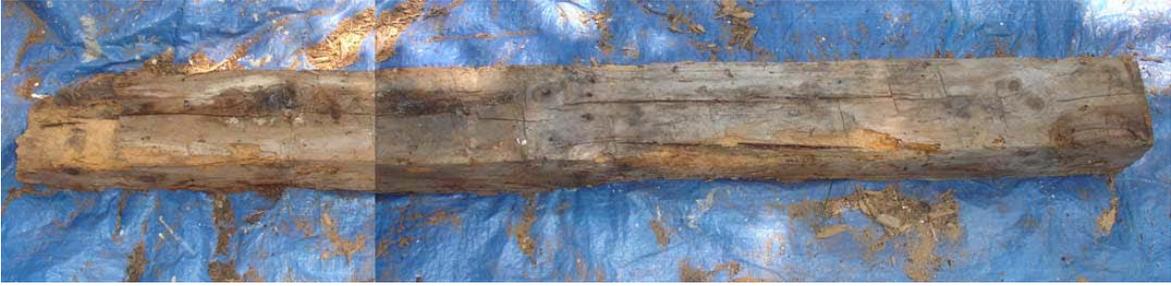
Figure 76. John Nelson Barn, hewn timber; 7 inches wide by 6 feet 9 inches long; evidence of cut and wire nails.

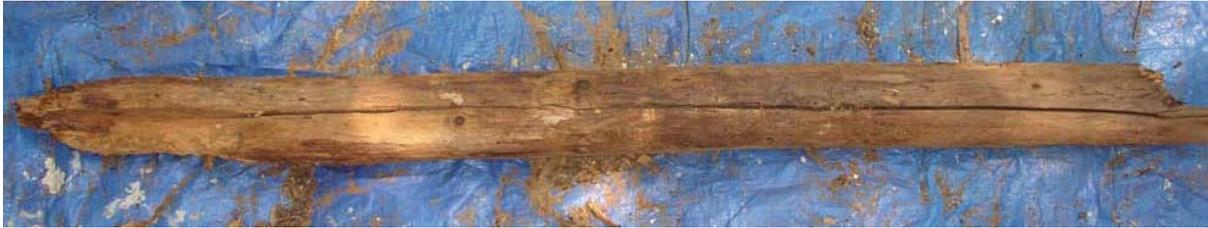
Figure 79. John Nelson Barn, waned edge timber remnant, possibly rafter; $4\frac{3}{4}$ inches by 5 inches by 6 feet.

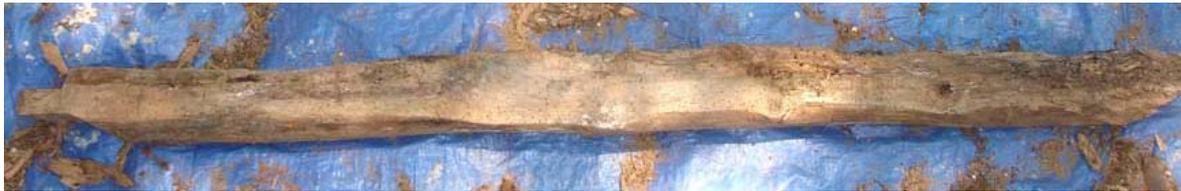
Figure 80. John Nelson Barn, waned edge timber remnant, possibly rafter; $4\frac{1}{4}$ inches by $4\frac{1}{2}$ inches by 5 feet 10 inches; full tenon (left) with angled cheek.

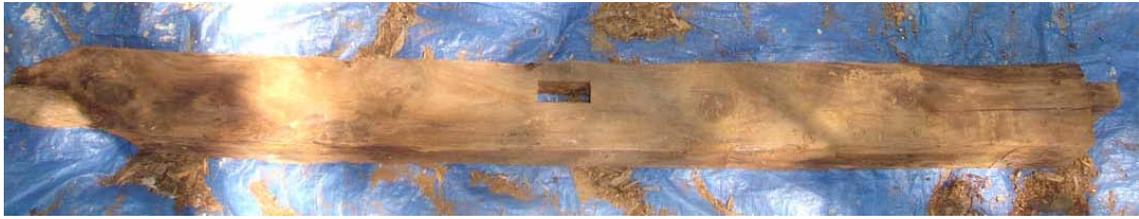
Figure 82. John Nelson Barn, hewn timber; 6½ inches by 7 inches by 7 feet long; full tenon (right); ¾-inch-by-¼-inch through mortise approximately 3 feet from cheek of tenon.

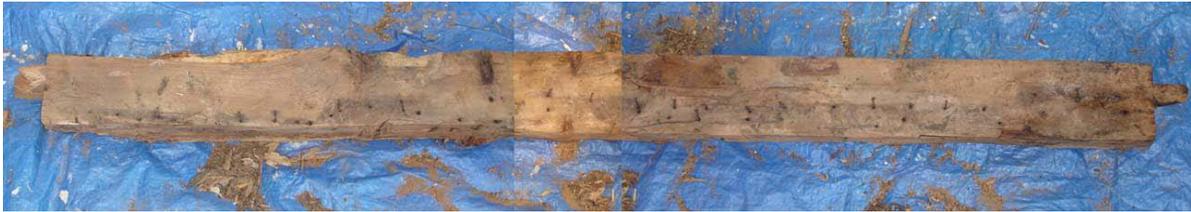
Figure 83. John Nelson Barn, hewn timber; 7¾ inches by 7½ inches by 8 feet 8 inches long; full tenons on both ends; evidence of both cut and wire nails; possibly section of south plate.
