HISTORIC STRUCTURES REPORT

ARCHITECTURAL DATA SECTION

THE WAYSIDE

Minute Man National Historical Park  
Concord, Massachusetts

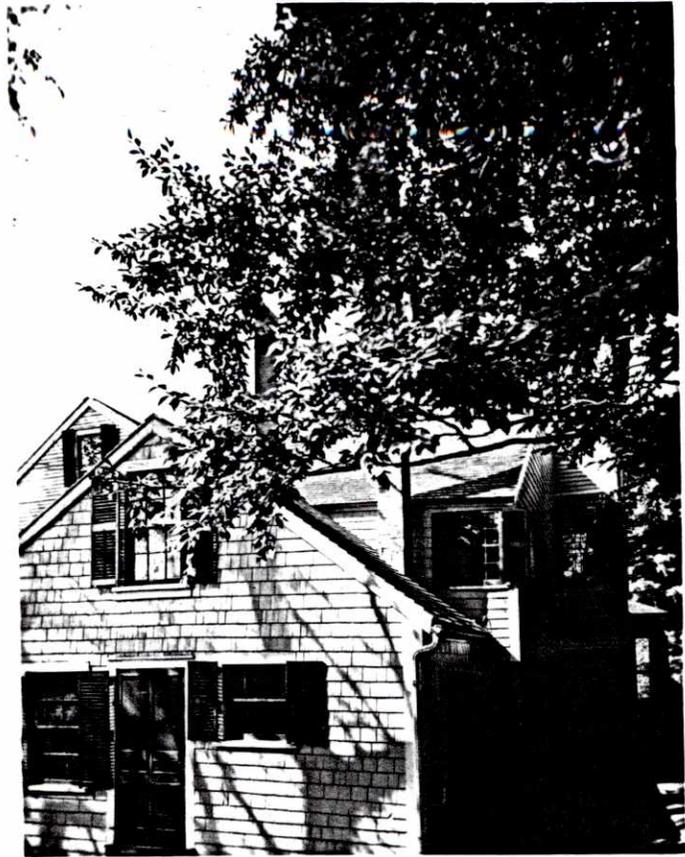
ILLUSTRATION NO. 7

Looking at the southeast end of The Wayside after completion of the exterior rehabilitation work in August, 1969. Compare this view with Illustration No. 10, a photograph taken in 1922.

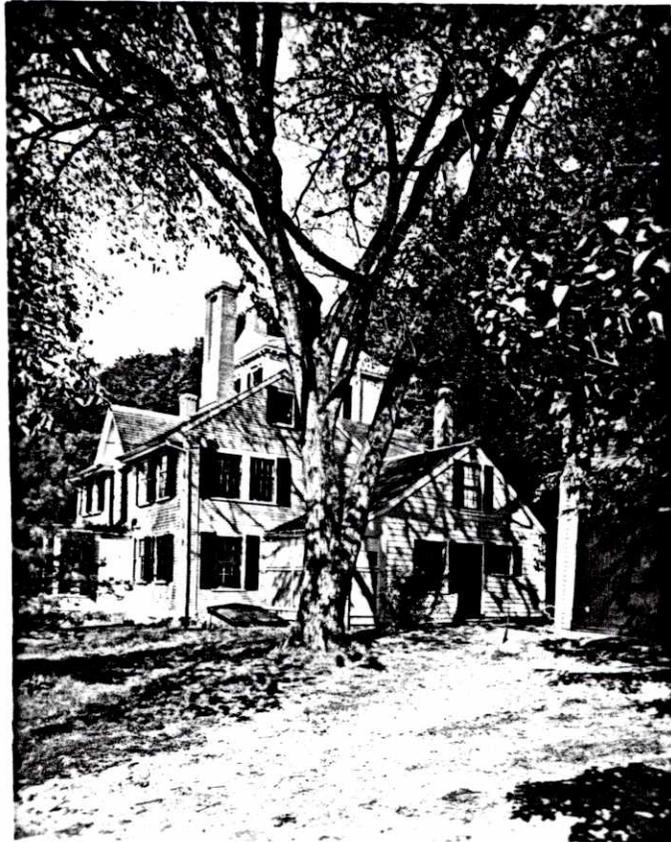
ILLUSTRATION NO. 8

This view, taken from the southwest, is probably the most photographed angle of the house and barn. Compare this photograph with the 1922 photograph on the cover of the Part II, Architectural Data Section, or with Illustration No. 1 of this report. Both views represent the target date of 1924 for the rehabilitation work. Illustration No. 8 shows the exterior of The Wayside as completed in August, 1969. The west and south walls of the barn were also repaired, clapboards scraped of loose paint and then repainted with a prime coat.

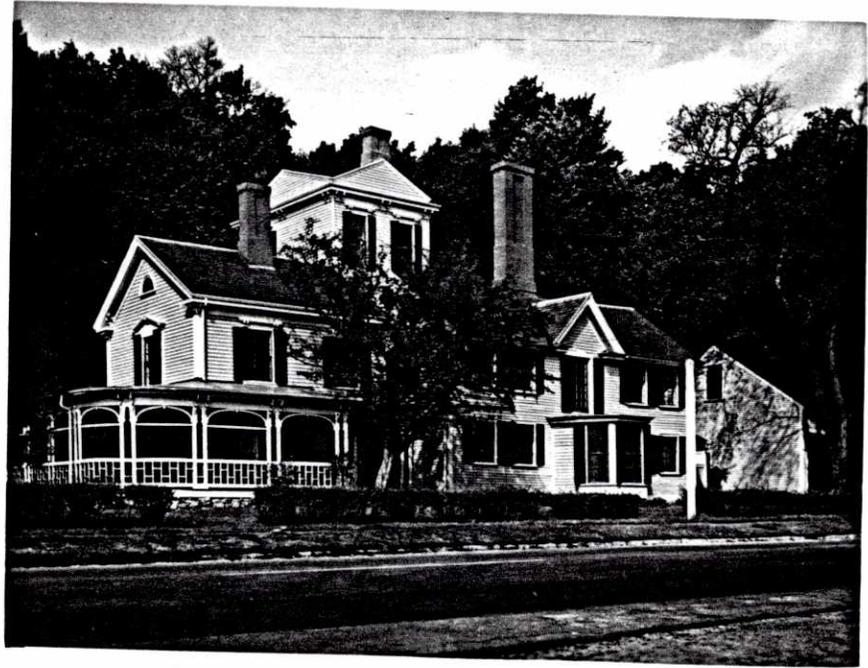
ILLUSTRATION NO. 9

The Wayside as seen from the west after completion of the exterior rehabilitation work. It compares favorably with Illustration No. 4, taken in 1916, found in the Part II, Architectural Data Section.

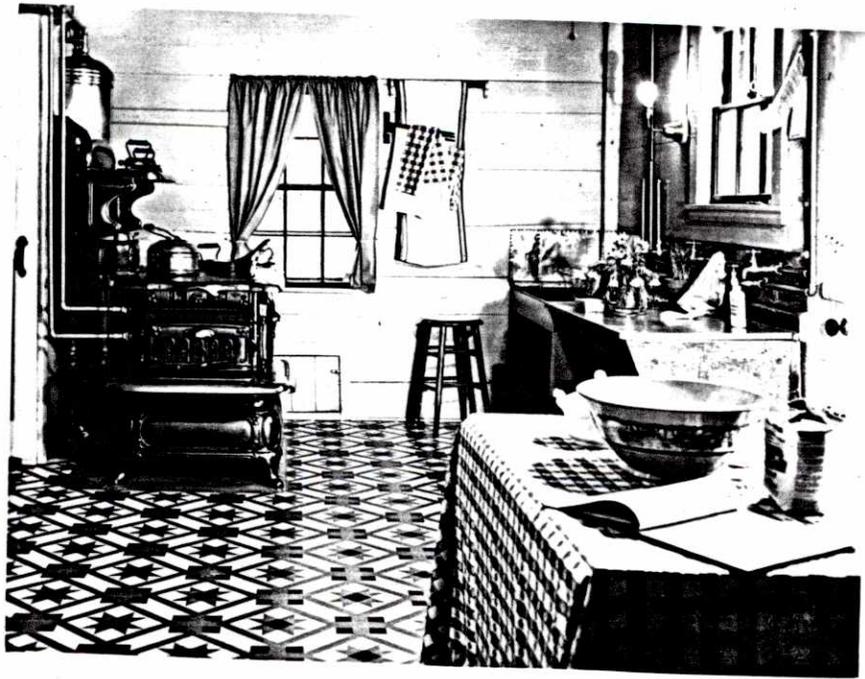
ILLUSTRATION NO. 12

View of Kitchen looking south with the Enclosed Porch of 1902 in the background. Porch shelves, ca. 1928, to the right were not removed as recommended in the Part II report.

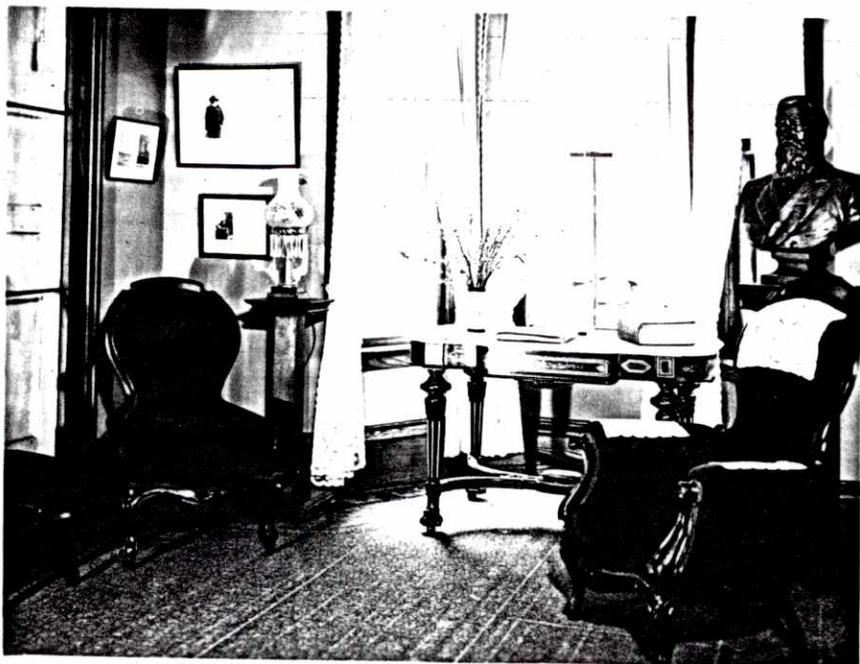
ILLUSTRATION NO. 18

The Piazza Room, looking northwest. The wallpaper is a poor silk screen reproduction of the 1899 wallpaper installed under the direction of Mrs. Lothrop. The wicker chair had some new decorative pieces replaced on the lower front sides under the seat, and along top of back.

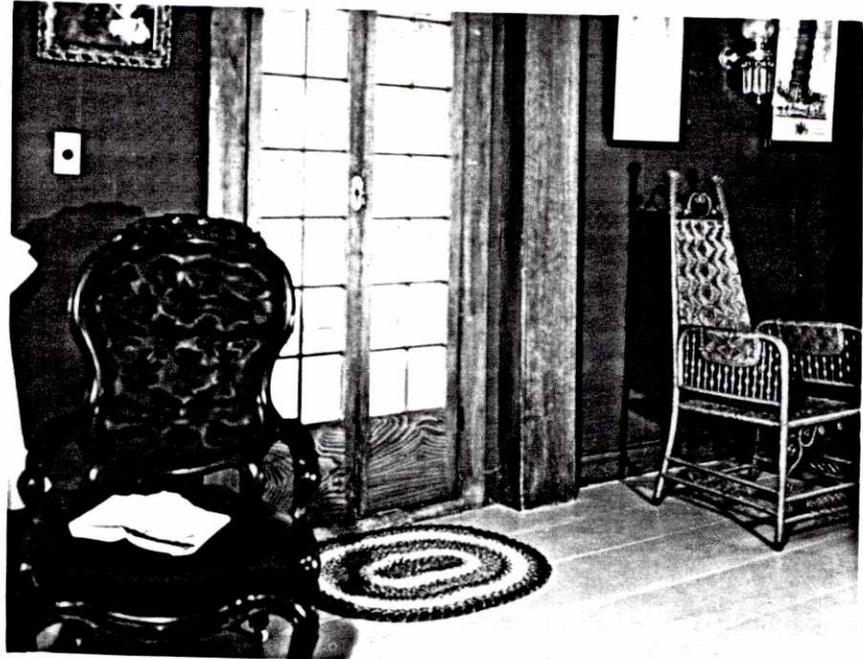
ILLUSTRATION NO. 19

Una's Room. View looking northwest at two of five pieces of bedroom furniture owned by D. L. Lothrop. The birch floor was refinished with <sup>shellac</sup> shelter, varnish and "butcher's wax" according to an itemized invoice of 1922.
