Tahoma Creek Bridge Focused Condition Assessment

Tahoma Creek Bridge focused condition assessment

Science Report NPS/SR—2024/103

Robert P. Jost, Taylor R. Kenyon

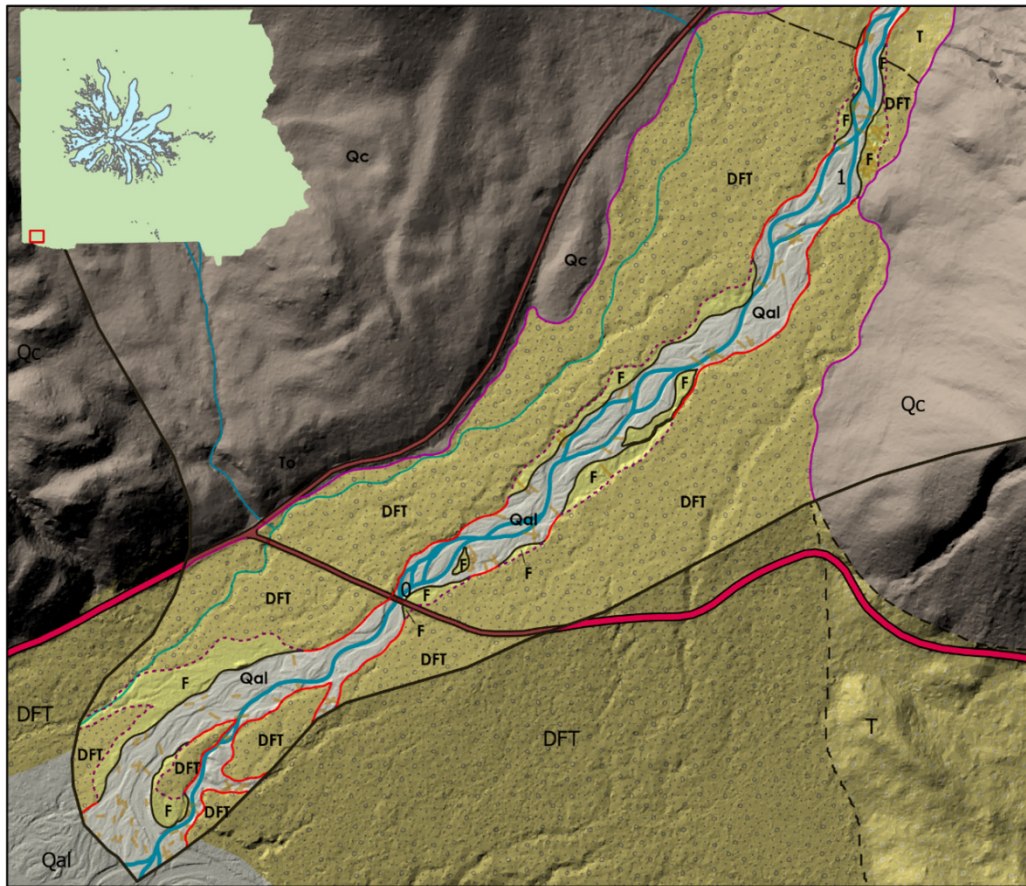
Figure 2. Surficial geologic map and study area for the Tahoma Creek Bridge reach (Modified from Figure 3 in Turley [2020]).

The study area encompasses the debris fan terrace (DFT) that has formed where Tahoma Creek begins to merge with the Nisqually River (Figure 2). The Nisqually-to-Paradise Highway traverses the full width of this convex landform, with the bridge located near the fan apex. Vehicles traveling along the road must climb the western limb of the fan to reach the bridge, and the western margin of the fan is as much as 6.3 m (20.7 ft) lower in elevation relative to the active channel (Figure 3).

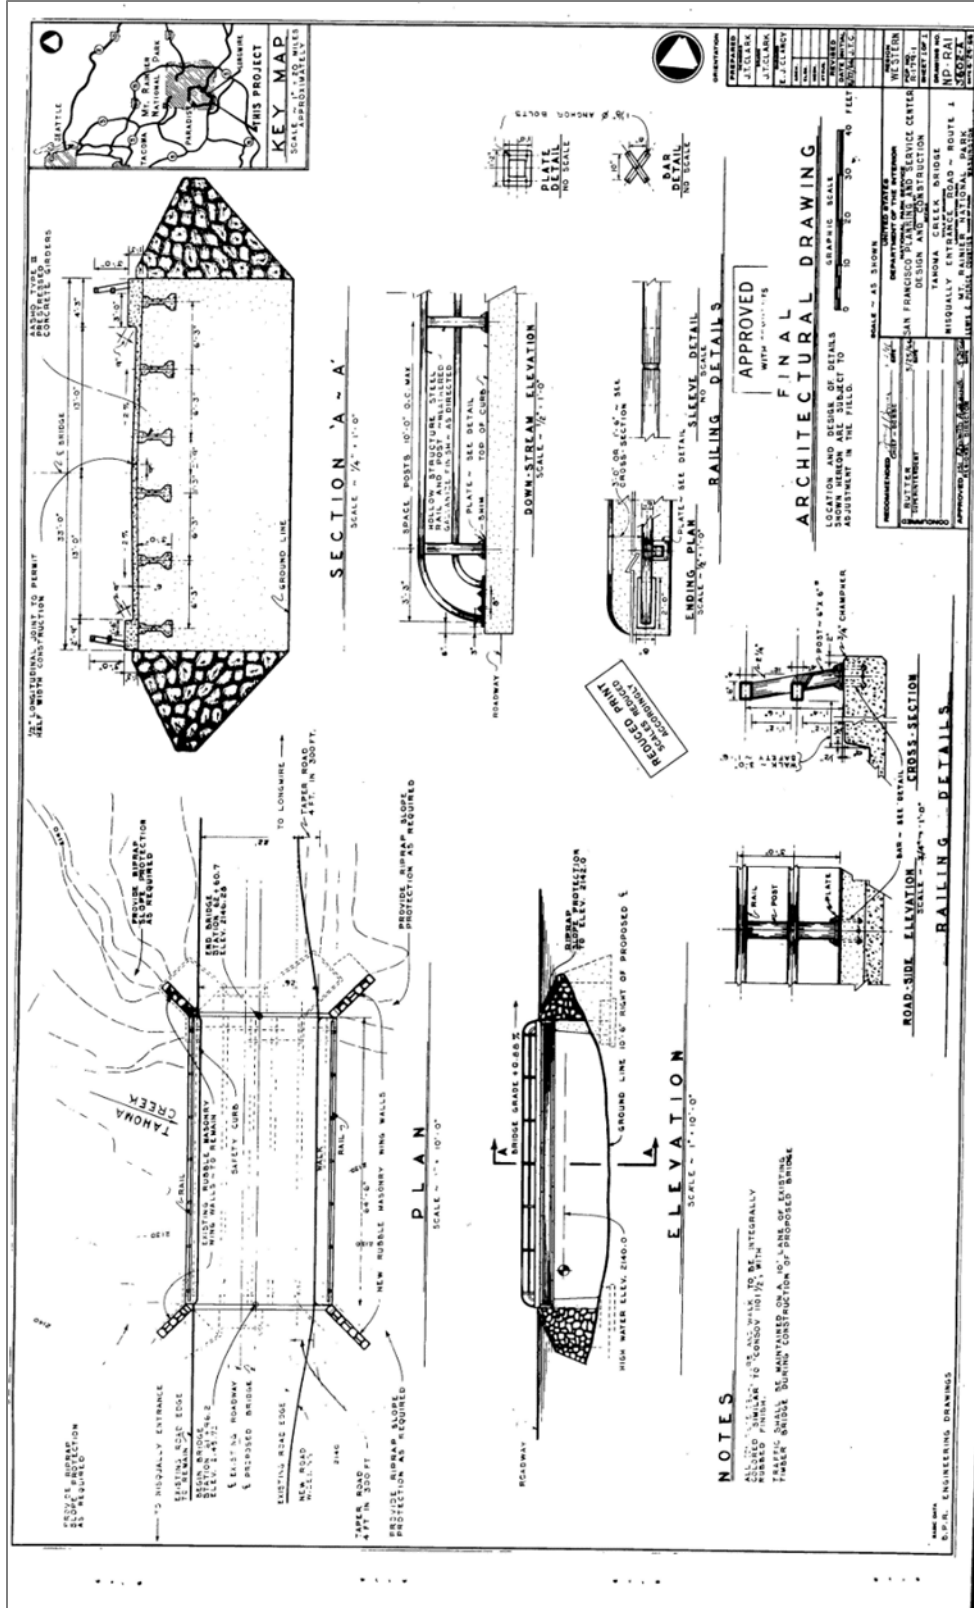
The deck spans 20 m (66 ft) over the floodplain, is 10 m (33 ft) wide, and runs at a grade of +0.88% from west to east (Figure 4). The abutments are 3.2 m (10.5 ft) tall, with shallow, concrete spread footings resting on the unconsolidated alluvium. The structure has roughly 0.3-m-thick (1 ft) concrete foundation “wings.” These wings project 45 degrees away from each corner of the bridge into the floodplain for 3.6 to 5 m (11.8 to 16 ft), creating a conic opening larger than the bridge span. Riprap lining the upstream banks was included in the 1966 design. The riprap structures are necessary to prevent erosion of the wingwalls and to maintain the alignment of the active channel.

Figure 4. Final architectural designs from 1966, which the existing bridge is based on. The deck spans 20 m (66 ft) over the floodplain, is 10 m (33 ft) wide, and runs at a grade of +0.88% from west to east (Modified from Clark 1966).

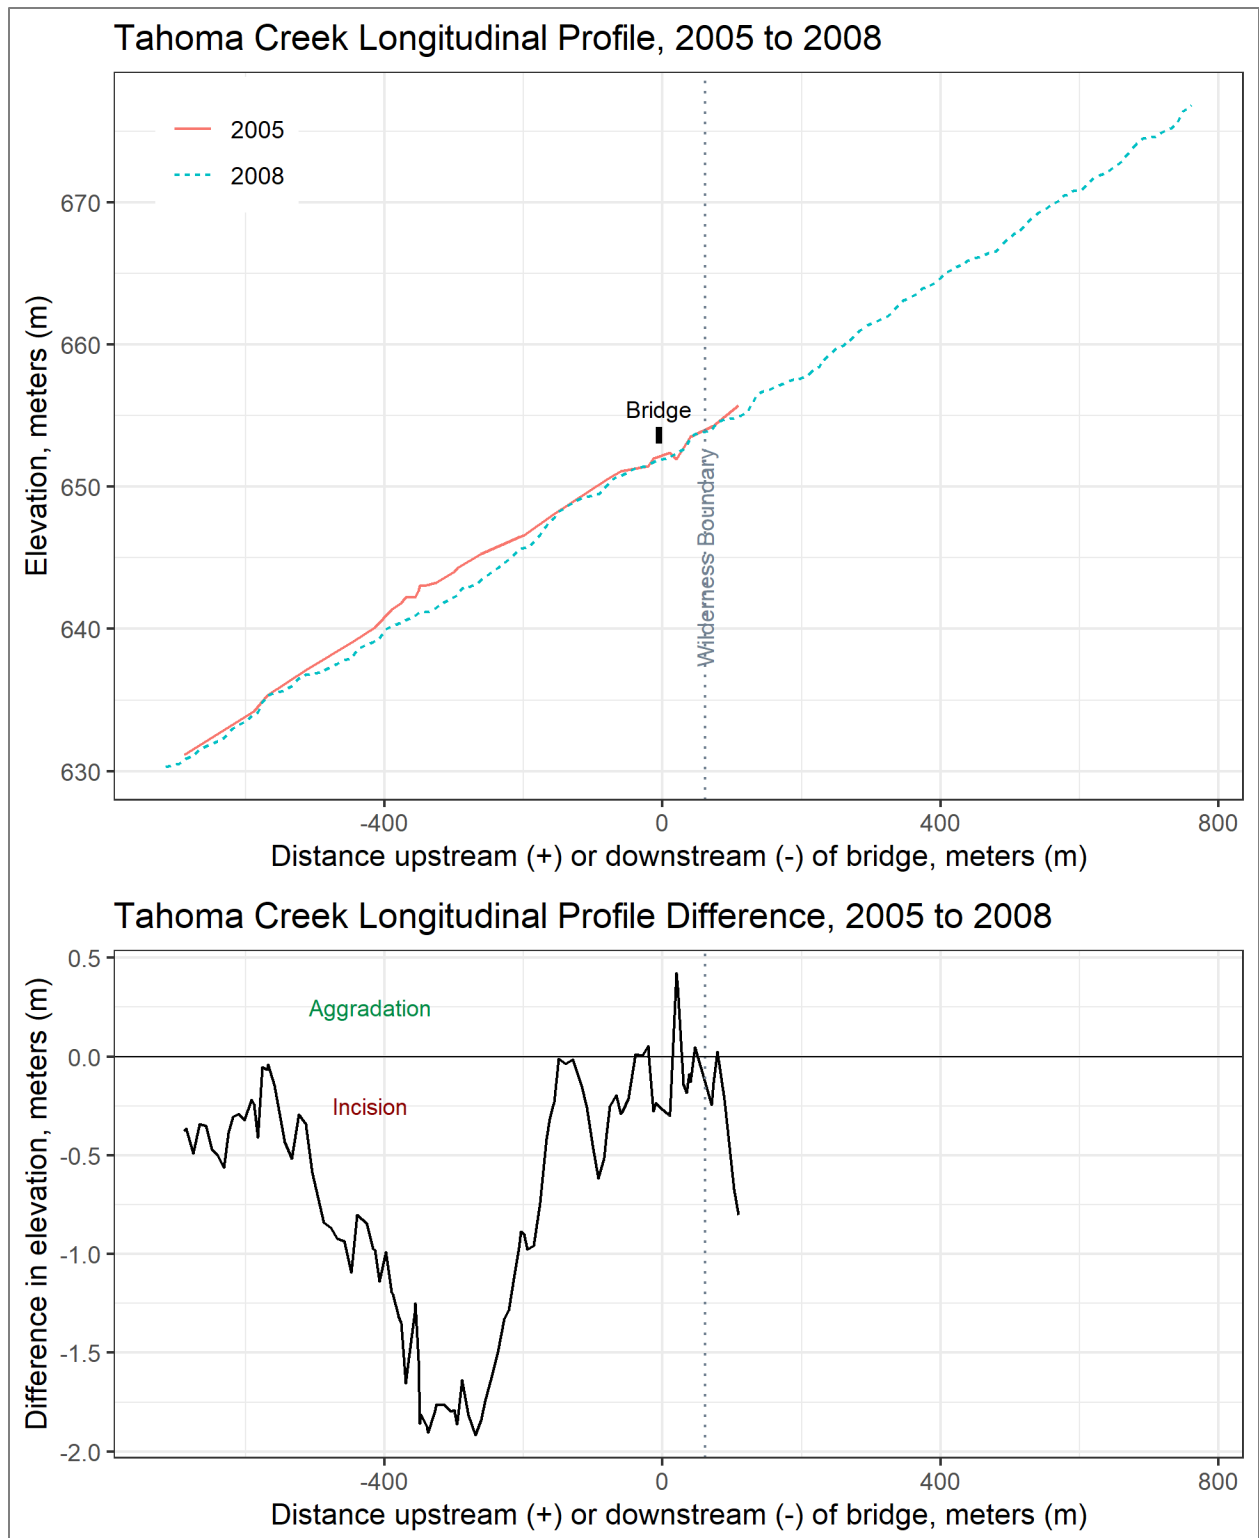
This appendix shows longitudinal profiles of Tahoma Creek in 2005, 2008, 2011, 2012, 2013, 2014, 2016, 2018, and 2020 (Figures 11 through 18). During this period, the profile elevation is lowered through dredging, and by the next time-step, the profile is at or above the previous elevation.

Figure 11. Longitudinal profiles of Tahoma Creek surveyed in 2005 and 2008 (top), and elevation difference between the two profiles (bottom). Elevation difference is calculated as the elevation of the more recent profile minus the elevation of the older profile, along the longitudinal distance of the profile. Vertical exaggeration: ~20.5x (top); ~285x (bottom).

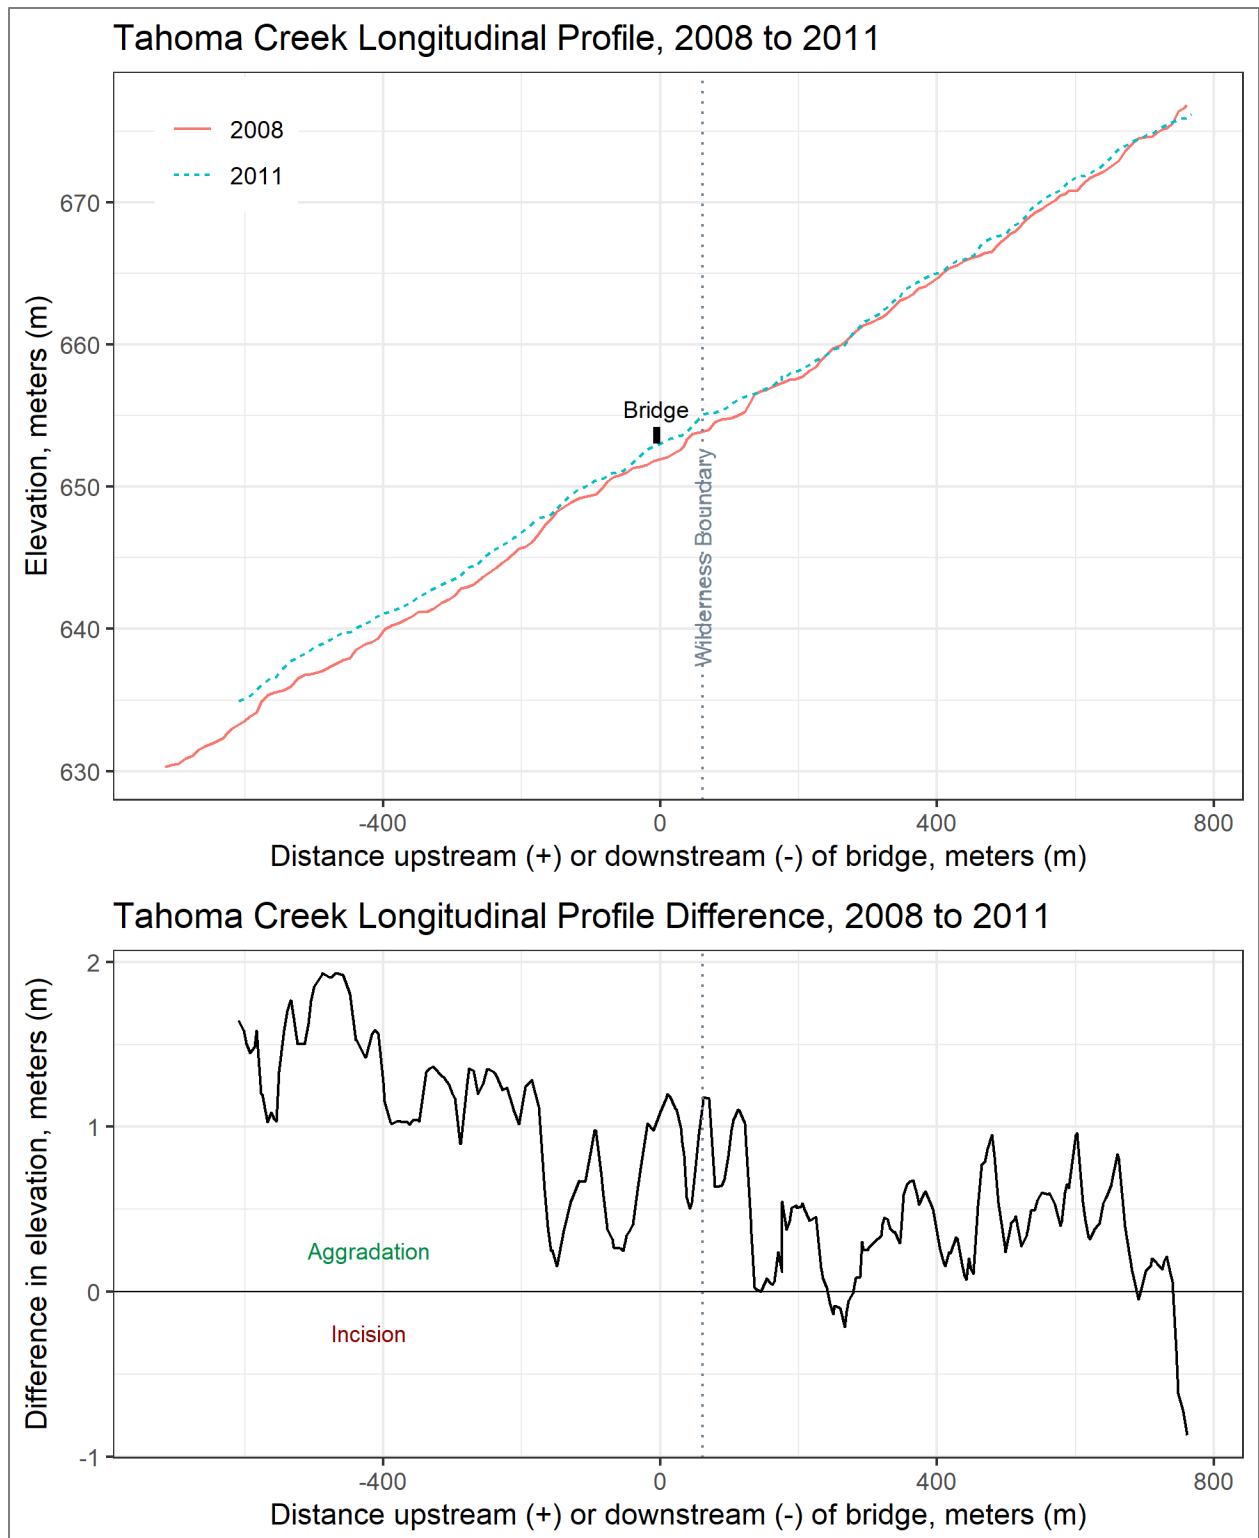
Figure 12. Longitudinal profiles of Tahoma Creek surveyed in 2008 and 2011 (top), and elevation difference between the two profiles (bottom). Elevation difference is calculated as the elevation of the more recent profile minus the elevation of the older profile, along the longitudinal distance of the profile. Vertical exaggeration: ~20.6x (top); ~239x (bottom).

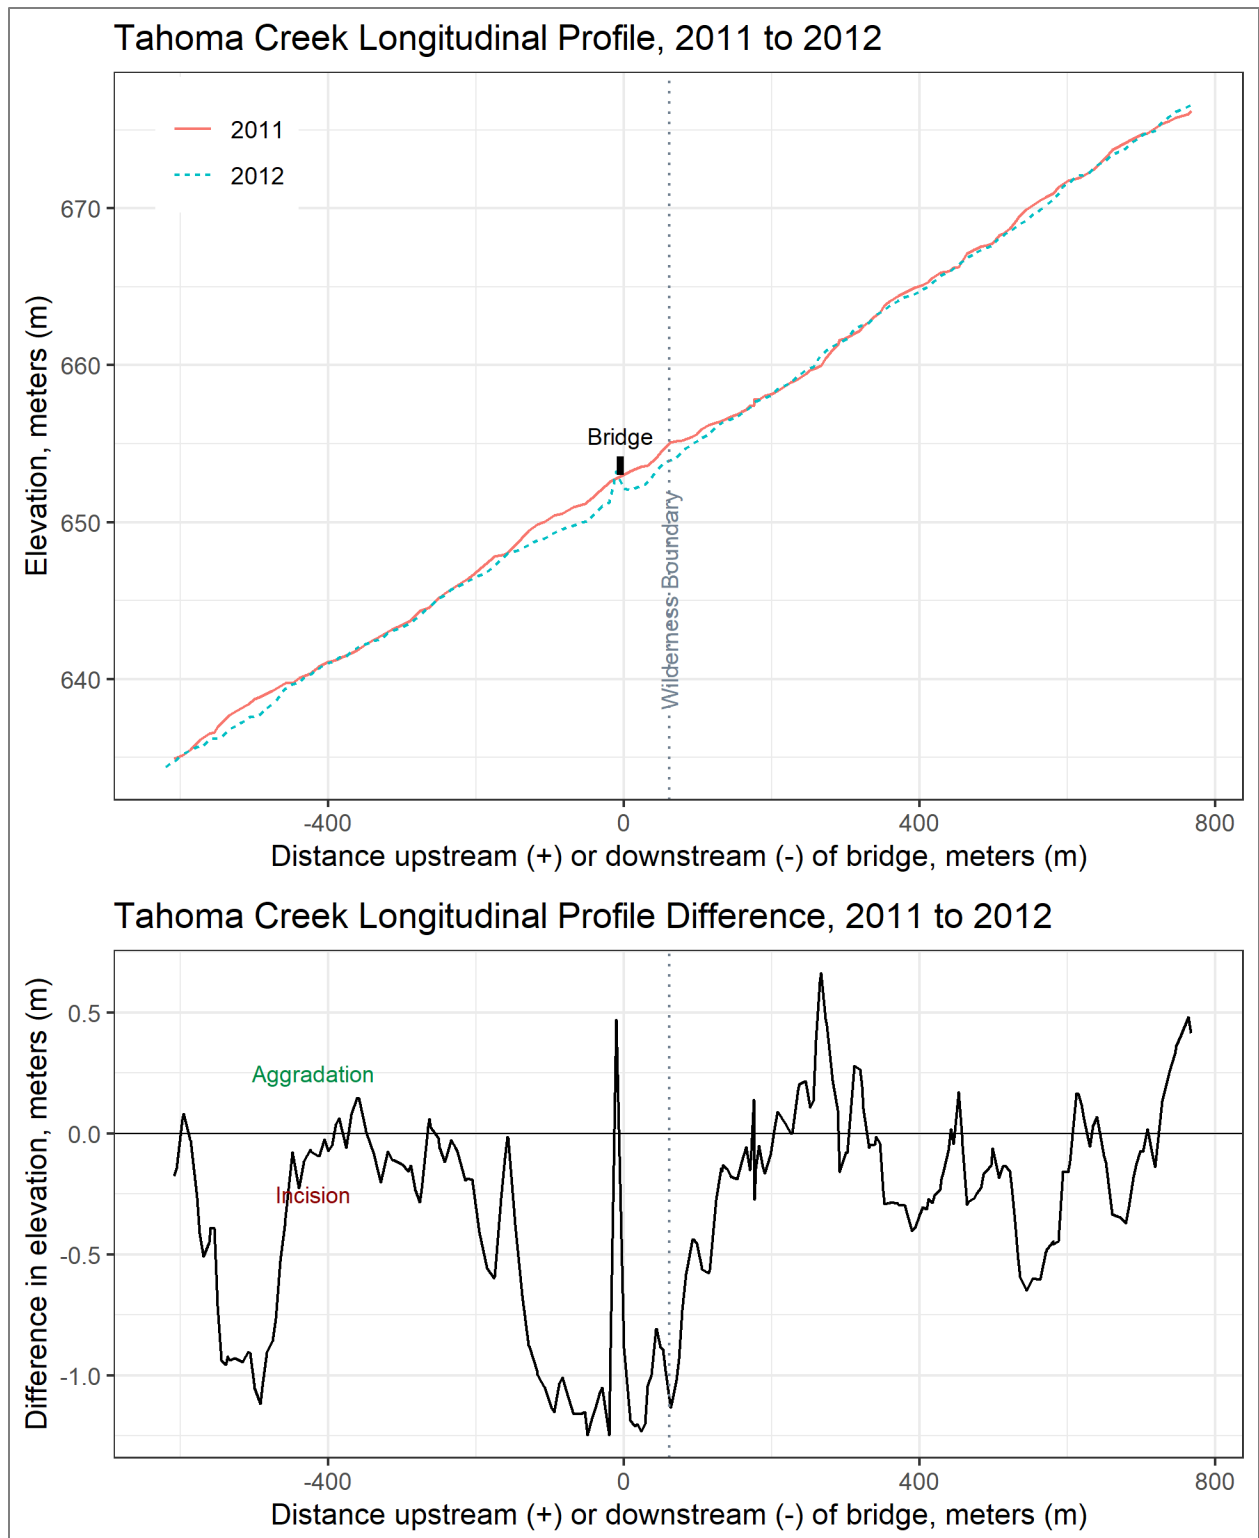
Figure 13. Longitudinal profiles of Tahoma Creek surveyed in 2011 and 2012 (top), and elevation difference between the two profiles (bottom). Elevation difference is calculated as the elevation of the more recent profile minus the elevation of the older profile, along the longitudinal distance of the profile. Vertical exaggeration: ~21.2x (top); ~328x (bottom).

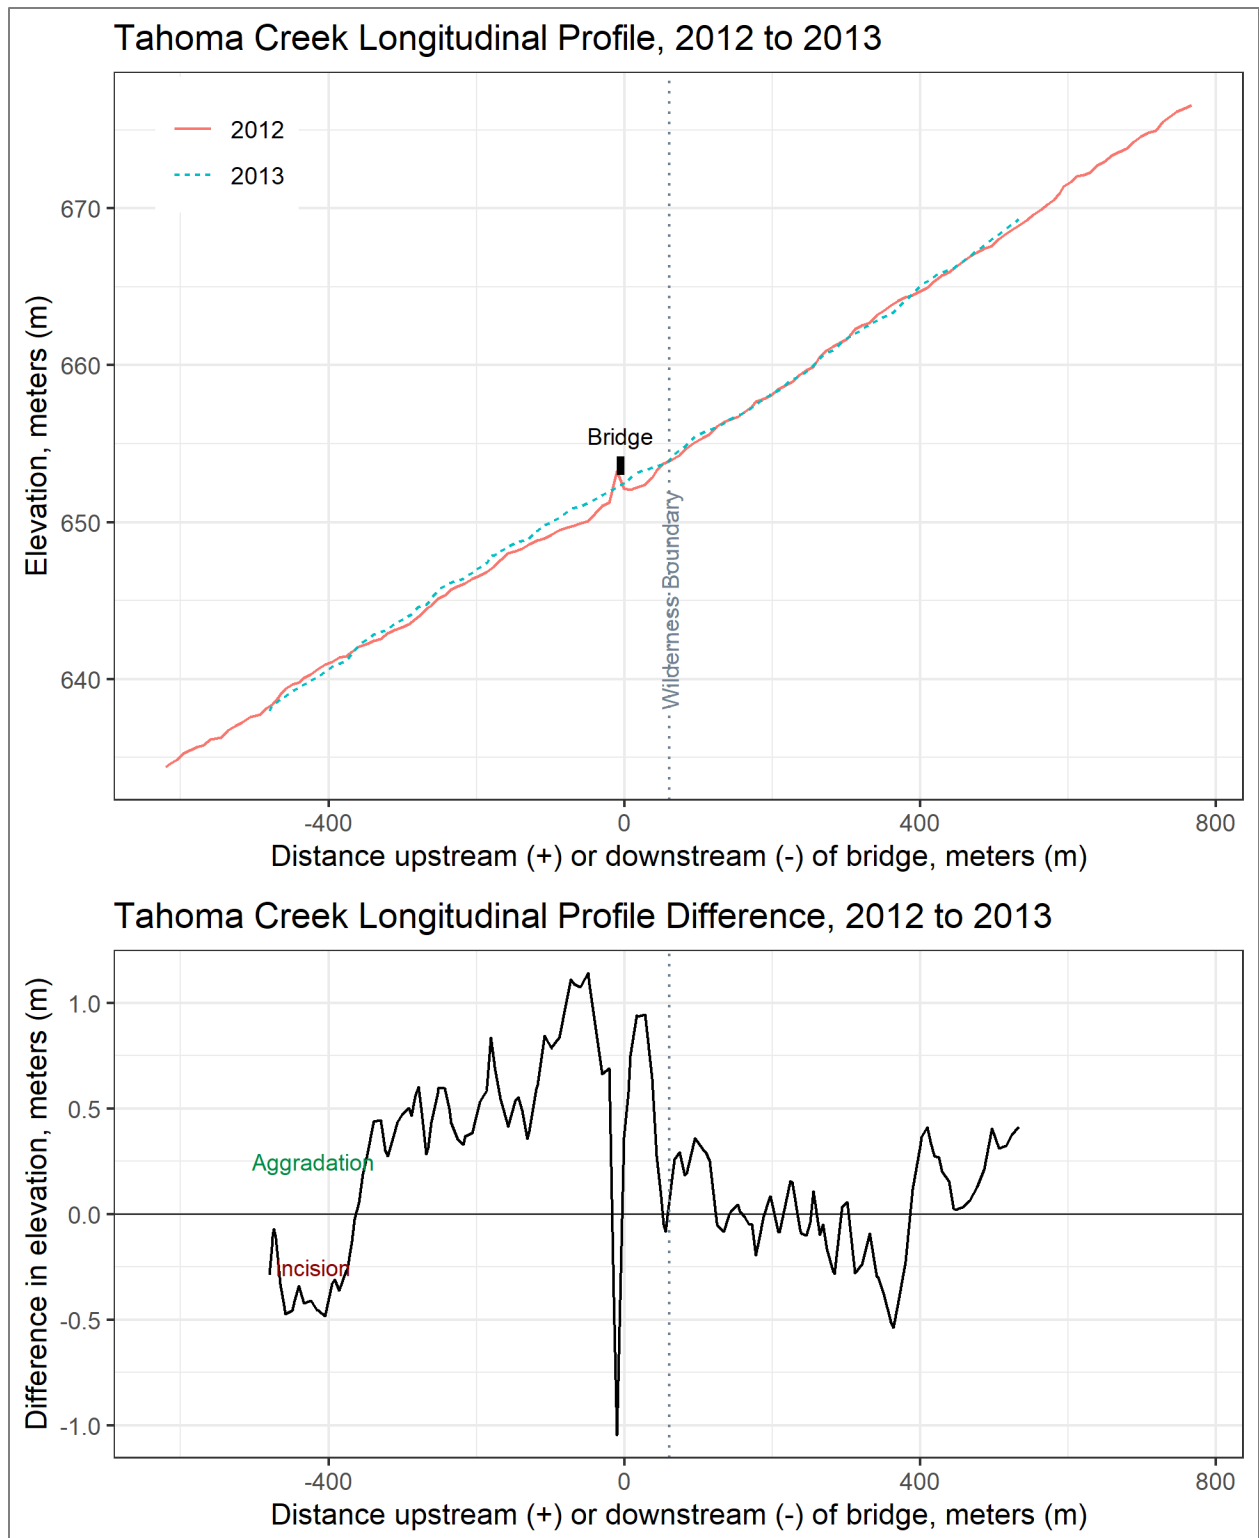
Figure 14. Longitudinal profiles of Tahoma Creek surveyed in 2012 and 2013 (top), and elevation difference between the two profiles (bottom). Elevation difference is calculated as the elevation of the more recent profile minus the elevation of the older profile, along the longitudinal distance of the profile. Vertical exaggeration: ~21.2x (top); ~286x (bottom).

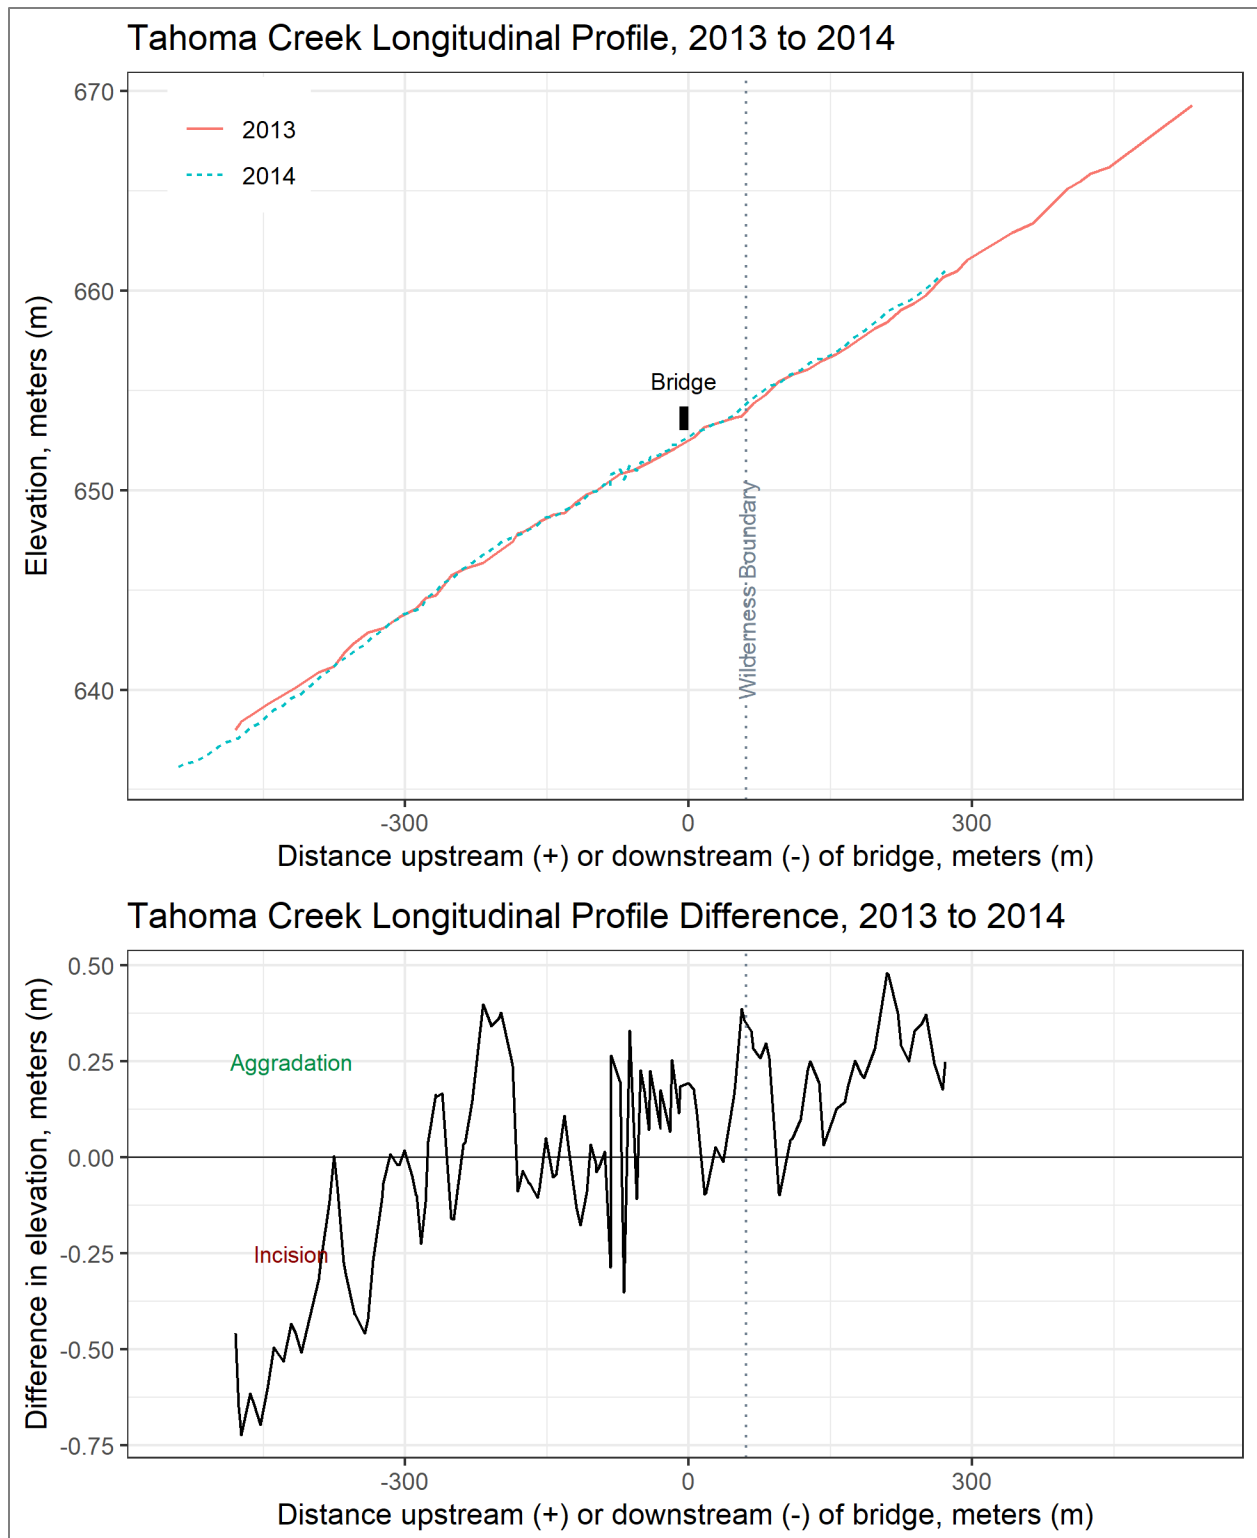
Figure 15. Longitudinal profiles of Tahoma Creek surveyed in 2013 and 2014 (top), and elevation difference between the two profiles (bottom). Elevation difference is calculated as the elevation of the more recent profile minus the elevation of the older profile, along the longitudinal distance of the profile. Vertical exaggeration: ~21.1x (top); ~406x (bottom).

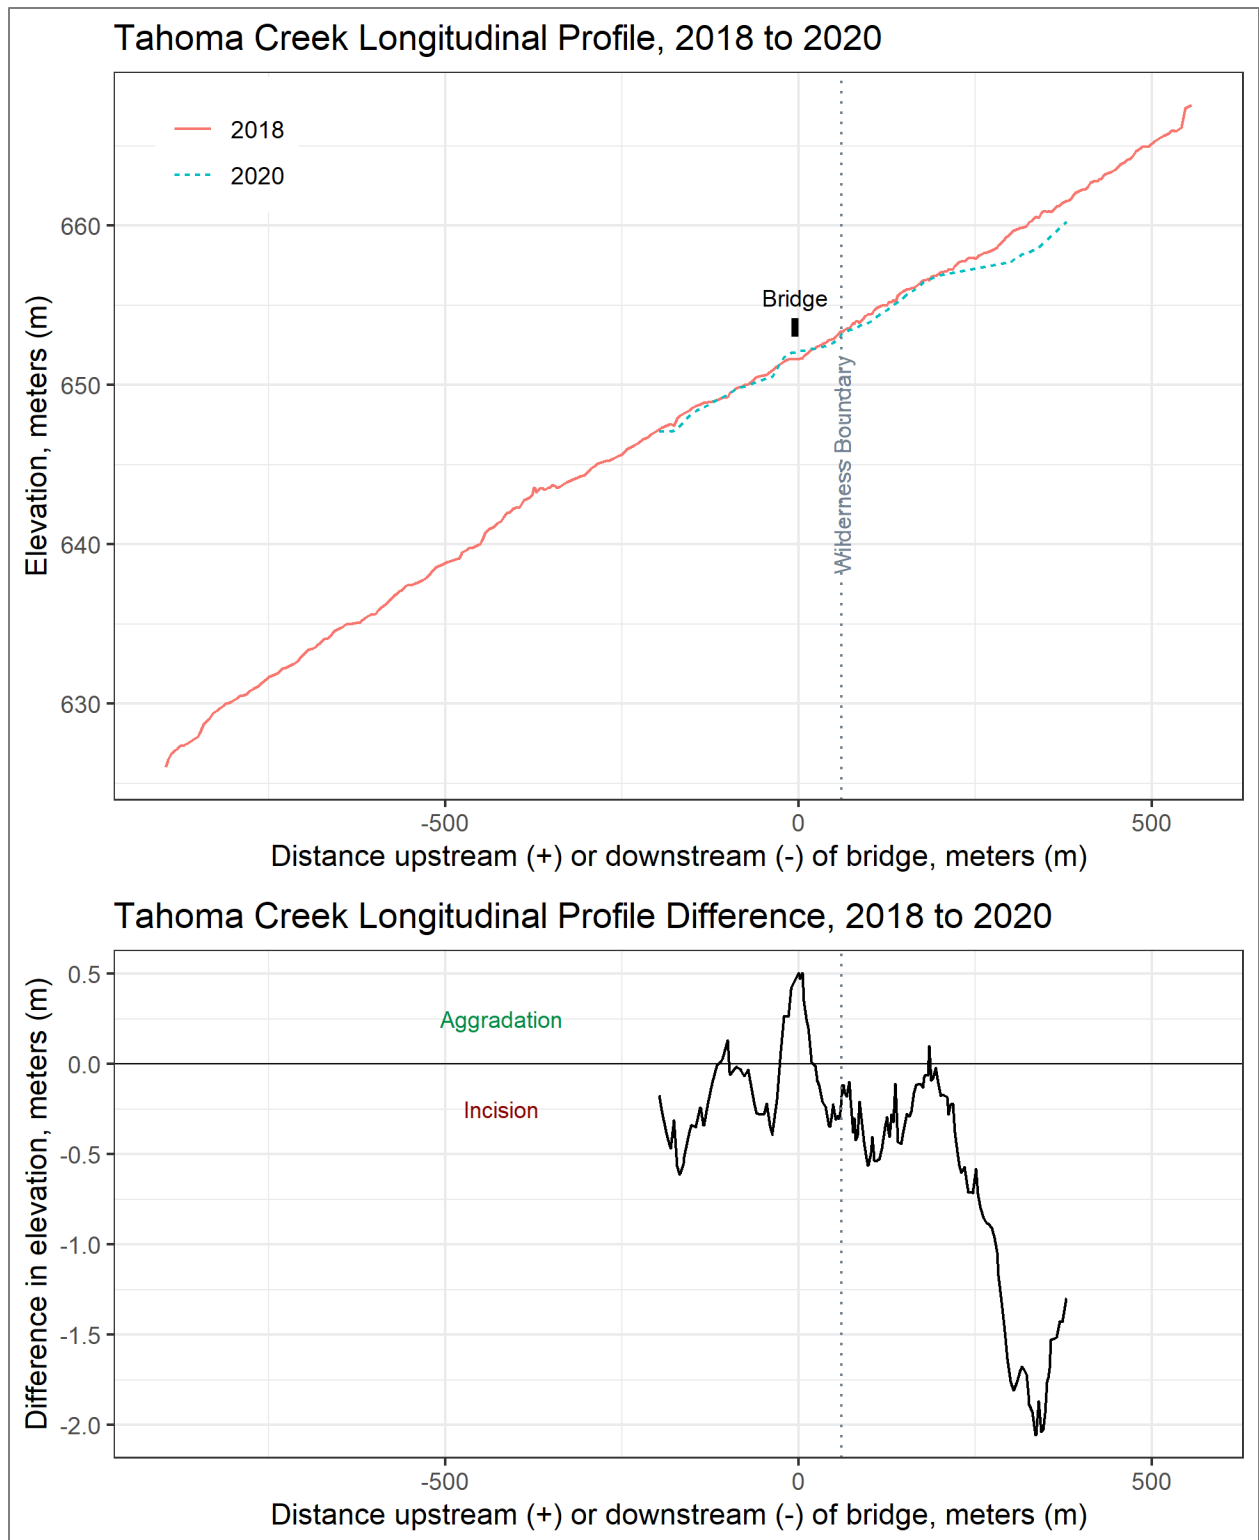
Furthermore, the change in profiles in Figures 16 and 17 were surveyed during a time when only one dredging operation took place (2016) and show less variability in elevation changes. It is especially interesting to note that the profile difference between 2018 and 2020 (Figure 18) is net negative. The profiles surveyed during time periods with frequent dredging have a more widespread aggradation signal along the profile. In contrast, aggradation appears more isolated during periods of less frequent dredging, and incision can be observed.

Figure 18. Longitudinal profiles of Tahoma Creek surveyed in 2018 and 2020 (top), and elevation difference between the two profiles (bottom). Elevation difference is calculated as the elevation of the more recent profile minus the elevation of the older profile, along the longitudinal distance of the profile. Vertical exaggeration: ~22.5x (top); ~256x (bottom).
