Melrose Servants' Barn

Historic Structure Report

Natchez National Historical Park

Natchez, Mississippi

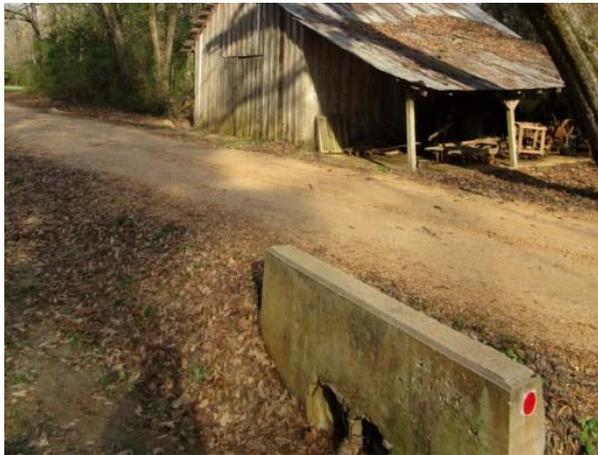
On the other three sides of the structure, the topography of the wooded site slopes gently away from the barn. The pair of drain pipes carries stormwater under the road to a drainage swale that generally runs parallel to the barn along its southwest side (refer to Figure 18).

FIGURE 18. Partial view of the Servants' Barn showing the attached, shed-roofed storage area on the southwest side. Tandem storm drainage pipes and concrete bulkhead are in the foreground.

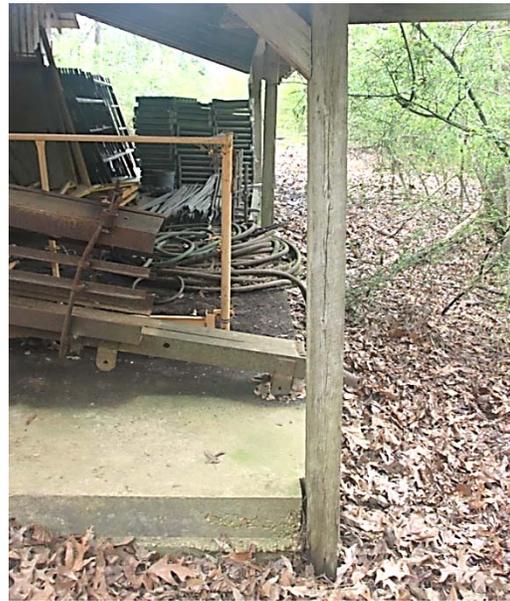
The barn has a concrete slab foundation that is visible above grade on the northeast and northwest elevations and a brick pier foundation supporting the raised wood floor of a smaller storage room to the east. The concrete slab of the covered storage area appears to be a later addition to the structure, as evidenced by a cold joint where the slab of the covered storage area abuts the concrete foundation under the barn and the condition of the slab placed around the posts at the perimeter of the covered storage area where the wood posts that support the roof simply extended to grade (Figure 22). This area under roof likely had an uneven dirt floor until the concrete slab was poured.

FIGURE 22. The concrete slab at the wraparound open storage area.

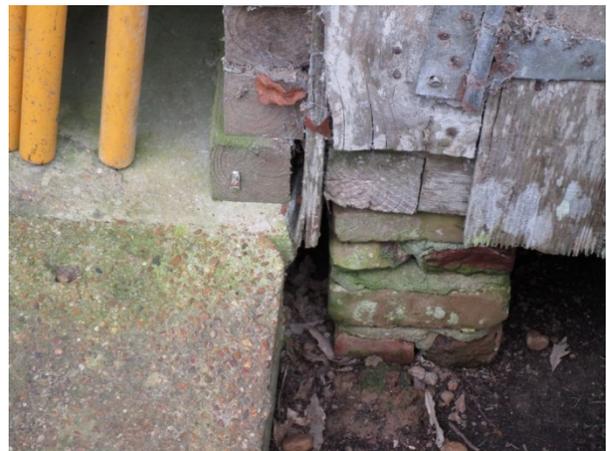
FIGURE 23. Edge of concrete ramp at the covered storage area, abutting an original brick pier at the rear corner of the northeast elevation.

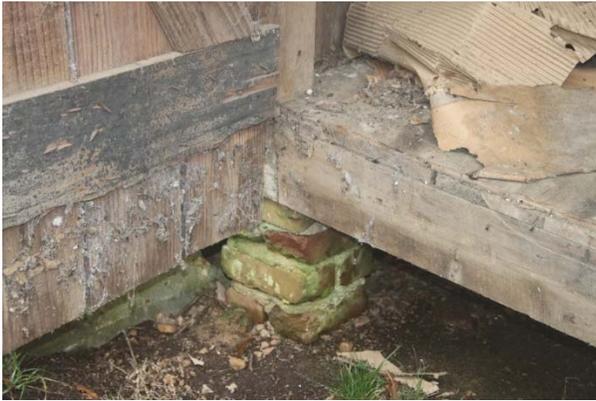
FIGURE 24. Brick pier at the northeast corner of the barn. Floor framing and exposed edges of the flooring are also visible.

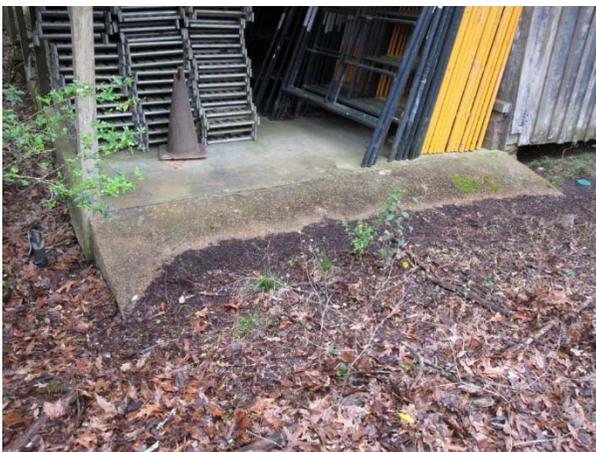
The top surface of the concrete slab of the covered storage area appears to be about even with the bottom edge of the 6 inch by 4 inch perimeter beams that span between brick piers. A short, steeply sloped concrete ramp makes the 15-inch transition from grade to the top of the slab at the east corner (Figure 25). From this point, the height of the slab above grade varies from 15 inches to 12 inches at the south corner and to barely above grade at the west corner next to the road.

FIGURE 25. The edge of the concrete slab slopes to grade at the covered storage area at the northeast corner of the barn.

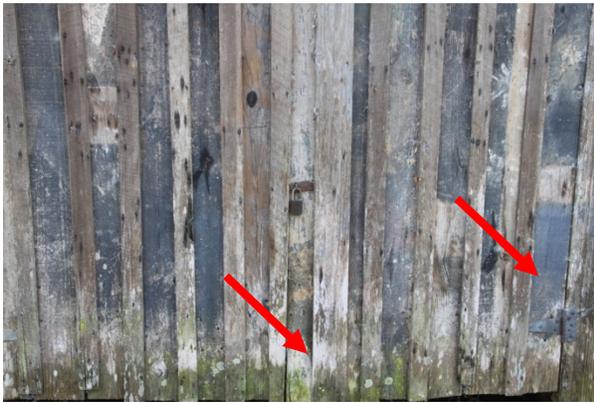
In addition to the weathered patina of the bare wood, the siding exhibits remnants of blue, gray, brown, and white finishes. A historic paint analysis, completed as part of this Historic Structure Report and included as Appendix D, concludes that the building may have been constructed of repurposed wooden boards then finished with a thin whitewash (possibly limewash with a carbohydrate and/or protein additive) to unify the appearance of the exterior walls. Biological growth may have targeted (i.e., eaten) the thin layer of whitewash and/or weathering may have washed away the very thin paint layer, leaving the mismatched boards visible (refer to Figure 27).

FIGURE 27. Weathered siding with remains of gray and white finishes.

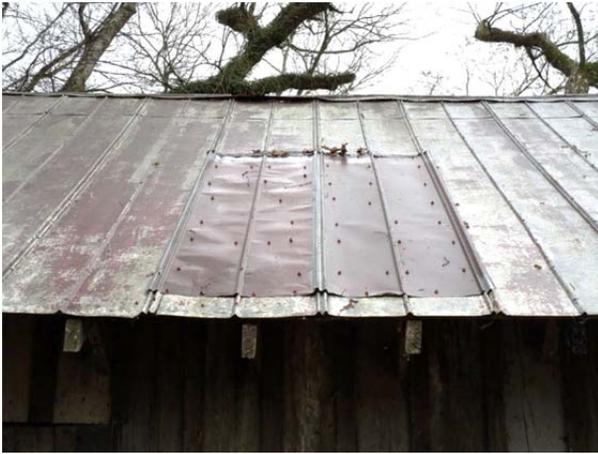
Currently available panels are typically formed with a tight V-crimp that does not accommodate a fastener at the top of the rib. The difference was observed at a patch location where a 4-foot-wide section of contemporary 5-V panel has been installed over the older material using new wood nailers and screws in the flat face of the panel (Figure 34Error! Reference source not found.Error! Reference source not found.). Although the age of the typical panel could not be confirmed in the field, the rolled crimps suggest that the primary panels may be original to the structure. Galvanized metal roofing panels are commonly available with a 32 or 29 gauge thickness; however, early panels were available in 22 gauge. The gauge of the panels was not confirmed in the field; however, the patch material appears to be of a thinner gauge than the original panel. The original roofing panels exhibit a dark red finish coat applied over a white primer (refer to Figure 33).

FIGURE 34. Contemporary 5-V roof panels used to repair the northeast side of the gable roof.

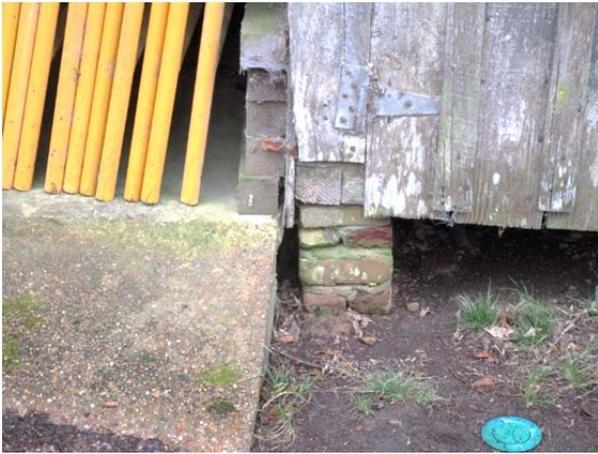
- On the southwest side of the covered storage area, the concrete slab is undermined (Figure 40).
- Spalled brick and deteriorated mortar joints were observed in the masonry piers that support the enclosed rear section of the barn (Figure 41 and Figure 42).
- As a result of inadequate consolidation, there are voids and exposed coarse aggregate in the edge of the concrete slab of the covered storage area (Figure 43).

FIGURE 41. A visible portion of a masonry pier on the northeast elevation.

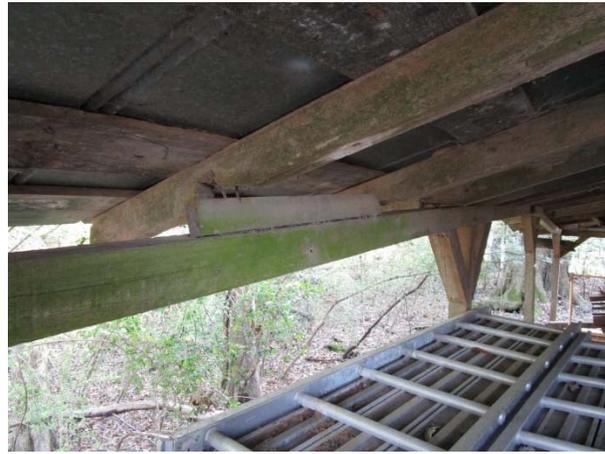
FIGURE 57. Deformation of wood framing members along the southeast elevation of the building.

- Decaying wood structural members at the east and west ends of the covered storage area have resulted in sagging beams and joist failures that also contribute to deformation of the metal roof panels, particularly along the eave (Figure 57 and Figure 58).
- Generally, deterioration of wood structural components was observed throughout the structure, especially where the wood has the most exposure to exterior environmental conditions (Figure 59 and Figure 60).

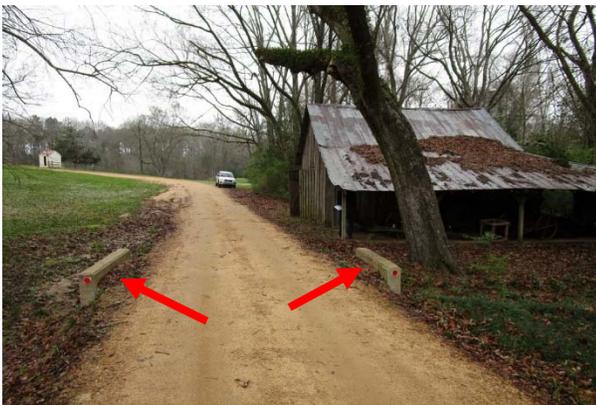
- Numerous rotted siding boards and battens were observed. Most of the decay occurs at the base of the siding where it is close to or in contact with the ground (Figure 61 and Figure 62). A number of gaps and openings in the siding in and the doors, because of rotten wood and missing battens, contributes infestation by rodents, birds and insects.
- The strap hinges and hasps on the carriage doors have corroded, and the screws fastening them to deteriorating wood will eventually fail (Figure 63).
- Some battens are missing on the carriage doors (Figure 64).
- The grade of the wooded area to the south of the barn flattens and appears to hold water between the uphill culvert at the road (Figure 65) and the inlet of a concrete headwall further in the woods to the east (Figure 66).

FIGURE 65. Concrete headwalls at culvert.

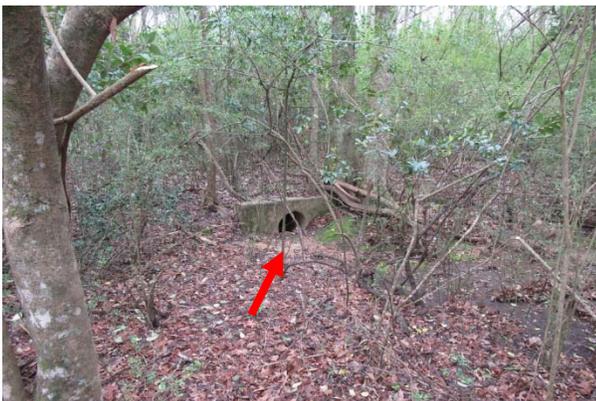
FIGURE 66. Inlet at concrete headwall in wooded area behind barn.

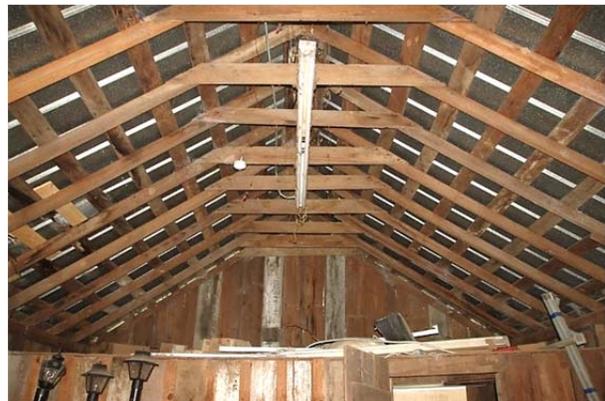
FIGURE 67. The interior toward the storage loft.

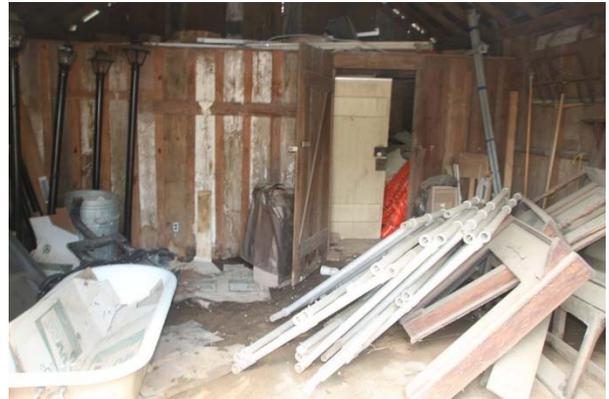
FIGURE 69. Interior view of the barn looking toward the door to the smaller space at the rear. Structural framing and wall cladding are exposed.

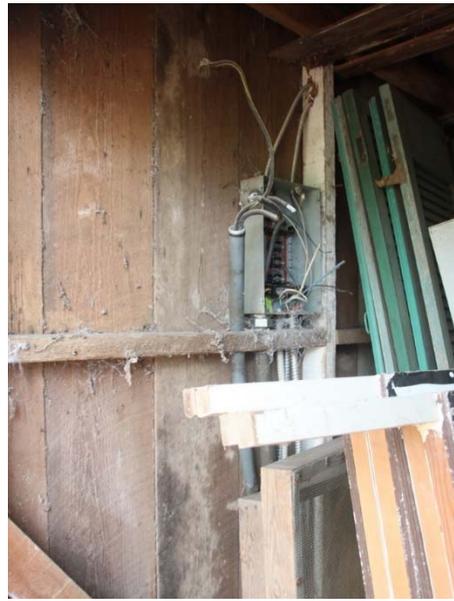
Electrical service to the building was observed to be from underground conduit rising from below the plywood floor of the secondary storage space to an uncovered electrical subpanel at the interior of the southeast wall. Adjacent to the panel is an abandoned conduit with exposed primary conductors (Figure 72). The grounding of the panel could not be confirmed. No disconnect for the incoming service was observed before the subpanel. The source and functionality of the underground service feeding the barn could not be confirmed during the site visit.

FIGURE 72. Electrical panel at southeast wall.

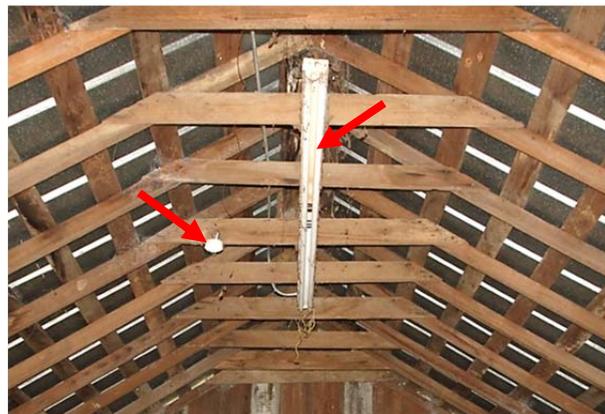
FIGURE 73. Fluorescent strip light fixtures mounted on the collar beam. Also note the smoke and fire sensor on the beam to the left of the light fixture.

- The electrical and lighting system and the fire and smoke detection system appear to be incomplete and not in compliance with current codes. Electrical devices, light fixtures, and the smoke and fire sensors need updating.
- The electrical subpanel located in the secondary storage space was observed to be uncovered. Exposed primary conductors were unprotected at the termination of an abandoned conduit adjacent to the panel.
- Plumbing was limited to one utility sink that was not in use. Connections to potable water and to a public sewerage system or a septic system are unknown. Additional research and investigation into the water and sewer systems are discussed in the Treatment chapter.
- Two fire extinguisher brackets are mounted to the interior of the jamb of the large doors in the main storage area. No fire extinguishers were present.

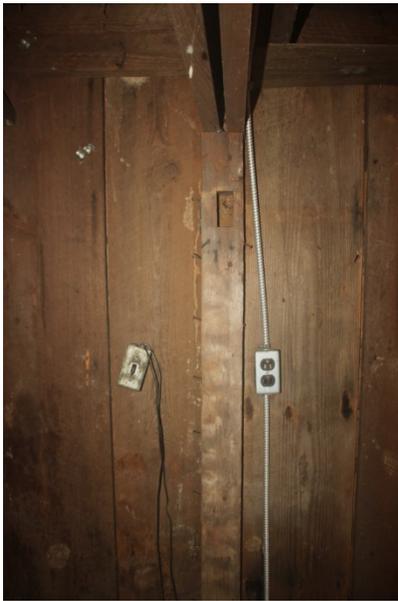
Leaving the panel are circuits of metal clad (MC) cabling that continue to electrical devices such as receptacles and light fixtures. Several conductors were observed to be disconnected from the busbar at the panel. The metal clad cabling appears to have been installed concurrent with the panel and fixtures such as the fluorescent light at the ceiling of the barn (Figure 73) and receptacles in metallic junction boxes throughout the structure (Figure 74). An opening in the southeast wall with an adjacent receptacle may have served a window-type air conditioning unit (Figure 75). No exterior light fixtures were found.

FIGURE 74. A disconnected switch (left) and receptacle with metal clad (MC) electrical cable (right) mounted to the wall.
