SNAKE HOUSE RUIN 1978

Stabilization of Snake House Ruin

Report submitted to
National Park Service
Southwest Cultural Resources Center
Santa Fe, New Mexico

May, 1979

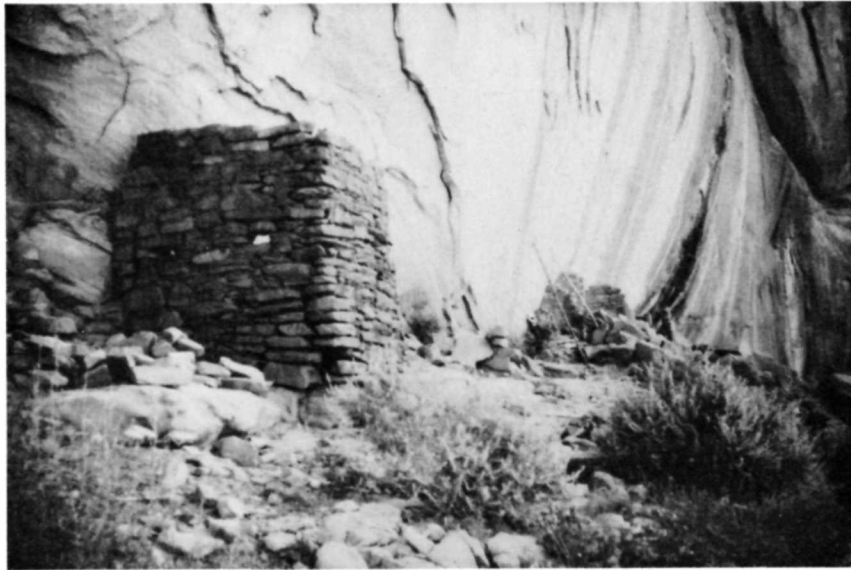
Figure 16.
View of Room 3 before any stabilization
attempts. Notice the lack of cliff over-
hang in the area.

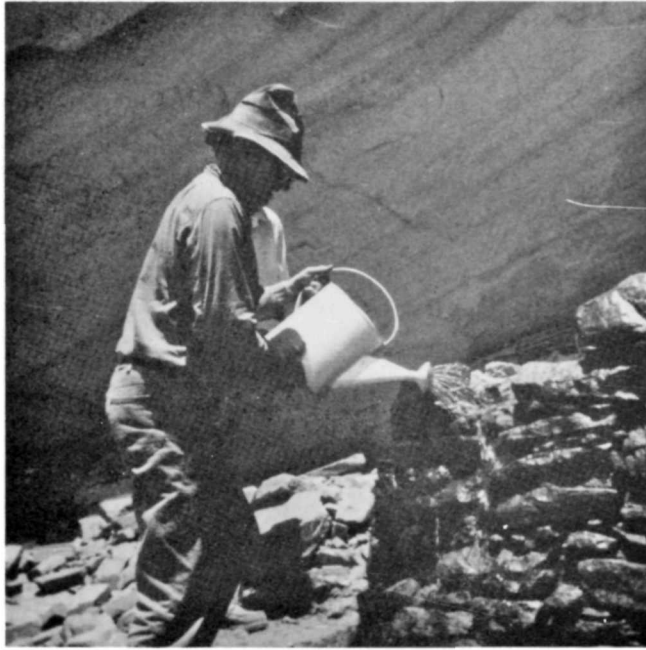
Figure 20.
First application of methyl methacrylate,
note application procedure.

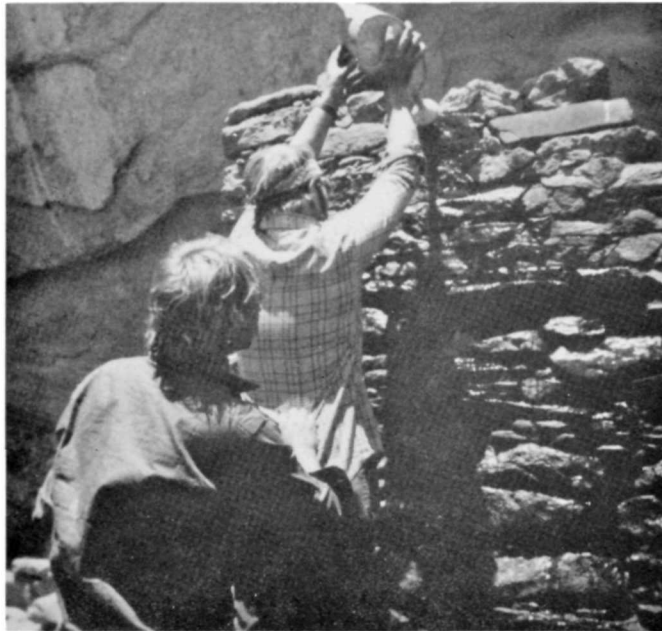
Figure 21.
Second application of methyl methacrylate
on highest portion of Room 3.

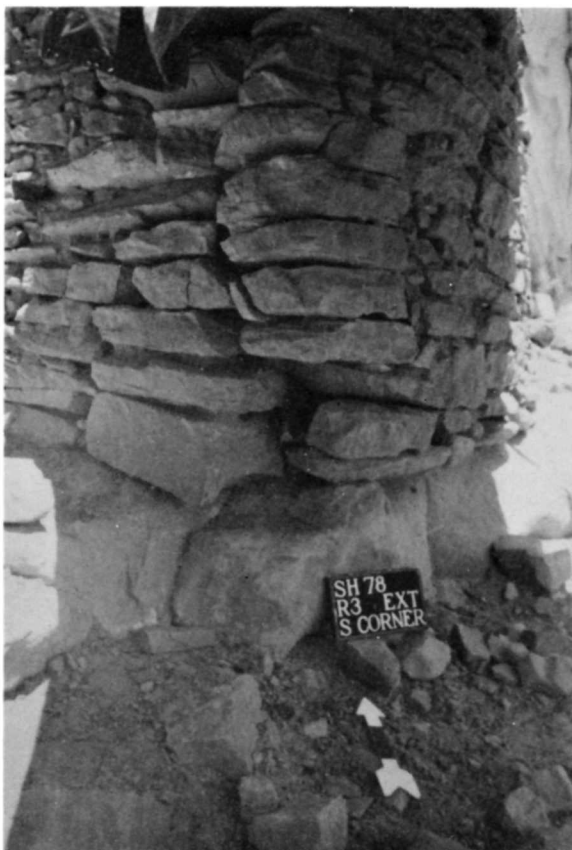
The base stones have eroded out of the corner. Mortar is very weathered as is the stone. As the wall has settled, it has buckled and leans toward the south corner. There is extreme pressure on the corner, and several stones have cracked. There is a small amount of bleeding on the interior mortar, and heavy bleeding on the exterior west and south walls. There appears to be evidence of a second story room, due to clay stains on the back of the cliff line, which are in line with beam sockets on the interior of room 3.

Figure 29.
SHP-78 1-11-13. Room 3, job 1 south exterior of corner before stabilization, May, 1978

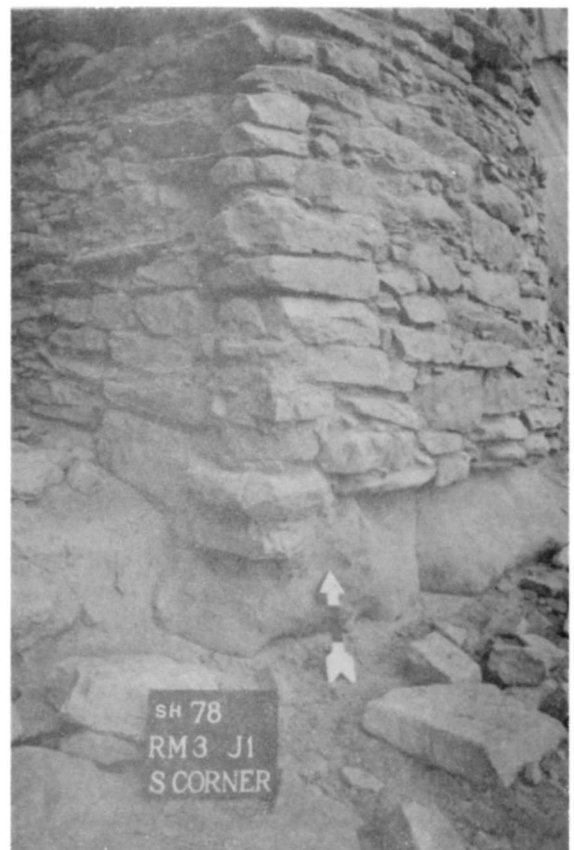
Figure 30.
SHP-78 3-6-31. Room 3, job 1 south exterior corner after stabilization June, 1978

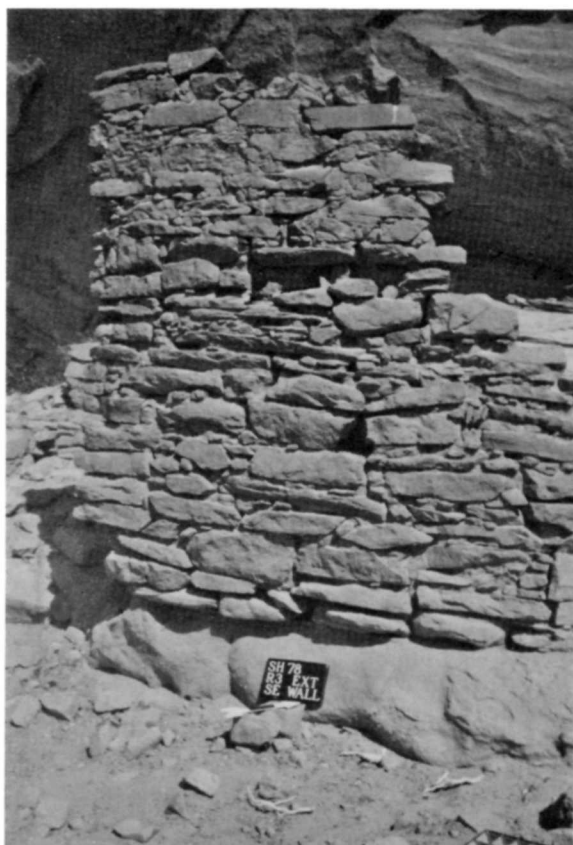
Weathered. Stone and mortar have pulled apart. The surface is sandy and tends to powder off easily. Several stones have fallen leaving large gaps. The outside areas of the beam seats are also eroded and need repair.

Figure 32.
SHP-78 1-2-4. Room 3, job 2 exterior of southeast wall, before stabilization, May, 1978.

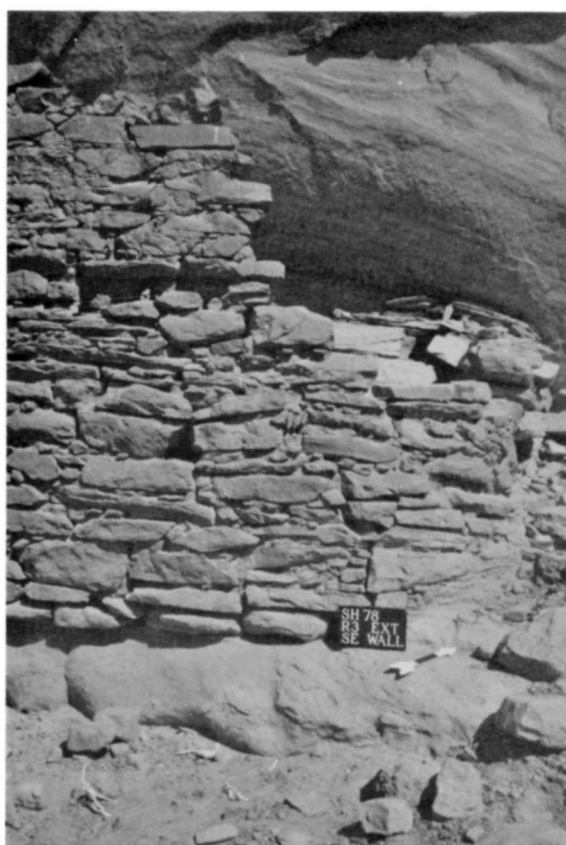
Figure 33.
SHP-78 1-2-5. Room 3, job 2 exterior of southeast wall, before stabilization, May, 1978.

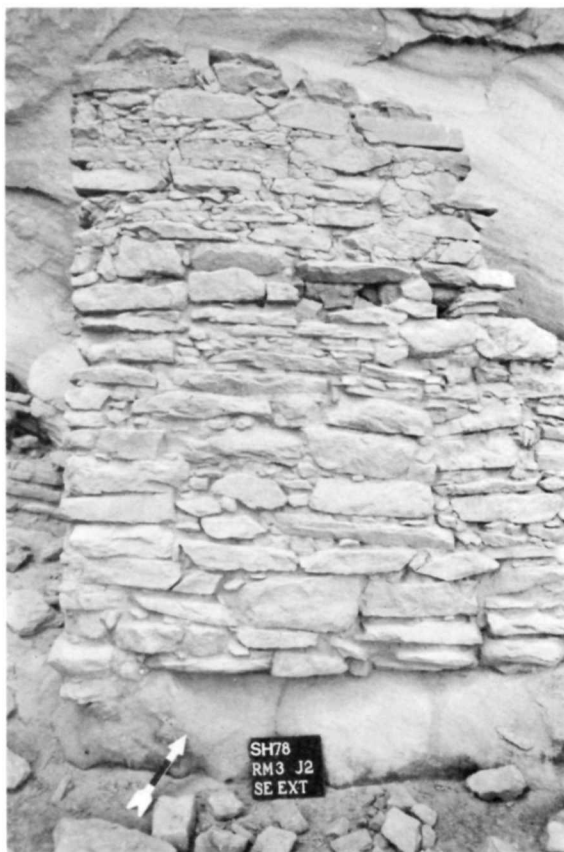
Figure 34.
SHP-78 3-7-32. Room 3, job 2,
southeast exterior wall after
stabilization, June, 1978.

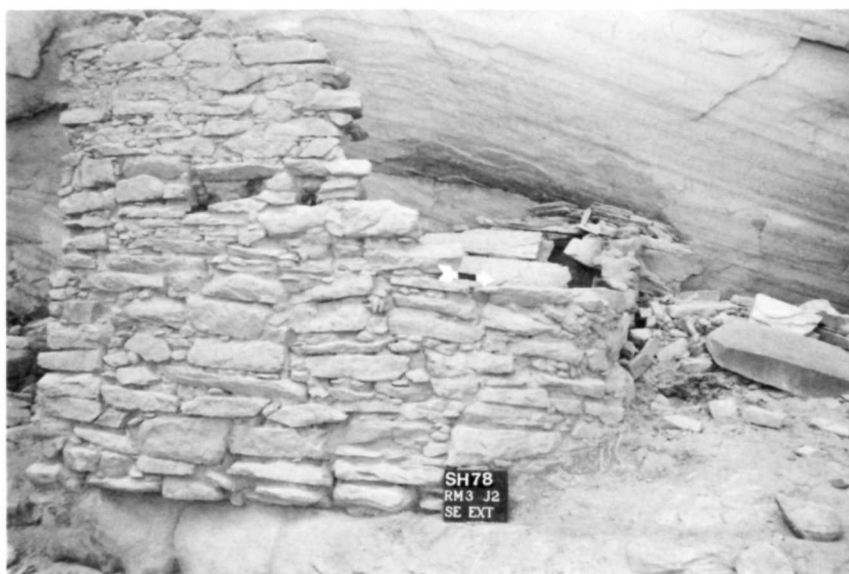
Figure 35.
SHP-78 3-9-34. Room 3, job 2, south-
east exterior wall after stabilization,
June, 1978

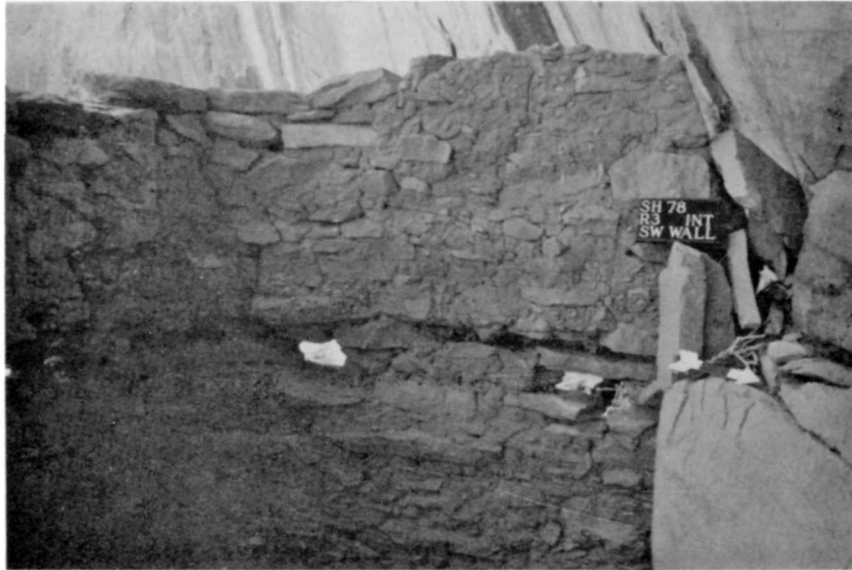
There is heavy erosion above and around the beam seats. Insects have also eroded the mortar leaving a honeycomb effect just above the beam seats. Since there are the remains of a second story above the beam seats, the weight of these stones are putting much strain on the weakened beam seat area.

Figure 36.
SHP-78 1-22-24. Room 3, job 3, Interior
of southwest wall before stabilization,
May, 1978.

Miscellaneous stones were replaced around the beam seats, but, in all cases this was only done to prevent further deterioration. What should be made clear is that no alteration of beam seats occurred other than general grouting. A total of five small stones, along with 10-15 small to medium true spalls were used.

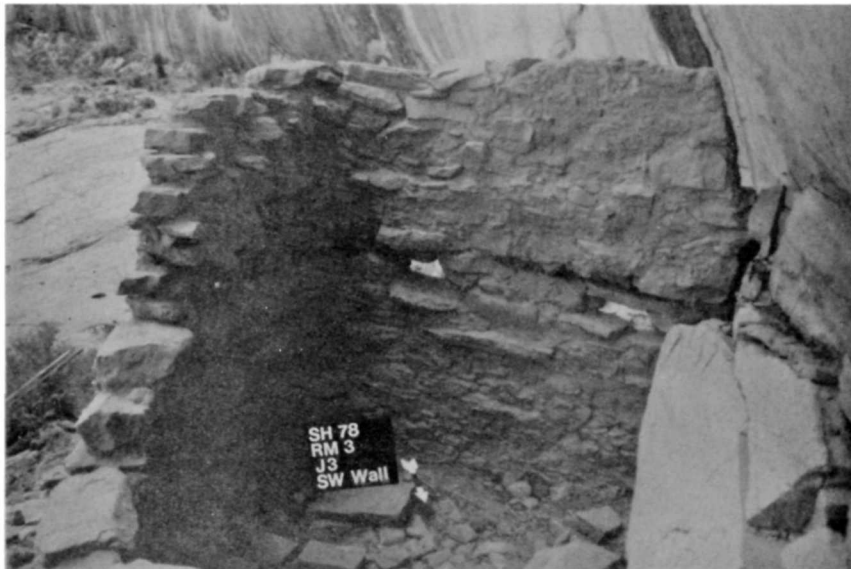
Figure 37.
SHP-78 3-10-35. Room 3, job 3, Interior
of southwest wall after stabilization,
June, 1978.

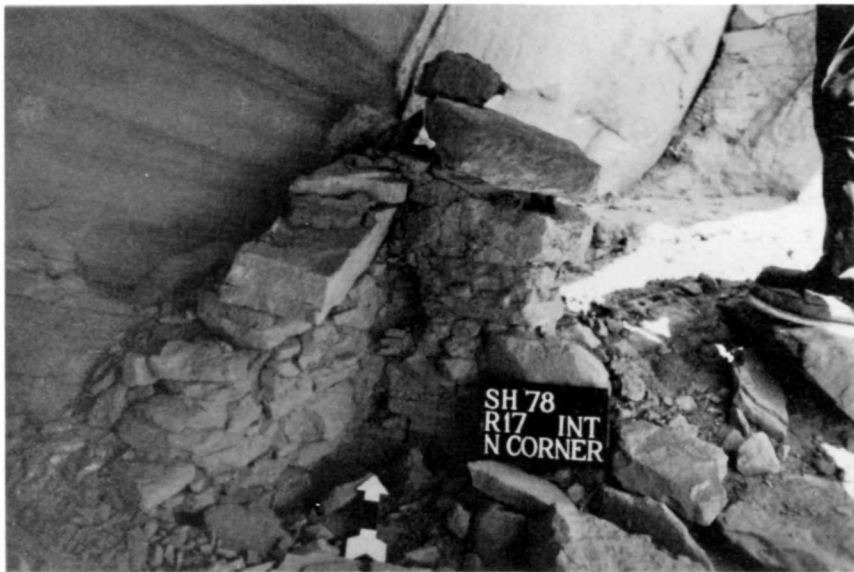
Mortar is cracked and crumbly. Corner has slumped inward and the top course and cap are loose. Only the northeast corner remains of the room, this is slowly pulling away from the cliff and falling inward. No mortar seems to have bled and remains flush with the stones. The room sits on bedrock, and the erosion of this bedrock seems to be the immediate cause of erosion. It is a small back room.

Figure 39.
SHP-78 1-12-14. Room 17, job 4,
interior of north corner before
stabilization, May, 1978.

Two courses, involving two large stones, were reset on the north wall. Ten small false spalls, 10-15 small true spalls, and 10-15 small levelers were all used. The cap rock on the east wall was replaced and a large stone was used to overlap and bond the two walls, connecting them at the corner. Both interior and exterior grouting was done.

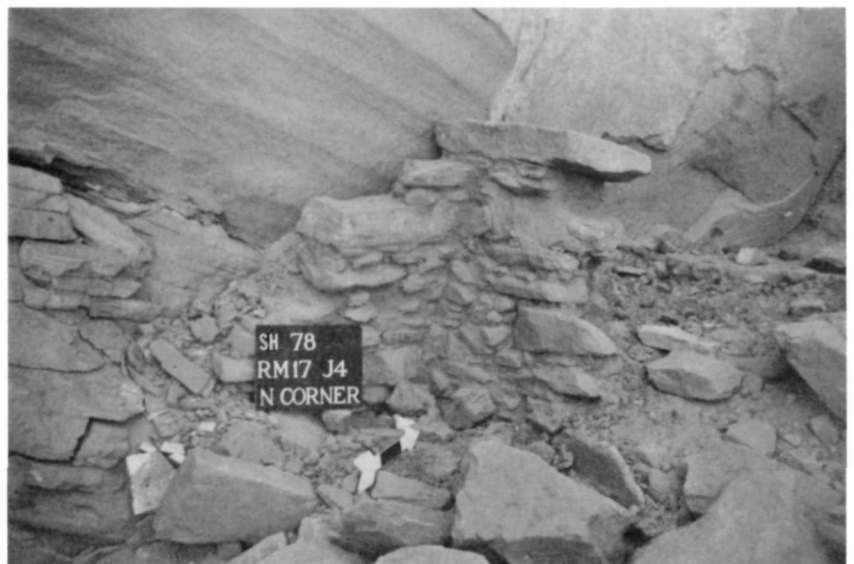
Figure 40.
SHP-78 3-4-29. Room 17, job 4,
interior of north corner after
stabilization, June, 1978.

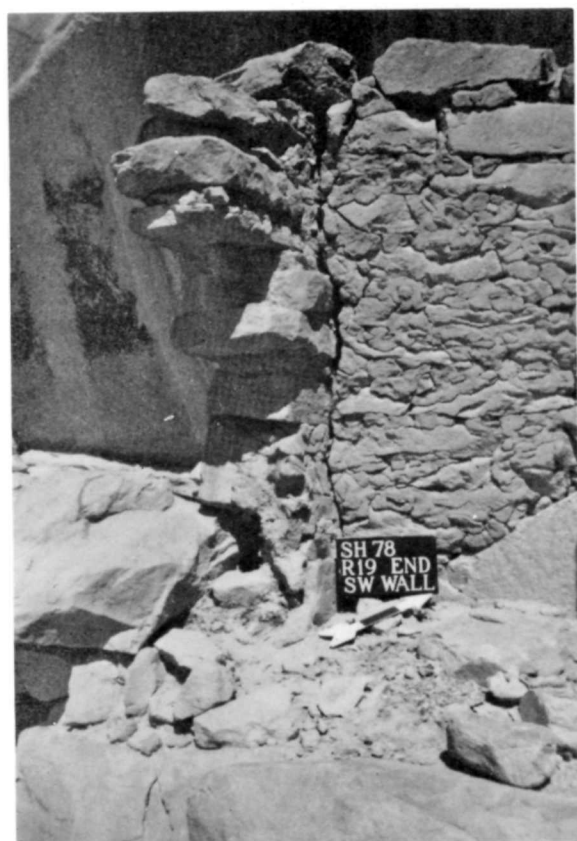
Top courses are overhung and undercut. Footing and bottom courses are washed out. On the bedrock base there is a grass/jacal layer that is now exposed. Wall is subject to a major water flow. The base of the northeast wall has tumbled and 6-8 courses need to be set in order to support the upper courses which remain intact. Deep grouting is also necessary. The wall is so exposed to water wash and the mortar has washed away leaving no support for the large stones

Figure 42.
SHP-78 1-9-11. Room 19, job 5, southwest wall end before stabilization, May, 1978.

All loose debris was removed and cleaned down to the bedrock. Two large stones served as the base, and were abutted up to the aboriginal wall. The wall was then built up eight random courses to the lowest overhanging stone. The wall was not constructed further. The end of the wall was capped but left unbroken. A total of three large stones, three medium stones, twelve small stones, 30 small leveler spalls, 35-40 small to medium true spalls, and 30-40 small to medium false spalls were used.

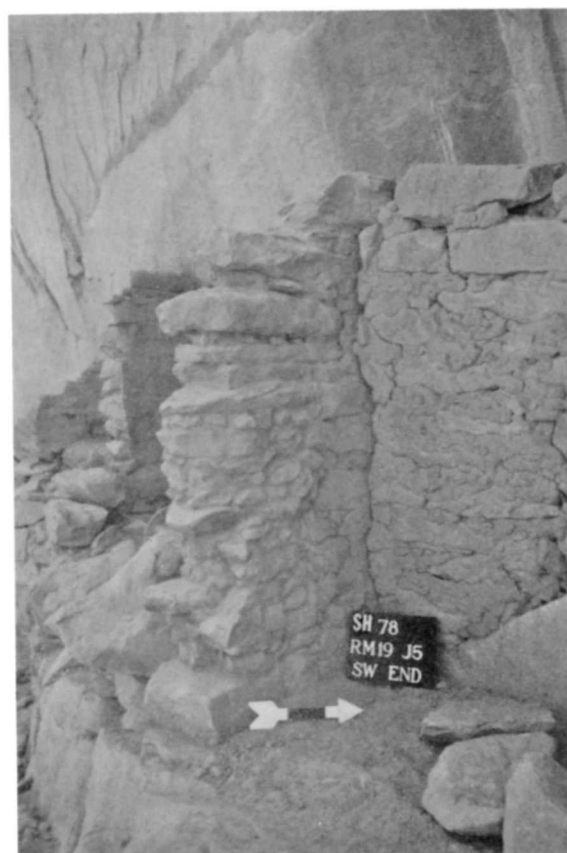
Figure 43.
SHP-78 3-11-36. Room 19, job 5, southwest wall end after stabilization, June, 1978.

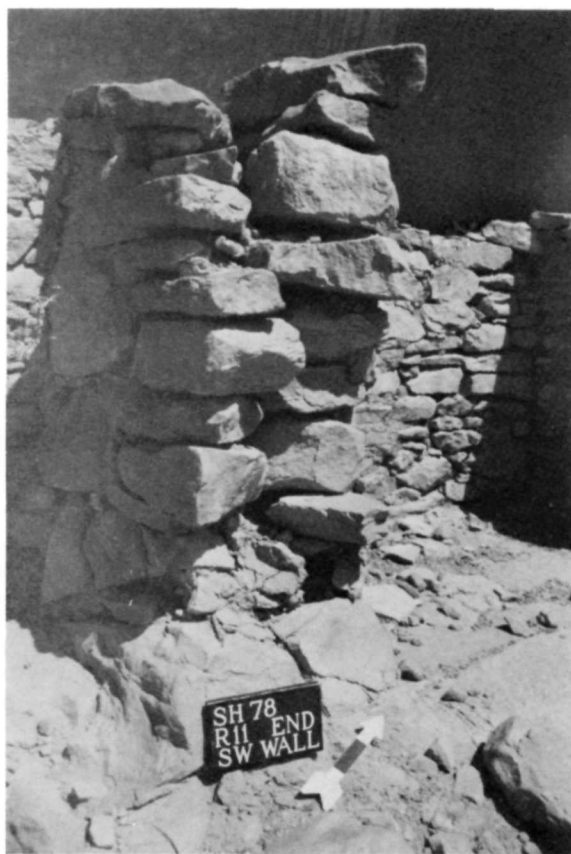
Mortar is completely washed out from between stones and courses. Stones are quite large and often rest only on chinks or other stones. The wall is leaning inward towards the west. A core is recommended

Figure 45.
SHP-78 1-8-10. Room 11, job 6,
wall end before stabilization,
May, 1978.

Deep grout and add a core for support. Mortar is nearly gone and the stones need some sort of support before they all fall out. Extensive grouting and heavy use of true spalls is needed.

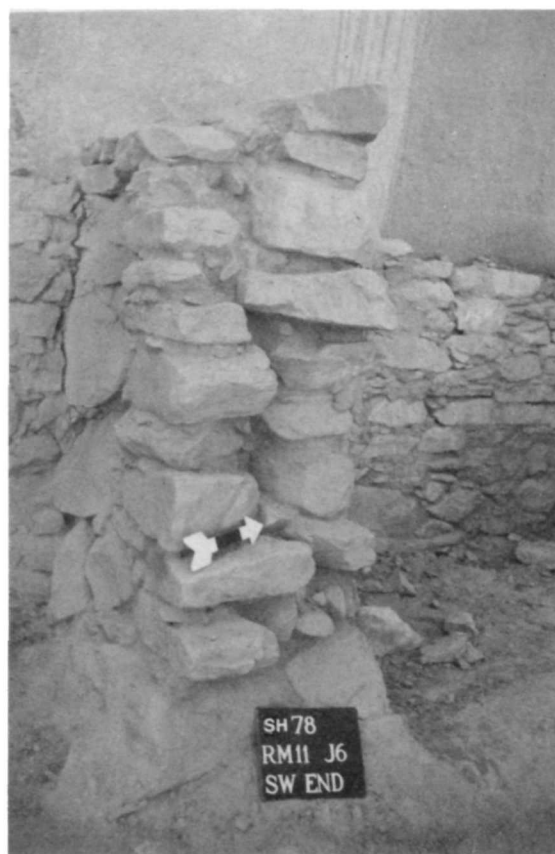
Figure 46.
SHP-78 3-3-28. Room 11, job 6,
wall end after stabilization,
June, 1978.

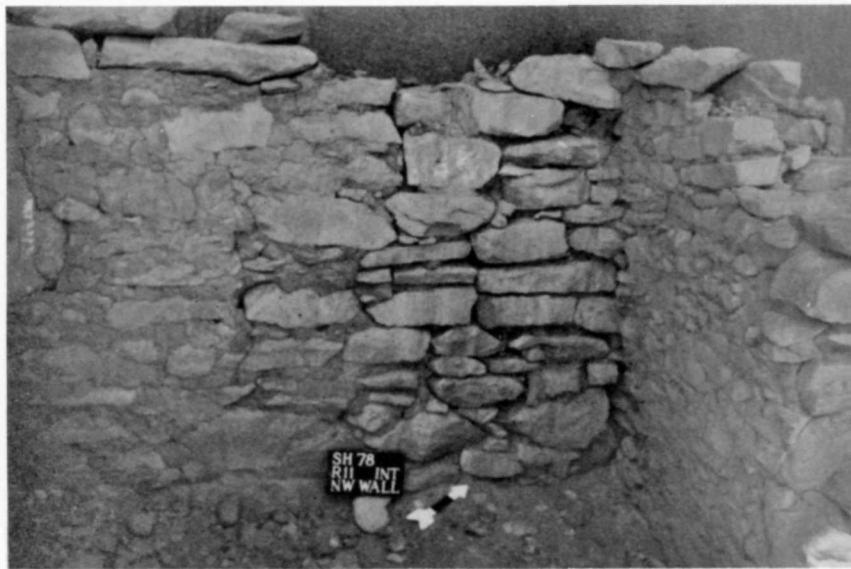
Corner and northwest section of the back wall are very eroded and void of mortar. A drip line seems to be the immediate cause. Stones are leaning towards the center of the room with no mortar support. The base is also eroded and undermined.

Figure 48.
SHP-78 1-13-15. Room 11, job 7-8, interior of northwest wall before stabilization, May, 1978

Deep grouting and adding of spalls is necessary.

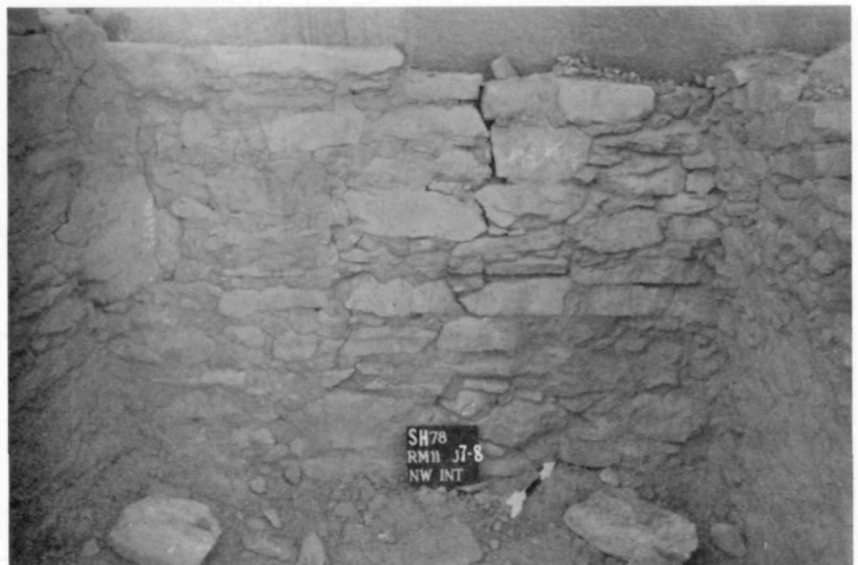
Figure 49.
SHP-78 2-21-33. Room 11, job 7-8, interior of northwest wall after stabilization, June, 1978

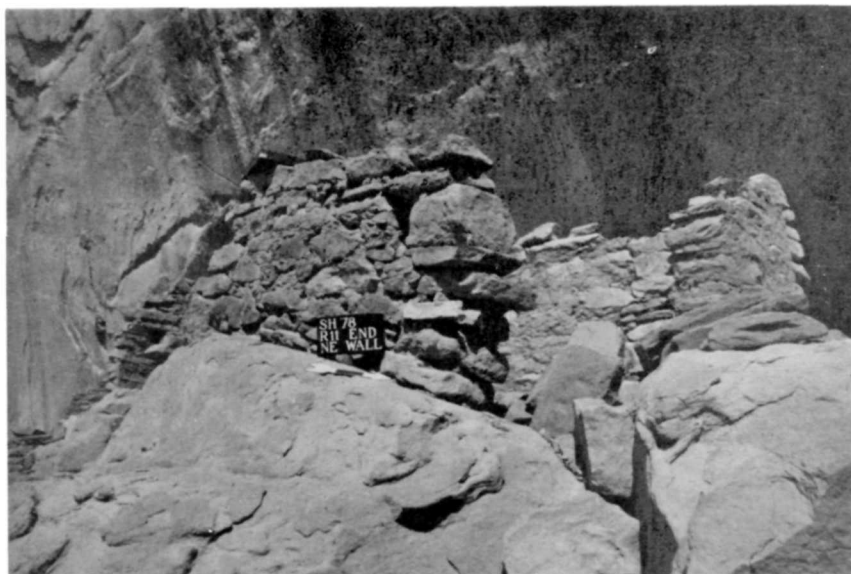
Cap stones need to be set. Course below the cap has extremely weathered mortar. Stones and wall itself are falling inward towards the center of the room. The wall is in a direct drip line.

Figure 51.
SHP-78 1-4-6. Room 11, job 9,
northeast wall end before
stabilization, May, 1978.

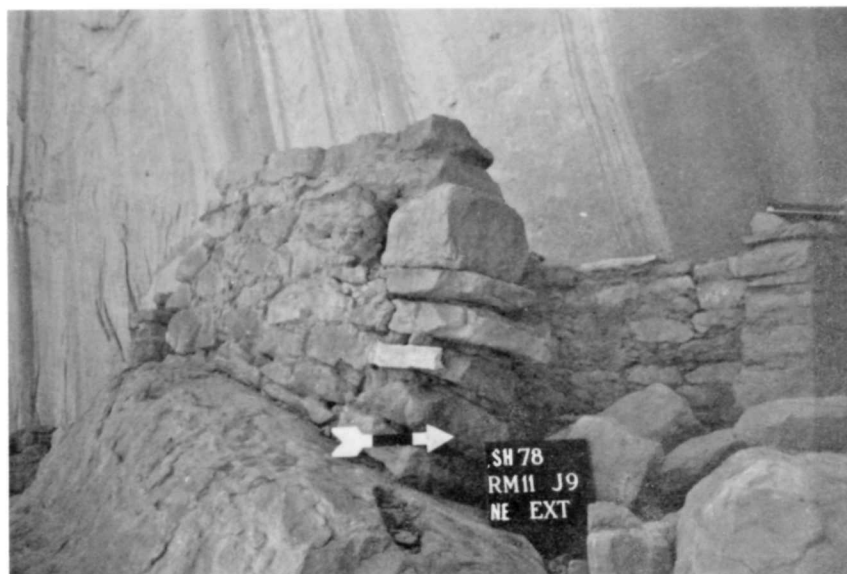
Figure 52.
SHP-78 2-20-32. Room 11, job 9,
northeast wall end after
stabilization, June, 1978.

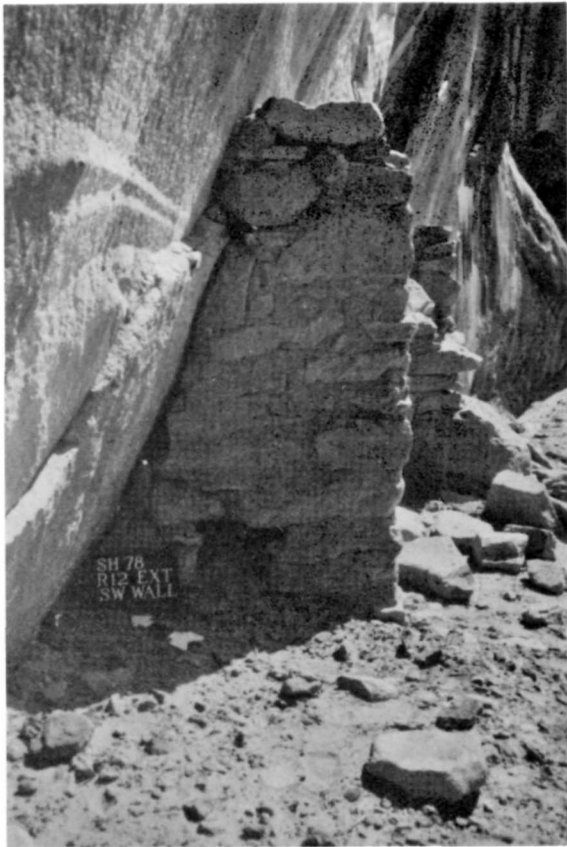
Top two courses and cap need to be reset. Top courses have pulled away from the body of the wall and are creating a strain. Some mortar has bled out and needs to be regouted. Room is in back row of rooms

Figure 54.
SHP-78 1-5-7. Room 12, job 10-11,
southwest exterior wall before stabilization, May, 1978.

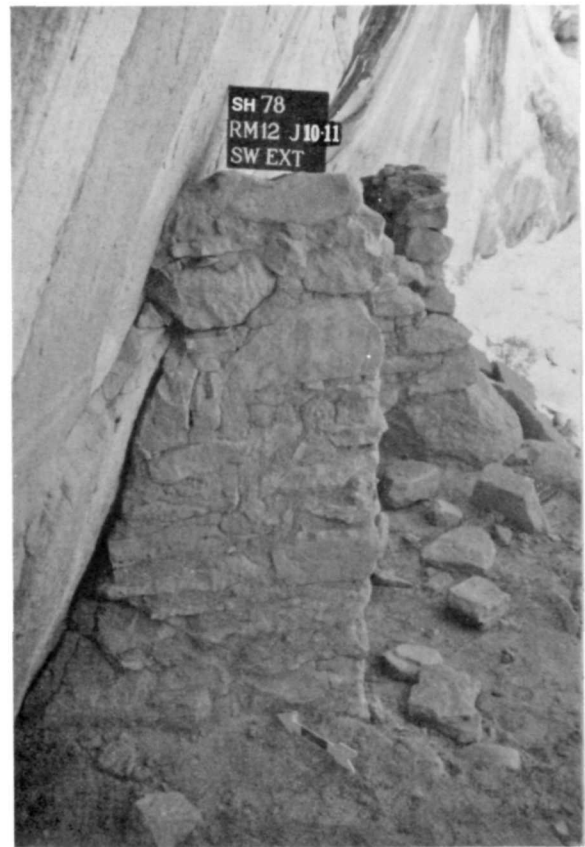
Figure 55.
SHP-78 2-18-30. Room 12, job 10-11,
southwest exterior wall after stabilization, June, 1978.

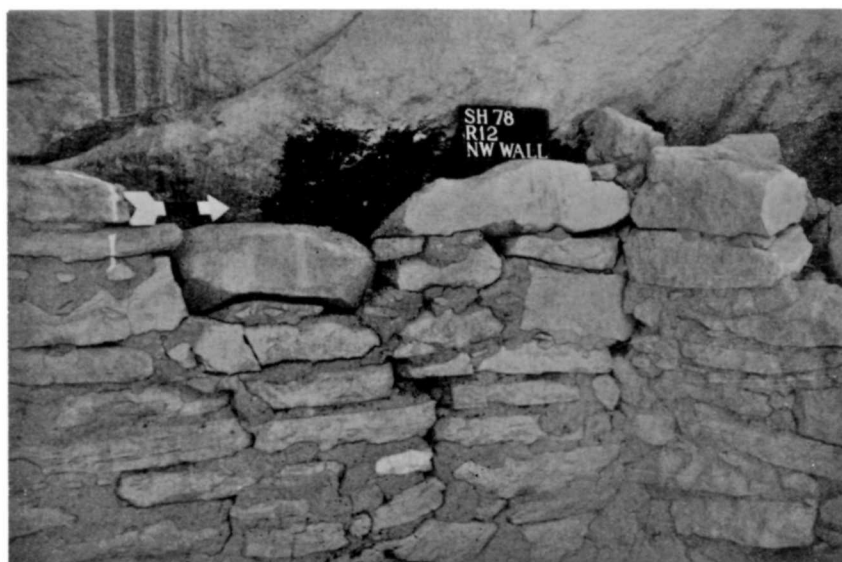
Top two cap stones are loose. Course underneath the cap is also loose. Sections of mortar are also pulling out. Erosion is due to water line and weathering.

Figure 57.
SHP-78 1-15-17. Room 12, job 12 northwest wall before stabilization, May, 1978.

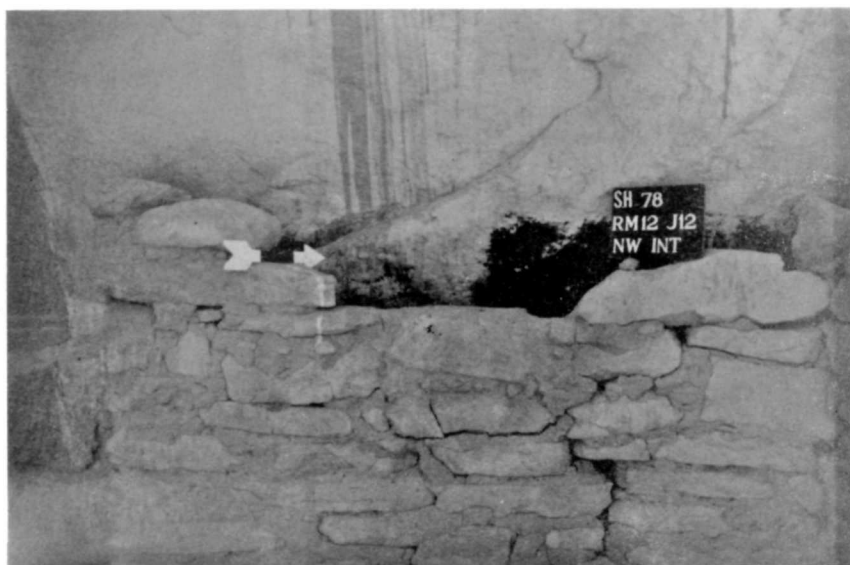
Figure 58.
SHP-78 2-17-29. Room 12, job 12 northwest wall after stabilization, June, 1978.

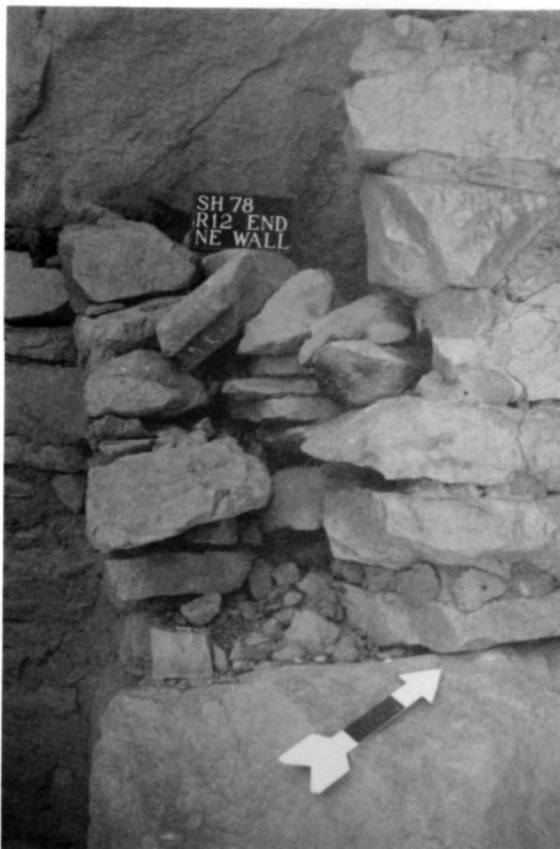
Double wall between Rooms 12 and 13 has slumped and fallen. The footing is bed rock, but it has been undermined and the first course from the ground is very weak. Approx. ten to twenty rocks have slumped and fallen from their original positions.

Figure 60.
SHP-78 1-21-23. Room 12, job 13 northeast end wall before stabilization. May, 1978.

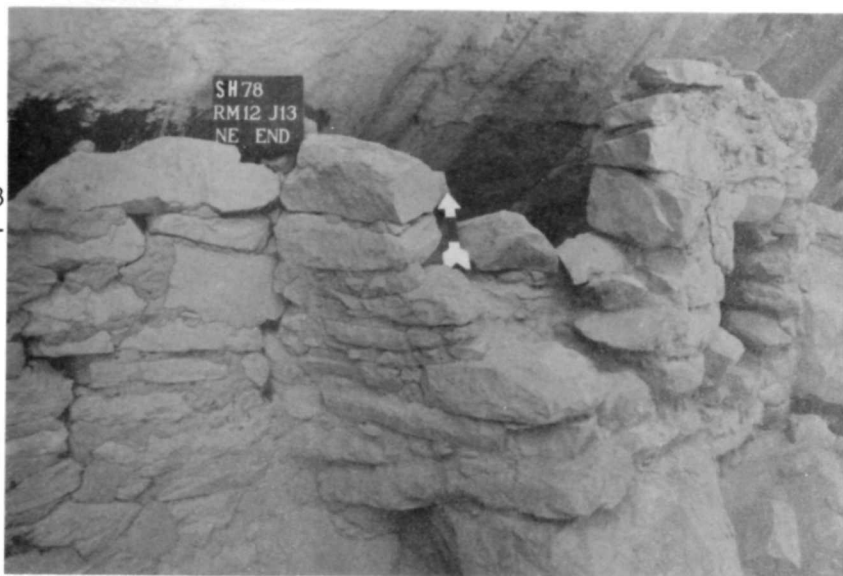
Figure 61.
SHP-78 3-12-37. Room 12, job 13 northeast end wall after stabilization. June, 1978.

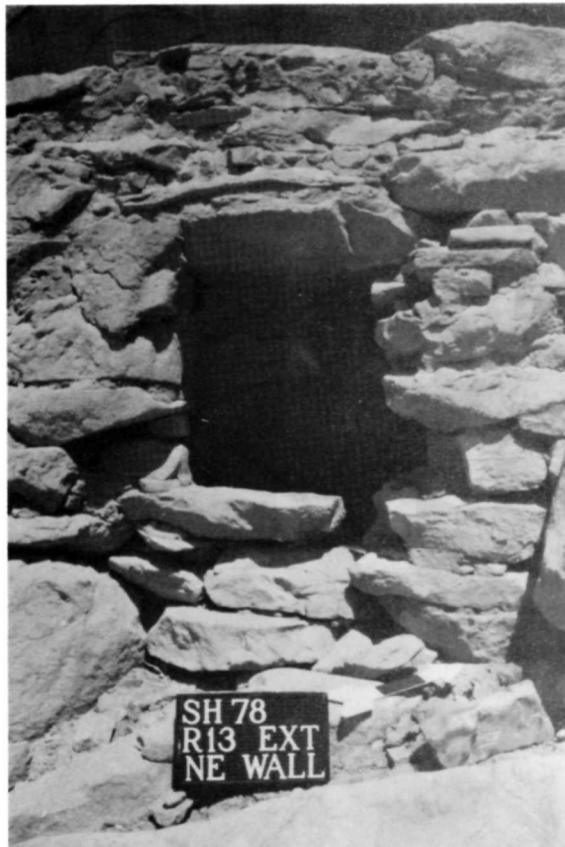
Stones under the door are separated and loose. Mortar is gone and there is no support for the wall or door lintel stones. The base is also eroded because of water wash from the cave back. The stones are eroded clean of mortar. The lintel of the door is still intact, but the door posts need grouting.

Figure 63.
SHP-78 1-10-12. Room 13, job 14 northeast exterior wall before stabilization, May, 1978.

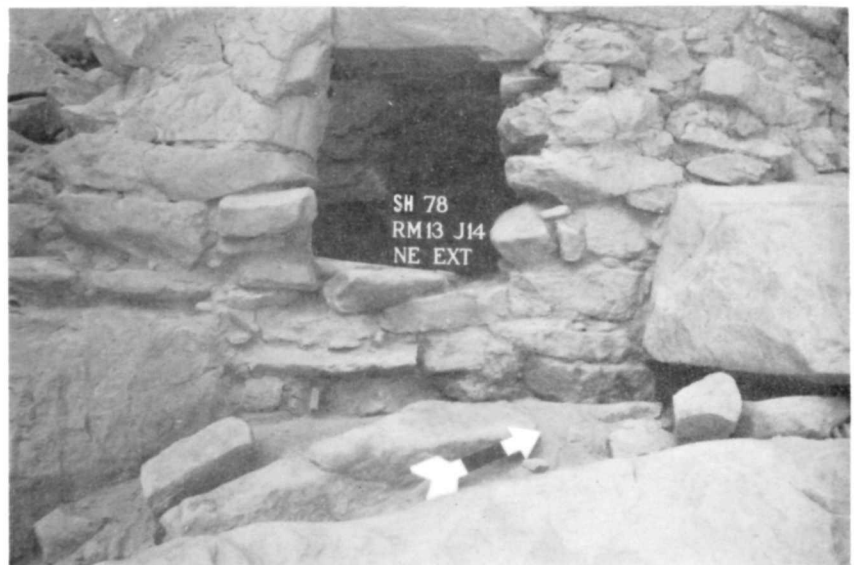
Figure 64.
SHP-78 3-13-38. Room 13, job 14 northeast exterior wall after stabilization, June, 1978.

Small extension wall between Rooms 13 and 14 is suspended in air over a large boulder. The cave back gives some support but the stones have pulled away from the mortar and will soon fall completely out. The wall is slumping both inwardly and down.

It was necessary to lay a one stone thick abutted wall, 5-6 courses high to support the slumping section. The base for this build up was hard packed rat excrement and five stones. As soon as the base was well set, one stone at a time was set on the one immediately below it from the base to the cliff overhang. The last stone set supported the loosened sections of the wall. Twenty medium true spalls and 20 medium levelers were used in the stabilization. The mortar joints were repointed as the mortar dried. A total of eight large stones were set as support for the wall. Five stones were used as a beginning base.

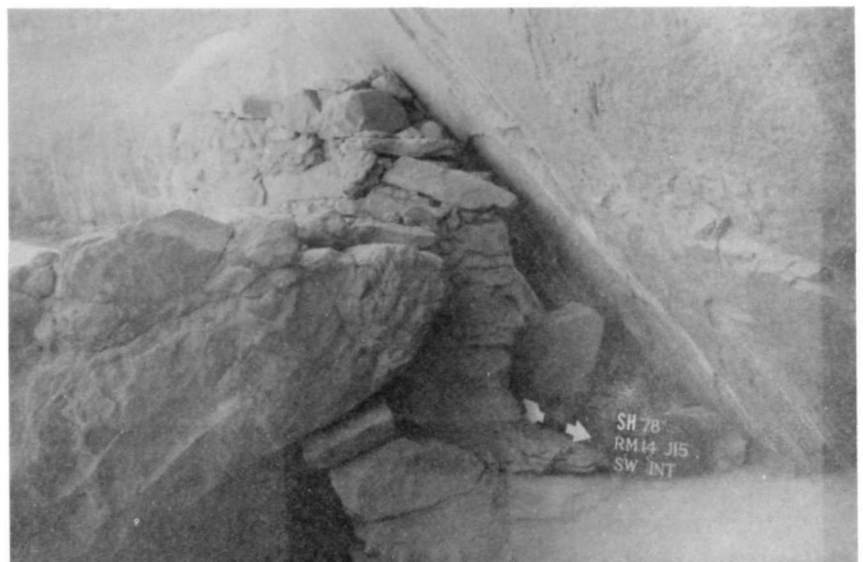
Figure 67.
SHP-78 2-16-28. Room 14, job 15 southwest interior wall after stabilization, June, 1978.

The base needs to be filled in and deep grouted. The entire hole must first be cleaned and repaired before the undermining causes the wall to fall. Dry lay may be necessary on the interior.

The base was first completely cleaned. One large stone was set on the bed rock footing, 2 more large stones were layed over this and 2 medium stones filled the final gap. One and a quarter buckets of mortar and 10-20 medium levelers, 20-30 medium true spalls and 10-15 small false spalls were all used to fill the void. The mortar was repointed at the joints. On the interior of the room a drylay wall was used to hopefully detour moisture from the base in the future.

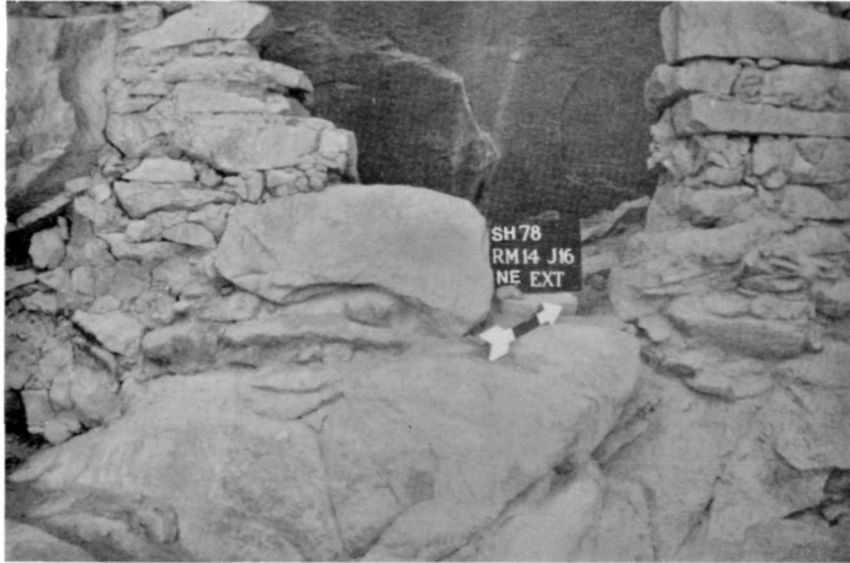
Figure 71.
SHP-78 3-14-39. Room 14, job 16, exterior
of northeast wall after stabilization,
June, 1978.

Cap stones have come loose and mortar has cracked. The wall is stable, but the cap will fall if it is not reset. The adobe seems to bond better with the stone in this area, than it does in other areas.

Top two courses in the cap need to be reset. Several stones are loose and cracks extend to the lower courses. Grouting and some relaying will retard this erosion.

The area was cleaned and brushed. Three cap stones were relaid in place. Four small stones were added in the cap to fill voids. Twelve small to medium spalls were added, they were true spalls, and ten small to medium levelers were also used. The entire area was deep grouted.

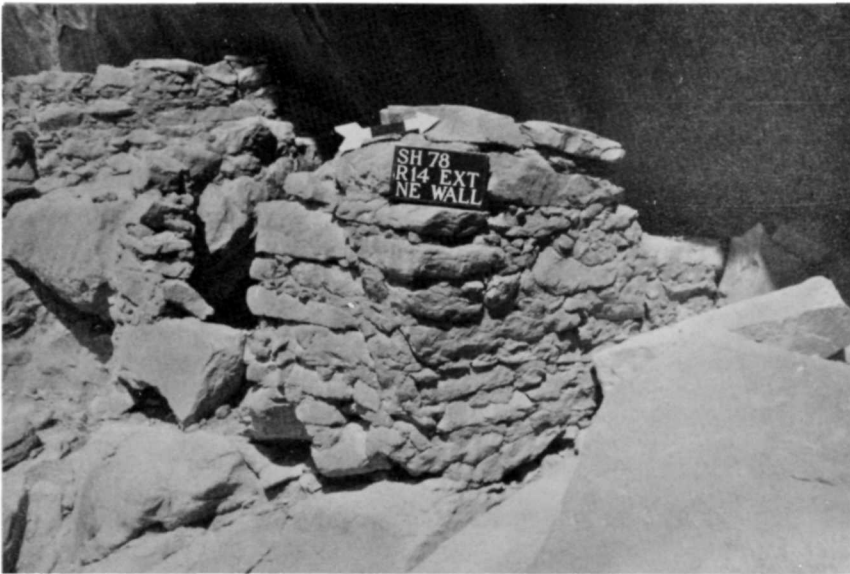
Figure 74.
SHP-78 1-6-8. Room 14, job 17-18
northeast exterior wall before
stabilization, May, 1978.

The entire base of the wall is eroded. Between the bed rock and the first course there is no mortar remaining, and little stone. The entire area is undermined. The bed rock on which the wall is built is extremely soft and crumbled. A new base needs to be built up.

This involved the removal of all loose debris within the hole, and filling the interior of the wall with dry lay, to prevent fill from spilling into the work area from within the room which was sloped downward towards the exterior south. The bed rock was used as the foundation. Two courses were built on top of this utilizing three and two medium stones consecutively. Three large true spalls randomly placed filled the remaining gap between the new coursing and the wall. A total of 20-30 small to medium true spalls, 10-15 small to medium false spalls, and 10-15 leveler spalls were used. The interior of the wall was left back 15cm to prevent further erosion of the fill within the room. Loose debris was ejected from the wall face, and all gaps were grouted. Fifteen to twenty small to medium spalls were used in the grouting.

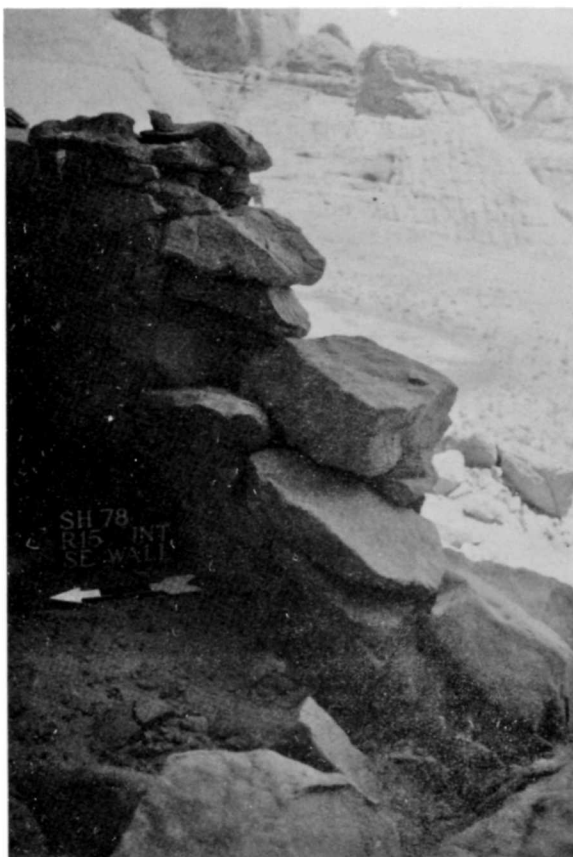
Figure 77.
SHP-78 1-17-19. Room 15, job 19 interior of southeast wall before stabilization, May, 1978.

The southwest half of the southeast wall needs to be deep grouted. Weathering and possible foot traffic have worn down the wall. The wall is much shorter on the southwest end. Deep grouting is also needed in the core.

The job essentially involved grouting a large void within the core of the wall. The gap was filled with successive layers beginning with mortar, which was tamped down followed by 20-30 small to medium true spalls, which in turn were tamped down. A total of 50-60 small to medium true spalls were used. In areas where fingers or sticks were not enough to push the mortar into voids, a grout gun was used. The exterior end was structurally supported in the core area. Two small stones and two large spalls were placed randomly within the core, approx. 15-20 small to medium spalls were used.

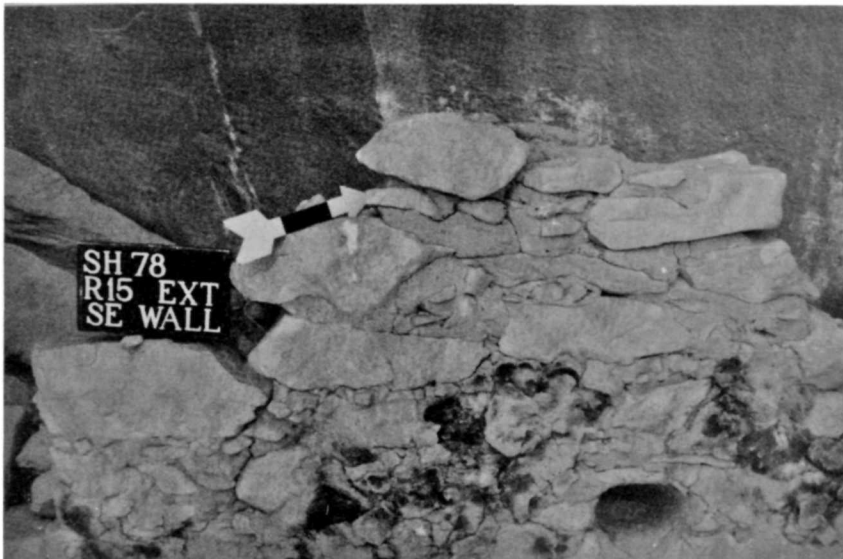
Figure 80.
SHP-78 1-18-20. Room 15, job 20 exterior of southeast wall before stabilization, May, 1978.

Two cap stones are loose and one or two are missing. The wall is in good condition in other respects.

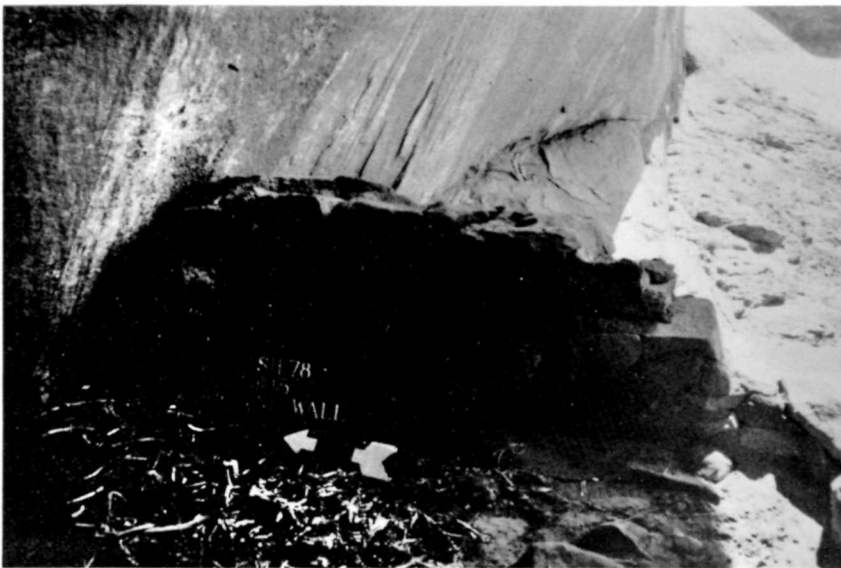
Figure 83.
SHP-78 1-7-9. Room 15, job 21-22
northeast wall before stabilization,
May, 1978.

Wall has pulled away from the cliff. Two to Six cm of crack have developed up the entire width of the wall. The wall has no support and is buckeling. Drip line is the immediate cause of the erosion, and will continue to wash the mortar out of the joints if the top of the wall is not contoured. The crack is 48cm high, 2-6cm wide, and 25-28 cm thick.

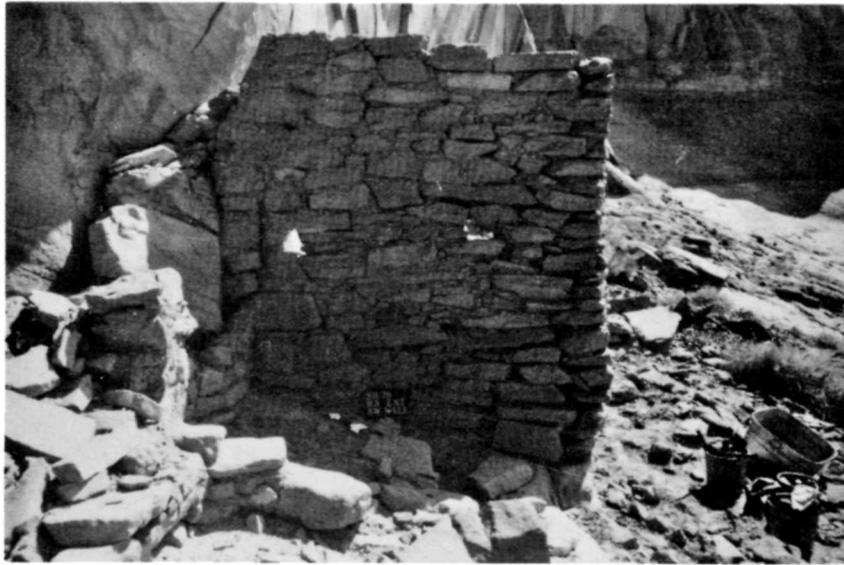
Figure 85.
SHP-78 1-1-13. Room 3, job 23 southwest
exterior wall before stabilization,
May, 1978.

Because stabilization was attempted in August of 1977 and was unsuccessful due to the weathering of the stone and mortar, there are many large areas to be grouted. The wall is heavily chinked with both small and medium sized spalls. Stones may need to be replaced around the beam seats.

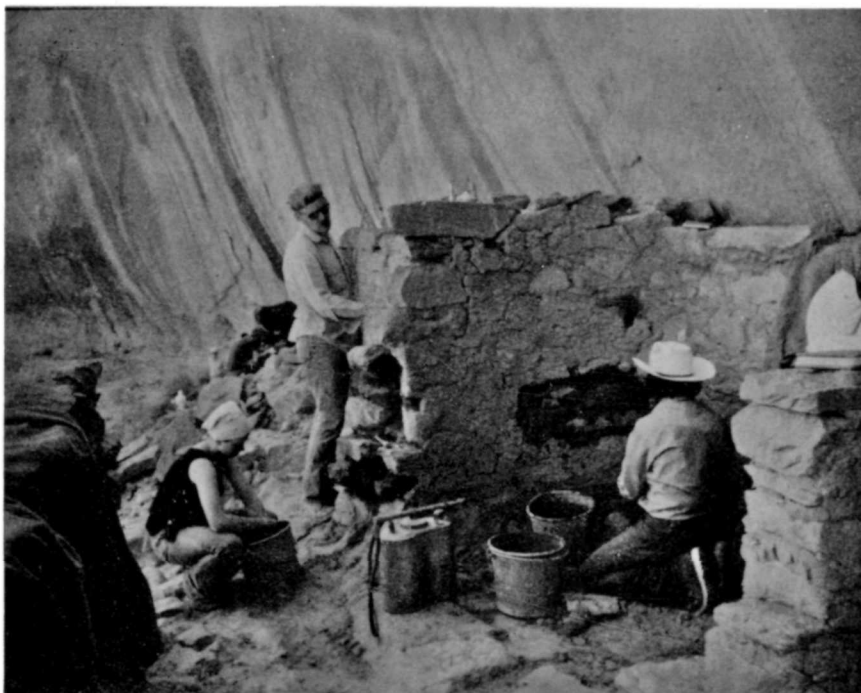
Figure 87.
Room 11, job 24 during stabilization,
May 1978.

There is an extensive void in the wall. Not only is it approx. 1m x 1m x 1.5m, but it also extends up into the core. The wall is sturdy but there is still a fair amount of weight over the top of the void.

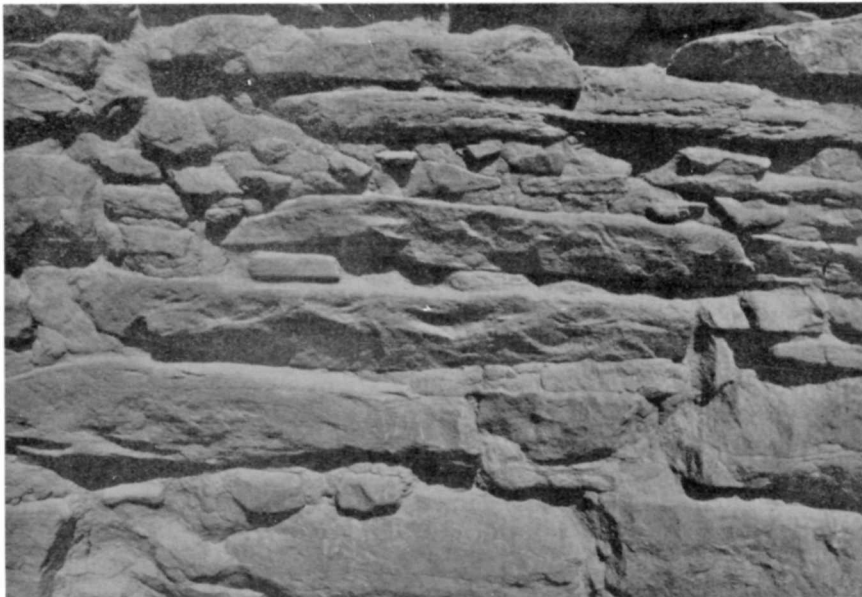
Figure 96.
SHP-78 4-6-8. Winter check
Room 3, southeast interior
wall. Note position of sec-
ond story floor beam seats.
March 1979.

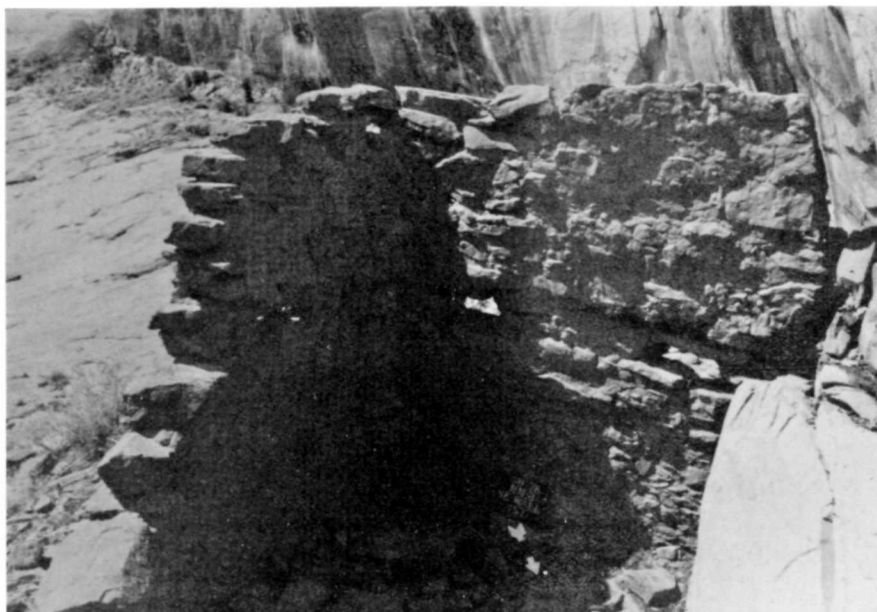
Figure 97.
SHP-78 4-7-9. Winter check
Room 3, southeast interior
wall. Close-up of beam seat
area. March 1979.
