SNAKE HOUSE RUIN 1978

Stabilization of Snake House Ruin

Report submitted to
National Park Service
Southwest Cultural Resources Center
Santa Fe, New Mexico

May, 1979

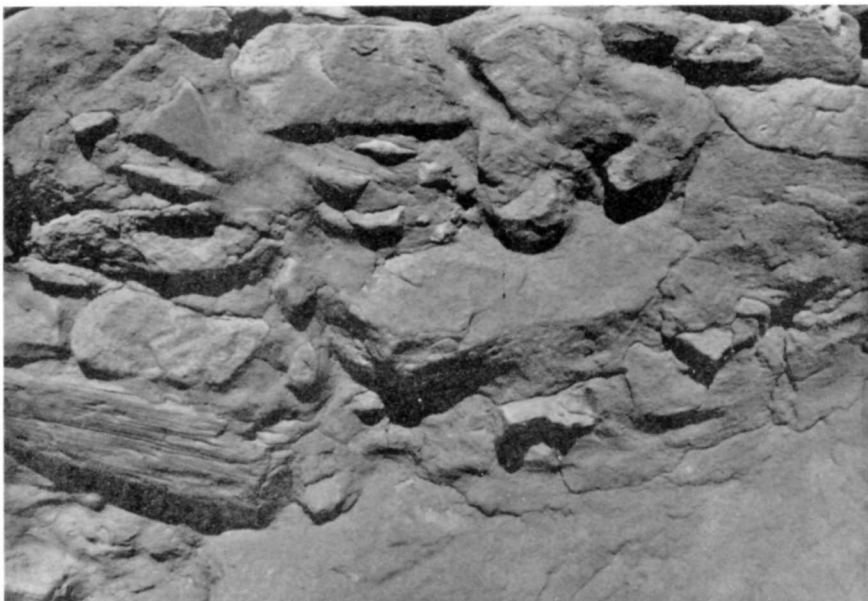
Figure 98.
SHP-78 4-10-14. Winter Check
Room 19, job 5; southwest
wall end. Note water marking
on mortar and stone. March
1979.

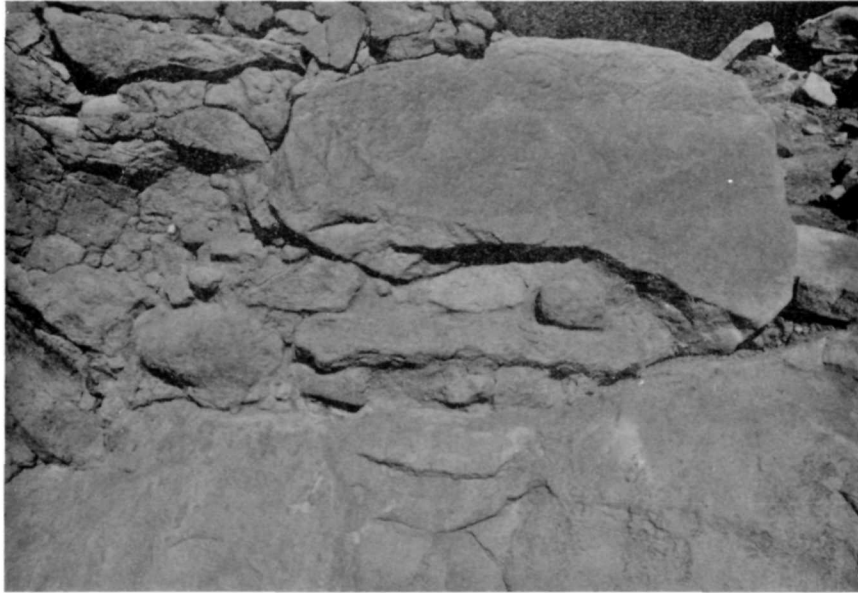
Figure 101.
SHP-78 4-8-10. Winter check. Room 14,
job 16, northeast exterior wall; close-
up of soil mortar. March 1979.

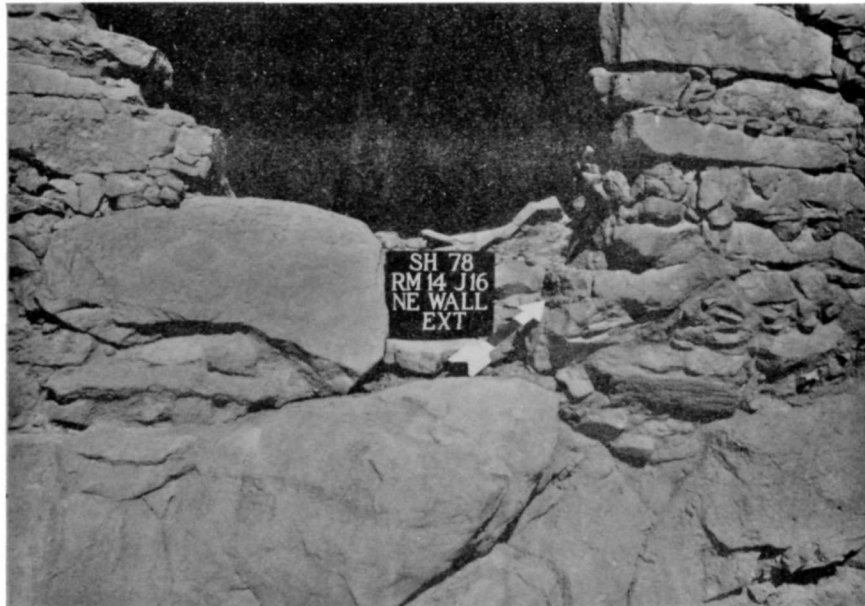
Snake House Ruin was checked in March, 1979. The stabilization aesthetically looks good. There is some minor cracking and heavy water wash. Room 14 and 19 both have viable water marks not only on the walls and cave back, but also water lines on the floors of the rooms. It looks as though water has stood in them for long periods of time and basal erosion is beginning. The worst effects on the ruin are weather related erosion factors. Many walls that were not stabilized have had mortar bed wash out since the stabilization was done, Summer 1978. Because of this it is recommended that an extensive regrouting and patching be done after the heavy rains of spring have slowed down.

Figure 102.
SHP-78 4-9-11. Winter check. Room 14,
job 16, northeast exterior wall. Extreme
washing. March 1979.
