PHYSICAL CONDITION ASSESSMENT

RESTORATION RECOMMENDATIONS

DOE CREEK SCHOOL

Henderson County, Tennessee

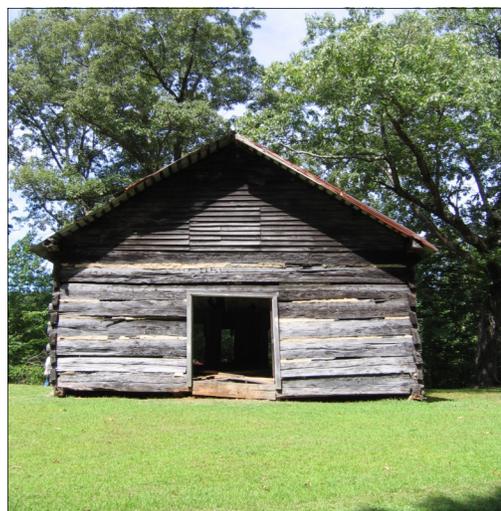
Flooring – Consists of 1” by 4” tongue-and-groove southern yellow pine boards. This flooring is well worn and probably would need to be replaced with similar new material. If enough could be salvaged, it could be used for the stage flooring.
