Sabine Hill

Elizabethton,
Carter County, Tennessee

Historic Structure Assessment

Summer 2012

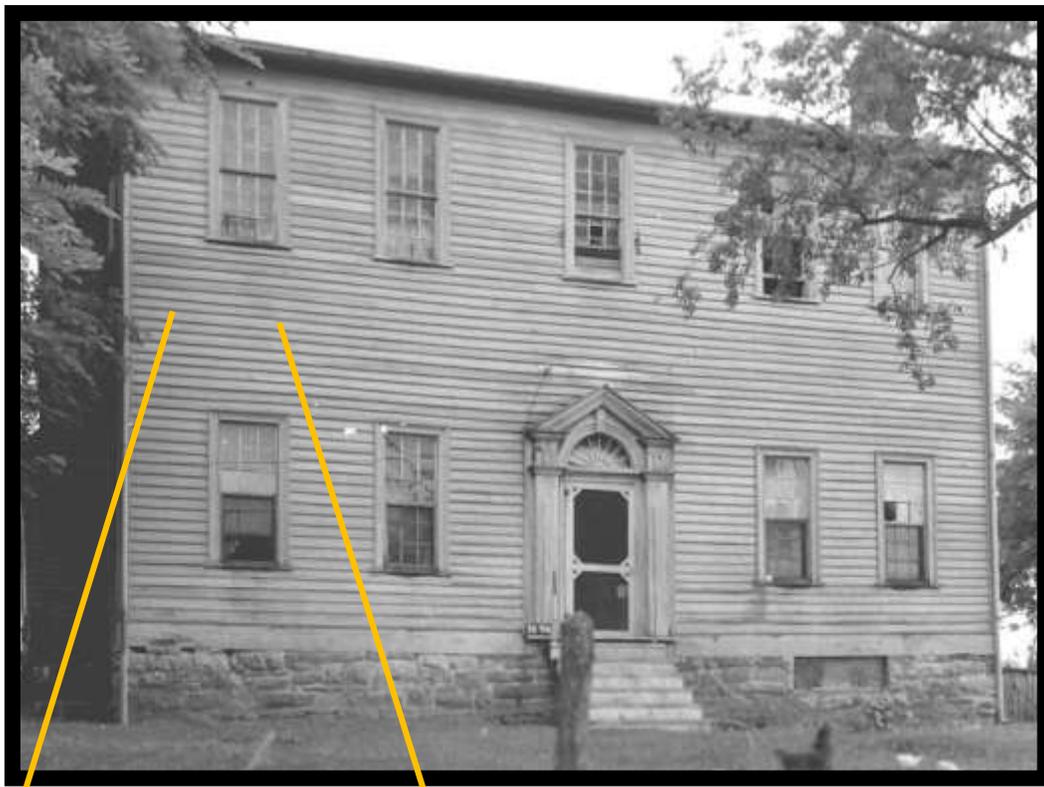
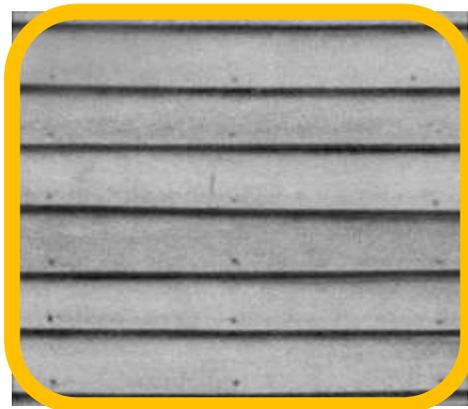
The dwelling has undergone various alterations over the years. A previous owner confirmed during a recorded interview that he had replaced much of the dwelling's weatherboard siding during the early 1950s (HABS photographs, when compared to those taken more recently, confirm this, see Figure 3), and that he later flipped and sanded weatherboard siding on the front of the house during the 1960s. Siding on the southeast façade and ell may also have been replaced or flipped (Figures 4, 5). It is possible that rough hewn logs were used in the original building, with any remaining primitive elements hidden by the current weatherboards.

Figure 3. 1936 HABS image of NW façade and siding close up.

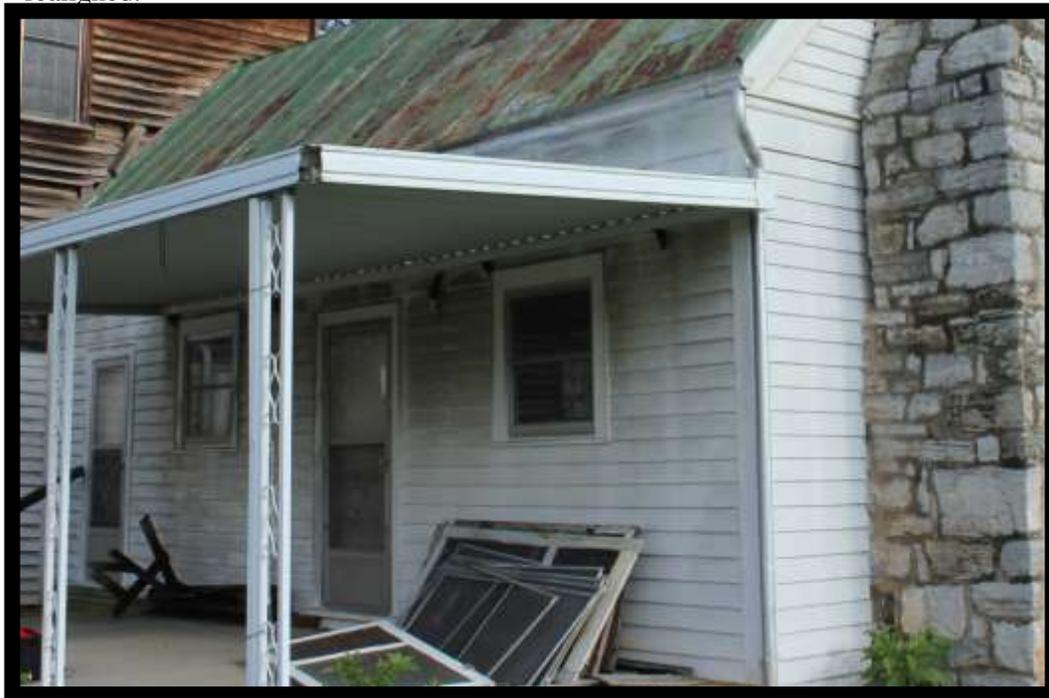
Figure 5. Photo of the SW façade of the ell addition clearly shows that the siding is modern.

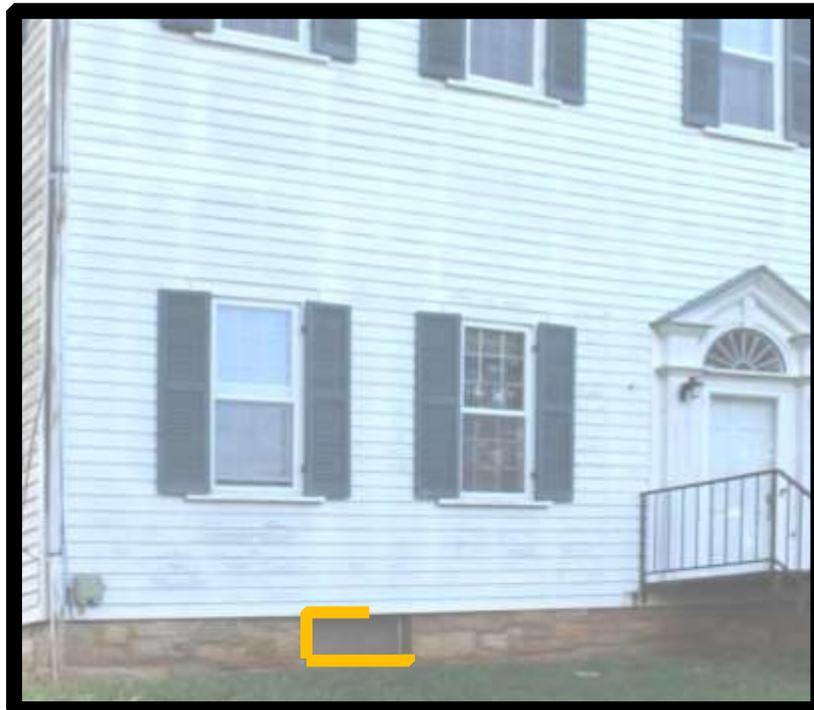
Extensive cracking and shifts in the foundation of Sabine Hill can be seen in the 1936 HABS photographs (Figure 6). The foundation of the house was reworked during the 1950s to correct cracking and tilting issues. Most of the foundation problems have been caused by a basement addition to the 1818 section of the house. The basement was added some time before 1936 as HABS images clearly show a basement entry and window (Figures 7). The basement walls were not properly reinforced when the basement was constructed and has caused the walls to weaken and start to give way.

Figure 7. 2011 photograph shows the addition of a basement window.

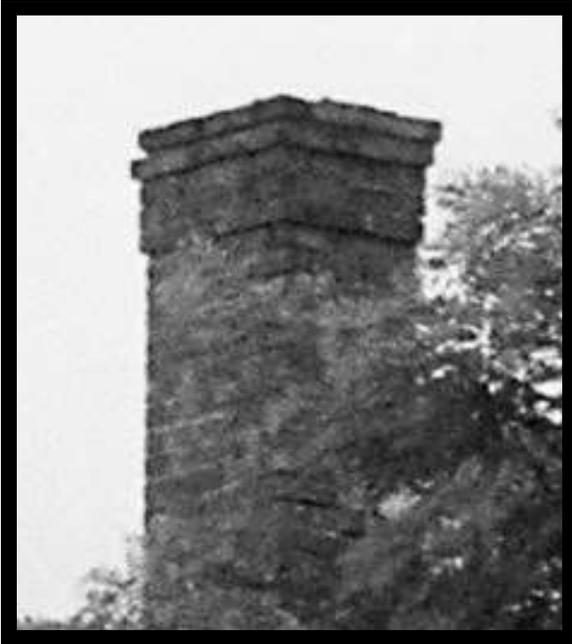
Figure 10. Close-up of SW chimney, HABS 1936. Note the decorative coping along the top of the chimney. This no longer exists.

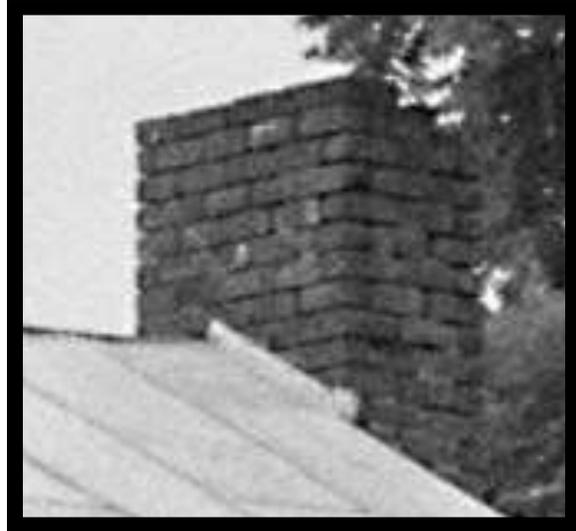
Figure 11. Close-up of NE chimney, HABS 1936. Note that the banding along the top is missing and part of the chimney is crumbling.

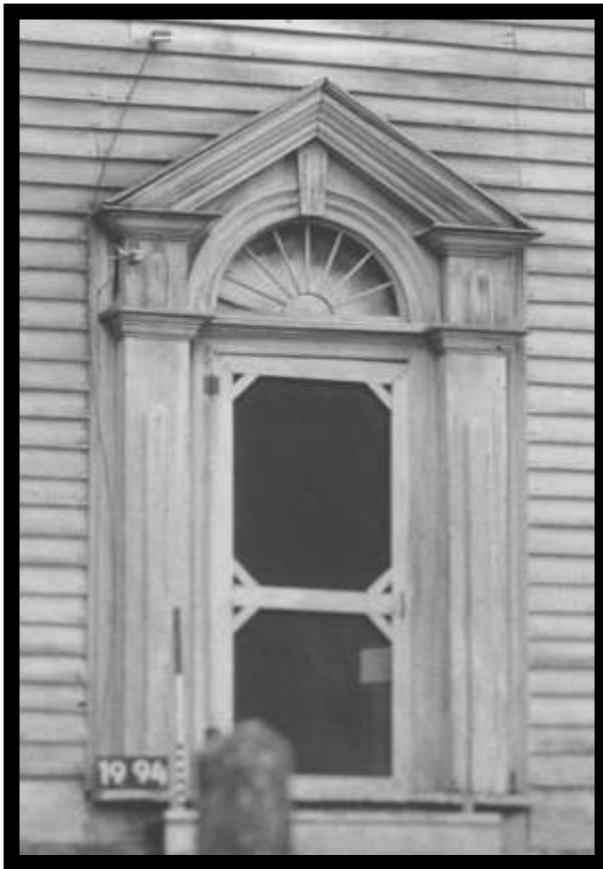
Several exterior doors on Sabine Hill have been either replaced or altered. The original 1818 front door surround was replaced with a close replica during renovation work in the 1950s and 1960s (1936 HABS photographs show the original surround, see Figures 17 and 18). Remnants of the 1818 surround are stored in a front parlor of the dwelling.

Figure 17. 1936 HABS photograph of the door surround.

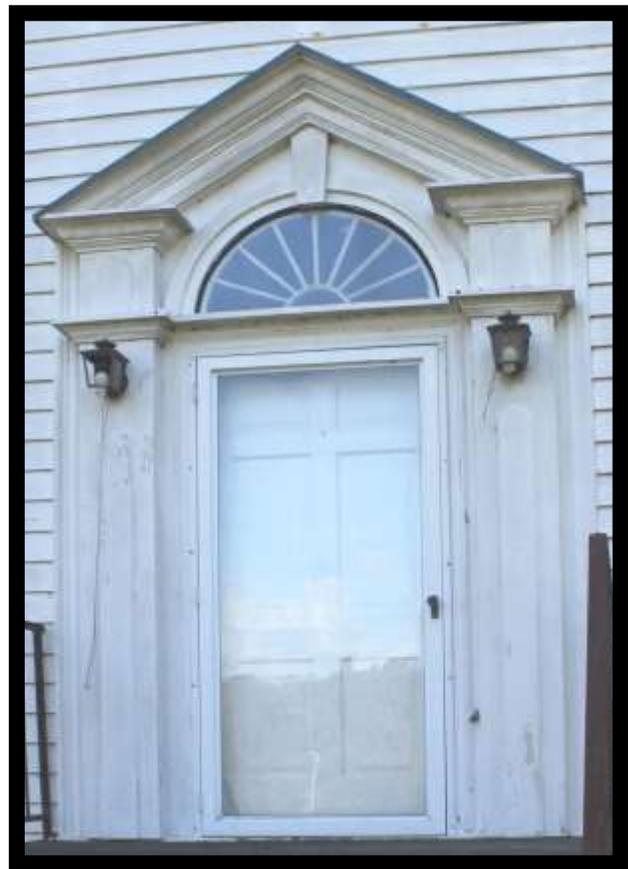
Figure 18. 2011 photograph of the current door surround.

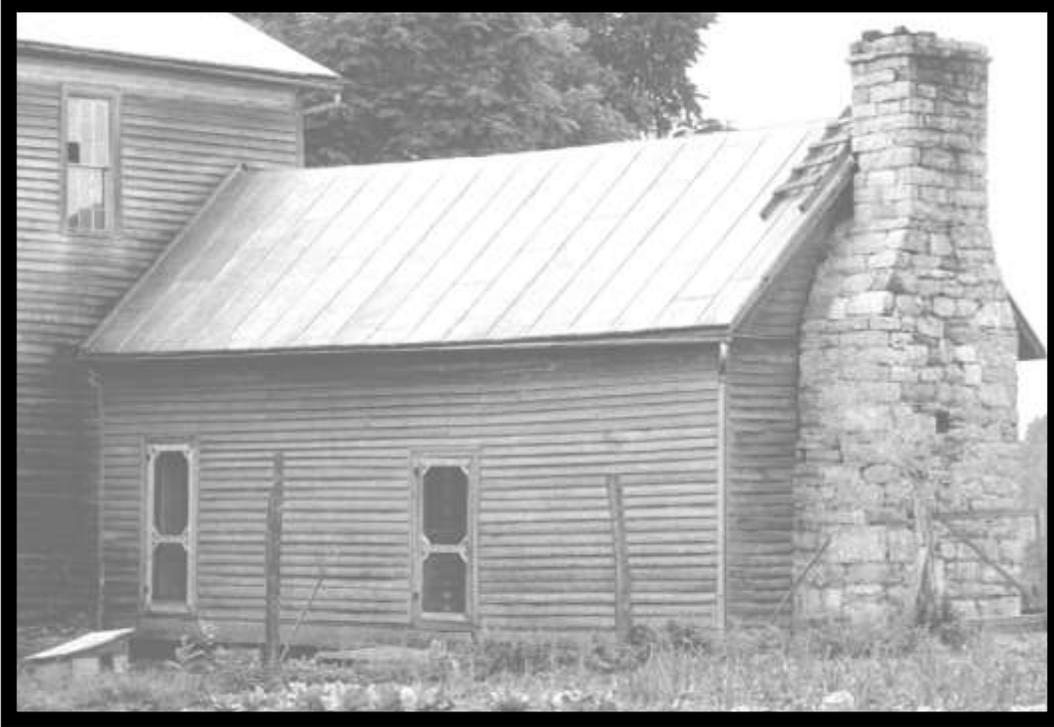
Figure 20. 1936 HABS image of the SW ell. Note that there are no porch or windows.

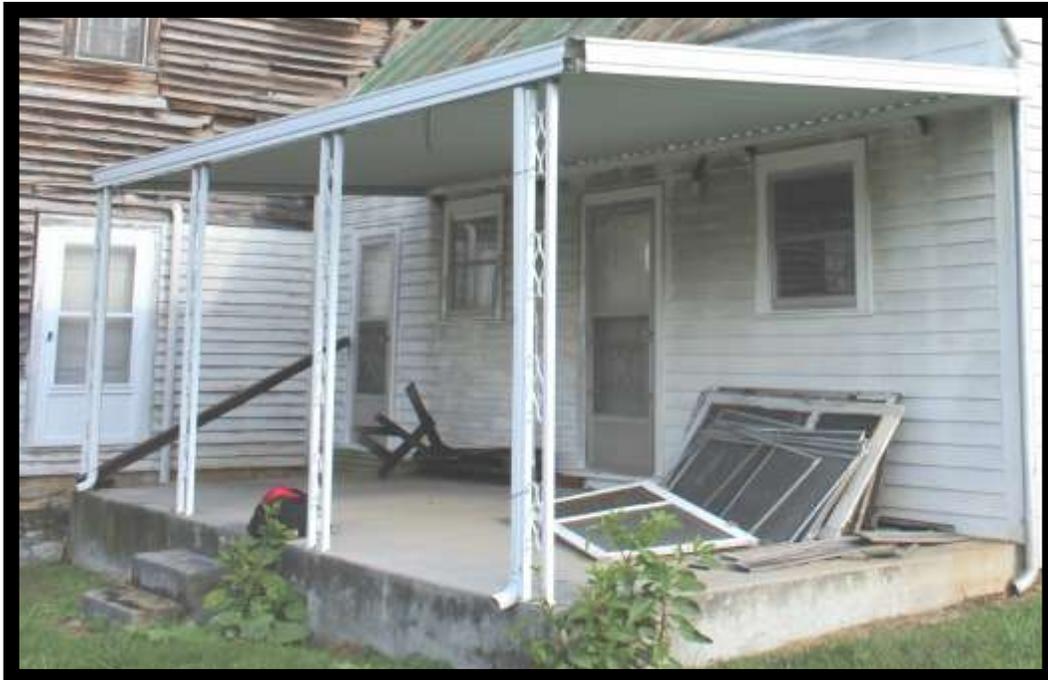
Figure 21. 2011 photo of the 1/1 double-hung sash and porch added during the 1960s.

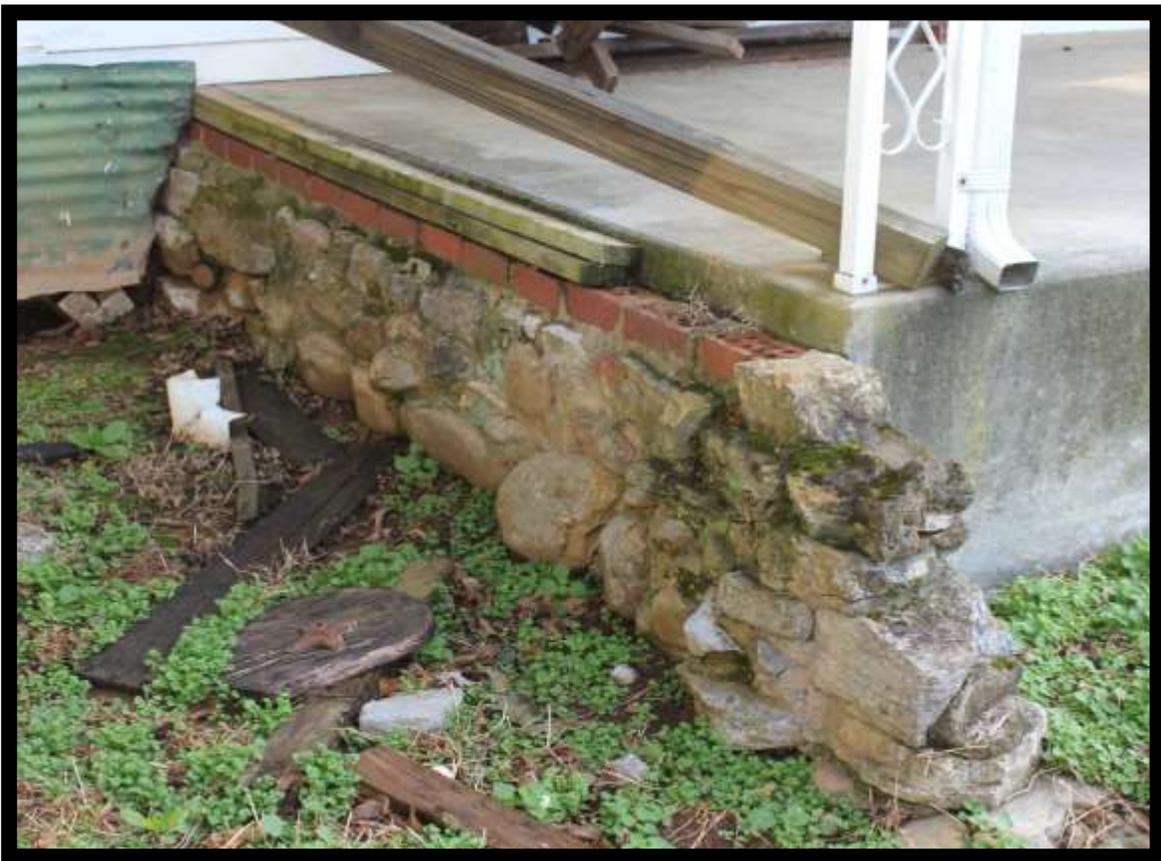
A poured concrete porch (c. 1955) was added to the rear (southwest) wall of the ell addition (Figure 20). A photo from the 1936 HABS report shows no porch and indicates that there probably never was one (Figure 21). A foundation extension can be seen along the poured concrete porch located on the west façade of the ell. The use of later brick and river rock denote that this foundation was later construction added c. 1950, and is non-load bearing (Figure 22).

Figure 22. 2011 photograph of the veneer over the porch that extends SW from the rear ell.
Porches

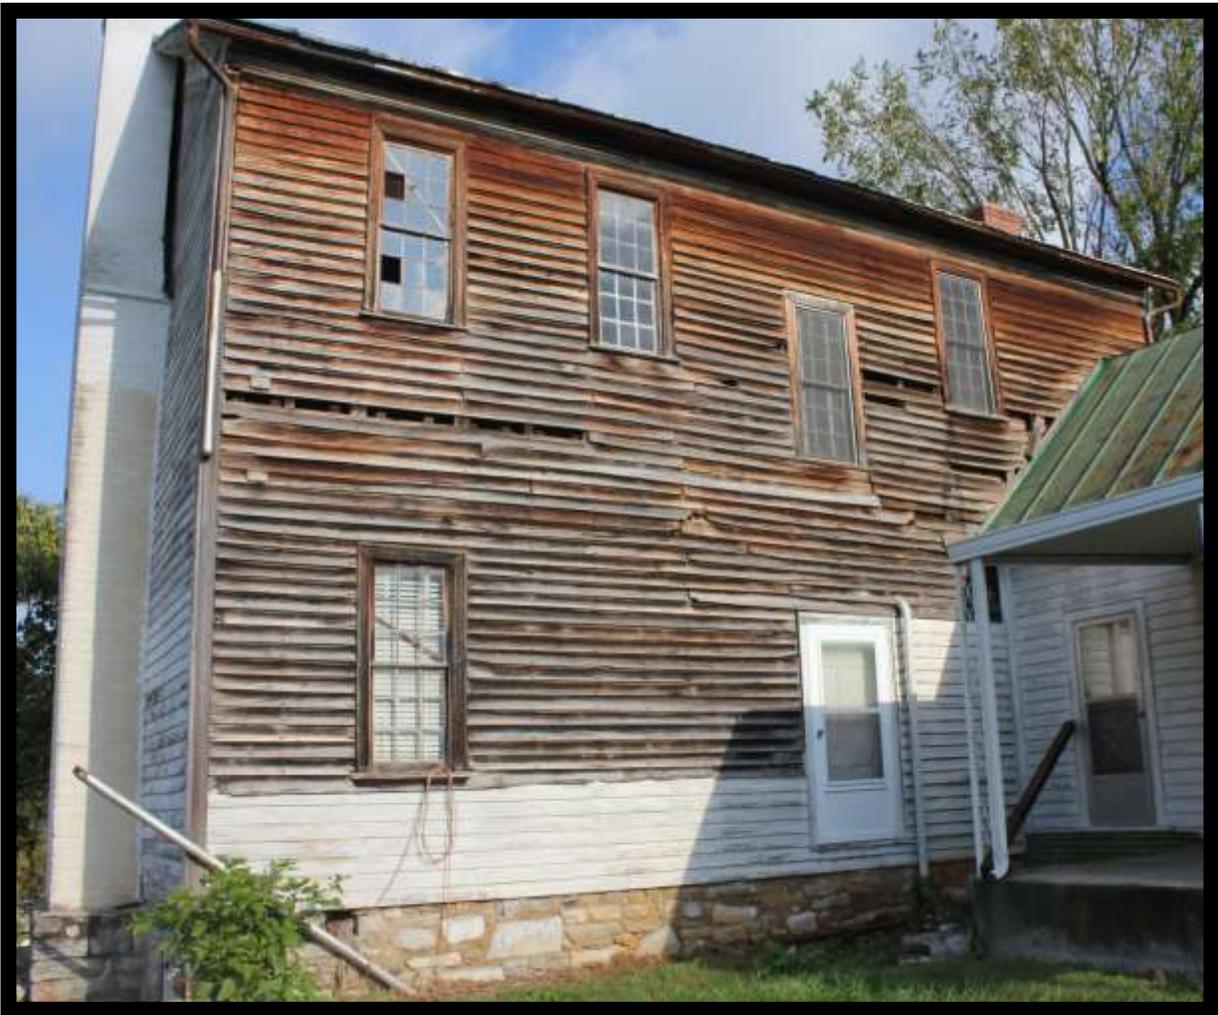
Figure 30. SE Façade, 1818 house.

The southeast façade of the main block is divided into five bays and has an attached ell. The first floor features a 9/9 double-hung wooden sash and a six-panel wood entry door. The builders probably anticipated adding the rear ell at a later time (Figure 30 & 31). Current images of the house suggest that the exterior weatherboard may not be original, or may have been flipped.

The boards are warped and should be replaced in-kind.

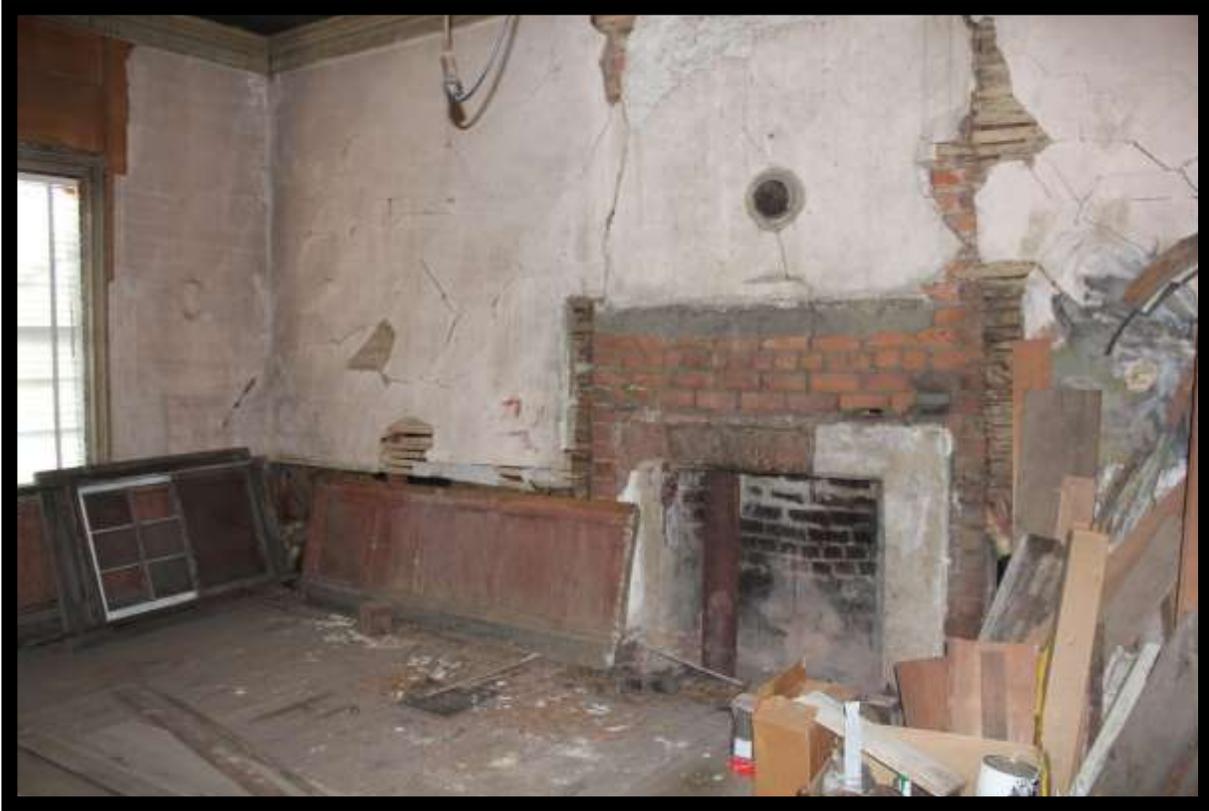
Figure 40. The “Red, White and Blue” Room.

Measuring 14’3” x 22’4,” the “Red, White, and Blue” Room is located on the southwest side of the main block and has much original material remaining, although in a poor state of repair (Figures 40-44). The walls are composed of plaster over wooden lath, which is crumbling in many places. The millwork is mostly intact and includes 6” baseboards, paneled wainscoting, a 3”-wide chair rail, and 6” crown molding with reed detail. The floor is composed of 6” poplar planks. The original mantel has been removed and may be stored on site. The fireplace surround is composed of brick laid in common bond with a surmounting flat jack arch. The surround has been plastered over at some point in the past.

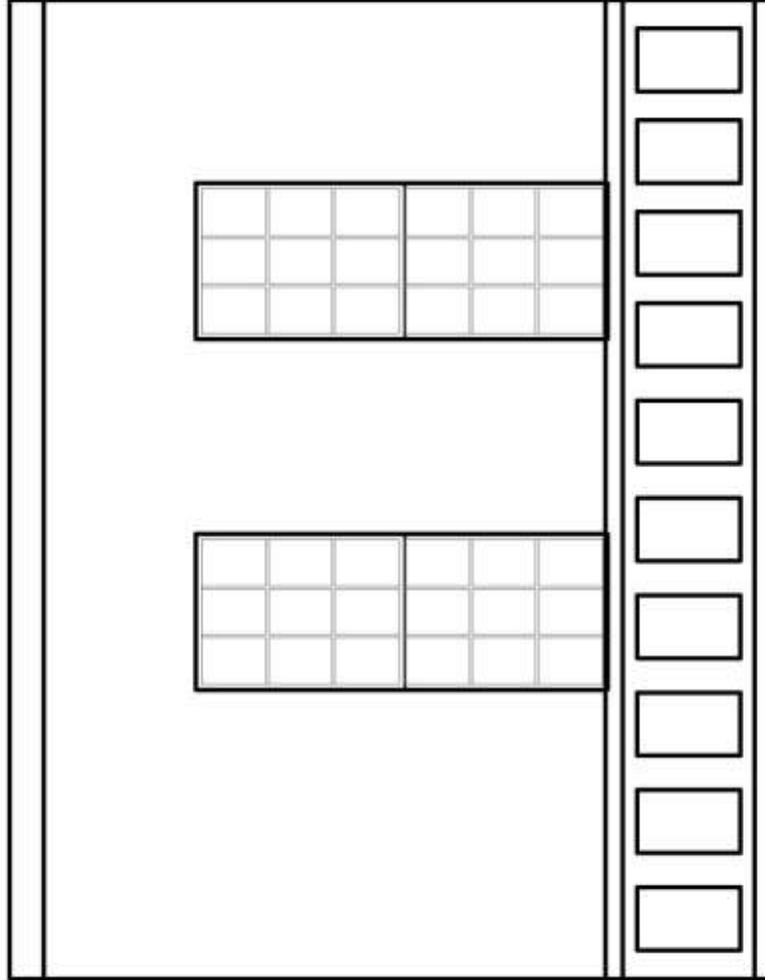
NORTH WALL
RED, WHITE, & BLUE ROOM

Figure 41. Red, White, and Blue room.

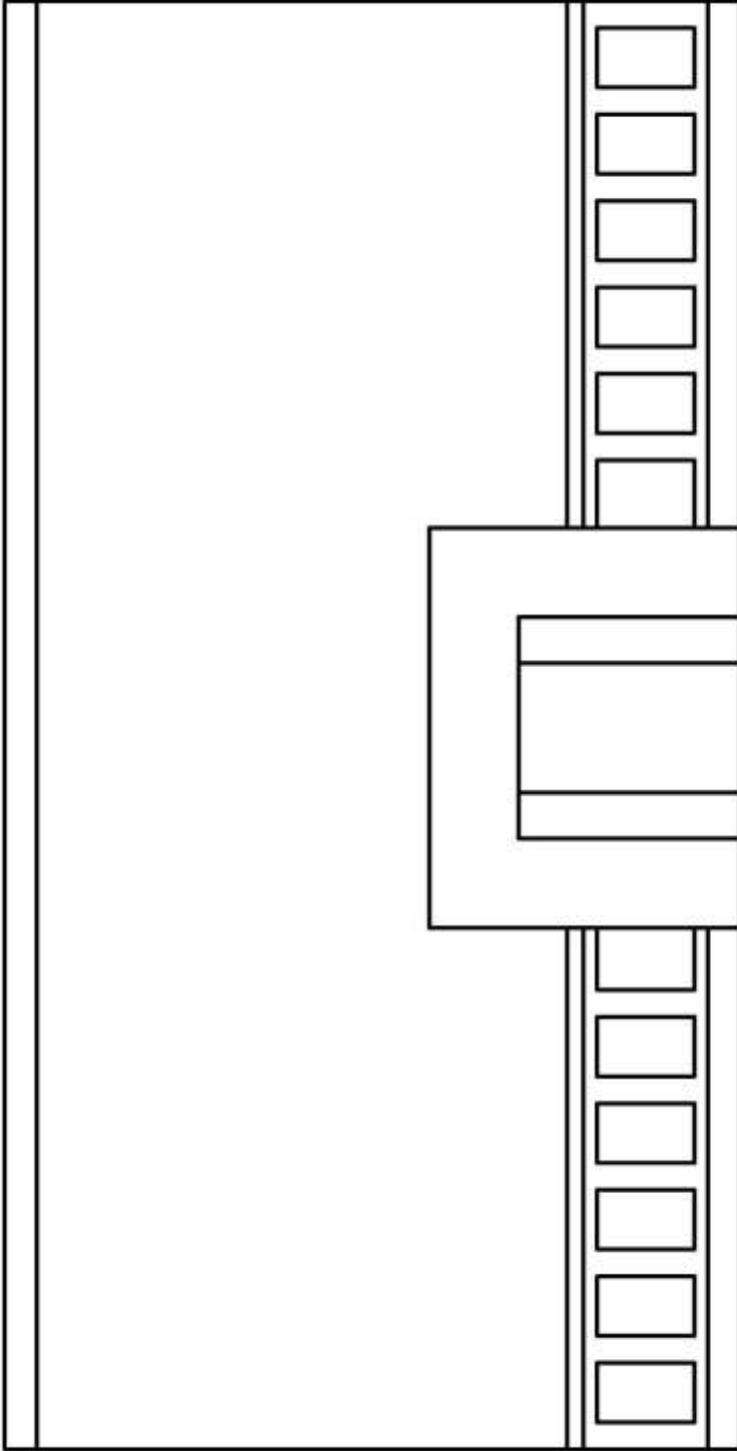
WEST WALL
RED, WHITE, & BLUE ROOM

Figure 42. Red, White, and Blue room.

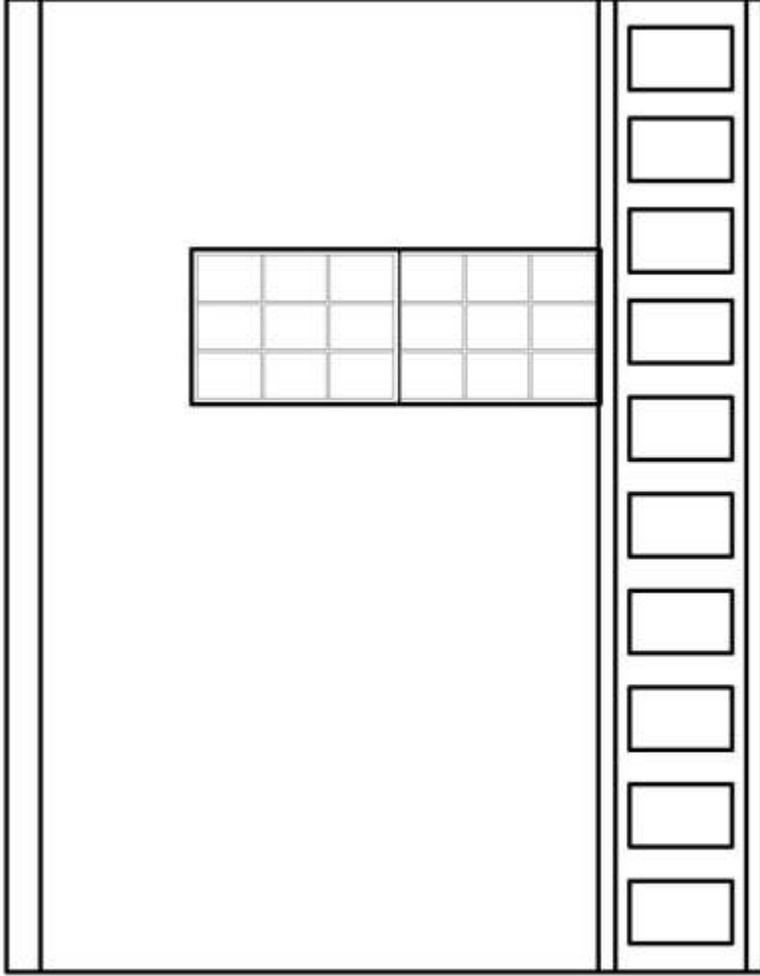
SOUTH WALL
RED, WHITE, & BLUE ROOM

Figure 43. Red, White, and Blue room.

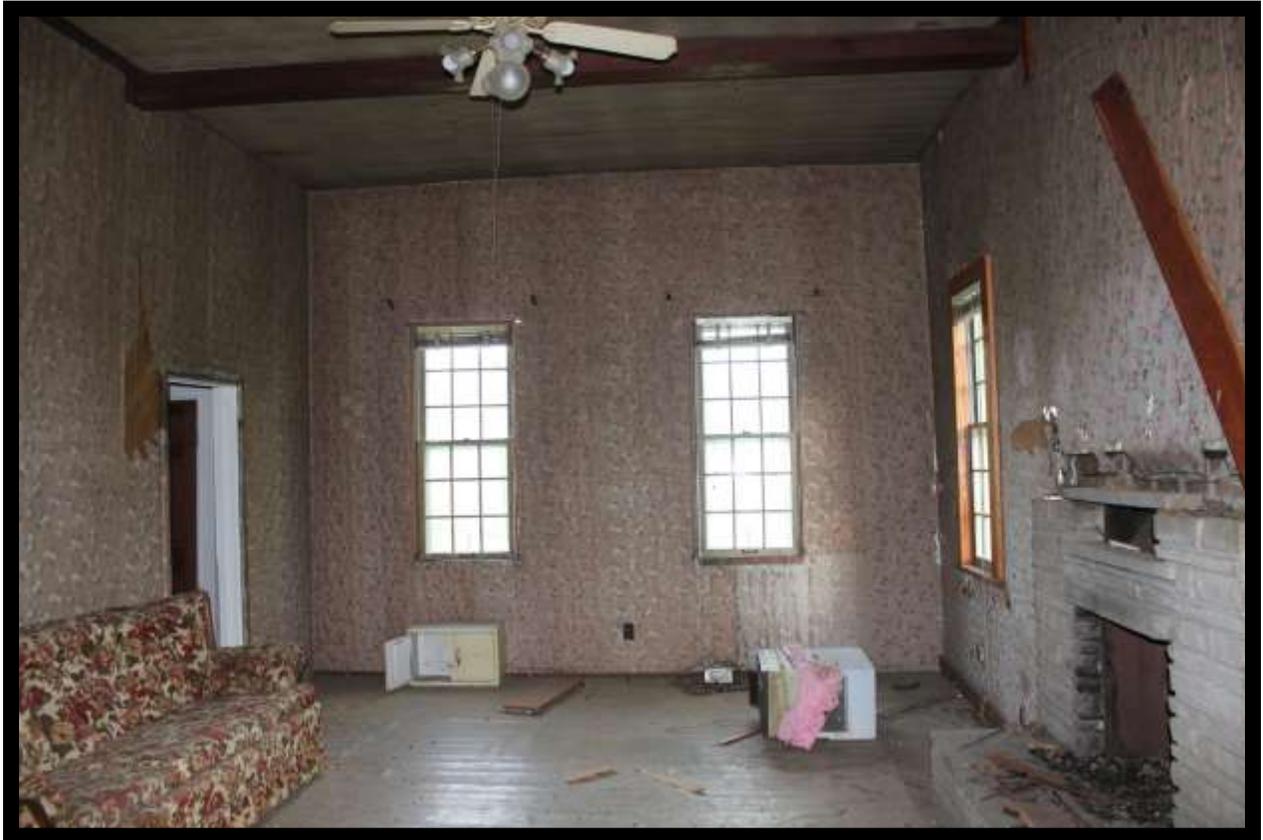
EAST WALL
RED, WHITE, & BLUE ROOM

Figure 44. Red, White, and Blue room.

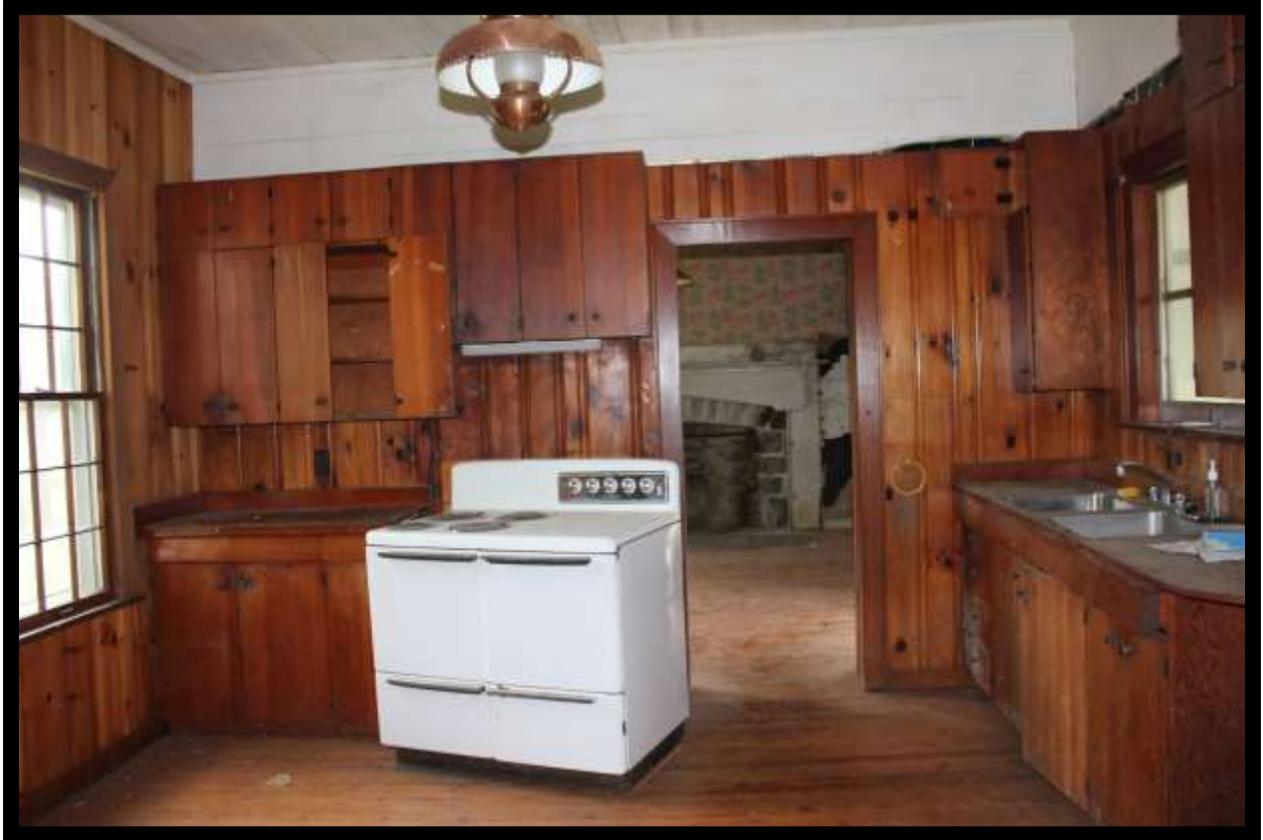
Figure 46. Hyphen Addition.

The hyphen portion of the ell addition has been converted into a modern kitchen, c. 1960 (Figure 46). The room measures 14'3" x 13'4". Little historic material remains exposed; the original wooden plank walls have been covered by a decorative board and batten pine boards.

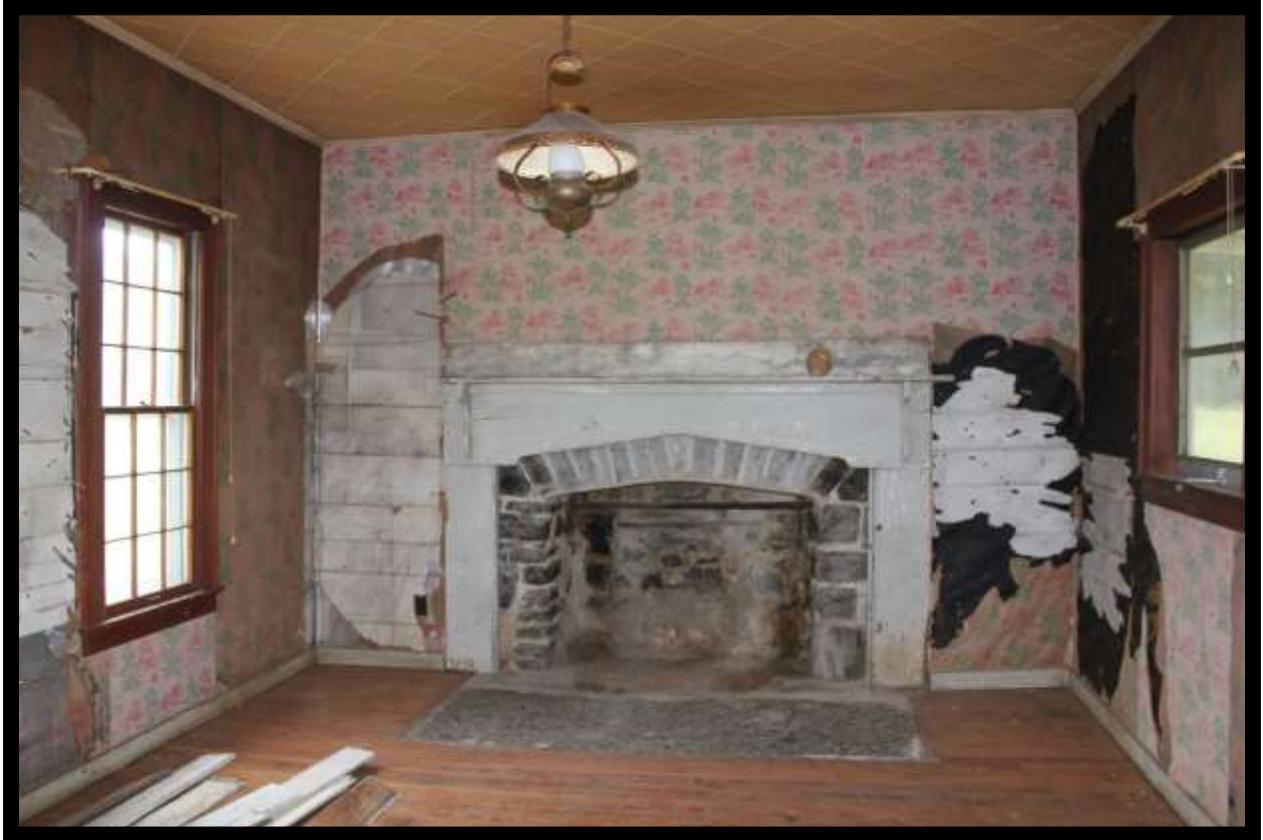
Figure 47. Kitchen Addition.

The kitchen portion of the ell measures 17'0" x 13'4" (Figure 47). Most original elements in this space remain intact. Horizontal wood plank wallboards are concealed beneath several layers of wall paper. The ceiling has also been covered with resilient ceiling tiles. The mantel on the south side of the space appears to be original and the fireplace surround is composed of rough-cut limestone blocks with a segmental arch. The crown and baseboard molding have been replaced. The floor covering consists of modern 3" pine plank flooring.

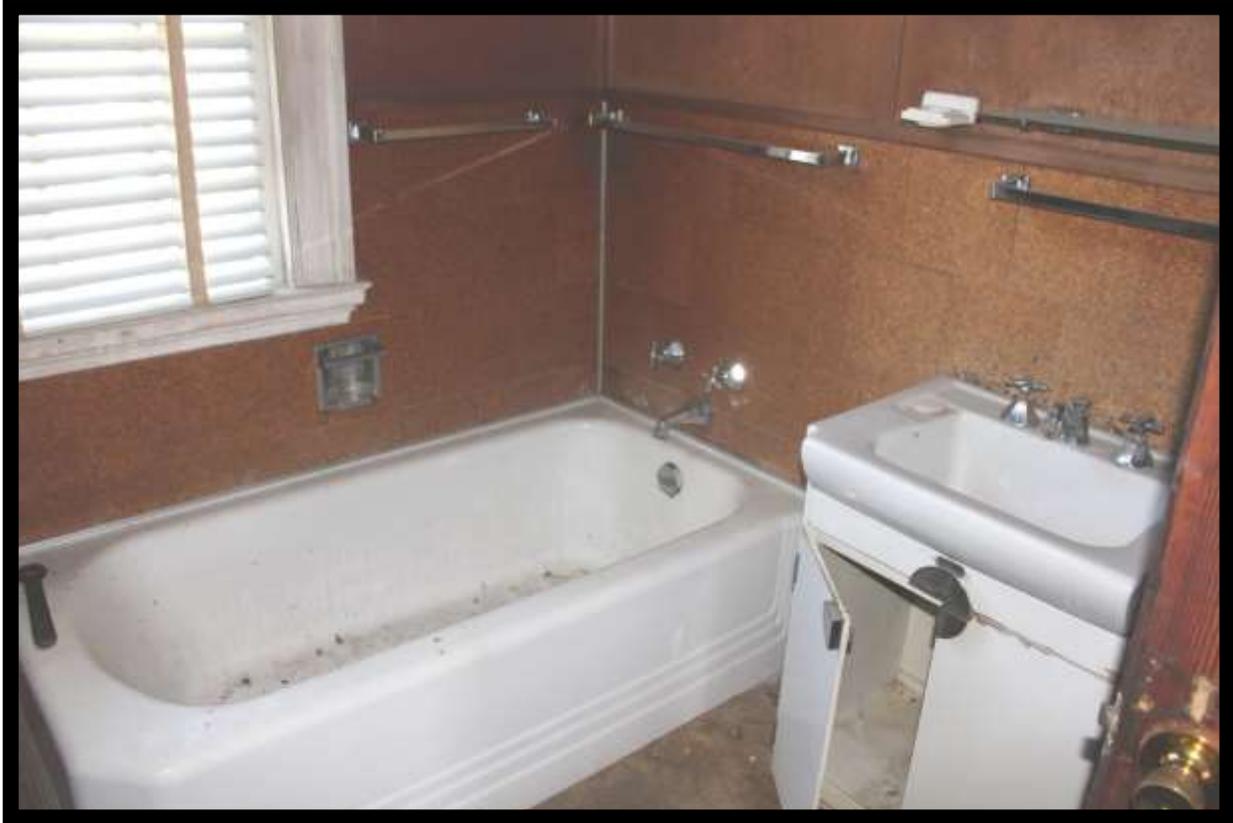
Figure 48. Landing Bathroom.

A small c. 1960s bathroom measuring 8'7" x 7'0" is located at the top of the stairs (Figure 48). Walls in this bathroom have been covered with cork tile and wood paneling. Modern plumbing and fixtures have been added.

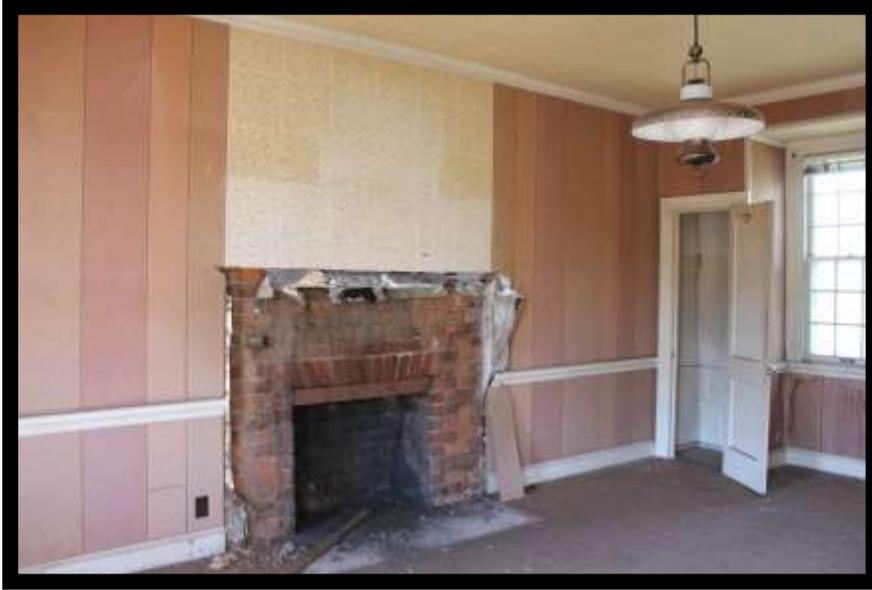
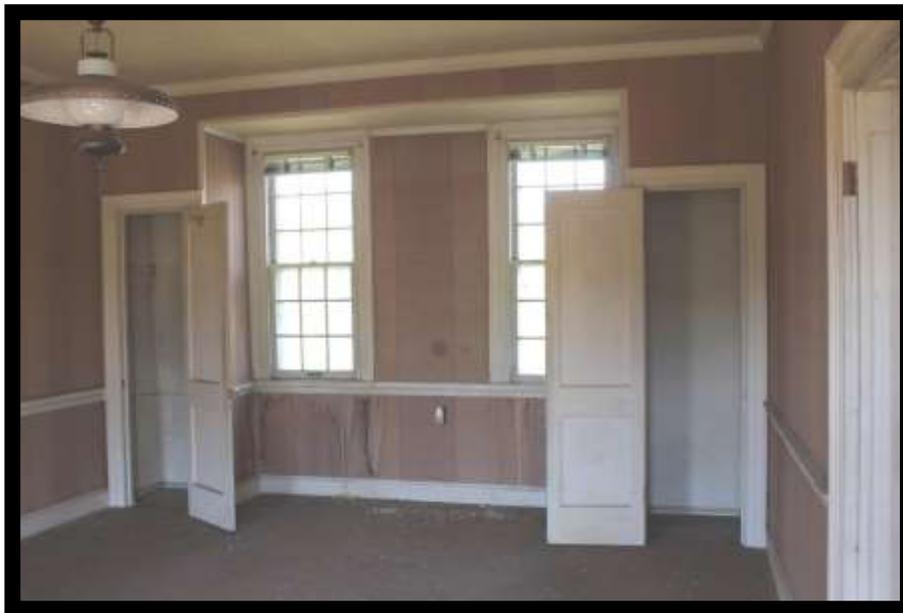
Figure 49. SW Bedroom fireplace.

Figure 50. SW Bedroom closets.

The bedroom on the southwest side of the main block has been completely altered, and little, if any, original building fabric exists (Figures 49, 50). The space measures 22'3" x 14'3". The walls have particle board paneling, and the ceiling has resilient tiles. Original molding was removed and replaced with modern stock. Two small closets were added on the west and east sides of the room. The fireplace mantel has been stripped away, but the hearth and fireplace surround are still visible. Flooring in the room is covered by carpet. All alterations to this space took place c. 1960.

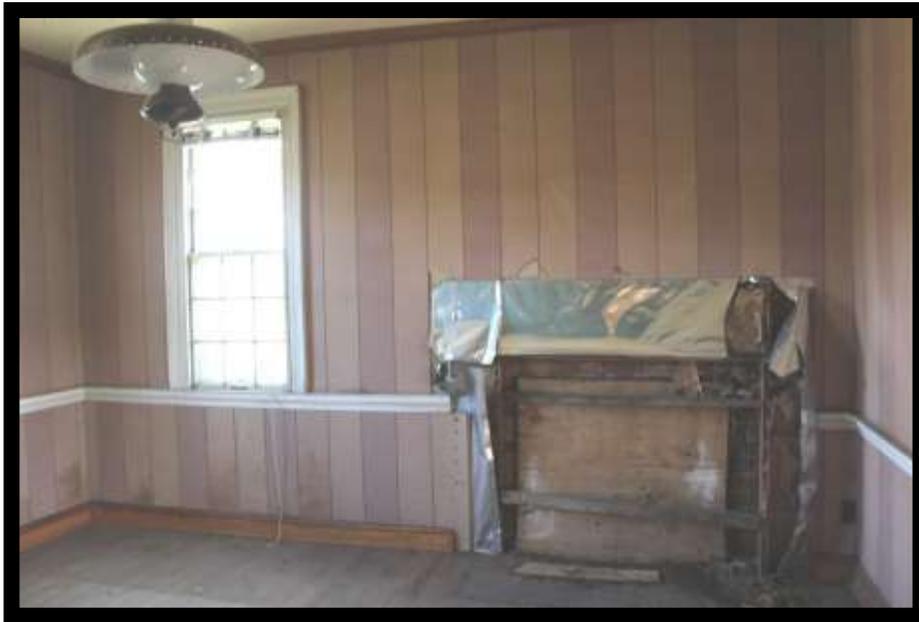
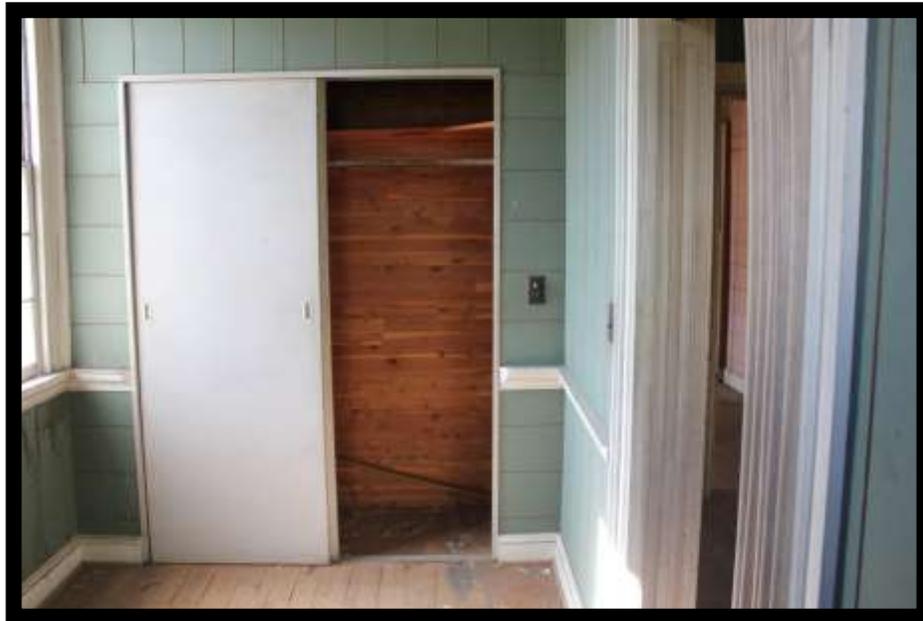
Figure 51. NE Bedroom fireplace.

Figure 52. NE Bedroom closet.

Like the southwest bedroom, the northeast bedroom has been greatly altered (Figures 51, 52). The space measures 14'10" x 14'4". The room has particle board wall covering, resilient ceiling tiles, and modern molding. The fireplace mantel has been removed from the space and the fireplace covered. The original wood plank floor remains intact, although a changing room

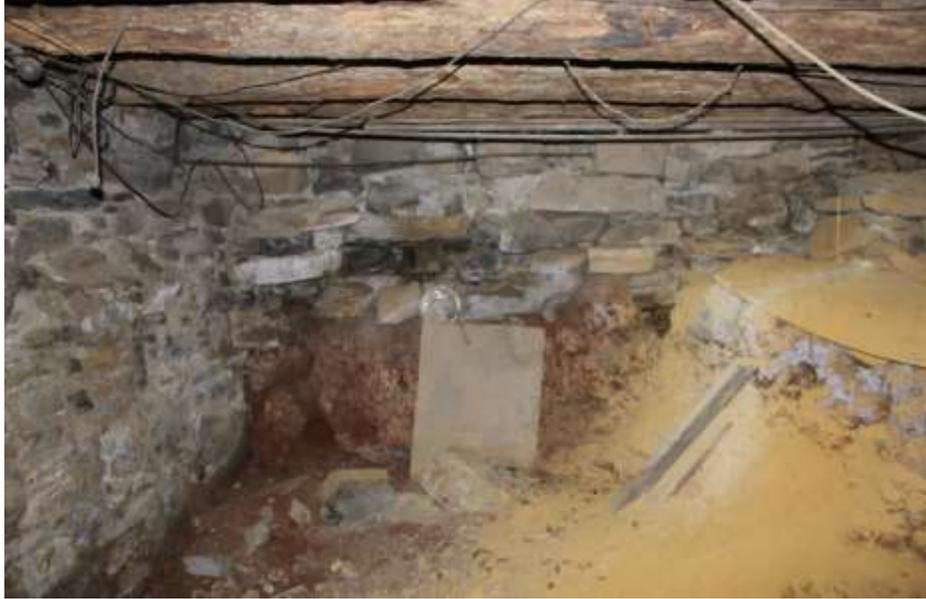
The basement is located beneath the main block of the house (Figures 53, 54). The portion located beneath the “Red, White, and Blue” Room has finished concrete floors, while the floor on the east side consists of dirt. The east side of the basement is structurally unsound. From the basement one can observe the full hardwood log sleepers that support the flooring above.

Figure 53. East Basement wall

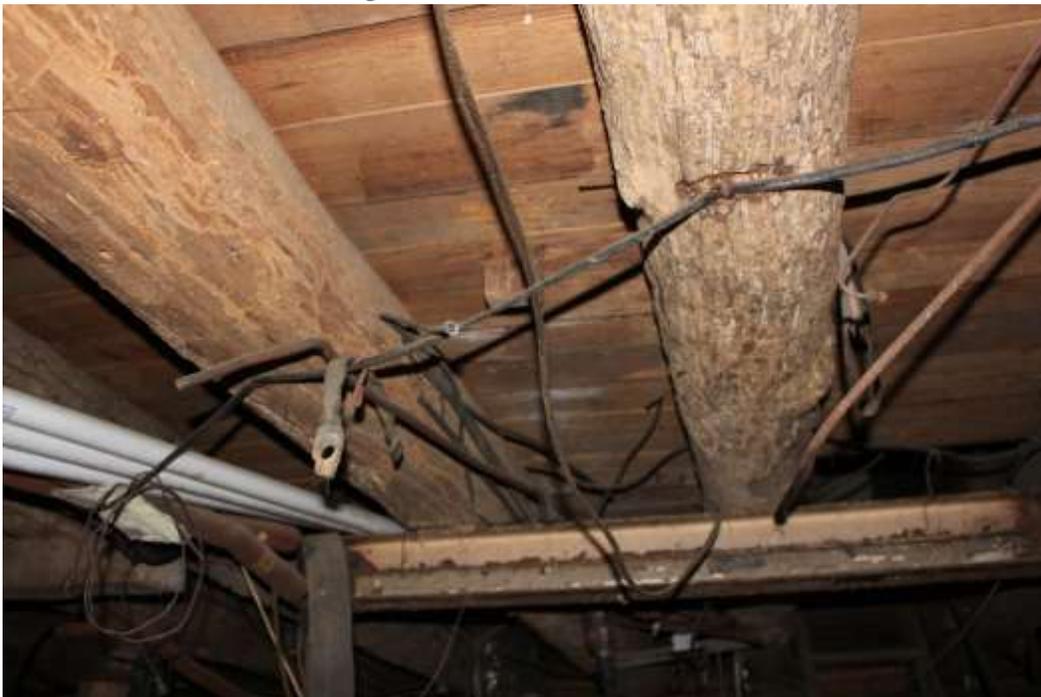
Figure 54. First Floor sleepers

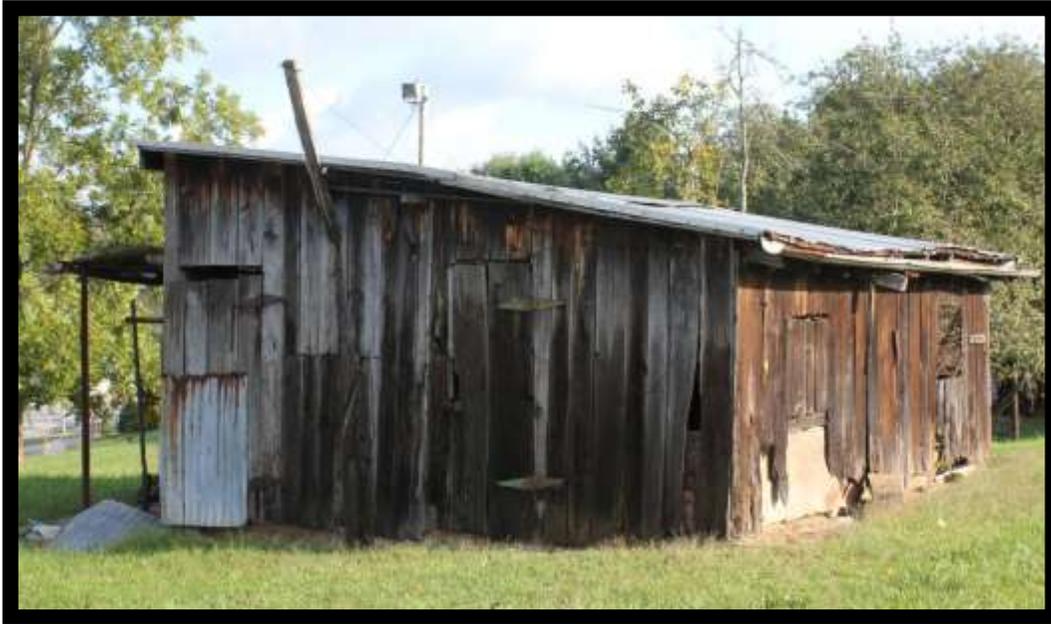
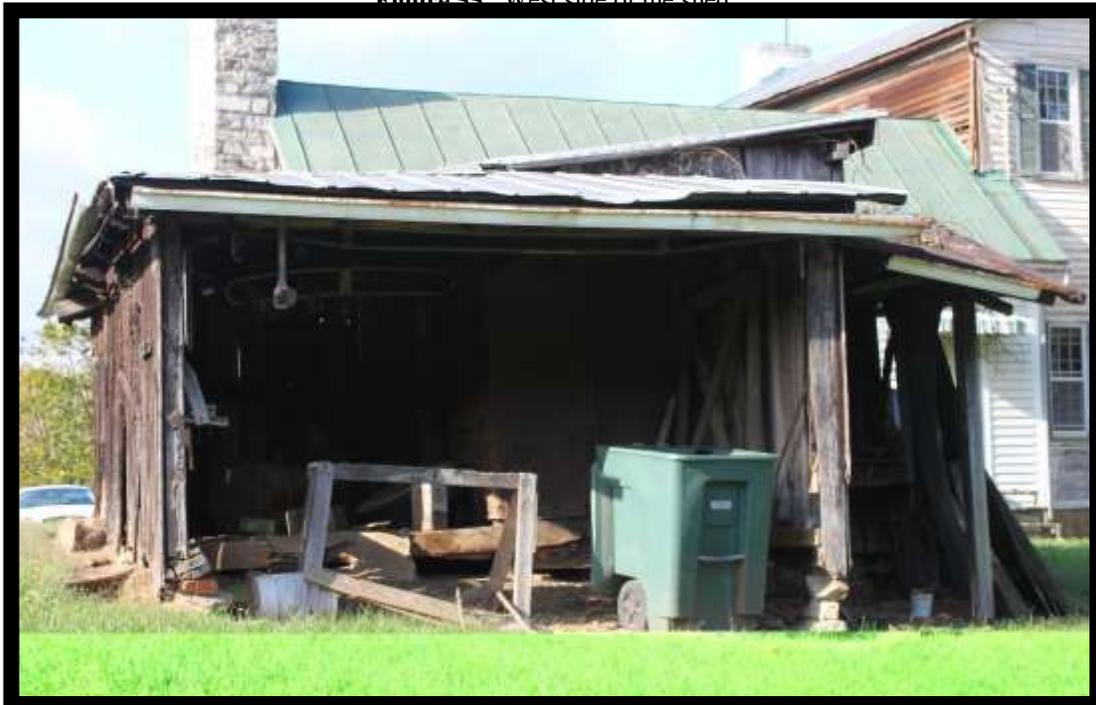
Figure 55. West side of the shed

Figure 56. East side of the shed.

A small storage shed sheathed with vertical boards is located to the east of the dwelling. The shed has moderately pitched flat roof covered in 5-V pattern sheet metal (Figures 55, 56).
Outbuildings—Barn
