Sabine Hill

Elizabethton,
Carter County, Tennessee

Historic Structure Assessment

Summer 2012

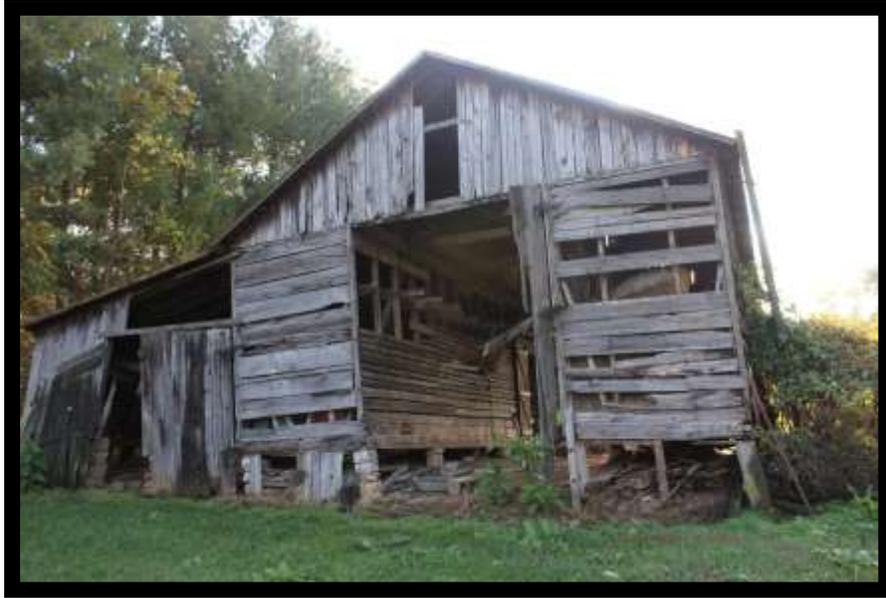
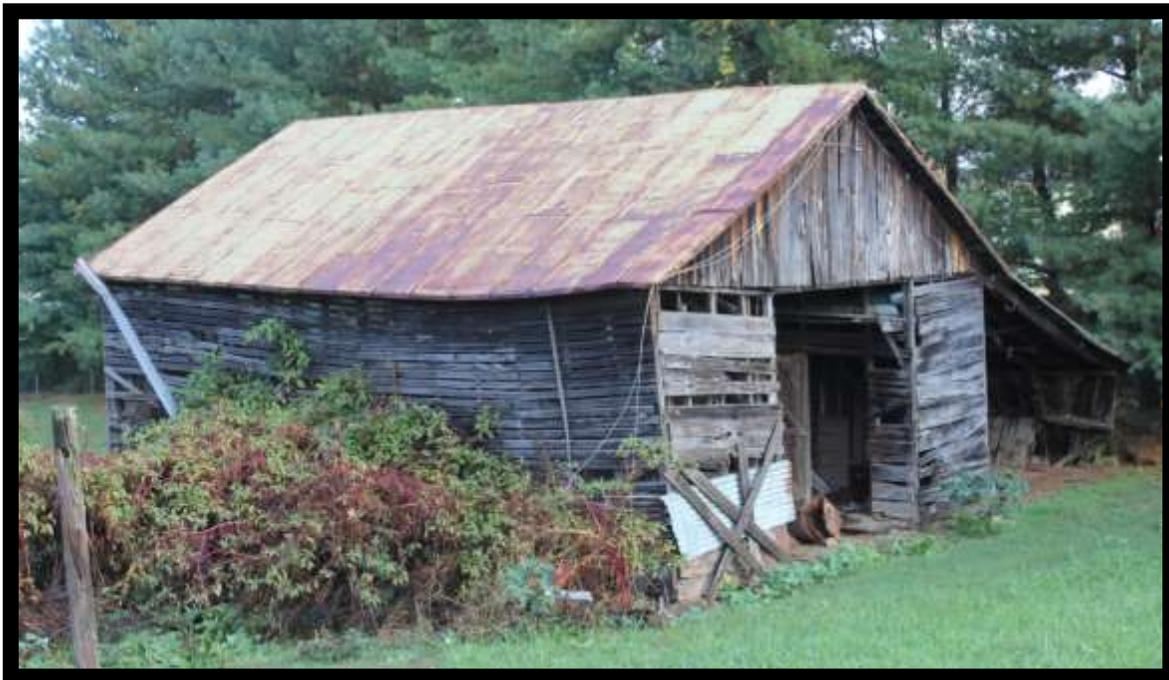
Figure 57. North side of the Corncrib.

Figure 58. South side of the Corncrib.

To the east side of the property there is a double pen drive-through corncrib sheathed in horizontal weatherboards on the first level and vertical board-and-batten siding in the gables.

The structure rests on a stacked limestone pier foundation and has a corrugated metal roof. There is a shed-roof addition on the east façade probably used to store farm implements (Figures 57, 58).

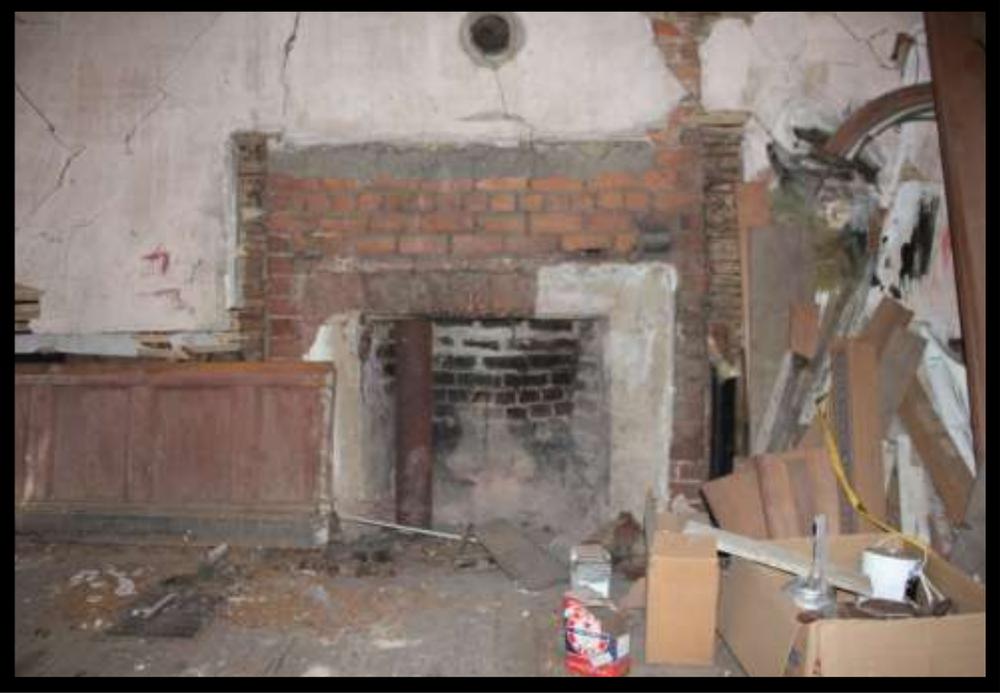
- Fireplaces have been severely altered throughout the house with the exception of the kitchen addition where the fireplace box and primitive mantle piece are intact (Figure 74).
- Fireplace boxes throughout the main house need to be repaired and/or rebuilt.
- Flues should be examined for proper ventilation and repaired/rebuilt for safe operation.
- Chimneys should be sealed to prevent moisture penetration.
- Mantles will have to be reconstructed and installed.

Figure 75. Fireplace on SW wall of “Red, White, and Blue” Room.

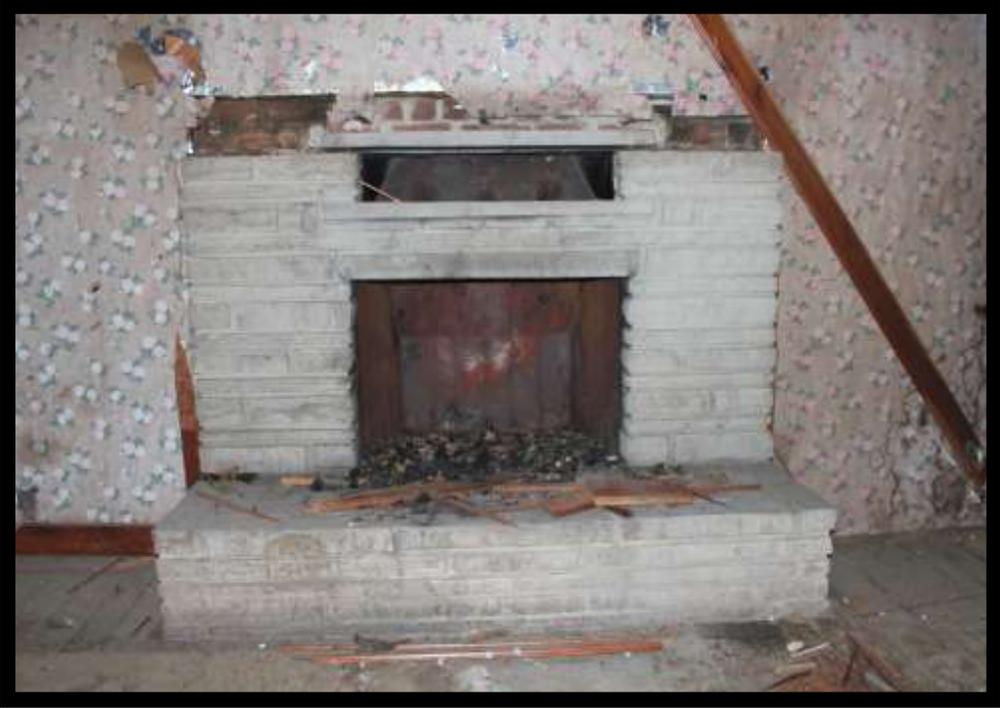
Figure 76. Crab Orchard stone fireplace with raised hearth in NE parlor.

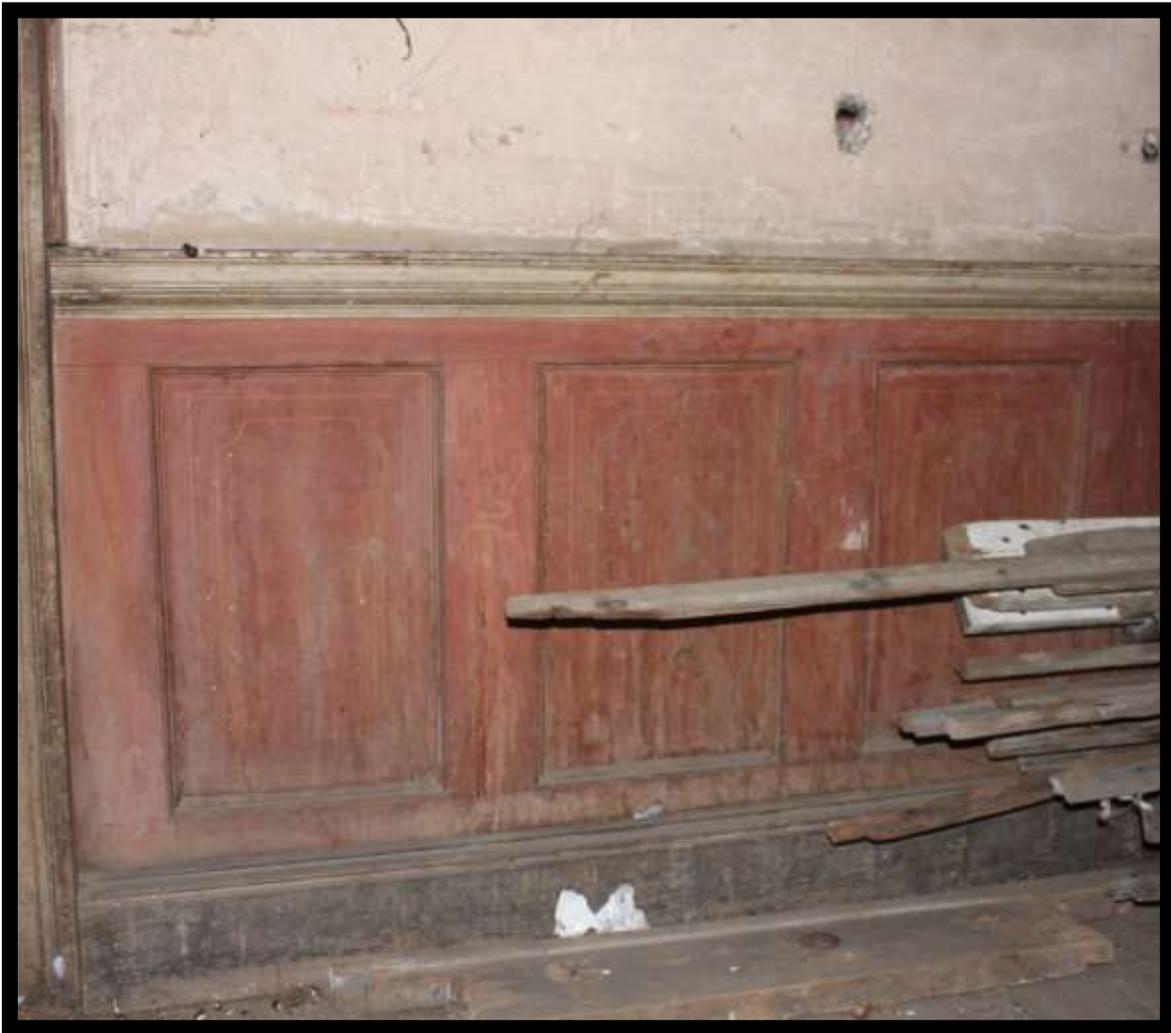
- With the exception of plasterwork and wainscoting in the “Red, White, and Blue” Room (Figure 79), wall coverings are not original. Paneling and wallpaper were added during the renovations of the second half of the twentieth century.
- Modern trim throughout the house was added during the second half of the twentieth century.
- Wainscoting in the “Red, White, and Blue” Room most likely is original. The
- eclectic collection of wall coverings should be stripped out and the walls returned to a representative nineteenth century appearance.

Figure 79. Wainscot panels in the “Red, White, and Blue” Room.

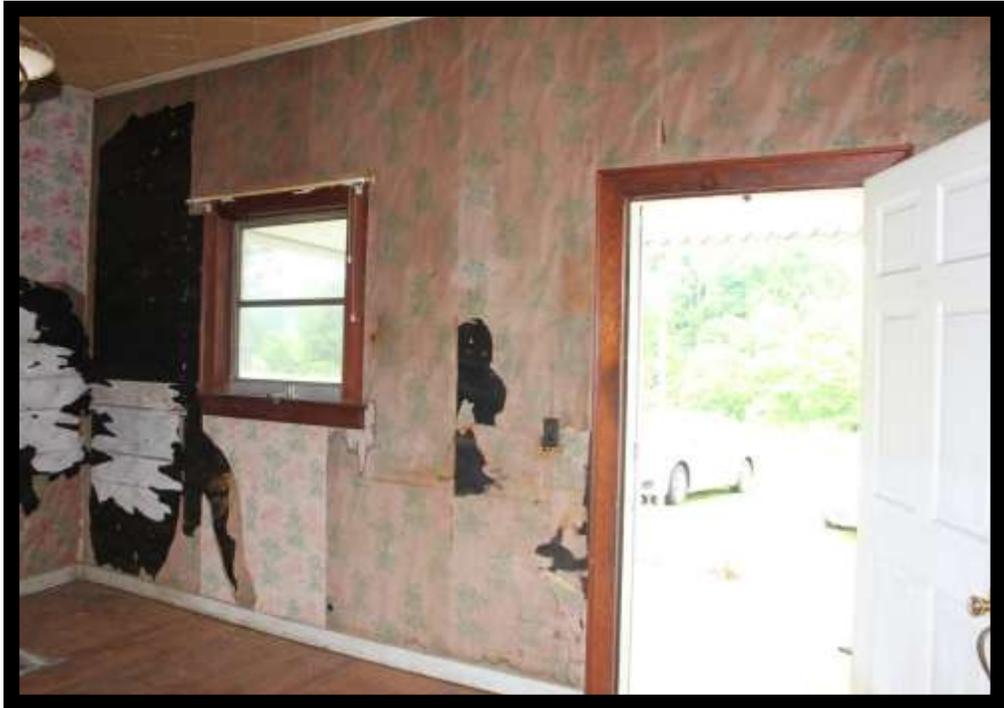
Figure 81. Wall coverings in hyphen.

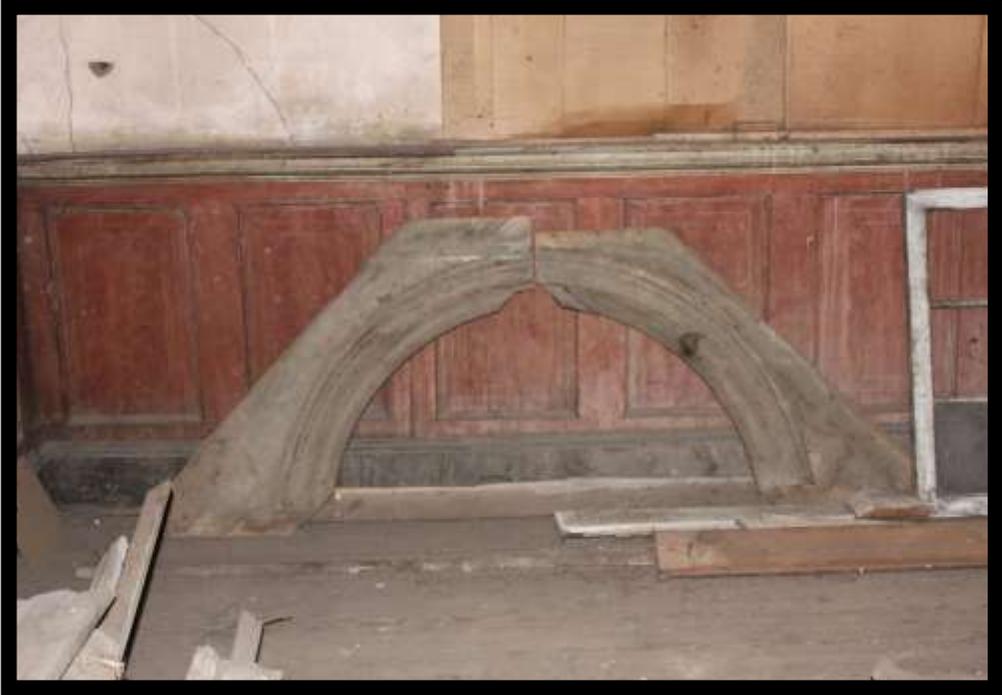
Figure 84. Original front entrance fanlight trim work stored in “Red, White, and Blue” Room.

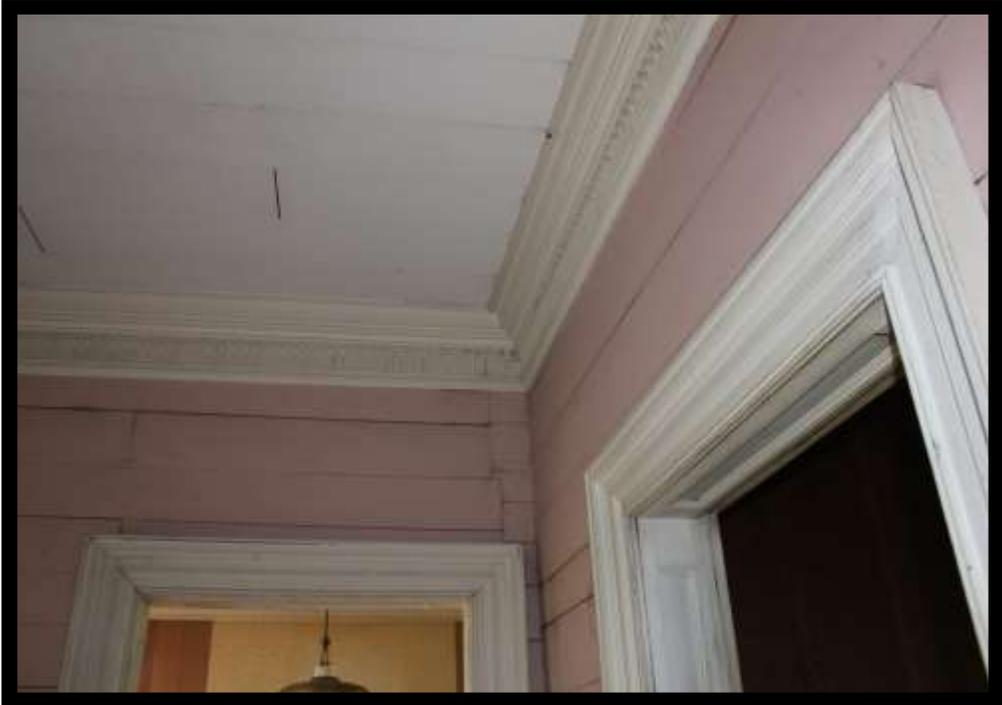
Figure 85. Replacement trim on doors and

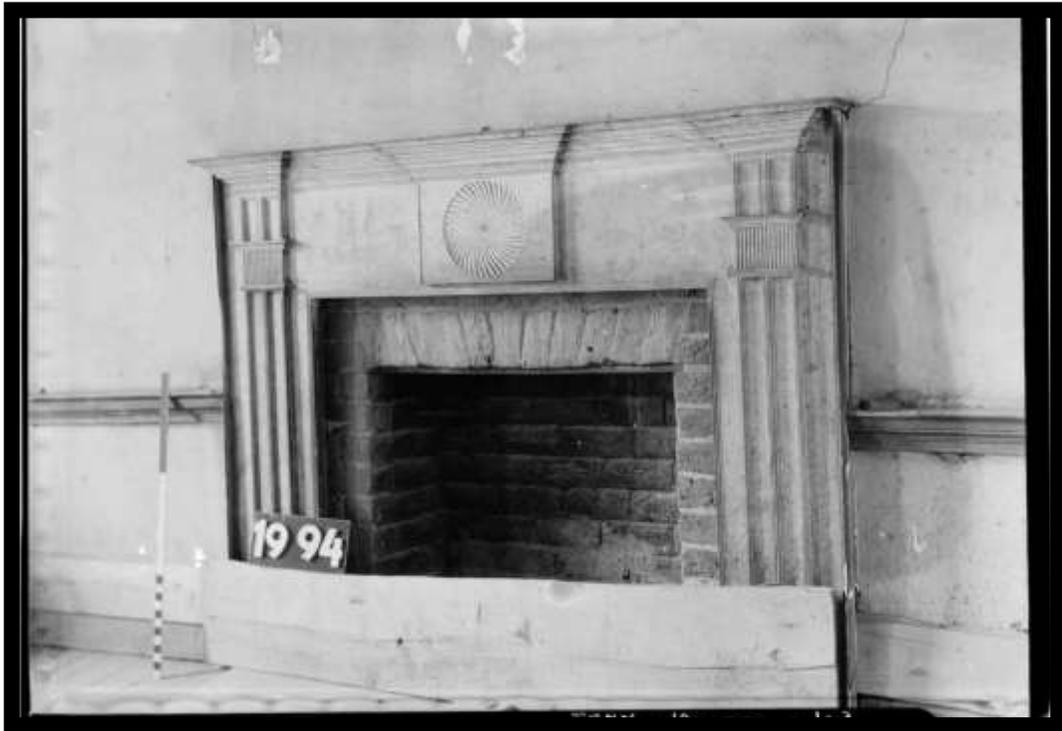
Figure 87. Historic American Buildings Survey, W. Jeter Eason, Deputy District Officer, Photographer June 11, 1936 DETAIL OF MANTEL.
