## **Executive Summary**

This Historic Structure Report was prepared as part of the implementation of the Olympic National Park General Management Plan (approved August 8, 2008 • See Appendix 1) and in accordance with the Secretary of the Interior's Standards for the Treatment of Historic Properties.

The subject of the report is forty-two structures within the backcountry of the Park.

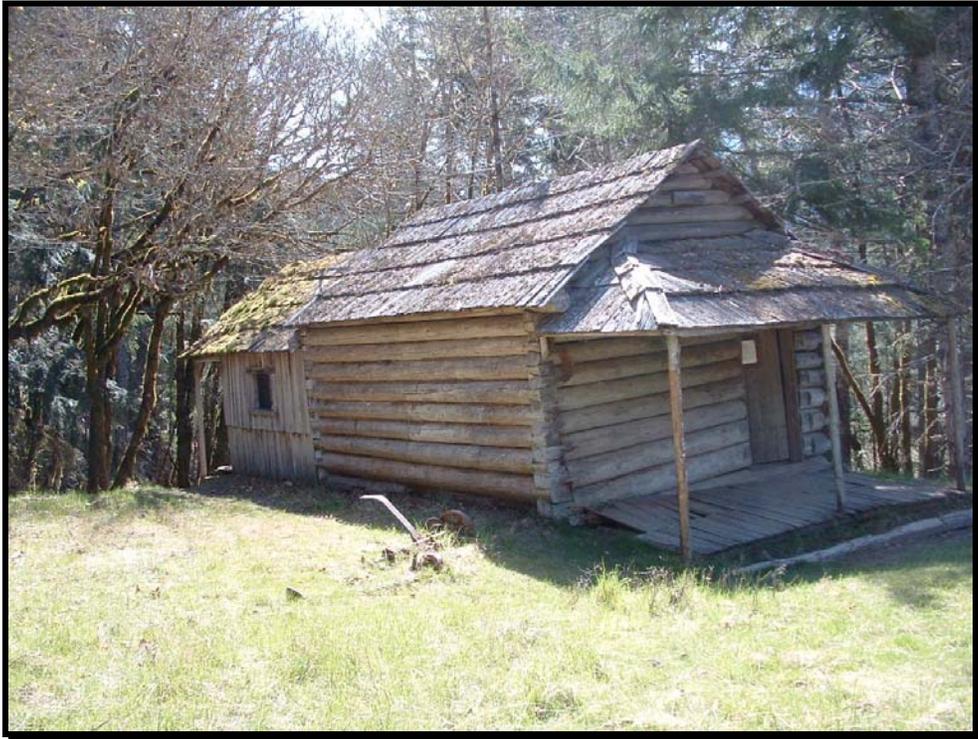
**Figure No. 1: Humes Ranch Cabin, June 2006**

Two critical site elements were noted in the Dalton Report in regards to the immediate area around the cabin. First was the essential need for better grade drainage around the cabin. The second was the original site context of the cabin. Sitting on the edge of a bench, the cabin looked over the south pastureland of the ranch and river below. Grant Humes had cut most of the vegetation away from the slope south of the cabin, allowing a sweeping view from the only window in the log portion of the cabin. This vegetation has re-grown over the years, contributing to a build-up of leaf litter on the roof, keeping the cabin damp and moist most of the year from shade, and, equally important, creating a false sense of landscape context for the building.

In 1994, an extensive floor frame was installed that cantilevers out and supports the log walls of the cabin. Even with this system, the soil build up on the north side of the cabin deteriorated the sill log causing settlement of the cabin structure. The Dalton report lists optional treatments for the floor and wall support system from making the floor independent of the walls to just replacing deteriorated logs and keeping the current floor frame.

With the current deterioration of the north sill log, the cabin is listing and torquing out of square. On the east wall, from the door head nearly to the peak, all the wall logs have been “spliced”. These splices are now opening up due to the cabin settlement. A continuity of connection has been lost.

The findings of the Dalton Report show the need to replace the roof of both the cabin and kitchen addition. The roof was leaking badly during the 2006 assessment.

The immediate improvement to the site grading around the cabin recommended in the Dalton Report is strongly endorsed. Site drainage is a critical element of a preservation program. In addition to soil removal around the cabin, consideration should be given to restoring the creek ditch and sloping grade to the ditch at the north and west sides.

It would be far better to select the option for the log walls of the cabin to rest on their own stone pier foundation, keeping sill logs off the ground and allowing for air circulation under the structure. The floor frame can remain on its pier block supports, but be independent of the walls.

As part of any work on the cabin, it is recommended that in addition to the noted log work of the Dalton Report on the east wall, logs E-9, E-10, and E-11 be replaced completely, providing a secure connection to the east ends of the north and south walls.

There is strong photograph evidence showing the original four-course roof on the cabin and the addition, and restoration to this pattern is recommended.

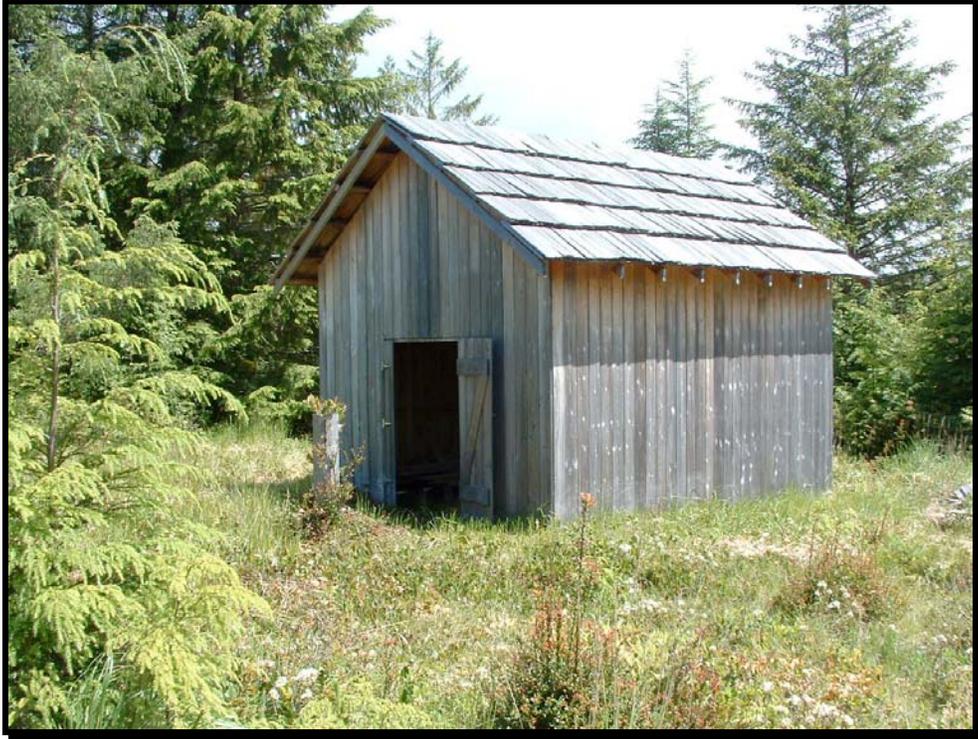
**Figure No. 7: Barn, Roose Homestead**

The Roose Homestead Barn was completely reconstructed in 2001 to match the original structure. All the building material is new, including new concrete pier blocks, sill beam, frame, siding and roof. The building is in very good condition and will just need periodic maintenance inspections from possible storm damage.

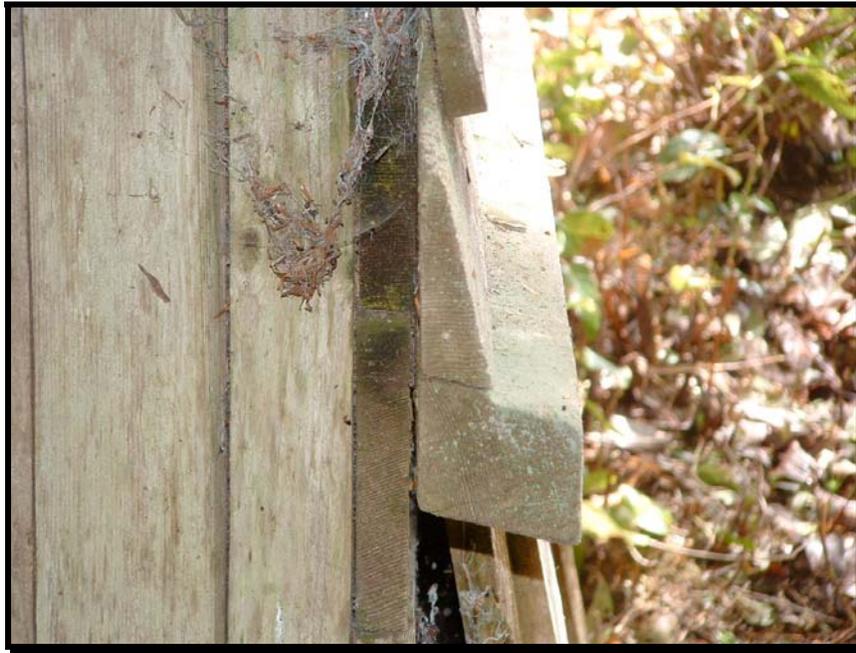
**Figure No. 11: Watertable, Root Cellar, Roose Homestead**

The workmanship of the building below this line is incongruous with what Peter Roose exercised on the house. Then there is the uneven termination of the siding at the west wall, suggesting at one time it extended further. It strongly appears this structure was altered after Roose' death by either having a portion of a building moved to the site, or an existing structure lifted. Without further historical research, it is difficult to understand how this building evolved.+.

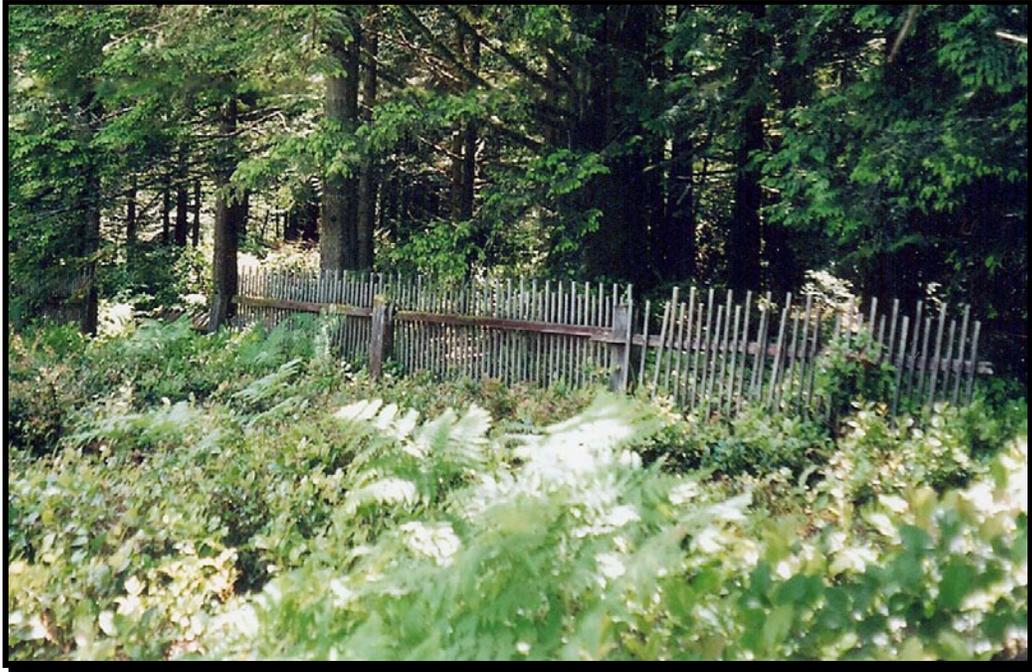
**Figure No. 13: Fence, Roose Homestead**

Around the perimeter of the Roose Homestead are remnants of a fence. These sections of wood fence have a delicate and refined character. The fence is more than a boundary for stock. It is a statement of domestication and order within the wilderness. A site condition assessment drawing completed by NPS in 1999 illustrated an extensive series of fencing throughout the homestead.<sup>4</sup> By 2009 most of the fencing had been lost to undergrowth and decay. The fence design and system defined the homestead and adds greatly to the character of the site. It is included here as a structure that should be preserved as part of the cultural landscape.

The fence should be preserved. New posts will be need, but many of the original pickets can be reused. While all the site fencing need not be restored, a selected section of fence should be preserved/reconstructed.

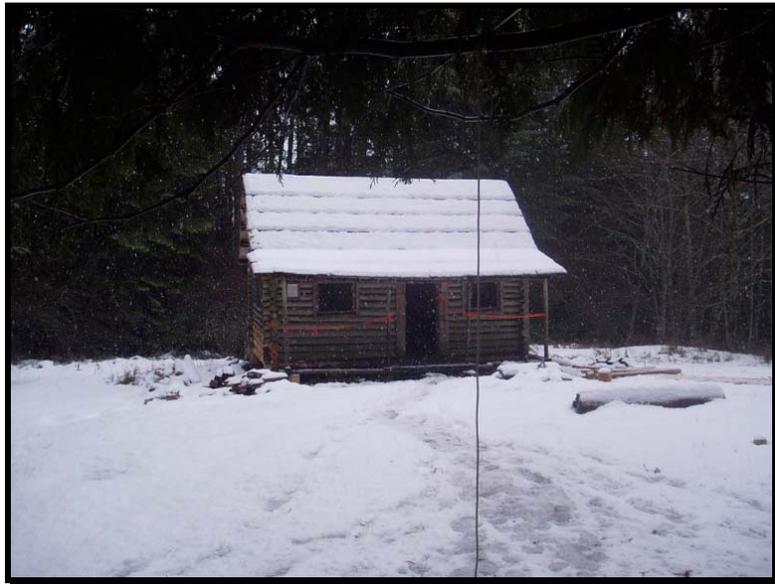
**Figure No. 2: Beginning of the Project**

The work entailed removal of the 11 x 8 shiplap interior walls sheathing and floor sheathing in order to replace deteriorated wall logs. Five complete wall logs were replaced along with a number of crown ends. The floor was

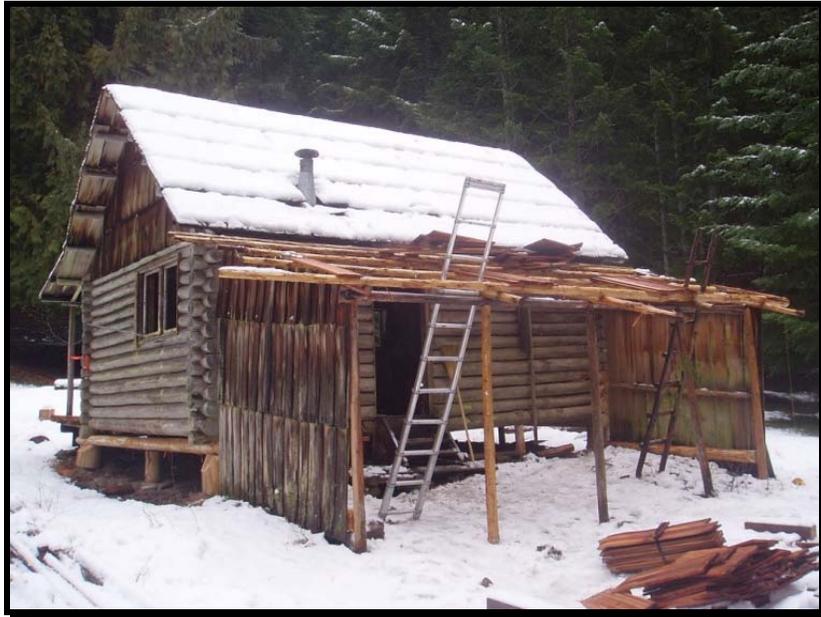
supported on random placed cedar piers. A new fir log center girt was installed on new cedar piers. New interior sheathing was installed on the floor and walls. 25% of wall sheathing is new and 70% of the floor sheathing is new. Missing pieces of door and window trim were installed to match existing. The framing for both the back and the front porch was replaced due to decay.

**Figure No. 3: Rear Porch Framing**

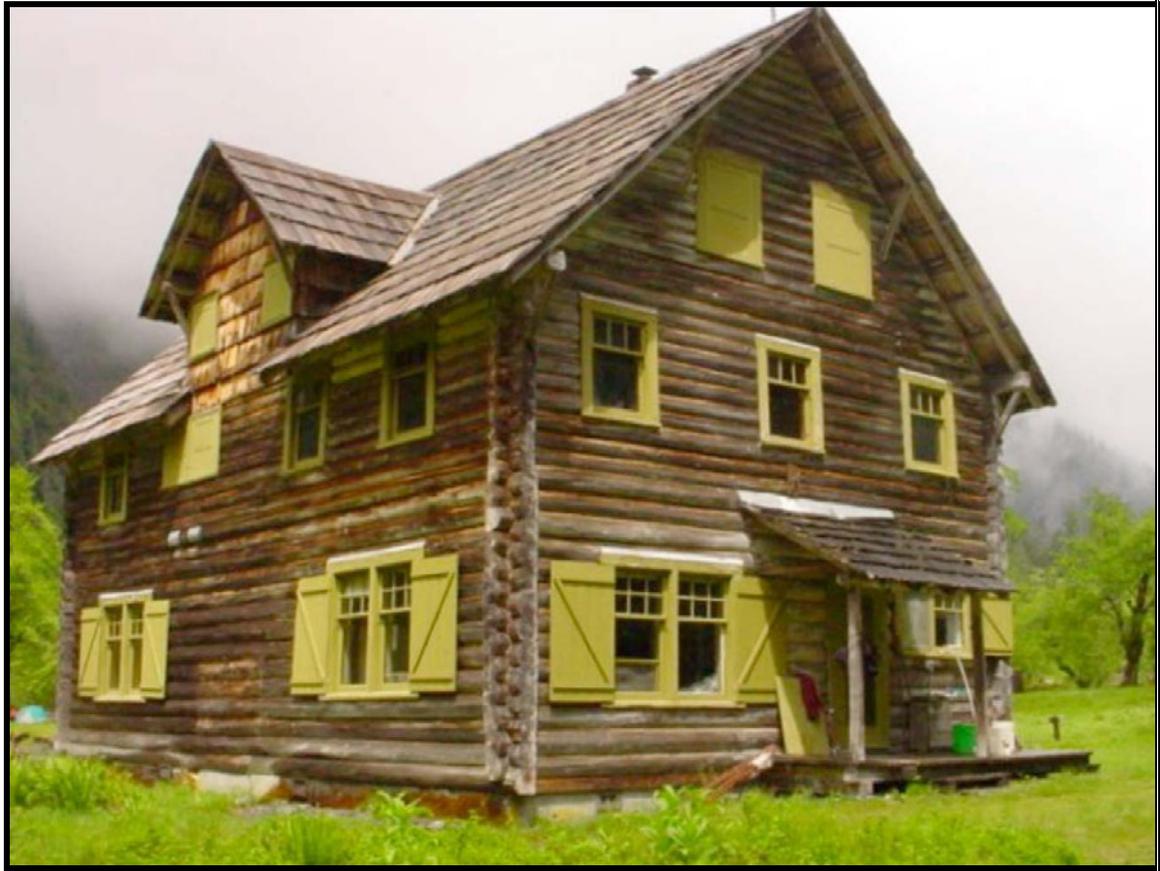
**Figure No. 2: Enchanted Valley Chalet, 2004**

replacement, though the extent and quantity was not discussed. The most extensive recommendation was for the complete replacement of the shake roof. It was felt that as of 2004 the roof had only a few more years of service left.

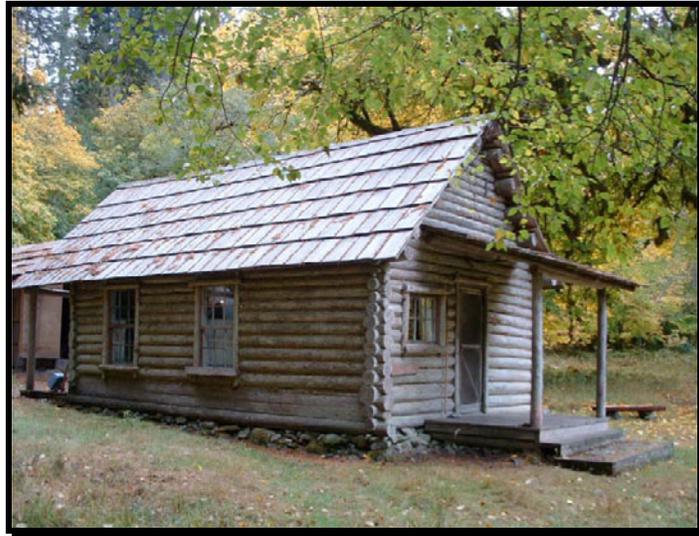
**Figure No.1:Elkhorn Ranger Cabin, October, 2006.**

The cabin was assessed in late 1990's. It was found to be in generally good condition. The only noted deficiencies were the ends of some floor joists raised out of the notch in the sill log at the NW corner causing a movement in the floor, a deteriorated sill log on the back porch, and a deteriorated area under the sink. In the spring of 1999, the floor was sanded and painted, windows glazed except for ones with cracked panes, some cupboard doors replaced, screen doors fixed, and the sink plumbing repaired.

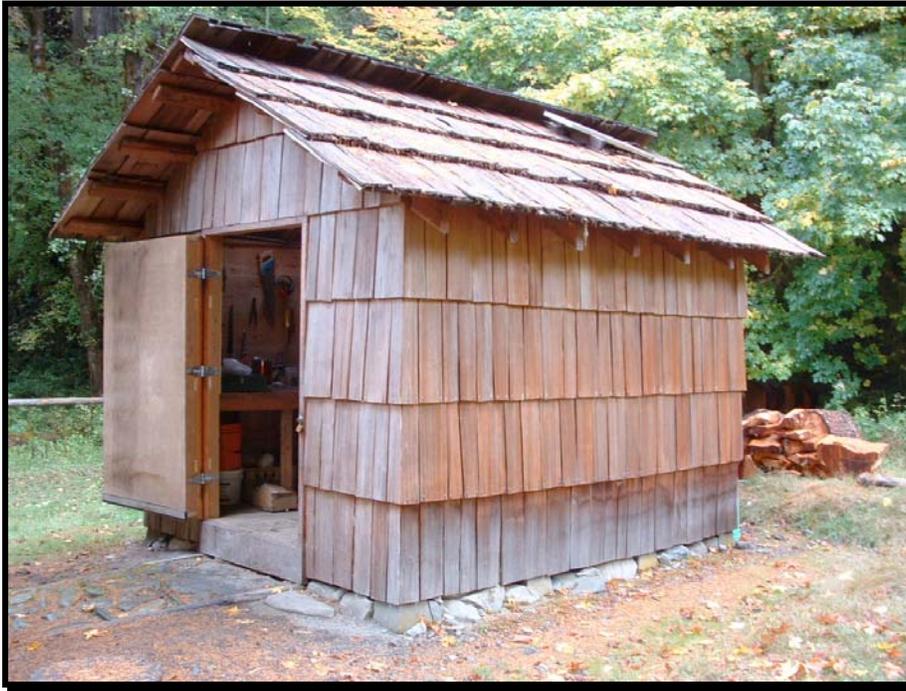
**Figure No. 6: Elkhorn Woodshed , October, 2006.**

Immediately behind the Ranger Cabin is a small 10' x 12' wood and tool shed. When the building assessment was conducted in the late 1990's the original structure was found to be in poor condition with rotting floor, sill beams, open holes in the shake roof and some deterioration of the wall frame. In the spring of 2000, a plan was implemented to completely reconstruct the woodshed. The building was sited three feet upslope from the original structure. The new shed is assembled from milled cedar. The rafters are clear vertical grain cedar. The roof and sidewalls are covered with cedar shingles. The building is in excellent condition and needs no discussion on its condition.

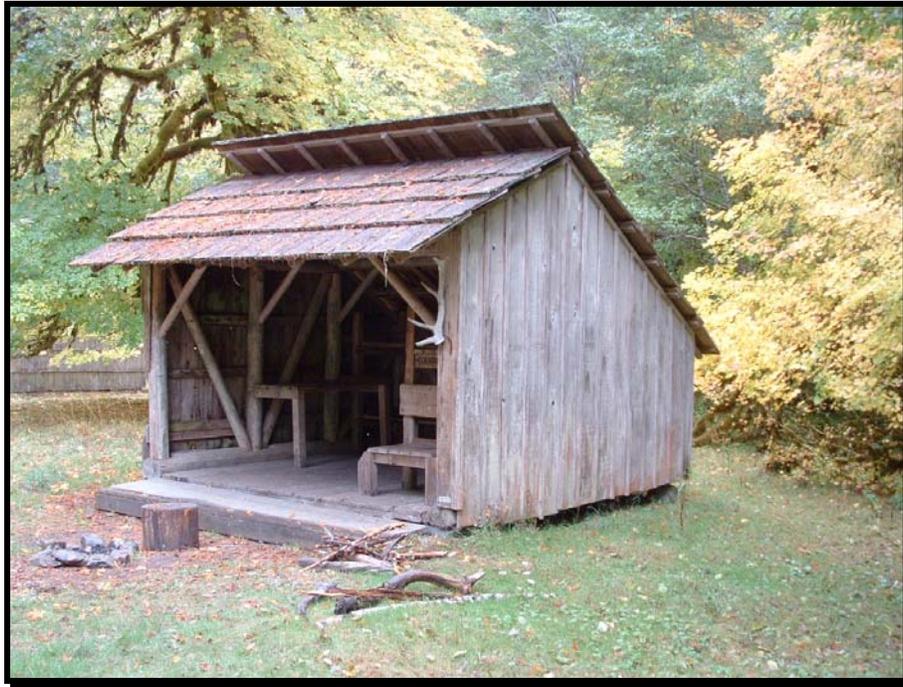
**Figure No. 7: Elkhorn Shelter, October, 2006.**

The Elkhorn shelter is a standard Forest Service L-4 plan from the early 1930's. Exact date of construction is unknown, but was in existence by 1940 and is attributed to the Forest Service as part of its trail system up the Elwha River. Originally sited closer to the river, the shelter was moved in the mid 1990's to the current location due to concern of flooding from spring runoff. (See section V.2, Period 1 of this report for more background on this type of shelter)

The frame consists of the typical log assembly. 10" x 12" sill logs support an exposed braced log frame. The sill logs on the north and east sides appear to have been replaced when the shelter was moved. There are signs of minor powder post beetle activity in the non-replaced sill. The log frame members all look to be in good condition.

The sidewalls are board and batten. This is most likely replacement of original cedar shakes. It was common to replace the shakes in the 1950's with board and batten. The north and east walls look to have been replaced during the move. The boards on the south side have shades of red oil coatings, similar to what is found on the cabin.

The roof is composed of 32" shakes with an 8" lap over pole rafters. Compared to an 1980's photograph it appears the roof and rafters were also replaced after the move of the shelter. It is in good condition.

Monitor condition of sill logs and base of vertical members for powder post beetle activity.

Conduct periodic inspection maintenance inspection of condition.

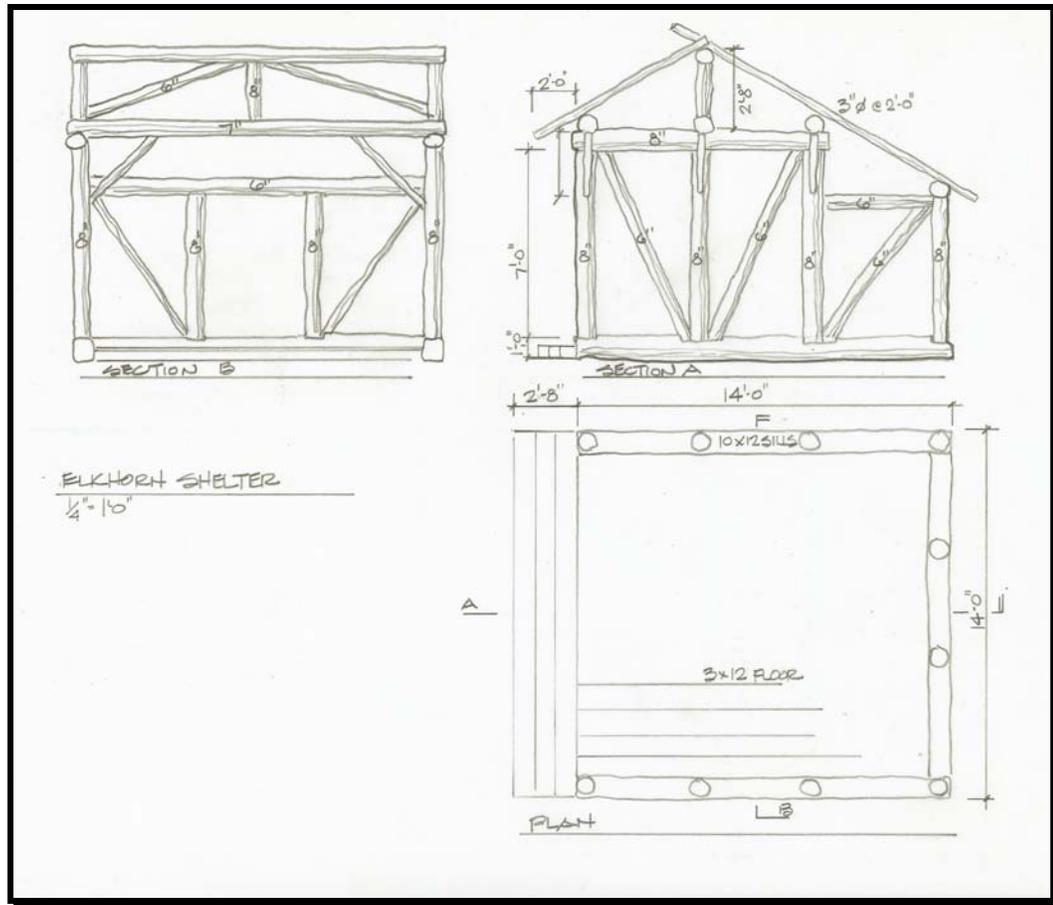
**Figure No. 8: Elkhorn Shelter.**

This shelter has two bunk frames and a wood floor on the interior. The bunks and floor are in serviceable condition.

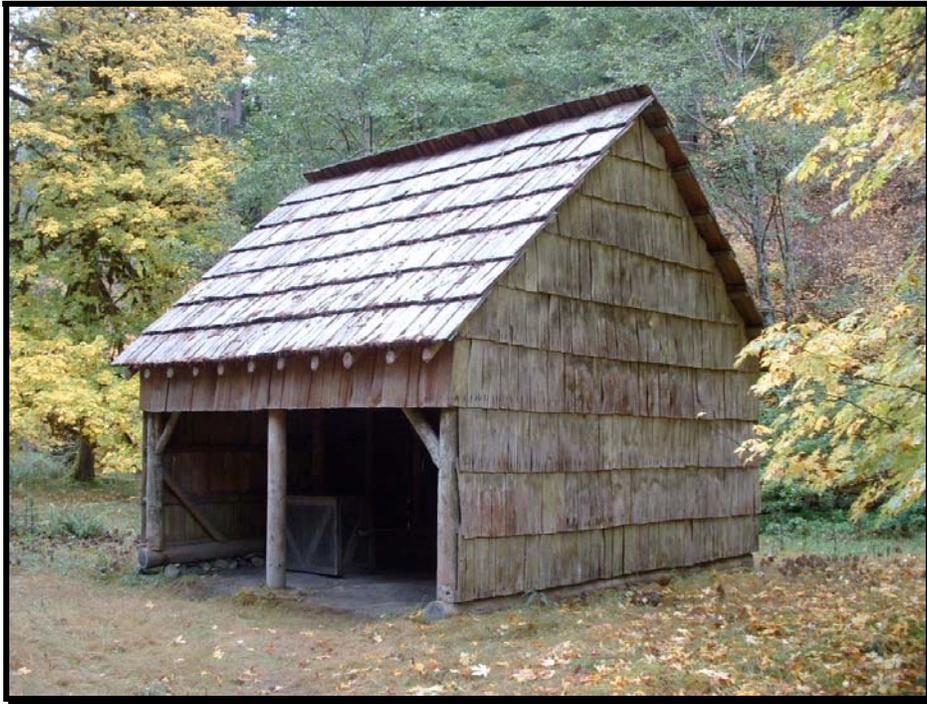
**Figure No. 9: Elkhorn Barn, October, 2006.**

The Elkhorn Barn is a log-framed structure with a steep gable roof. According to the National Register Nomination, the barn was constructed by the Civilian Conservation Corps (CCC) in the summer and fall of 1933. The structure has undergone substantial changes since construction. The function of the building evolved from a barn to a modified trailside shelter. By the 1970's the stalls, mangers, and hayrack had been removed and the wall of the two side bays had been opened. Similar to the Elkhorn shelter, the barn was moved in the mid 1990's to the present location due to concern with river erosion. In the move the building was turned 180°, reversing all former orientation descriptions of the building. Since it was standard practice for Forest Service barns to have a stock door on a gable end and the current sidewall nailer poles for the shake siding are not framed for a stock door, the stock door and its frame apparently were removed when altering

the building to a shelter type function. During an assessment in the 1980's it was noted that there were two shake covered doors on the south wall (now the north side). There is currently only one door on the north side. In addition, a considerable number of the log frame members appear to have been replaced at the time of the move in the 1990's, including sill logs and knee braces. Considerable portions of the north and east walls have had their shakes replaced also. On those shakes not replaced there are faint traces of red log oil. On the interior, the front half has a dirt floor while the rear half has a floored landing.

The shake-covered sidewalls are generally in good condition. There are though several shakes on the east rake of the north gable wall that are deteriorated. These shakes protect the connections of the frame.

The roof consists of 34" shakes with a 6" lap. The roof shakes appear to have been installed in the 1990's during the move. Except for a minor accumulation of duff and leaves, the roof is in good condition.

The frame appears to be in good condition. The horizontal shake nailer poles of the sidewalls give the structure stability and should be monitored for any connection failure or deterioration.

Replace north gable wall shakes.

Conduct periodic maintenance inspection for winter damage or loss of shakes.

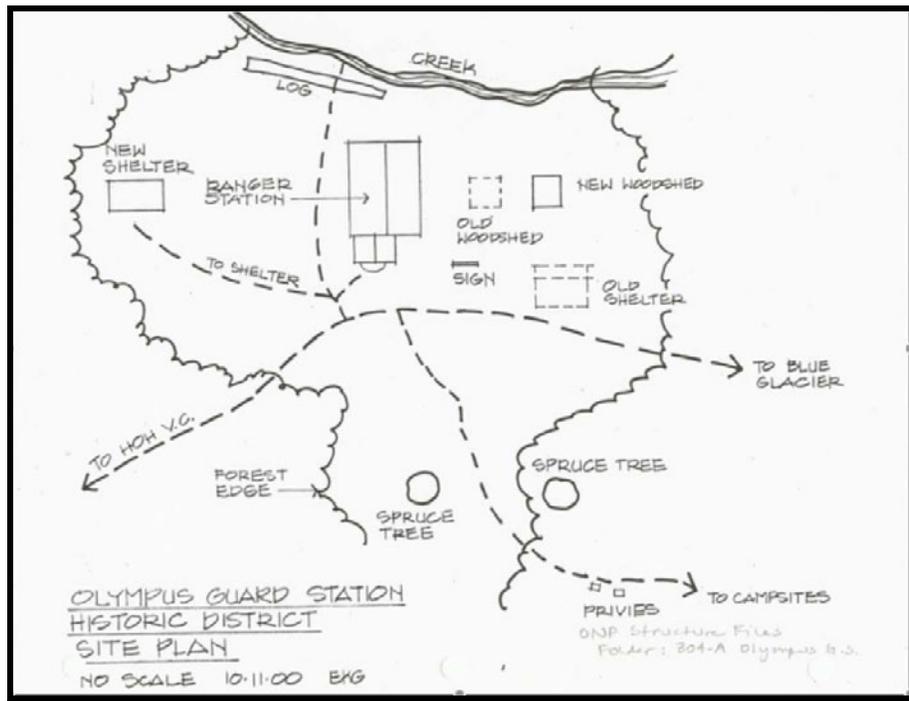
**Figure No. 1: Olympus Ranger Station Site Plan, October 2000.**

It appears the good drainage patterns are being maintained around the buildings. This practice should be continued to allow airflow around the sill logs and to reduce moisture content of local grade.

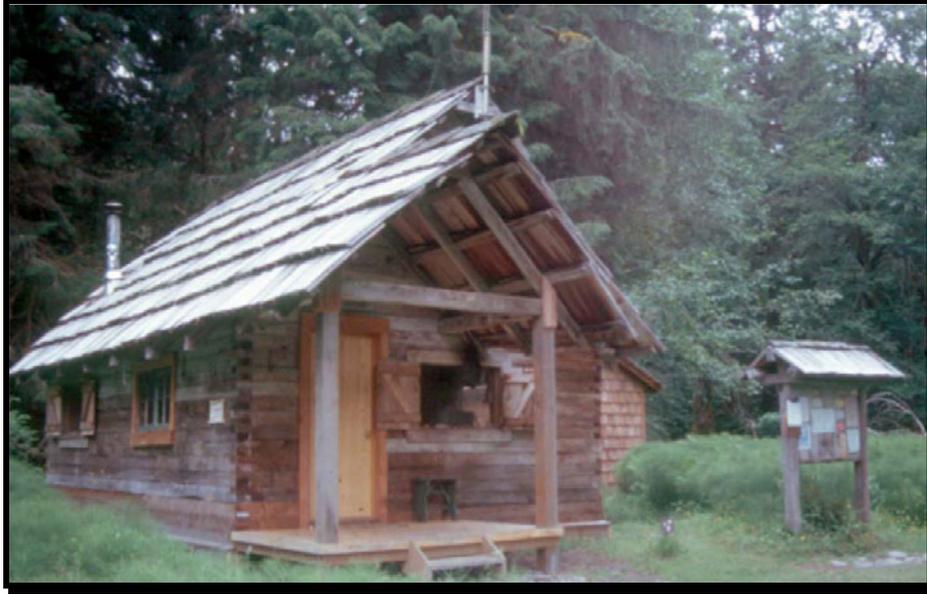
**Figure No. 2: Olympus Ranger Cabin**

The 1985 assessment proved to be correct in its assumption of serious deterioration advancement in the floor and lower log walls. By June of 1996, field reports were noting settling of both the east and west walls, a pronounced lean in the south gable above the door, and gaps developing between the wall logs.

Given the extensive work of the 1998 project, the cabin is in good condition. The ventilation under the floor and site drainage will always require annual maintenance to insure a conducive environment for long-term preservation. Of major concern is the condition of the roof. The 1985 assessment found the shake roof to be relatively new, but given a factor of 25 years of service, the roof needs to be monitored closely and likely scheduled for replacement in the next five years. The skylights should be removed along with the loft.

Being a vital visitor contact station and administrative site, the cabin should receive a high priority for fiscal maintenance support.

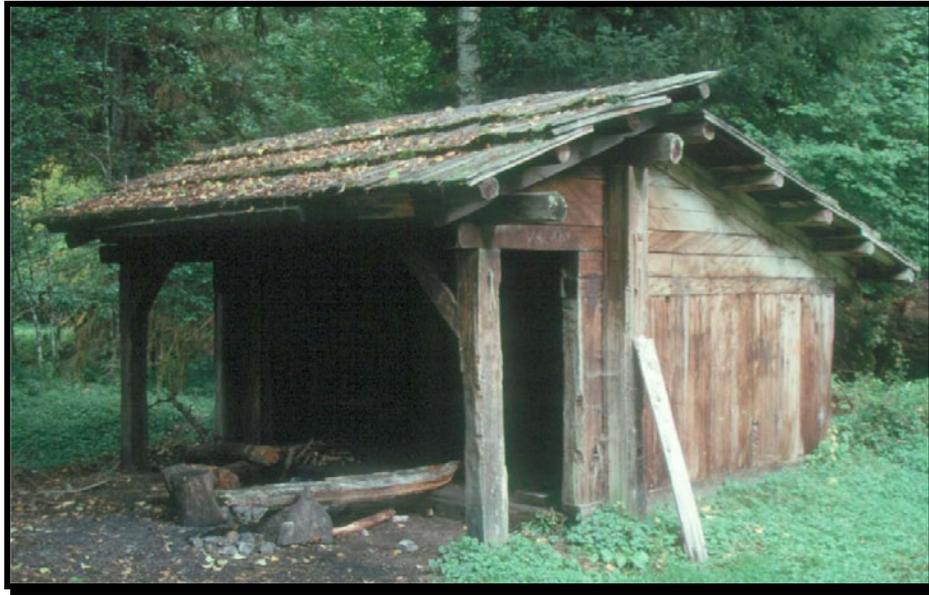
**Figure No. 4: Olympus Shelter**

The shelter condition was reviewed during the 1998 work on the cabin. The only work done to the shelter was to install a complete new shake roof.

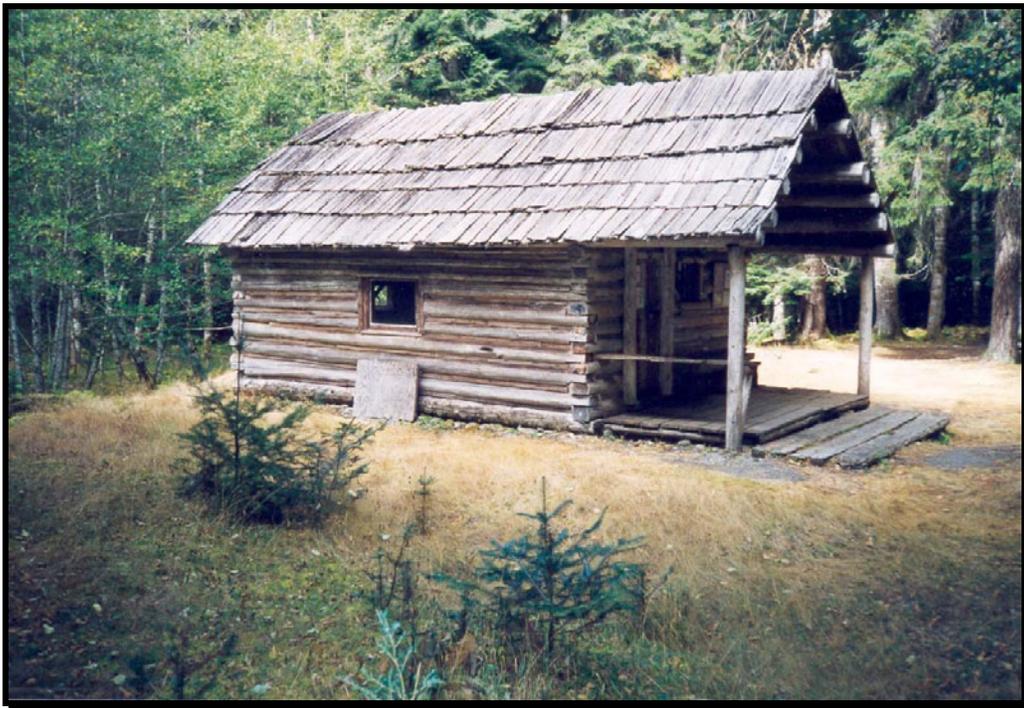
**Figure No.2: Hayes River Patrol Cabin**

The cabin was last assessed in 2006. It was found to be in generally good condition. Recent repairs include significant work on the porch. This work included new sill logs, floor joists, deck, fascia board and steps. Deficiencies, though, were noted.

Both the north and south sill logs were observed to have significant deterioration. The north wall sill log was 40% rotten, all along the bottom face. The south log was 30% rotted in the bottom half.

Many loose and out of place shakes at the southeast corner of the roof. From the inside there are open holes and white mold on the underside of the shakes. In addition, the guy-wires on the stovepipe have failed.

Both sill logs will need to be replaced. This should be done in conjunction with some probable repair of the stone foundation and site grading.

The roof shakes need to be replaced for a watertight weather envelope. If the shakes are from the rebuilding of the cabin in 1970, then a complete new roof needs to be installed.

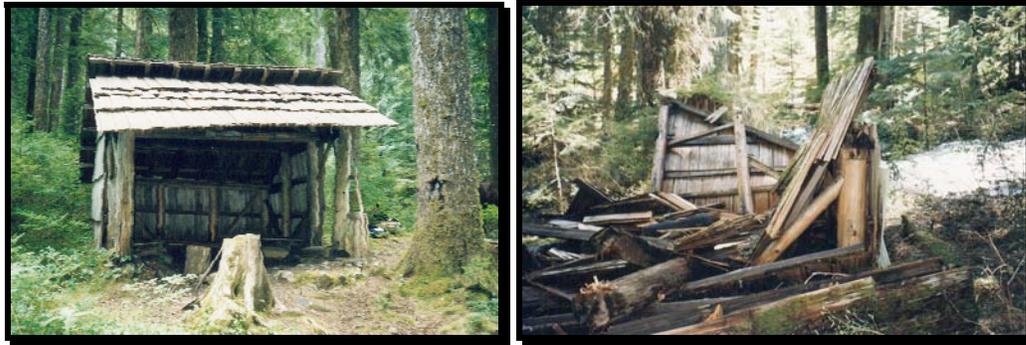
**Figure No. 1: 21 Mile Shelter. The image on the left was taken in 1998, while the image on the right was in 1999.**

Over the winter of 1999, 21 Mile Shelter collapsed. The cause appears to have been a combination of being in poor condition and heavy winter snow. The shelter had been assessed in 1998. At that time, it was noted that all the sill logs were rotted and the structure was beginning to lean and rack to the east.

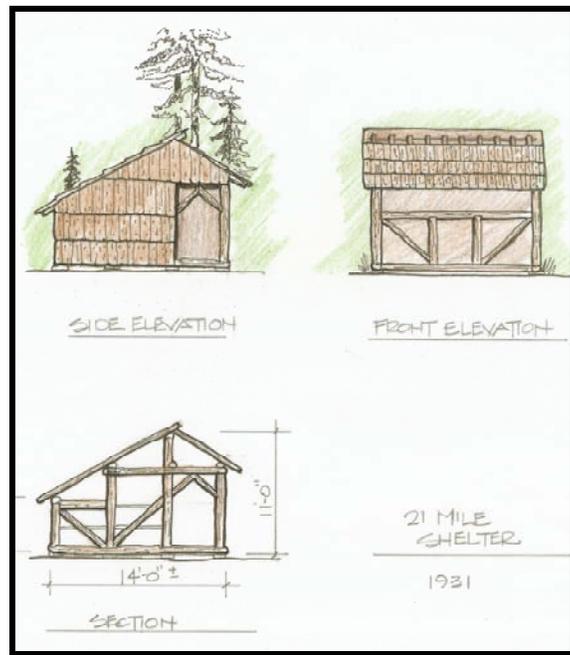
The design is a variation of the Forest Service L-4 plan. As seen in Figure No. 2, the principal variation is the sidewall diagonal framing and the un-walled bay on the sidewalls.

**Figure No. 2: A sketch of the 21 Mile shelter showing the diagonal sidewall framing and its relationship to the open side bay.**

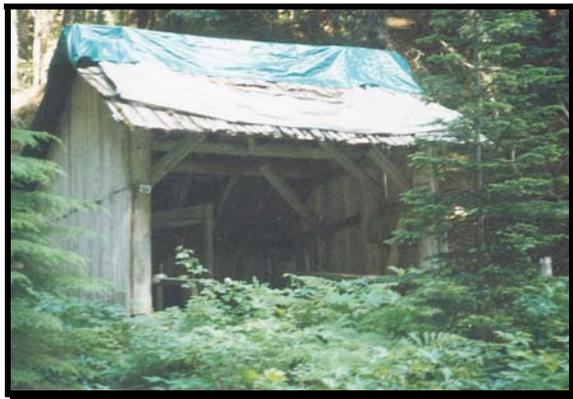
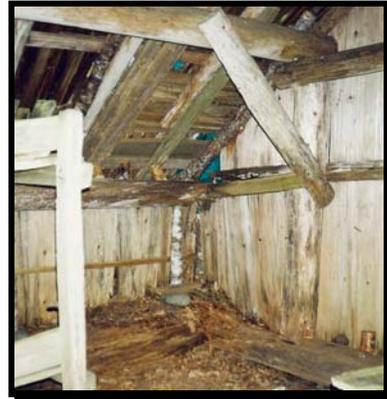
**Figure No. 1: North Fork Soleduck Shelter. These images were taken in 1998, showing the poor condition of the roof and deteriorated sill logs.**

In the spring of 2000, a work project was planned to make needed repairs to the structure. It was extensive in its scope:

In the November of 2000, the above scope of work was executed. The site was highly recontoured for positive drainage, the frame repaired, a new shake roof installed, new cedar siding installed, and the bunks rebuilt. (See Figures No. 2 and 3)

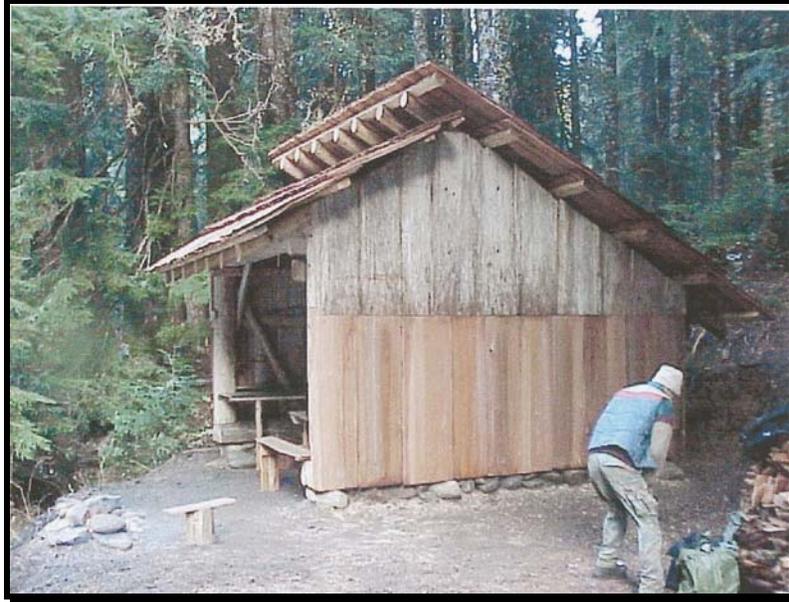
**Figure No. 2: North Fork Soleduck Shelter after 2000 rehabilitation.**

From the record photographs, the work seems to have been well executed. The shelter was assessed in 2006 and no traces of deterioration or roof leakage were found. Vegetation was found around the base of the building and removed. The shelter was described as being in “very good condition”. Applying the general recommendations of periodically maintaining the site grading, cleaning the roof of debris and checking the integrity of the frame should allow the shelter to remain in good condition for many years.

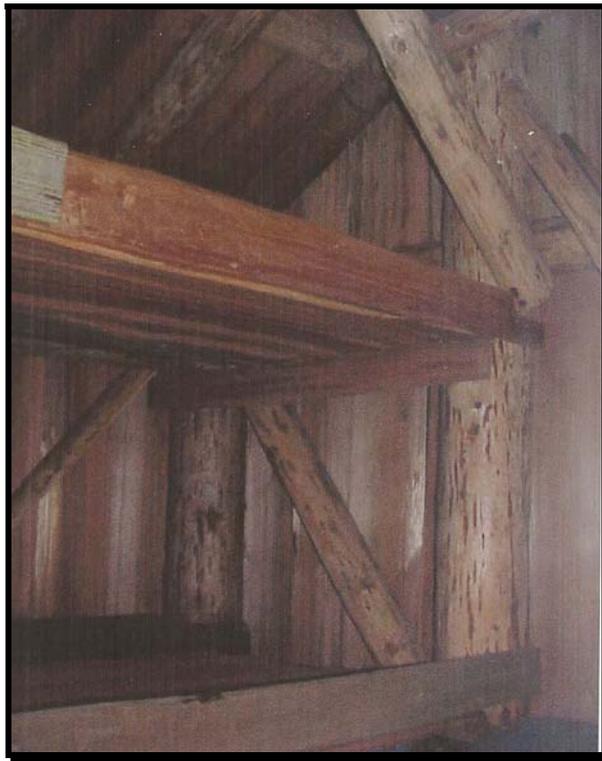
**Figure No. 3: Rebuilt bunks and frame.**

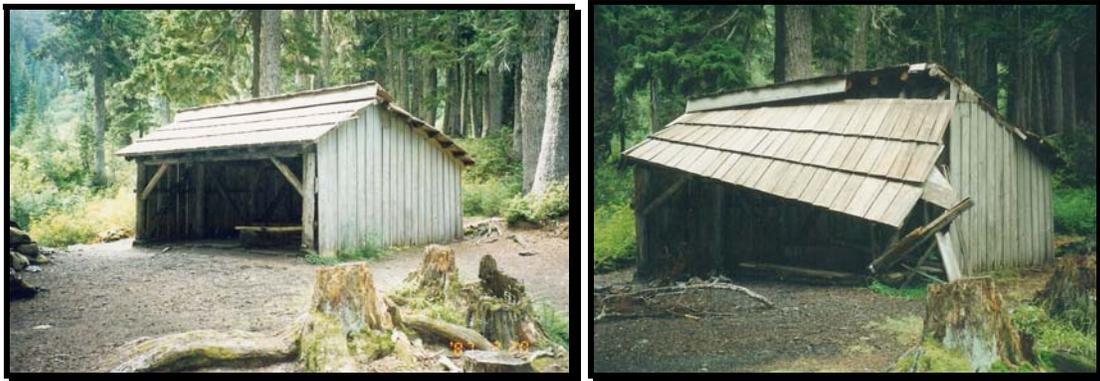
**Figure No. 1: Anderson Pass Shelter. The image on the left was taken in 1998, while the image on the right was in 1999.**

During the winter of 1998-99, the Anderson Pass shelter suffered a partial collapse at the southeast corner. The cause appears to have been a combination of being in poor condition and heavy winter snow. The shelter had been assessed in 1998. At that time, there were some minor repairs that needed attention, one being repair of the east side rear roof sidewall overhang, which had collapse. Otherwise, the structure appeared in good condition. The earlier maintenance records to mention Anderson Pass shelter from 1956 only noted the need to replace two bunks. <sup>1</sup>

Seven years after the partial collapse in 1999, a damage assessment was conducted in 2006. This time the west side roof overhang had broken off, the sill logs had significant rot, the front corner log columns had failed, and frame was racking to the SE. Substantial repair work was recommended.

Replace east and west side 16" diameter fir sill logs.  
Replace both front 10" fir corner column logs  
Salvage front purlin log and reuse  
Replace front bay 6" knee braces  
Replace sidewall 6" diagonal frame brace  
Provide an intermediate 10" log column under front purlin.

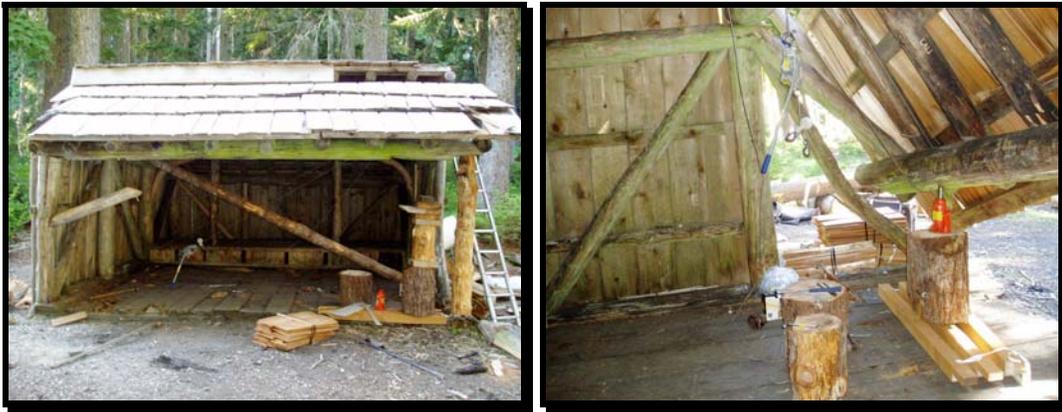
**Figure No. 3: Repair work underway during 2006**

During the summer of 2008 extensive repairs were undertaken to address the issues noted in this condition assessment. The shelter is now in very good condition.

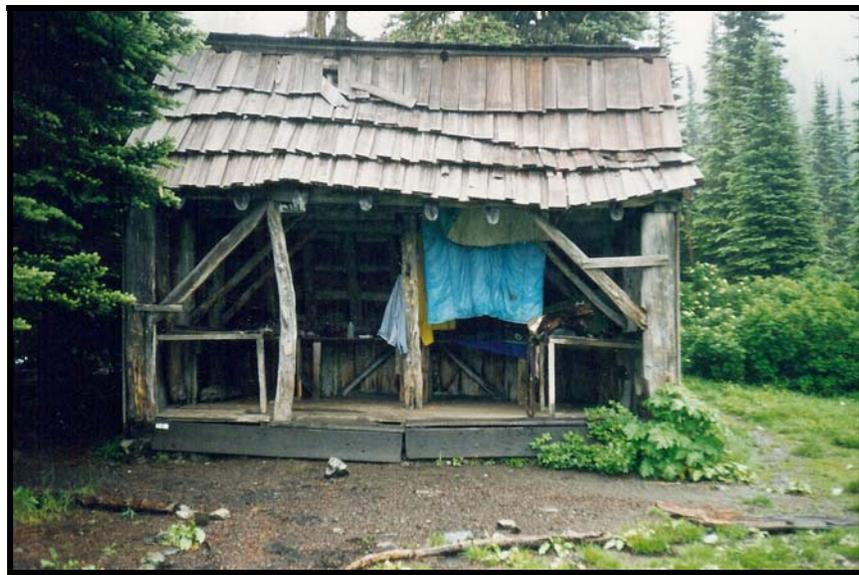
**Figure No. 1: Home Sweet Home Shelter in 1998.**

During the 1998 assessment, it was noted that seven rafters had broken under snow load on the front roof. Similar to Anderson Pass, the shake nailer board eave extensions had also broken on the east side of the rear roof section.

During the winter of 1998-99, a tree fell on the shelter resulting in major damage.

Between the measurements, description, and the photographic evidence from the 1998 assessment, the shelter could be rebuilt to meet the Secretary’s Standards. It is recommended consideration be given to adding additional interior support either through bunk frames and/or additional columns.

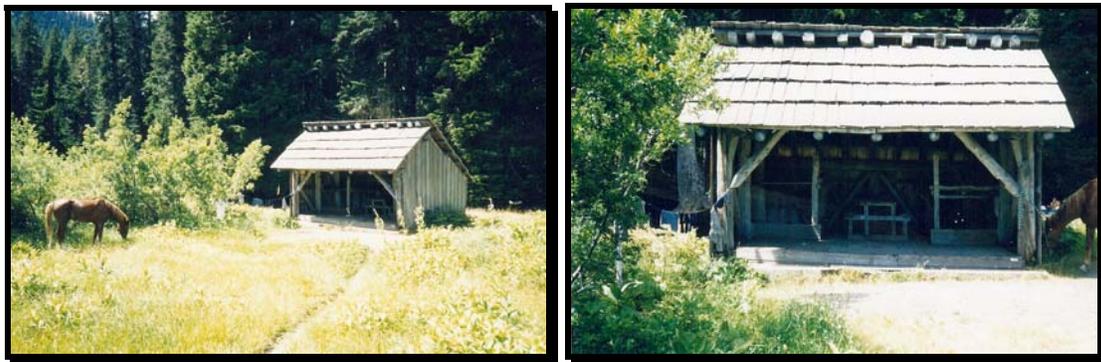
**Figure No. 1: Low Divide Shelter in the summer of 1998.**

The earliest NPS records of shelter maintenance show the shelter was reshaked in 1953, eighteen years following construction. By 1956, it was listed as needing four new bunks repaired. In 1971 it was “rebuilt” by the Student Conservation Program (SCP), and was listed in 1974 and 1980 surveys as being the “excellent” condition. In the 1998 assessment, the shelter was noted as being in good condition, the only deficiencies being some minor rot on the sill logs and serious dry rot in the base of the front column of the southeast corner.

In the case of Low Divide Shelter, between the measurements, description, and the photographic evidence from the 1998 assessment, the shelter could be rebuilt to meet the Secretary’s Standards. It is recommended consideration be given to adding additional interior support either through bunk frames and/or additional columns.

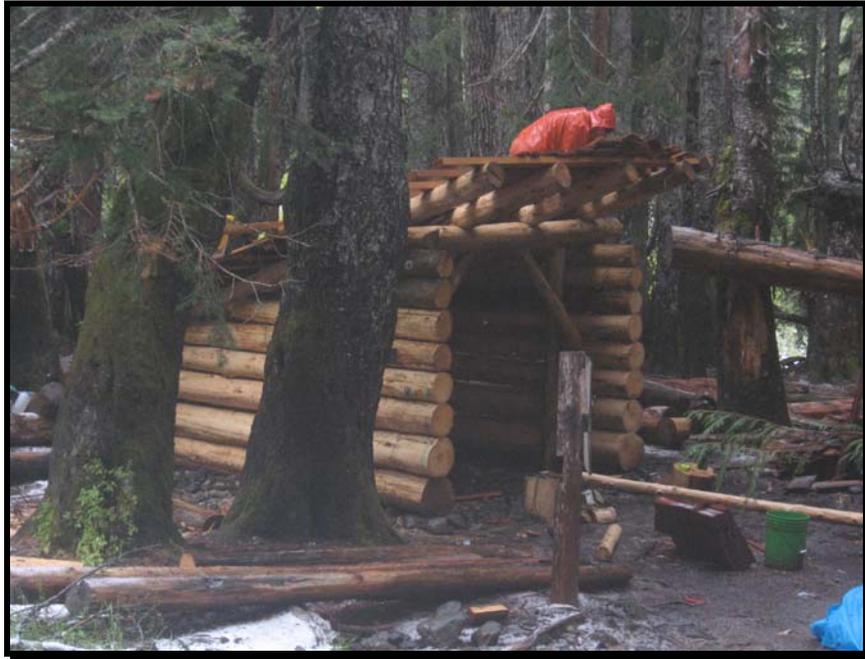
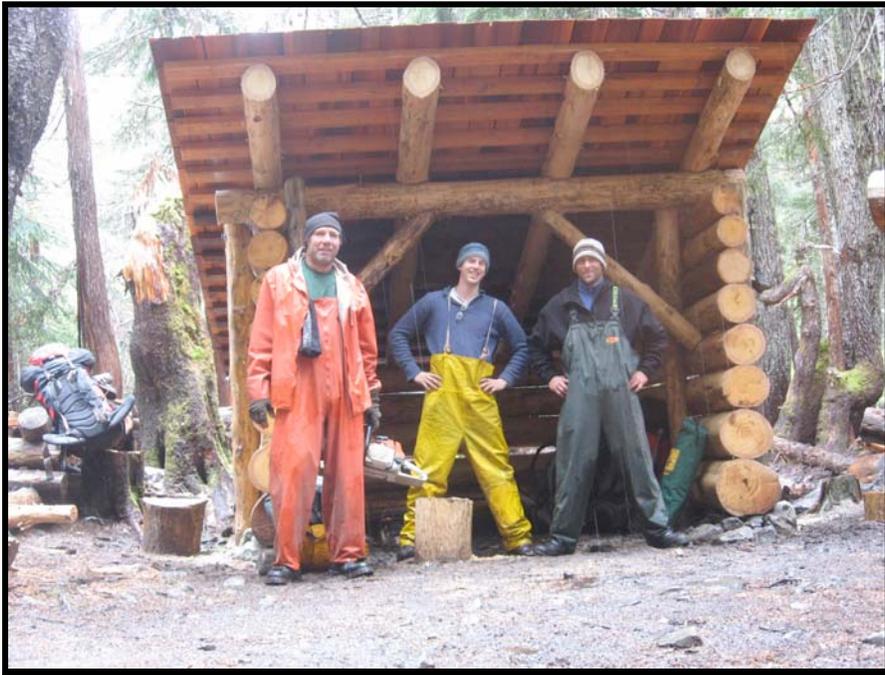
**Figure No. 1: Blue Glacier #1 Shelter following repairs, 2008.**

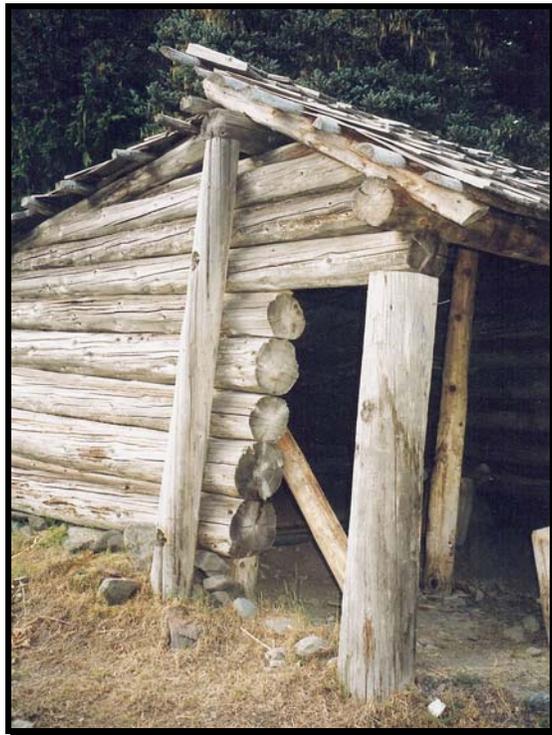
**Figure No. 2: Bear Camp Shelter; upright supports are all deteriorated at base.**

Essentially, all the wall logs up to the roofline will need to be replaced. The tapered sidewall logs appear to be salvageable. This work, though, will need to be coordinated with some changes in the design of the roof.

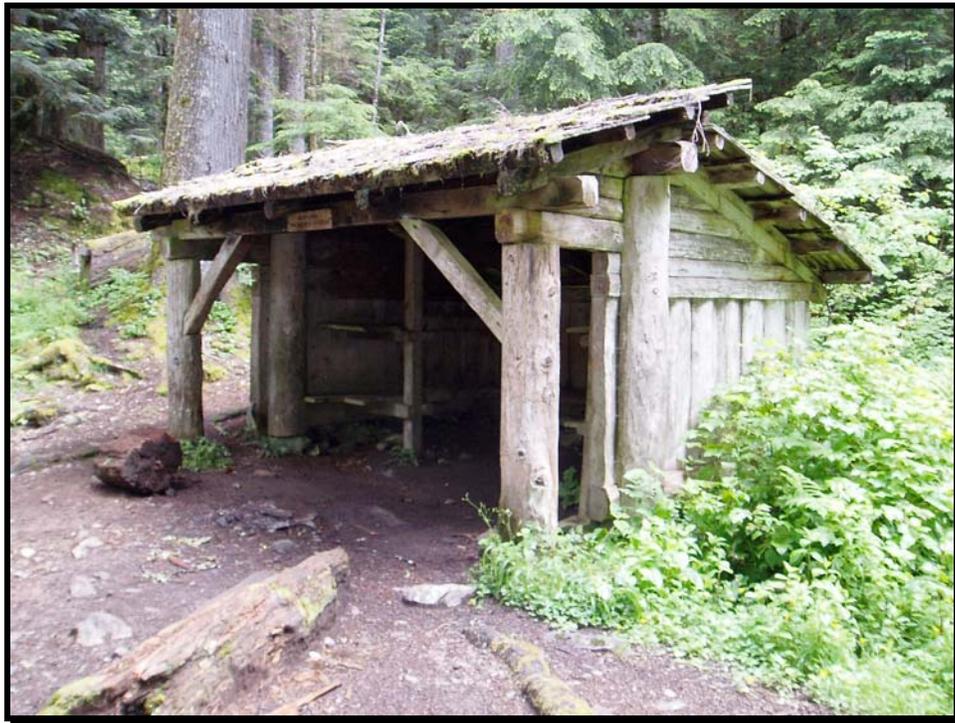
**Figure No. 2: Elk Lake Shelter, July 2004.**

Regrading of site for moisture management and sill log exposure required. Site vegetation should be cleared.

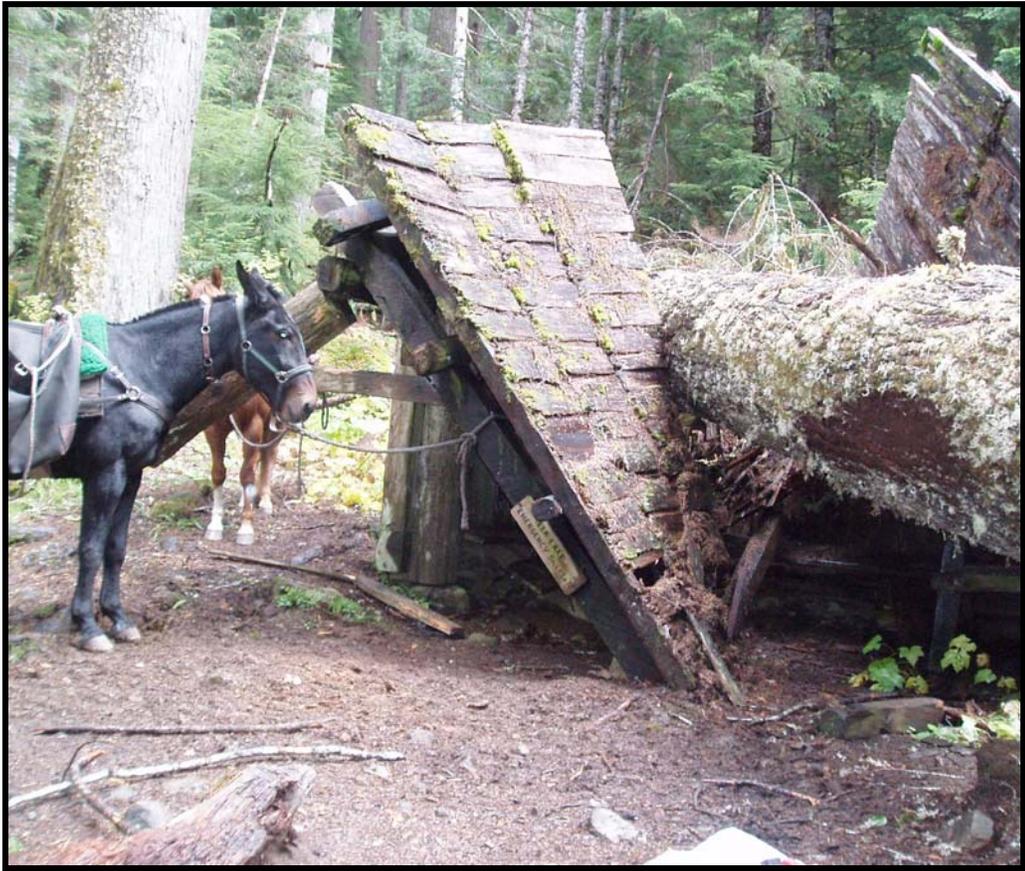
During the winter of 2006 and 2007, a tree fall damaged Elk Lake Shelter. The shelter is scheduled to be rebuilt in the summer of 2009.

**Figure No. 3: Elk Lake Shelter, October 2007**
