## **Executive Summary**

This Historic Structure Report was prepared as part of the implementation of the Olympic National Park General Management Plan (approved August 8, 2008 • See Appendix 1) and in accordance with the Secretary of the Interior's Standards for the Treatment of Historic Properties.

The subject of the report is forty-two structures within the backcountry of the Park.

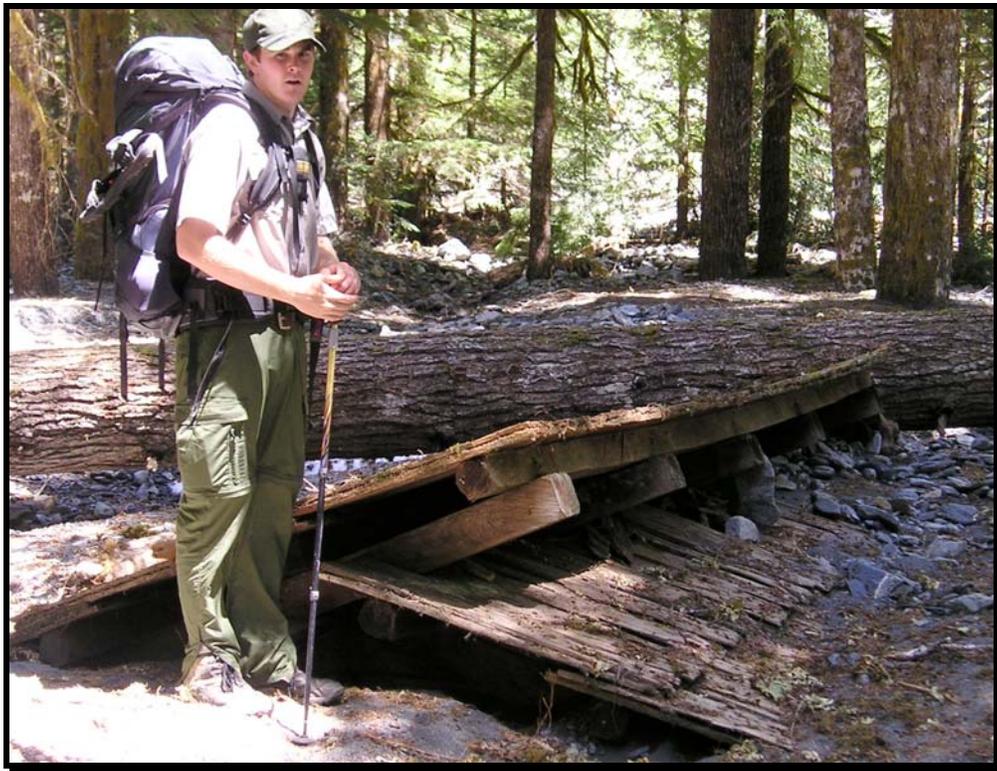
Sometime during the winter of 2007-2008 a gravel flow swept through and buried most of Twelve Mile Shelter.

**Figure No. 3: Twelve Mile Shelter taken during the summer of 2008..**

Given the measurements, description, and the photographic evidence from the 2006 assessment, the shelter could be rebuilt to meet the Secretary's Standards.

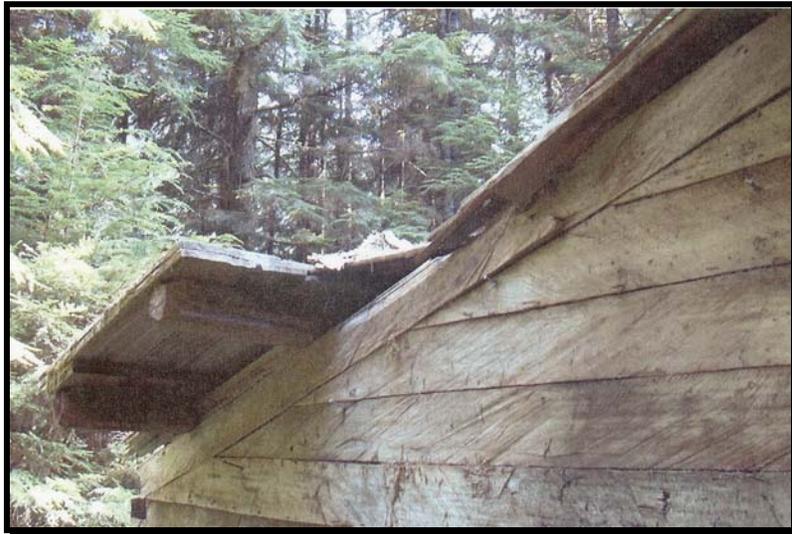
**Figure No. 3: Trapper Shelter, August, 2006; note broken top plate and roof purlin.**

Within the gable end walls, damage has occurred. This apparently is from a fallen tree. One 4" x 4" sidewall top plate is cracked and has the end missing. The damage also includes several broken roof purlins. Due

to the damage, four (4) non-original log posts have been inserted within the shelter to support the roof.

The shake roof will need to be replaced and during this work, at least two new roof purlins and one roof plate will also need to be replaced.

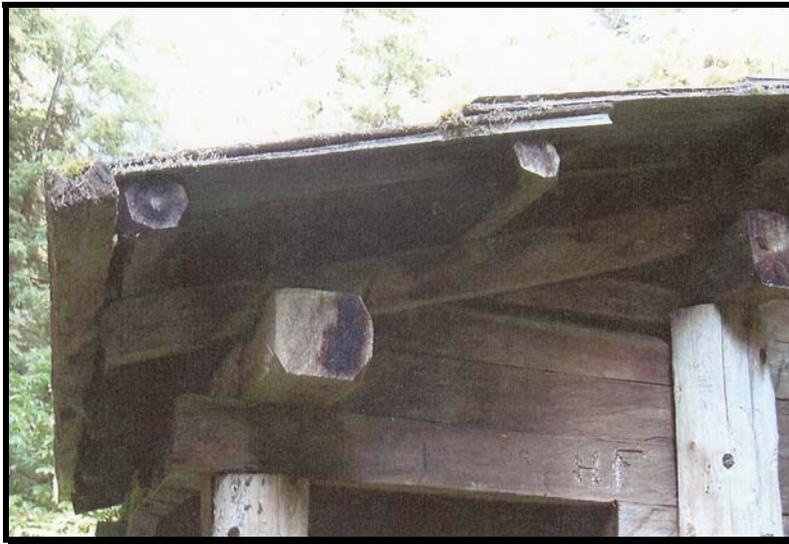
The shake roof is composed of 44” shakes with a 9” to 10” lap. Many of the shakes were damaged in the tree fall, are heavily laden with moss, and in very poor condition. Unlike other shelters, the front roof overhang has a wooden gutter, albeit in poor condition.

**Figure No. 4: Trapper Shelter, August, 2006; note wood gutter at front eave.**

A complete new shake roof is needed for this shelter. The gutter appears serviceable and should be reused.

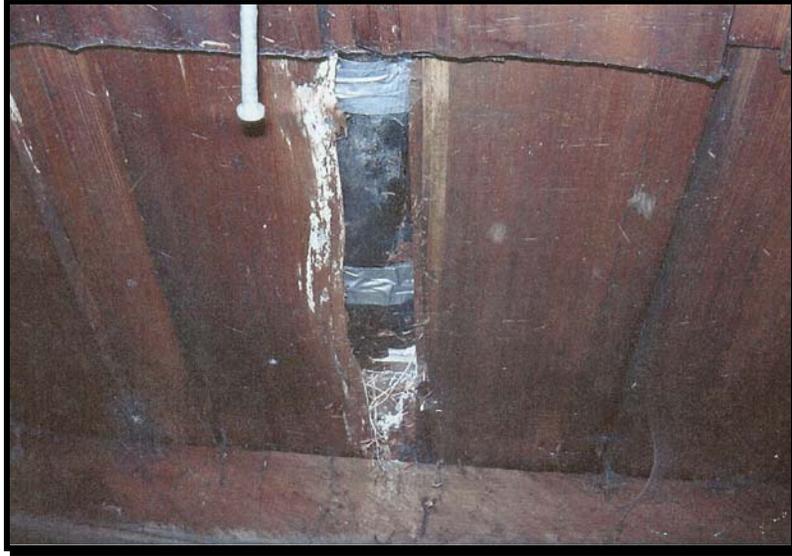
**Figure No. 5: Trapper Shelter, August, 2006; note Duct Tape over hole in the roof.**

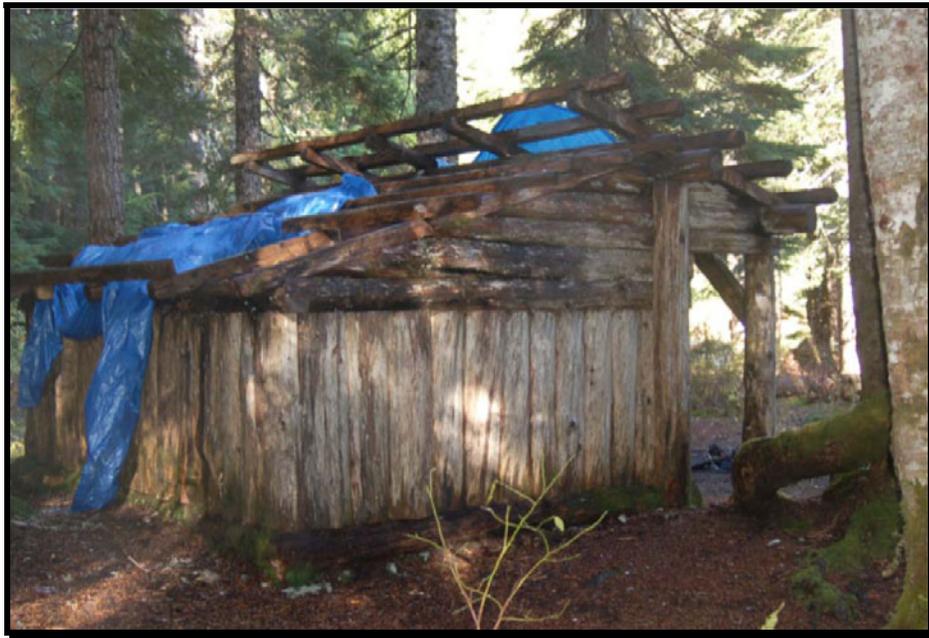
**Figure No. 1: Mink Lake Shelter, October 2007**

The 1974 shelter survey listed Mink Lake as being in poor condition. The 1980 survey though assessed the shelter as being in good condition. The last assessment was conducted in October of 2007, finding the shelter in good condition though lacking roof shakes.

The Mink Lake Shelter was re-roofed and one front column/stone pier replaced in the fall of 2008.

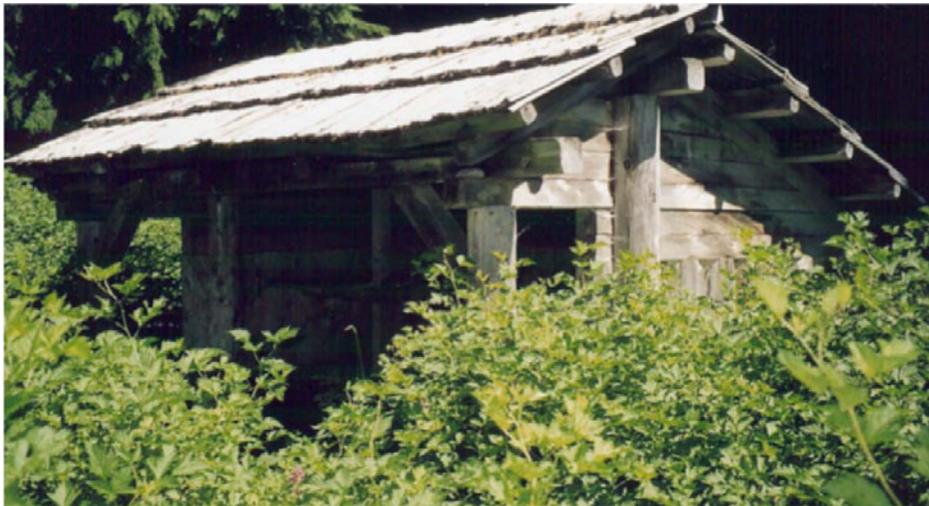
**Figure No. 1: Happy Hollow Shelter, built 1963.**

Both the 1974 and 1980 shelter surveys list Happy Hollow Shelter as being in excellent condition. The assessment of October 2007 found the shelter in good condition with the exception of modest deterioration at the base of the main columns and sill log.

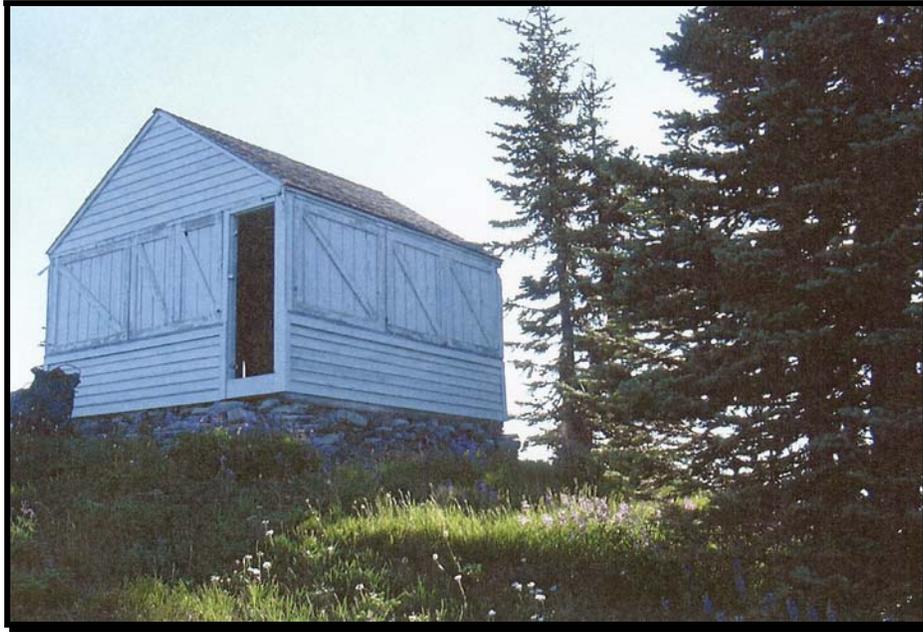
**Figure No. 4: Dodger Point Lookout House, 2006.**

The base of the building should be leveled and at least at the corners for a distance back of several feet, the dry stone wall foundation should be rebuilt to a more stable assembly. Secure connections need to be made between the sill, floor joists, and the corner studs, tying all securely together. This will entail removal of some of the exterior siding.

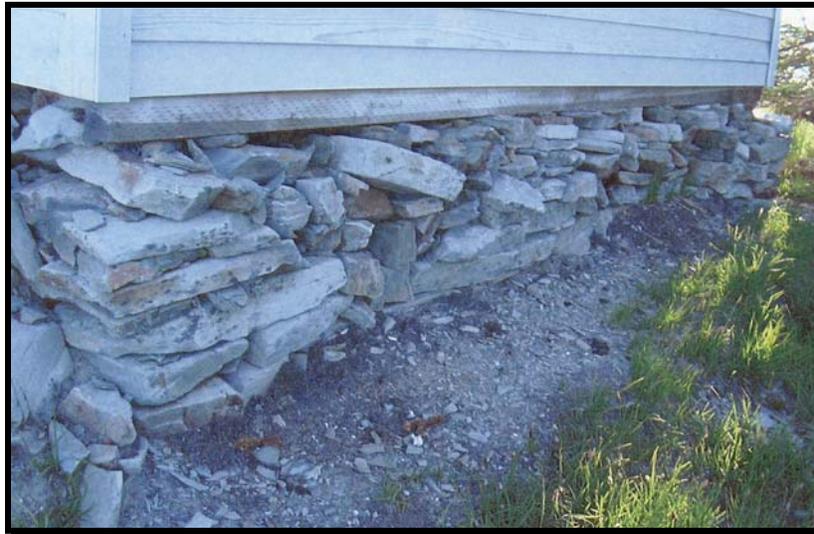
**Figure No. 5: Dry Stacked rubble foundation, 2006.**

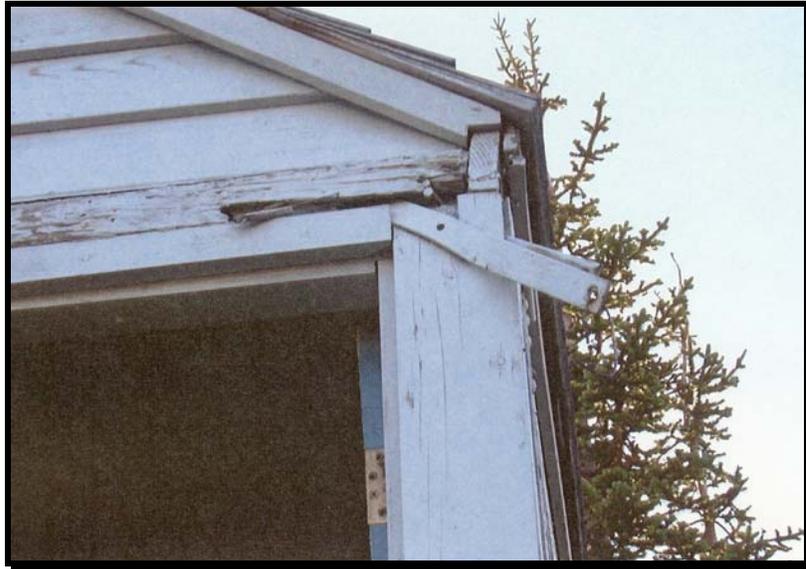
**Figure No. 6: Note the outward rotation of the wall plate above the door trim.**

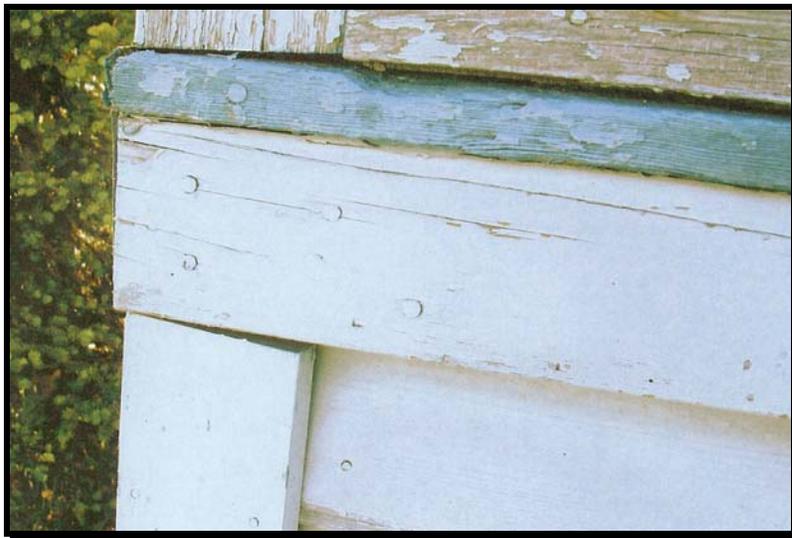
**Figure No. 7: Note racking of the trim as the frame distorts.**

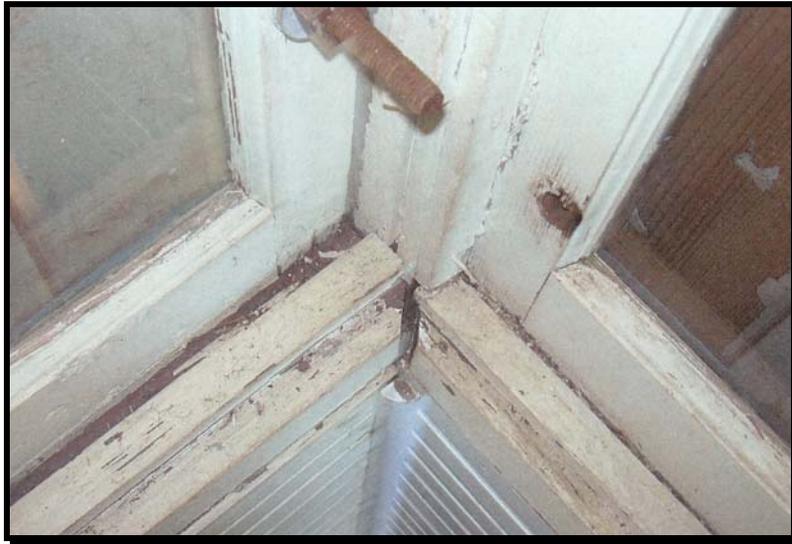
**Figure No. 8: Interior corners also show signs of the frame distortion.**
