National Park Service  
U.S. Department of the Interior

Organ Pipe Cactus  
National Monument

**Emergency Actions to Stabilize Quitobaquito Pond,  
and Related Activities**  
**Final Project Report and Revised Biological Assessment**  
**ESA Emergency Consultation #22410-2008-FE-0273**  
**July 2008**

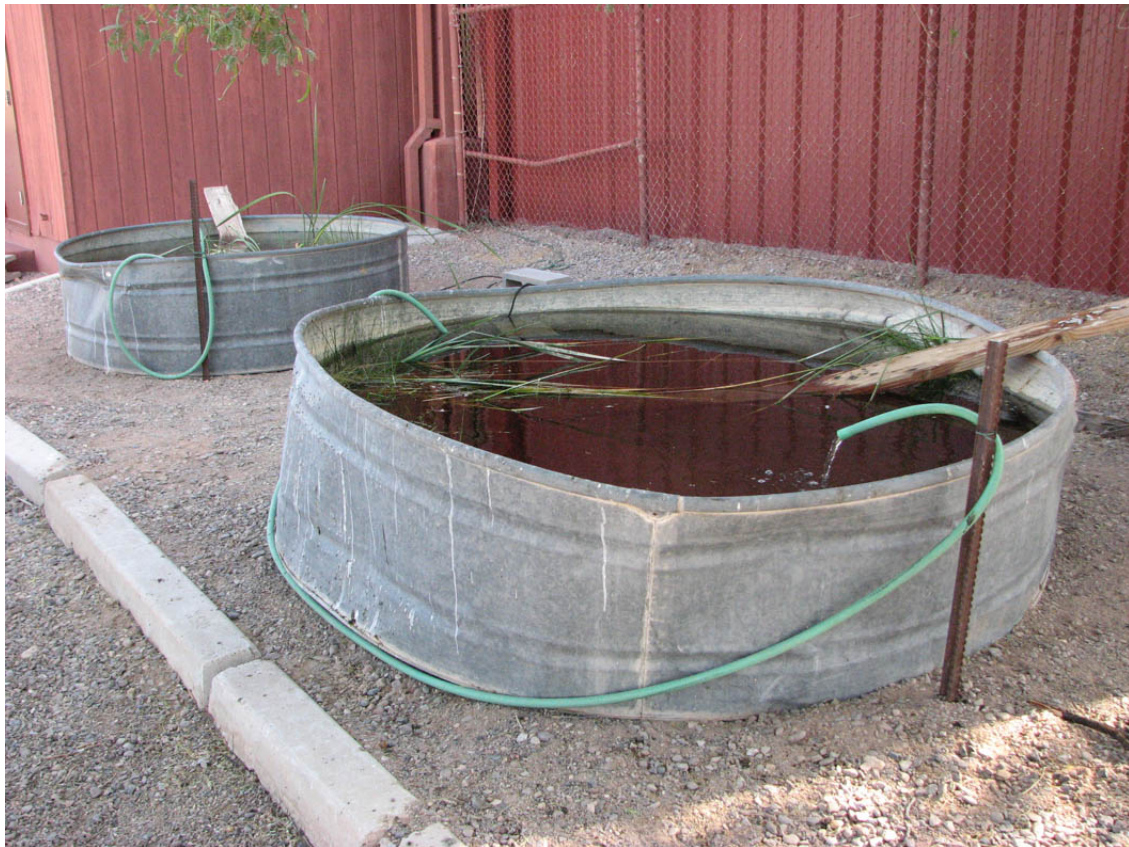
Figure 16. Temporary holding tanks for Quitobaquito pupfish in headquarters area. May 2008. Organ Pipe Cactus National Monument, Arizona.

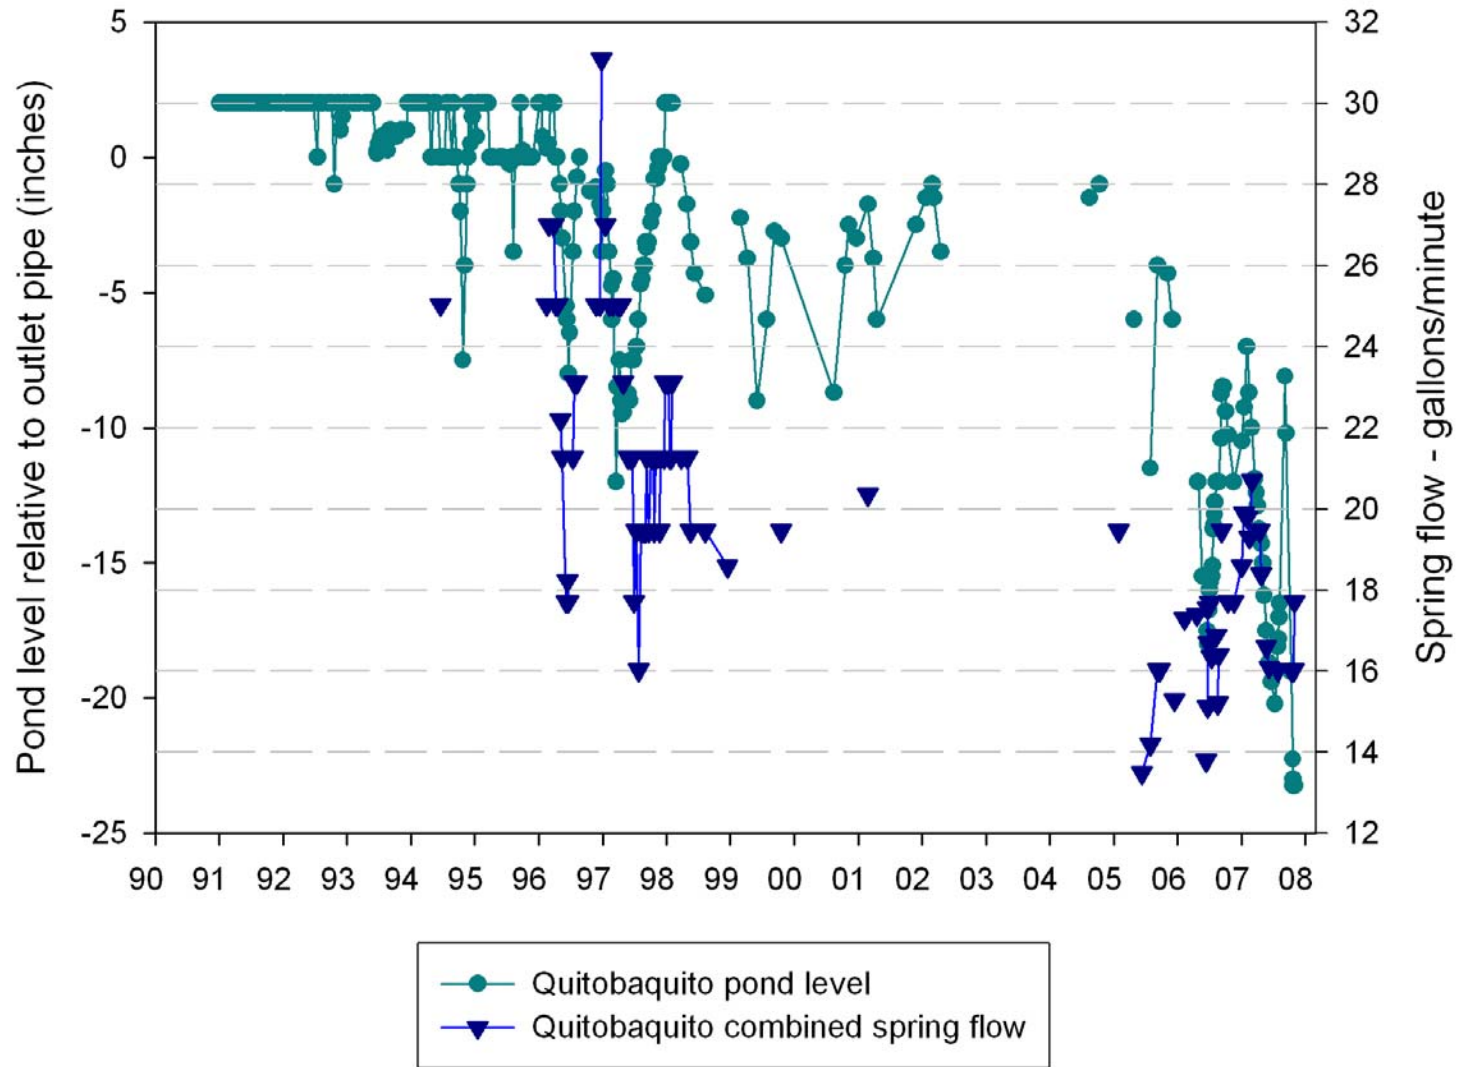
24,500 gal/day (net daily loss) - 10,558 gal/day (estimated transpiration) =  
13,942 gal/day Unknown Loss = 581 gal/hr = 9.61 gpm

Quitobaquito Pond Level and Spring Flow, 1991-2007
