PECOS NATIONAL HISTORICAL PARK  
KOZLOWSKI'S TRADING POST RESTORATION PROJECT

EAST WING MILLWORK RESTORATION  
COMPLETION REPORT

Prepared for  
Pecos National Historical Park  
March 2011

by  
School of Engineering, University of Vermont

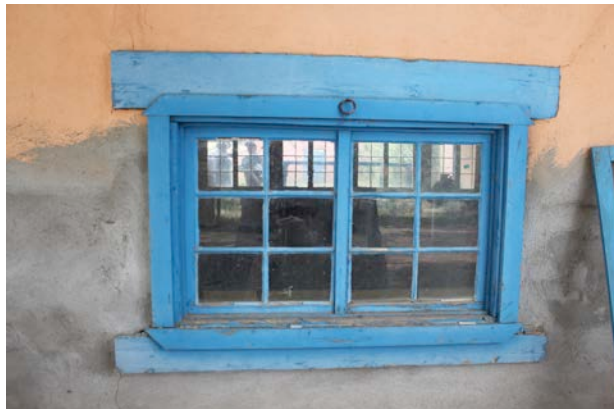
Exterior before treatment

This window is constructed of two factory made wooden sashes, probably intended for a double hung window, set side by side to give the appearance of a paired casement window. Sash features an ogee profile in 1 1/8" stock (Profile B), which only appears in one other unit, S1W2. Sashes are installed directly in rough buck and the opening has no lintel above the buck. A piece of molding has been applied where the sashes meet to give the appearance of an astragal. The window is inoperable; no hinges or other hardware to facilitate opening.

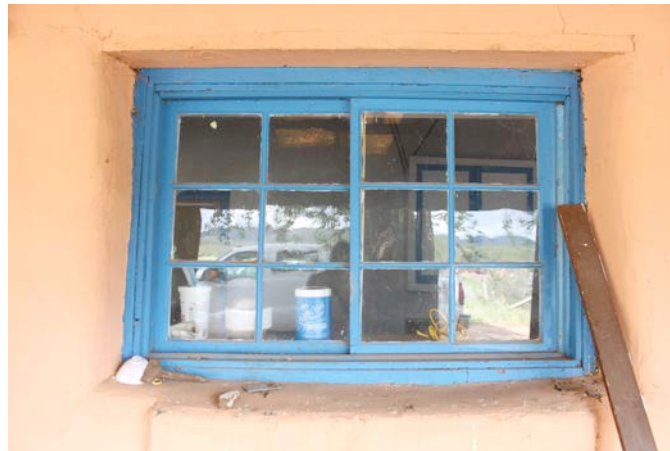
Exterior before treatment

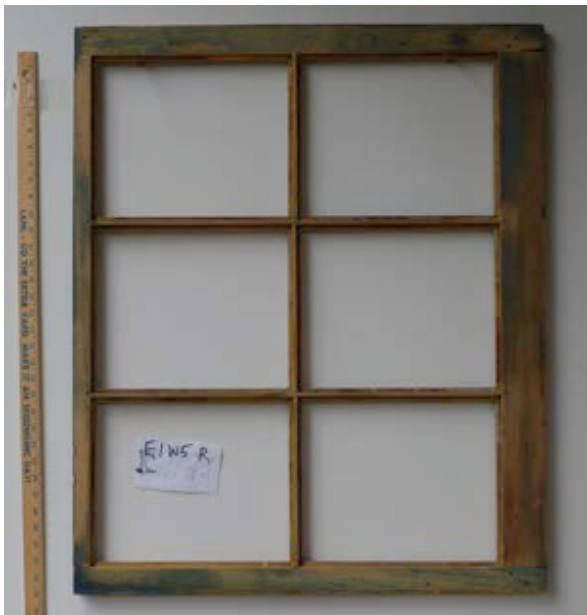
Right sash prior to treatment

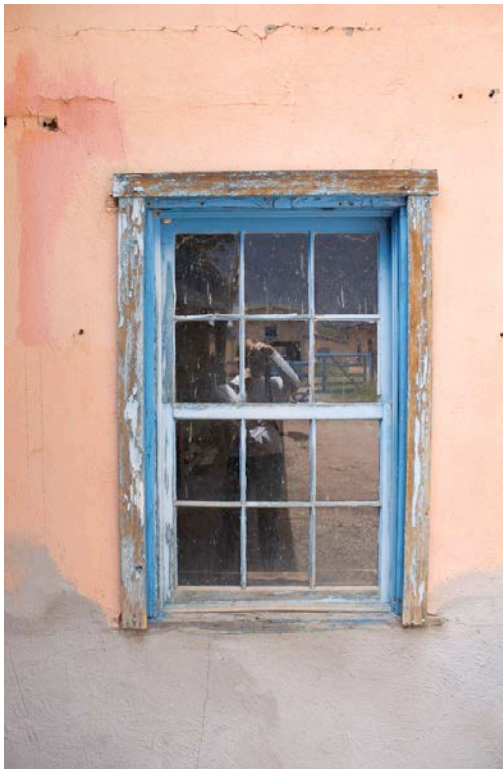
- Sill swollen and bowed and cracked at the center

Exterior before treatment

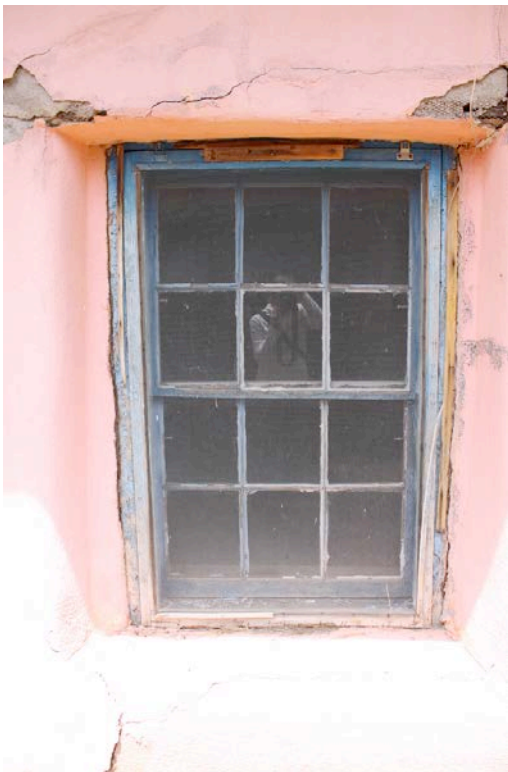
- Weathered exterior
- Missing an ornamental brace in the upper corner of the door
- Screen stop has been replaced and is mismatched

Exterior before treatment

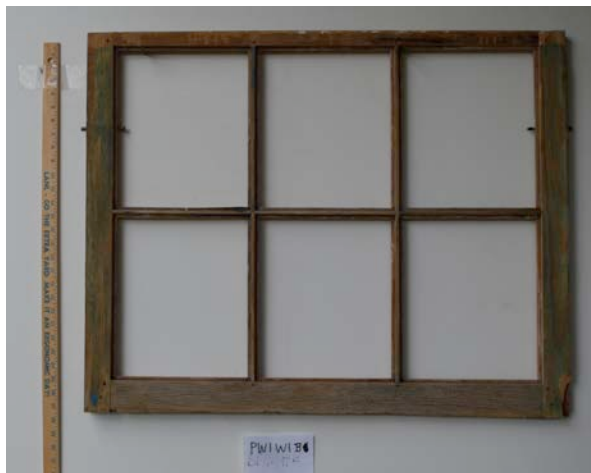
Lower sash prior to treatment

- Dutchman to meeting rail at bottom of vertical muntin #2
- Dutchman around pin holes at bottoms of both stiles on exterior face
- Repaired tenon at left end of meeting rail

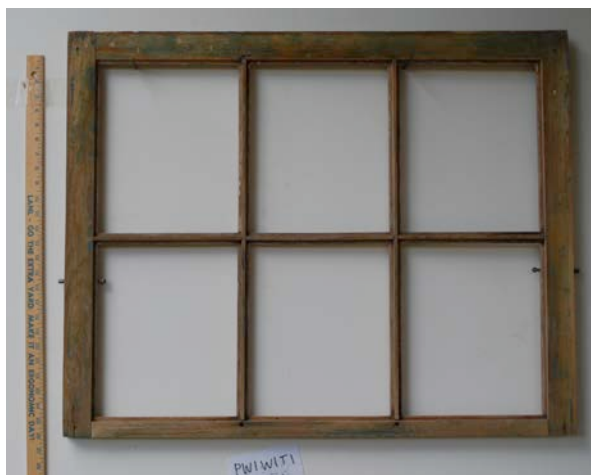
Upper sash prior to treatment

- 4" dutchman at bottom of exterior face, left stile

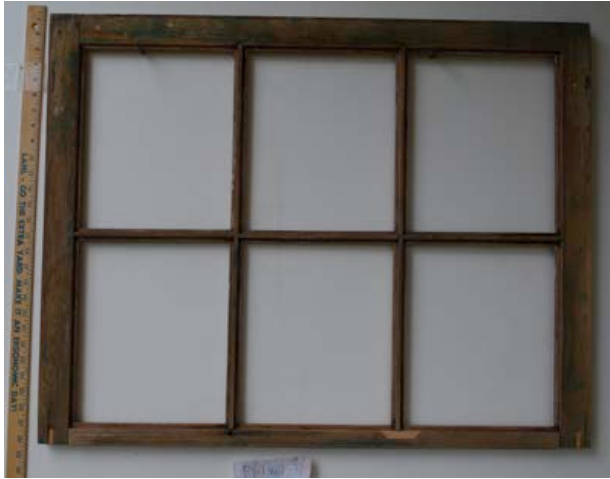
Upper sash after treatment

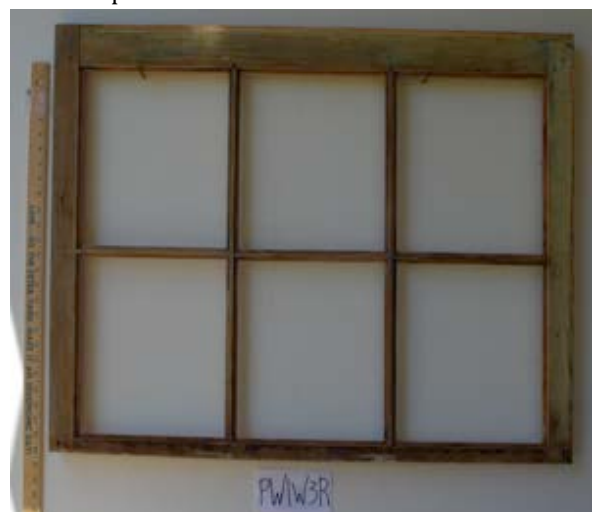
Right sash prior to treatment

- 1" additional material laminated to bottom stile
- Dutchman to left rail at junction with horiz. Muntin #1
- Dutchman to meeting rail at junction with horiz. Muntin #2

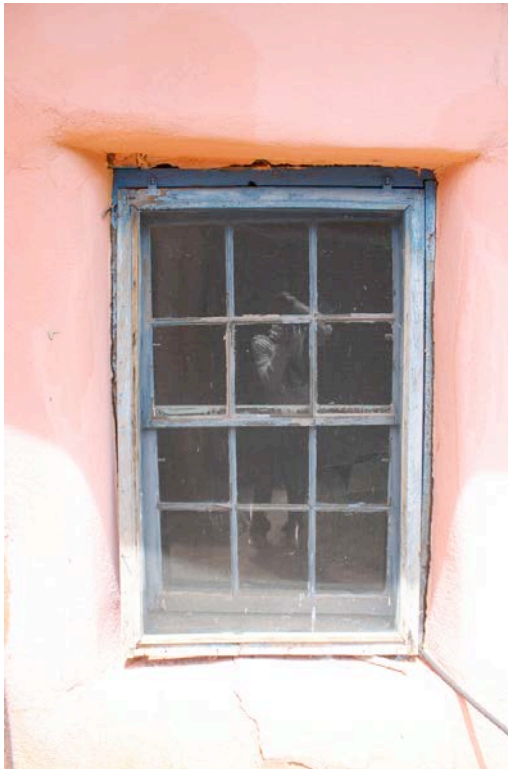
- Upper sash bottom rail weathered
- Gaps at joints from wood drying
- Gap between jamb and sash at top of the window that has been filled with paper
- Broken stop molding

- Very weathered and warped
- Some molding missing
- Hardware intact

Exterior before treatment

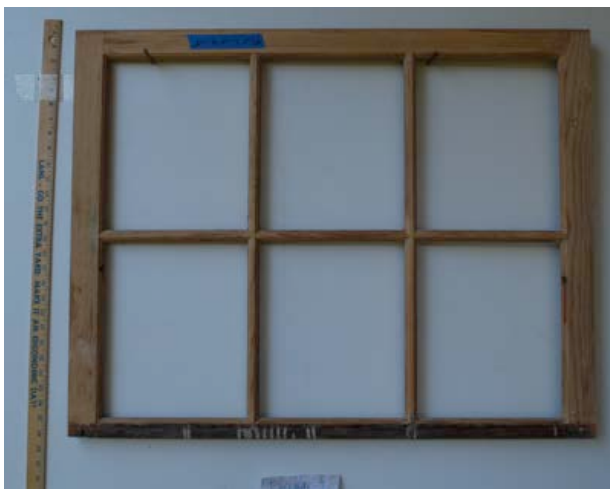
Upper sash after treatment

- Dutchman to upper corner of right stile, exterior face
- Dutchman to meeting rail at both vertical muntin junctions
- Metal pins replaced with wooden dowels, upper corners only

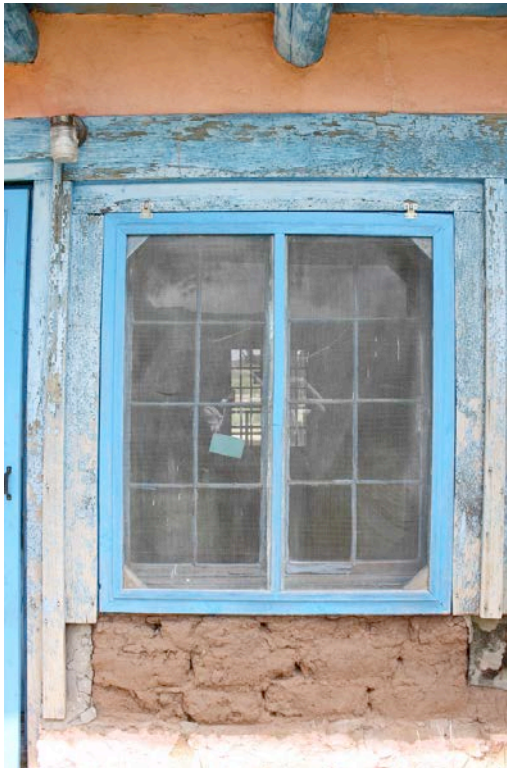
- Astragal broken
- Swing-side bottom rail severely weathered
- Gaps at lower joints from wood drying and shrinking
- Window puttied closed Glued shut Bottom rail of fixed sash visibly broken
- Visible gaps at joints from wood shrinkage

Exterior prior to treatment

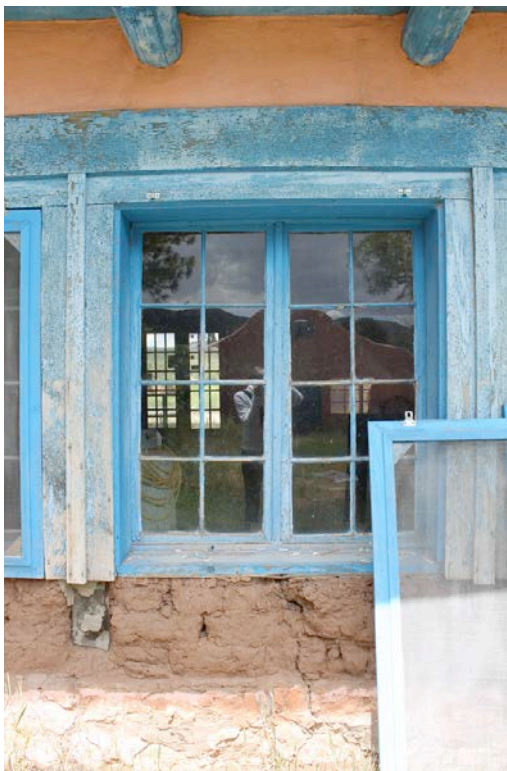
Exterior prior to treatment

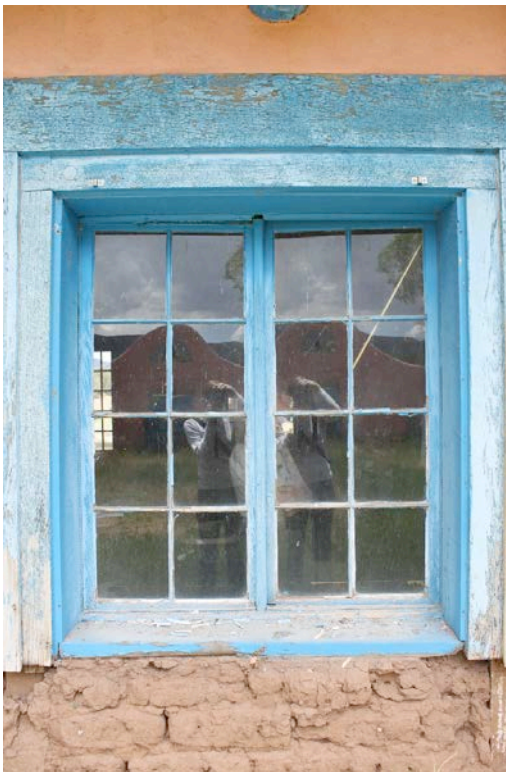
- Operable
- Severe weathering 3/4 of the way up the window
- Joints in the lower 3/4 of the sashes are very loose
- Swing-side sash bottom rail broken near operable edge
- Window does not close entirely
- Material added to top of swing-side sash
- Some muntins in swing-side sash bowed and out of alignment

Exterior before treatment

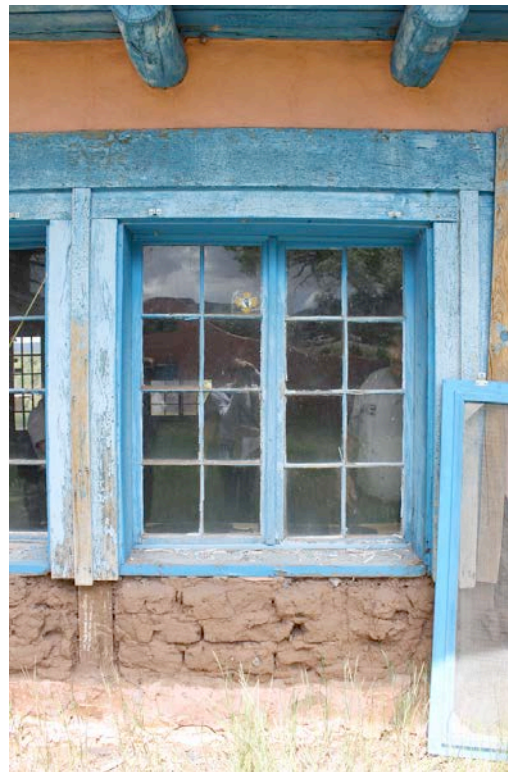
- Severe weathering 3/4 of the way up exterior fascia
- Swinging bottom rail broken from joint at center edge
- Material added to top rail of swinging sash
- Bottom rail of swinging sash cut down to fit jamb causing a broken joint and bowing in the second and third horizontal muntins
- Window inoperable, caulked closed
- Top rail of swinging sash cracked at joint
- Bottom rail of fixed sash broken

Exterior before treatment

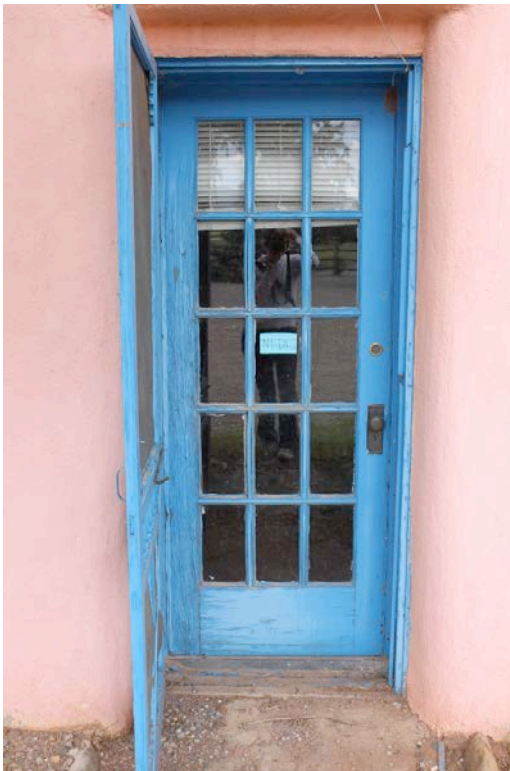
- Threshold is partially missing and rotted

- Weathered exterior
- Missing an ornamental brace in the upper corner of the door
- Screen stop has been replaced and is mismatched

- Strip, sand, and re-glaze
- New jamb and threshold fabricated

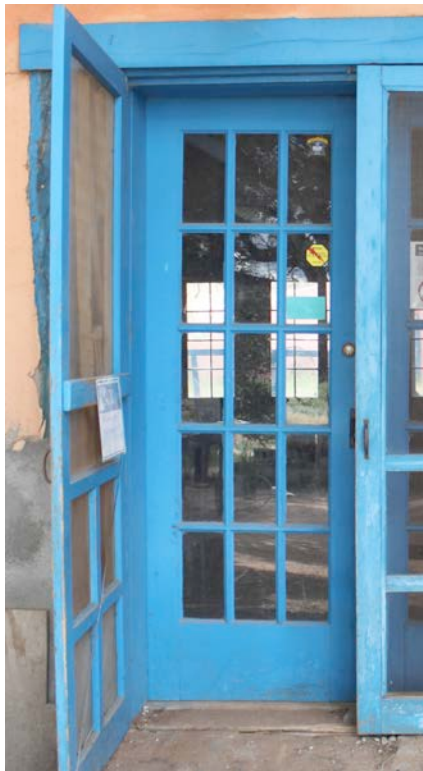
- Threshold is partially missing and rotted

- Chunk missing from top rail on the inside
  - Bottom most exterior molding missing
  - Bottom stiles show moderate signs of decay
- Partial piece of exterior threshold molding remains

- Deadbolt has been replaced

TREATMENT: Replacement units (doors and jambs) were fabricated for units E1D1-3

E1D1 is now a fixed sidelight. Dimensions: 78 ½" x 26 ½"

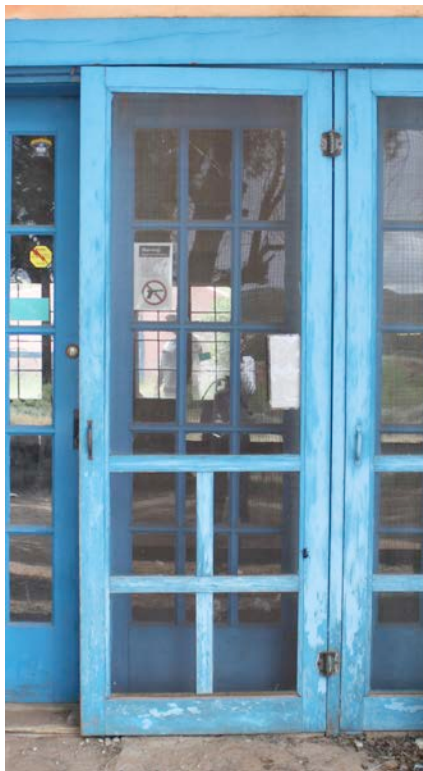
- Some damage near strike plate
- Newer lock applied
- Astragal cracked 24" up from bottom
- Portion missing from top of lock stile

- Threshold is partially missing and rotted

- Bottom exterior molding missing
- Bottom of both stiles show signs of decay

- Deadbolt has been replaced

TREATMENT: Replacement units (doors and jambs) were fabricated for units E1D1-3  
New door dimensions: 78 ½" x 36"

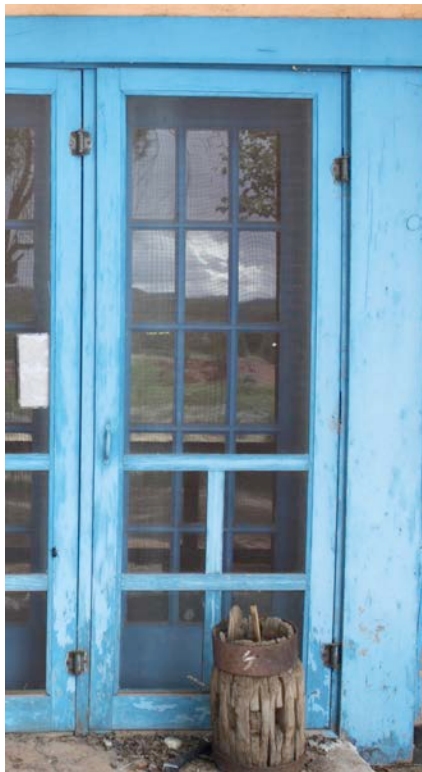
- Chunk missing from lock stile

- Threshold is partially missing and rotted

- Plywood panel added to bottom section of door
- Inner stile has big gouge at bottom
- Casing along out edge of jamb missing

TREATMENT: Replacement units (doors and jambs) were fabricated for units E1D1-3  
E1D1 is now a fixed sidelight. Dimensions: 78 ½" x 26 ½"

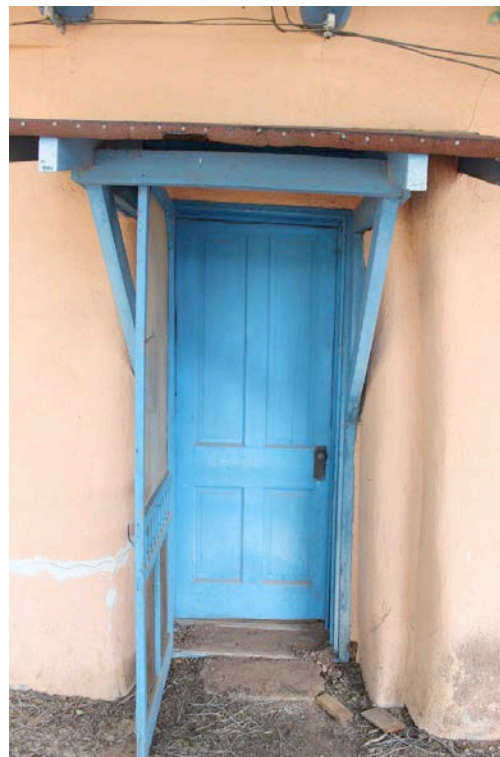
- Top rail cut at an angle to accommodate jamb
- Upper panel on handle side cracked
- Lock stile damaged by hammer
- Gaps at top and bottom handle side joints
- Stop molding cracked
- Gouged above lock on interior handle side stile

- Casing cut to accommodate crooked jamb
- Hinge side of jamb cracked
- Threshold decayed
- Hinge side stile has a big gouge at chest level

- Top rail cut at angle to accommodate jamb
- Bottom rail shows signs of decay
- Bottom of both stiles show signs of decay
- Stop molding damaged near bottom of jamb

- Replaced lock stile
- Extended hinge stile
- Replaced top rail
- Repaired upper south panel
- New jamb and threshold fabricated

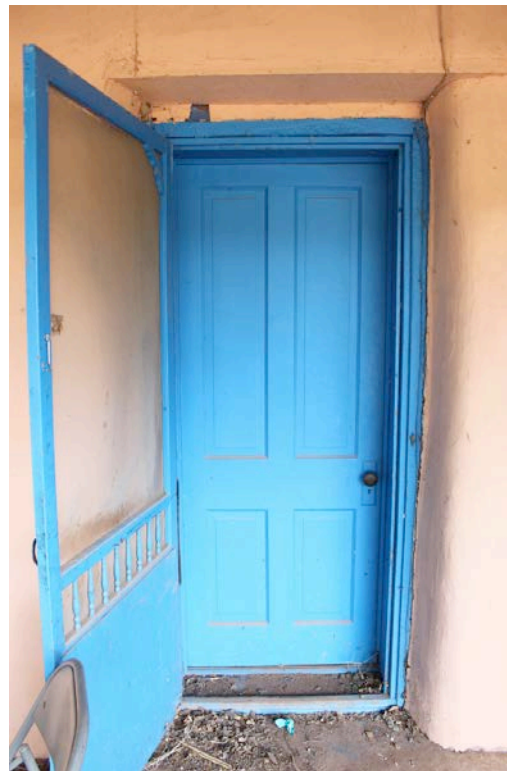
- Threshold is partially missing and rotted

- Weathered exterior
- Missing an ornamental brace in the upper corner of the door
- Screen stop has been replaced and is mismatched

- Deadbolt has been replaced

- Strip, sand
- New buck,jamb and threshold fabricated
