**552-554 BROADWAY**  
New York, New York

# Preservation Tech Notes

## **HISTORIC GLASS** NUMBER 2

### **Repair and Rehabilitation of Historic Sidewalk Vault Lights**

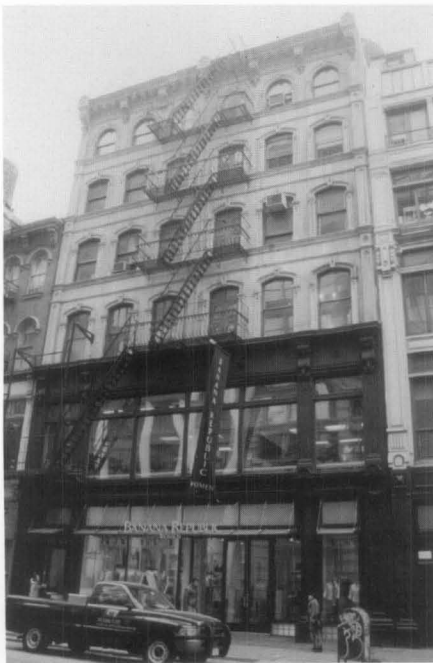
Figure 1. A cast-iron storefront was added to 552-554 Broadway in 1897. The storefront included a fifty-four foot long assembly of cast-iron vault lights set in the sidewalk. Glass lenses in the panels allowed light to enter the basement area, increasing rentable space for the building owner.

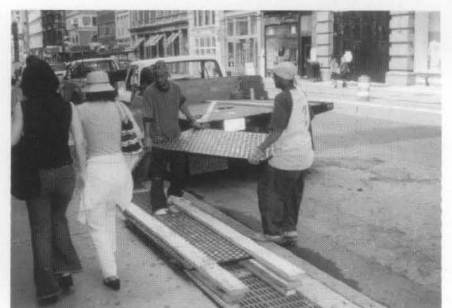
Figure 11. Just prior to installation, each panel was lifted by hand from the back of a truck and stacked on the sidewalk.

Following fabrication, the new panels were shipped to the contractor who set the new glass lenses and transported them to New York City for installation alongside the repaired panels (see figure 11).
