## **THE HEXAGON (Ephraim Shay House) Harbor Springs, Michigan**

## **METALS:**

### **NUMBER 3**

## **In-Kind Replacement of Historic Stamped Metal Exterior Siding**

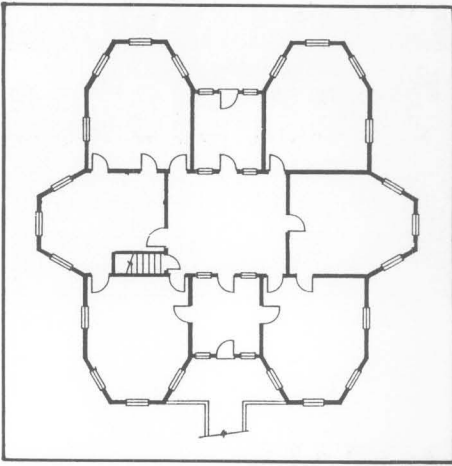
1. Windows in each elevation of the hexagonal wings offer views in every direction from the center of the house. This first floor plan of the Hexagon shows the new, post-rehabilitation uses. Drawing: Jeffrey Pascale, from plans by Richard Hiler.

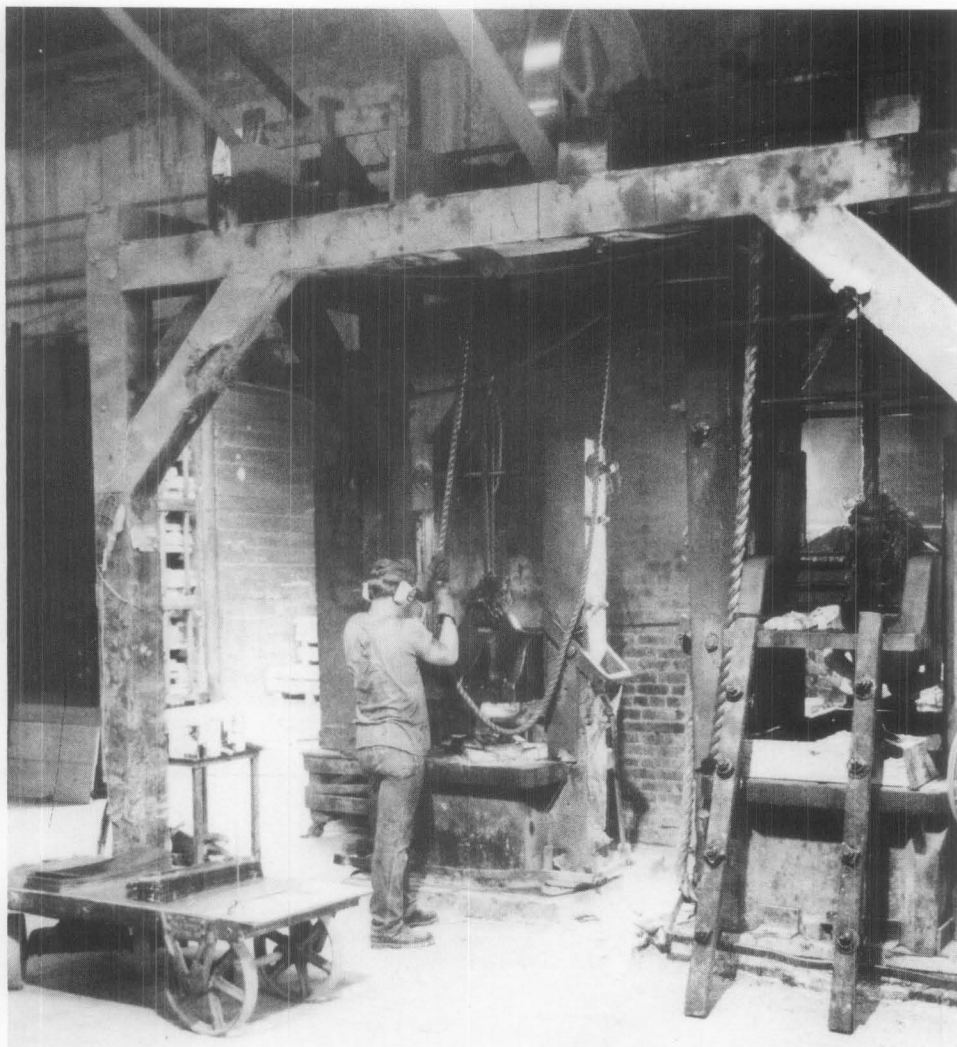
6. The stamped-metal siding was made the traditional way using gravity drop hammers and cast-iron dies. Photo: Lance Carlson.

After being awarded the contract, the sheet metal company proceeded first with making the cast-iron die sets that were needed for four of the five sheet metal patterns used on the exterior of the building. Two different approaches could be used to make the die sets. Where samples of the historic design have survived in relatively good condition, as with the case of the Hexagon, they can be cleaned and repaired to serve as a three-dimensional model for the casting of the dies. Since the cast-iron will shrink in casting as it cools from a liquid to a solid (approximately 3/16" per foot), the new die set will create a pattern that is slightly smaller than the original.

This approach, however, is cheaper than the second alternative: creating a model that is 1-1/2% larger than the original, to compensate for the shrinking that will occur when the casting cools. This method may be necessary where the historic pieces are too deteriorated for use as a model; where the historic pattern is missing altogether; or where a precise match is required (such as when only selective pieces on a wall require replacement). In such cases, a drawing of the design to be replicated is first produced, increasing the dimensions to correct for the eventual shrinkage. Then a three-dimensional model of the drawing is constructed in clay, plaster, or wood. Next a cast-iron mold of the model is produced from which the male-female die set used in the actual stamping process is created.

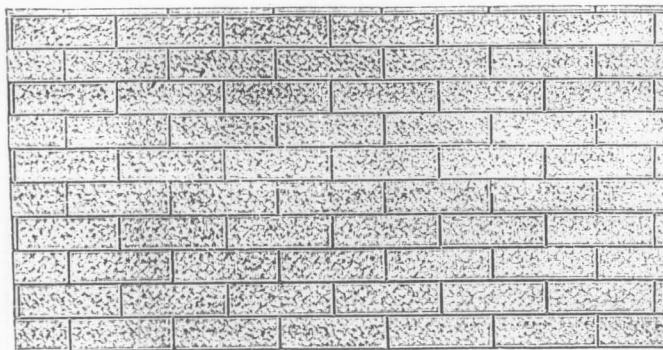
PRESSED STEEL, BRICK SIDING.

Galvanized or Painted.

Each of the stamped designs was reproduced in the same metal used to make the original. The stock brick pattern was stamped into 28-gauge galvanized steel sheets measuring 28" by 60" (see figure 7). Galvanized steel is often used for exterior installations, due to its resistance to corrosion. Moreover, galvanized steel is strong enough to produce very stiff sheets of stamped siding in large sizes that can cover a fairly large area with minimum nailing support.
