## WILSON'S BRIDGE

Chester County,  
Pennsylvania

## Preservation Tech Notes

## Rehabilitating a Historic Truss Bridge Using a Fiber Reinforced Plastic Deck

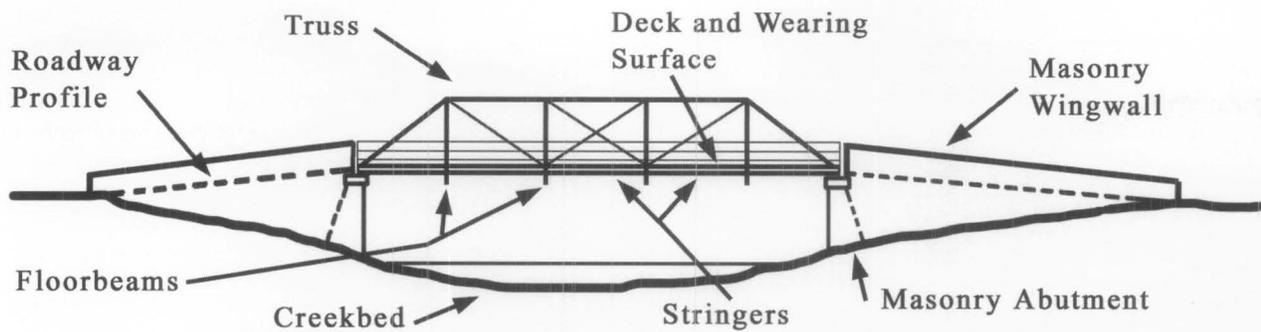
Figure 1. Drawing of Wilson's Bridge showing major structural and site components. Drawing: Chester County Engineering Department.

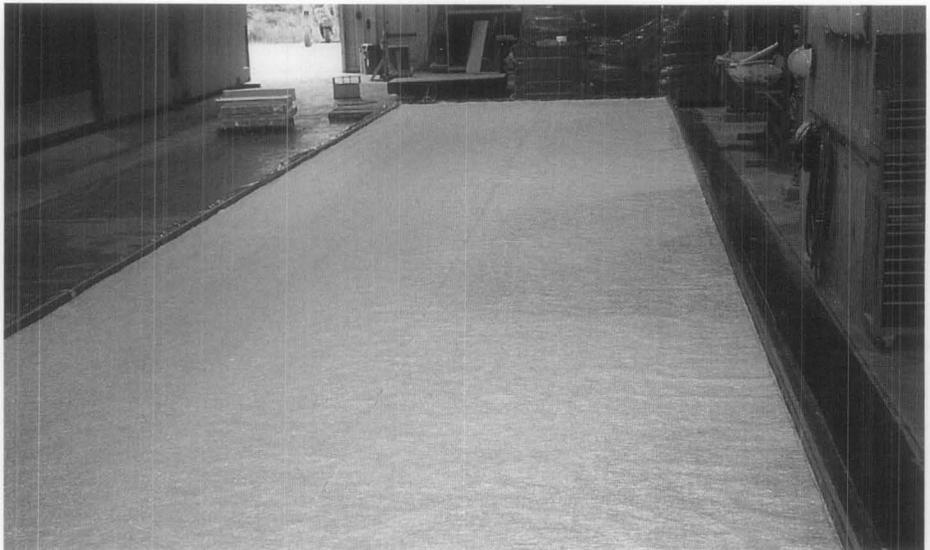
Figure 6. Taken at the composite manufacturer, this photo shows layers of fiberglass arranged around the deck core and placed in the mold. The mold was then infused with a resin that sealed the layers into a one-piece panel. Photo: Hayati Catbas, Hardcore Composites.

The manufacture of the FRP deck was made possible by a number of recent innovations in composite material production. The Wilson's Bridge deck was fabricated using an adaptation of the technique known as vacuum assisted resin transfer molding, or VARTM. In this technology, a plastic honeycomb core is sandwiched between fiber layers in a mold (see figure 6). The mold is sealed and a vacu-

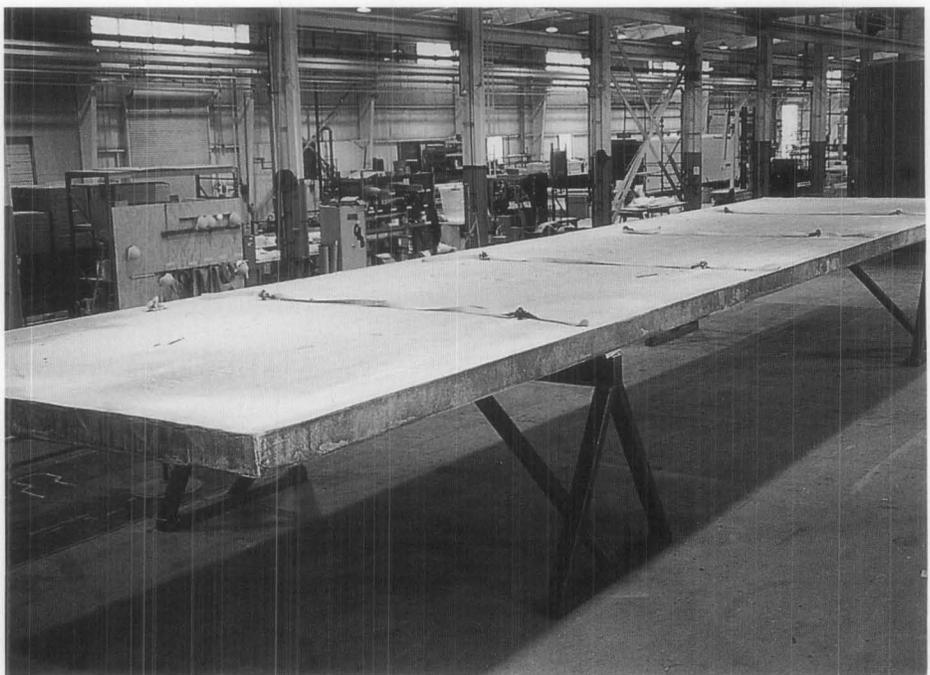
Figure 7. After the panel had set into a solid mass, workers removed it from the mold and sanded and finished all surfaces. The last steps included painting the deck and installing the oak plank wearing surface. Photo: Hayati Catbas, Hardcore Composites.

um removes air while drawing a resin into the mold and through the fiber/core sandwich. It sets into a uniform, seamless panel that is then sanded and finished (see figure 7). Closed vacuum infusion molding processes such as VARTM allow for the creation of three-dimensional structural elements that are extremely light yet durable.

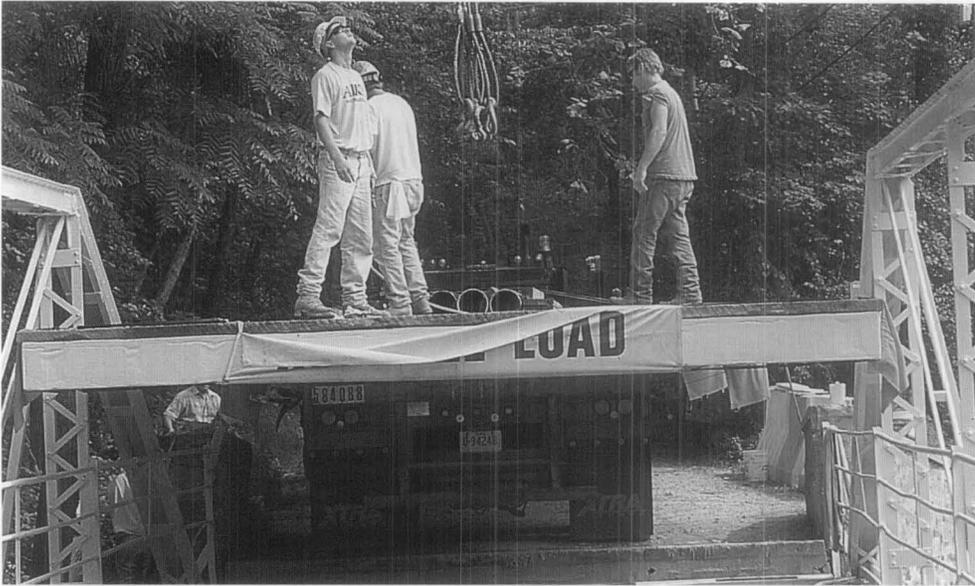
Figure 10. When the deck arrived at the site, the trailer was backed onto the bridge approach and crane cables secured to the deck. Although the road beyond that side of the bridge is a dead end, the truck driver was able to maneuver across a vacant site to get the deck on the opposite side of the creek.

were glued at regular intervals to the top surface of each floor beam (see figure 9). A twenty-ton crane then lifted the deck off the trailer bed and, with guidance from the workers, slowly lowered it into position (see figures 10 and 11). Lag bolts with steel clips were inserted into predrilled holes along the underside of the deck, securing the deck to each of the floor beams (see figure 12).

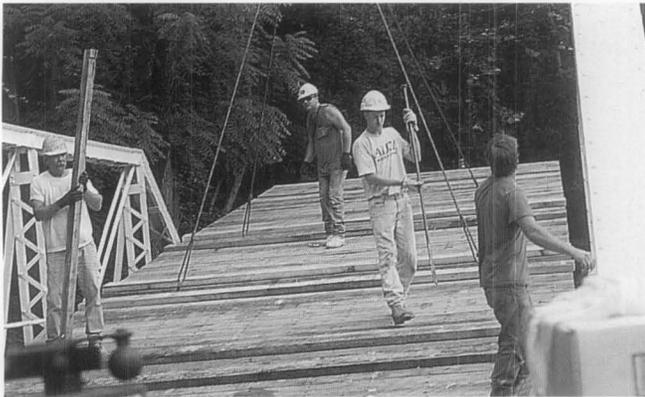
Figure 11. As the deck was lifted off the trailer and onto the floor beams, workers wedged timbers and bars along the sides to prevent the deck from damaging the truss and to help place the deck in position.

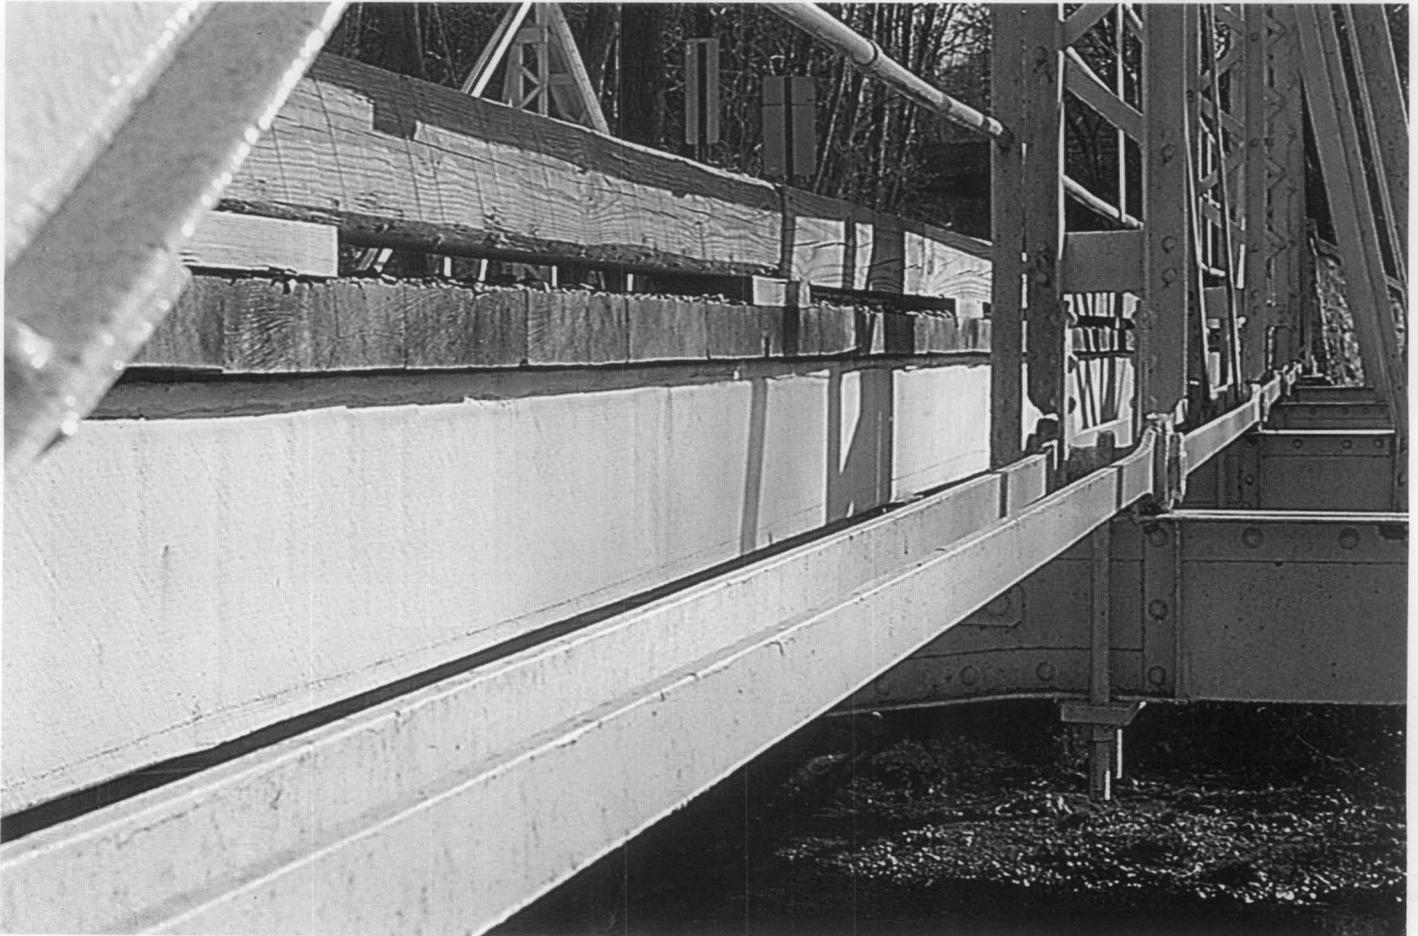
Figure 14. The composite deck, painted to match the superstructure, is visually compatible with the historic bridge as it originally appeared with timber stringers. The new deck and wearing surface are the same thickness as the previous system of steel stringers, nail-laminated deck, and bituminous surface. Photo: Chad Randl.

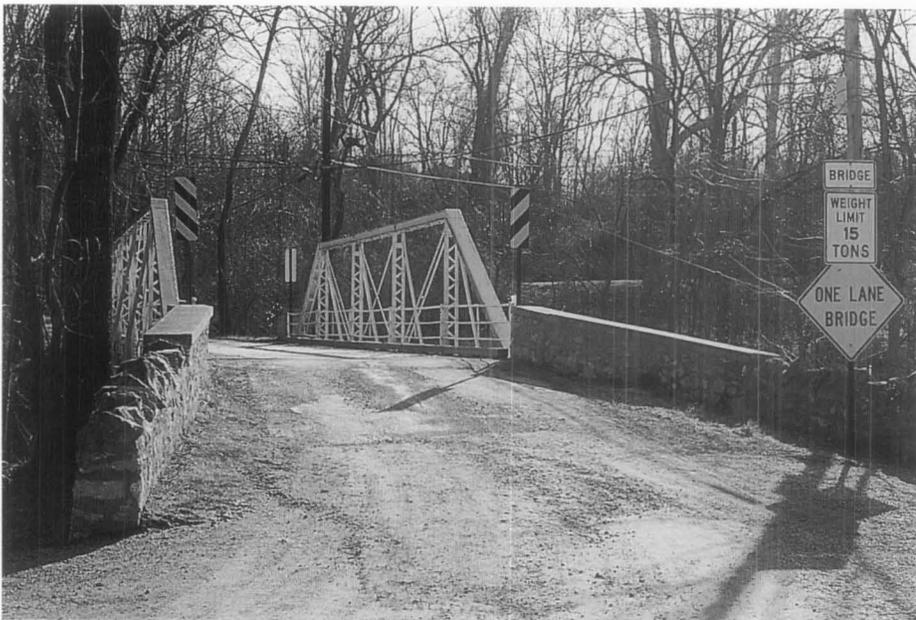
Figure 15. The landscape surrounding Wilson's Bridge has changed little since the span was constructed in the 1800s. The use of a composite deck and plank wearing surface in place of the deteriorated, fourth generation deck was an innovative solution that allowed the bridge to remain in place and in use with little change to its historic character. Photo: Chad Randl.
