ALDRIDGE HOTEL Shawnee, Oklahoma

Preservation Tech Notes

METALS NUMBER 6

Repair and Reproduction of Metal Canopies and Marquees with Glass Pendants

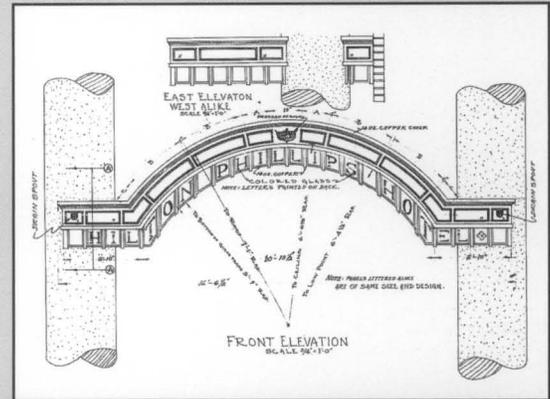
Figure 4. Original drawing for the main south entrance canopy for the Hilton Philips Hotel, later named the Aldridge Hotel. Note the lettering along the front glass panes. Drawing: Courtesy of the Hill Firm.

To install the new panes, a bead of clear silicone sealant was applied in the top and bottom of the metal frame, helping to secure the glass and prevent it from rattling in heavy winds. The glass was then slid into the top receiver and set into the bottom. The side tabs located on the back of the pendant frame were folded over to secure the glass. Since the original drawings showed the building's name painted on the back of the glass panes, this signage was recreated with the current name, the Aldridge Hotel (see figure 4).

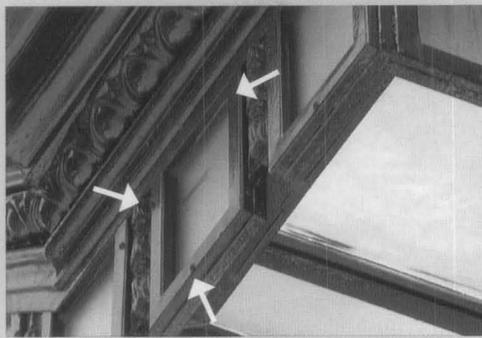
With the simple double-faced pendant frames on the left, the front and back faces are screwed directly to each other as indicated by arrows. The pendants on the right are single faced with the glass held in place by putty. Each pendant is secured to the top of the canopy and to adjacent pendants. Screw connections are indicated by arrows.
