WORTHINGTON HOUSE Monocacy National Battlefield Frederick County, Maryland

WINDOWS NUMBER 10

Temporary Window Vents in Unoccupied Historic Buildings

PTN-11

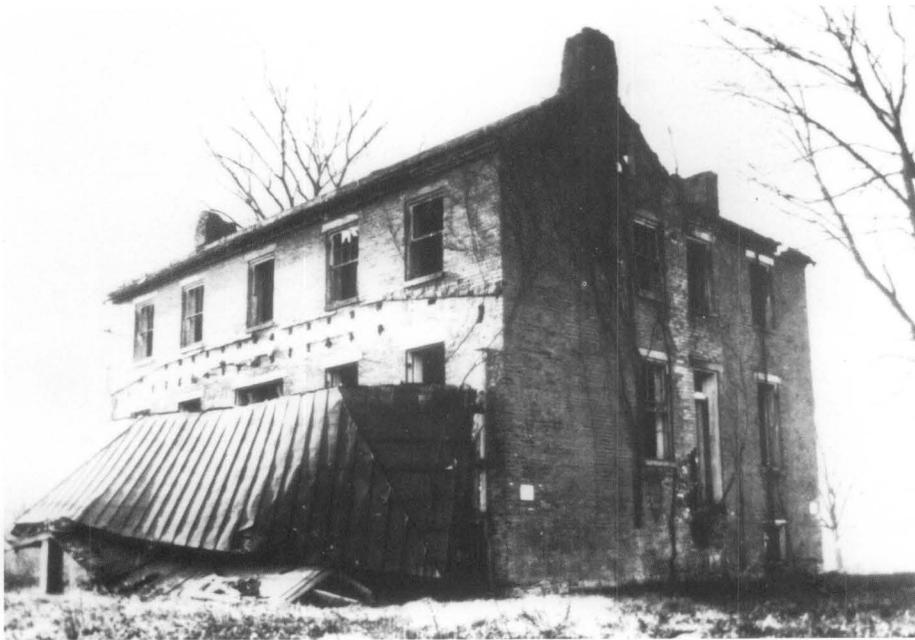
Figure 1. Full louvered vents were installed in all single-sash openings in the basement because of the more severe moisture problems present in that location. Photo: Charles Fisher
