Tech Notes

NUMBER 15

Interior Storms for Steel Casement Windows

THE DRAKE HOTEL (DRAKE TOWER) Philadelphia, Pennsylvania

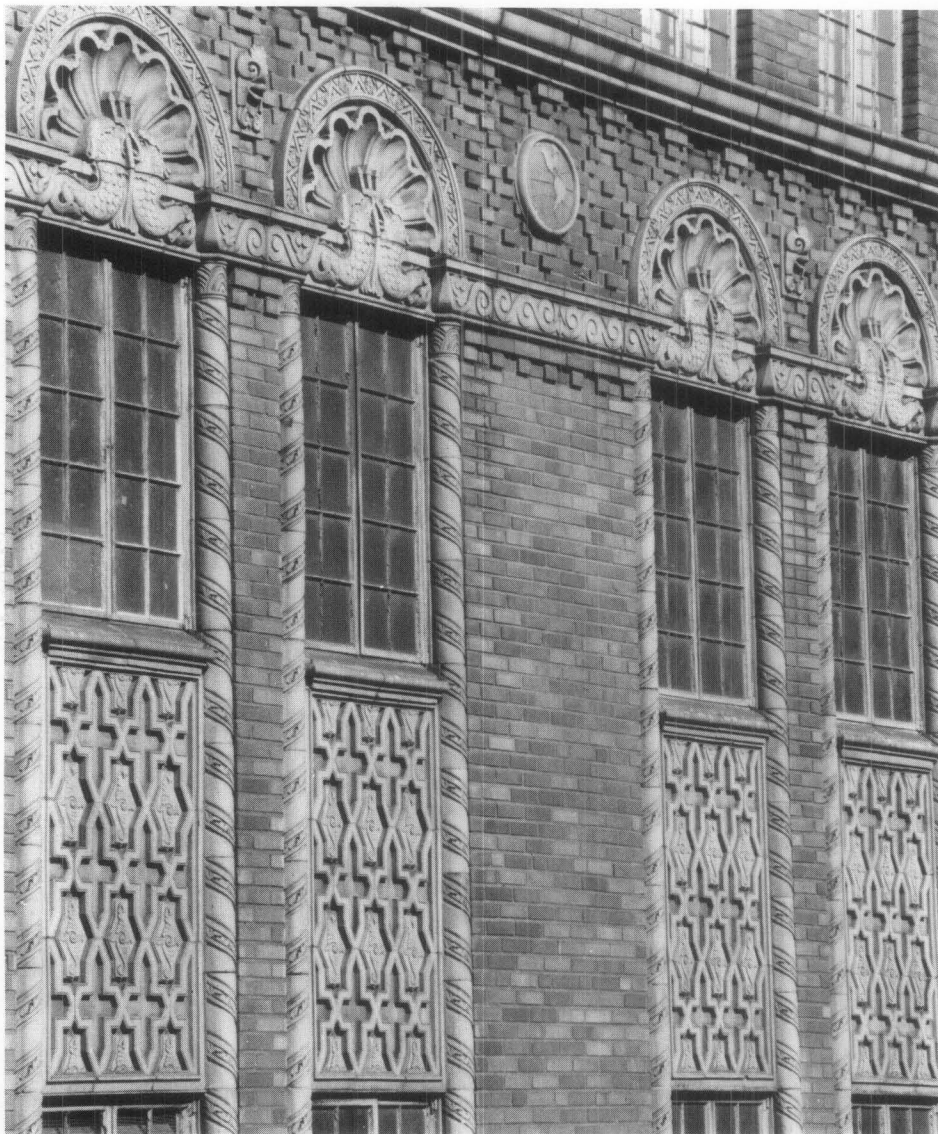
The Drake Tower, as it is known today, has over 1600 steel casement windows, richly adorned with terra cotta detail on the lower and uppermost floors (see figure 1). In between, the wall is simply detailed, characterized by the expanse of masonry and the organization and appearance of the steel casement windows with their multi-pane configuration and vertical meeting line. During the recent renovation, the steel casement windows were maintained and their energy performance enhanced inexpensively through addition of interior storm windows.

Figure 1. The steel casement windows on the lower and uppermost floors were richly adorned with terra cotta detail. Photo: Mort Bond/National Register Collection.
