Tech Notes

WINDOWS NUMBER 17

Repair and Retrofitting Industrial Steel Windows

LIPPINCOTT PRESS BUILDING Philadelphia, Pennsylvania

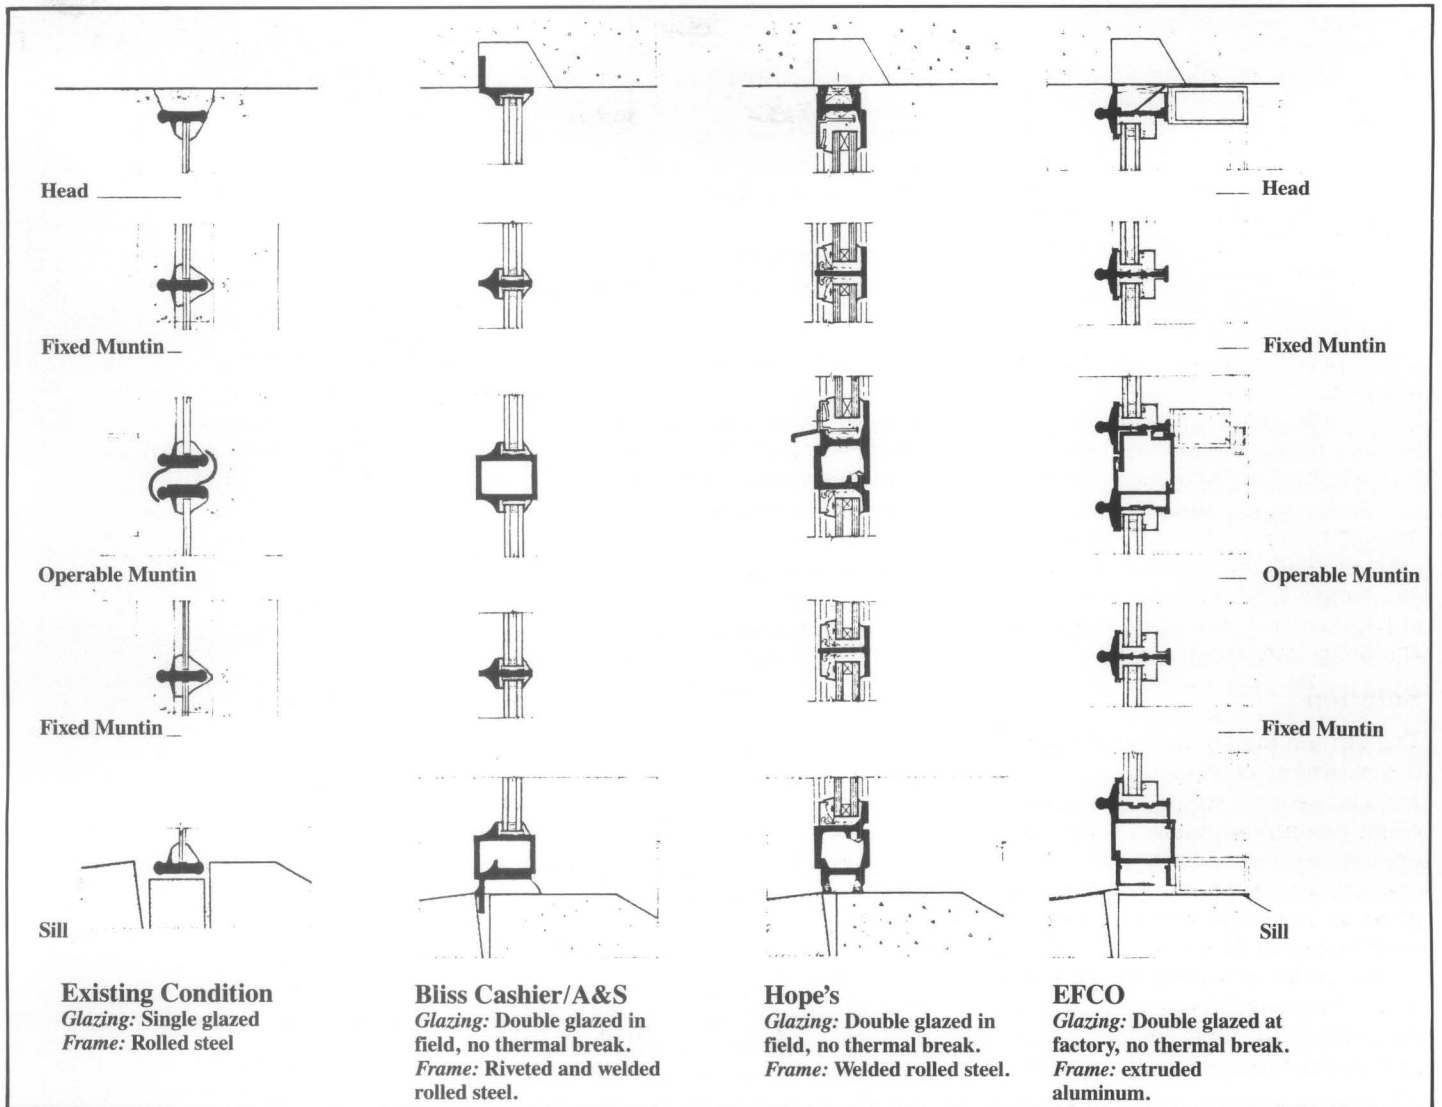
Figure 3. Comparative window sections showing the existing steel window on the left and the three thermally glazed replacement proposals on the right. Drawing: H2L2 Architects.

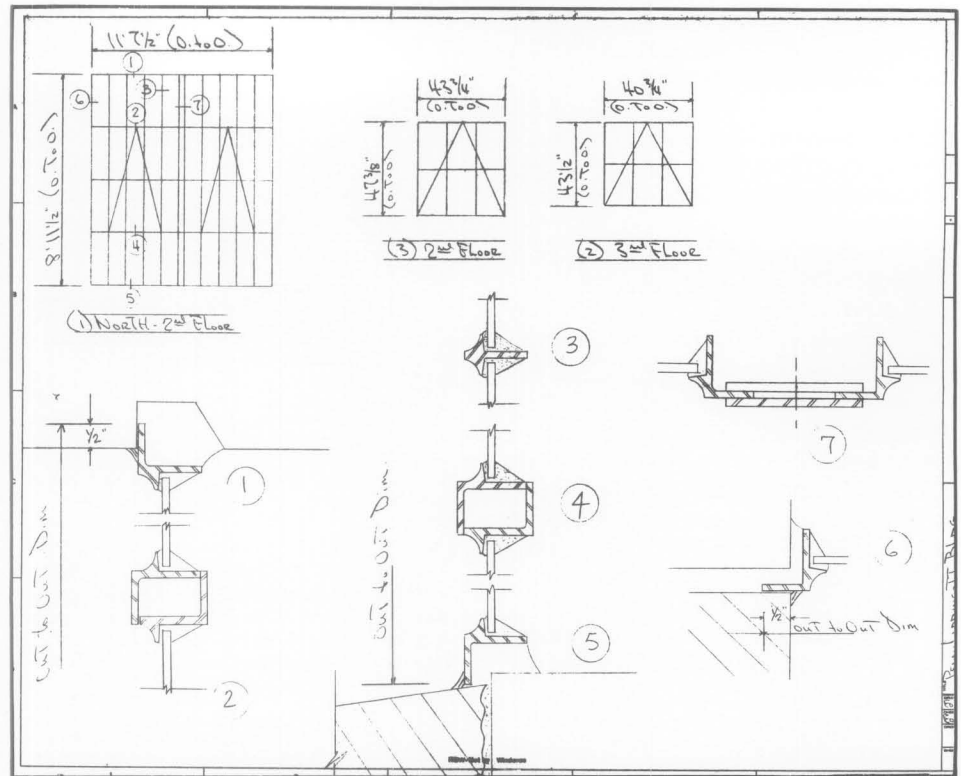
Figure 9. Sectional drawings of replacement window manufactured by A & S Window. Drawing: Winderco, Inc.

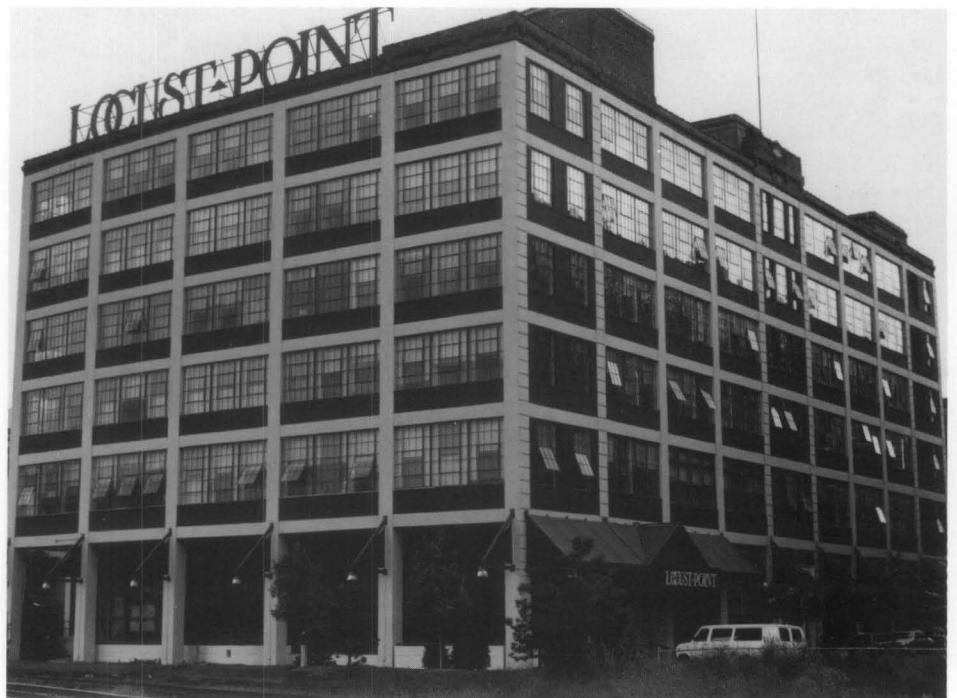
Figure 13. Lippincott Press Building (now Locust Point) after repair of the multi-light steel windows. Photo: Robert Powers.

and supervising the workers. For optimum paint performance and long-term maintenance, the repaired steel windows should have been sandblasted to fully remove the remaining paint and rust and to ensure a long-lasting bond between the steel and the new coats of paint. The additional cost would undoubtedly be justified by the more effective paint finish. Finally, although the storm window installed met the energy and overall visibility criteria established for the project, alternative schemes could have been developed that more closely reflected the operational and structural design of the historic steel window.
