# Preservation Tech Notes

## WINDOWS NUMBER 22

### Maintenance and Repair of Historic Aluminum Windows

**Kaaren R. Staveteig**  
Technical Preservation Services  
National Park Service

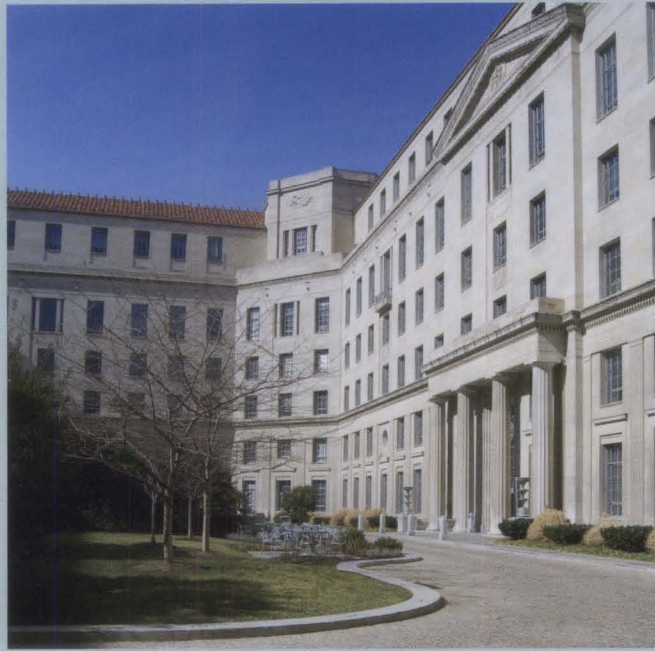
*Figure a. In the primary courtyard within the U.S. Department of Justice Building, the aluminum windows emulate the appearance of steel windows with true divided lights. Depending on the floor level and location, the windows differ in size and consist of a varying combination of fixed lights, casements, and a hopper-style unit.*

A window survey was first undertaken to record the condition of each window and to inventory the hardware, fasteners, and missing frame pieces. Although the windows retained a high degree of historic integrity, some changes had been made over the years. To allow for the installation of ventilation louvers or window-mounted air conditioning units, over 400 of the hoppers below the casements had either been removed or had been rendered inoperable and the wide vertical muntin removed. Although the historic windows were not designed for weatherstripping, some of the windows had been retrofitted with weatherstripping to reduce air infiltration as a result of worn hardware or deflections in the operable units. At various times, caulk had been applied to set in replacement glass or to fill in unwanted gaps. Areas of surface deterioration were also evident including discoloration and varying degrees of corrosion and pitting.

The renovation plan called for cleaning the aluminum window parts, replacing the existing glass and any missing or damaged parts, and making the historic windows fully operable again. Mock-ups of all phases of the work were required early on to establish the work standard to which the finished job would be held. It was anticipated that most of the work could be done in place, with work on the interior and exterior portions of each window done simultaneously.

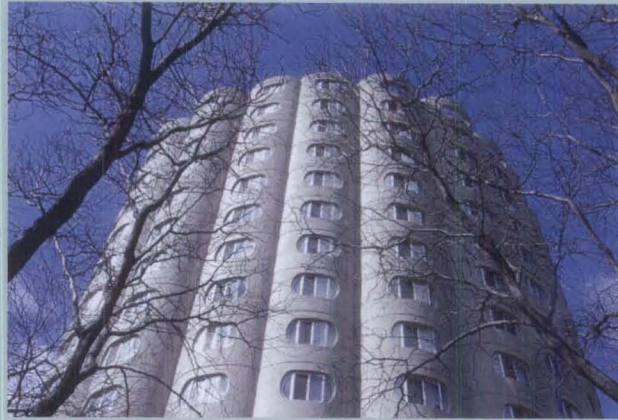
*Figure a. One of two identical 16-story senior citizen apartment buildings within the Raymond M. Hilliard Center, each with 182 apartment units. The window openings are elliptical in shape and center on each reeded bay. (Photo: Holsten Real Estate Development Corp.)*

The decision was made to save the historic windows for the first four floors of the towers, since they would be most visible from the ground. Units on the first four floors in bad condition were to be replaced by windows in better condition relocated from above floors. Matching aluminum replacement windows were to be installed on the upper floors.

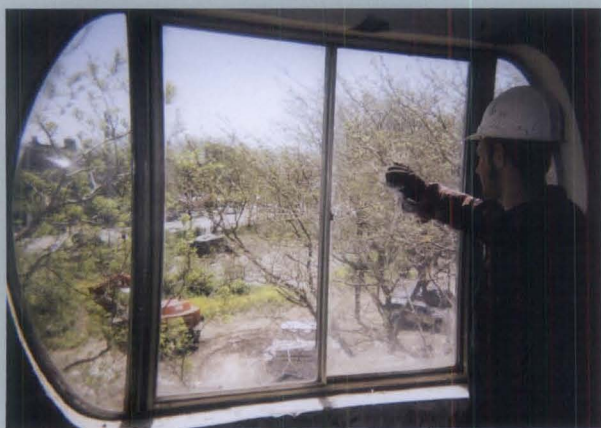
*Figure f. Repair and replacement work was done from the inside to lessen the risk of damage to the outside finish. (Photo: Holsten Real Estate Development Corp.)*
