Tech Notes

OLD WATKINS NATIONAL BANK

WINDOWS

Interior Metal Storm Windows

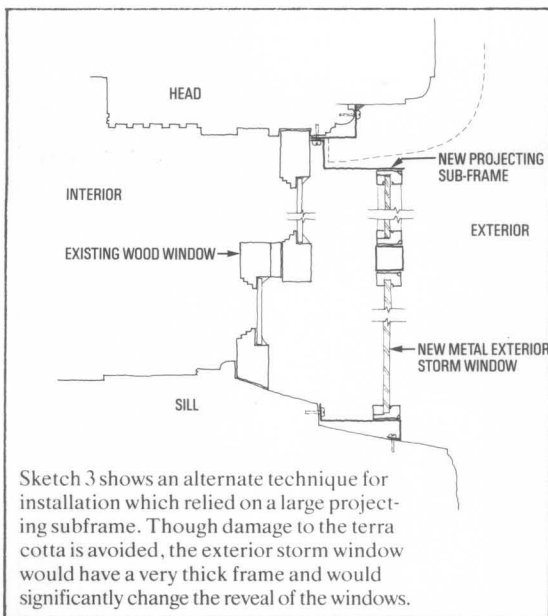
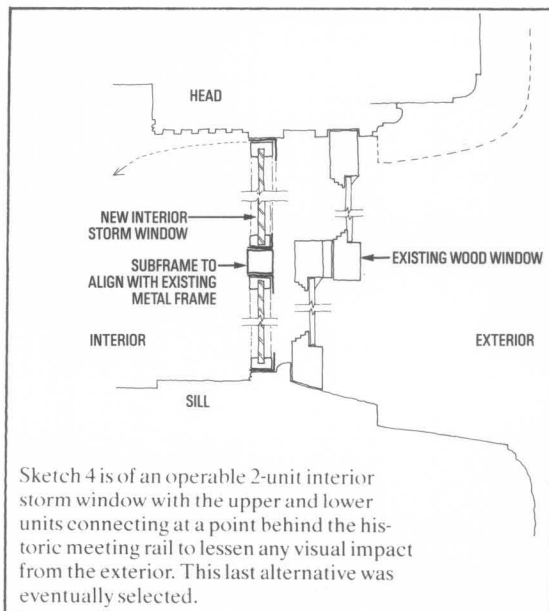
Use of exterior storm windows was initially explored both for energy conservation purposes and as a way to extend the useful life of the original windows (*see figure 2*). Unfortunately, the prices quoted for exterior storm windows by local contractors were around \$65,000, nearly double the budgeted amount. In addition to the high cost of exterior storm windows, one further problem with an exterior storm application arose when it was discovered that the decorative terra cotta capitals adjacent to the upper level window openings returned against the original frames. As a result, the proposed exterior storm windows could not be easily installed in these locations without cutting back or covering portions of the terra cotta (*see figure 3*).

Figure 3. Exterior storm windows were initially considered but presented several problems. The terra cotta capitals on the pilasters returned against the windows, making normal installation difficult without damaging the terra cotta. Many of the windows also had round heads which would require additional custom work—these same windows on the interior had square tops. Photo: Charles E. Fisher
