Darrah Hall

Historic Structure Report

Reconstruction Era National Historical Park

Beaufort, South Carolina

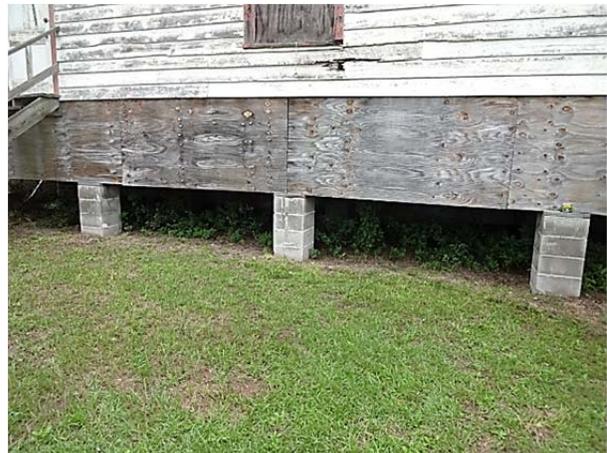
Foundation. Darrah Hall sits on a series of masonry piers (Figure 29). There are thirty-five piers supporting the building, with seven rows of five running north-south. The piers are typically 16 inches by 16 inches in plan. The north-south spacing between the piers is approximately 9 feet 8 inches, while the east-west pier spacing is not regular, ranging from 15 feet 2 inches at the center of the building to approximately 7 feet at the west end of the building. The piers along the perimeter of the building are largely constructed of brick masonry, with the exception of three piers at the center of the west elevation, which are constructed of concrete masonry units (refer to Figure 29 and Figure 30). While the brick piers appear historic, it is not known if they date to the construction of the building or were added at a later date. The piers beneath the interior of the building are typically constructed of concrete masonry units (Figure 31). It is unknown when the concrete masonry unit piers were added to the building.

FIGURE 30. Piers constructed of concrete masonry units at the west elevation.

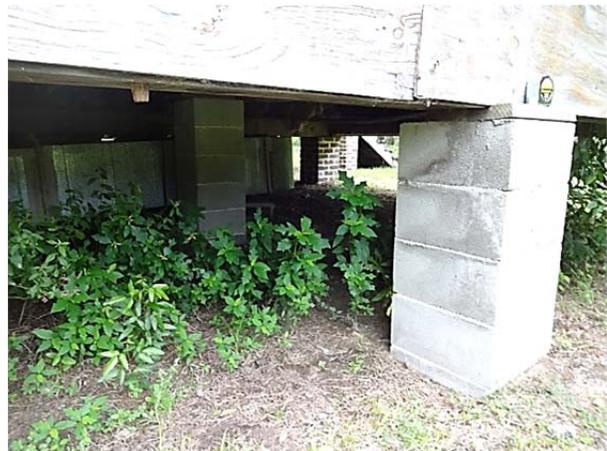
FIGURE 31. The piers beneath the interior of the building are constructed of concrete masonry units.

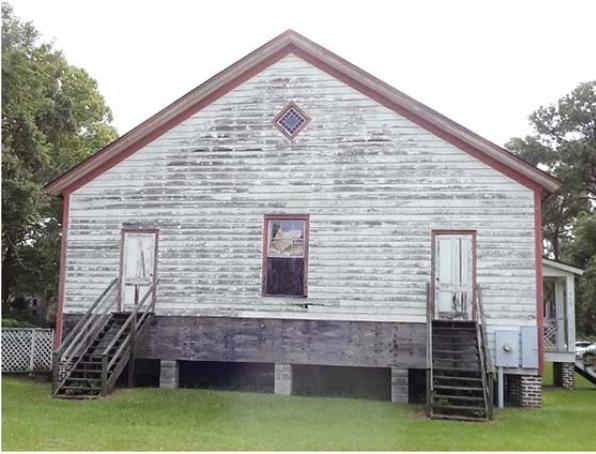
The lower portion of the west elevation is clad with plywood (Figure 37). The plywood cladding extends from the north end of the elevation to the south door. The plywood is present only below the sills of the doors.

FIGURE 37. Plywood cladding at the base of the west elevation.

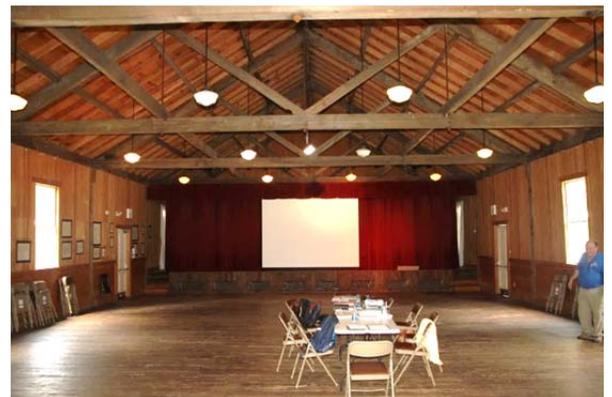
FIGURE 89. Interior of Darrah Hall looking west toward the stage.

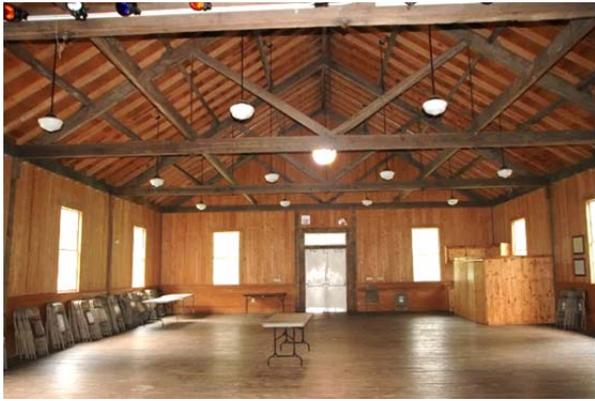
FIGURE 90. Interior of Darrah Hall looking east towards the main entrance.

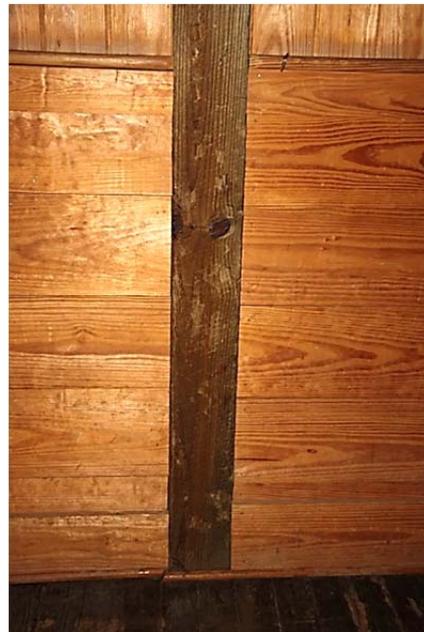
All the wood wainscot and wall cladding have a clear, semi-gloss finish and is in good condition generally (Figure 95). Early photos show the interior of Darrah Hall with exposed wall framing, so it is likely that wood cladding was installed during a 1990s renovation project when the building was initially insulated and air conditioned. However, there is very little documented information regarding the scope of work for that project.

FIGURE 95. Note the sheen of the clear finish on this wainscot.

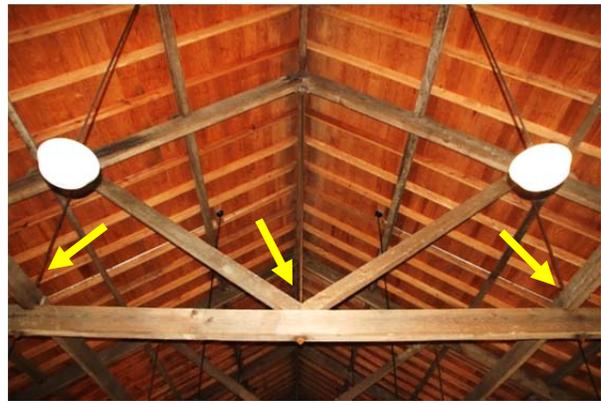
FIGURE 97. View of heavy timber trusses. Note steel rods at timber connections.

- The heavy timber trusses are character-defining elements of the interior. Although the wood has developed a patina, the members appear to be sound.
- Vertical steel rods tie together the timber connections of the trusses. Rust has developed on the rods, particularly on the bottom ends where there are nuts and washers.

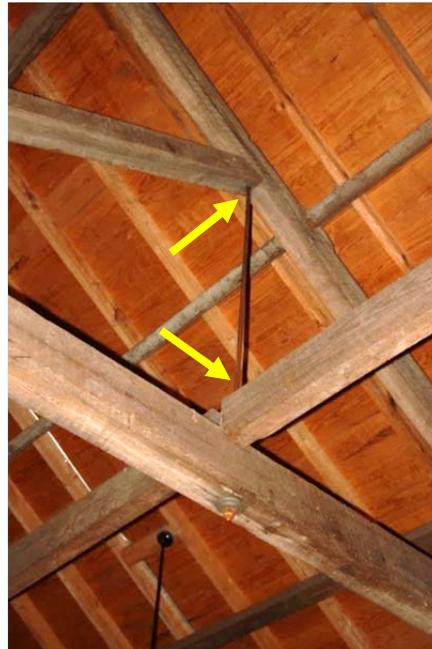
FIGURE 98. Steel rod at timber connections.

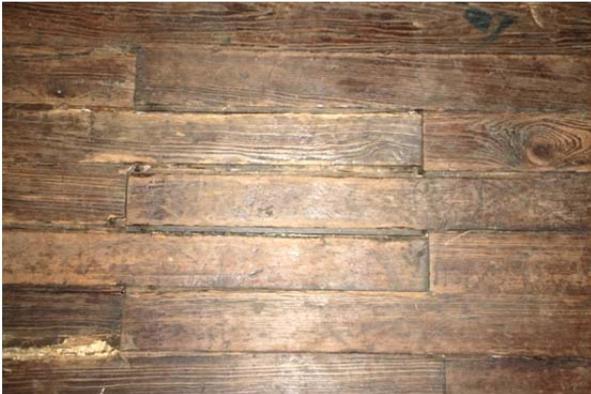
The Floor. Most of the existing 4-inch-wide wood flooring is original, and it appears to be heart pine with a medium brown stain (Figure 100). During the initial site visit in August 2017, Penn Center and National Park Service staff confirmed that a section of flooring was repaired and replaced. The date for the repairs was not specified. Newer floor boards were observed within an area from the base of the stage to the east about 11 feet and across the width of the building.

FIGURE 100. Flooring. Note medium brown color.

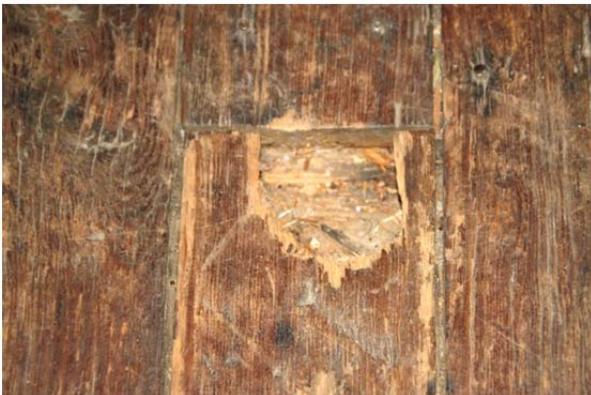
The original flooring is worn, with widespread cracks and splits and numerous holes and gouges (Figure 101). Previous attempts to patch some holes were observed (Figure 102).

FIGURE 101. Hole at the end of a floor board.

- The heart pine flooring is badly worn, with widespread cracks and splits and numerous holes and gouges. The joints between floorboards have widened.
- Vertical boards on the face of the raised platform / stage are discolored and marred, and the finish is worn off in numerous places.

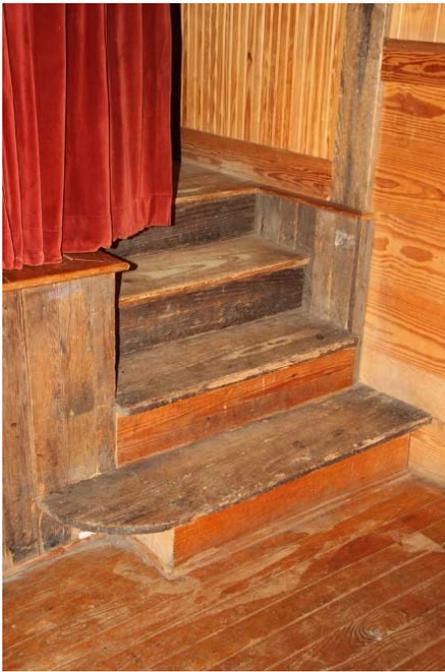
FIGURE 104. Steps up to the raised stage.

At the north and south ends of the platform there are steps up to the level of the stage. The steps are 2 feet 11 inches wide and have three treads and four risers (Figure 104). There are no handrails at either set of steps. Flooring on the raised platform / stage is the same as it is in the main space.

- Steps on the north and south ends of the stage are badly worn. Some treads have split and some nosings have splintered. There are no handrails.
- From the interior, the windows are in fair condition and exhibit minor deterioration. Also see above for a further condition assessment of windows on the exterior.

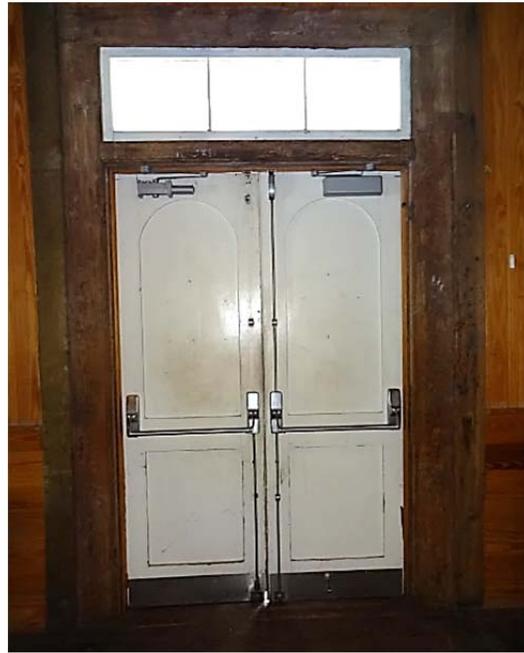
FIGURE 105. Main entrance doors with arched top panel

- Window locks are present, but there are no lift handles on the lower sashes.
- The pair of doors at the main entrance is in fair condition because it is protected from the weather by the east porch. Door hardware and locks may need to be replaced soon.

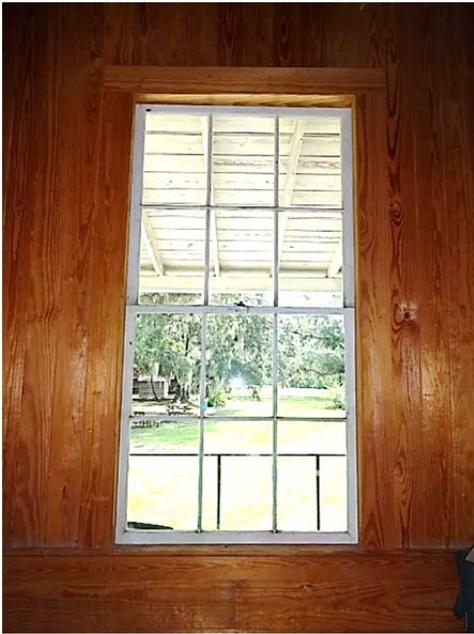
From inside, the six-over-six, double-hung, wood windows are in fair condition. Brass window locks are present, but there are no lift handles. At the time of the site visit, it was not determined if all the windows were operable (Figure 107). Further discussion of these windows is provided at the beginning of this this section.

FIGURE 107. Typical wood, double-hung window from inside.

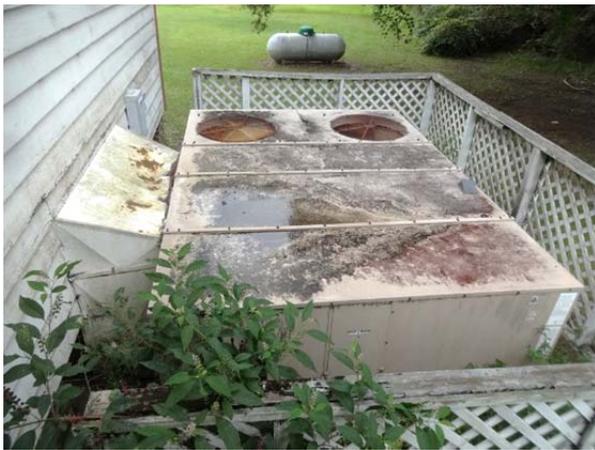
Mechanical and Electrical Systems. The current heating, ventilation, and air conditioning system (HVAC) is old and inefficient. It consists of a 1975 vintage, 15-ton York package unit next to the porch on the north side of the building. Propane gas is supplied by a tank which sits near the northwest corner of the building. Insulated supply ducts are routed under the building to floor registers inside Darrah Hall (Figure 112, Figure 113, and Figure Figure 114). Return air is pulled under the stage through damaged metal grilles in the vertical face of the platform (Figure 115). It could not be determined whether the space under the stage is a return air plenum or if there are return air ducts that run back to the outside HVAC package unit. Current codes would not allow the space under the stage to be a return air plenum.

FIGURE 112. HVAC package unit and propane gas tank beyond.

- The mechanical system is old and inefficient. It may not continue to operate for much longer.
- Ducts in the crawlspace are on the ground and can be inundated during heavy rains and flash flooding on St. Helena Island. Some duct insulation is torn and missing.

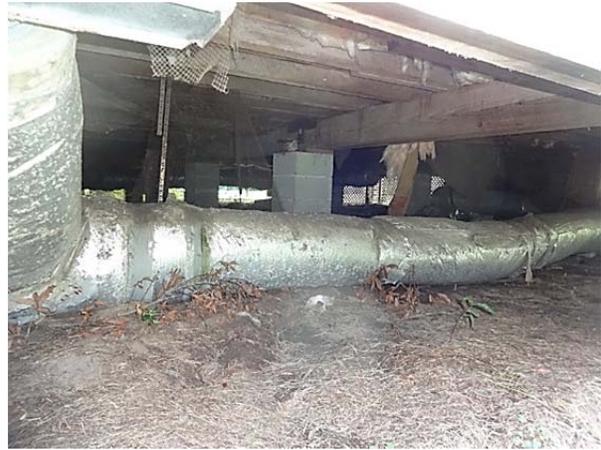
FIGURE 113. HVAC ducts in the crawlspace under Darrah Hall.

Main ducts in the crawlspace under the building are lying on the ground and duct insulation is deteriorated or missing. Dirt and small debris have accumulated in the floor registers and the grills are rusted and damaged (refer to Figure 114). Controls are limited to a single thermostat, and it is not known if the HVAC system runs on a schedule in order to maintain a consistent temperature and control humidity levels or if the system is only in operation when Darrah Hall is occupied (Figure 116). Operating the system intermittently or not at all for periods of time will eventually be detrimental to the historic materials in the building.

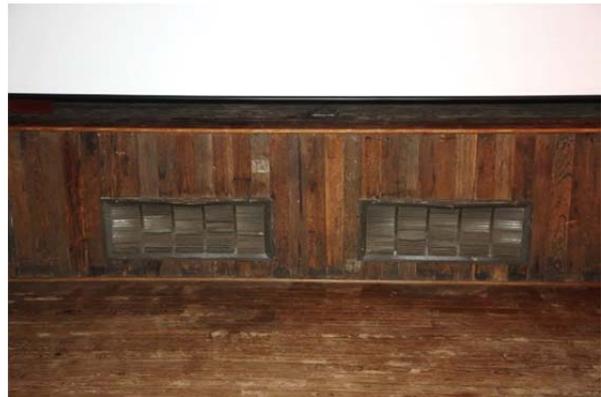
FIGURE 115. Metal return air grilles in the vertical face of the stage.

- HVAC supply and return air grilles are damaged and rusted.
- Batt insulation under the floor has fallen and some is missing.
- The electrical system seems adequate for now, but will require planned upgrades to accommodate new HVAC equipment and controls and modern electronic devices as this new park expands its programs.

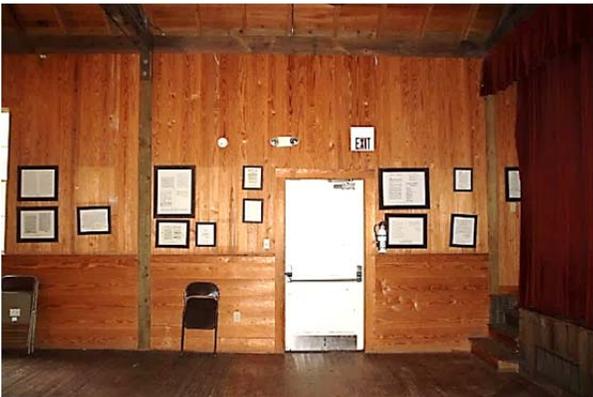
FIGURE 121. Exit sign, emergency light and smoke detector above south door.

Basic life safety requisites are addressed by illuminated exit signs and battery-powered emergency lights above the main entrance and doors on the north and south sides of the main interior space (Figure 121 and Figure 122). There are no exit signs or emergency lights near the two doors in the west wall at the back of the stage. Some of the emergency lights are broken, and they

- Current life safety measures are outdated and may no longer comply with current codes.
- All existing devices like illuminated exit signs, battery-operated emergency lights, and smoke and fire detectors should be tested for proper operation. A few of these devices are broken and should be repaired or replaced.
