TUGBOAT *HERCULES*

Historic Structure Report

1990

Prepared by
Tri-Coastal Marine, Inc.
200 Burrows Street
San Francisco, California 94134

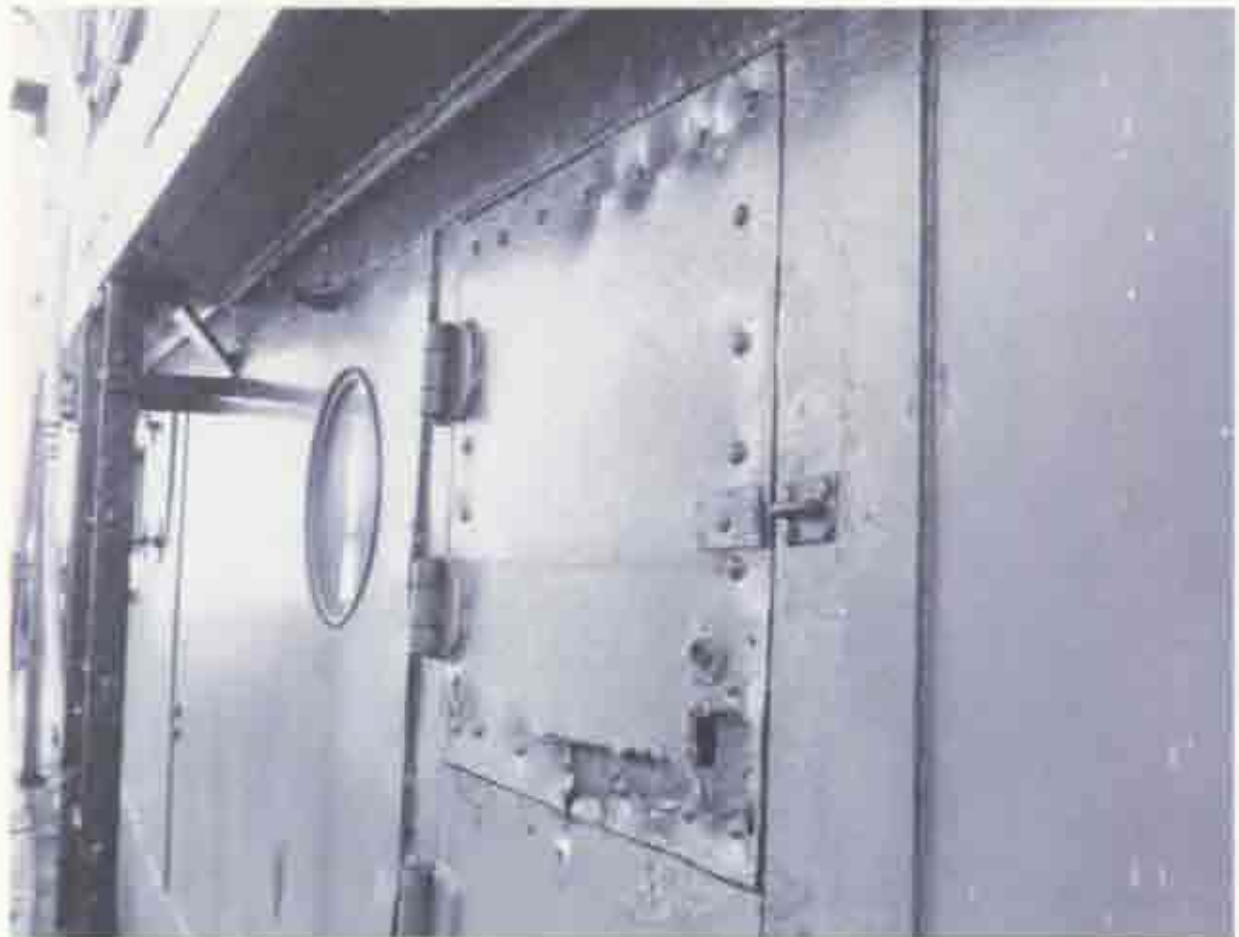
Photo: Tri-Coast Marine

Fig. 21. Wastage typical of that seen in local areas of HERCULES' deckhouse.

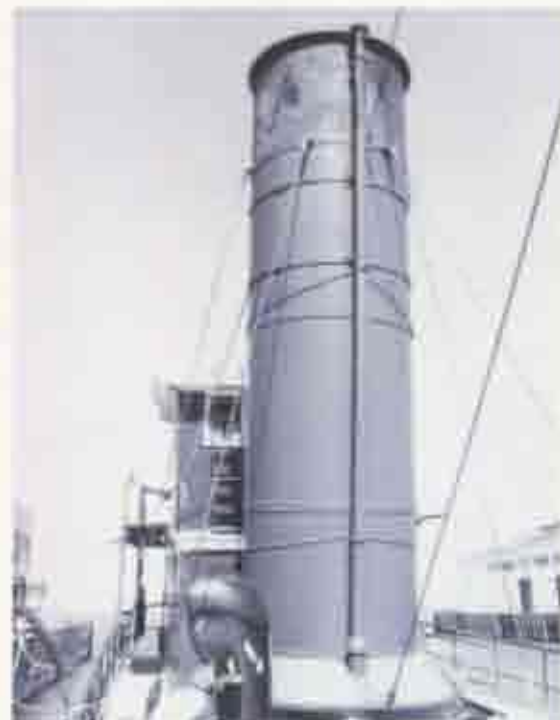
Photo: Tui Coastal Marine

Fig. 25. The smoke stack as viewed from aft. The stack has been rebuilt at least once during HERCULES' working life, as evidenced by a combination of welded and riveted construction, but retains its original form. The tall stack is a significant feature of steam tugs.

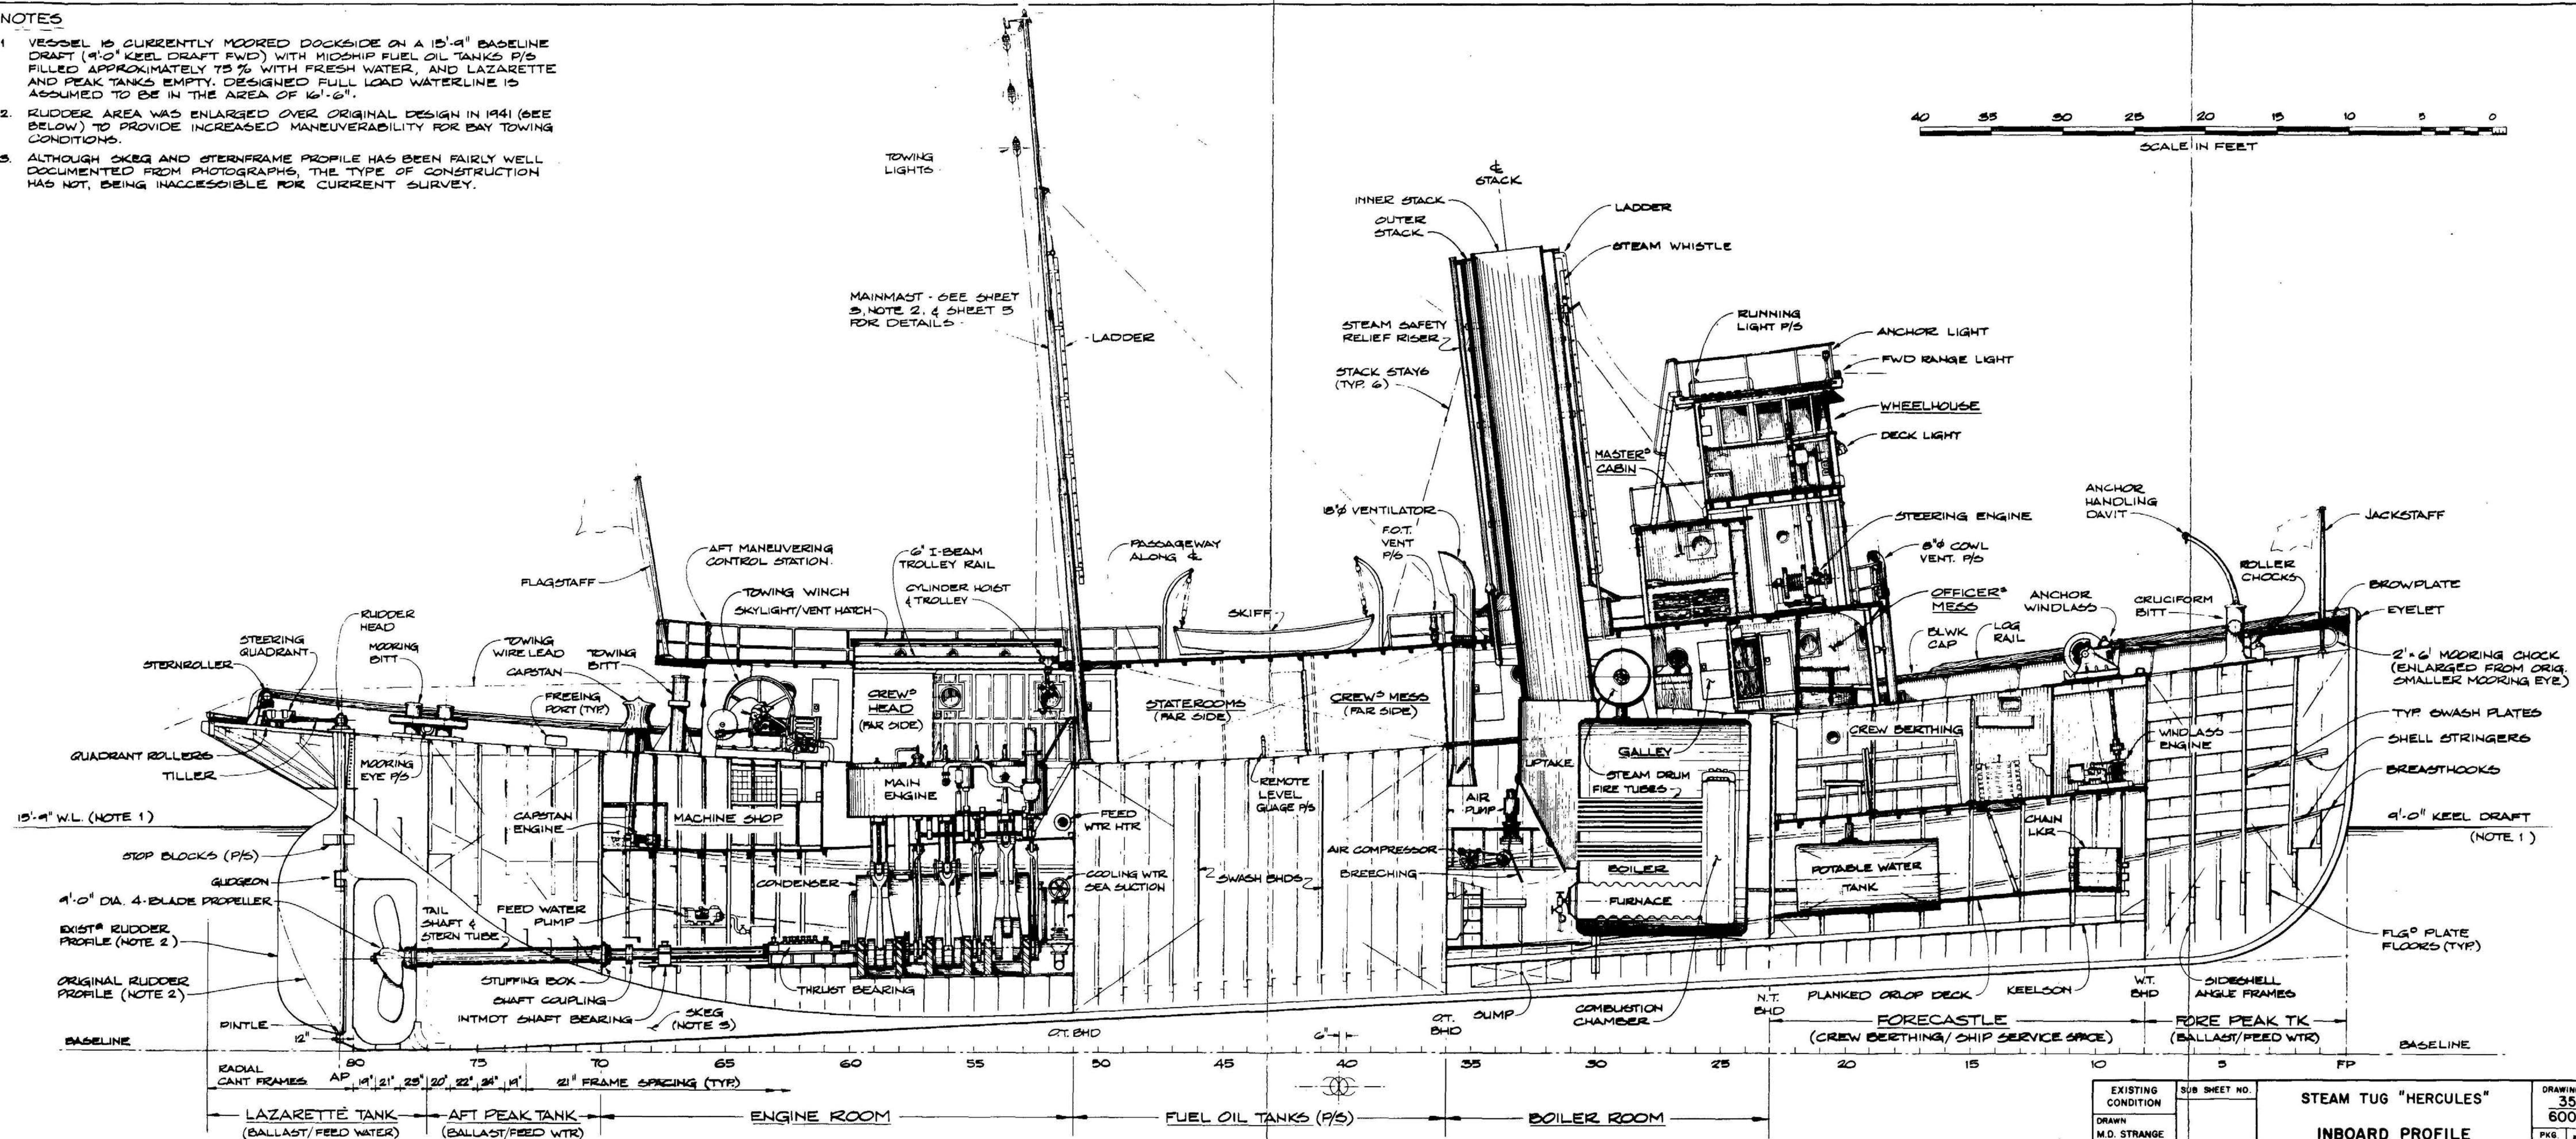
EXISTING CONDITION	SUB SHEET NO.	STEAM TUG "HERCULES"	DRAWING NO. 350
DRAWN M.D. STRANGE		INBOARD PROFILE	60000
TECH. REVIEW D. BIRKHOFF		SAN FRANCISCO MARITIME NATIONAL HISTORICAL PARK	PKG. NO. SHEET 2
DATE 12/89			OF 5

1. VESSEL IS CURRENTLY MOORED DOCKSIDE ON A 15'-9" BASELINE DRAFT (9'-0" KEEL DRAFT FWD) WITH MIDSHIP FUEL OIL TANKS P/S FILLED APPROXIMATELY 75% WITH FRESH WATER, AND LAZARETTE AND PEAK TANKS EMPTY. DESIGNED FULL LOAD WATERLINE IS ASSUMED TO BE IN THE AREA OF 16'-6".
2. RUDDER AREA WAS ENLARGED OVER ORIGINAL DESIGN IN 1941 (SEE BELOW) TO PROVIDE INCREASED MANEUVERABILITY FOR BAY TOWING CONDITIONS.
3. ALTHOUGH SKEG AND STERNFRAME PROFILE HAS BEEN FAIRLY WELL DOCUMENTED FROM PHOTOGRAPHS, THE TYPE OF CONSTRUCTION HAS NOT BEEN ACCESSIBLE FOR CURRENT SURVEY.

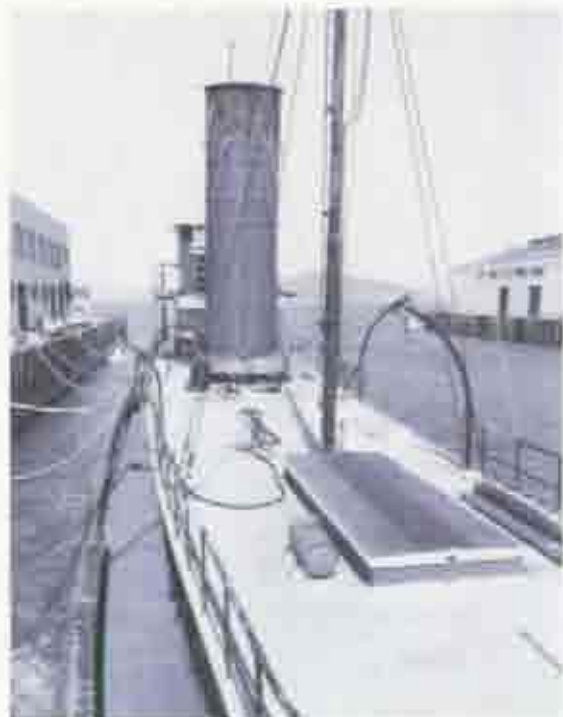
Photo: TUG-Costal Marine

Fig. 26. Boat deck, looking forward from port side, 1989. The lifboat and skiff normally stowed here have been removed to Museum storage.
